Post-buckling damage tolerance of welded omega-stiffened thermoplastic panels with initial damage

van Dooren, Kevin; Bisagni, Chiara

Composite Structures

Delft University of Technology, Faculty of Aerospace Engineering, Delft, The Netherlands

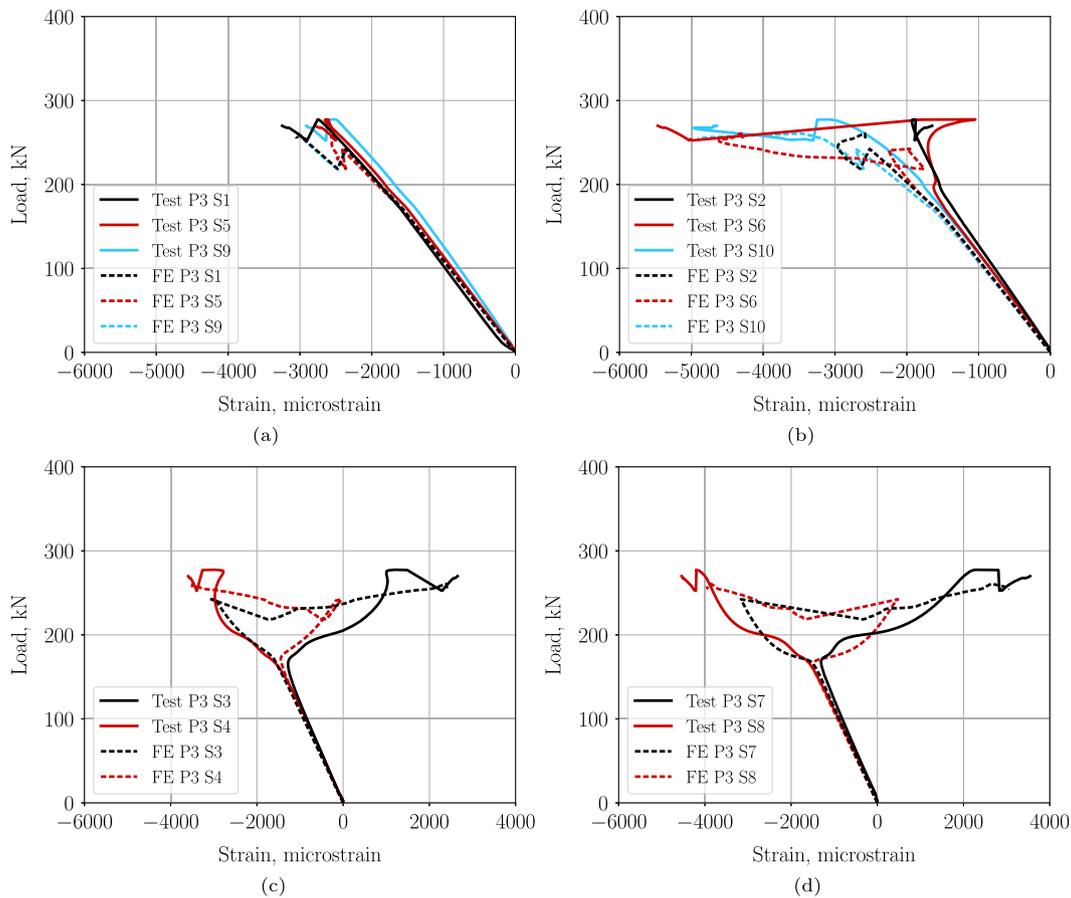
Fig. 29. Experimental and numerical compressive strains of the panel 3: (a) caps; (b) skin under stringer; (c) bay 1; (d) bay 2.

The strains on the caps of the panels are reported in Fig. 29(a). It is seen that there might be a small loading imperfection, and a load drop due to a skin-stringer separation event. The strains underneath the stringer are reported in Fig. 29(b). Before buckling a minor difference in strains can be seen in the skin, indicating a small loading imperfection. After buckling the strains diverge, with large strain changes in the

post-buckling field. These large changes are caused by the skin-stringer separation event, which also leads to a load drop.

The strains in bay 1 start to diverge immediately after buckling, and show jumps in strain due to the skin-stringer separation event, as reported in Fig. 29(c). The numerical analysis predicts similar behaviour initially, although with opposite bending component, and larger jumps in strain in the post-buckling field. The strains in bay 2 present a high bending component in the post-buckling field, as reported in Fig. 29(d). A strain jump occurs due to the skin-stringer separation event, with S7 also presenting an increase in strains just before the separation event. The numerical analysis predicts an opposite bending component with larger jumps of strain in the post-buckling field due to the skin-stringer separation event.

The post-buckling strains underneath the stringer and in the bays are highly affected by the buckling shape (Figs. 19, 24, 29 and 35), which in turn can be affected by the location of the initial damage. Each damaged configuration shows different behaviour due to the

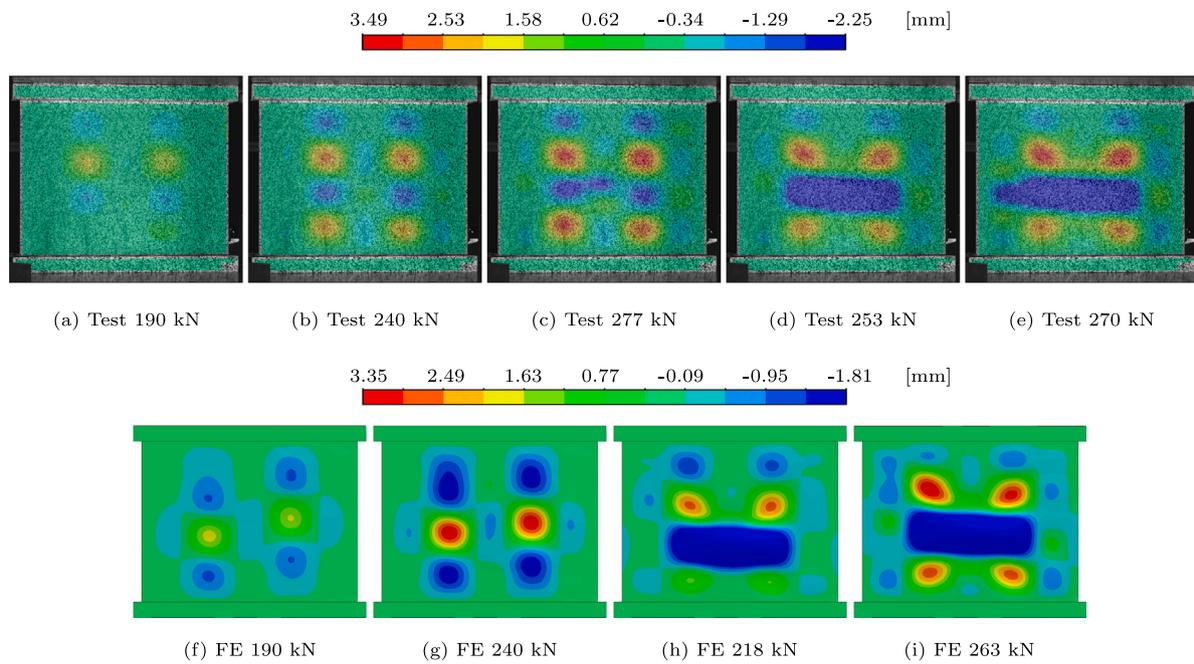
Fig. 30. Experimental (a-e) and numerical (f-i) out-of-plane displacement of panel 3.

Panel 3 shows a four half-wave initial buckling shape, with the fourth half-wave barely visible in bay two, as reported in Fig. 30. At higher load levels the fourth half-waves become more prominent. At 277 kN the initial damage opens, with the outward half-waves in the bay and underneath the stringer connecting. After the skin-stringer separation event there is large out-of-plane displacement in the middle of the panel, due to the separation between skin and stringer. At 270 kN, just before final failure, the large half-wave in the middle of the panel grows towards the side of the panel. The numerical analysis predicts a three half-wave buckling shape, with an anti-clockwise skew in terms of half-wave position. At 218 kN, after the skin-stringer separation event, a large area of high out-of-plane displacement is seen, similar to the test results. At 263 kN the area of high out-of-plane displacement has moved upwards, indicating separation growth in an upwards direction.

(Figs. 25, 30 and 36), while the pristine panel endured a sudden jump from three to four half-waves (Fig. 20). The initial damage locations appear to “attract” the half-waves and the opening of the initial damage can be seen from the DIC measurement. The opening seems to grow, indicating that stable separation occurs followed by unstable skin-stringer separation. Indications of stable separation can be heard from the GoPro footage of all panels with initial damage, and most notable on the footage of panel 3. The fracture surface of panel 3 also showed lighter areas around the damage location, indicating stable separation growth (Fig. 33). It is however difficult to determine how much separation growth occurs before final failure, without utilizing other measurement techniques more specifically for capturing damage growth.

The numerical analysis has difficulty predicting the influence of the initial damage on the buckling shape (Figs. 20, 25, 30 and 36). Instead of predicting four half-waves, the three half-wave buckling shapes show longer half-wave lengths, for the outwards half-waves close to the locations with initial damage. These structures are highly sensitive to imperfections, and the difference between test and analysis might be caused by how, and which imperfections are included in the

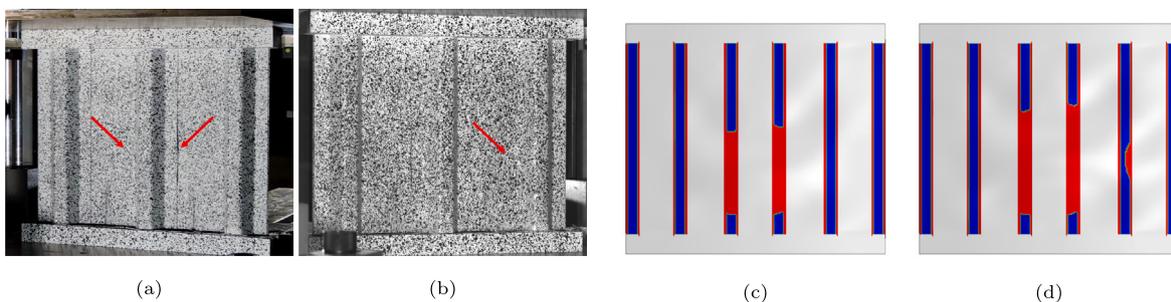
Fig. 31. Comparison of failure behaviour of panel 3: (a) start of failure during test; (b) propagation of failure during test; (c) start of failure in analysis; (d) propagation of failure in analysis.

Panel 3 endured a skin-stringer separation event of the middle stringer, which did not lead to panel collapse, as reported in Fig. 31(a). The event started with stable crack growth, heard on the GoPro camera footage, for approximately 15 s. This stable crack growth seems to

occur at the initial damage in the middle of the panel, as DIC measured an increase in out-of-plane displacement at this location. The stable crack growth is followed by unstable crack growth that results in a large separated area. After loading continued, final failure occurred

with further separation of the middle stringer, followed by separation of the right stringer, as reported in Fig. 31(b). Similar behaviour is predicted by the numerical analysis, as reported in Fig. 31(c-d). Both flanges of the middle stringer separate initially, and final failure starts by separation of the right stringer.

All panels fail due to skin-stringer separation. Panel 3, with two initial damages, showed a skin-stringer separation event of the middle stringer, where both welds separated approximately from the bottom to the top damage (Fig. 31). This, however, did not lead to stringer failure, and the panel collapsed due to skin-stringer separation after more load was applied.

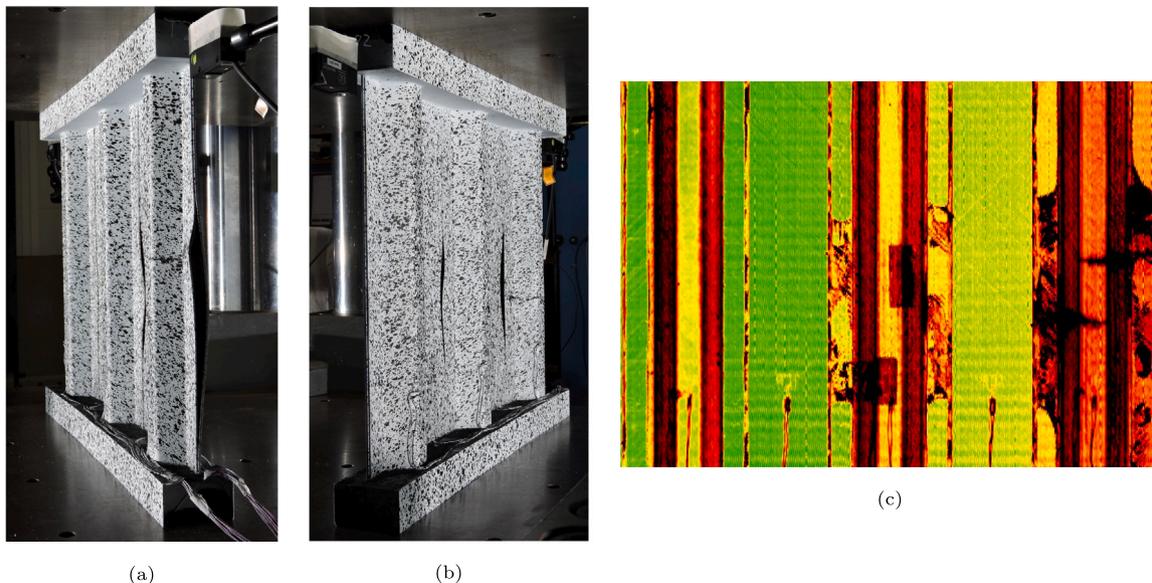
Fig. 32. Post-failure of panel 3: (a) photo right side; (b) photo left side; (c) c-scan.

The post-failure state of panel 3 is reported in Fig. 32(a-b-c). The middle and right stringer present large separated areas, with the right stringer having the largest separated area. The right stringer also presents two fractures across the stringer, in the middle of the panel. All flanges which have separated also have delaminations of the stringer flanges. The left stringer has no visible separations and no material damage.

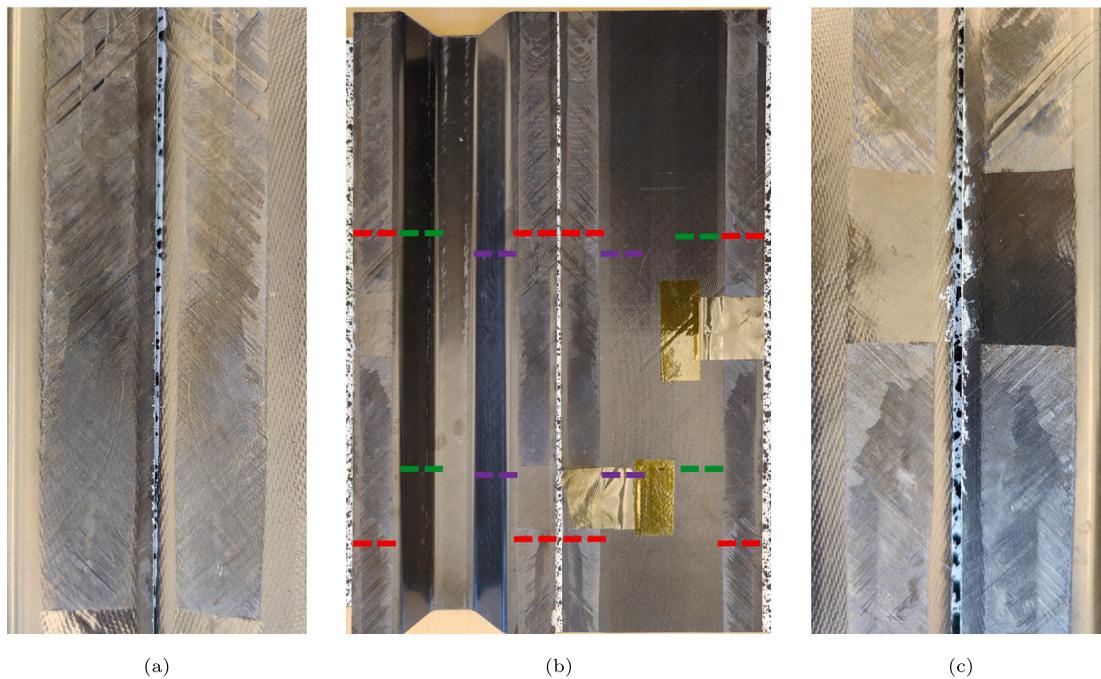
Fig. 33. Fracture surface of welds of middle stringer of panel 3; (a) close-up of the area between purple dashes; (b) fracture surfaces of middle stringer, with the stringer and skin on the left and right side respectively, with red dashes indicating the area that separated in the test; (c) close-up of the area between green dashes.

After the test, the middle stringer of panel 3 is removed to investigate the fracture surfaces of the failed welds. The weld can be distinguished by the rough surface with visible fibres Fig. 33(b). The area in between the red dashes corresponds to the area that separated during the test. The two yellow foils of the initial damage are visible on the skin, while on the stringer two smooth areas can be seen that correspond to the same initial damage locations. The areas in between the purple and green dashes are highlighted in Fig. 33(a) and (c), respectively. The skin is mostly intact in the area that separated in the test, with limited fibre pullout and no obvious delaminations. The stringer has a few locations with delaminations, and small pieces of the stringer ply remain on the skin. The bottom 0 ply of the stringer is visible in a few small areas where the bottom 45 ply has delaminated.

On the fracture surfaces, lighter and darker areas can be identified. There are lighter areas around the middle initial damage and the

opposite weld, with an elliptical shape. These areas correspond to the location where DIC measured higher out-of-plane displacement before the first separation event. This might indicate that the lighter areas are caused by stable crack growth, while the darker areas are due to unstable crack growth.

On the fracture surface on the opposite side of the middle initial damage, next to the elliptical lighter area associated with the stable crack growth, dark elliptical marks can be seen. These markings indicate crack growth with an elliptical crack front shape. The crack growth seems to go in a sideways direction towards the bay and a downward direction towards the second initial damage location.

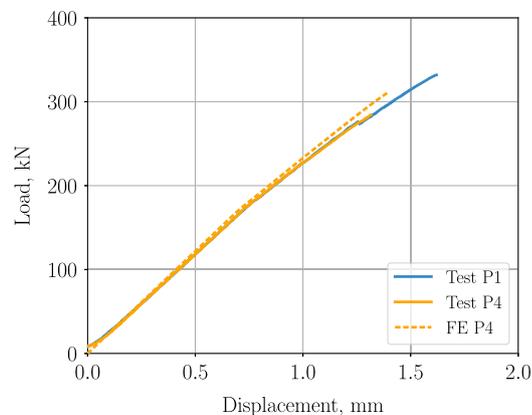
Fig. 34. Load-displacement curves from tests and numerical analysis of panel 4.

The load–displacement behaviour of panel 4 is reported in Fig. 34. Panel 4 has an approximate stiffness of 236 kN/mm before buckling. It buckles at a load of 177 kN and fails at a load of 284 kN. This is a reduction of 14.5% in comparison to the pristine panel failure load. The numerical analysis over-predicts the failure load by 9.3%, which is the largest difference between numerical results and test results of all panels. This might be due to the location of the damage, which is in one of the side stringers.

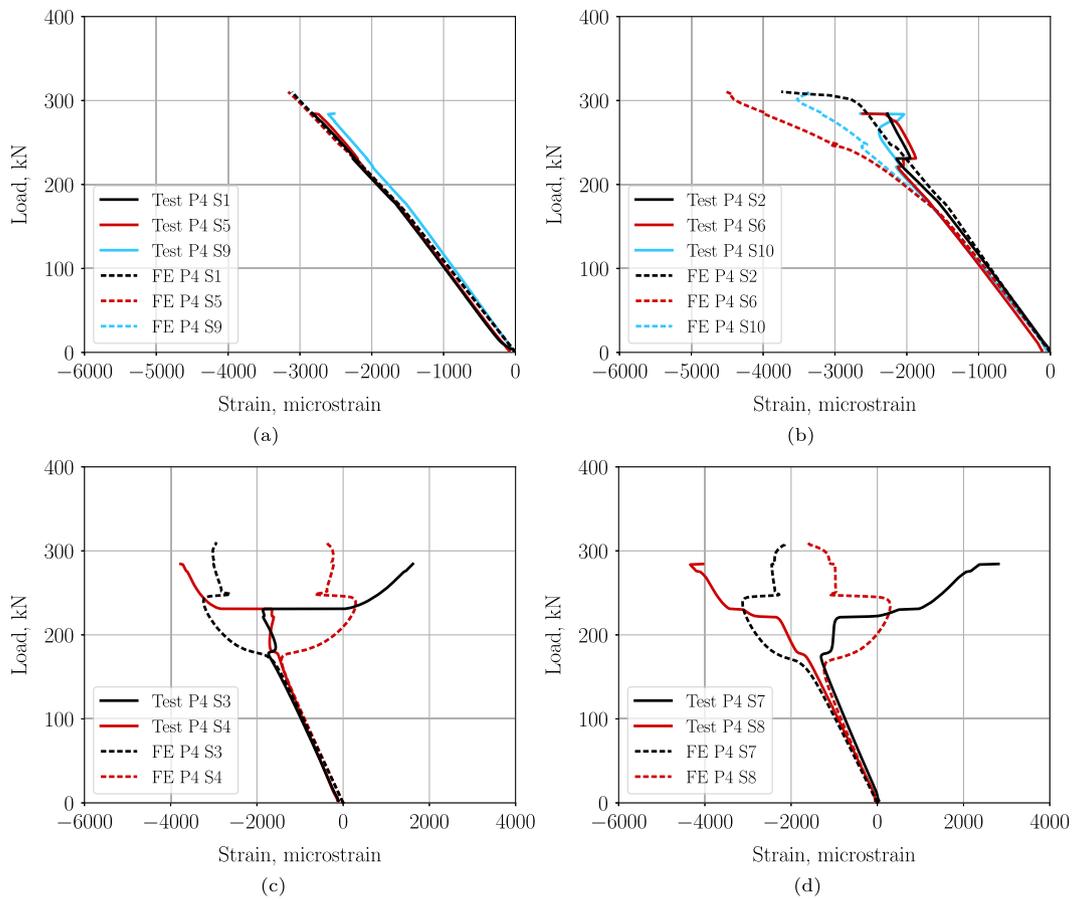
Fig. 35. Experimental and numerical compressive strains of the panel 4: (a) caps; (b) skin under stringer; (c) bay 1; (d) bay 2.

The strains of the stringer caps are reported in Fig. 35(a). They are comparable to the previous panels, with a small reduction in strains of S9 just before final failure. The strains under the stringers are reported in Fig. 35(b). In post-buckling they present jumps and divergent

behaviour due to buckling shape changes, and a sudden increase just before final failure.

The strains in bay 1 show convergent behaviour initially after buckling, as reported in Fig. 35(c). Then they suddenly diverge considerably with a large bending component. The numerical analysis predicts diverging strains immediately after buckling, with a jump in the post-buckling field. The strains in bay 2 present similar behaviour to bay 1, as reported in Fig. 35(d). In post-buckling, they present an initial small bending component, after which the strains diverge due to high bending levels. The numerical analysis predicts divergent strains at a lower load, indicating buckling in the bay starts at a lower load than the test.

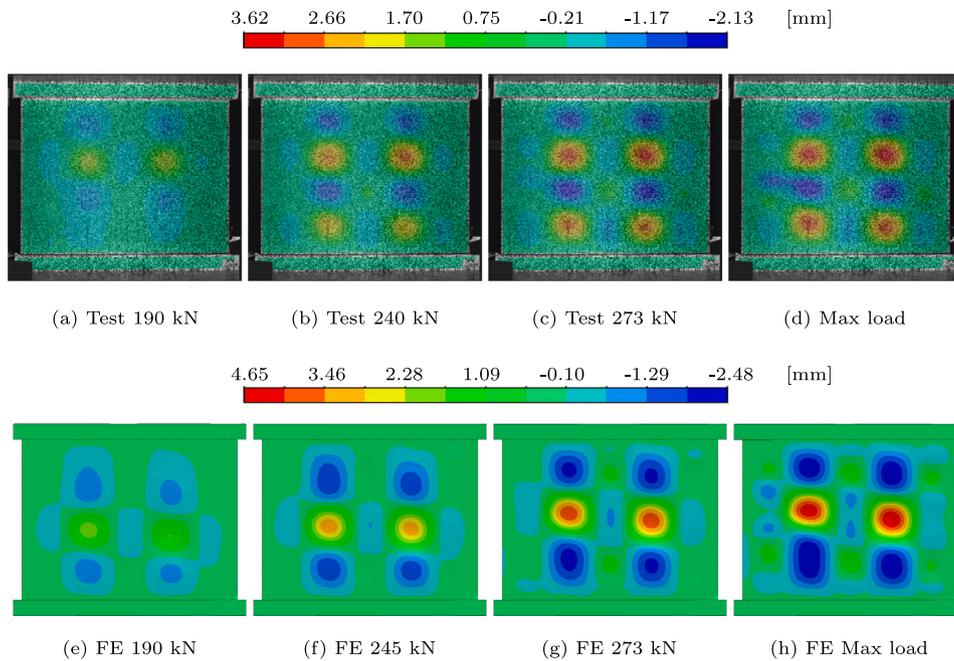
Fig. 36. Experimental (a–d) and numerical (e–h) out-of-plane displacement of panel 4.

The panel has an initial three half-wave buckling shape, with the half-waves positioned towards the top of the panel, as reported in Fig. 36. The bottom inwards half-waves have a higher half-wave length, and at higher loads the fourth half-waves appear at this position. At the maximum load the damage in the stringer opens, with inward half-waves connecting between the bay and underneath the stringer. The numerical analysis predicts a three half-wave buckling shape, with the

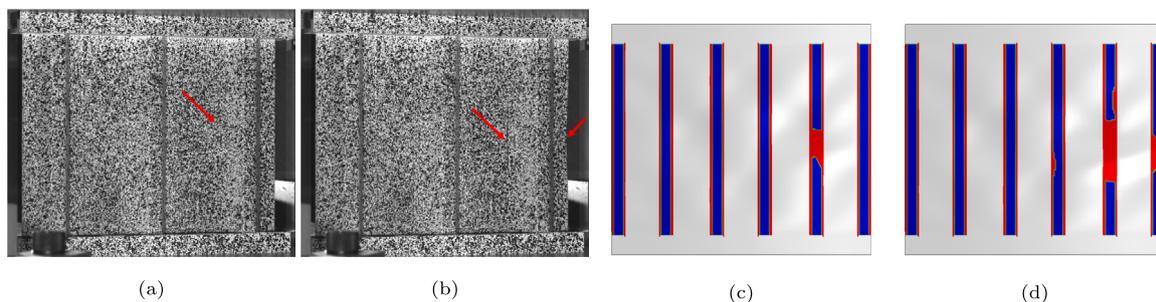
Fig. 37. Comparison of failure behaviour of panel 4: (a) start of failure during test; (b) propagation of failure during test; (c) start of failure in analysis; (d) propagation of failure in analysis.

The final failure is captured by the high-speed camera and starts in the left flange of the right stringer, where the initial damage is located, as reported in Fig. 37(a). This is followed by the separation of the right flange of the same stringer, Fig. 37(b). Before final failure occurs, a ticking sound can be heard on the GoPro footage, indicating stable separation. The numerical analysis predicts the same start location at the initial damage, Fig. 37(c). Then separation starts in the right flange of the right stringer and in the middle stringer's left flange, as reported in Fig. 37(d). This behaviour was not seen during the test.

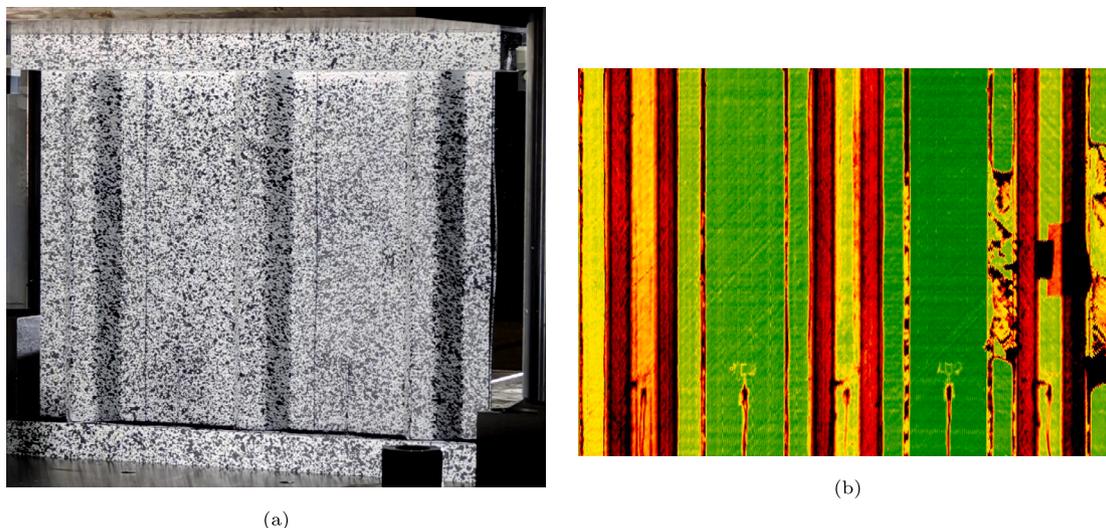
Fig. 38. Post-failure of panel 4: (a) photo; (b) c-scan.

The post-failure state of panel 4 is reported in Fig. 38(a-b). Only the right stringer has large separated areas, with a fracture in the right flange. The middle stringer welds present small separations at the inner weld edge, as the weld becomes slightly narrower in some areas.
