## Effect of salt spray ageing on the fracture of composite-to-metal bonded joints

Arouche, M.M.; Saleh, M.N.; Freitas, S. Teixeira de; Barros, S. de

International Journal of Adhesion and Adhesives

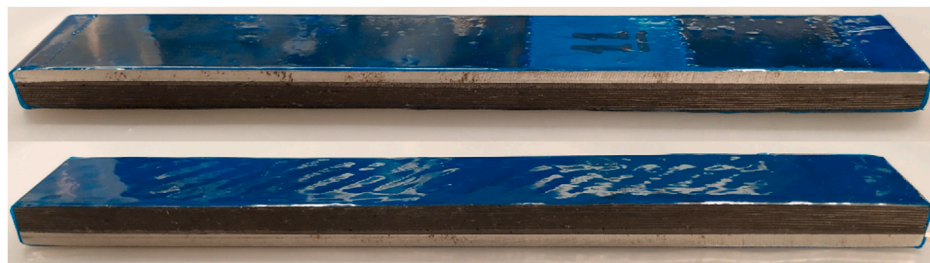
**Fig. 2.** A specimen prepared for ageing.

Specimens were placed for ageing in a salt spray chamber. A solution of 5% mass sodium chloride [NaCl] was atomized at 200 ml/h and 35 °C. The exposure zone remained in a relative humidity between 95% and 98% and pH between 6.5 and 7.2, according to the ASTM B117 standard practice [30]. Specimen's top and bottom surfaces were covered with a layer of tape to avoid degradation of the adherends as shown in Fig. 2.
