THE ROTTERDAM HARBOUR POLICE STATION

DAPHNE FAHRNER & DILETTA WESEL
VACANT HERITAGE | POLICE REAL ESTATE
MSc3/4 AR3AH105 | FALL 2021 -2022

This booklet is part of a graduation project of the studio Heritage & Architecture as a completion of the master programme Architecture, Urbanism and Building Sciences at the University of Technology in Delft. The graduation studio consists of a project for the Dutch Police. Due to changes in the working field, a part of their real estate needs to be redeveloped (Weessies, 2017). However, these police buildings, located throughout the Netherlands, deal with unique elements such as security fences and partially closed facades. This means that they cannot simply be regarded as ordinary real estate.

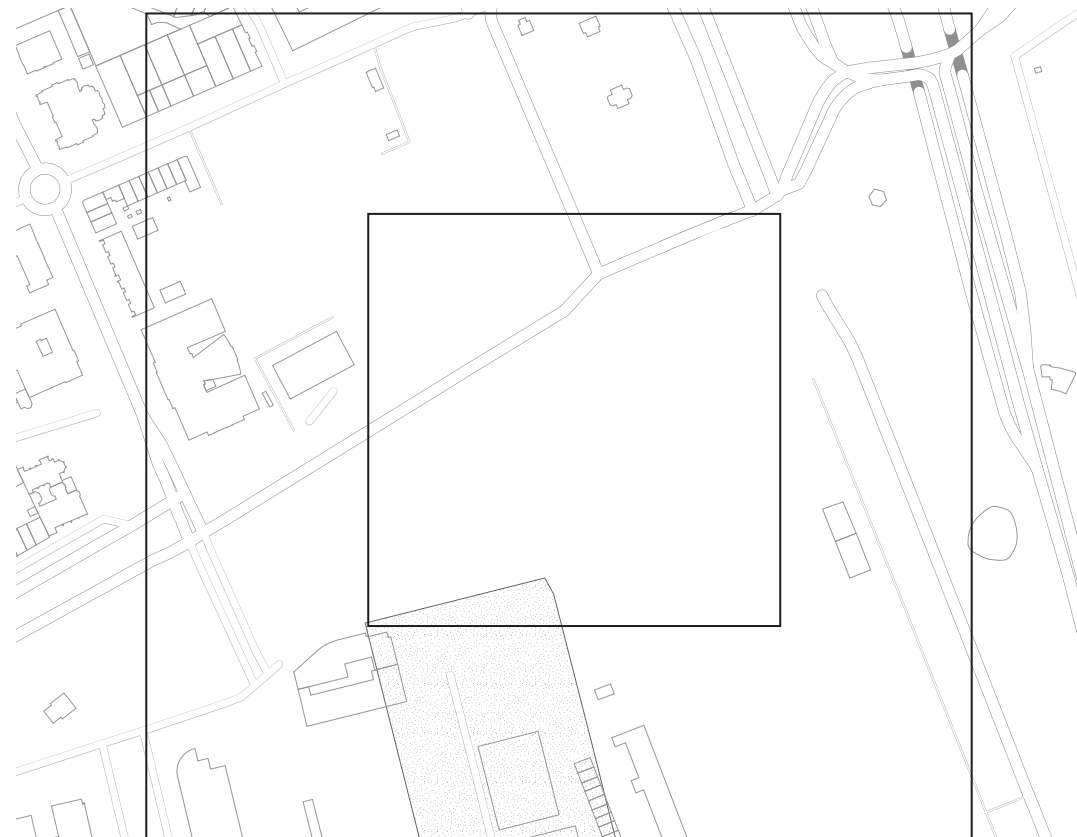
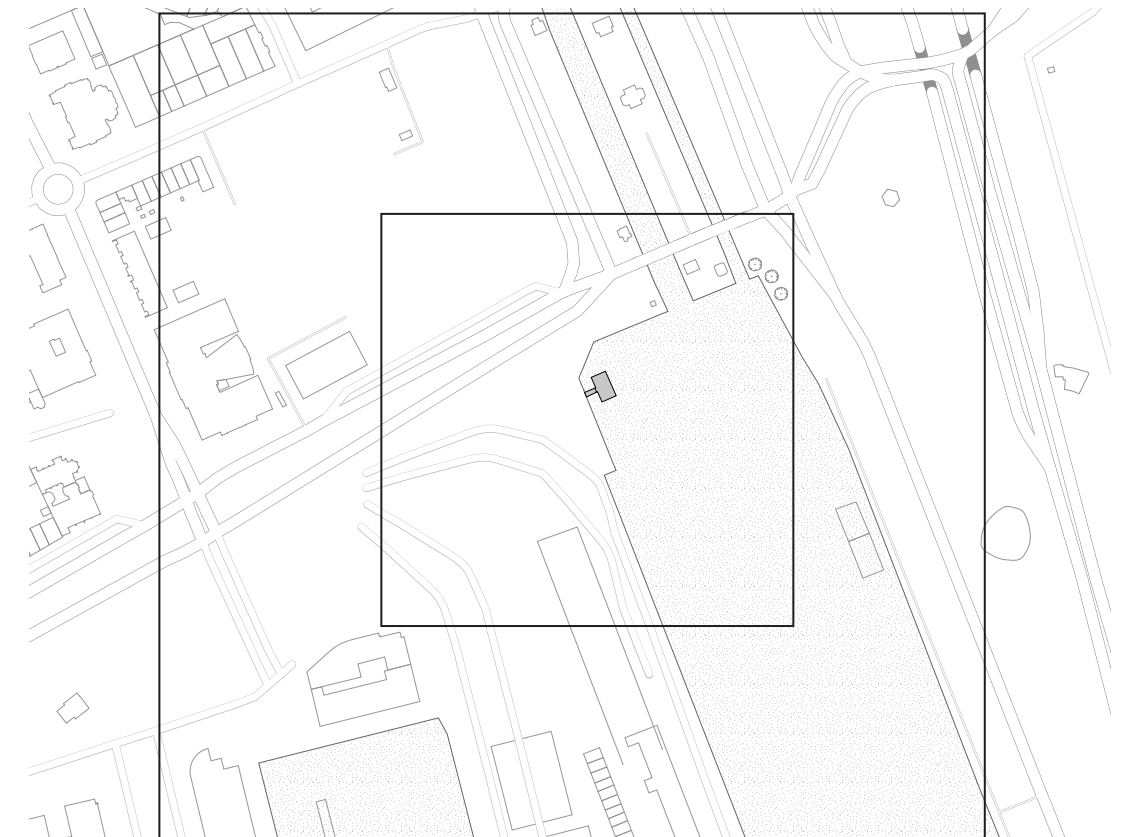
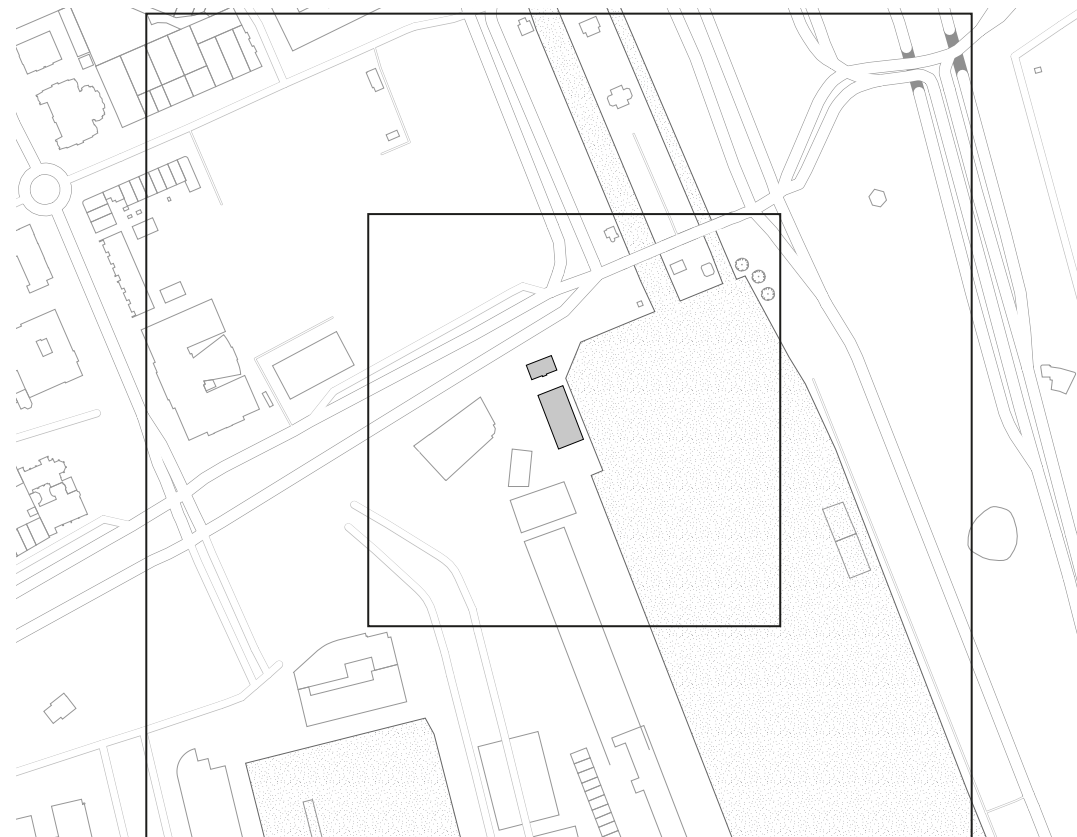
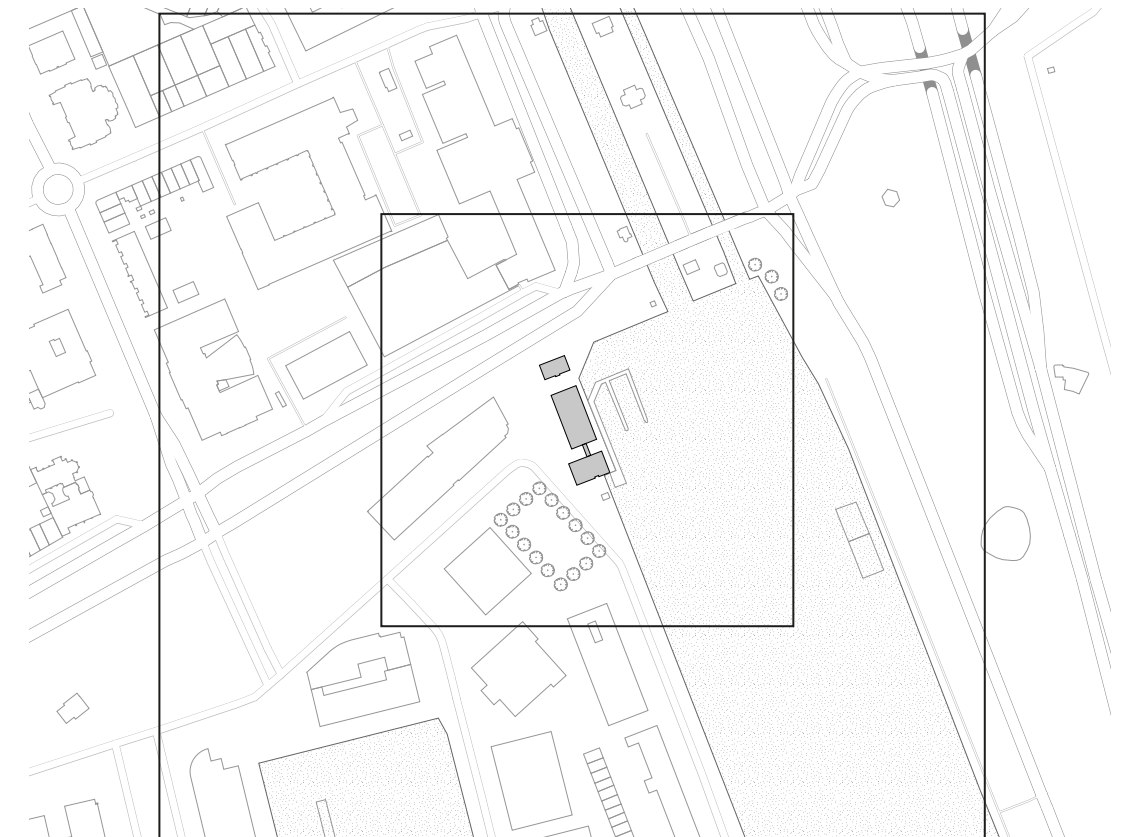
Fig. 4a: Parkhaven 1850 (Zijlstra et al., 2021–2022)

Fig. 4b: Parkhaven 1911 (Zijlstra et al., 2021–2022)

Fig. 4c: Parkhaven 1940 (Zijlstra et al., 2021–2022)

Fig. 4d: Parkhaven 1994 (Zijlstra et al., 2021–2022)

The Harbour Police Station is located in the neighbourhood Schiedam, bordering the Parkhaven. The lay-out of this harbour has been changed many times. However, in this urban area, the first harbour activities took place between 1850–1911 as shown in figure 4a and 4b (Kadaster, n.d.). In 1911 the (former called) River Police moved into their own residence on a floating pontoon in the Parkhaven (Kramer, 2014). In 1933 they got a new office on the quay at the Sint Jobsweg 6 (Manneke, 1995).

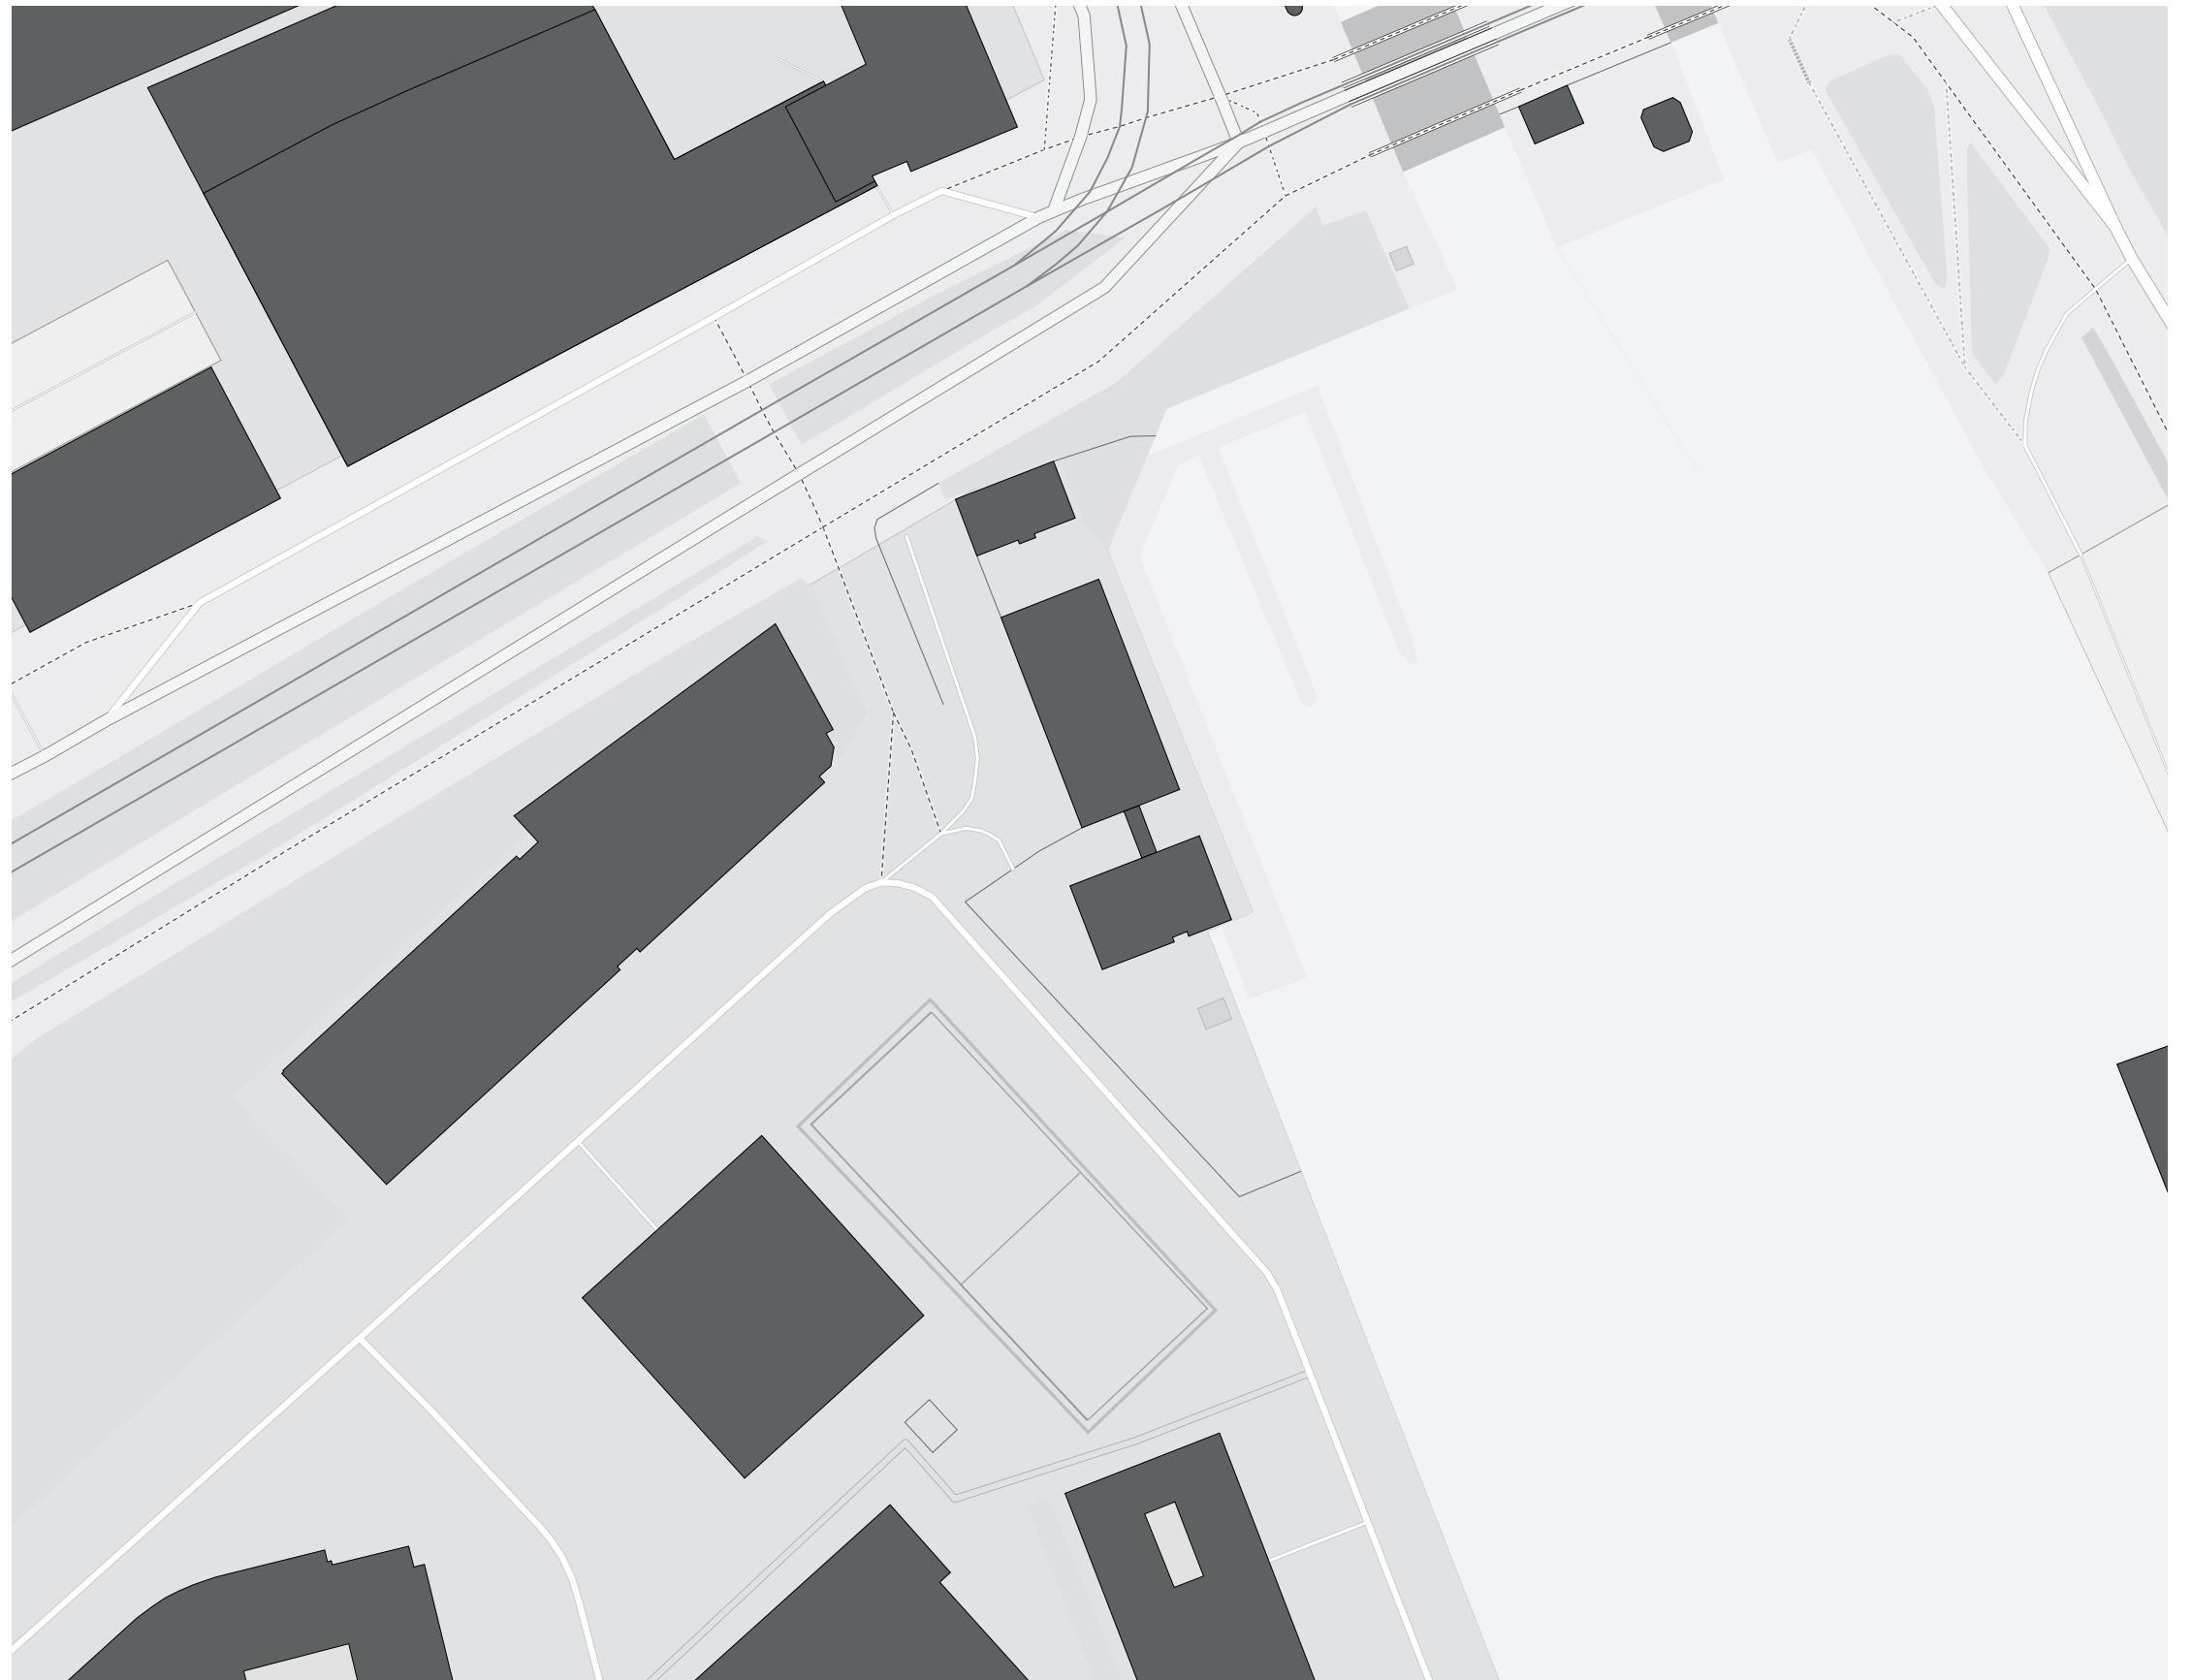
Fig. 17: Built and open spaces

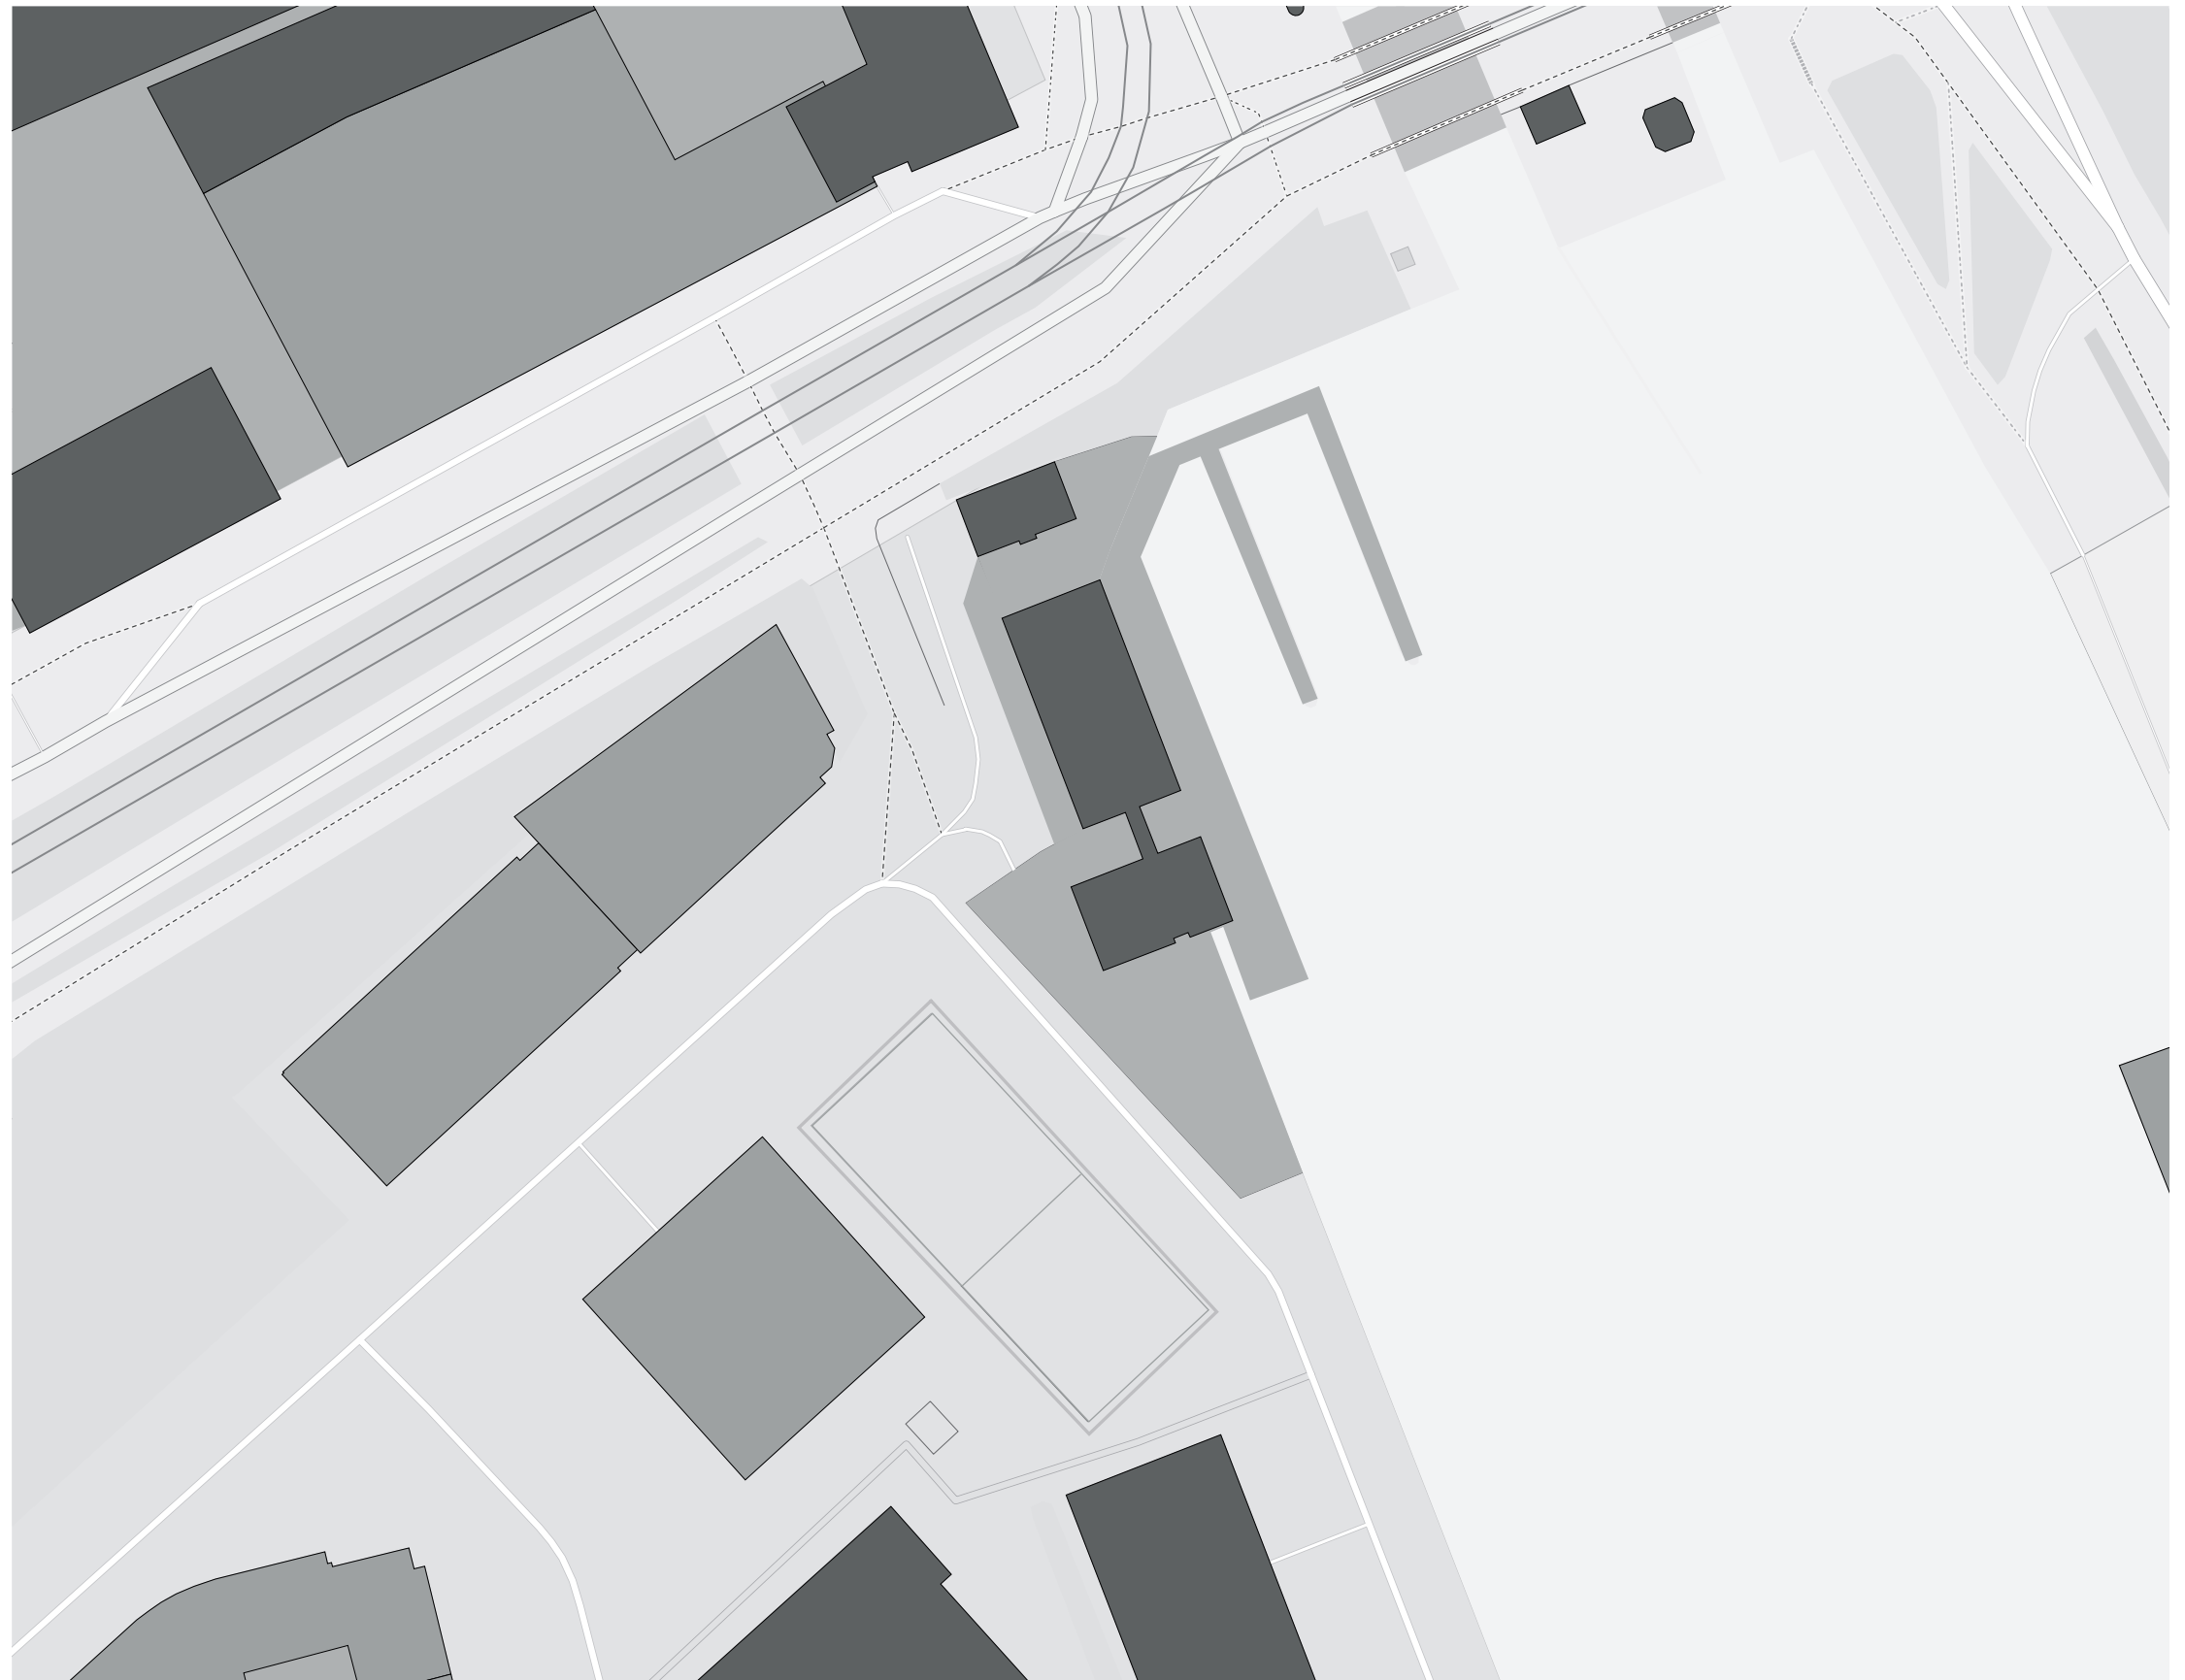
Fig. 18: Private, semi and public buildings and areas

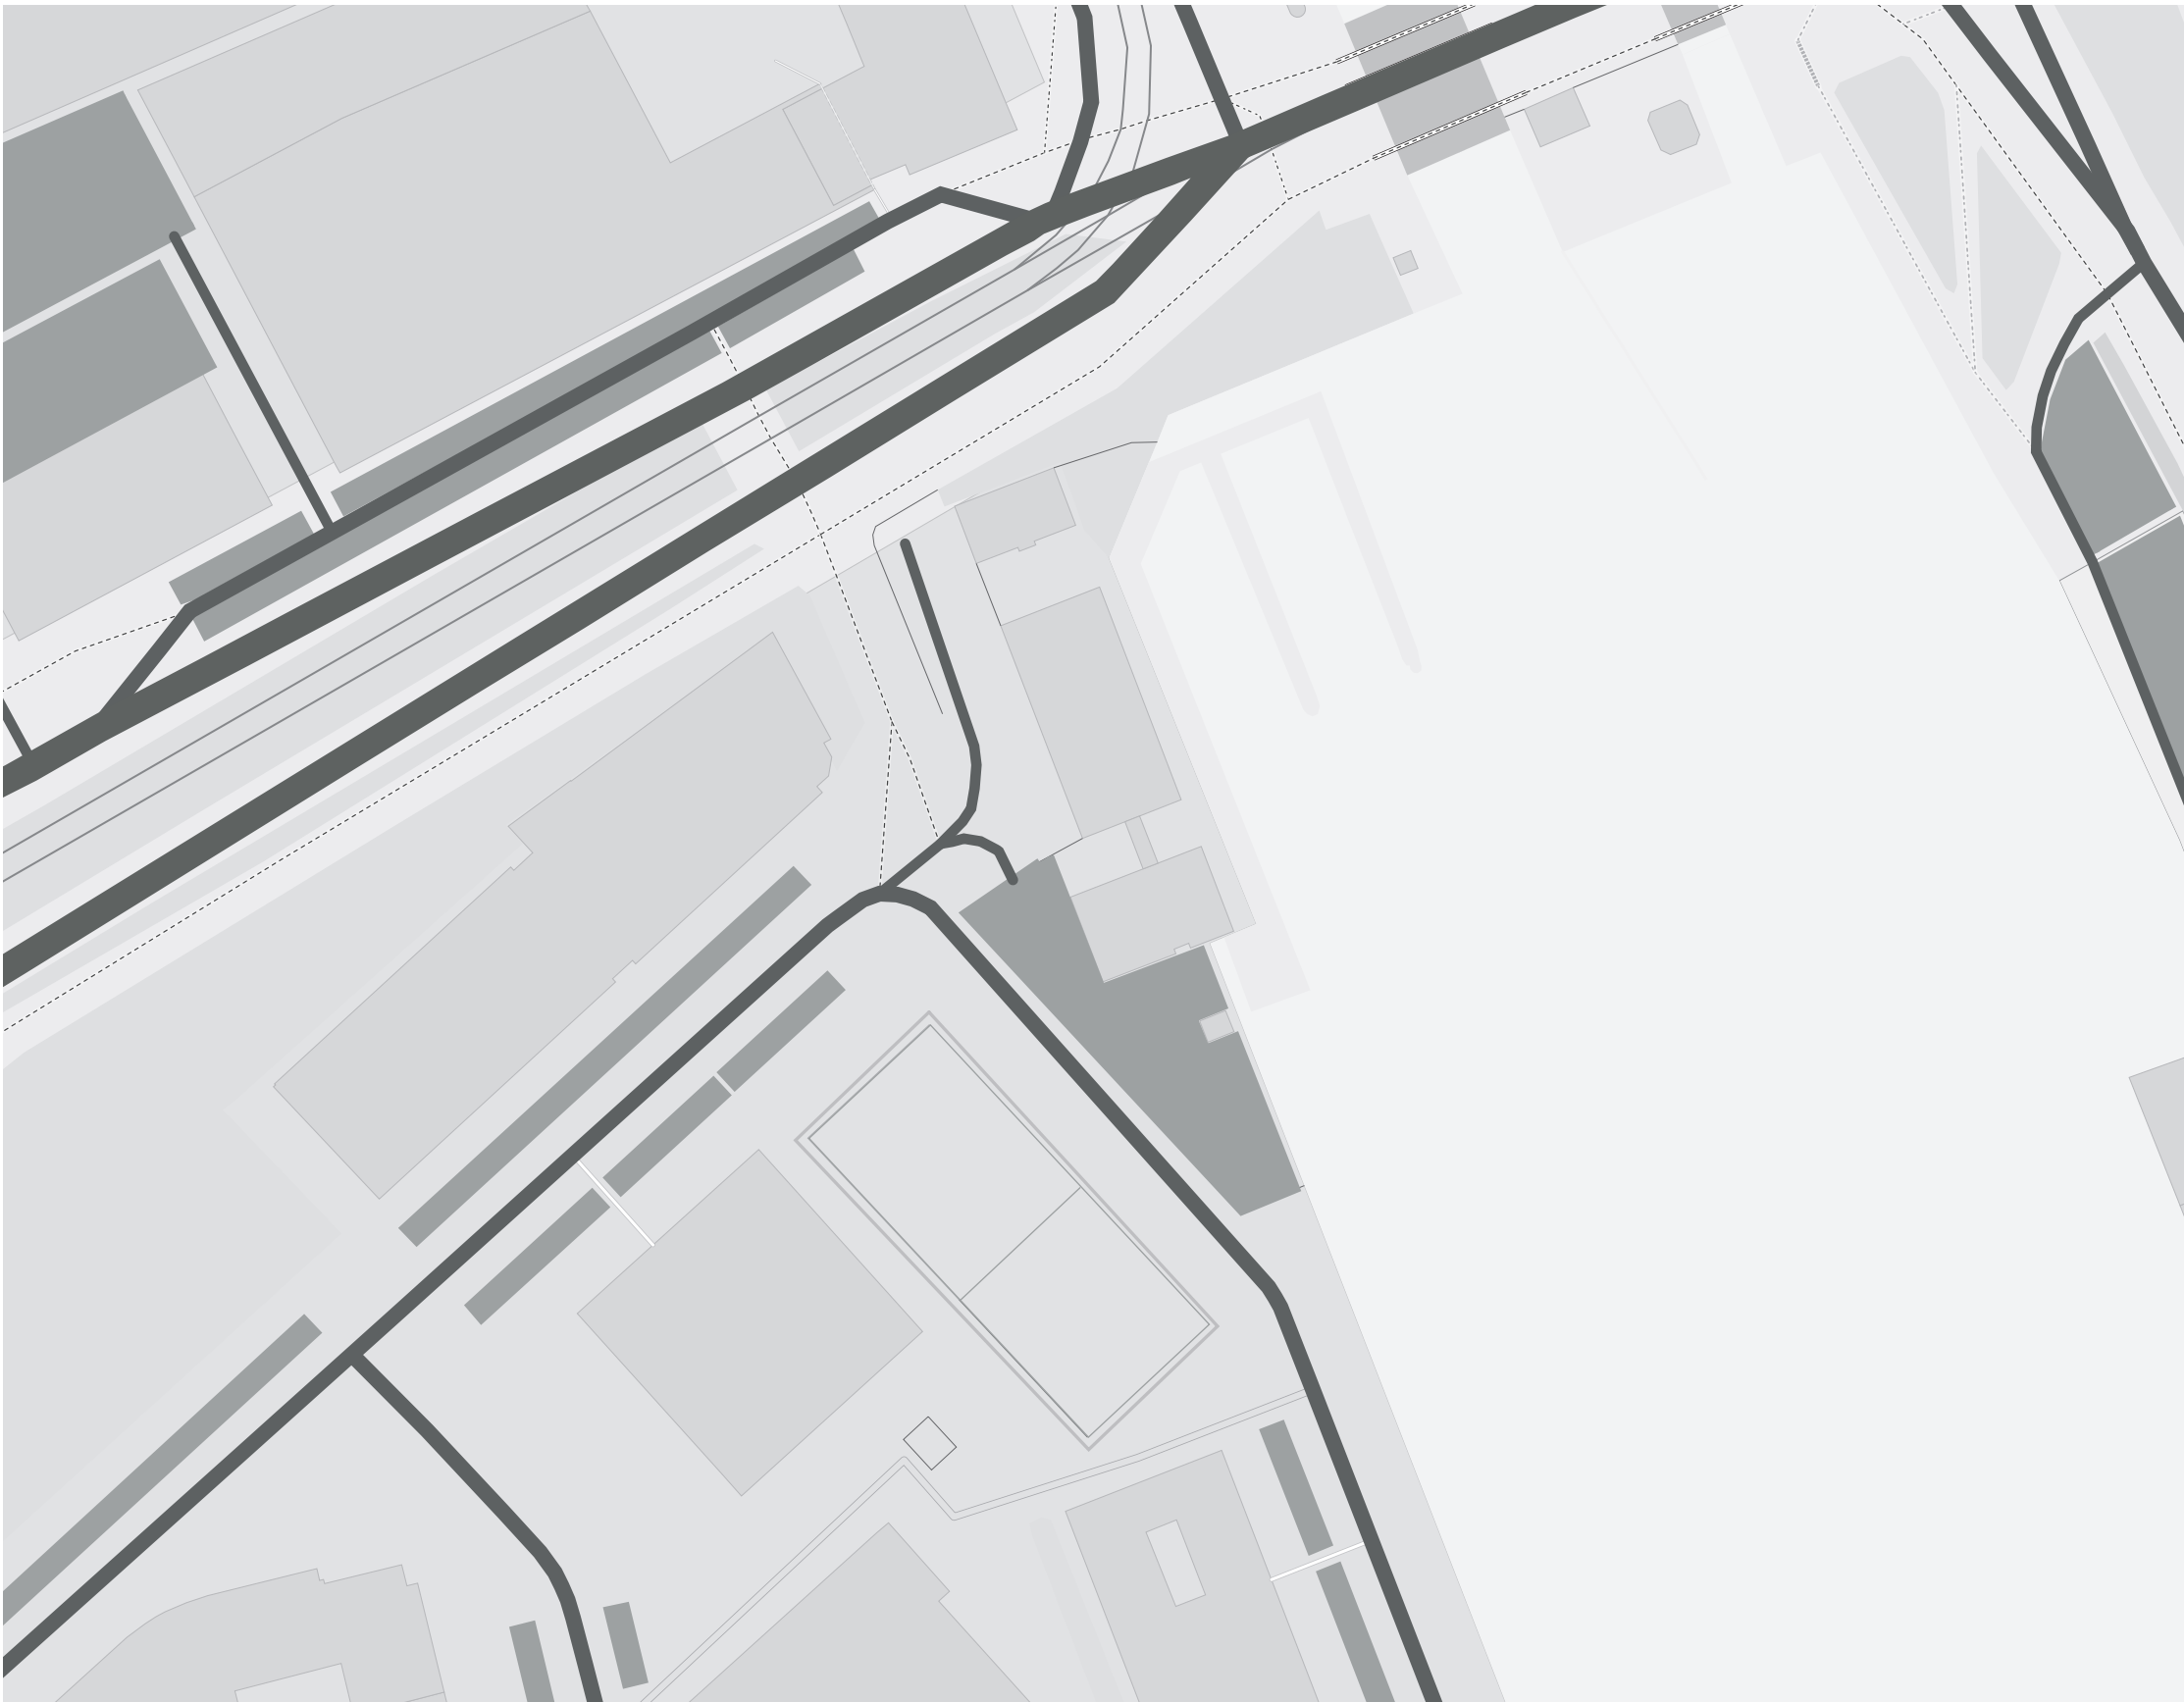
Fig. 19: Infrastructure relating to car

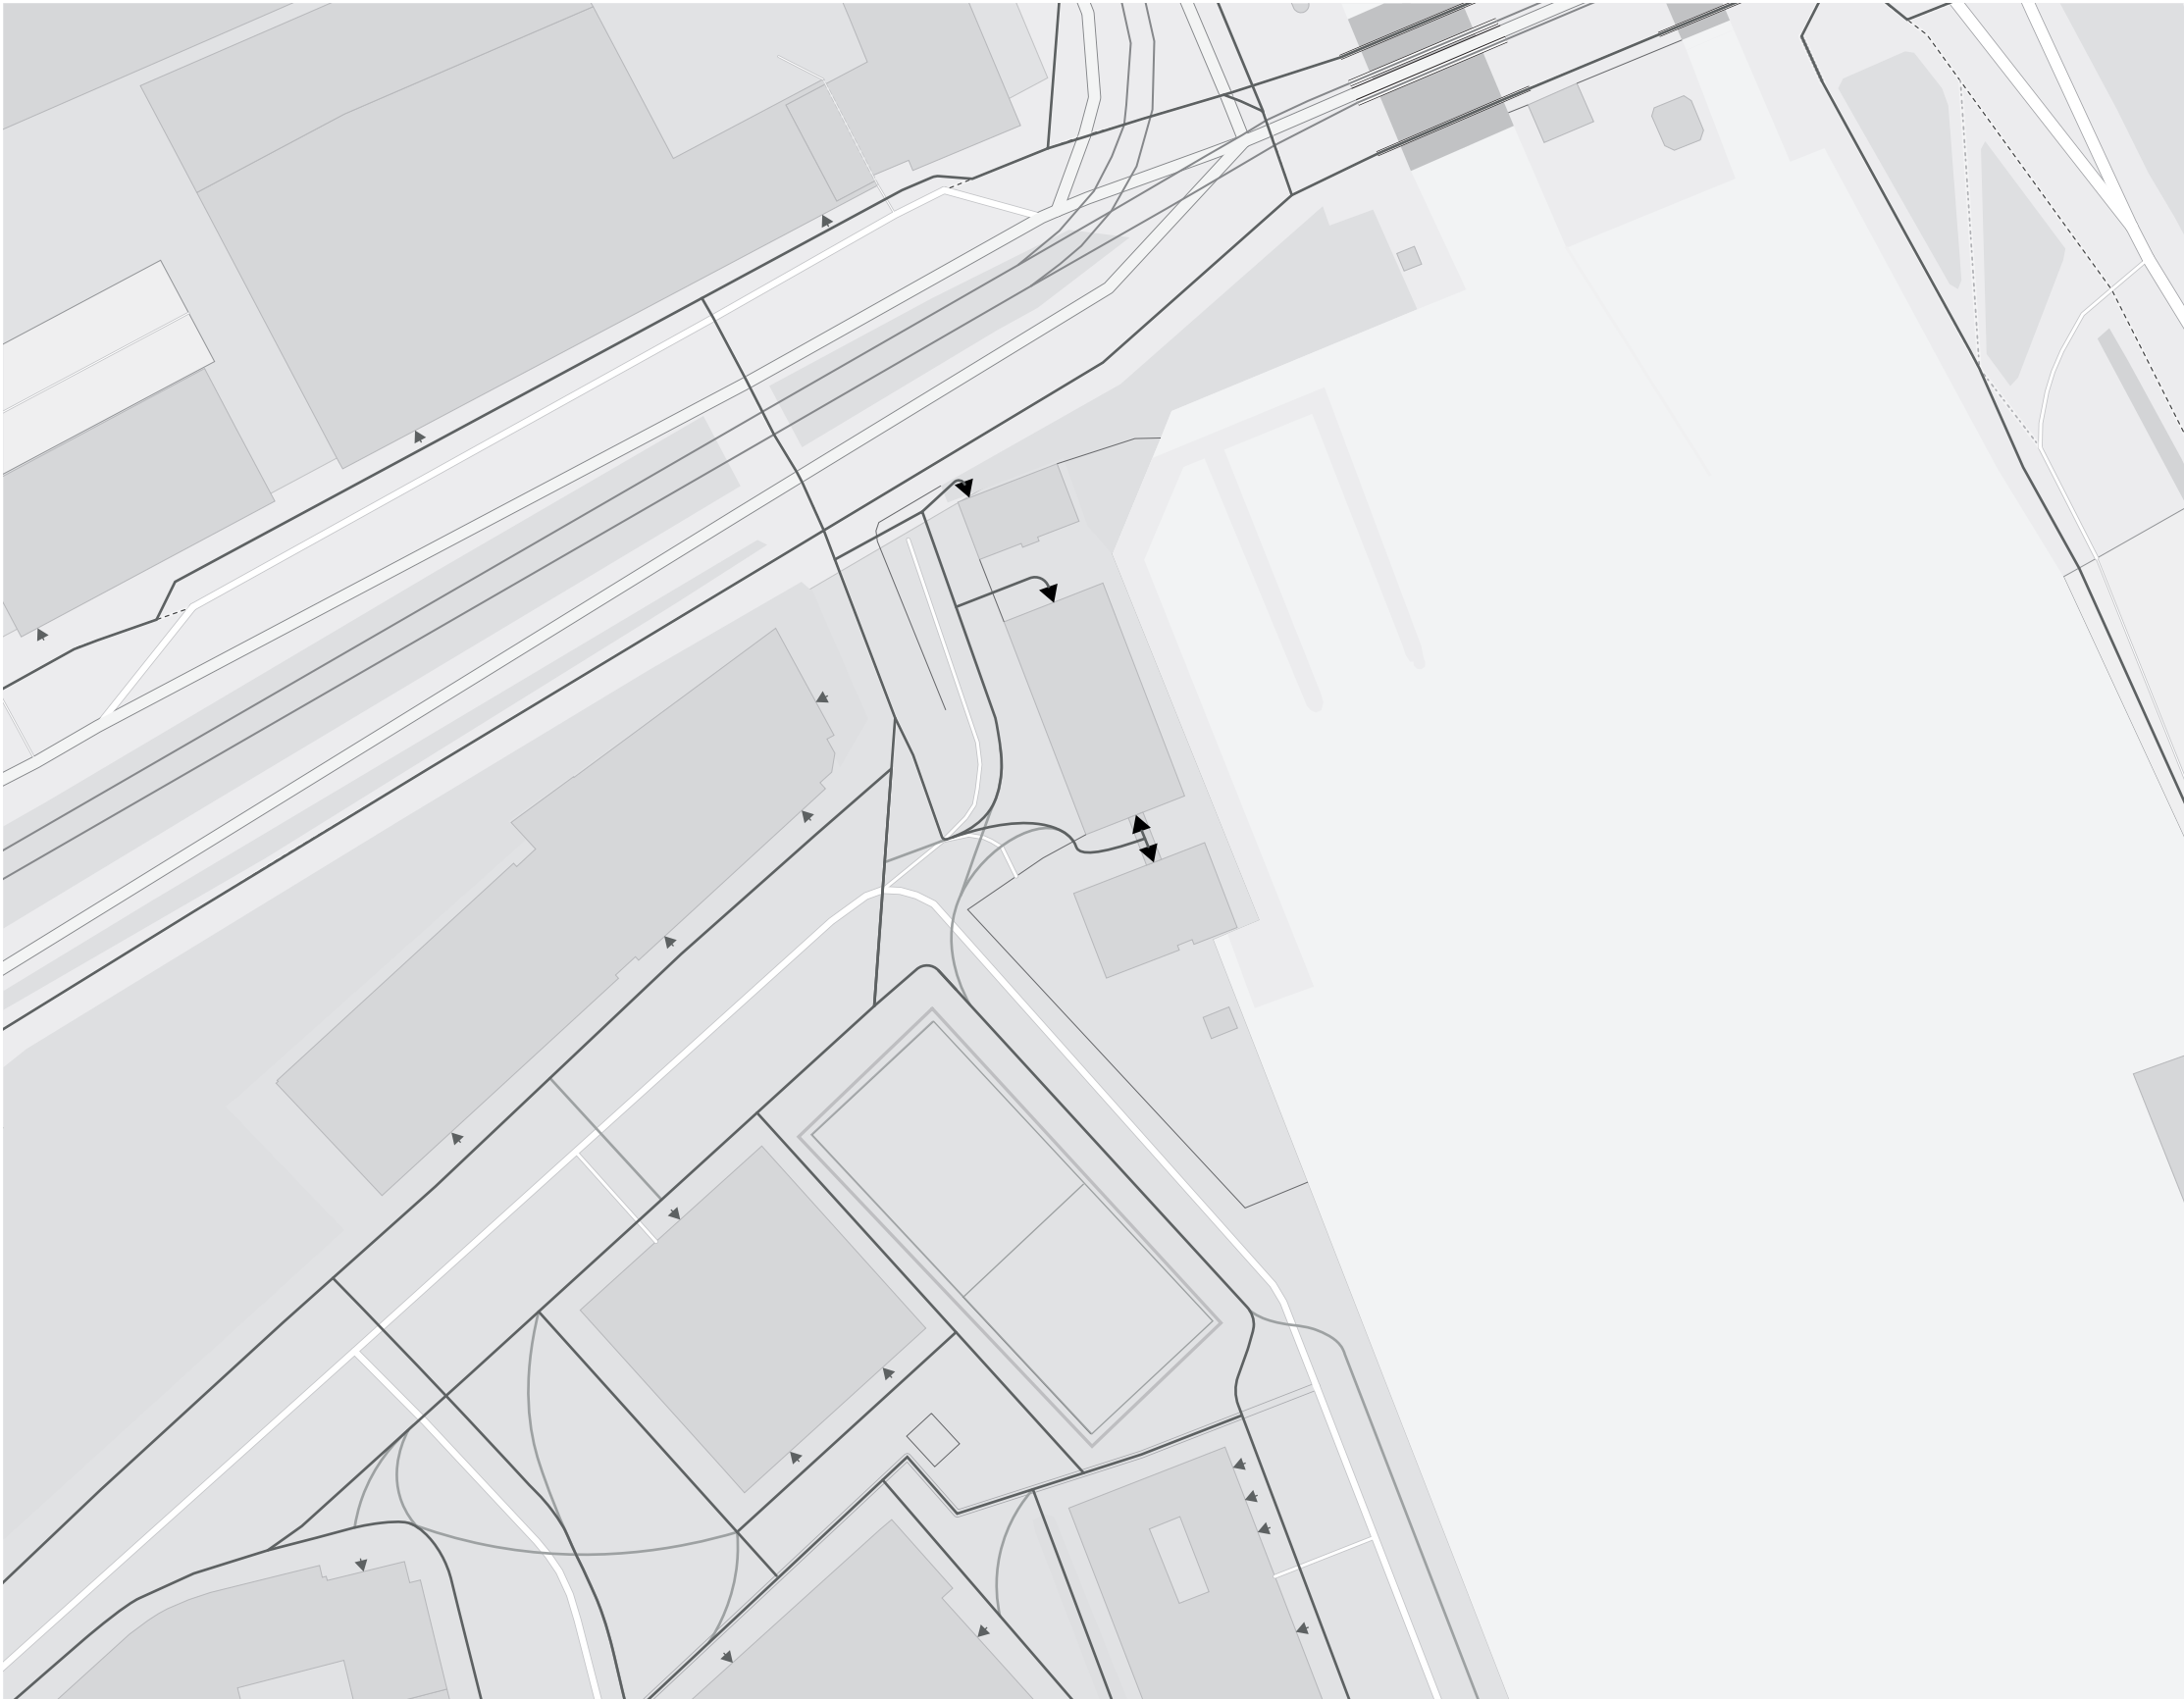
Fig. 20: Infrastructing relating to walkers

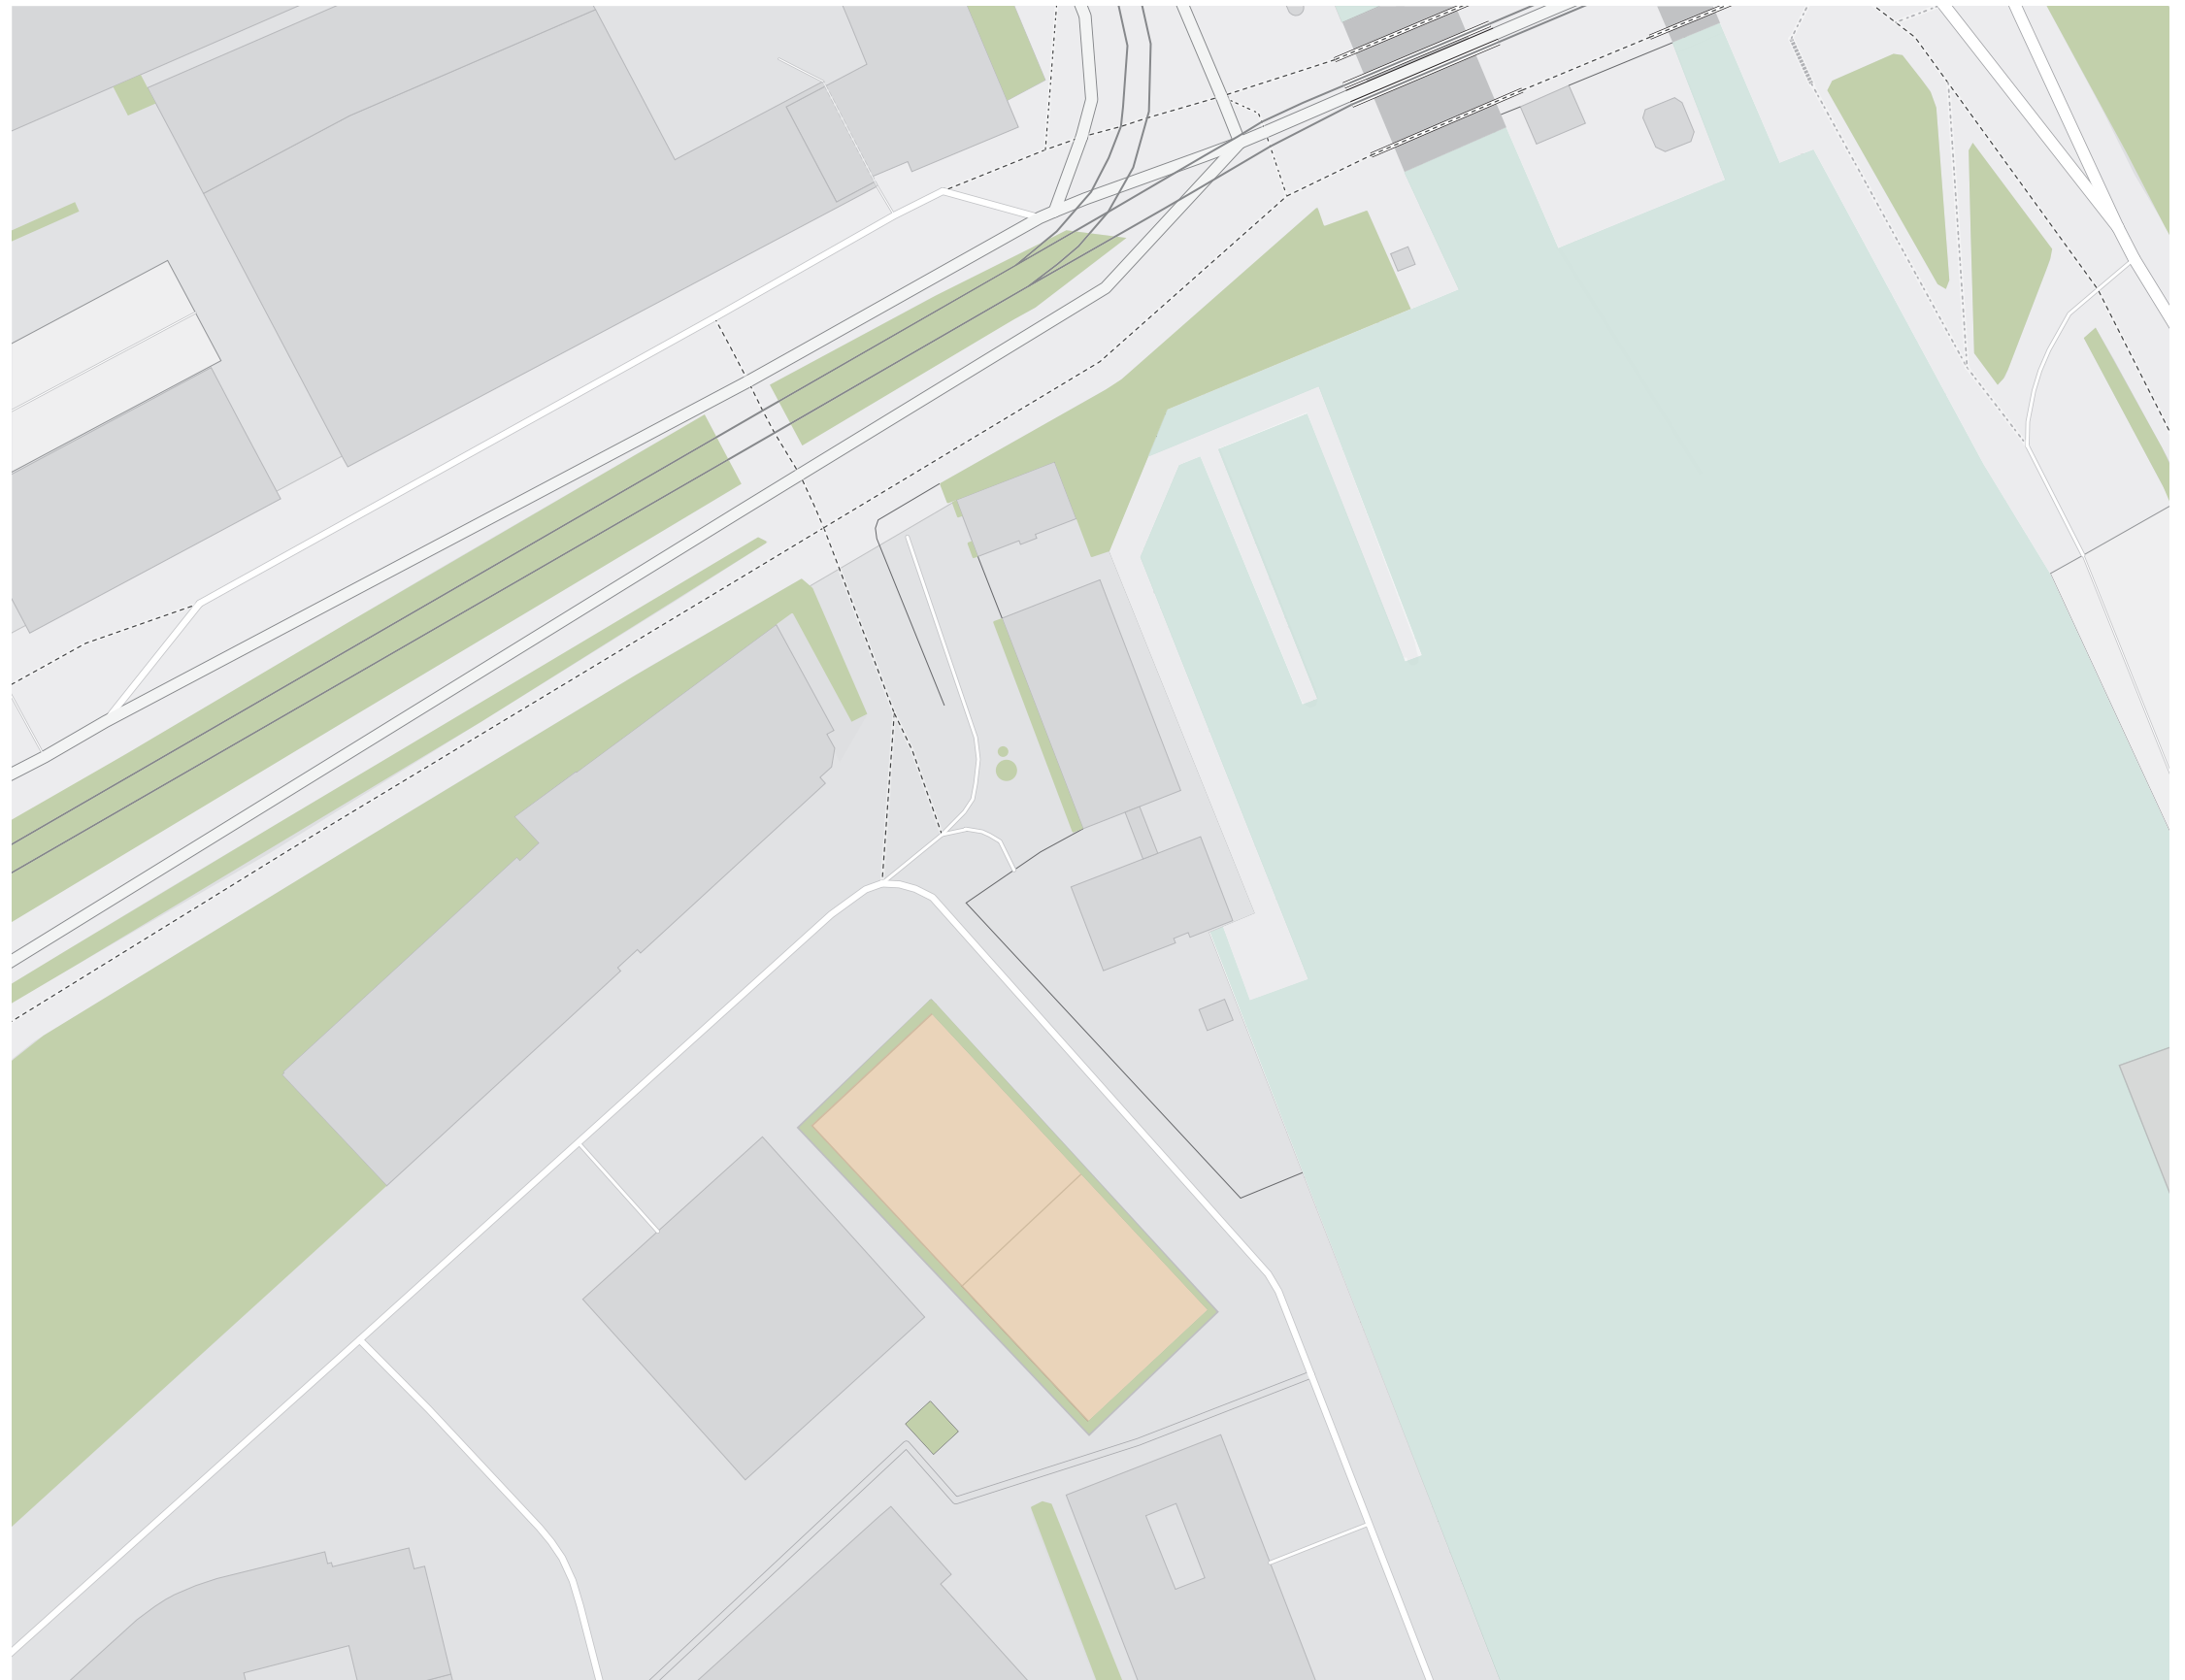
Fig. 21: Green, water and recreational areas
