THE ROTTERDAM HARBOUR POLICE STATION

DAPHNE FAHRNER & DILETTA WESEL
VACANT HERITAGE | POLICE REAL ESTATE
MSc3/4 AR3AH105 | FALL 2021 -2022

This booklet is part of a graduation project of the studio Heritage & Architecture as a completion of the master programme Architecture, Urbanism and Building Sciences at the University of Technology in Delft. The graduation studio consists of a project for the Dutch Police. Due to changes in the working field, a part of their real estate needs to be redeveloped (Weessies, 2017). However, these police buildings, located throughout the Netherlands, deal with unique elements such as security fences and partially closed facades. This means that they cannot simply be regarded as ordinary real estate.

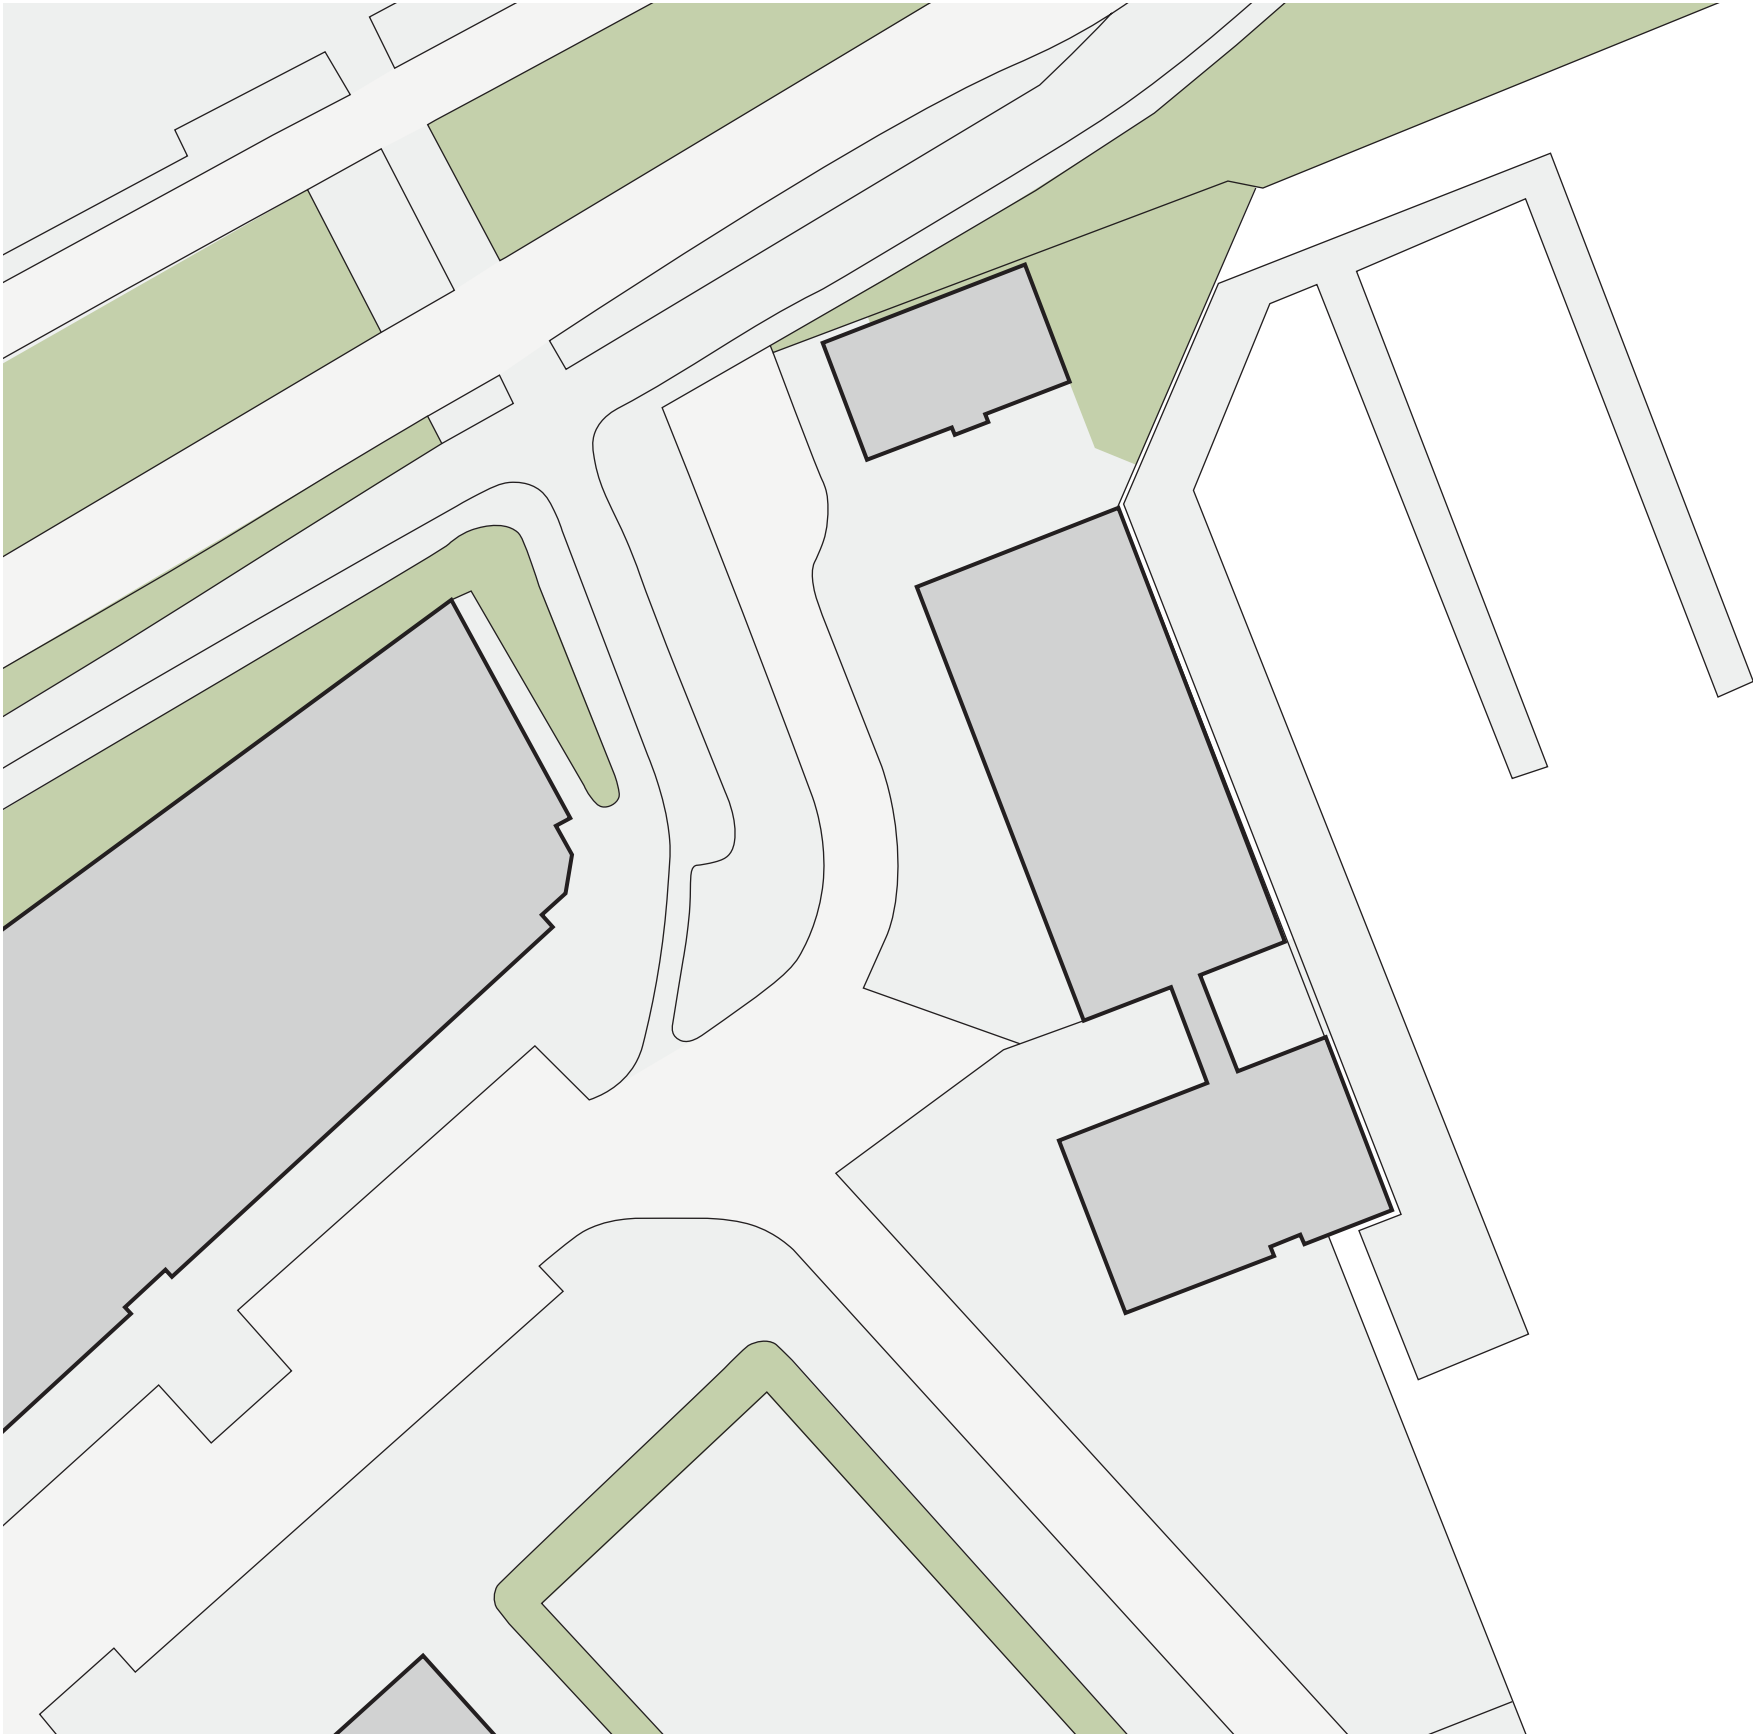
Fig. 22: Direct surrounding of the Harbour Police Station

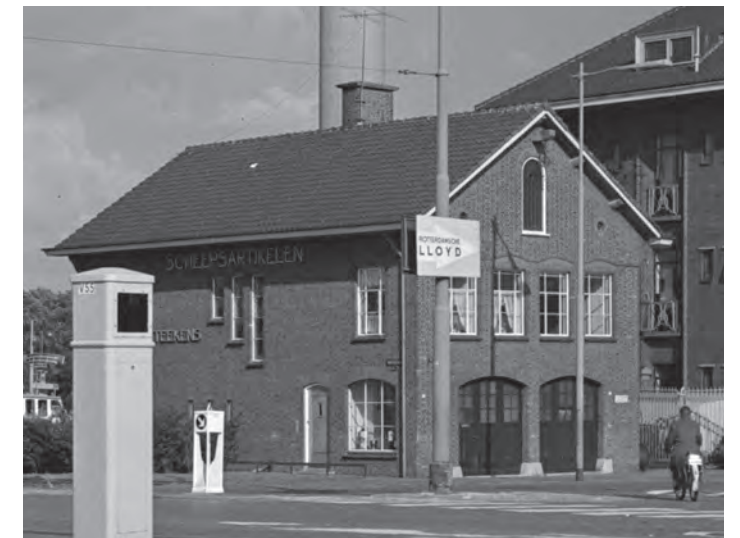
Fig. 41: 1933 building (Stadsarchief Rotterdam, n.d.)

Fig. 42: 1940 building (Seelbach, 2014)

Fig. 43: 1994 building (Boss-19, 2015)

When looking at the River Police building Struijs designed as an extension of the original housing (fig. 43), the contrast between old and new is striking, especially because of the form: the lectern-like roofs and the height of the new brick building contrast with the low old office with its hipped roof with tiles (Galema & Tijhuis, 2006).

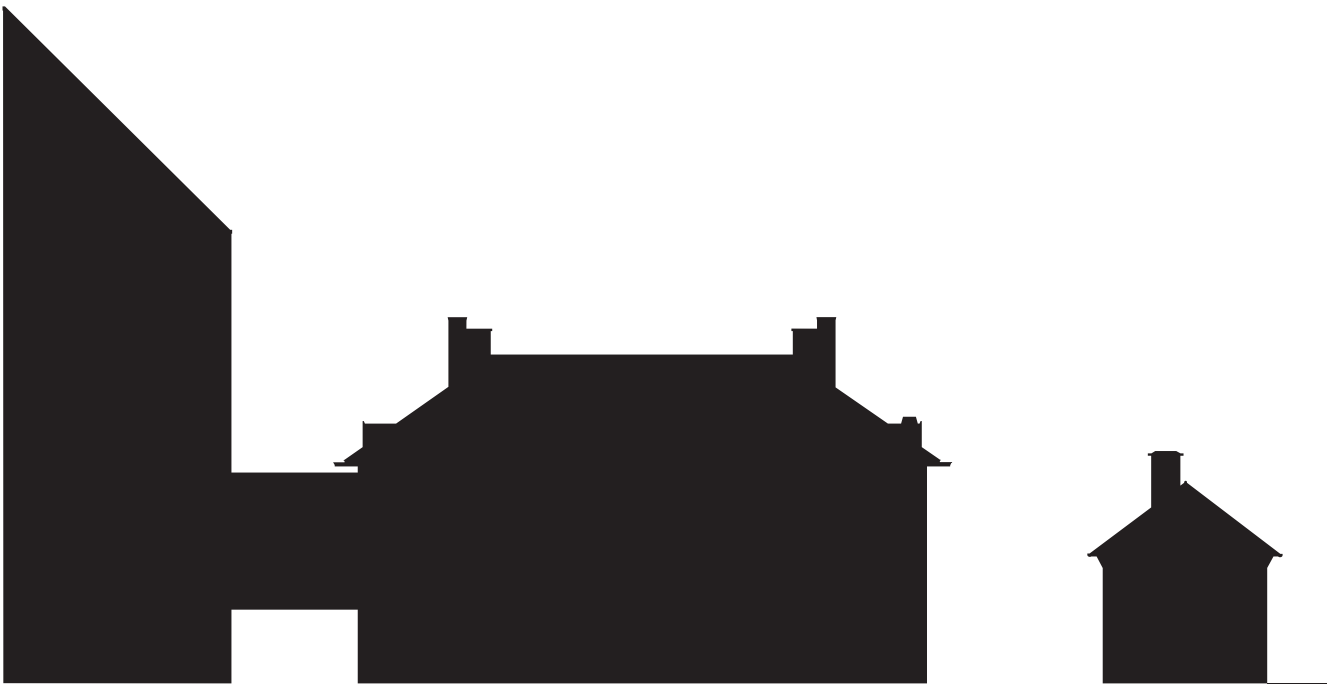
Fig. 48a: East facade

Fig. 48b: North facade

Fig. 48c: West facade

Fig. 48d: South facade

The Rotterdam Harbour Police Station is composed of a composition of three buildings, located at the Sint Jobsweg parallel to the Parkhaven. The composition can be described as the planned arrangement of parts to form a whole. Nowadays, the Harbour Police consists of a tower, a connected building block and a detached house (fig. 48a and 48c).

From the east and west side, visual order is created by the three volumes. Towards the river, the Maas, the buildings are getting higher. As a result, the composition towards the River Maas can be described as monumental.

The buildings all have different proportions. As an example, the middle building is the widest, while the tallest building is only a little wider than the smallest building. In contrast to the height and width, the depth of the buildings do not differ a lot (fig. 48b and 48d).

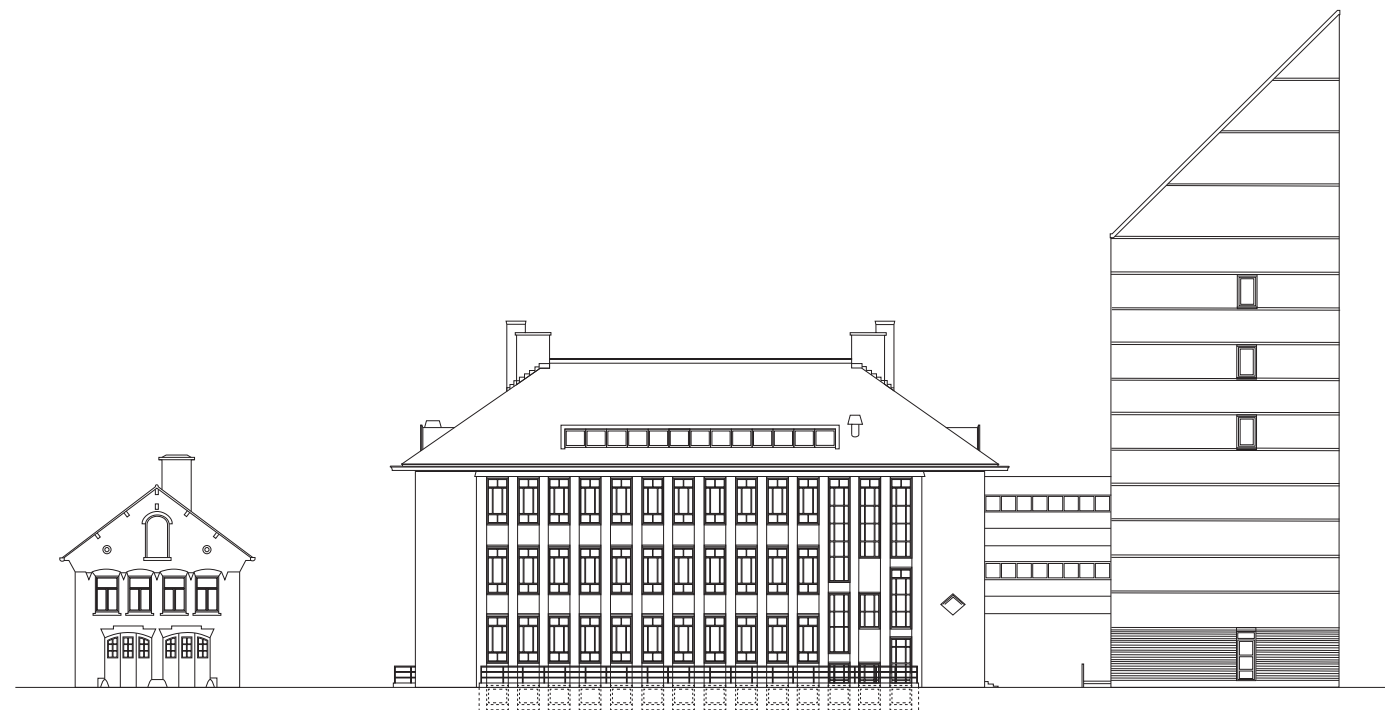
Fig. 49a: East facade

Fig. 49b: North facade

Fig. 49c: West facade

Fig. 49d: South facade

Apart from these scales, shapes and volumes, the buildings also have a specific appearance as a result of the facade designs. Therefore, the facade drawings are shown on the right to provide some general insights in the design of the three buildings. The highest building dates from 1994 and has a formal character. The middle 1933 building is the oldest and has a traditional appearance. The 1940 building is built as a residence and workshop, which is reflected by its design. Moreover, it will be analysed more intensively in the next subchapter.

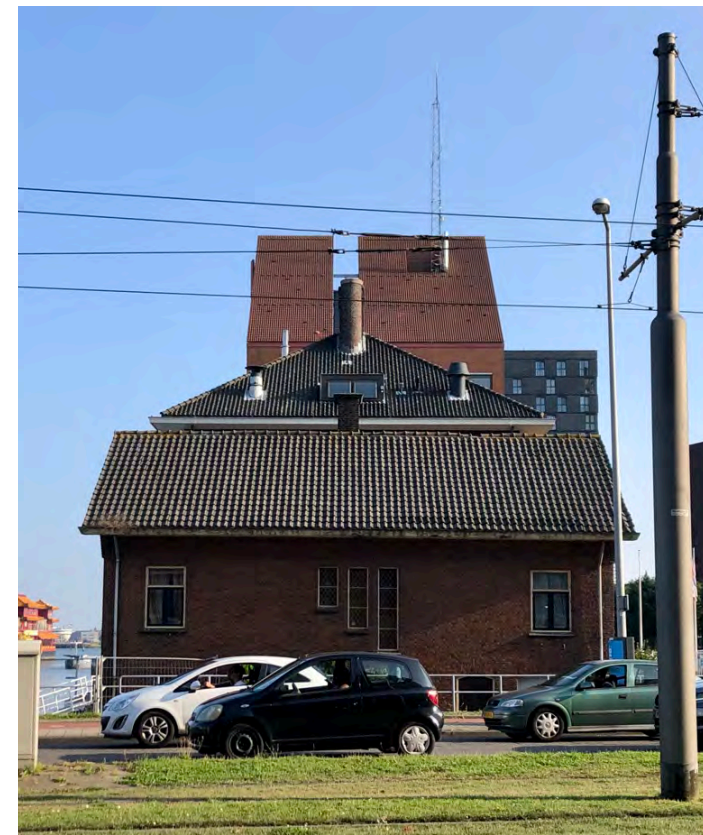
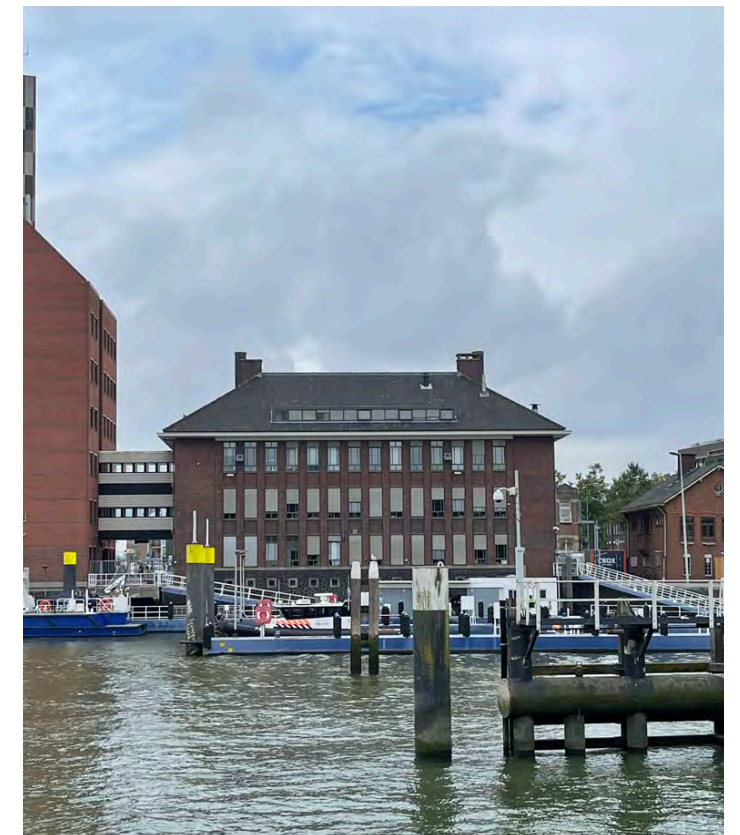
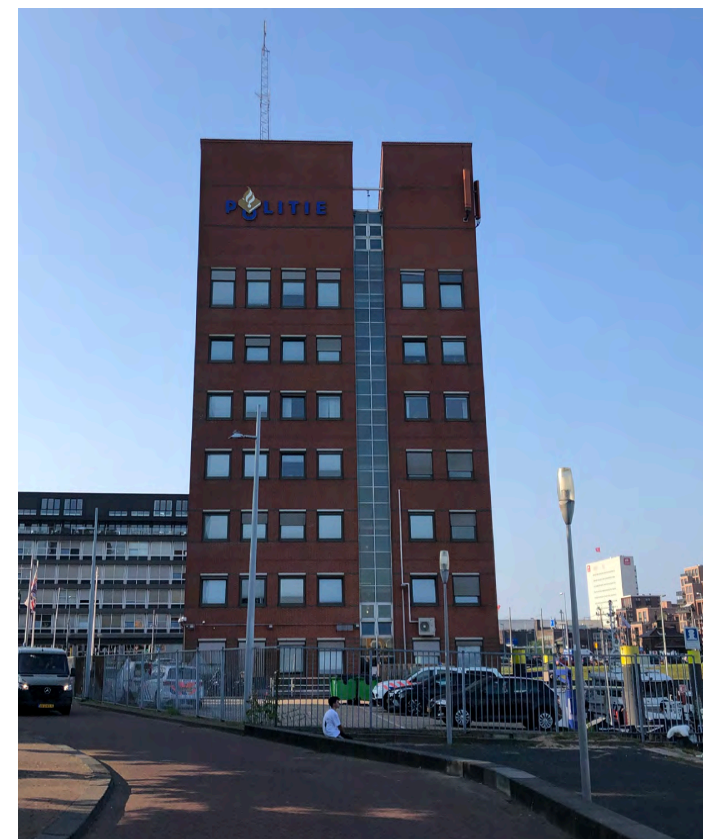
Fig. 55: Top view Rotterdam Harbour Police Station

Fig. 56: North facade

Fig. 57: East facade

Fig. 58: South facade

Concerning the orientation of the building, the images on this page show each side of the harbour Police Station. The West side is considered to be the front, since this is the side that one has to approach to enter the building. Subsequently, the East side is considered to be the backside. This is also in line with the fact that this side is the least approachable as a result of the water inbetween the viewer and the building. Furthermore, the North and South sides are regarded as the end views of the buildings.

In line with the drawings concerning the daylight, the relation between interior and exterior can be analysed. Namely, the windows give insight in the interior functions. As an example, the offices all have similar windows. Furthermore, the stairs are emphasized in the west facade of the 1933 and 1940 building. In addition, the next subchapter will tie in to these notions.

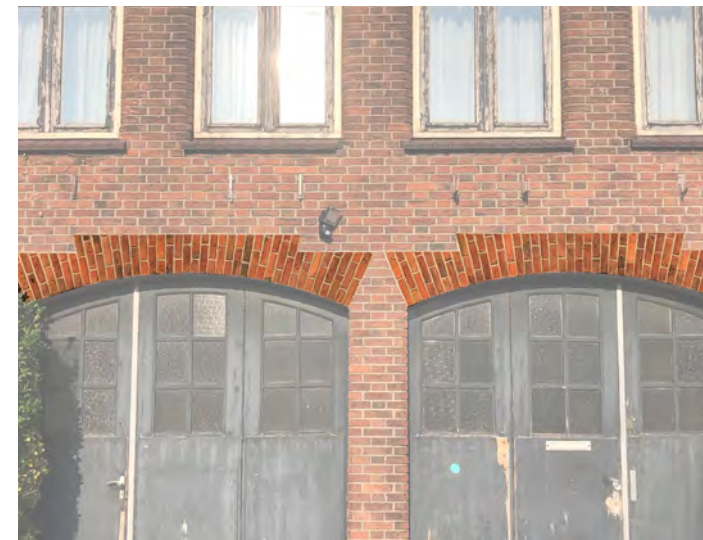
Fig. 71a: Segmented arches 1940 building

The former residence, which is known as the smallest of the three buildings, has the highest level of perceived detail. As an example, the patterns in the brickwork contribute to its dynamic character as can be seen in figure 71. Namely, the voids are not featured with lintels, but with masonry that is laid down vertically instead of horizontally. Moreover, most of them are flat arches. The little voids on the second floor contain bull's eye arches and semicircular arches. The openings on the ground floor contain segmented arches. These are so-called stretchers and cockscombs and these are especially used above the doors. These kind of constructions can decompose and transfer the forces resting on it to the sides. Furthermore, it provides some extra ornamentation. In addition to this variation of arches, the architect added other decorative elements like the usage of divergent bricks. The specific elements are highlighted in the images on the right. In addition, the balcony on the southside is decorated by gabs in the brickwork. Furthermore, the composition of the north facade is, contrary to all the other facades, free from symmetry. In this way, it seems that the windows are used to decorate the building and to create a more informal character.

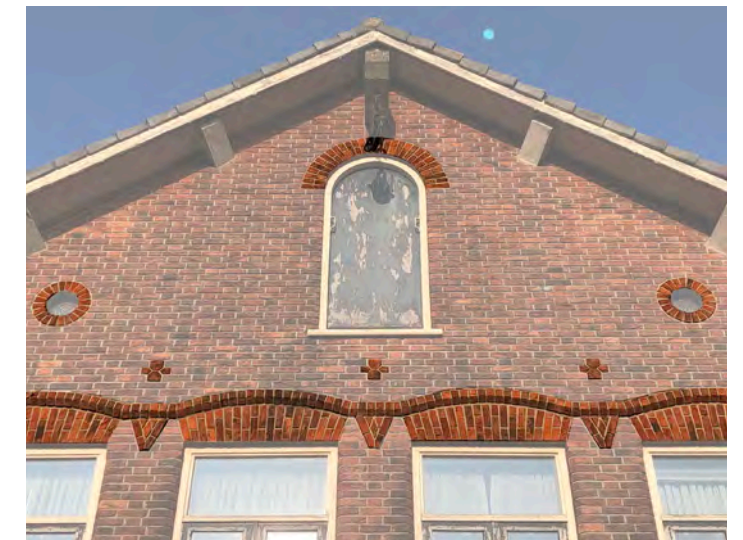
Fig. 71b: Variation of arches 1940 building

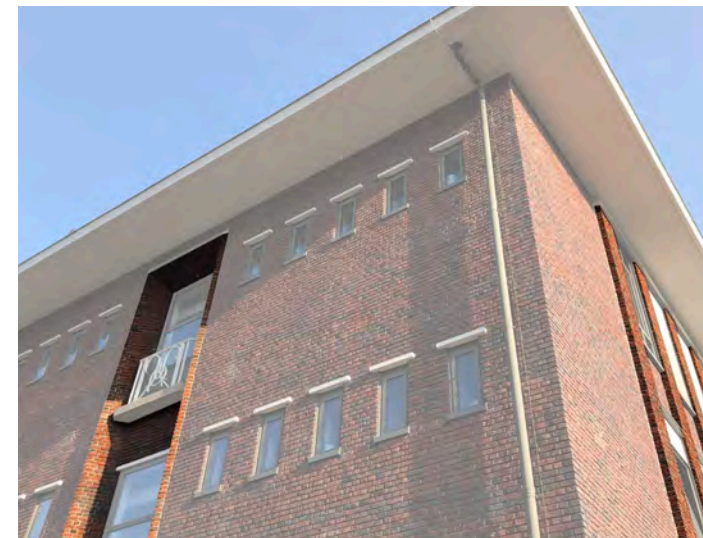
Fig. 72a: Notches and thickness 1933 building

The middle building, dating from 1933, has a dynamic surface as well. In this situation this is - among other things - the result of depth and variation in brickwork. In the north and south facade, fences are bordering the balconies (fig. 72a). They are light and elegant as a result of its material and its shape. Furthermore, at the short sides, lintels are used to support the brickwork

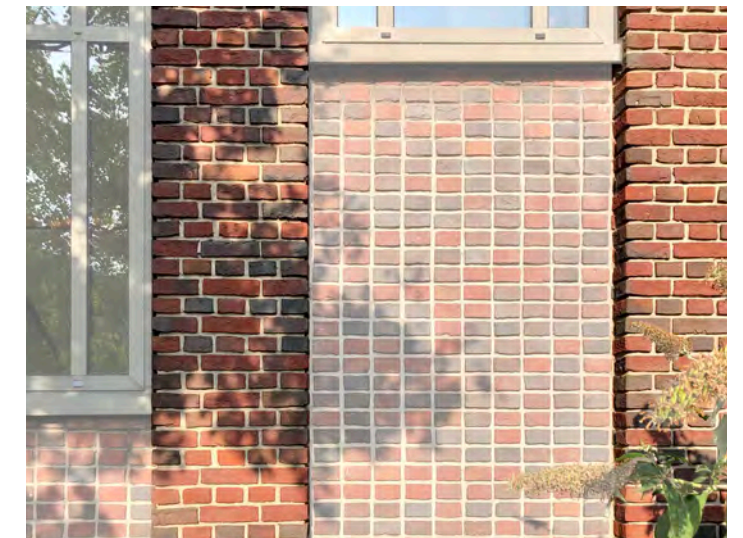
Fig. 72b: Depth of brick in the 1933 building

above the voids. On the east and west facade there are no lintels, since the construction is supported by a roll layer. On these facades, rhythm is created by the vertical lines that are shown in figure 72b. At these locations, the brickwork is placed (about 100 mm, so one brick) towards the front. Also, two types of bonds were used as an esthetic element. The stack bond is used between the windows, as can be seen in the image. In the west facade, the windows on the right also contribute to the dynamics and decoration of the facade, since it breaks the rhythm.

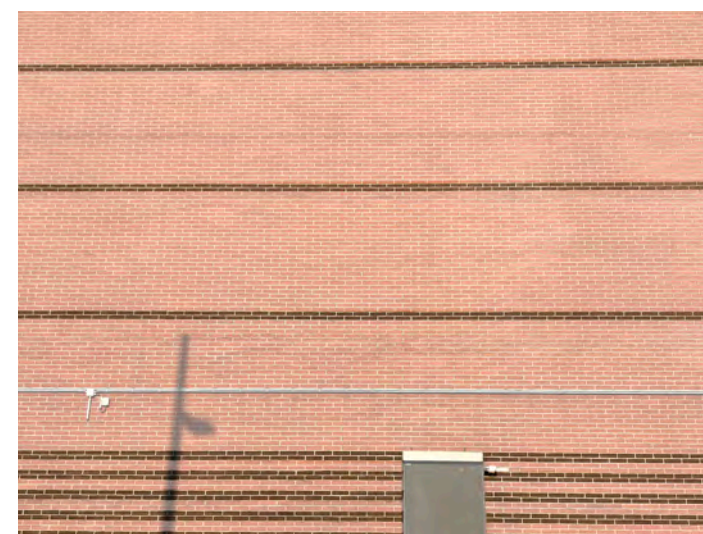
Fig. 73a: Colour layers 1994 building

The 1994 building shows less ornamentation than the other two buildings. The building is quite formal and tends to have almost no decorative aspects. The manganese stone layers are used to emphasize the positions of the windows. At the same time, it creates a rhythm and can be seen as a subtle way of decoration (fig. 73a). The distance between the dark brown layers differs from the top to the bottom. The distances at the top are quite large, while at the bottom only two layers of brickwork are alternated each time. Furthermore, the glass corridor zone, which is located a bit backwards from the facade, provides some depth, as can be seen in figure 73b. In addition, the lintels that are used throughout the building are shown. Overall, the facades tend to have a quite formal character, which is not inviting the passersby. Nevertheless, the main entrance has a little more detail and attraction, due to the depth difference and the design of the banister.

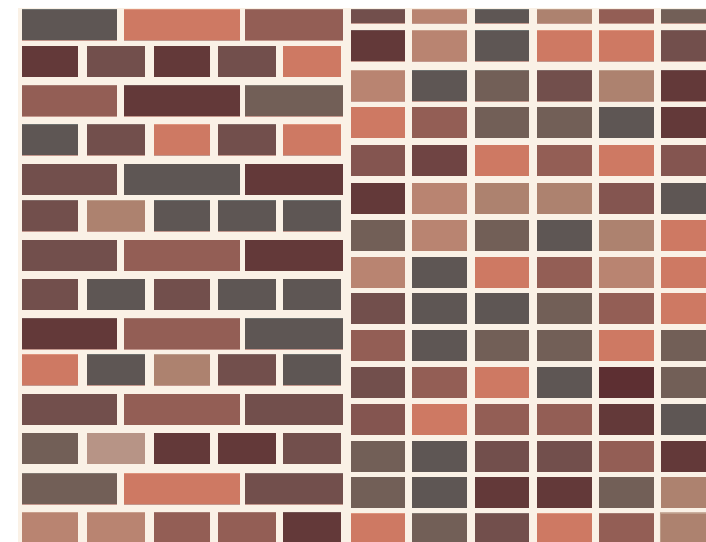
Fig. 79a: Medium building 1933

Fig. 79b: Medium building 1933

The middle building consists of some brownish bricks as well. Again, there is more variation visible within the facade when we take a closer look. The colours of the separate bricks vary from orange to brown and from red to grey. However, those bricks are more (but not completely) equal coloured than the ones that are mentioned before (fig. 79b).

As mentioned before, the middle building has two types of brick bonds. Nevertheless, the same kind of bricks are used. The texture is rough, but not as raw and groovy as the bricks of the small building. It is assumed that the facades consist of revolver press bricks, since they have some texture and there is a little difference in colour.

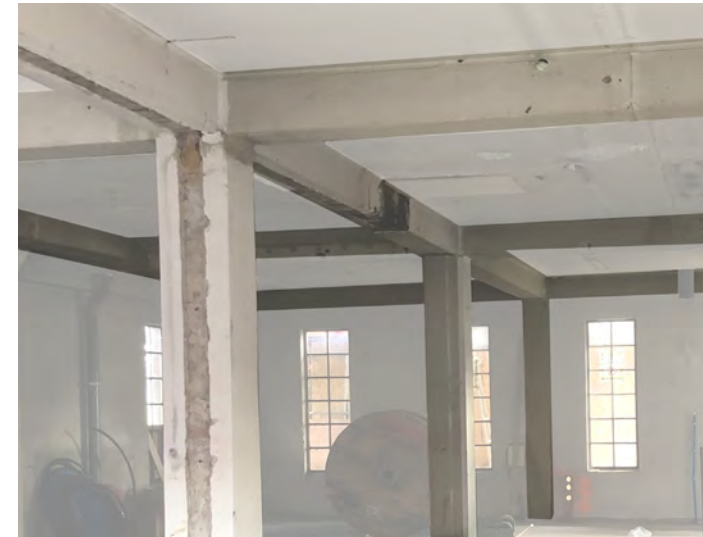
Fig. 81a: Concrete construction 1940 building

The second material we want to adress is a quite hidden material, since it is mainly used for structural reasons: concrete. It can be found in the cellar, floors and stairs. Furthermore, concrete lintels can be found in the exterior.

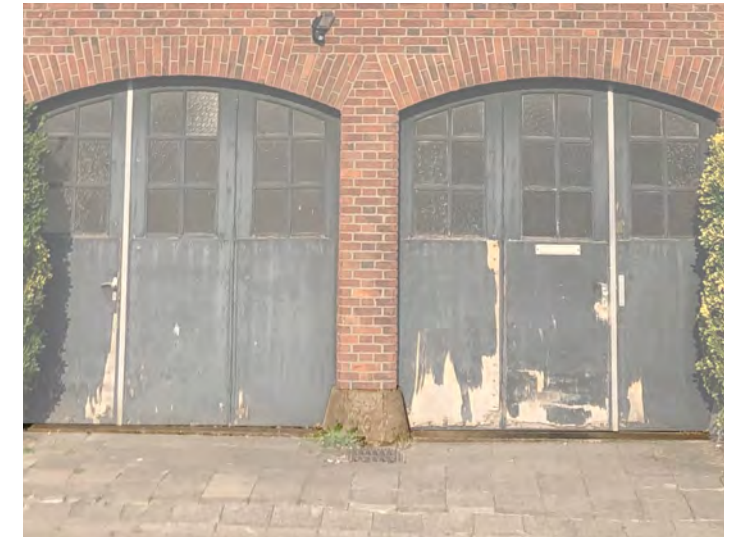
Fig. FIX81bME: Concrete sill 1940 building

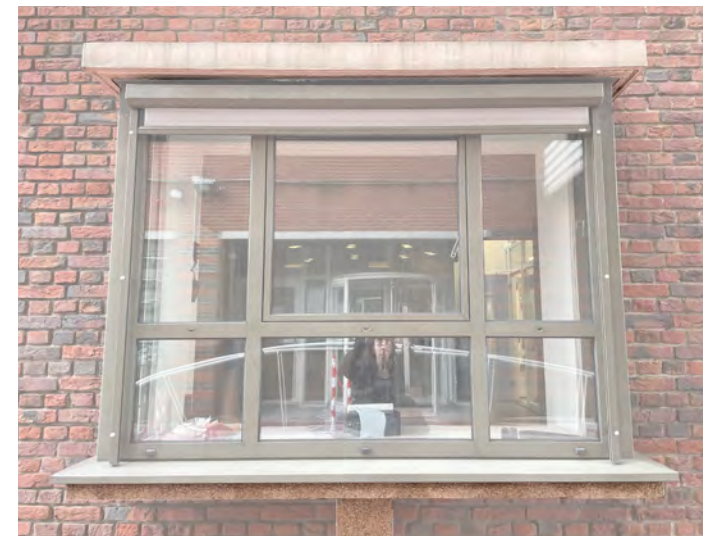
Fig. 82a: Lintels 1933 building

The construction of the 1994 building is made of concrete as well. Again, especially the cellar is mainly constructed from concrete. To emphasise this, even the stairs from the ground floor towards the cellar are materialised in concrete. However, in contradiction to the 1933 building, not only the cellar but also the remaining floorlevels are supported by concrete columns. Furthermore, in line with the middle building, the lintels above the windows are made of concrete. As can be seen in the images (fig. 82a and 83b), the appearance of the lintels are quite similar.

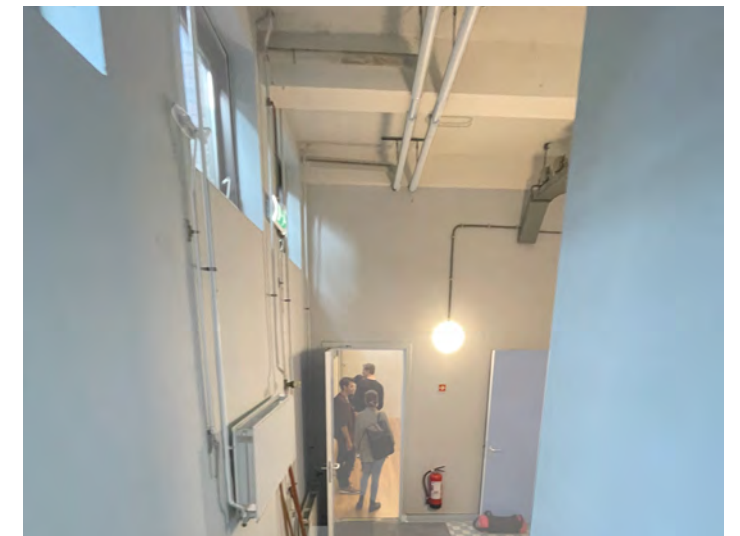
Fig. 82b: Concrete cellar 1933 building

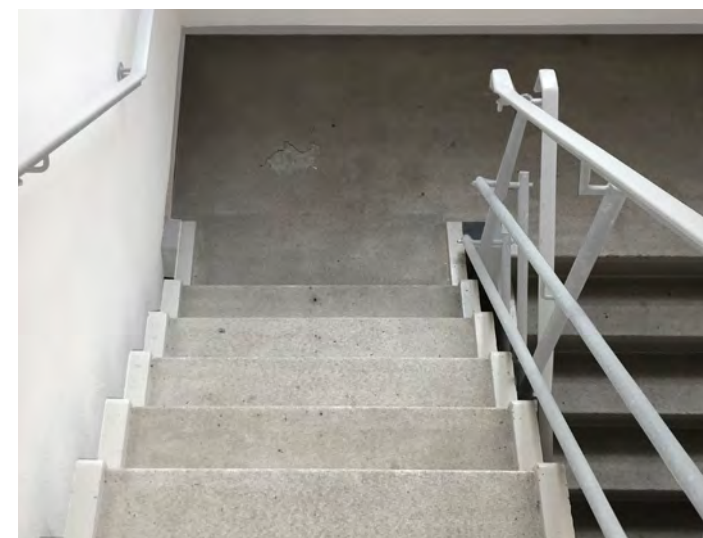
Fig. 83a: Concrete stairwell 1994 building

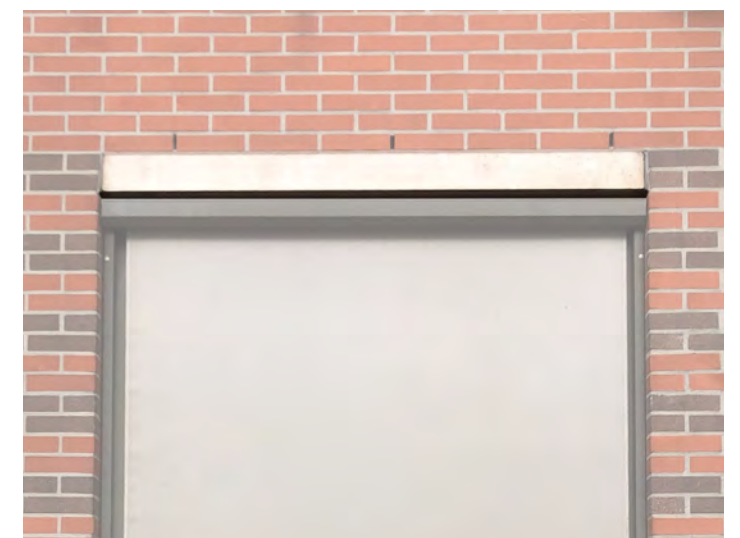
Fig. 83b: Lintels 1994 building

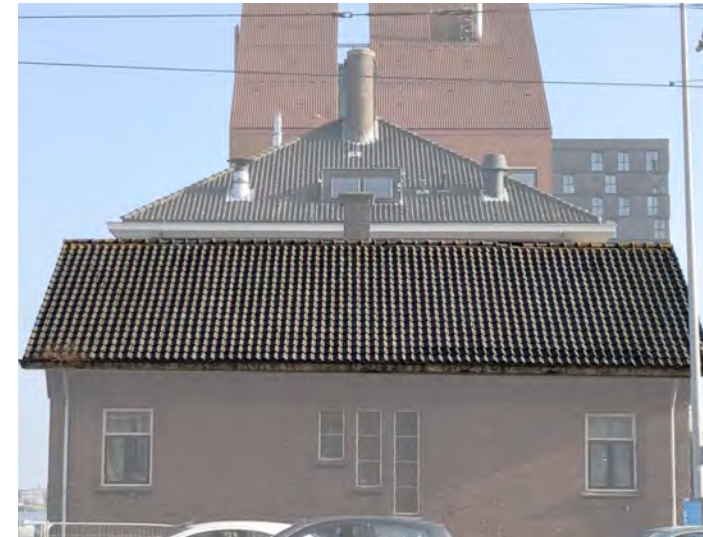
Fig. 84a: Roof tiles 1940 building (and others)

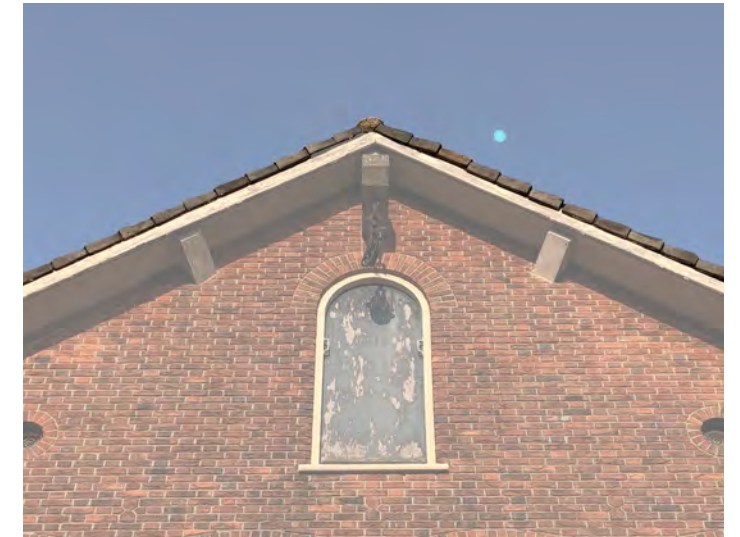
Fig. 84b: Roof tiles 1940 building

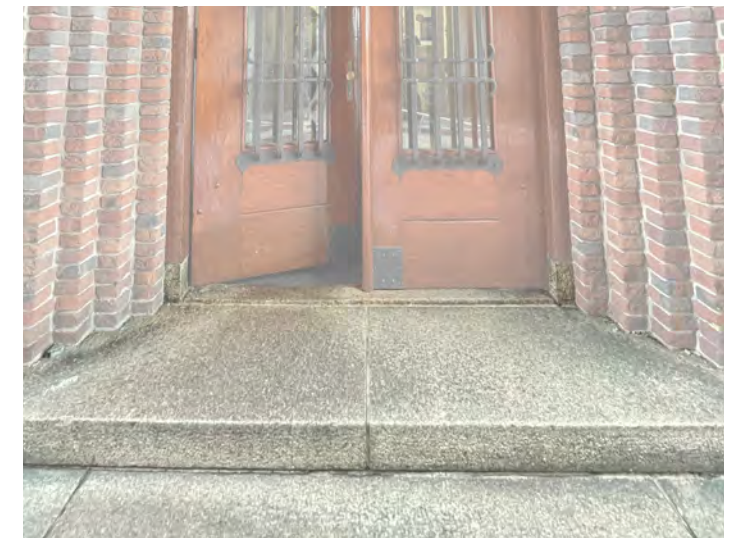
Fig. 85b: Stair steps main entrance 1933 building

When we take a closer look, natural stone can be found at the various stairs. As well inside as outside, granite and hard stone details are used.

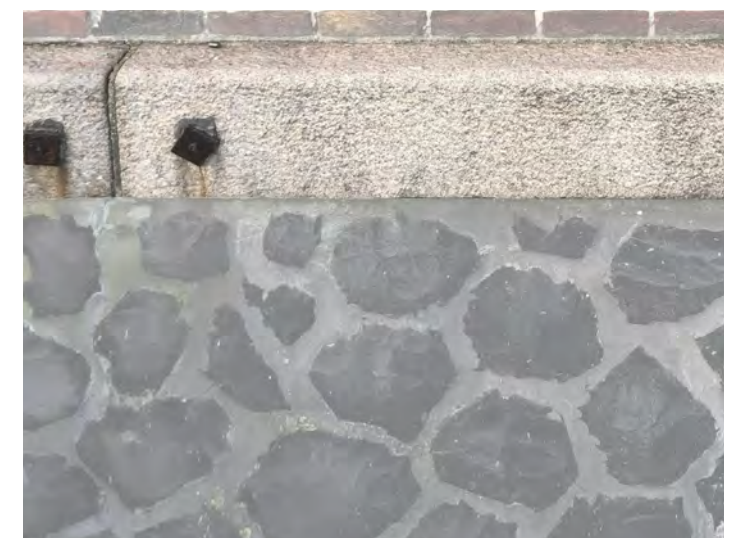
Fig. 86b: Natural stone quay apron

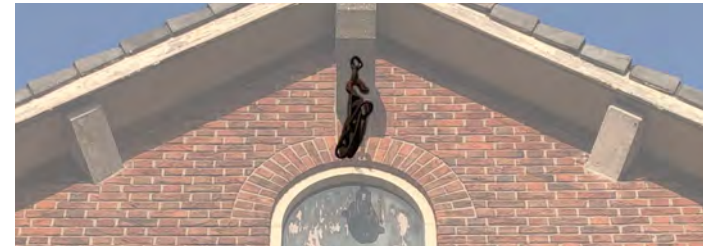
Fig. 87a: Iron details west facade 1940 building

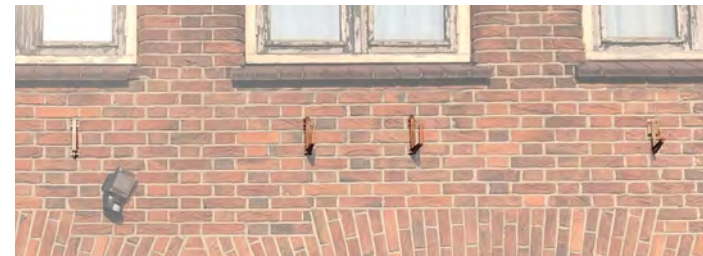
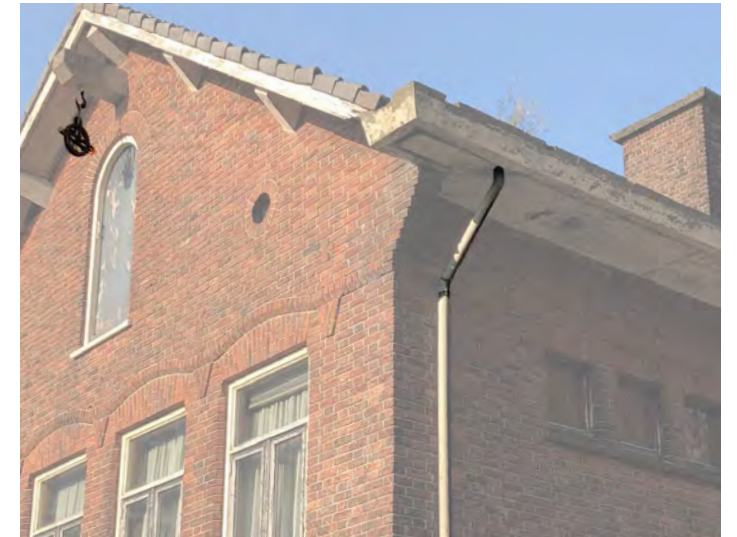
Fig. 87b: Iron detail and gutter 1940 building

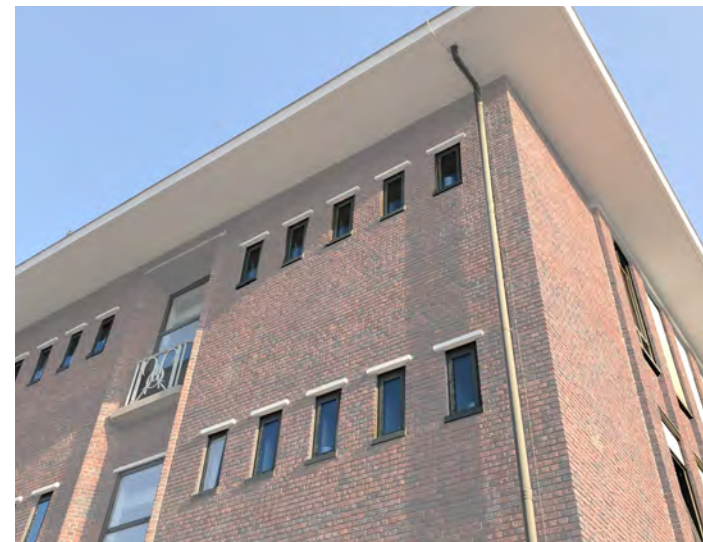
Fig. 88a: Steel windows and fence 1933 building

The materialisation of the middle building contains quite some ironwork. To start, the buildings is provided with numerous high steel window frames. Furthermore, the fences at the balconies at the north and south side are made of iron as well as shown in fig. 88a. In addition to this, the same accounts for the fence that is decorating the entrance door. Concerning the interior of this building, some police related ironwork is present. Namely, regarding the function of the Harbour Police Station, cells were needed. Even though it is not clearly visible from the outside, from figure 88b it becomes clear that at some windows within the building the cell fences are still present.

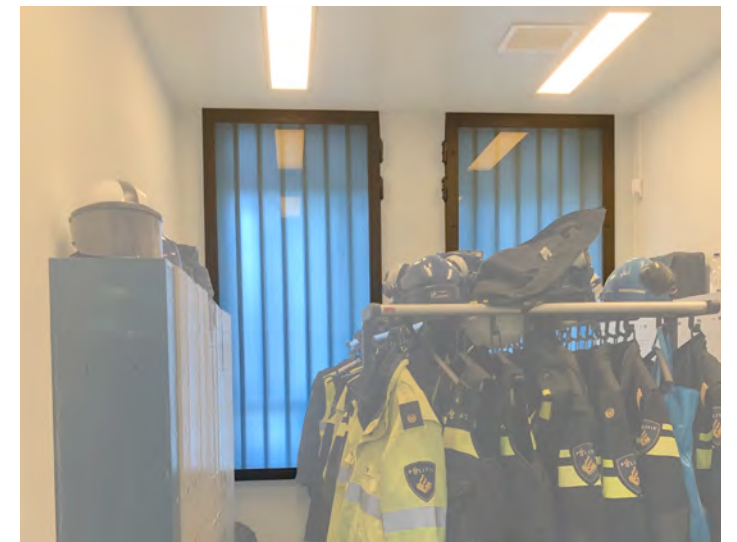
Fig. 88b: Steel window frame and cell fences

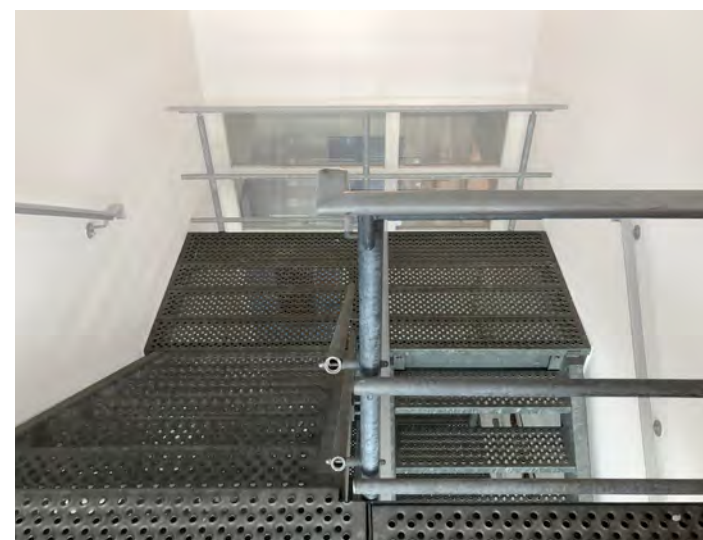
Fig. 89a: Steel stairs 1994 building

The ironwork of the 1994 building is partially similar to the 1933 building. Namely, the windows consist of the same steel window frames. In this figure, the fences that are surrounding the area are also visible and those are made of steel as well. In line with this, the entrance of the newest building consist also largely of ironwork as can be seen on the right. Last but not least, the connection between the two buildings is made of steel plating.

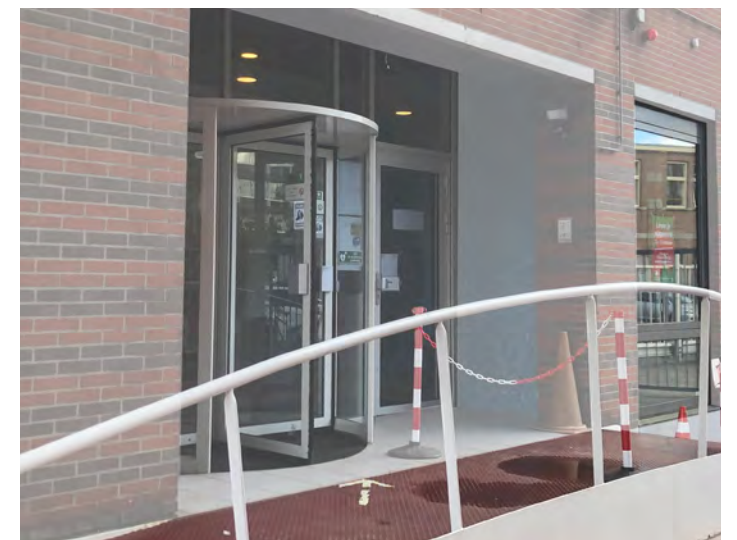
Fig. 89b: Steel ramp and aluminium door

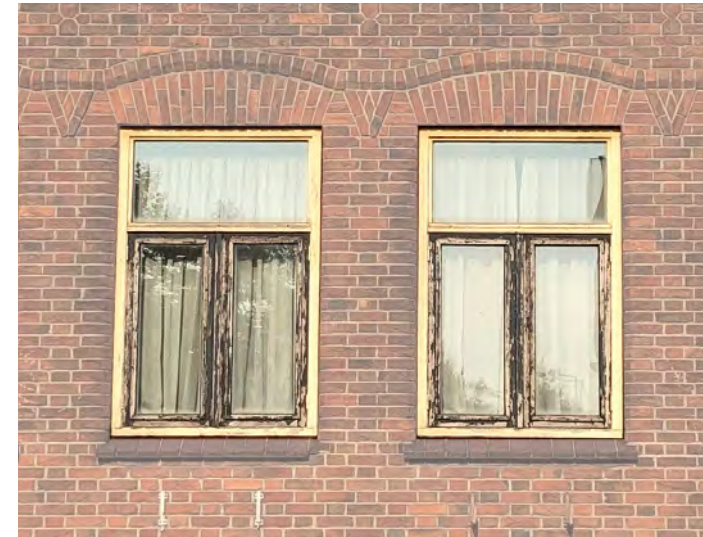
Fig. 90a: Wooden window frames 1940 building

In the smallest building, the carpentry is immediately visible. Namely, the doors, door frames and window frames are all built up of wood. However, the images also show that (especially) the window frames are somewhat deteriorated and are in need of a renovation.

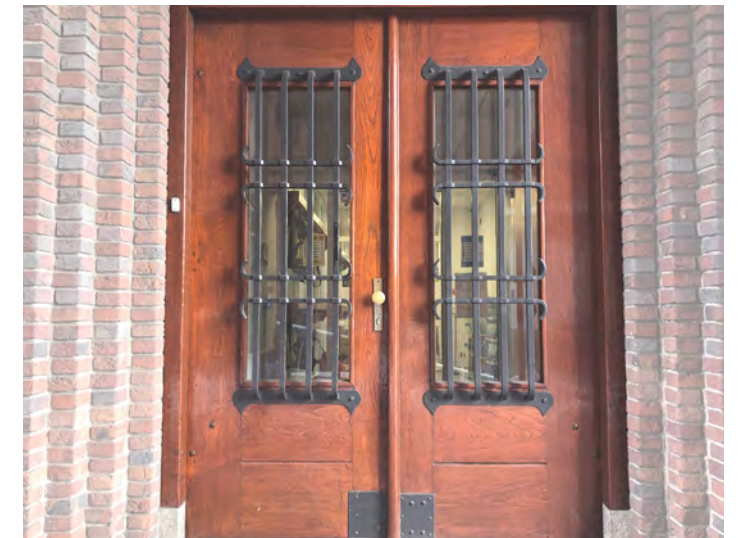
Fig. 91b: Wooden door (iron fences) 1933 building

The entrance door of the 1933 building is made of wood as well, as shown on figure 91b. This is the only wooden element that is visible from the outside. However, it does contribute to the monumental character. After entering the building, more wood is visible in the interior. As an example, the majority of the doors inside are made of wood. Thereby, details like the banisters are also made of wood. Further to the top of the building, the roof has a wooden construction as well.

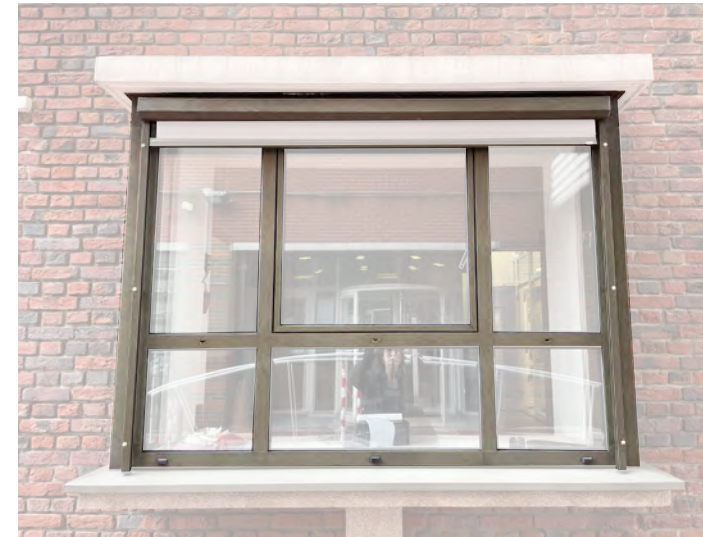
Fig. 100a: Aluminium window frame 1933 building

When looking at the 1933 building, the main material used for the window frames is aluminium. As previously said, this building has undergone a renovation in 1994 in which, among other thing, the original windows were replaced with aluminium ones. Most likely, the original material was steel, material which was largely used at the time. As said, all windows were replaced, but the original shapes were maintained, except for the fact that five windows were removed in order to have the bridge connection between the 1933 and 1994 building. The only wooden element present, is the front entrance door which has been included since it presents some glass elements. The door, in contrast with the windows is an original element.

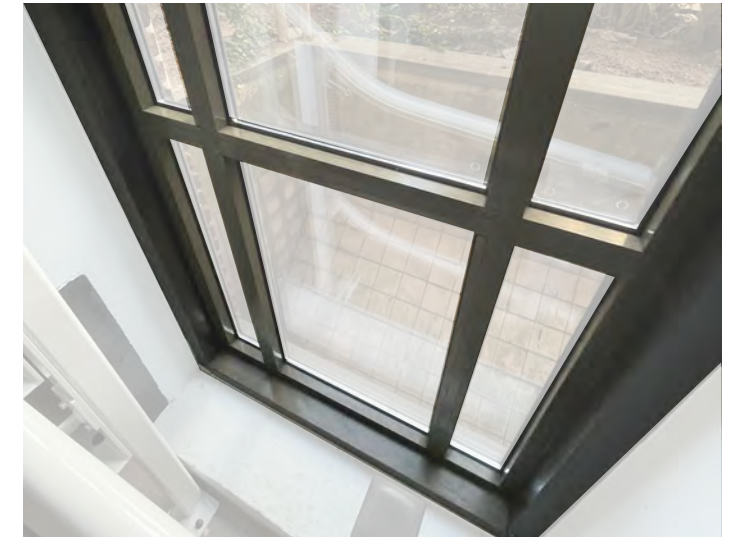
Fig. 100b: Aluminium window frame 1933 building

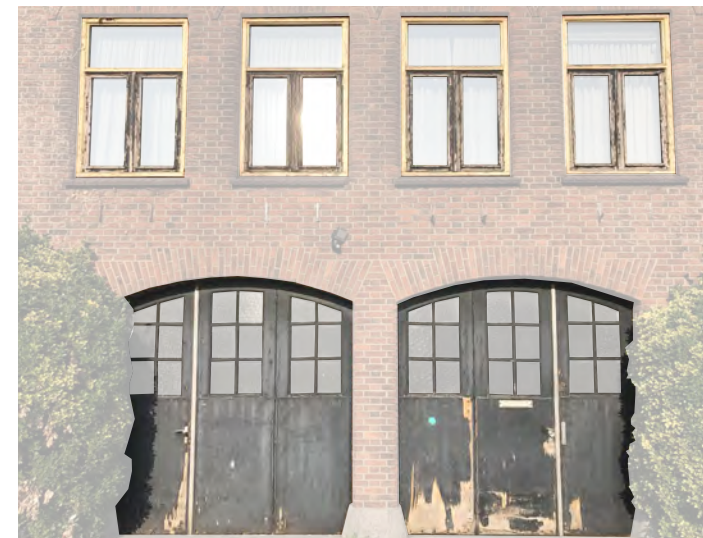
Fig. 101a: Wooden window and door frames 1940 build.

The 1940 building, besides steel window frames, presents wooden windows. Wooden windows continued to be used for residential houses even when steel became more utilised in the production of window frames.

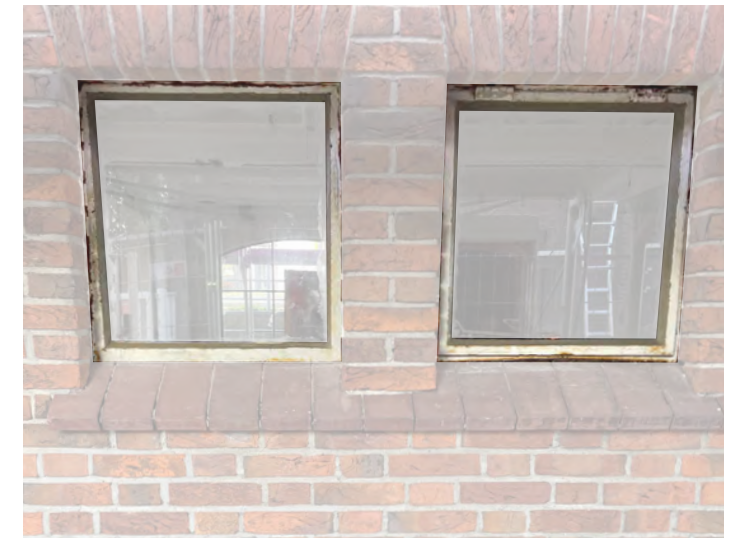
Fig. 101b: Steel window frames 1940 building

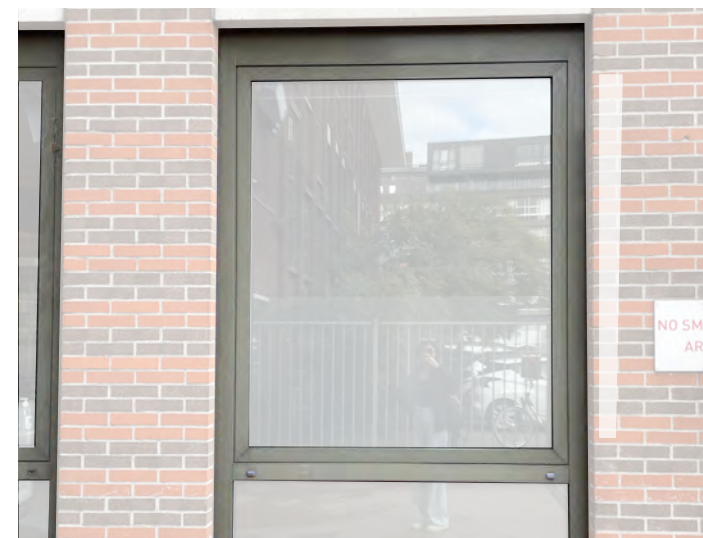
Fig. 102a: Aluminium window frame 1994 building

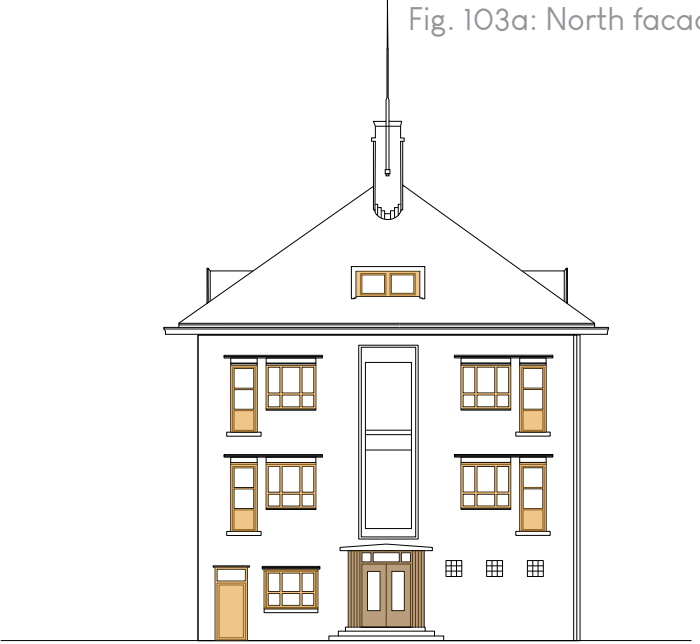
MATERIALITY OF WINDOWS

- Wood
- Steel
- Aluminium
