THE ROTTERDAM HARBOUR POLICE STATION

DAPHNE FAHRNER & DILETTA WESEL
VACANT HERITAGE | POLICE REAL ESTATE
MSc3/4 AR3AH105 | FALL 2021 -2022

This booklet is part of a graduation project of the studio Heritage & Architecture as a completion of the master programme Architecture, Urbanism and Building Sciences at the University of Technology in Delft. The graduation studio consists of a project for the Dutch Police. Due to changes in the working field, a part of their real estate needs to be redeveloped (Weessies, 2017). However, these police buildings, located throughout the Netherlands, deal with unique elements such as security fences and partially closed facades. This means that they cannot simply be regarded as ordinary real estate.

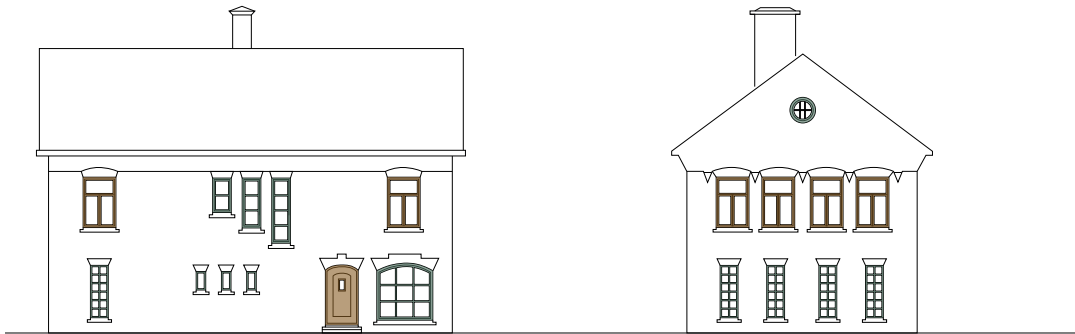
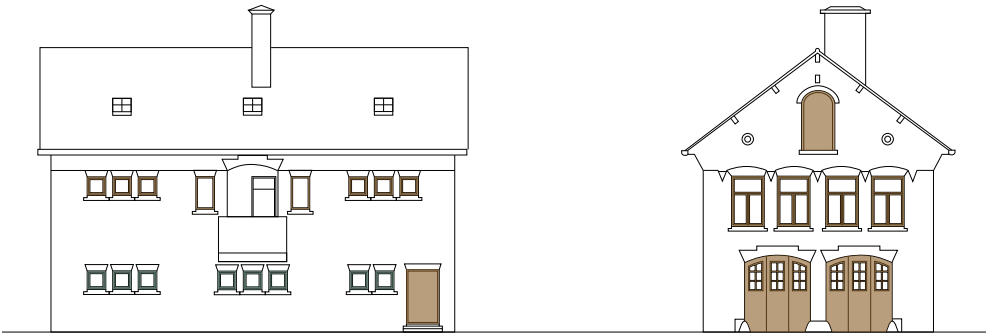
MATERIALITY OF WINDOWS

- Wood
- Steel
- Aluminium

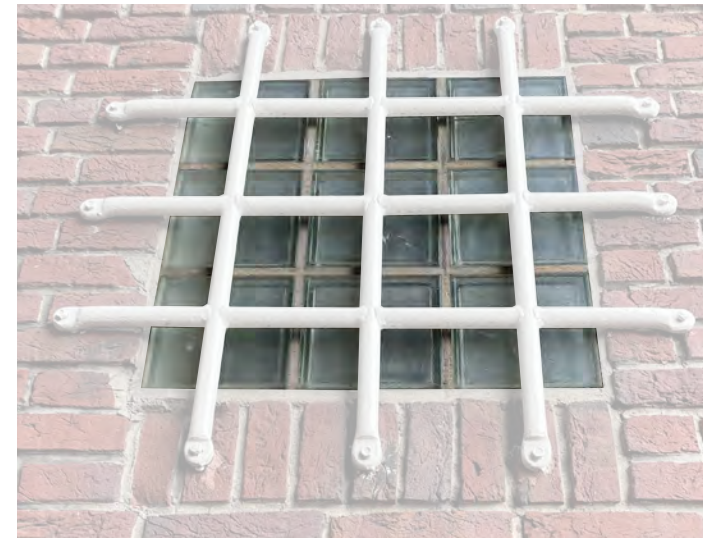
Fig. 107a: Glass brick 1933 building

Glass brick was introduced in the early 1800's to provide light to cellars and ships' bowels. In the 1900's, thanks to the introduction of glass manufacturing, it became possible to introduce glass blocks as a large-scale spatial element. It was not until the 1930's that the further development of machine production produced more satisfactory types which were easier to work. Glass block can be used both as wall components or as floor components. In the 1933 building, these have been used as wall components in order to ensure light into cellars.

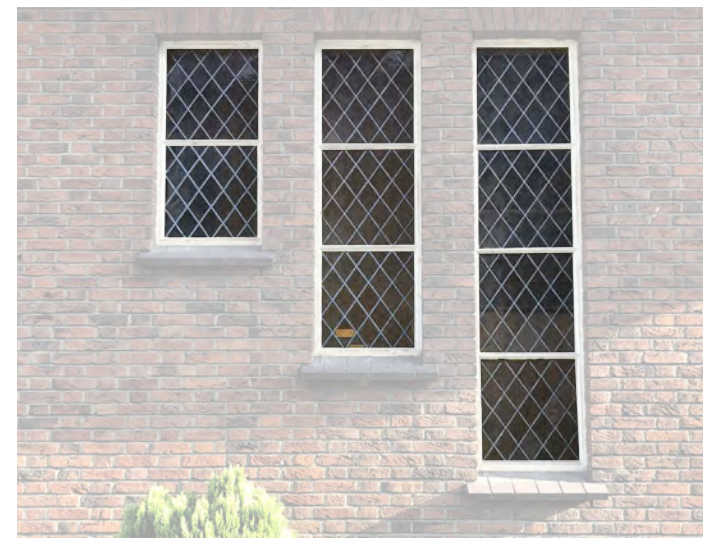
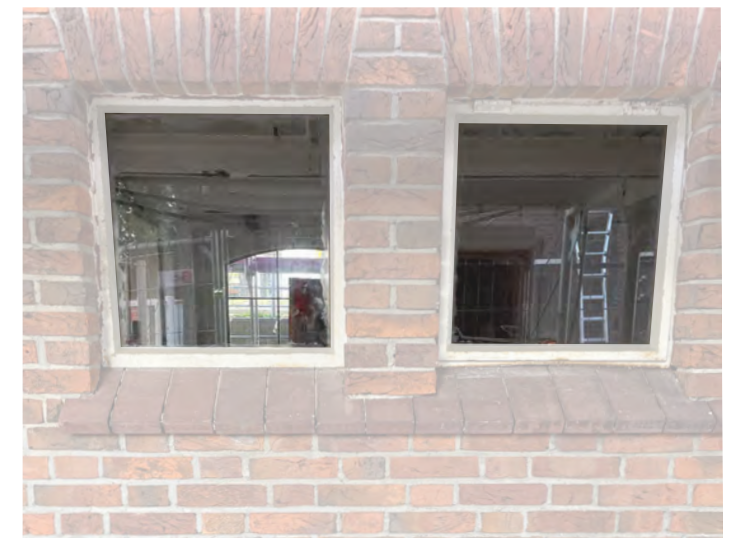
Fig. 108a: Single glazing 1940 building

Fig. 108b: Single glazing 1940 building

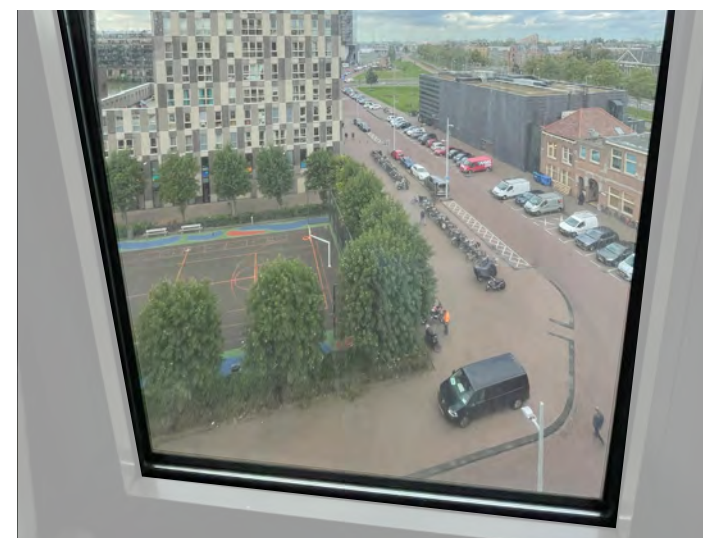
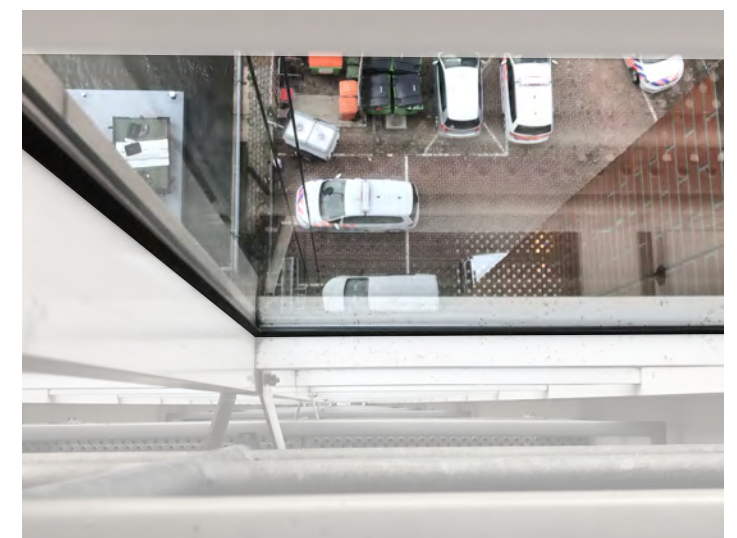
Fig. 109a: Double glazing 1994 building

Fig. 109b: Double glazing 1994 building

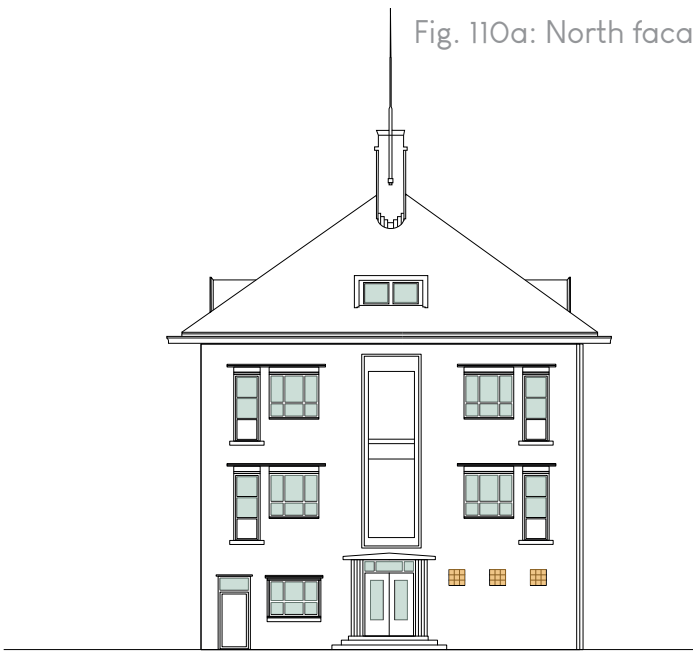
GLAZING

The 1933 building presents overall double glazing. This is the result of the renovation that took place in 1994. Only a small number of windows have remained the same. These, which can be seen (in green) are present on the East facade, which is facing the water. These windows are placed in the basement. Moreover, three windows (in yellow) placed on the South facade are made out of glass block. Unless the original glass blocks had been damaged and therefore needed to be replaced, it can be assumed that these are original as well since the use of glass blocks was introduced in the late 19th century, and since these appear in the original facade drawings.

- Double glazing
- Single glazing
- Glass block

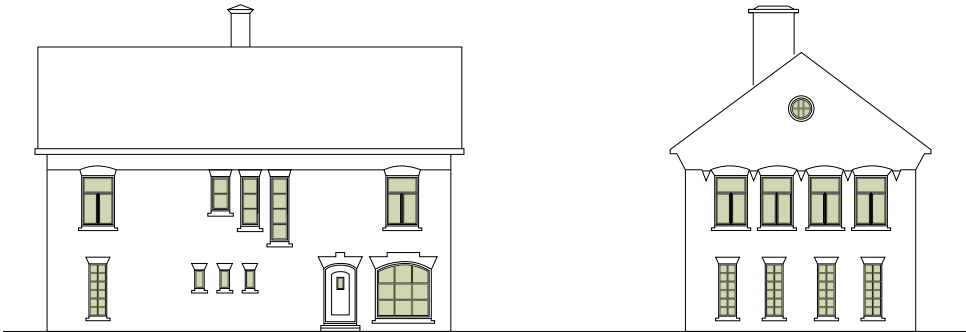
GLAZING

- Double glazing
- Single glazing
- Glass block

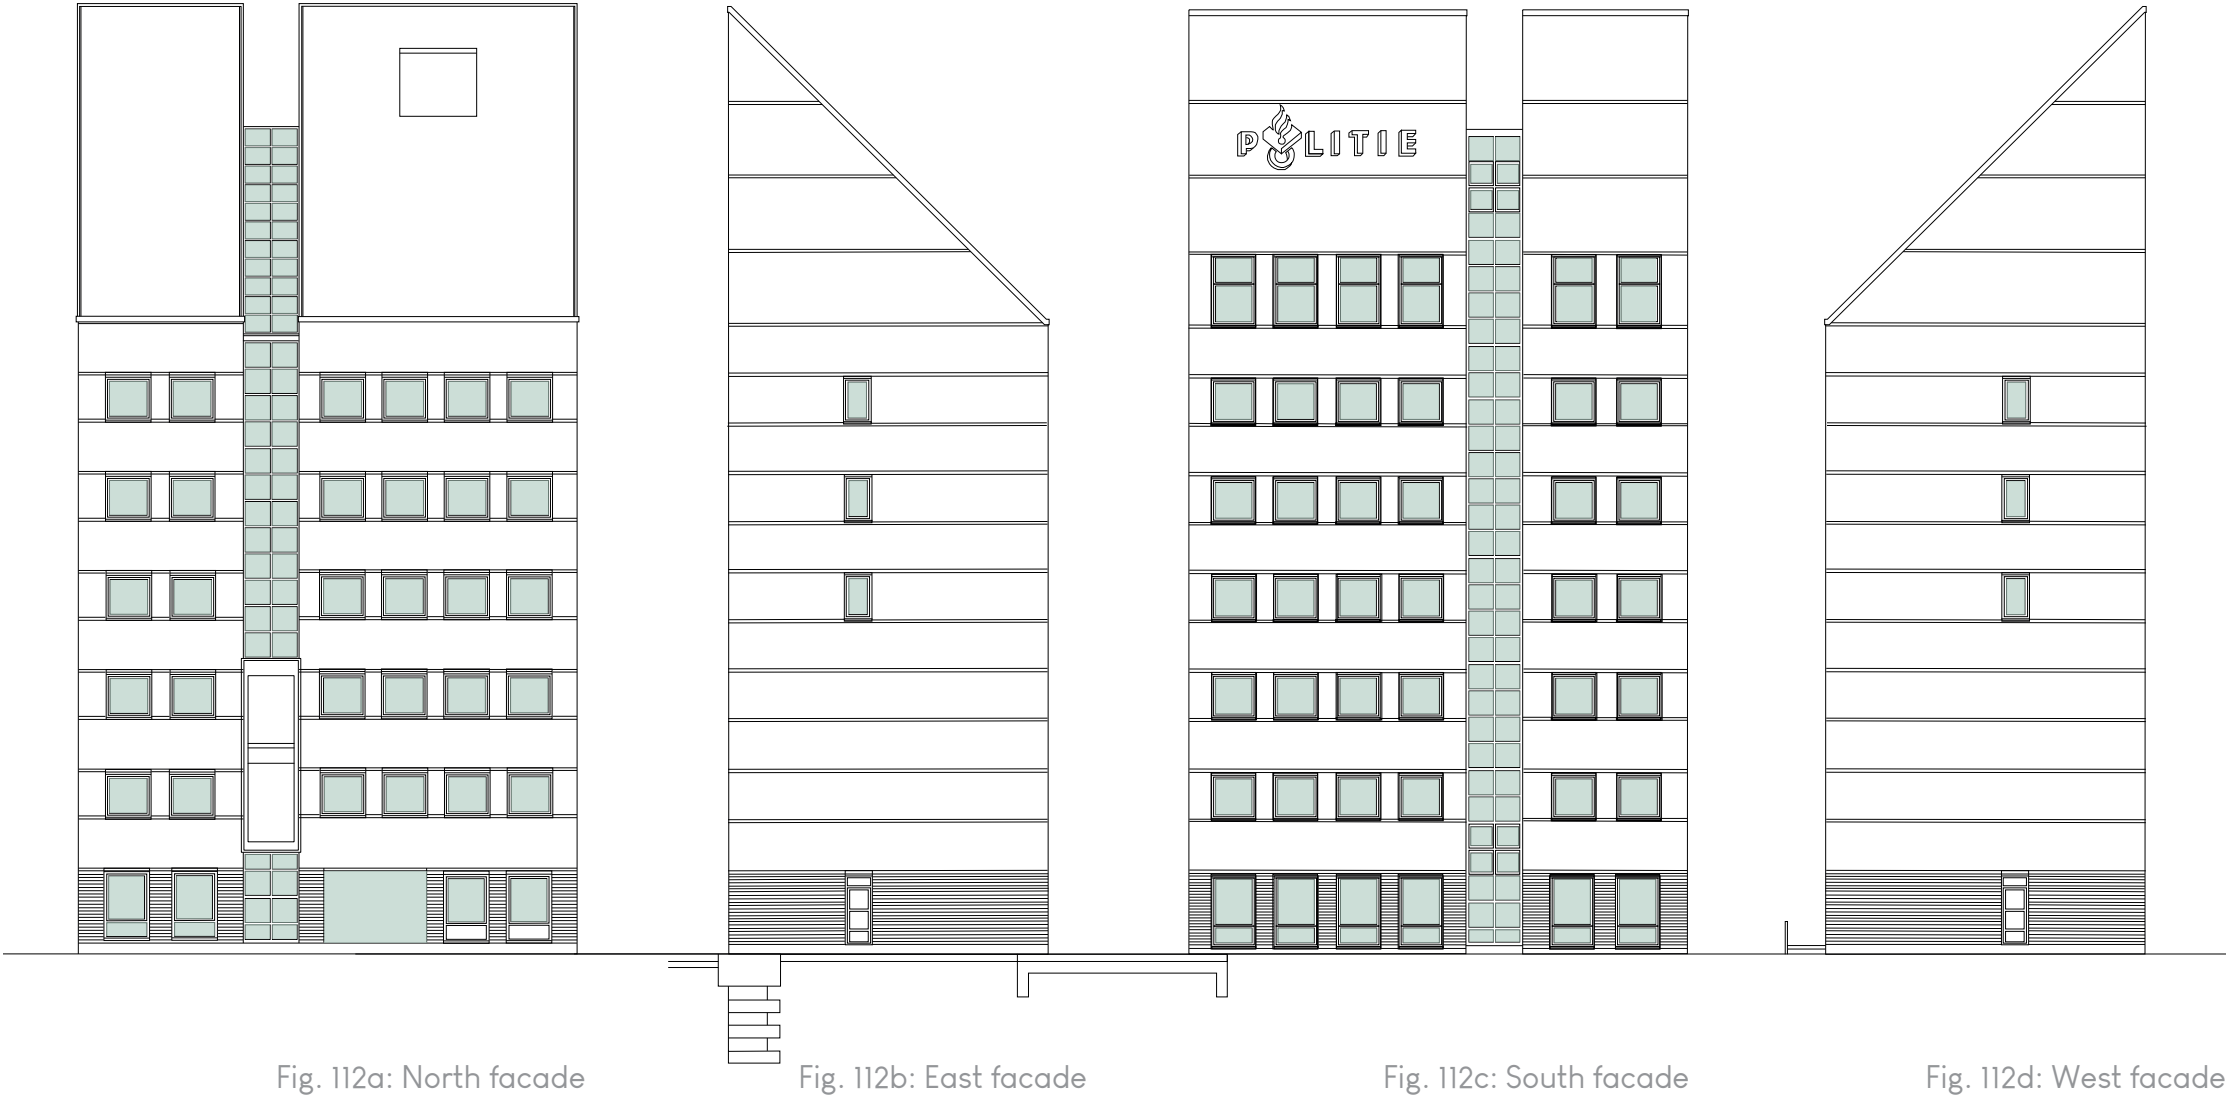
- Double glazing
- Single glazing
- Glass block

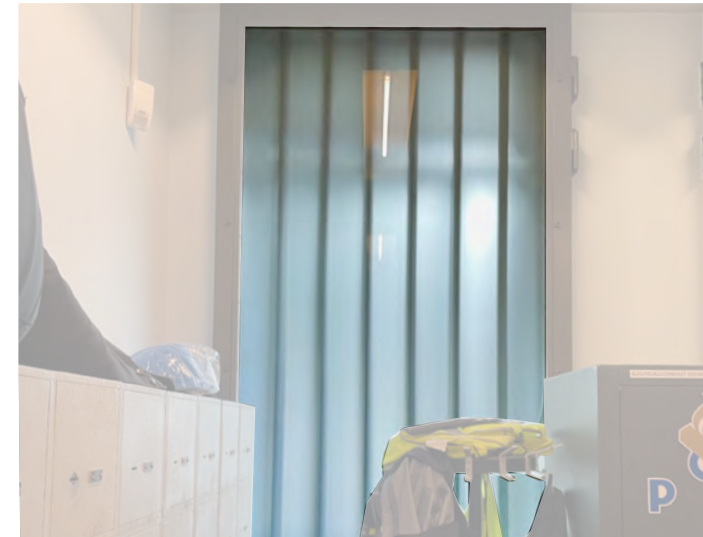
Fig. 114a: Frosted glass 1933 building

Frosted glass is used in the 1933 building in order to give privacy. In fact, frosted glass is a transparent sheet of glass that is turned opaque through sandblasting or acid etching.

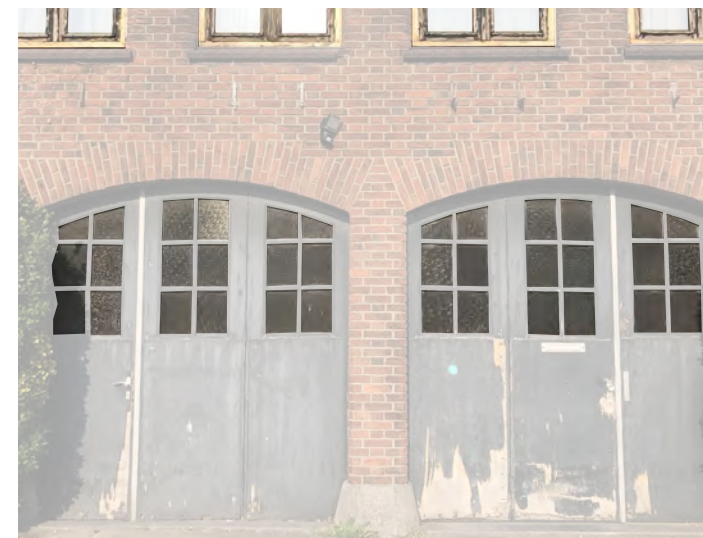
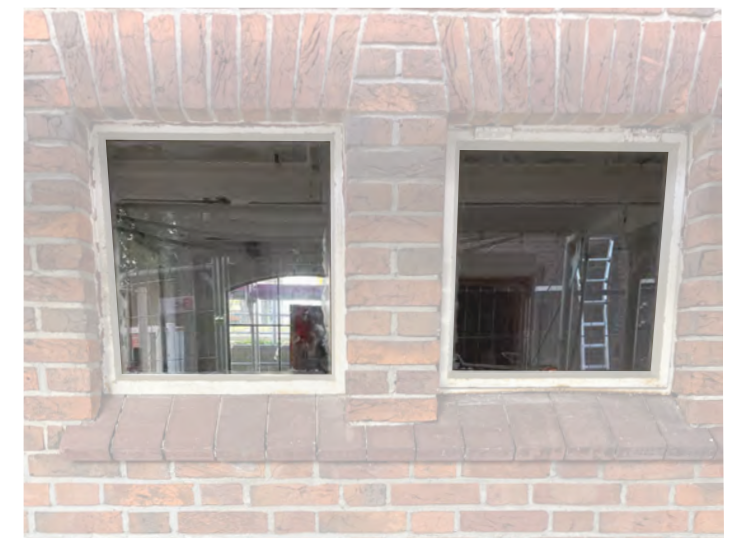
Fig. 115a: Stained glazing 1940 building

Fig. 115b: Transparent glazing 1940 building

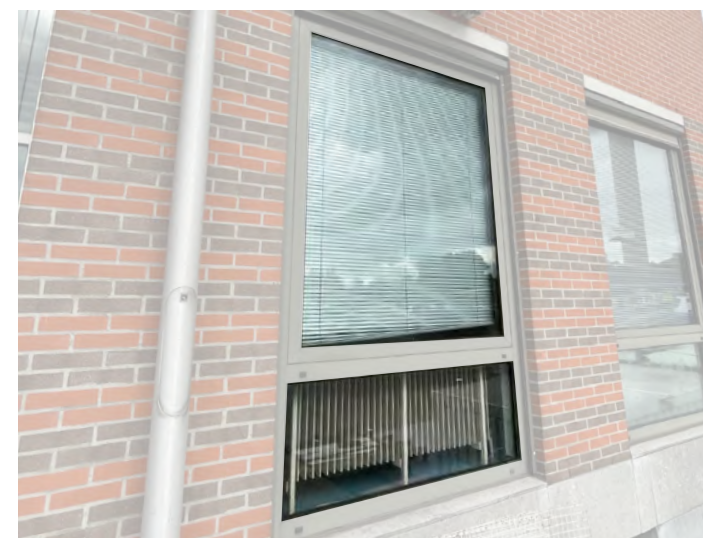
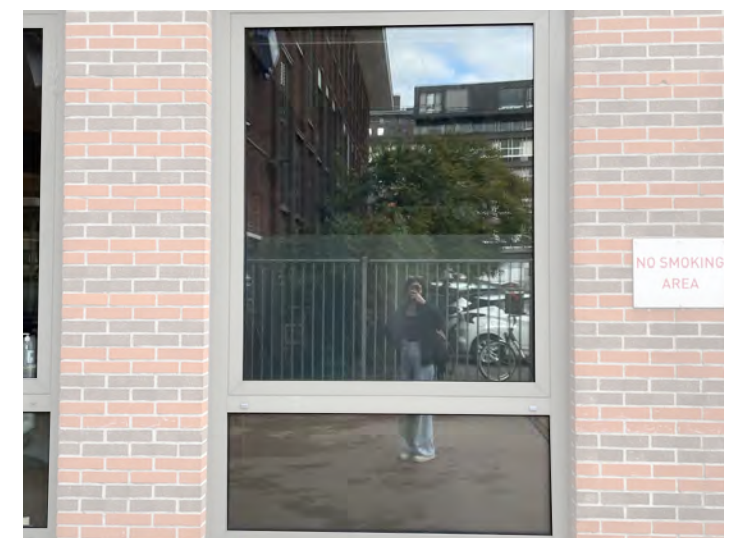
In the 1994 building some part of a number of windows placed on the ground floor present a part of glass which reflect the surface. This has been done in order to give privacy to the interior.

Fig. 116a: Transparent glazing 1994 building

Fig. 116b: Transparent, Reflective glass 1994 building

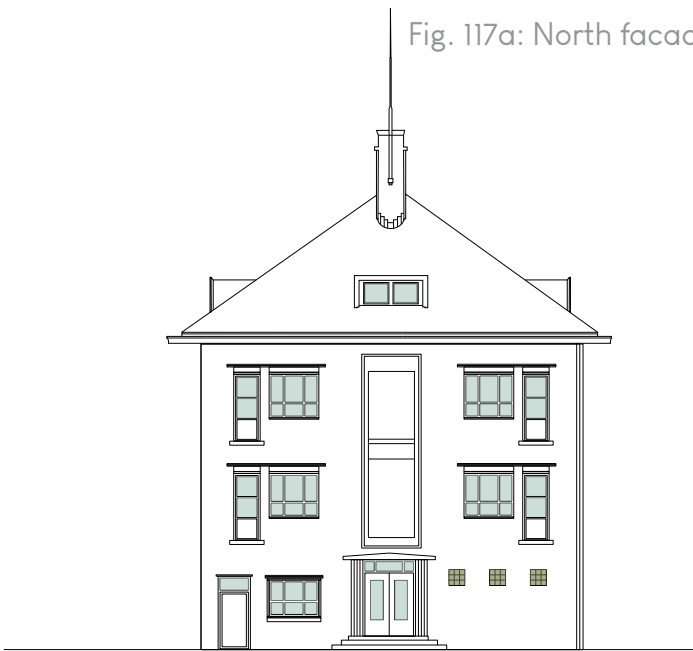
GLASS TRANSPARENCY

- Transparent
- Frosted glass
- Stained glass
- Reflective

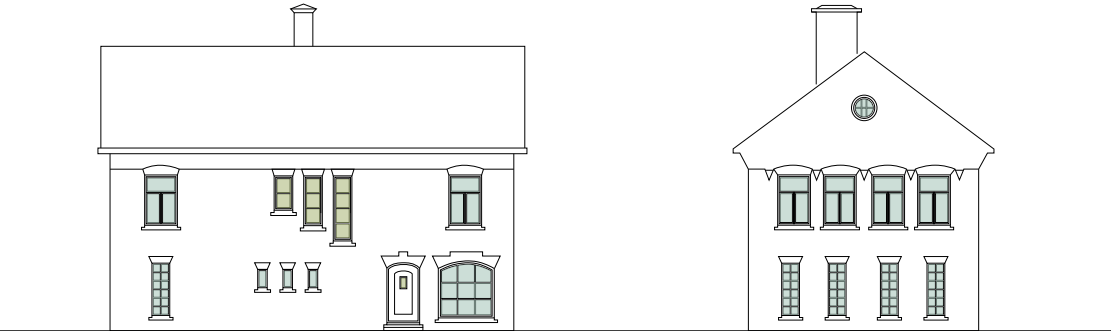
GLASS TRANSPARENCY

When looking at the glass transparency of the 1940 building it is visible that it presents both transparent and frosted glass, as can be seen in the image on the right. Most of the windows are transparent expect, the steel frosted windows placed on the first floor, which are placed in proximity of the staircase, and the windows placed on the ground floor of the West facade. These are placed in the doors of what used to be the main entrance to the shop placed on the ground floor.

- Transparent
- Frosted glass
- Stained glass
- Reflective

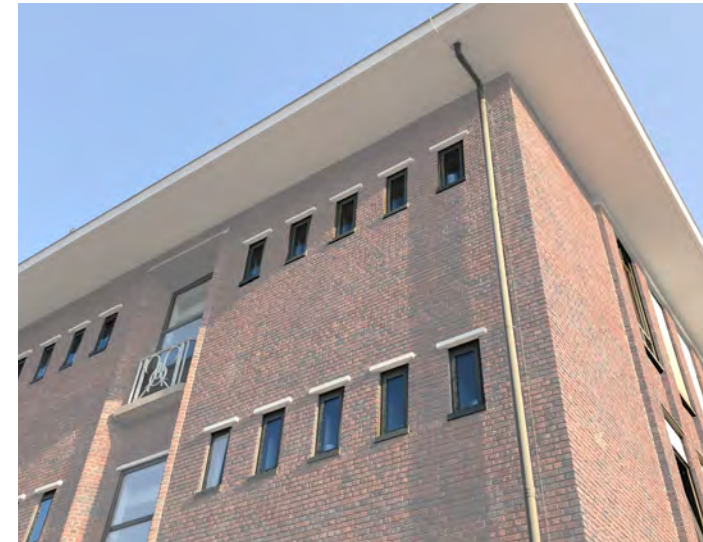
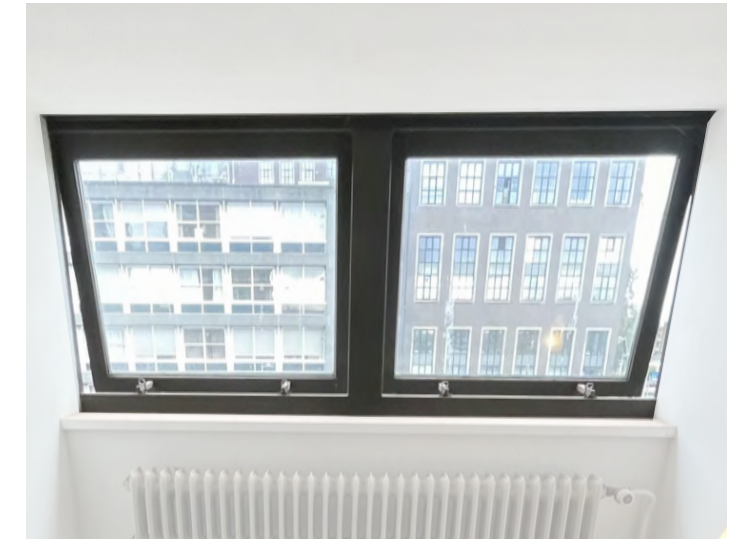
Fig. 121a: Fixed windows 1933 building

Fig. 121b: Awning windows 1933 building

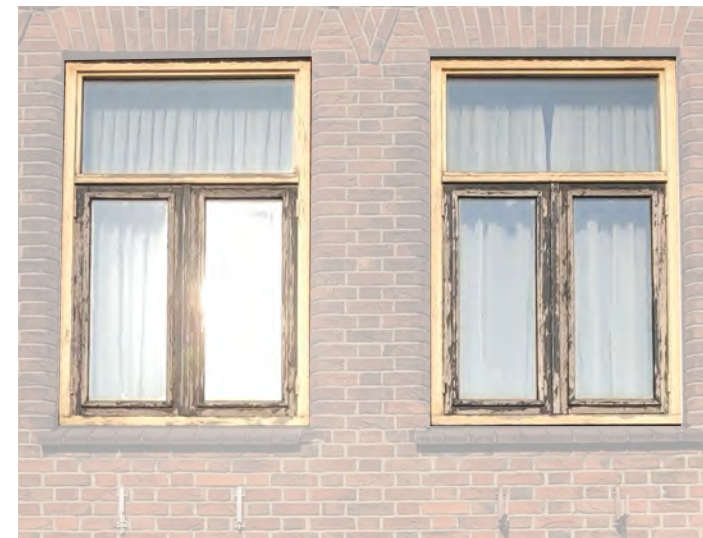
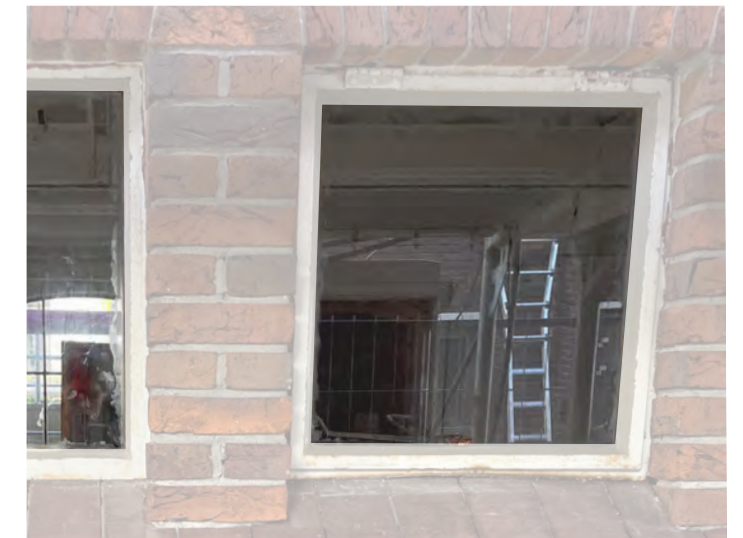
The casement windows is only present in 1940 building. This is a classic typology which is often used in residential buildings. These windows are made out of two parts which can both be opened towards inside.

Fig. 122a: Casement window 1940 building

Fig. 122b: Awning window 1940 building

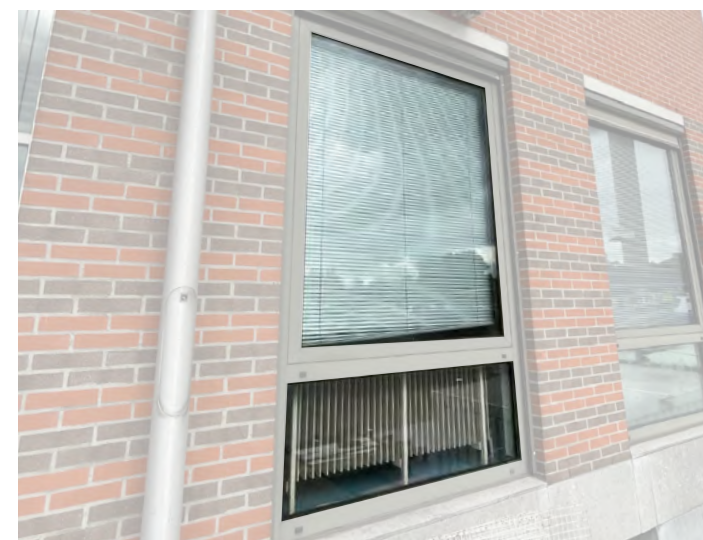
Fig. 123a: Tilt and turn + fixed window 1994 building

Fig. 123b: Tilt and turn + fixed window 1933 building

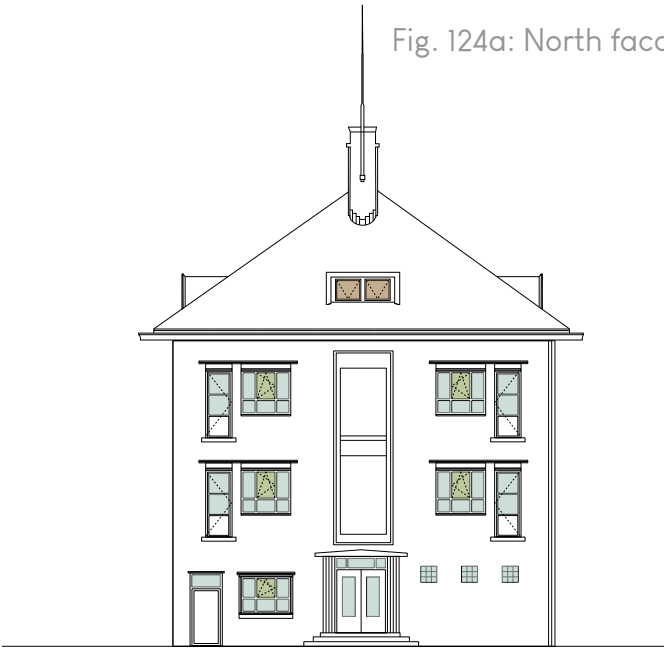
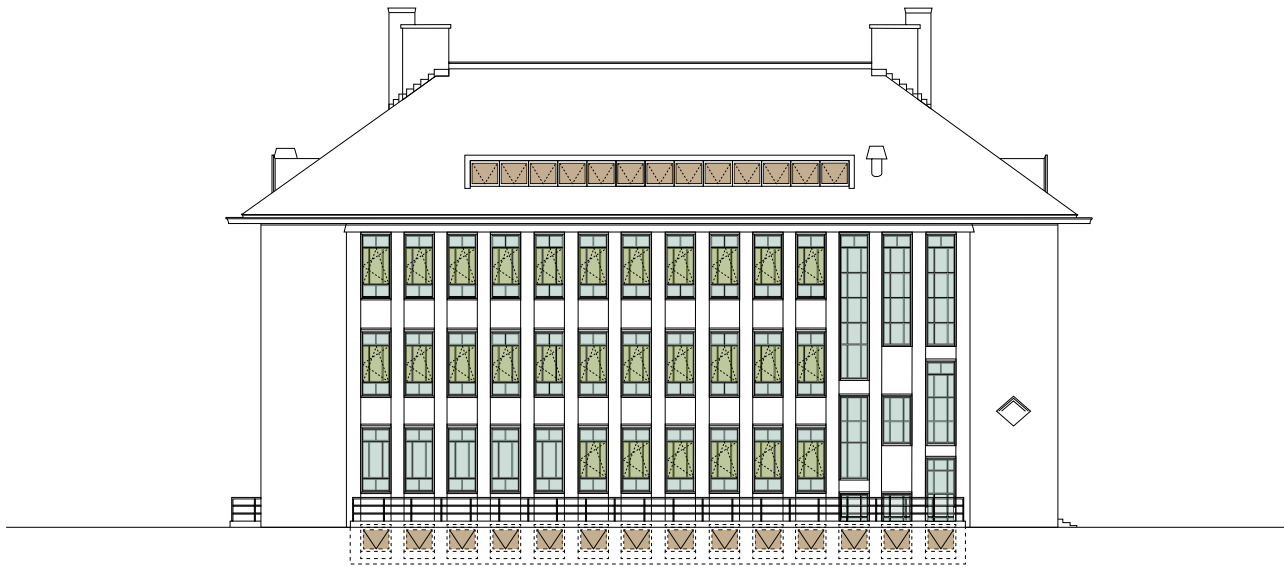
Fig. 124b: East facade

OPENING TYPOLOGY

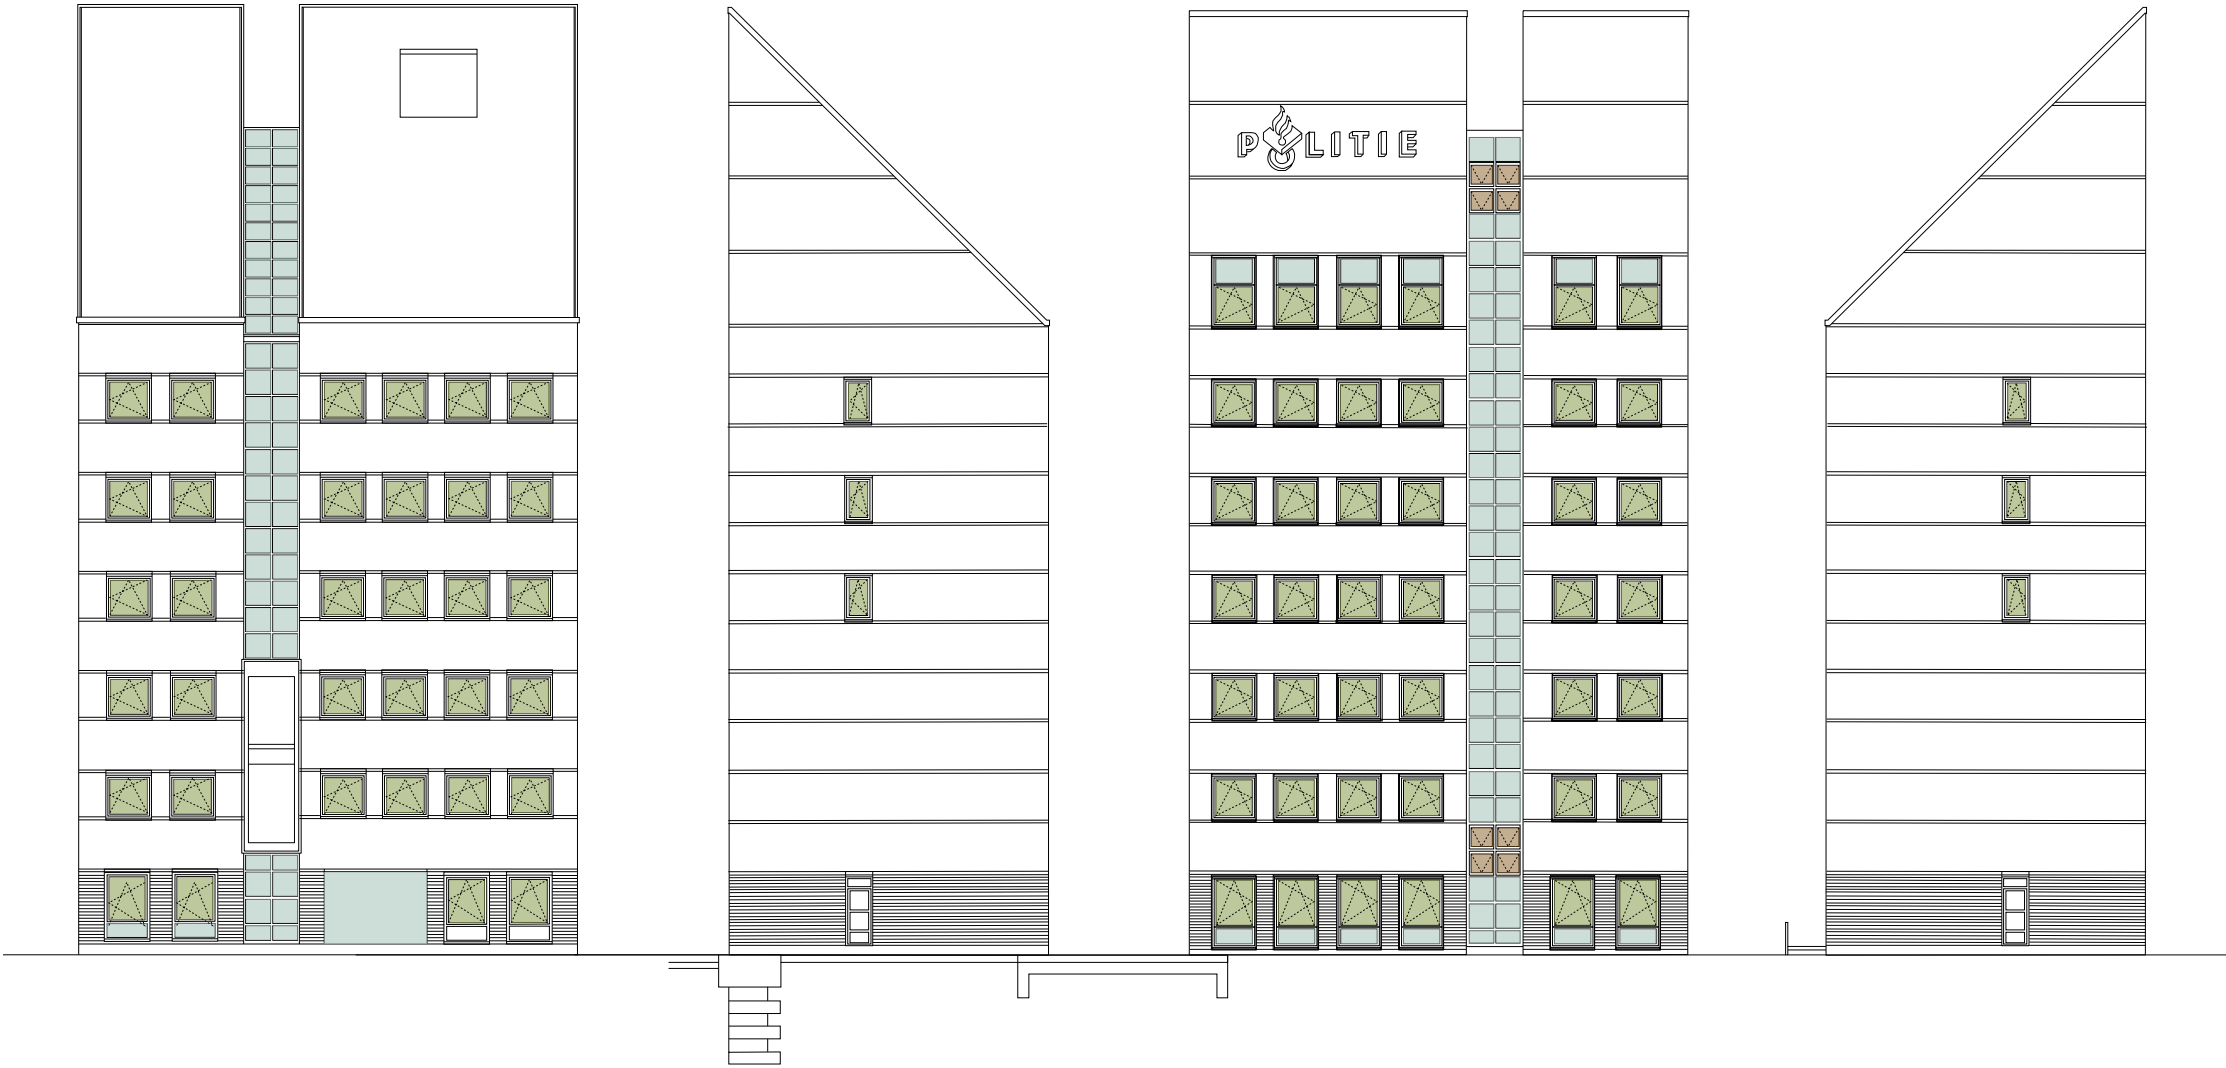
Fig. 126a: North facade

Fig. 126b: East facade

Fig. 126c: South facade

Fig. 126d: West facade

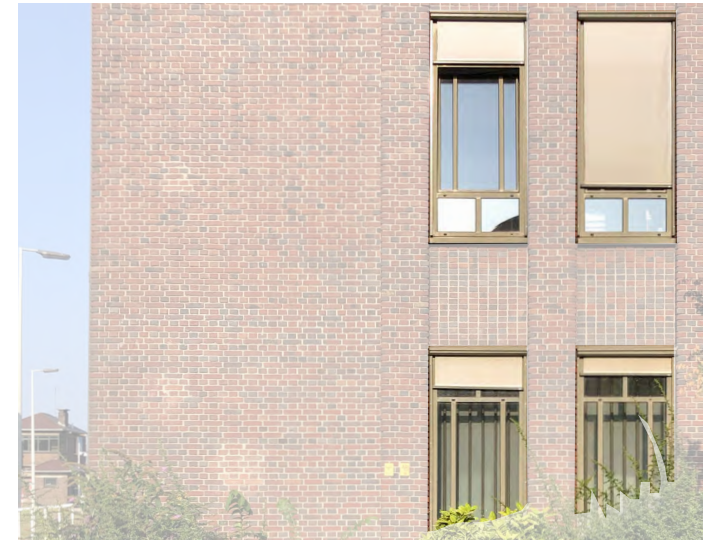
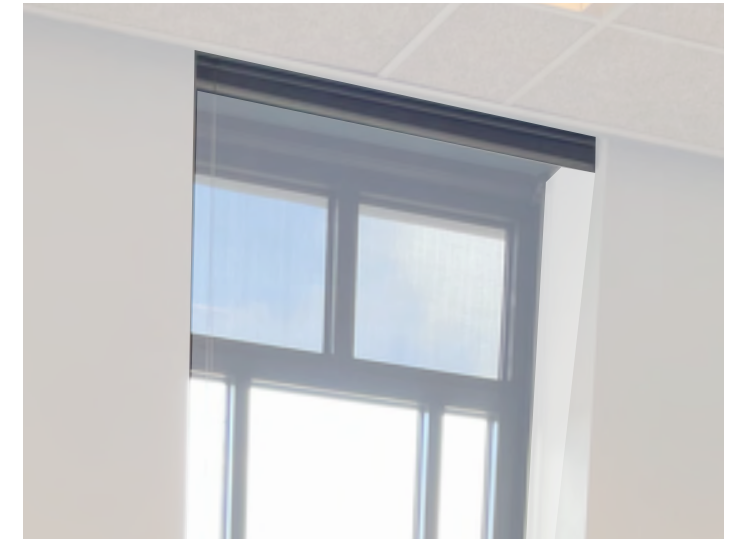
Fig. 128a: Exterior shades 1933 building

Fig. 128b: Interior shades 1933 building

The majority of the windows present, together with exterior shading, interior shades. These are venetian blinds. These, together with the exterior blinds, can give total privacy to the interior space.

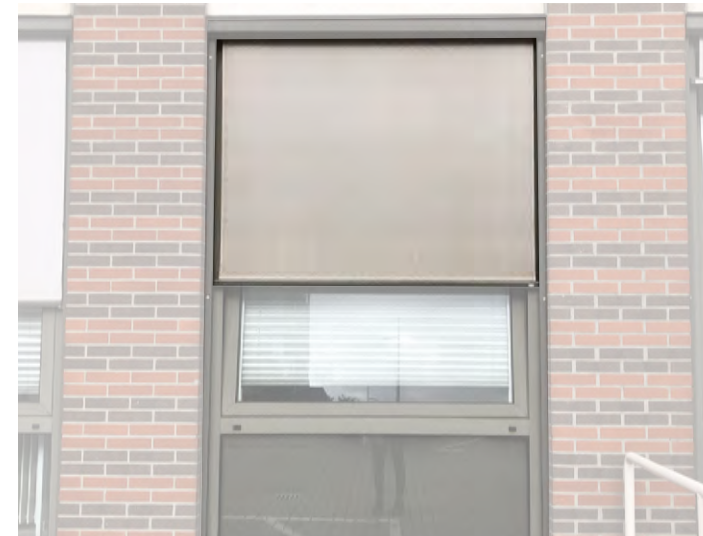
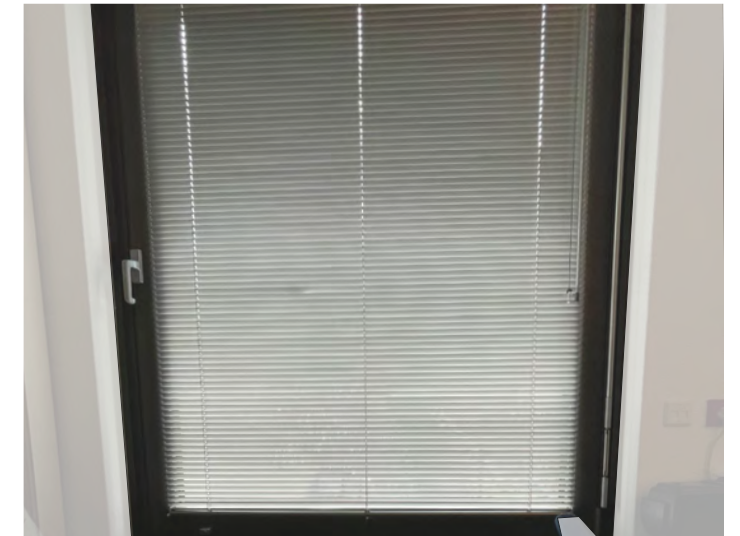
Fig. 129a: Exterior shades 1994 building

Fig. 129b: Interior shades 1994 building

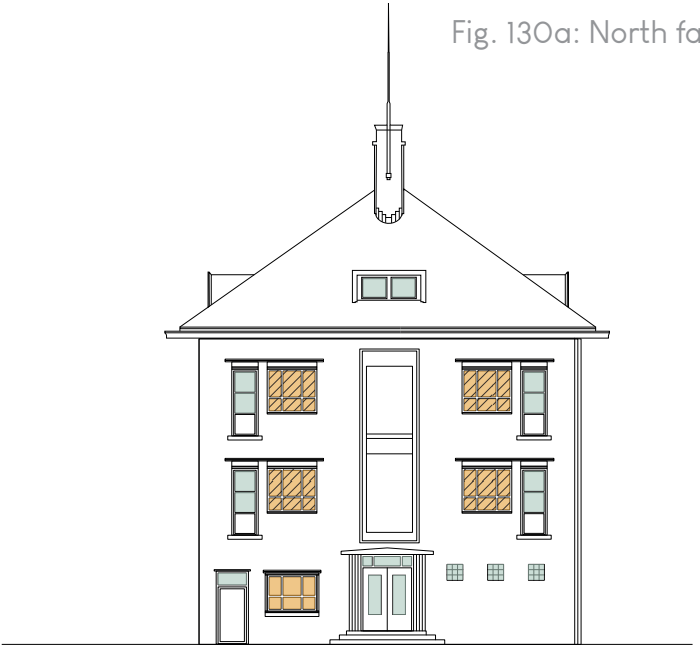
Fig. 130a: North facade

Fig. 130b: East facade

Fig. 130c: South facade

Fig. 130d: West facade

When looking at the sun shades placed in the 1933 building we can see two typologies. In fact, apart of the windows which do not present any kind of shades, neither inside or outside, to be seen in light blue, there are windows which present only external shades and windows which present both interior and exterior shades. The windows which do no present any shades are present on the North facade. The windows which do not present interior shades but do have exterior ones are placed on the West facade. These, are the ones placed in proximity of the staircase and five windows on the ground floor, in proximity of the cells. All the exterior sun shades are automatized and unfold them self when there is too much light penetrating the interior.

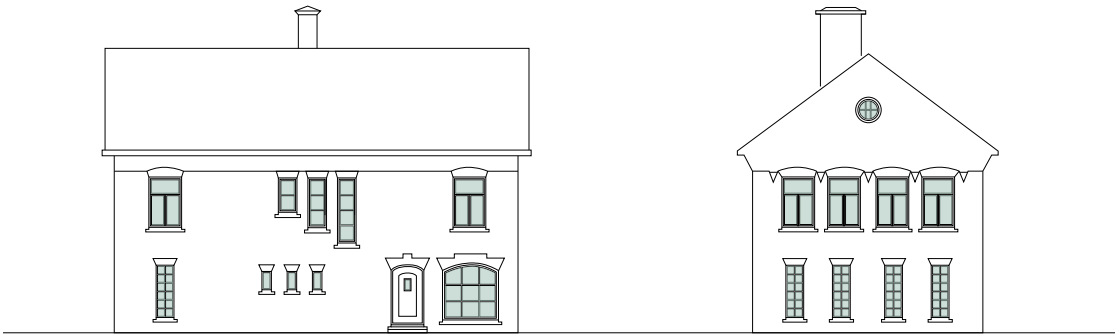
Fig. 131a: North facade

Fig. 131b: East facade

Fig. 131c: South facade

Fig. 131d: West facade

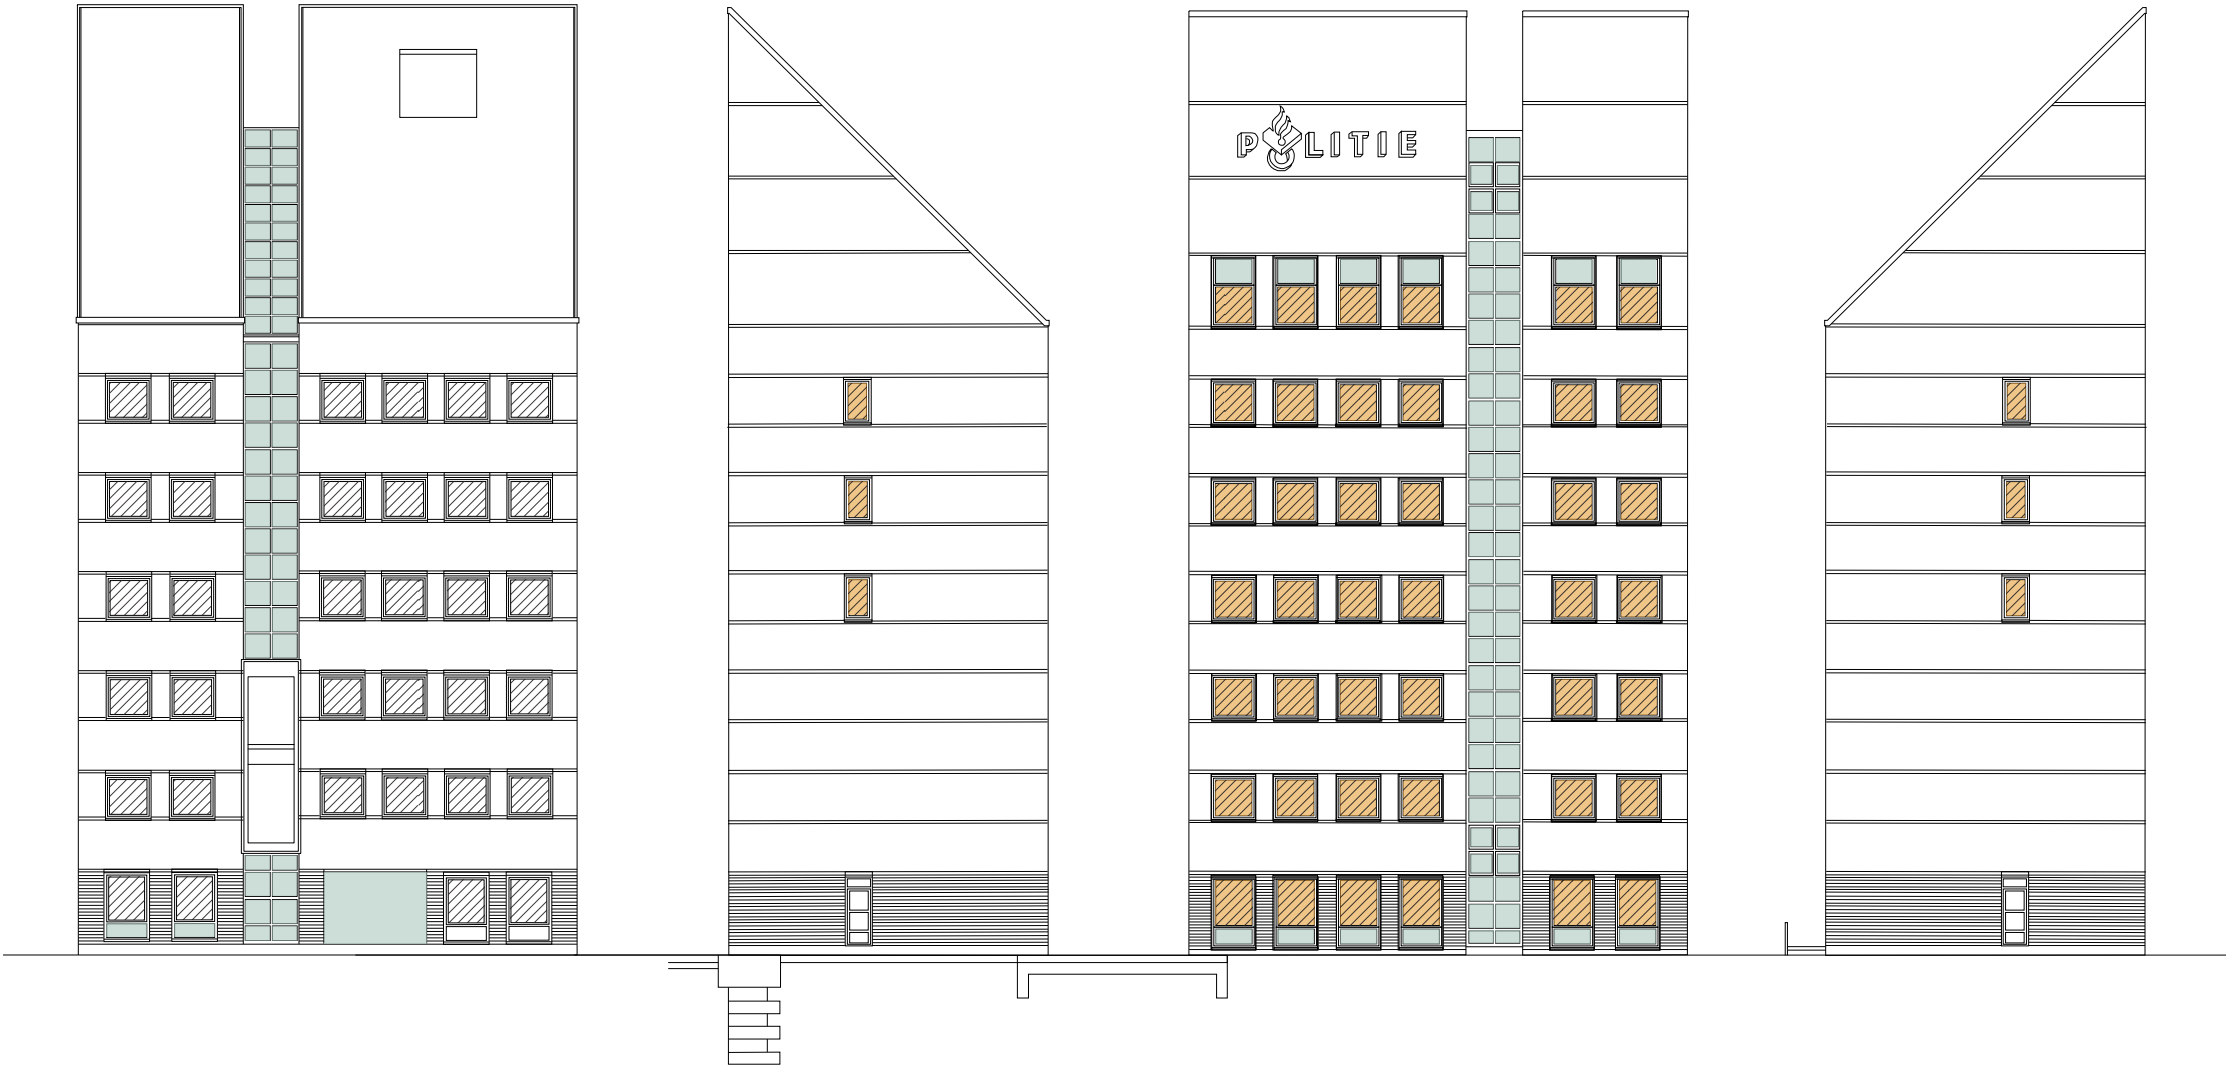
Fig. 132a: North facade

Fig. 132b: East facade

Fig. 132c: South facade

Fig. 132d: West facade

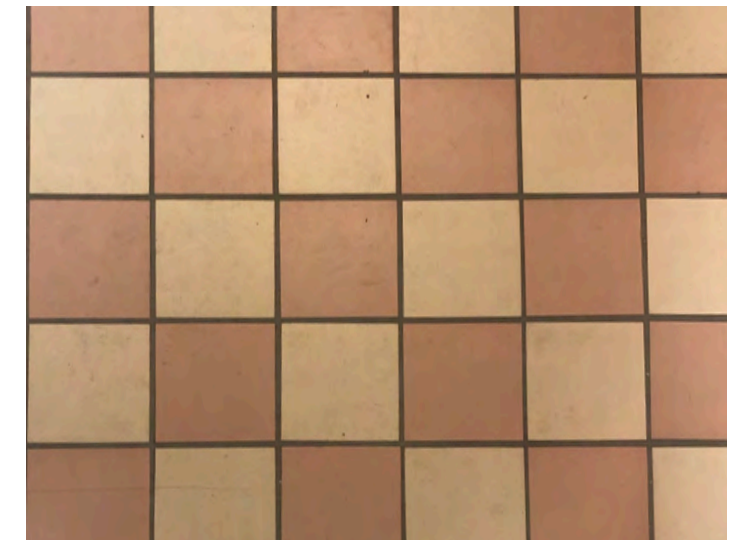
Fig. 134a: Light tiling

Fig. 134b: Light tiling

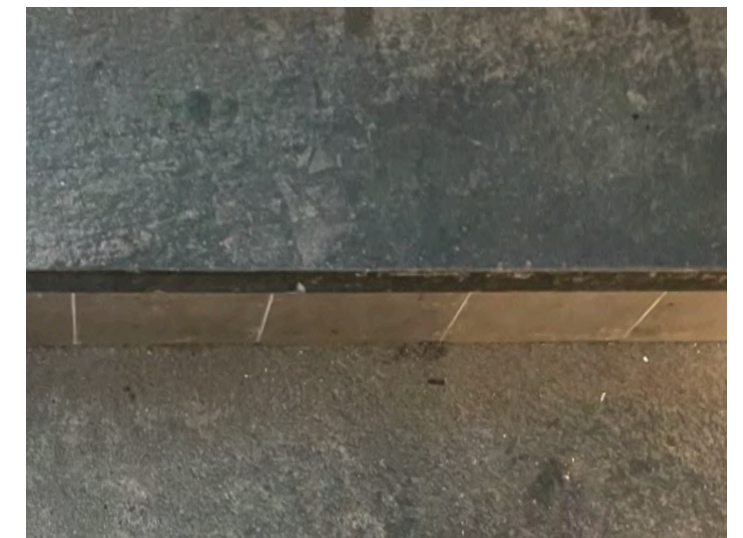
Fig. 135a: Materiality of the stairs

Fig. 135b: Materiality of the stairs

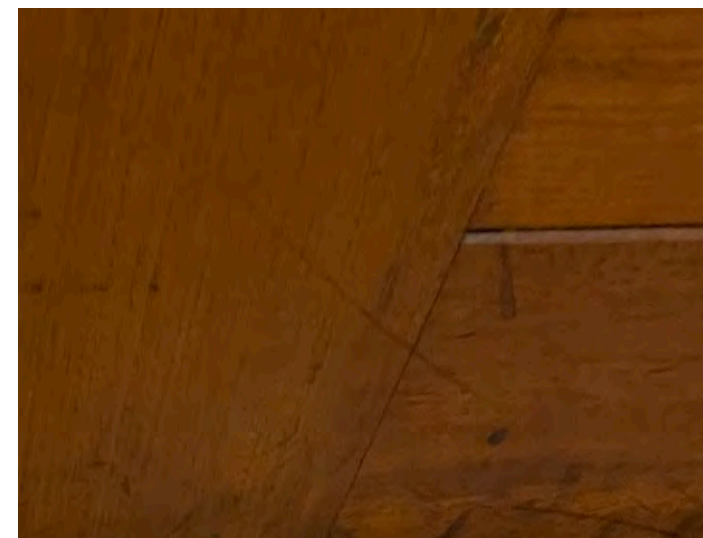
Fig. 136a: Wooden door

Fig. 136b: Board doors

The doors of both buildings are, similar to the tiling, quite consistent. The majority of the doors are added during the renovation and new construction and they appear in orange and blue. They are assumed to be board doors with a flat, flush inner door and honeycomb filling. In the 1933 builing another kind of door is used as well. The old original wooden doors, bordering the corridor, are conserved and thus still in use. The majority of both type of doors have glass panels, which contribute to the transparency within the buildings. Nevertheless, the more private functions like bathrooms and toilets are of course provided with solid doorspanels.
