Booklet: Monumental analysis

Oudezijds Voorburgwal 30, Amsterdam

INTRODUCTION

This booklet was created for a thesis about the energy renovation of monumental buildings (Green Light District: Energy renovation of monumental buildings). The objective of the thesis is to create a generic approach for the energy renovation of monumental buildings. The scope of the research is limited to monumental buildings constructed before 1900 in the city of Amsterdam.

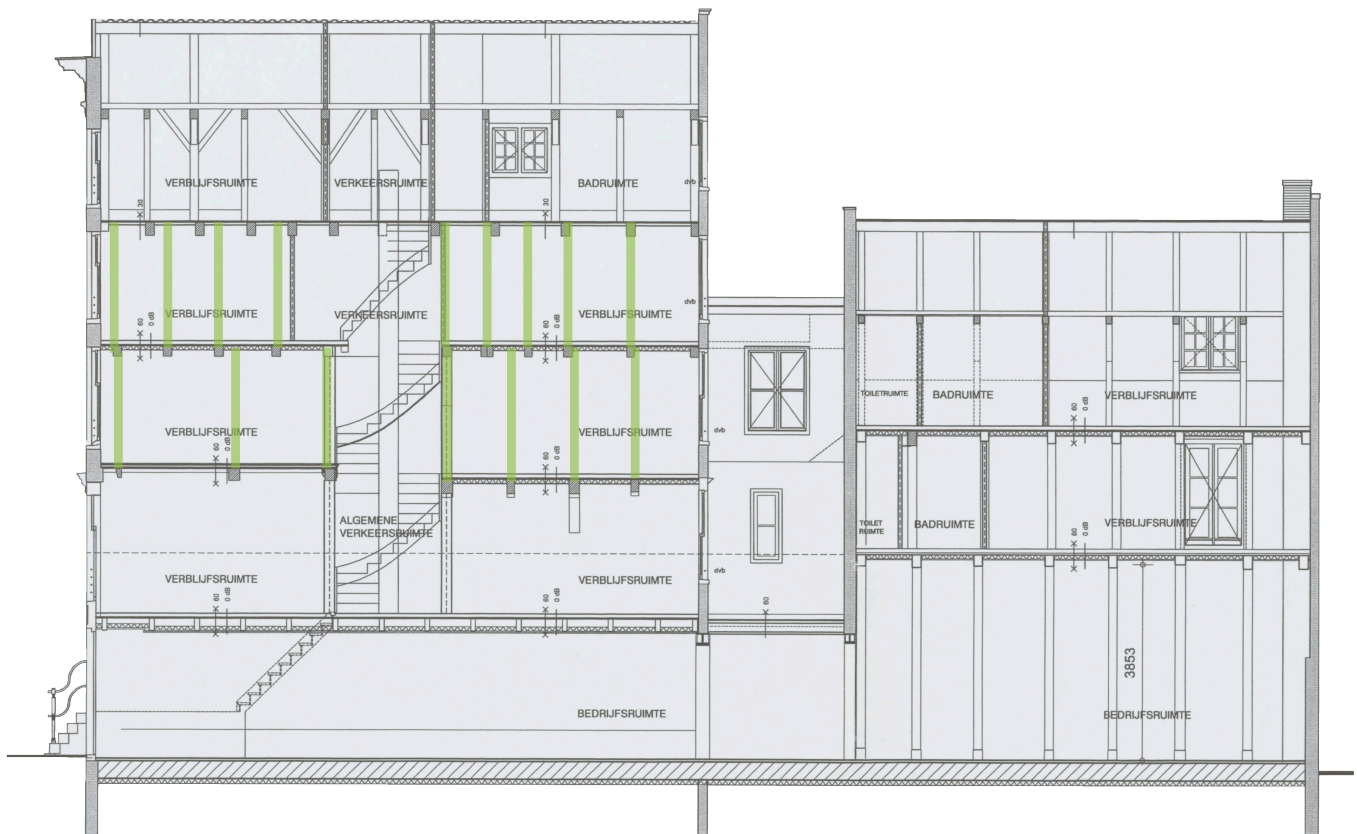
Section. Source: Adapted from Stadsarchief Amsterdam, 2005.

When looking at the floor structures of the different floors of the front house in the section it can be noted that the floor beams are not vertically parallel. A difference in the position of the floor beams can also be noted in the floor plans (see blue circles on next page). That the floor beams are no longer vertically in line can confirm that the wooden structure is no longer in use. After all, with the use of constructive walls the beams do not have to be vertically parallel. It could also confirm that the floors have been altered through the centuries. However, if the load bearing structure has always consisted of the walls, the floors did not necessarily have to be vertically parallel from the construction on.

At the fourth floor of the front house the distance between the floor beams is quite regular. This could indicate that the fourth floor was added later on, this will be elaborated on further in the analysis.

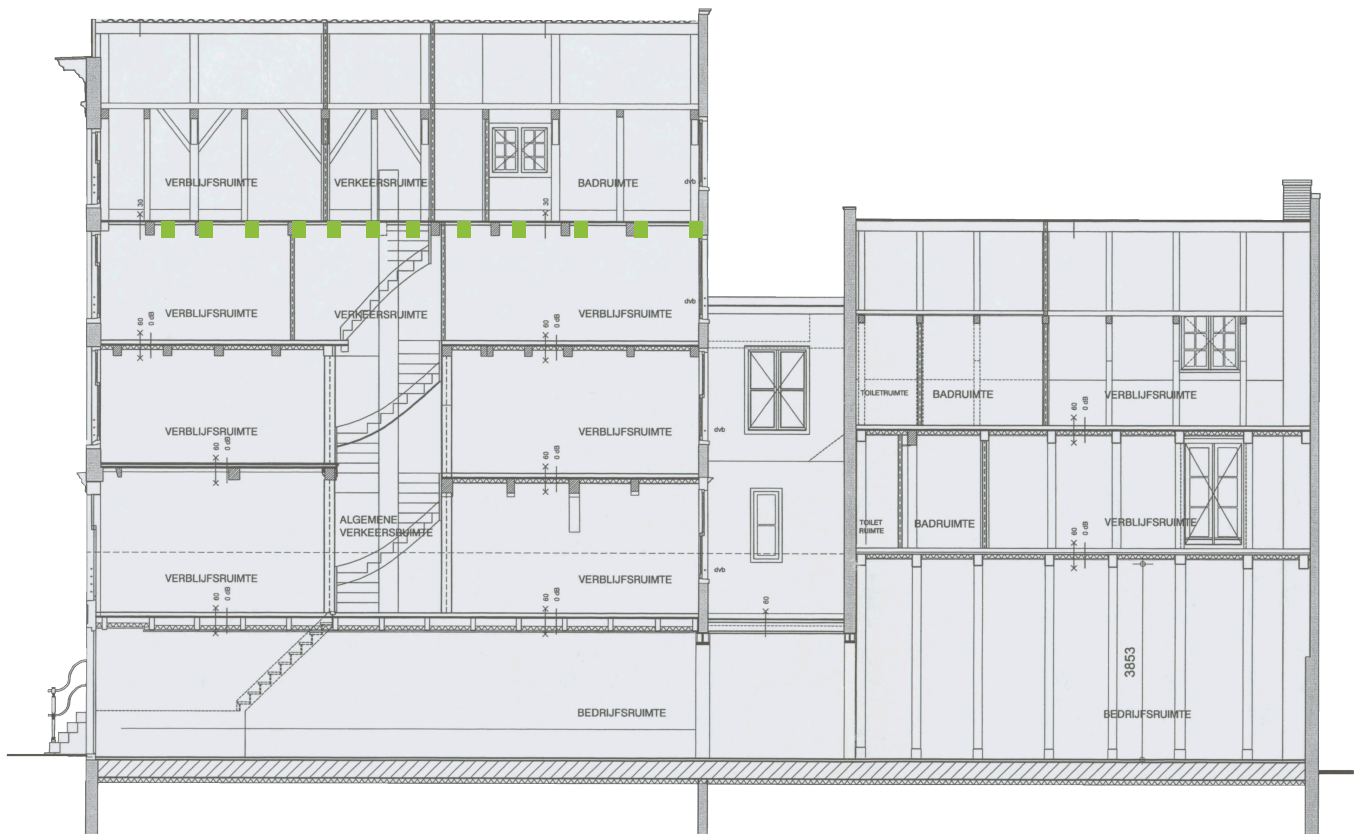
Section. Source: Adapted from Stadsarchief Amsterdam, 2005.

The floor structure of the fourth floor of the front house is quite symmetrical. This could be an indication that the floor was added later on. The building historical examination estimates this was done in the 18th century (de Roon & Erfgoed Amsterdam, 2005). This floor addition also makes it likely that between the original East facade and the current East facade another facade was used for the building. However, no traces were found for this during the building historical examination.

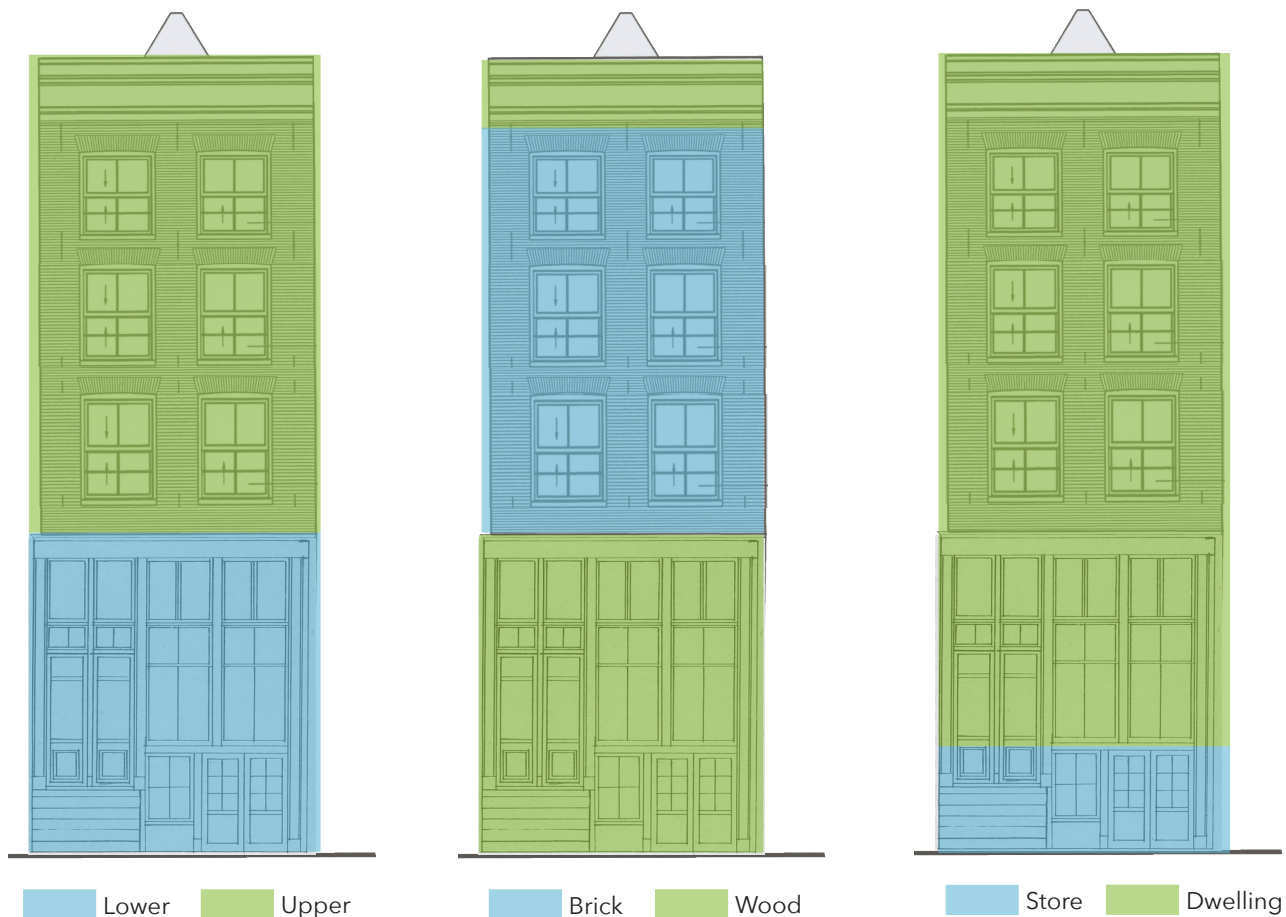
Organization. Source: Adapted from Stadsarchief Amsterdam, 2005.

Materialization. Source: Adapted from Stadsarchief Amsterdam, 2005.

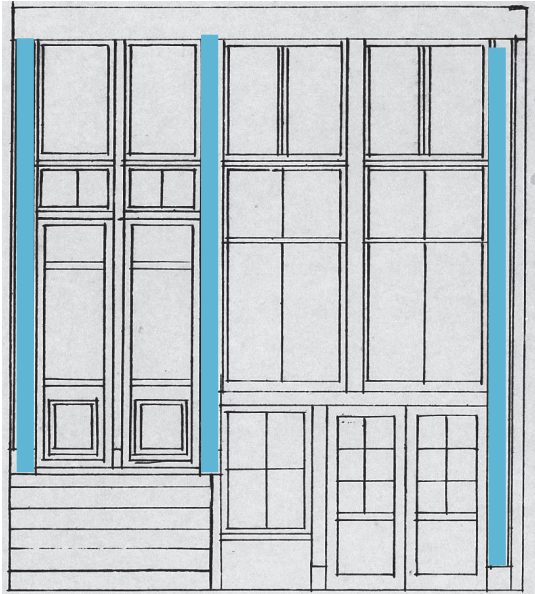
Pillars. Source: Adapted from Stadsarchief Amsterdam, 1872.

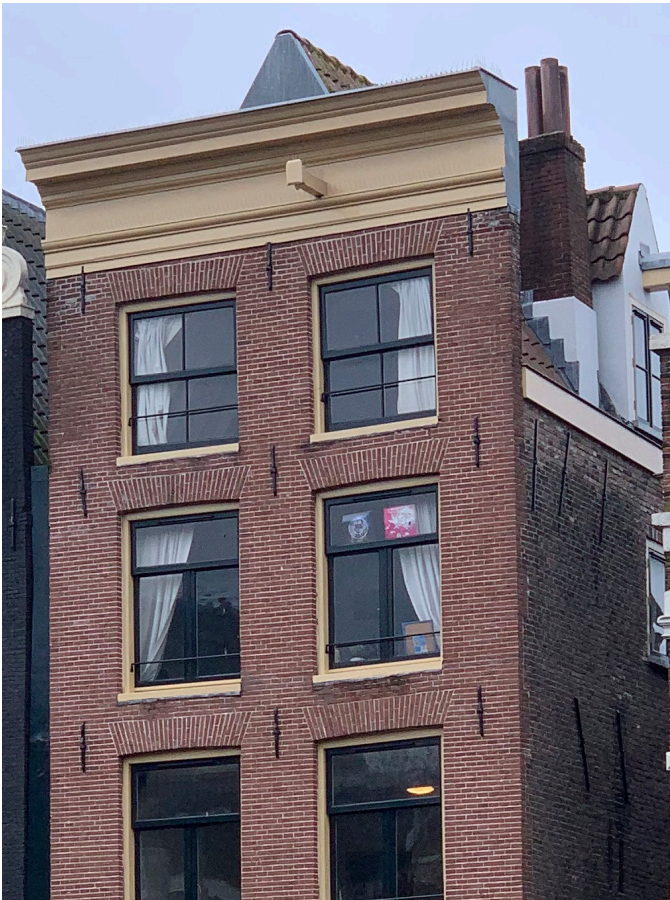
Zoom-in wooden cornice top of facade. Own picture

Zoom-in wooden lower facade. Own picture.

Looking at the material of the East facade it appears as if the facade is made from wood. However it should be noted that it is likely that the wood is just decoration 'pasted onto' a brick structure. This can be observed when looking at the pictures above. This has most likely always been the case.

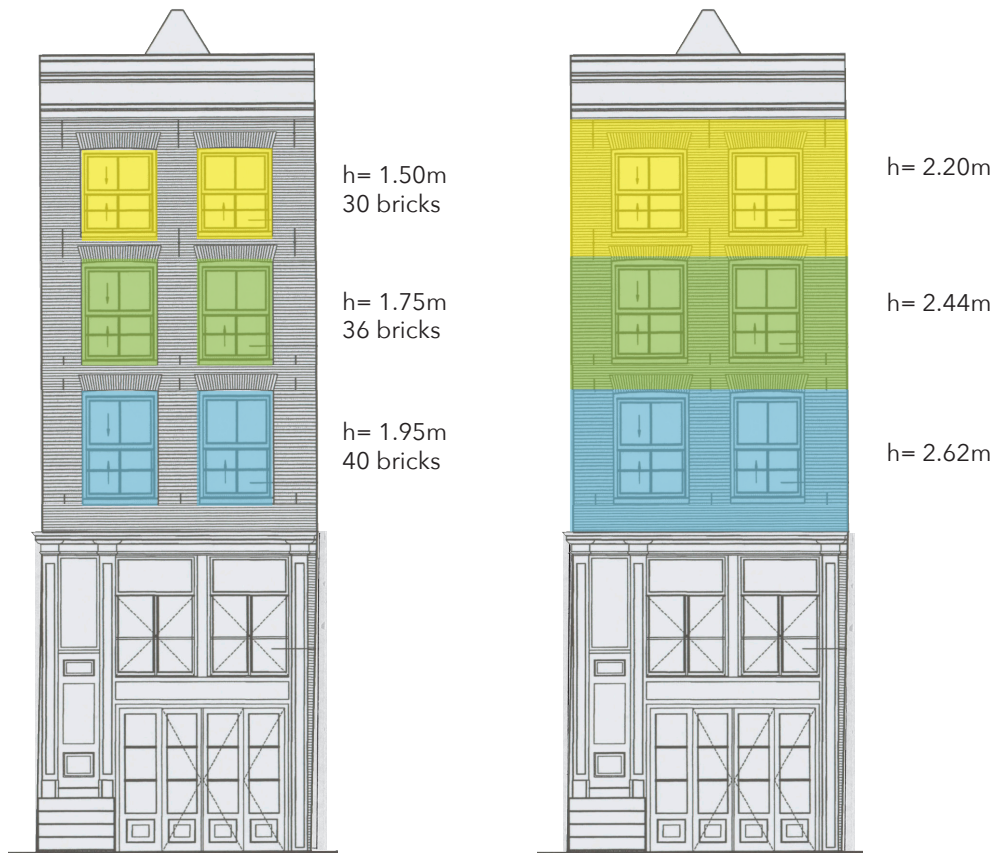
Window height. Source: Adapted from Stadsarchief Amsterdam, 2005.

Floor height. Source: Adapted from Stadsarchief Amsterdam, 2005.

When analyzing the windows of the upper facade it can be observed that the height of the windows decreases towards the top of the facade. An explanation for this could be that the floor height also decreases towards the top of the house. Another explanation could be due to the amount of daylight entering the houses. Often in canal houses the size of the windows decreases towards the top of the facade due to the fact that more daylight can enter higher up in the building (Vereniging Vrienden van Amsterdamse Binnenstad, 2006). The exact reason why the window height decreases towards the top of the facade is unclear, however the author thinks it does not have any architectural or aesthetic reason as the height difference is hardly visible from the street.

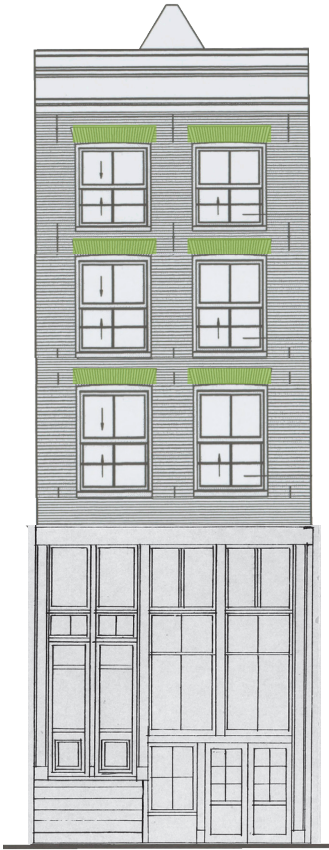
Buttresses. Source: Adapted from Stadsarchief Amsterdam, 2005.

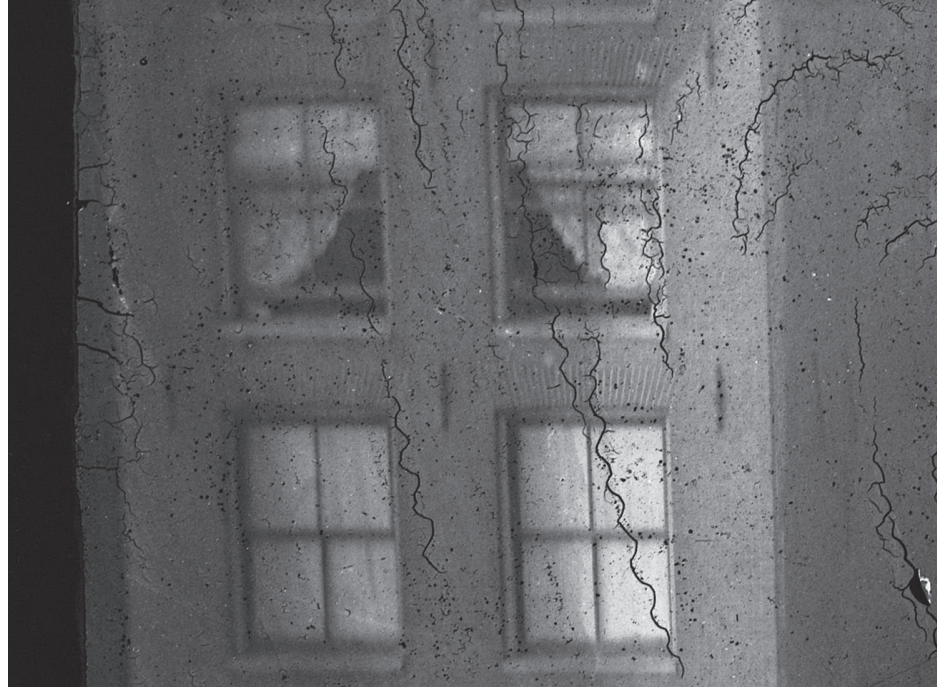
Buttresses. Source: Stadsarchief Amsterdam & J. Olie, 1861.

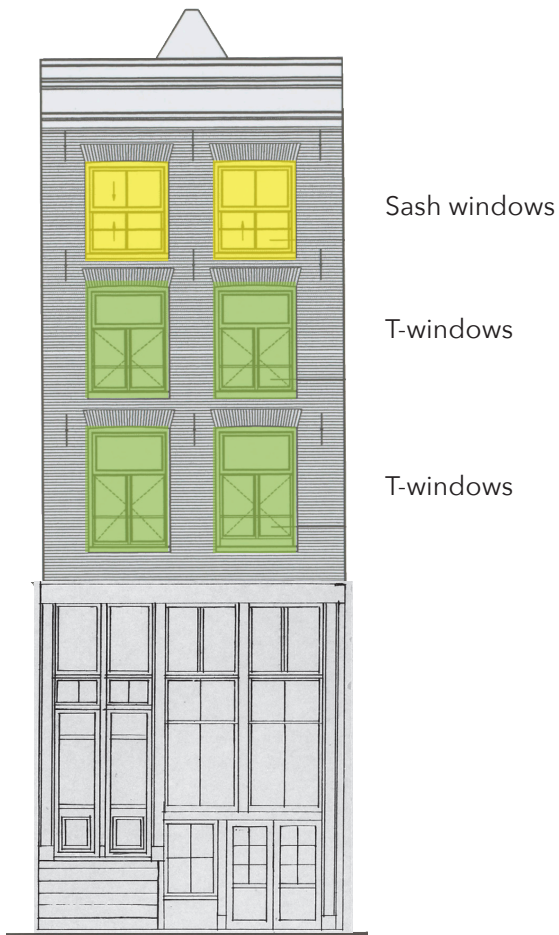
Window type. Source: Adapted from Stadsarchief Amsterdam, 2005.

There are two types of windows at the upper facade: sash windows and T-windows. Only the upper two windows are sash windows. When looking at the image of 1861 of the facade it is noticed that previously all windows were sash windows. It can be concluded that the lower windows were once replaced (between 1861 and 1936). In the 19th century sash windows were often replaced with T-windows as they were easier to open and had less draught issues (Vereniging Vrienden van Amsterdamse Binnenstad, 2006). However, it is not fully clear why the upper windows were seemingly not replaced.

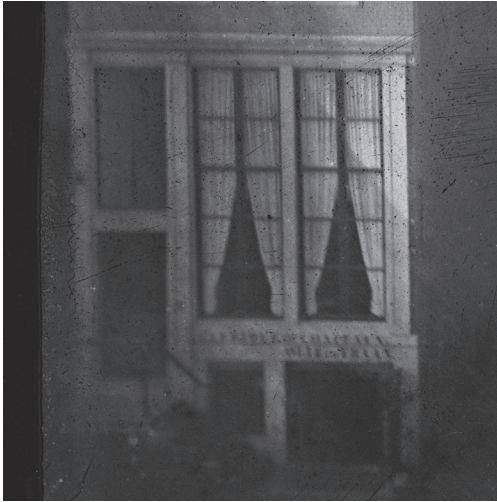
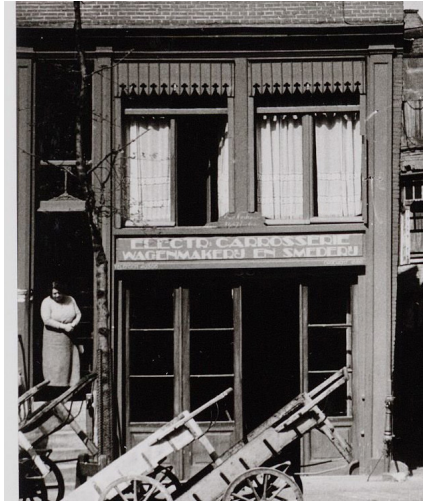
Lower East facade in 1861. Source: Stadsarchief Amsterdam & J. Olie, 1861.

Lower East facade in 1872. Source: Stadsarchief Amsterdam, 1872.

Lower East facade in 1936. Source: Stadsarchief Amsterdam, 1936.

Lower East facade after 1936. Source: Stadsarchief Amsterdam, 1872.

Looking at pictures of the lower East facade throughout the years it can be noted that the lower East facade of the front house has been altered slightly. The main difference is the height of the windows on the first floor. On the pictures above it can be noted that the height of the windows on the first floor in 1861 and 1872 was higher than in 1936. Consequently the height of doors on the ground floor has changed as well.

There are traces that the first floor was lifted (see further on in the analysis) giving a proper explanation to the change in window height of the lower facade. Most likely the floor height was altered due to a change in function.

Another alteration which can be observed between 1872 and 1936 is that not only the composition of the facade in the vertical direction has been altered, but also in the horizontal direction. The width of the door and stairs has been altered. No explanation was found for this alteration. It seems as if a feature of the lower East facade is the possibility to alter according to the wishes of the functions behind the facade. The facade is quite flexible.

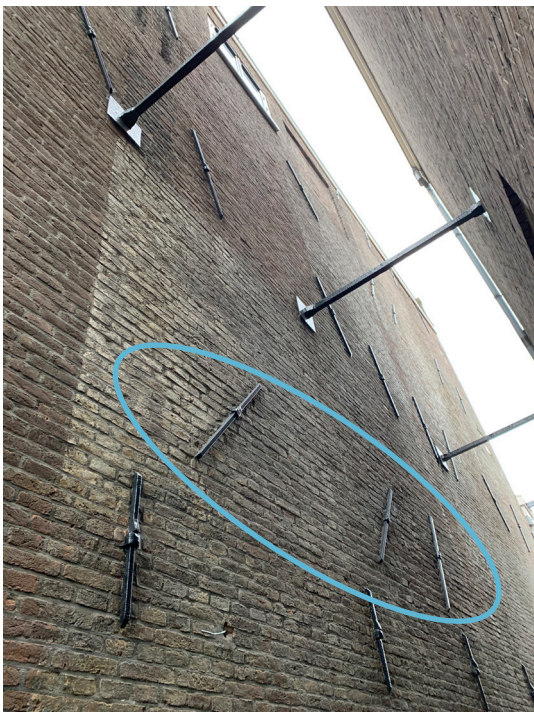
Floor height & wall anchors. Source: Adapted from Stadsarchief Amsterdam, 2005.

Wall anchors North facade. Own picture.

As can be seen on the drawings above, the steel wall anchors on the North facade (at the Suikerbakkersteeg) coincide with the floor levels. The anchors are located at the same height as the floor beams. An exception is at the height of the ground floor.

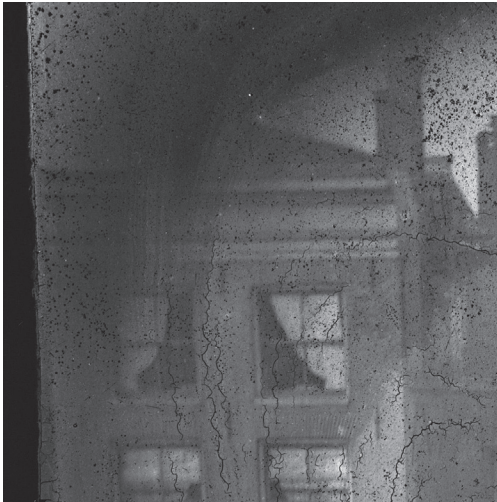
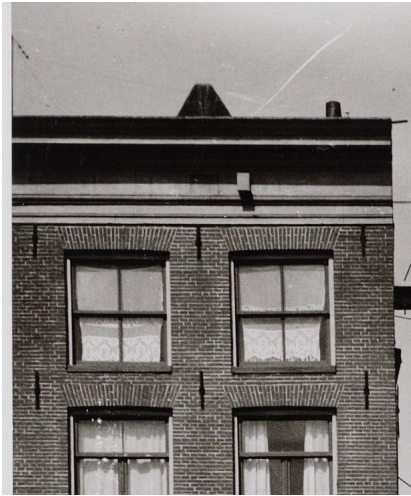
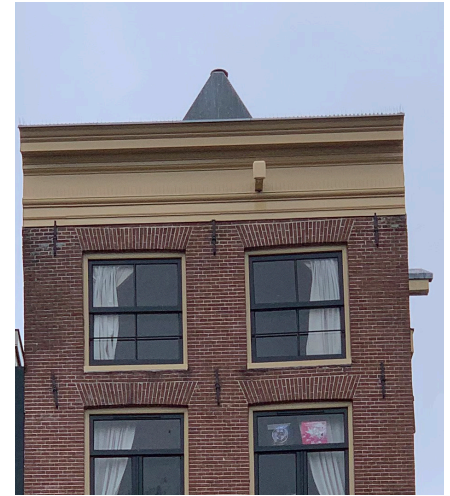
Roof structure in 1861. Source: Stadsarchief Amsterdam & J. Olie, 1861.

Roof structure in 1936. Source: Stadsarchief Amsterdam, 1936.

Roof structure in 2021. Own picture.

When comparing the picture taken in 1861 with the picture taken in 1936 it can be seen that the structure of the roof has altered. In 1936 the roof had a steep pitched inclination whereas in 1861 the roof seems to have a smaller inclination and seems to be higher. It is thus highly likely that the current roof structure is not original anymore. Which was also confirmed when looking at the structure of the roof (see page 19).

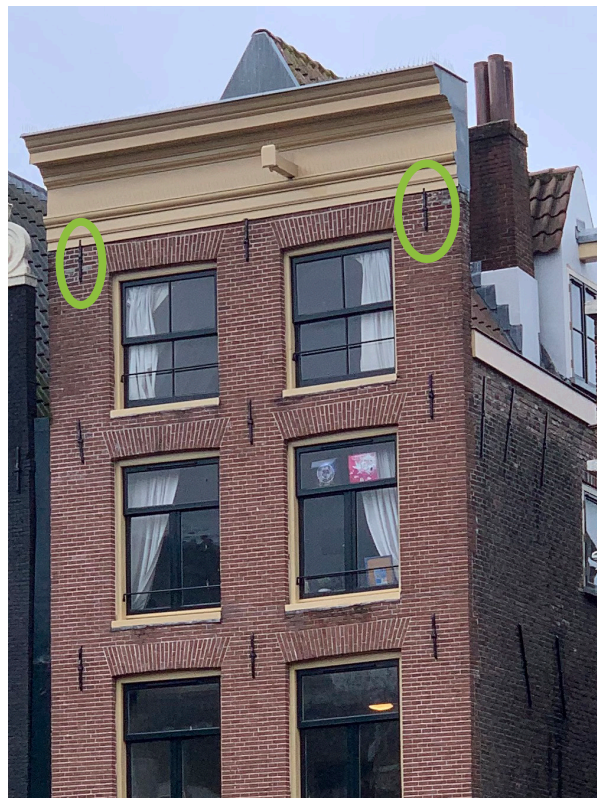
Looking at the picture below it can be seen that the outer wall anchors at the top seem to have lost their function as there are no beams or roof behind it. This also confirms that the roof structure has most likely been altered throughout the years.

Wall anchors. Own picture.

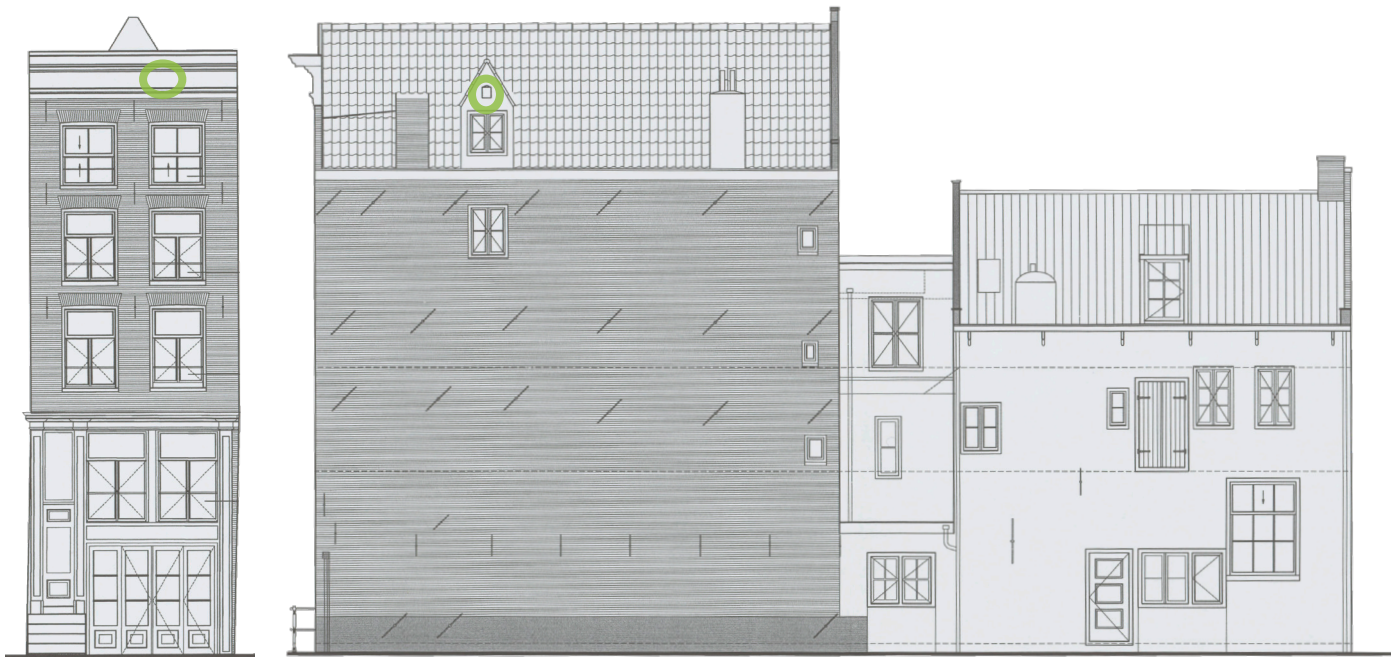
Lifting beams in 2021. Source: Adapted from Stadsarchief Amsterdam, 2005.

Lifting beams in 1861. Source: Stadsarchief Amsterdam & J. Olie, 1861.

Lifting beams in 1936. Source: Stadsarchief Amsterdam, 1936.

The building has two lifting beams. One on the East elevation (not visible in the drawing) and one on the North elevation. On the picture of 1861 it can be observed that the lifting beam on the side of the building was already present but the lifting beam at the front of the building was not. No explanation was found for the presence of two beams. The author thinks a possible explanation could be that because there are no windows in the alley on the first, second and third floor nothing could be lifted up to those floors. As the lifting beam in the East facade is in the middle of the first floor it is also possible that it was used for lifting goods to the first floor.

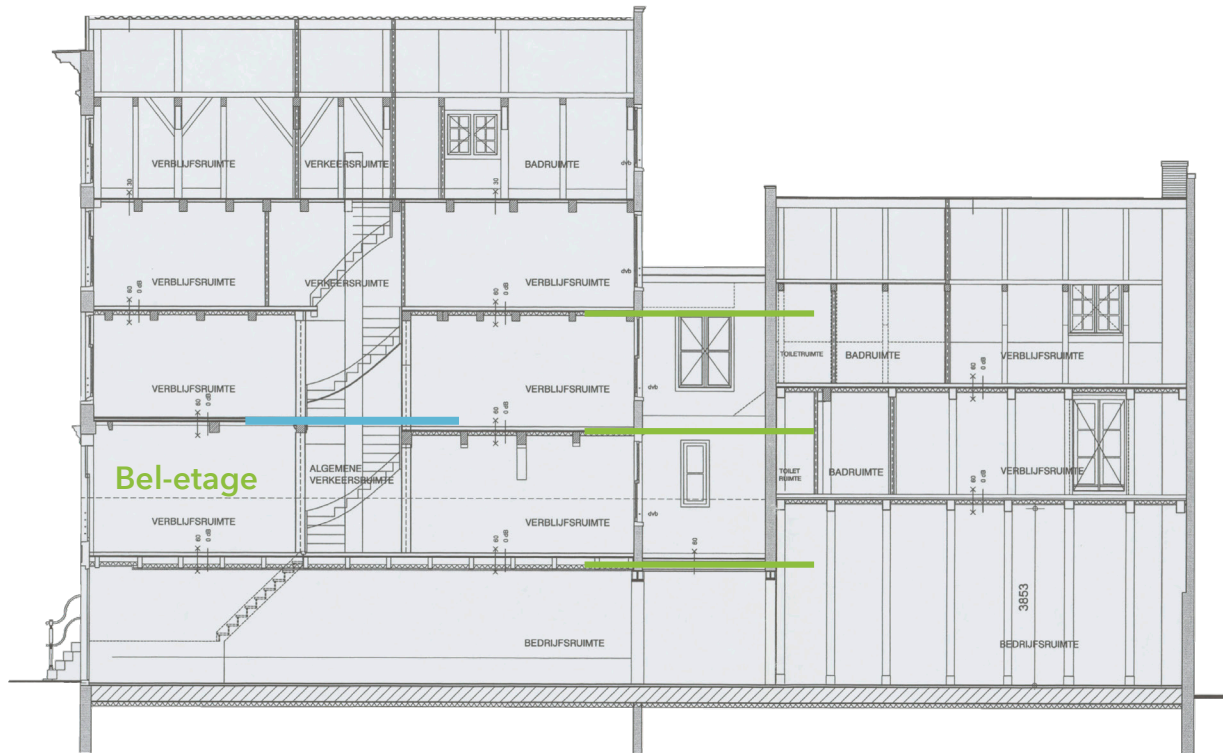
Height difference of floors. Source: Adapted from Stadsarchief Amsterdam, 2005.

When looking more closely at the second floor of the front house it can be noted that the height level of the floor is different in two. In the 16th century this could be an indication that the function in the lower part was not as important as in the higher part. Previously it was mentioned that the first floor used to be the bel-etage. This could explain why the front part is higher. According to the building historical examination the height difference is due to a phase difference in the construction (de Roon & Erfgoed Amsterdam, 2005).

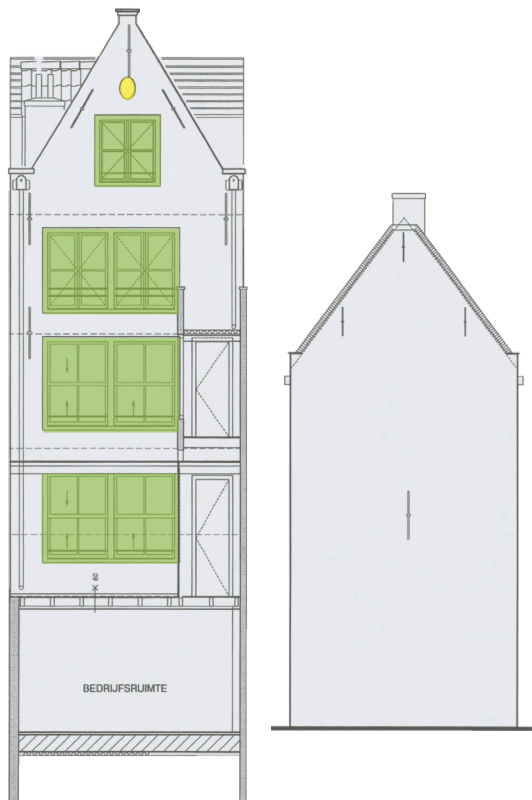
All windows of the front and back house currently have single glazing. During the renovation in 2005 no double glazed windows were placed. Several windows however were equipped with a windowpane behind the existing window ('achterzetraam').

It is difficult to determine which windows have monumental glazing. As mentioned before the windows of the East facade of the front house were replaced between 1861 and 1936 and are thus most likely not monumental. According to the building historical examination done in 2005, none of the windows of the West facade of the front house are older than a century. During the renovation in 2005 the circular window on the attic of the front house (yellow in West elevation) was closed (de Roon & Erfgoed Amsterdam, 2005).

L to R: East elevation front house, North elevation, West elevation front house, West elevation back house. Source: Adapted from Stadsarchief Amsterdam, 2005.

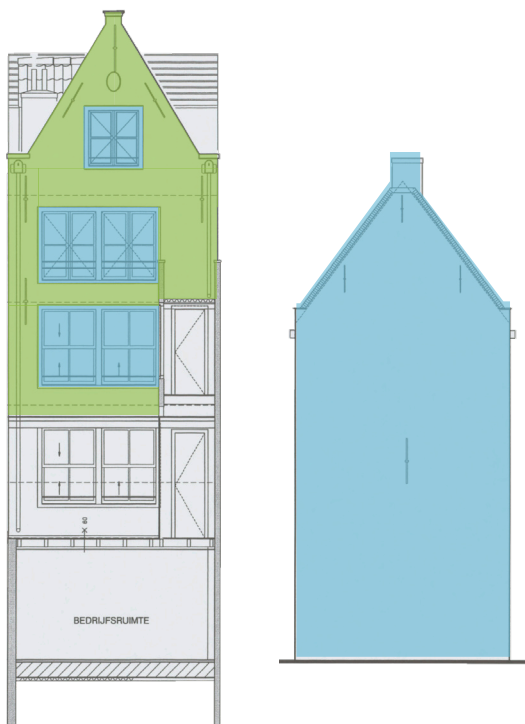
L to R: Mapped values of the East facade front house, North facade, West facade front house, West facade back house. Adapted from Stadsarchief Amsterdam, 2005.

The roof tiling of the front house is most likely not original and thus not necessarily valuable. The chimneys and dormer on the roofs are deemed valuable because they were most likely modified after the roof alteration between 1861 and 1936. Concerning the windows of the West facade of the front house the building historical examination deems it unlikely that they are older than a century and are thus not of value. Most of the windows of the East facade were replaced between 1861 and 1936 and are not of monumental value (except the windows of the fourth floor). Probably none of the windows have monumental value.

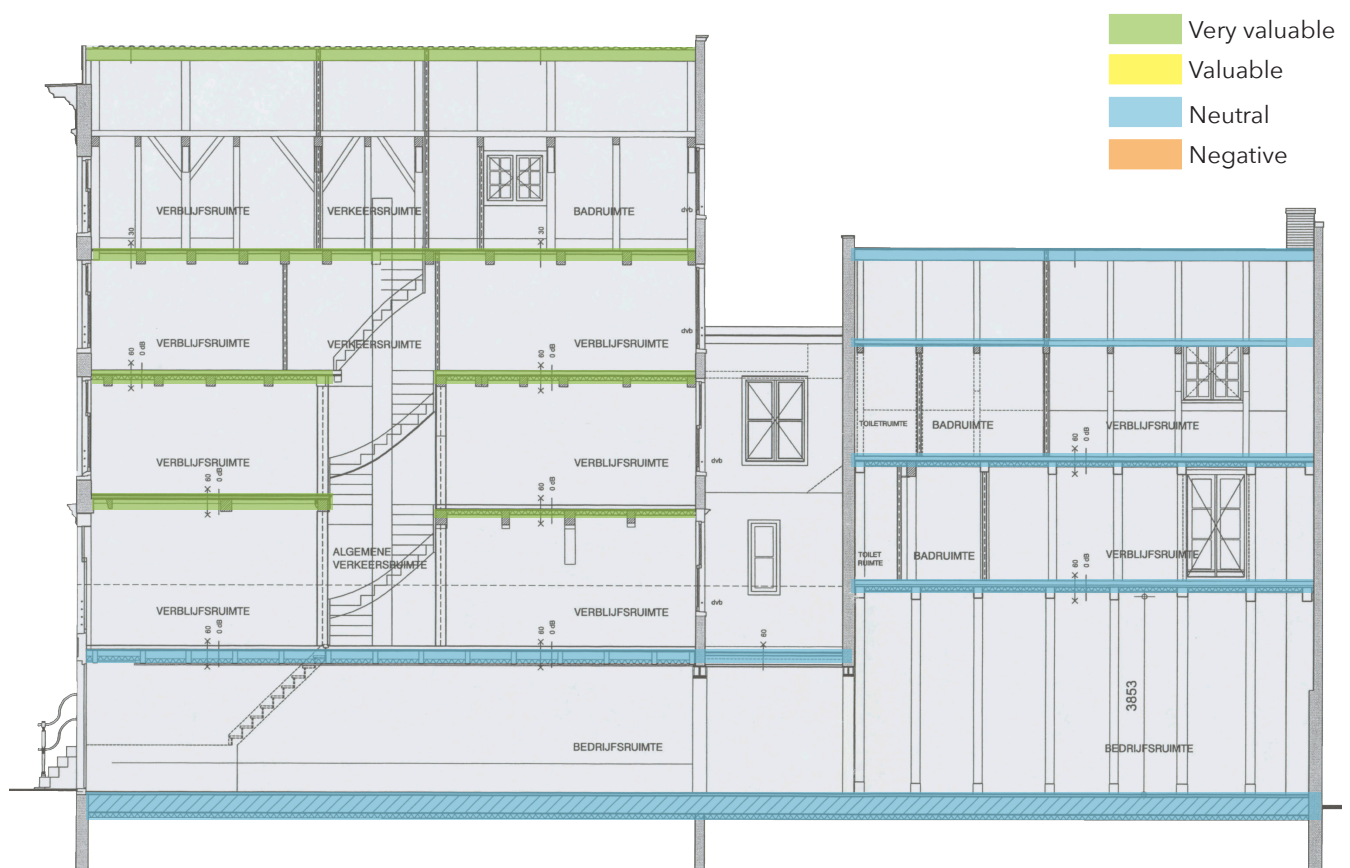
Mapped values of the structure. Adapted from Stadsarchief Amsterdam, 2005.

Since the back house was reconstructed in 2005, the structure of the building is not of monumental value. However, looking at the front house the floor structure of the second and third floor can be traced back to the 17th century and is of high value. The fourth floor dates back to the 18th or 19th century when the building height was increased and the roof was reconstructed. The roof and fourth floor are also of high monumental value. The ground floor and first floor of the front house were reconstructed in 2005 and not valuable.
