## **Buckling and failure assessment of curved butt-joint stiffened thermoplastic composite panels with roller boundary conditions**

van Dooren, Kevin; Waleson, Jan; Chapman, Mark; Bisagni, Chiara

Composites Science and Technology

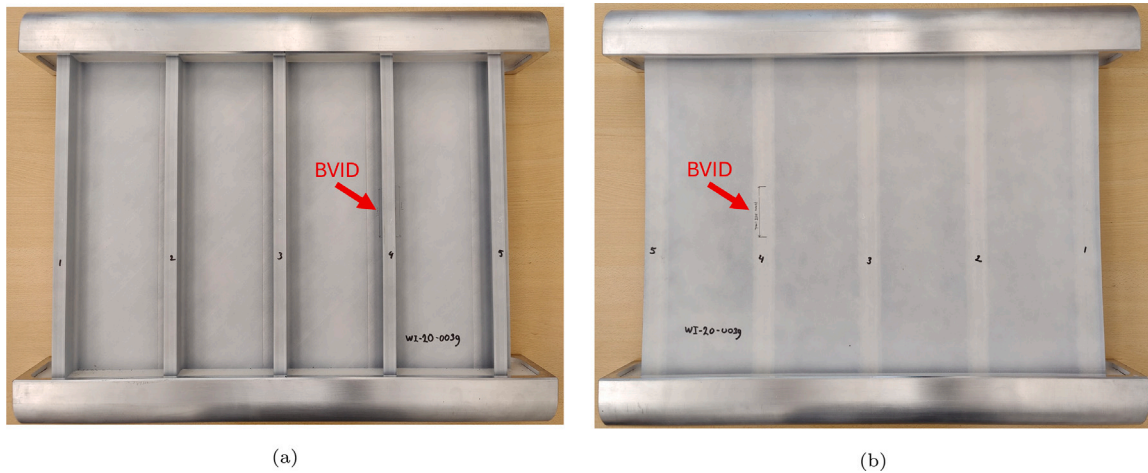
Fig. 1. Panel: (a) stringer-side; (b) skin-side.

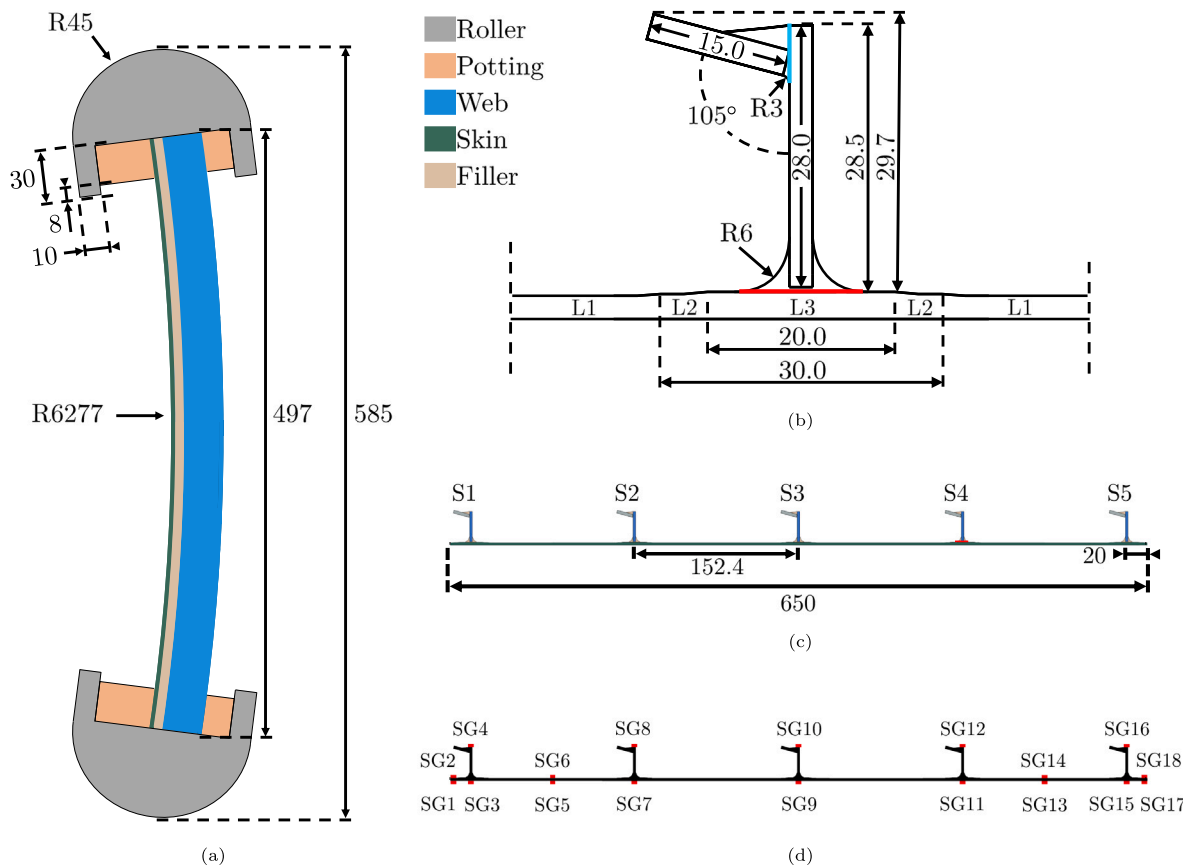
Fig. 2. Panel geometry: (a) side-view illustration ; (b) stringer cross-section; (c) panel cross-section; (d) strain gauge positions.

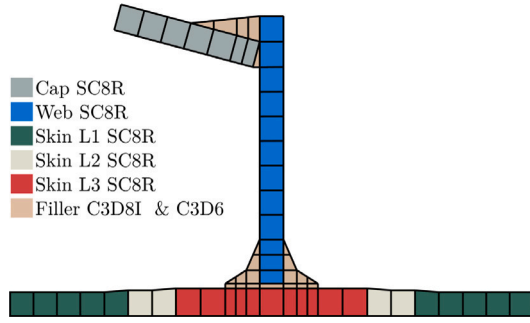
Fig. 3. Mesh of the stringer cross-section.

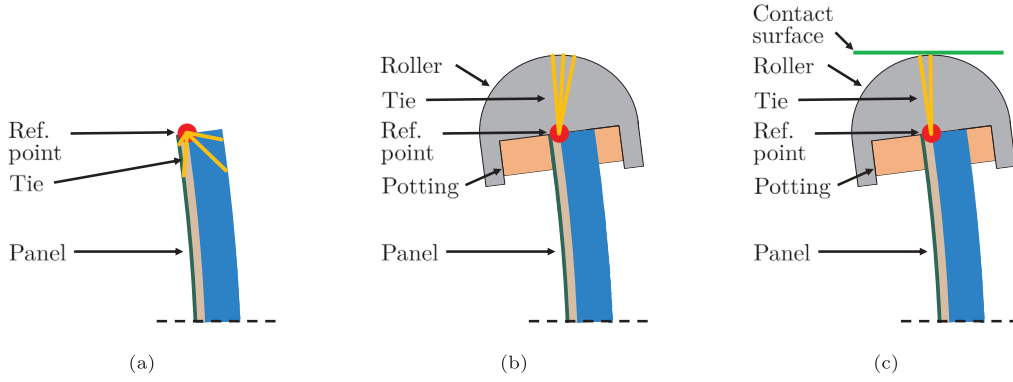
Fig. 4. Comparison of the three approximations of the roller boundary conditions: (a) method 1, panel only; (b) method 2, roller; (c) method 3, roller with contact.

The roller boundary condition is approximated in three ways, as shown in Fig. 4.

The first method utilizes a reference point in the centre of the roller radius, as shown in Fig. 4(a). This reference point is tied to the region of the panel that is inside the potting material, but no actual potting material is modelled. The reference point is constrained in all degrees

The second method models the potting and roller as shown in Fig. 4(b). The panel, potting and roller are connected with shared nodes. There is a reference point in the centre of the roller radius, which is tied to a small region on the outside of the roller radius. This region is kept small to approximate a contact area. The reference point is free to rotate around the axis in the centre of the roller radius, compression is applied in the longitudinal direction, and the remaining degrees of freedom are constrained. The load is transferred from the reference point to the contact area through the rigid body ties. This method aims to approximate the application of compression through contact

The third method adds contact between the roller and a contact surface to apply compression, as shown in Fig. 4(c). This method still uses a reference point in the centre of the roller radius, which is tied to a region on the outside of the roller. This region is to the left of the initial contact point of the roller with the contact surface. It does not come into contact with the contact surface, as the roller rotates in an anti-clockwise direction under compression. The reference point is constrained in all degrees of freedom except for rotation around the axis in the centre of the roller radius and the longitudinal direction. The purpose of the reference point is to keep the panel in place and

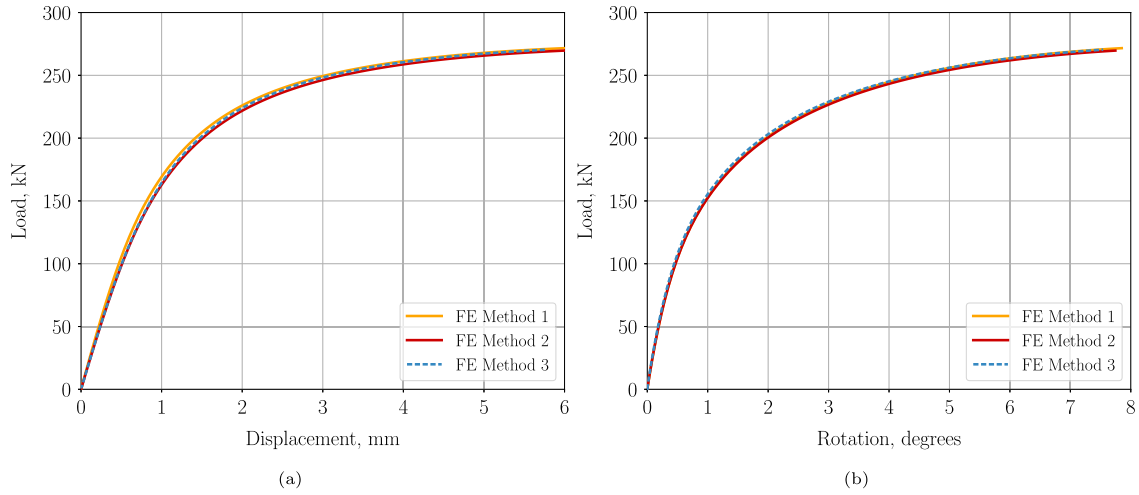
Fig. 5. Load displacement (a) and rotation (b) curves of the analyses with different boundary conditions.

The load–displacement graph of the three analyses is reported in Fig. 5(a). The difference in load–displacement behaviour is minimal between the three different boundary condition methods. Method 1 shows an initial higher stiffness compared to methods 2 and 3 but converges with method 3 at higher displacements. Method 2 matches with method 3 initially but shows a slightly lower load at higher displacements. The roller load–rotation of the three analyses is reported in Fig. 5(b). Only the top roller rotation is reported for conciseness, as the rotation of both rollers is indistinguishable in the analysis. All analyses show similar behaviour, with method 3 initially presenting a higher rotational stiffness and method 2 having a lower overall stiffness. The two outer stringers, stringers 1 and 5, displace in the lateral direction during loading, as illustrated in Fig. 6(a). The maximum lateral displacement of stringer 1 and minimum of stringer 5 are reported in Fig. 6(b) and (c), respectively. Method 2 and 3 have very similar behaviour, while method 1 has a higher stiffness, especially for stringer 1. This is most likely caused by the rigid body tie in the potting region of method 1, instead of the physical modelling of the potting for methods 2 and 3.

This comparison shows that method 1 is an efficient option for a similar load–displacement behaviour compared to method 3, which should be the method closest to reality. However, taking into account the differences in the deformation of the panel and the implementation of damage evolution in the following analyses, method 2 is considered a good compromise in terms of results and computational time. All analysis results in the following sections are obtained using method 2.

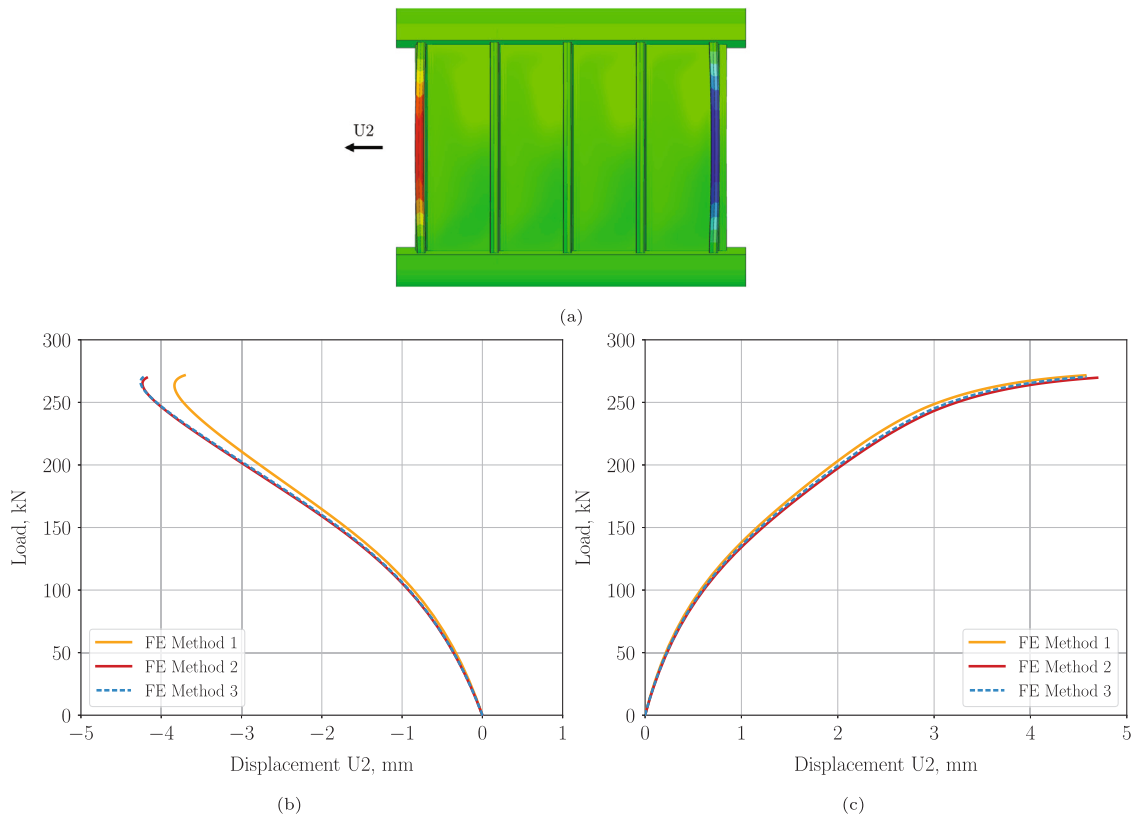
Fig. 6. Load versus lateral displacement of the analyses with different boundary conditions: (a) contour plot FE method 2; (b) negative displacement; (c) positive displacement.

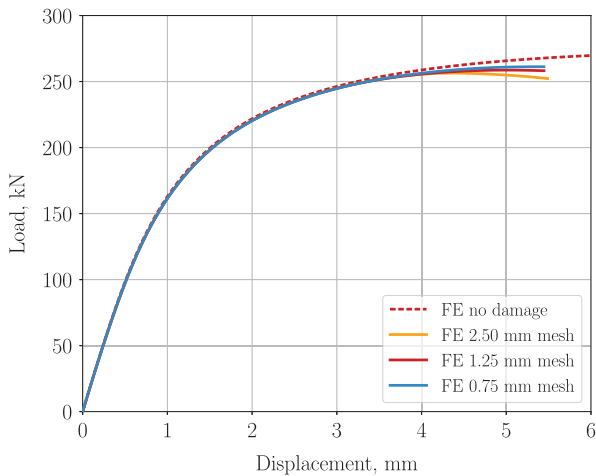
Fig. 7. Load displacement curves of mesh-size sensitivity study of damage.

A mesh size sensitivity study is executed incorporating material damage and damage evolution, which are also compared to the results without damage evolution. The considered mesh sizes are 0.75, 1.25 and 2.5 mm, with one element through the thickness of the composite laminates. The load–displacement results are reported in Fig. 7. The analyses with damage evolution start to show material softening at 2.56 mm of displacement for a mesh size of 2.50 mm, and at 2.50 mm of displacement for a mesh size of 1.25 and 0.75 mm, which can also be partially attributed to increment timing. At higher displacements, however, there is a sensitivity to mesh size, with a larger mesh size leading to more softening. The difference is more pronounced between the analysis with a mesh size of 1.25 and 2.5 mm, above an applied displacement of 4 mm. Consequently, the analysis results in the following sections are obtained using a mesh size of 1.25 mm.

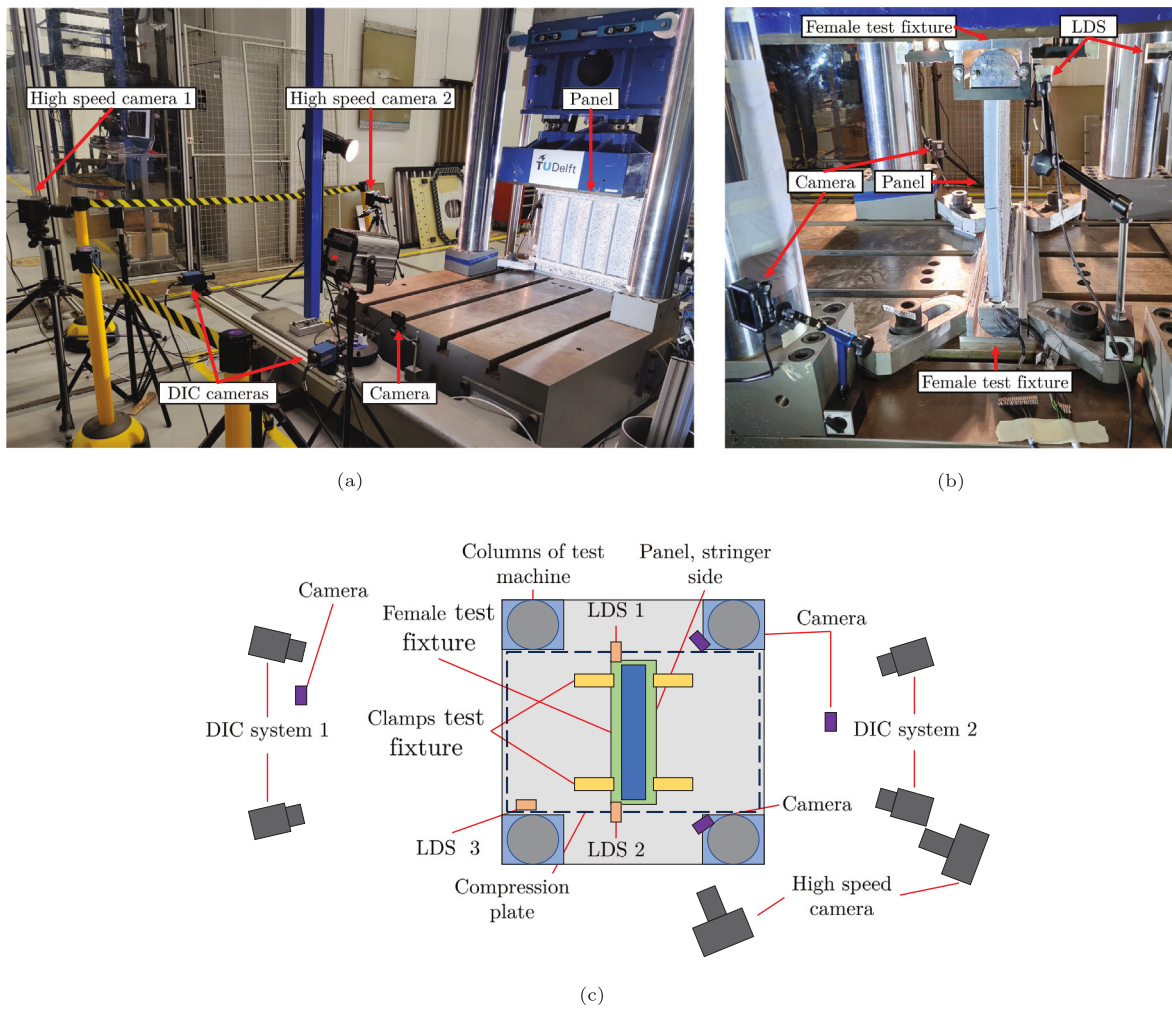
Fig. 8. Test setup: (a) stringer side; (b) side-view; (c) top-view illustration.

The experimental test setup is shown in Fig. 8 from the stringer-side of the panel (a), from the skin side (b) and with a top-view illustration (c). A female test fixture is clamped to the top compression plate and base of the test machine. The female test fixture is a machined aluminium profile with vertical uprights to limit the movement of the rollers, and to which white paint and black speckles are applied for Digital Image Correlation (DIC). The top and bottom female test fixtures are aligned such that the uprights on the right side, as seen in Fig. 8(b), can be used to align the panel at the start of the test. The top fixture has hangers mounted to the side to catch the top roller in case of panel collapse. The inner width of the fixtures is 102 mm, which is 12 mm wider than the rollers. This allows for free rotation of the rollers

The tests of panel 1 and panel 2 are executed at a loading rate of 0.25 mm/min. The force is measured by the load-cell of the MTS test machine and the displacement of the compression plate is measured by three Linear Displacement Sensors (LDS). Two LDS are placed next to the panel and one LDS is placed on the corner of the compression plate. The different locations allow to determine load imperfections, as shown in Fig. 8(c).

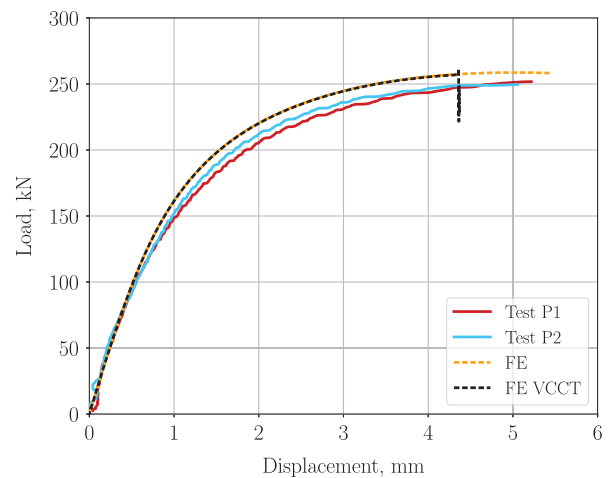
Fig. 9. Load-displacement curves from tests and numerical analysis.

The load-displacement curves of the tests and numerical analysis are reported in Fig. 9. The panels show a decreasing stiffness due to the curved geometry and roller boundary condition, clearly seen at loads above approximately 120 kN. At higher loads close to failure, the load-displacement behaviour starts to plateau. The stiffness of panel 1 and panel 2 are similar. The stiffness of panel 1 is slightly lower between

approximately 1 and 4 mm of displacement, which can be caused by material softening due to the pretest. Panel 1, with BVID, fails at a load of 251 kN and 5.22 mm of displacement, while panel 2 fails at a load of 249 kN and 5.06 mm of displacement. Unexpectedly, the panel with BVID shows a slightly higher failure load and displacement, which indicates that the BVID is not critical for the failure mode that causes the collapse.

The numerical analysis predicts the initial stiffness well, but above 100 kN it starts to over-predict the stiffness. However, the plateau behaviour at higher loads is predicted well. The analysis with VCCT is conservative in predicting failure due to skin-stringer separation, which did not appear to be the critical failure mode in the test. The following sections, therefore, only show results from the analysis without VCCT.

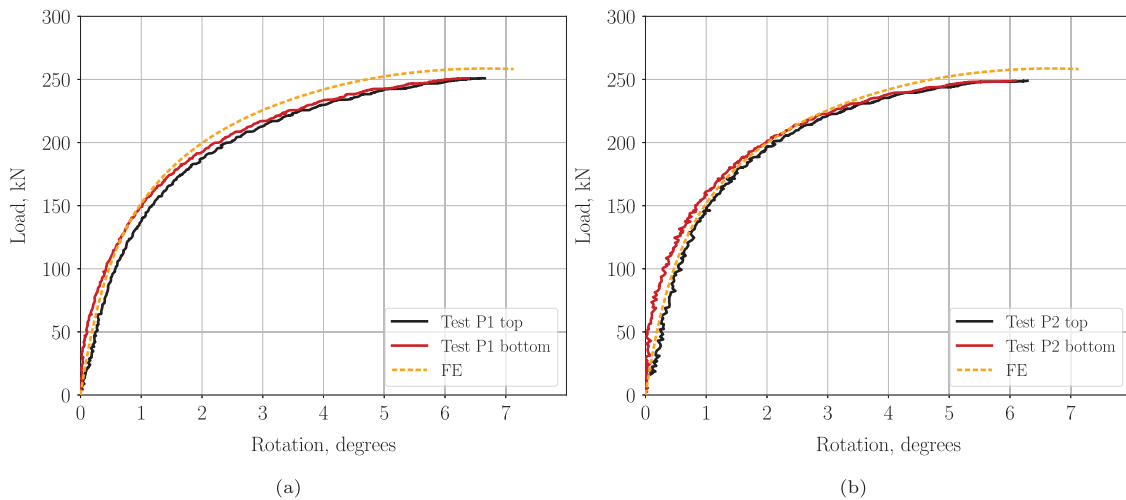
Fig. 10. Load-rotation curves from tests and numerical analysis: (a) panel 1; (b) panel 2.

The rotation is calculated from the average out-of-plane location of the top and bottom half of the flat vertical plane of the rollers, as measured by DIC, in combination with the height of this plane. The load-rotation curves of the tests and numerical analysis are reported in Fig. 10. The load-rotation curves are similar to the load-displacement curves, with a decreasing stiffness with an increase in load and a plateau at higher applied displacements. There is a small difference in rotation between the top and bottom rollers initially for all tests, which stays constant after settling. Panel 1 seems to have a slightly lower amount of rotation than panel 2, indicating a higher bending stiffness.

The numerical analysis predicts the rotation of the rollers well, with an under-prediction of the rotation at higher loads, above approximately 1.5 and 3 degrees of rotation for panels 1 and 2, respectively.

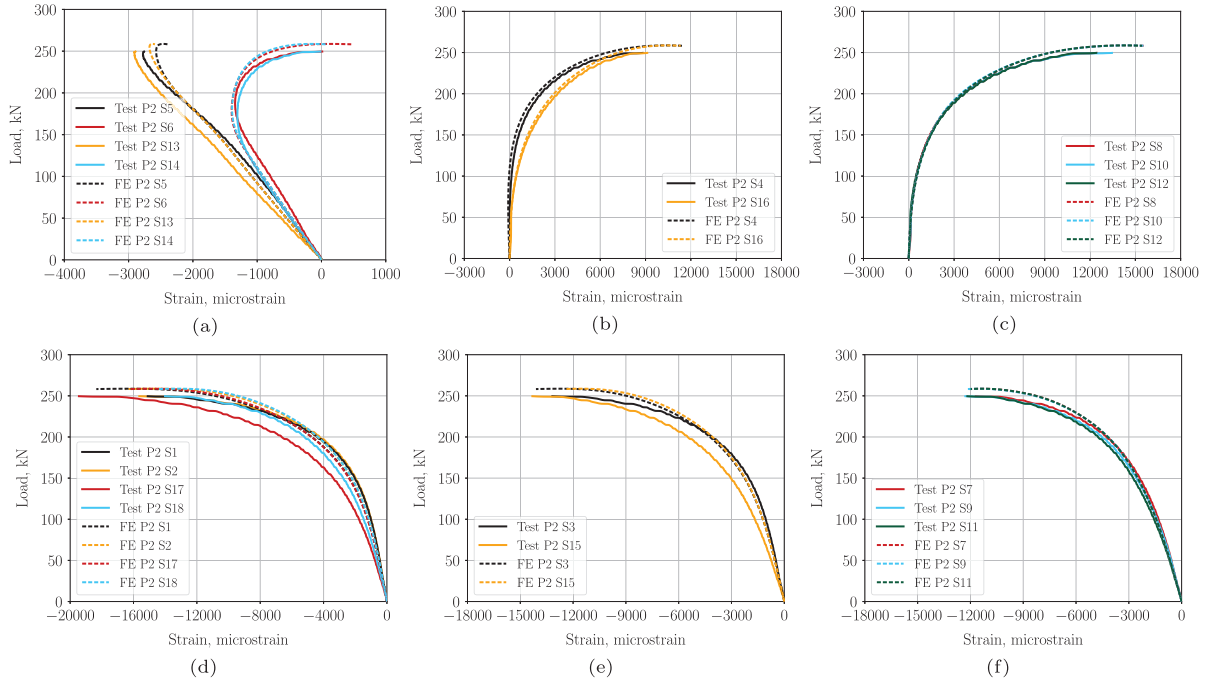
**Fig. 11.** Experimental and numerical compressive strains of panel 2 in pristine condition: (a) bays; (b) top of side stringers; (c) top of middle three stringers; (d) free edges; (e) bottom of side stringers; (f) bottom of middle three stringers.

The measured strains of the test till failure of panel 2 are reported in Fig. 11. The strains of panel 1 are not reported for conciseness, as there is a high level of similarity with panel 2. The strains measured by the skin strain gauges show negative strains, indicating compression, and the strain gauges on top of the stringer webs show positive strains, indicating tension. This is due to the combined compression and bending loading. The strains also reach higher values than the more typical compression tests, with strains up to 19400 microstrain. The strains show a slight loading imperfection in the skin, while the stringers are equally loaded. The outer stringers, strain gauges 4 and 16, do show differences, but this can also be caused by geometric differences instead of a loading imperfection. The highest strains are in the stringer area and free edges, with lower strains in the middle of the bay.

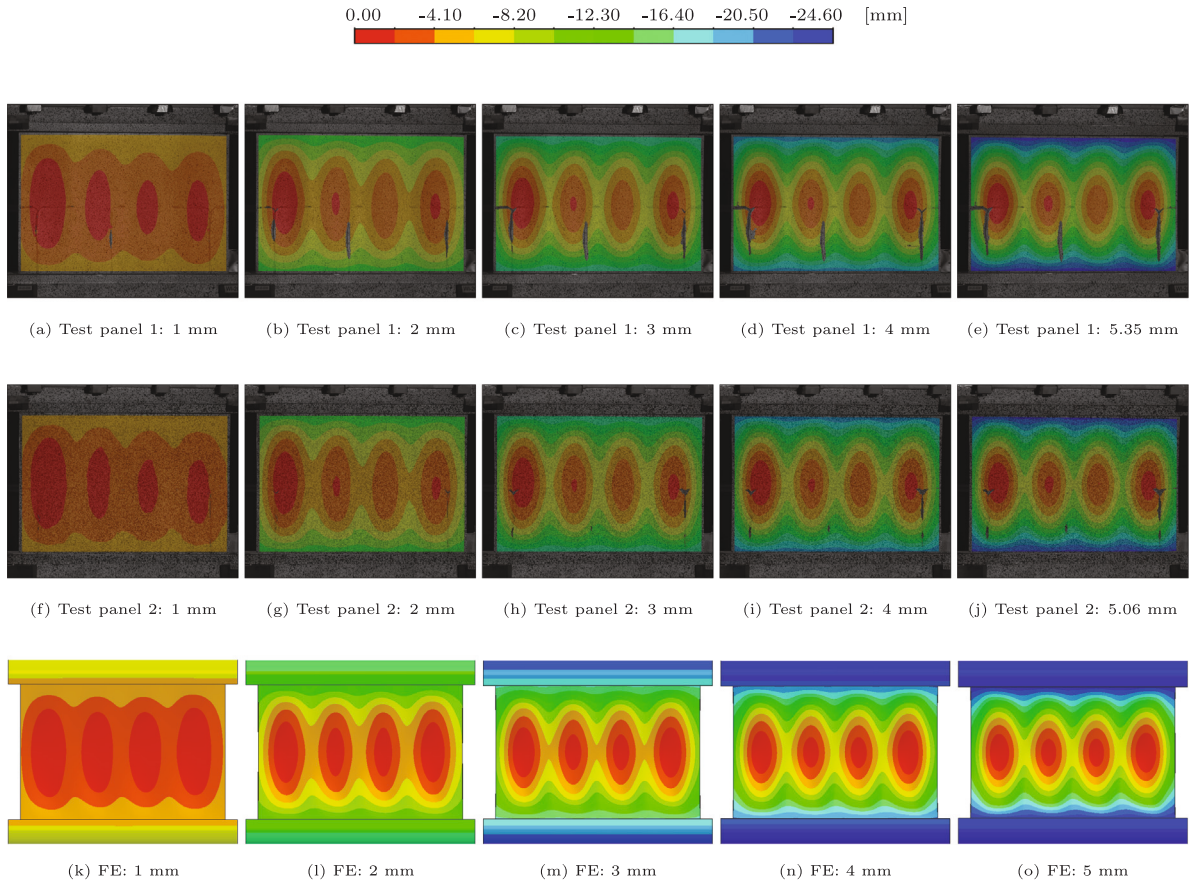
**Fig. 12.** Out-of-plane displacement: (a-e) test panel 1; (f-j) test panel 2; (k-o) FE.

The out-of-plane displacement of the skin is measured during the tests by DIC, and is reported in Fig. 12. The scale of the contour plot is based on the out-of-plane displacement of the skin at the maximum load. For each plot, an offset is applied to the displacement field, such that the scale's maximum is at the maximum out-of-plane displacement point of the panel. This eliminates the contribution of the rolling motion of the panels to the out-of-plane displacement and results in a clearer comparison.

The out-of-plane displacement of the test of panel 1 is plotted in Fig. 12(a-e) in steps of 1 mm of longitudinal applied displacement and at the maximum applied displacement. The panel shows a single half-wave in each bay, with the highest out-of-plane displacement at the left side of the panel. The evolution of the out-of-plane displacement is gradual, with an exponential increase of displacement w.r.t. the load. The three bays on the right initially have similar out-of-plane displacement, but at higher applied displacement, the bay on the rightmost side starts to have higher displacement than the middle two bays. At the maximum applied displacement, the difference in out-of-plane displacement is 2–2.5 mm between the middle two bays and most left bay, and a 1 mm difference between the most left and right bay. These differences can be due to loading imperfections but are also due

The out-of-plane displacement of the test of panel 2 till failure is plotted in Fig. 12(f-j). The out-of-plane displacement behaviour of panel 2 is similar to panel 1, in terms of total out-of-plane displacement and the differences between the four bays. There is no visible difference in the out-of-plane displacement of panel 1 and 2 due to the BVID of panel 1.

The out-of-plane displacement of the numerical prediction is reported in Fig. 12(k-o). The numerical analysis accurately predicts the out-of-plane displacement behaviour, with only minimal differences due to loading and geometric imperfections not considered in the analysis. The differences between the bays are lower than what is measured in the tests, with the most left and right bays having a 0.3 mm difference in out-of-plane displacement at 5 mm of applied displacement, and the middle two bays a 1 mm difference compared to the outer bays.

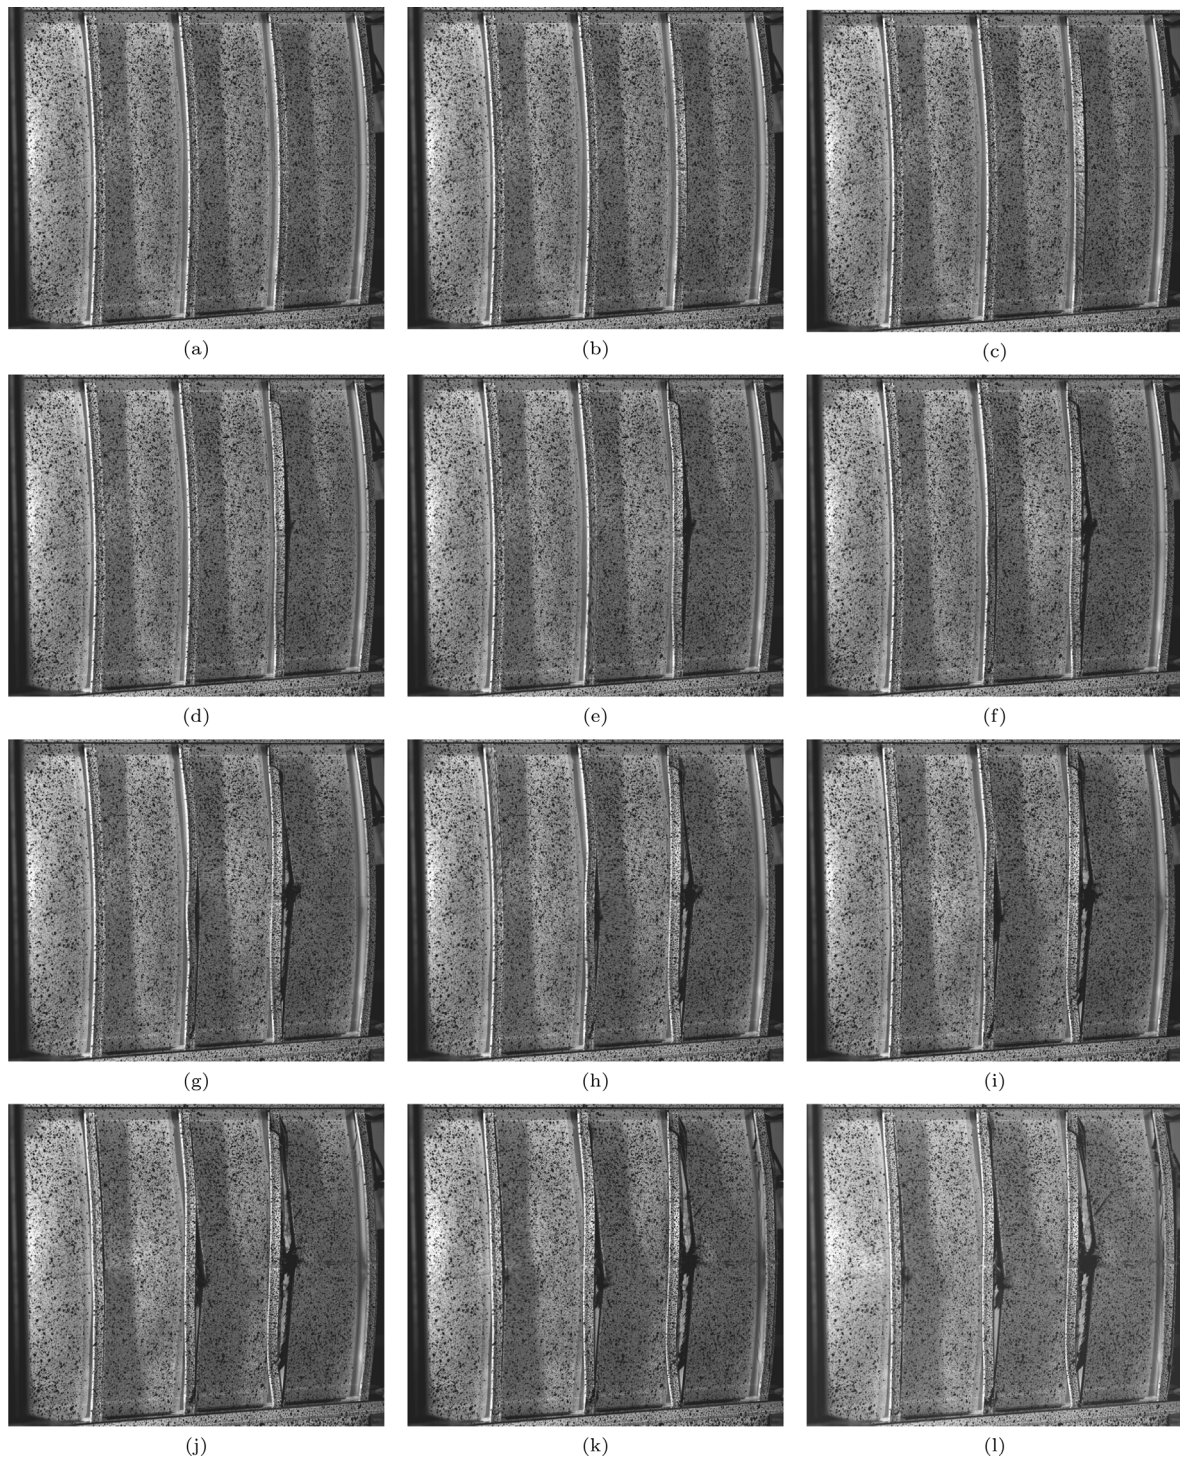
**Fig. 13.** High-speed footage panel 1: (a–b–c) stringer 4 cap separation; (d) stringer 4 web fracture; (e–f) stringer 4 cap separation; (g) stringer 3 web fracture; (h) stringer 2 cap separation; (i) stringer 5 butt-joint failure; (j–k) stringer 2 web fracture, stringer 5 cap separation; (l) stringer 5 web failure.

The panel collapse sequence of panel 1 is reported in Fig. 13 over a total time period of 1.1 ms. Panel collapse starts with the cap separating from the web of stringer 4 (a), the stringer with a BVID in the butt-joint skin-stringer interface. The cap completely separates in the following two frames and fractures at the top of the panel (b-c), followed by failure of the web (d). Then, the cap of stringer 3 separates from the web (e), and the cap fractures at the bottom of the panel (f). The web

of stringer 3 fails next, and the web of stringer 2 shows delaminated plies at the web-cap interface (g). The cap of stringer 2 then separates almost completely from the web within one frame (h). The butt-joint of stringer 5 is the first visible skin–stringer interface that shows failure (i), with the failure occurring at the top of the panel. Due to the separation of the caps from the webs, most butt-joints can no longer be seen. After the butt-joint failure, the cap of stringer 5 separates from the web, simultaneously with the web fracture of stringer 2 (j–k). Lastly, the web of stringer 5 fails (l).

The frames of the high-speed footage are further analysed. When the caps separate from the web, the caps displace towards the skin in the middle of the panel. The caps hit the skin once or multiple times, with the skin also displacing out-of-plane in waves. When web fracture occurs, a few caps detach further and pull partially out of the potting material. After failure is completed, the caps return close to their initial position.

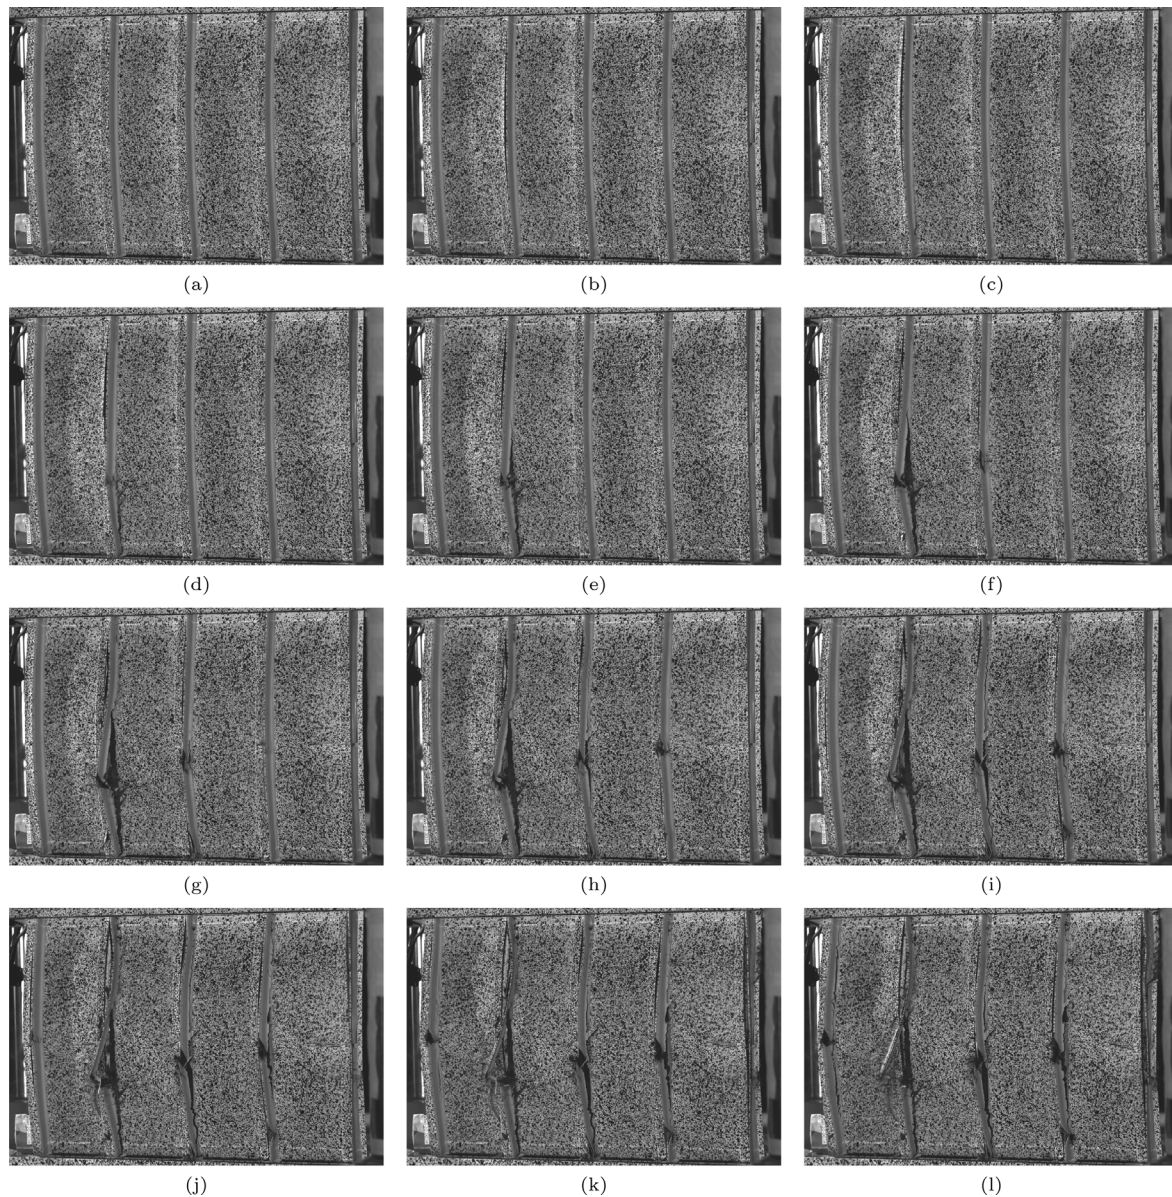
Fig. 14. High-speed footage panel 2: (a–b) stringer 2 cap separation; (c) stringer 2 butt-joint failure; (d) stringer 2 web fracture; (e) stringer 3 cap separation; (f) stringer 3 butt-joint and web failure, stringer 4 cap separation; (g) stringer 4 butt-joint failure; (h–i) stringer 4 fracture, stringer 1 cap separation; (j) stringer 5 cap separation, stringer 1 web fracture; (k) stringer 1 and 5 butt-joint failure; (l) stringer 5 web fracture.

The panel collapse sequence of panel 2 is reported in Fig. 14 over a total time period of 2.3 ms, as every 2nd frame is reported. Panel collapse starts with the separation of the cap of stringer 2 in the middle

of the panel (a–b), with a fracture in the cap at the bottom of the panel. The butt-joint of stringer 2 then separates from the skin at the bottom of the panel (c), which grows in an upward direction and is followed by fracture of the web (d). The cap of stringer 2 then separates from the web and fractures at the bottom of the panel (e). The butt-joint of stringer 2 fails at two locations, in the middle and bottom of the panel, and the web fractures (f). In the same frame, the cap of stringer 4 starts to separate, followed by further separation and fracture of the cap and failure in the butt-joint (g). The web of stringer 4 then separates, while the cap of stringer 1 also separates from the web (h–i). The web of stringer 1 then fails and the cap of stringer 5 separates from the web (j). The butt-joint of both stringer 1 and 5 then fails (k), and lastly, the web of stringer 5 fractures (l).

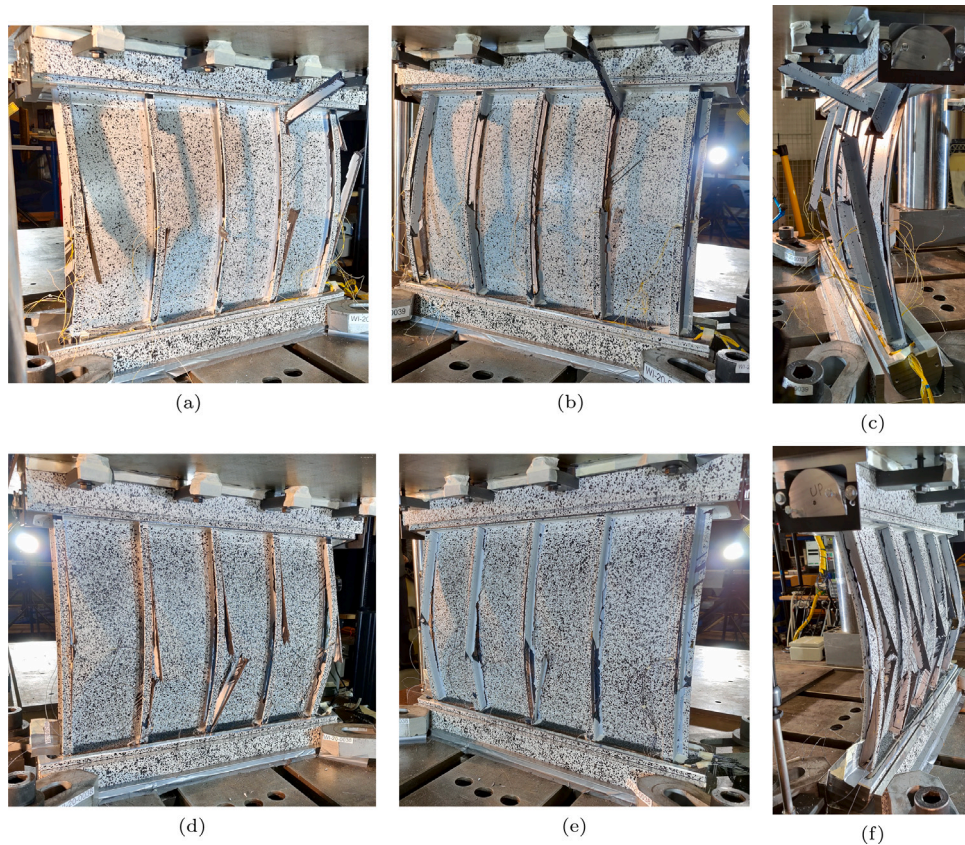
Fig. 15. Post-failure photos: (a) panel 1 left-view; (b) panel 1 right-view; (c) panel 1 side-view; (d) panel 2 left-view; (e) panel 2 right-view; (f) panel 2 side-view.

Photos of panel 1 after failure are reported in Fig. 15(a–c). The caps, once separated from the webs, show fractures in several locations.

The caps of stringers 1, 2 and 5 are also partially pulled out from the potting material. The failure between cap and web seems to occur in two different ways, with the top ply of the web being delaminated and pulled off partially, and with separation between the web and the short fibre filler. In the middle of the panel, it seems that failure and delamination of the web plies is more common, with small pieces of the ply still attached to the cap, while towards the top and bottom of the panel, failure occurs at the interface between the web and short fibre filler. All the webs separated from the skin at the butt-joint. The webs present one or more fractures in each web and parts of the web are no longer attached to the panel. The failure in the web and skin region is mostly in the butt-joint. Stringer 1 has a part of the ply delaminated from the skin at the bottom of the panel, and the remaining butt-joints only show minimal pulled-off fibres. Failure in the butt-joint can be roughly divided into three types of failure: failure at the interface between skin and butt-joint, failure in the short fibre filler and failure at the interface between web and butt-joint. There are no visible fractures in the skin, but there is likely damage inside the laminate. There are indications of damage at the back of the skin, with paint chipped off.

Photos of panel 2 after failure are reported in Fig. 15(d–f). The failure modes, that are initially visible, are similar to panel 1. Stringer 2 fails first and has considerable amounts of fibre pullout from the skin, especially towards the top of the panel. The biggest difference, however, is that the edge of the skin, on the side of stringer 5, shows a large fracture. A close-up picture of this fracture is reported in Fig. 16. The skin is fractured across the thickness of the laminate and has a visible length of approximately 60 mm as seen from the stringer-side of the panel. Further propagation is visible on the back side of the skin, with propagation in a downward direction, leading to a total visible length of approximately 100 mm.

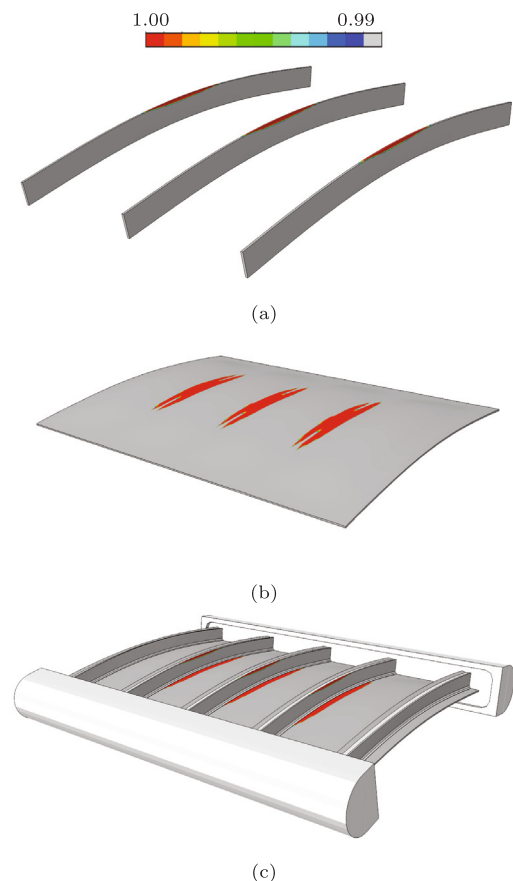
Fig. 18. Matrix tensile damage variable contour plot, at 5.26 mm of displacement: (a) middle three webs; (b) skin; (c) panel.

Although the numerical model is not able to predict the sudden failure of the panel, as it does not take into account delamination between each ply, it is able to correctly identify the critical plies. Contour plots of the Hashin matrix tensile damage variable are reported in Fig. 18 for the middle three webs (a), the skin (b) and the full panel (c). The top  $-45$  ply is most critical in the web, closely followed by the  $45$  ply. At 5.26 mm of displacement, the area with a damage variable

higher than 0.99 for the  $-45$  ply reaches the bottom of the cap-web joint. This means that the short fibre filler joint is locally connected only to a failed ply, at the free edge of the web laminate.

The skin also has areas with a damage variable above 0.99, and the top  $45$  ply is the most critical. However, this can be considered less critical than the web, as the top skin plies are in tension, with no free edge and continuous fibres underneath the joint, making it less likely for this ply to delaminate compared to the web plies.
