Non-destructive inspection technologies for repair assessment in materials and structures

Developments in the Built Environment

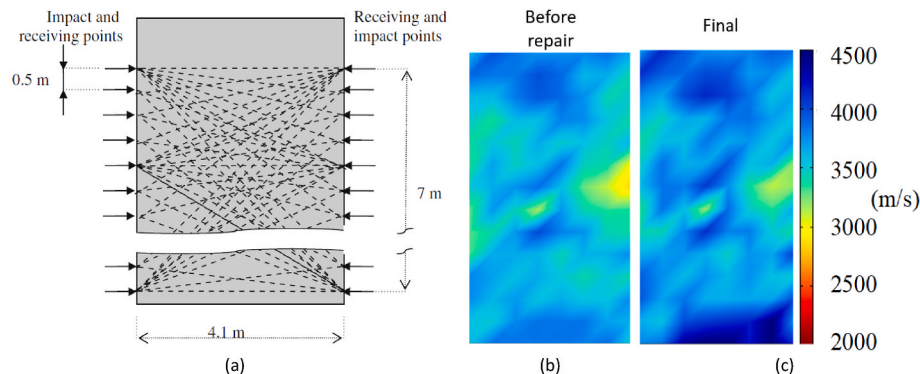
Fig. 3. (a) Schematic representation of concrete cross section with elastic wave paths, (b) wave velocity tomograms before and (c) after repair through grout injection (Shiotani et al., 2009).

condition and the repair effectiveness of grouting (through a certain predefined grid) in pylons of a water intake facility (Shiotani et al., 2009). The final modulus of the cementitious grout was nominally 21.5 GPa, while the one of the original concrete was evaluated at 35 GPa. After grouting was performed and allowing the necessary curing period, through-thickness elastic wave testing was conducted (Fig. 3(a)) and compared to the results of the reference investigation before repair. The excitation was conducted with a pneumatic impact hammer, and low frequency accelerometers (up to 40 kHz) were used to capture the response from opposite sides of the structure. Low frequencies were necessary due to the large size and long propagation distances, while stacking of approximately 800 individual excitations was also applied to enhance the signal-to-noise ratio of the waveforms. Combining the transit time of all different wave paths, tomography results showed the distribution of reference damage (Fig. 3(b)), while after injection and hardening of the grout (Fig. 3(c)), there was an overall velocity increase of approximately 5–10 % (Shiotani et al., 2009), with specific regions showing greater or limited restoration.

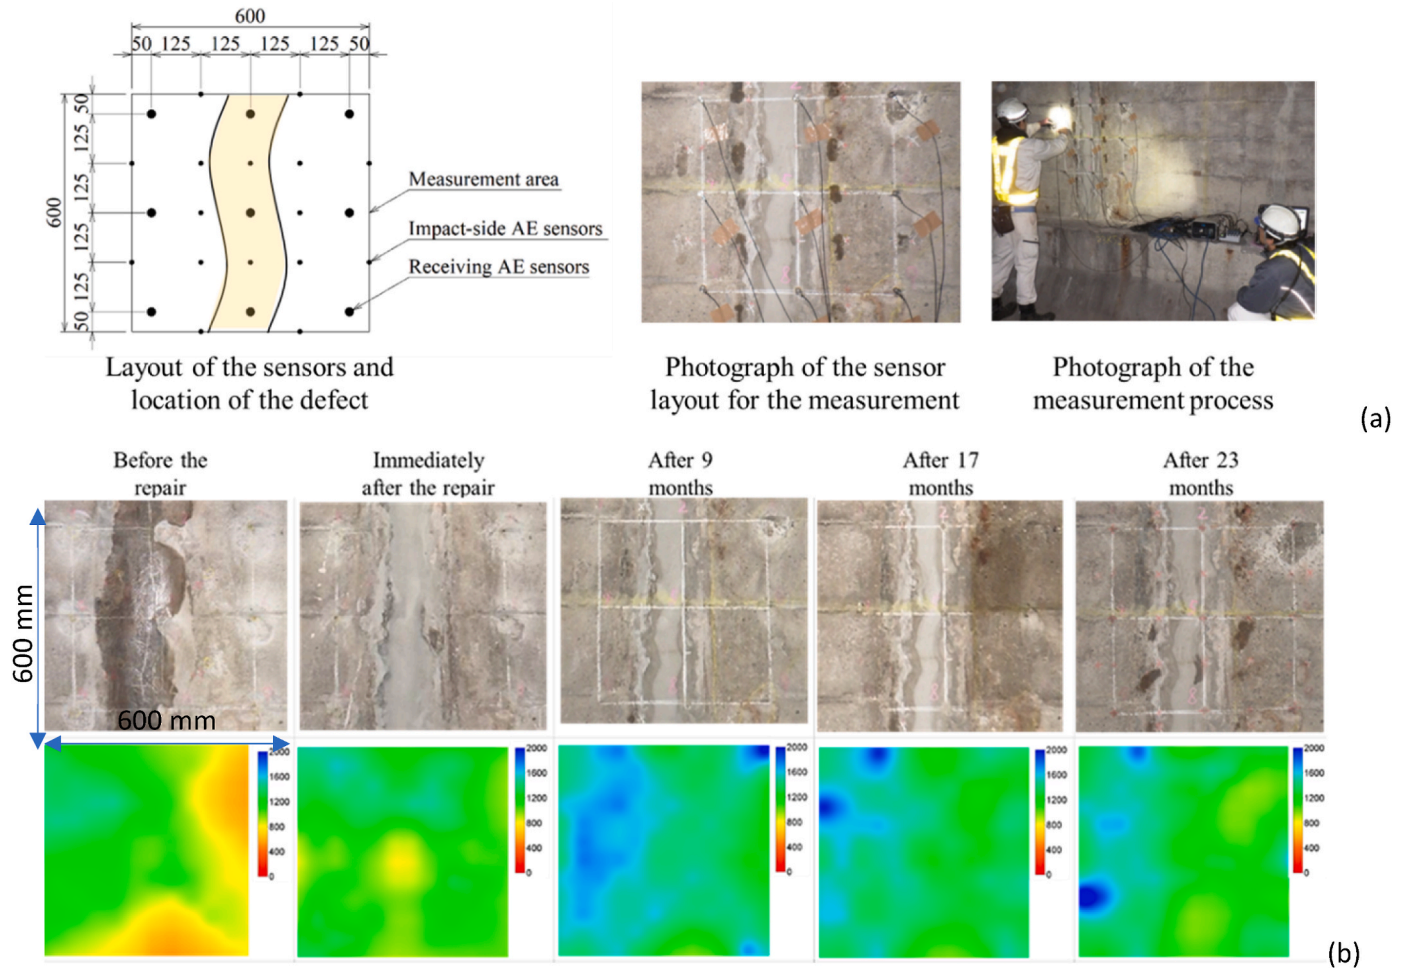
Fig. 9. Surface wave tomography: (a) schematic representation and photograph of the inspected area, (b) monitoring results (photographs of the surface at the corresponding times and tomograms (the colormap is in m/s, Ogura et al., 2023)).

Based on surface waves, “surface wave tomography” is a type of elastic wave tomography focusing on the “Rayleigh” wave that propagates along the surface, like in the above-mentioned case. The method consists of attaching an group of AE sensors to the surface of a structure in a pattern and introducing elastic waves by means of impacts of steel balls of different diameters. This allows the measurement of surface wave velocity between impact points and AE sensors. This data is then processed by the tomography algorithm, which reconstructs a tested structure's elastic wave velocity distribution. Elastic wave velocity distribution is visualized as a contour plot, where areas with low elastic wave velocity correspond to areas with defects. In the specific application, a water leak in an underground structure was monitored before, immediately after the repair and 9, 17 and 23 months later. Fig. 9(a) shows the layout of the sensors used in this inspection, as well as photographs taken during measurements. Nine receiving sensors were placed in three lines and three rows (500 × 500 mm), and impact-side sensors were placed at 16 arbitrary points. The outer receiving sensors were arranged symmetrically with respect to the defect, and the inner ones were positioned on the center line of the measurement area. This sensor arrangement made a total of 144 scan lines. The sensors used in this study were 60 kHz resonant AE sensors. The inspection showed that immediately after repair, the velocity increased, indicating the crack filling by the repair agent (Fig. 9(b)). After 9 months, there was a slight increase in velocity, which can be explained by additional hydration of the repair material due to existing moisture. After 17 and 23 months, there was a minor decrease in velocity, which can be explained by minor water leaks, observed during the visual inspection. Minor water leaks can indicate a recurrence of cracking, which can decrease the velocity. Therefore, Rayleigh elastic waves indicate the initial condition and the effectiveness of repair, while allowing monitoring at later ages.

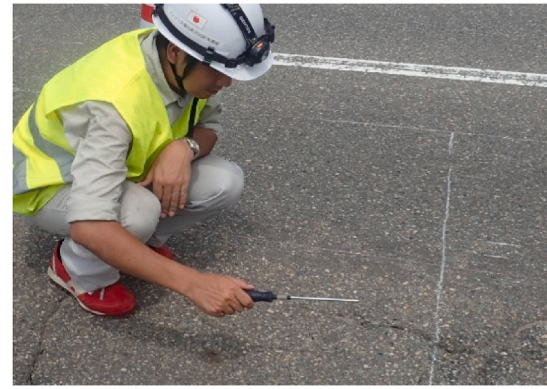
Fig. 11. (a) Analysis model for AE tomography, (b) steel-ball tapping (Okude et al., 2018).

Fig. 11(a) shows the model of AE tomography analysis and the positions of the sensors. The shaded part at the top of the model indicates the asphalt layer with thickness of 50 mm. As elements for AE tomography analysis, the applicable region was divided in 16×8 , which gives a total of 128 elements. In this study, elastic waves were excited by steel-ball tapping. A steel-ball of 5 mm diameter was tapped at several locations on the asphalt surface, ensuring that the distribution of impact points was as uniform as possible at the target area. The steel-ball tapping is illustrated in Fig. 11(b) (Okude et al., 2018).

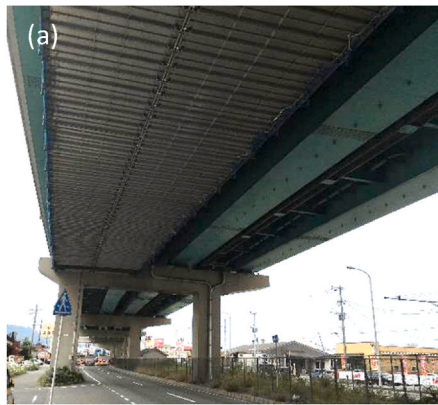
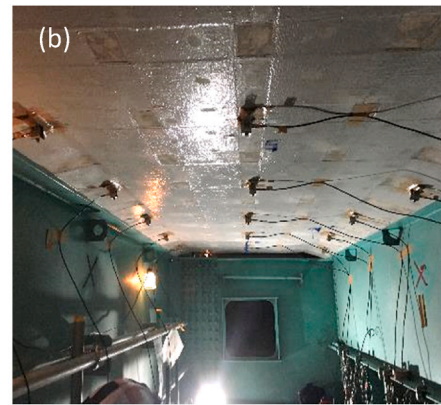
Fig. 13. (a) Tested highway bridge, (b) sensor arrangement for the measurement before repair.

The effect of repair by epoxy injection on an RC slab of a highway bridge was visualized (Takamine et al., 2018). The results before and after repair were compared to visualize the soundness based on the elastic wave source distribution by measuring the elastic waves generated by the traffic. Fig. 13 shows an overview of the measurement. The bridge of interest is a highway bridge in service, and elastic waves generated by vehicle traffic were measured for the RC slab. The target panel had cracks which were visible from the underside and was reinforced with CFRP sheets. Eighteen AE sensors were installed in a grid pattern of 3×6 on the underside of the deck. The sensor spacing was 780 mm in the bridge axis direction and 700 mm in the direction perpendicular to the bridge axis.

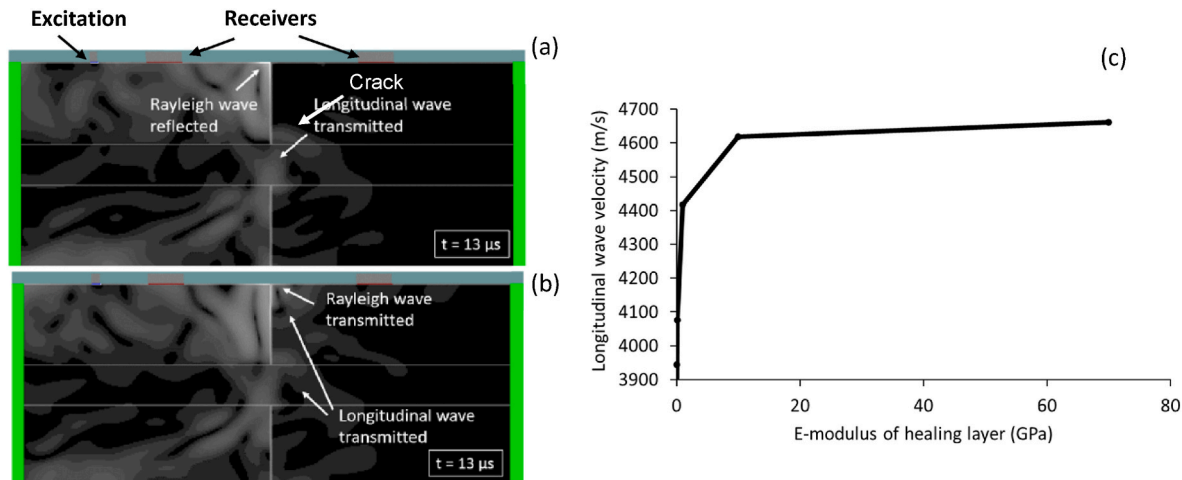
Fig. 16. Simulated wave displacement field in mortar (a) in the presence of crack (b) with healing agent in the crack, (c) simulation of wave velocity dependence on E-modulus of healing material (Lefever et al., 2022a).

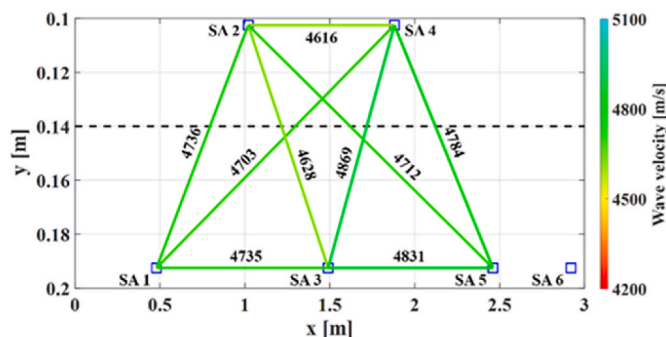
Fig. 23. Wave velocity in each ray path on the 757th day (Cheng et al., 2022).

newly-cast concrete. The sensors formed ray paths across the old and new concrete and their interfaces. Potential changes in wave velocity between the ray paths across the interfaces would indicate potential delamination. Over a two-year period, measurements were taken, and the comparison of wave velocities in different ray paths did not indicate any delamination in the newly applied concrete cover (Fig. 23). The method is demonstrated to be effective for long term monitoring of repair patches.

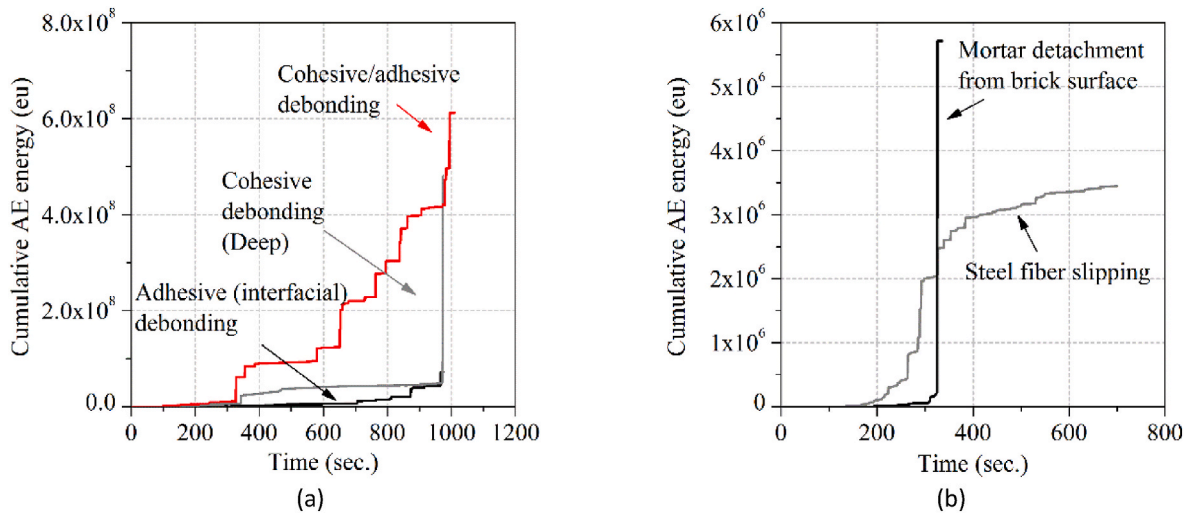
Fig. 28. (a) Representative results of cumulative AE energy measured during shear bond tests on brick specimens with FRP-strengthening and (b) SRG-strengthening (Verstrynge et al., 2016).

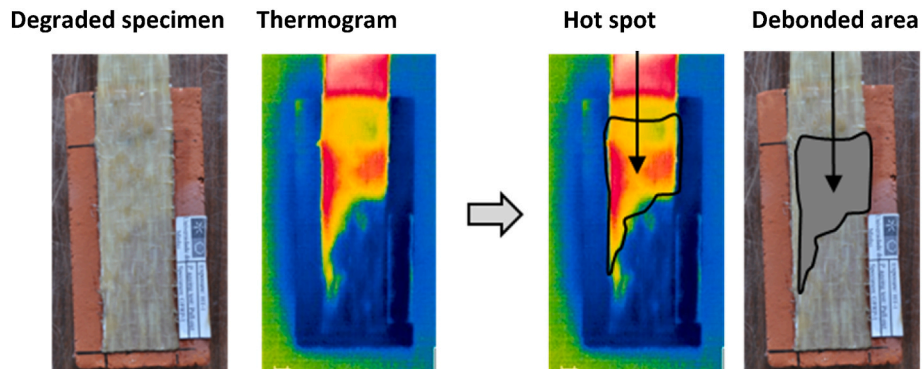
Fig. 30. Debonding detection with infrared thermography (Ghiassi et al., 2013; Verstrynge et al., 2016).

the specimens. The existence of discontinuities, such as interfacial defects or delaminations, affects the thermal properties. The temperature decay in degraded areas is altered, which can be identified as hot spots in the thermal images, as exemplified in Fig. 30. This test provides a picture of the potential detachments. However, high thermal conductivity (carbon or steel fibres) or high matrix thicknesses could limit the detectability of the test.
