INTRODUCTION TO THE MANUAL *For the Web*

Manual of River Restoration Techniques

RESTORING MEANDERS TO
STRAIGHTENED RIVERS

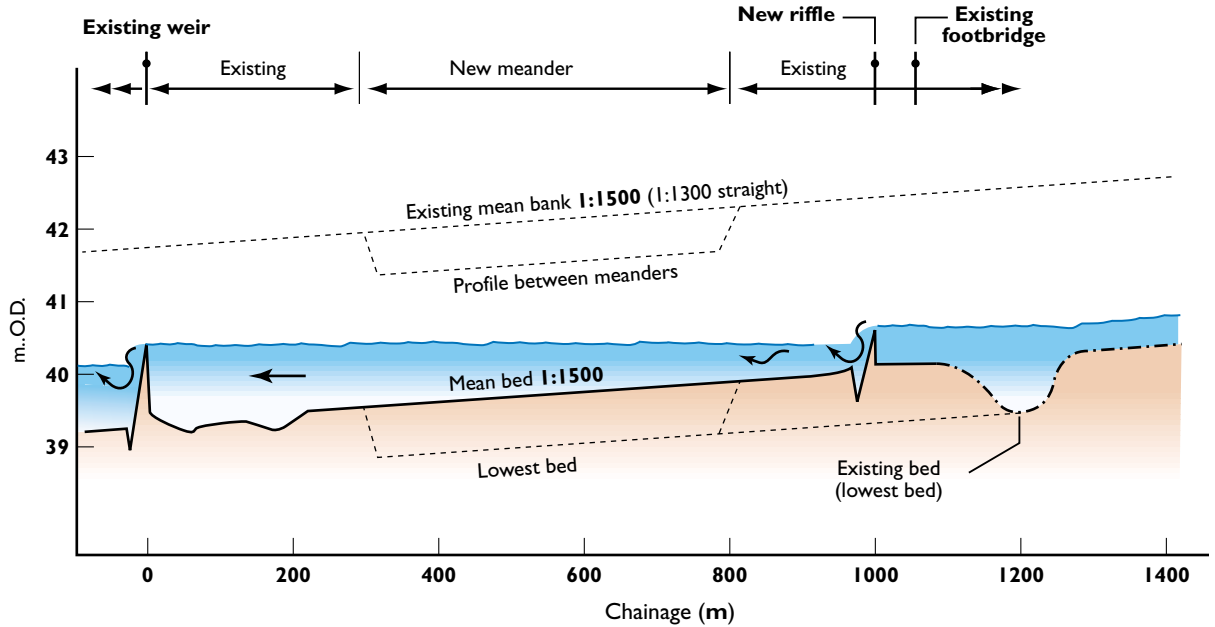
Figure 1.4.2
LONGITUDINAL PROFILE

The original mean bed gradient of 1:1300 paralleled the mean bank gradient at a depth of c. 2.4m.

The new mean bed gradient and level matches the existing but flattens to 1:1500 because of the increased length created. Bed scour around each meander was expected to reach c.1m depth as observed at an existing bend at ch. 1200m. This is shown as 'lowest bed' on the long section 1m below mean bed. Conveyance of floodwaters across the new meanders was facilitated by a general lowering of inter-meander land levels by c. 0.6m. This also enhanced water storage aspects of the 1 in 100 year flood hydrograph, attenuating the peak flow downstream.

Longitudinal profile (fig. 1.4.2)

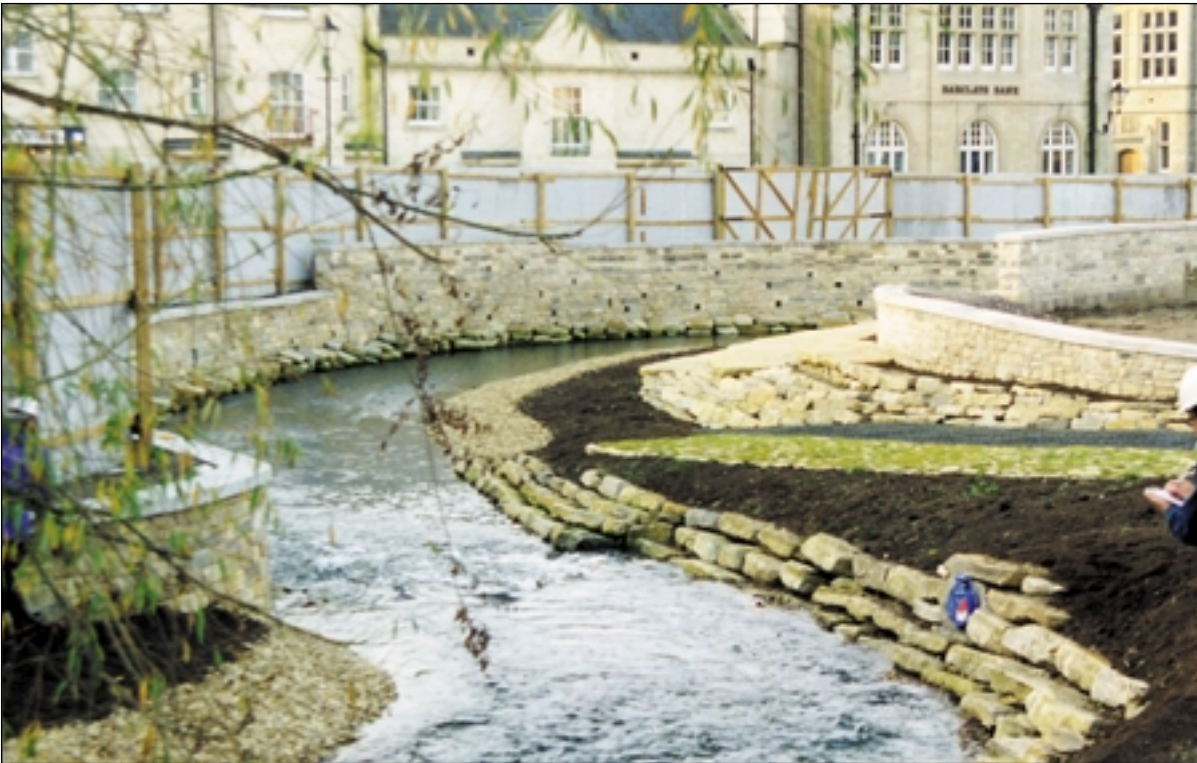
View of Section A (fig 1.5.3) on completion

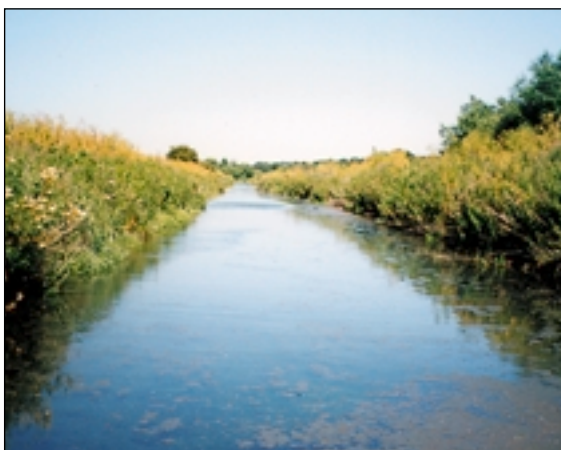
Canalised course of the Little Ouse

The new canalised course was straight, trapezoidal, c.6m wide and 1-2m deep, with 3m dry, steep banks dominated by tall ruderals and grass. In-stream habitat was poor, macrophytes were confined mainly to the shallow margins, and the substrate was dominated by sand with some silt and gravel.

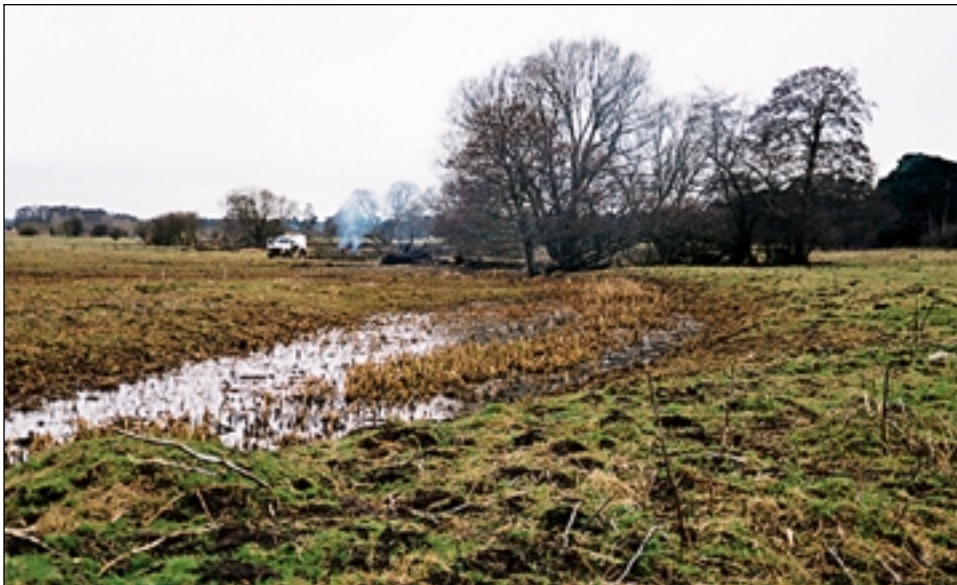
Looking downstream along the old meanders

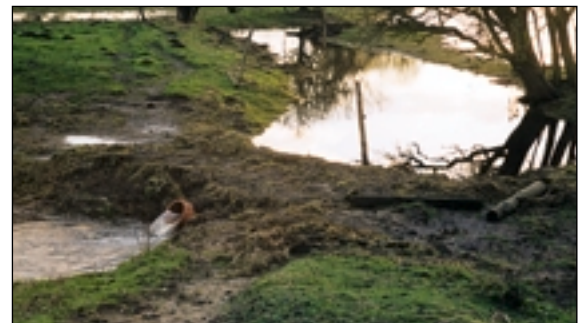
Sluice, bund and upstream flooding area

In the middle of the meandering reach a marshy backwater section was isolated with a bund at the upstream end to protect the habitat from high velocity flood flows.

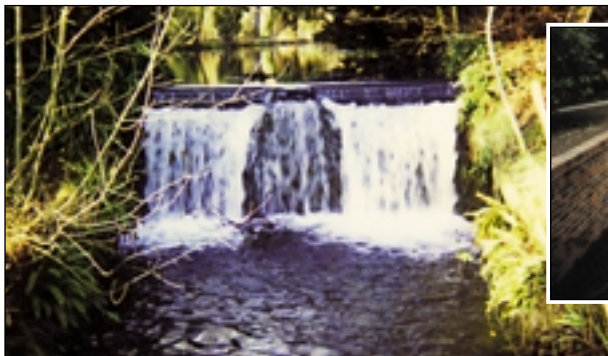
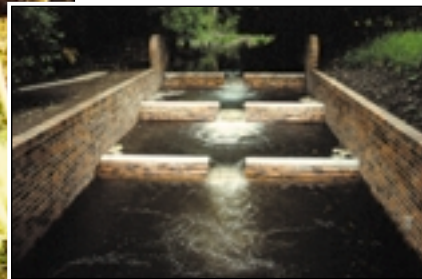
Mill weir and replacement fish-pass

A mill weir on the River Chess was removed and replaced with a fish-pass. This would provide the opportunity for fish passage to be restored and enable enhancement works to the impoverished channel upstream (see 3.9).

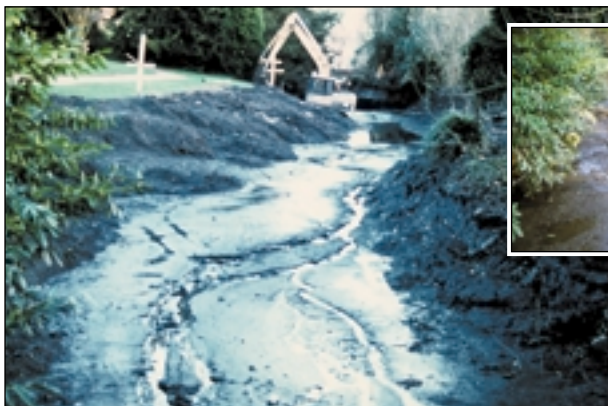
Exposed silt, looking towards mill weir.

Inset above: Dredged.

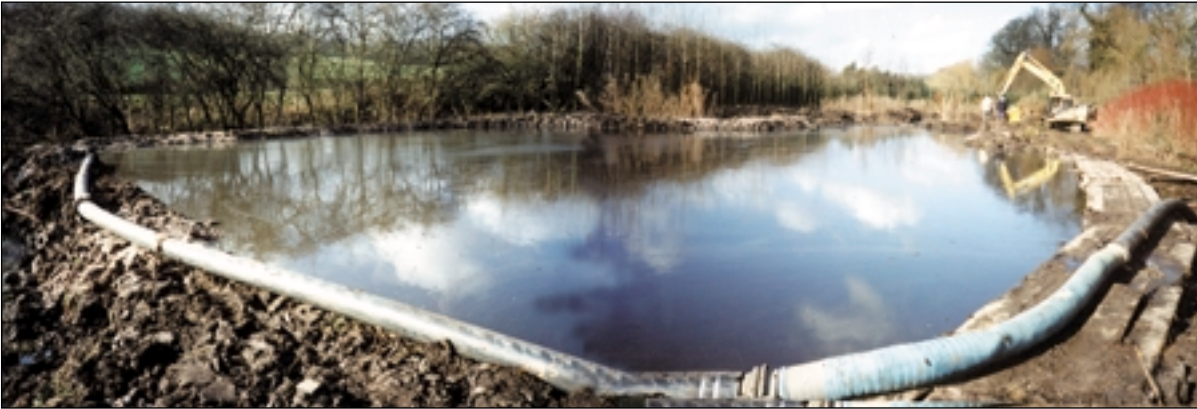
Lagoons and stilling basin – February 1995

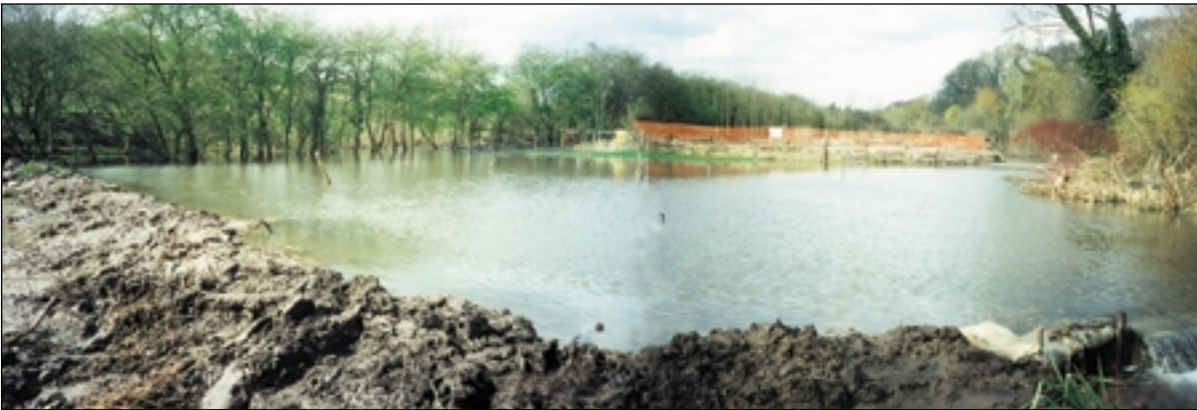
Lagoons, stilling basin and overspill – March 1995

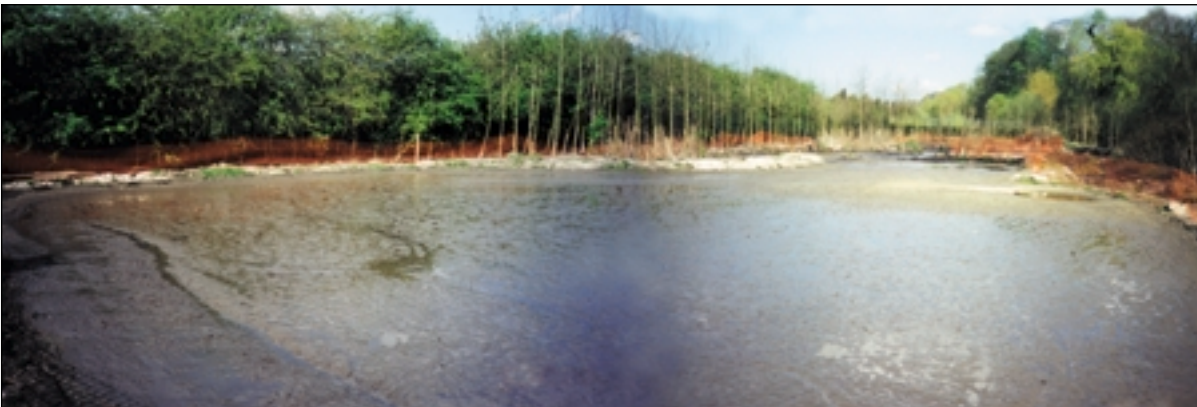
Retained silt load – April 1995

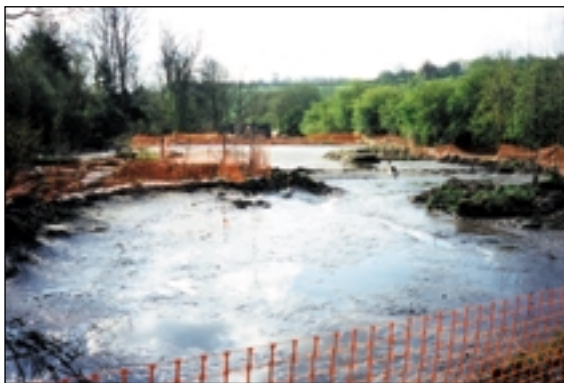
Dewatering – April 1995. View from inlet channel

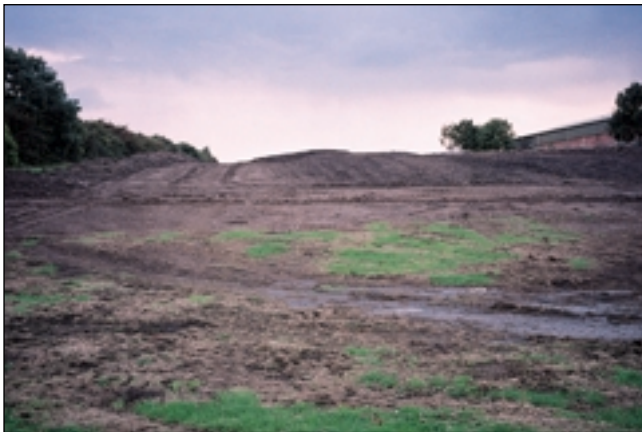
Keepsafe landform during construction

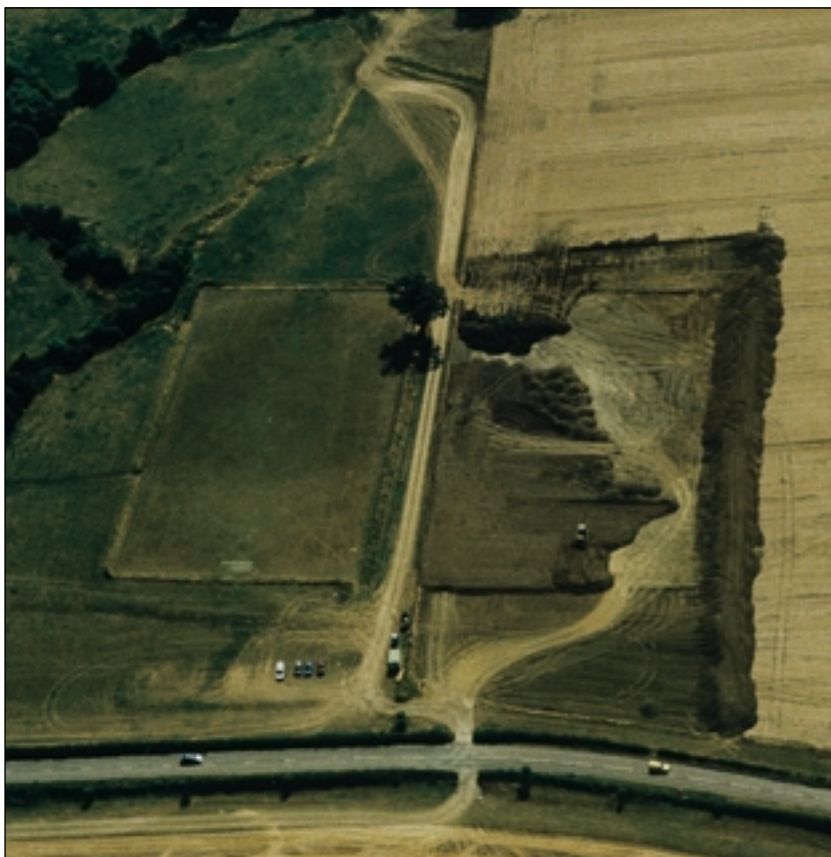
Construction of landform in arable field to right of football pitch – 1995
Photo: Environment Agency

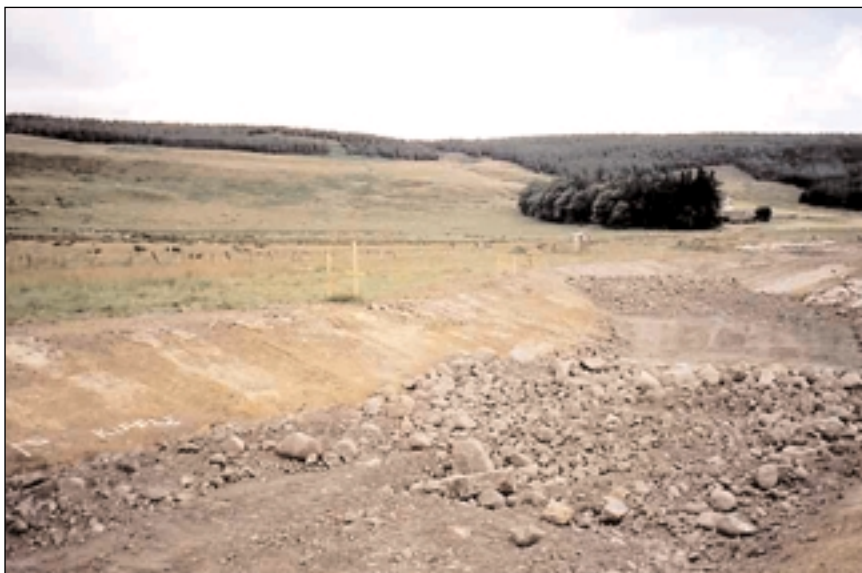
Shaping the new channel within the clay lining

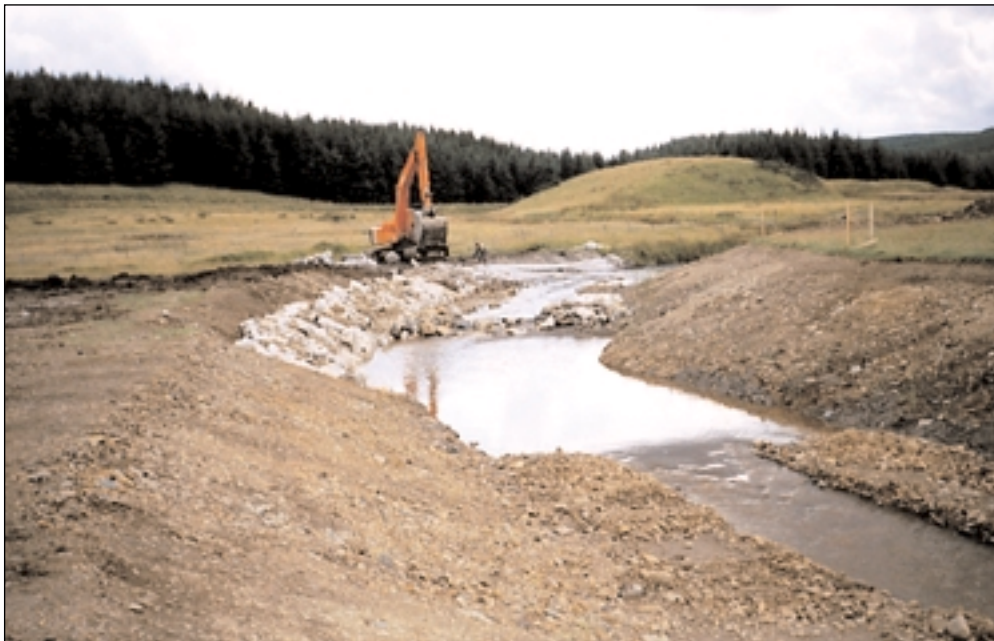
The 'constructed' run-pool-riffle sequence

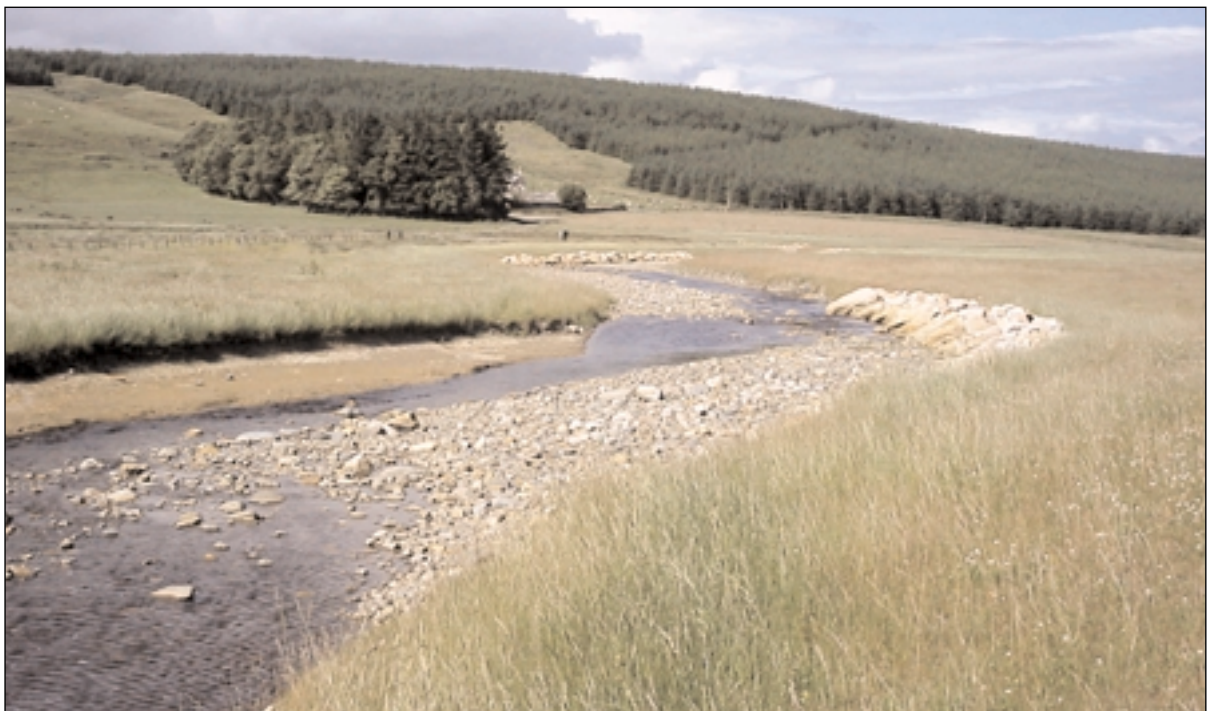
One year on and natural redistribution of in-channel sediments is helping to 'soften' the engineered channel

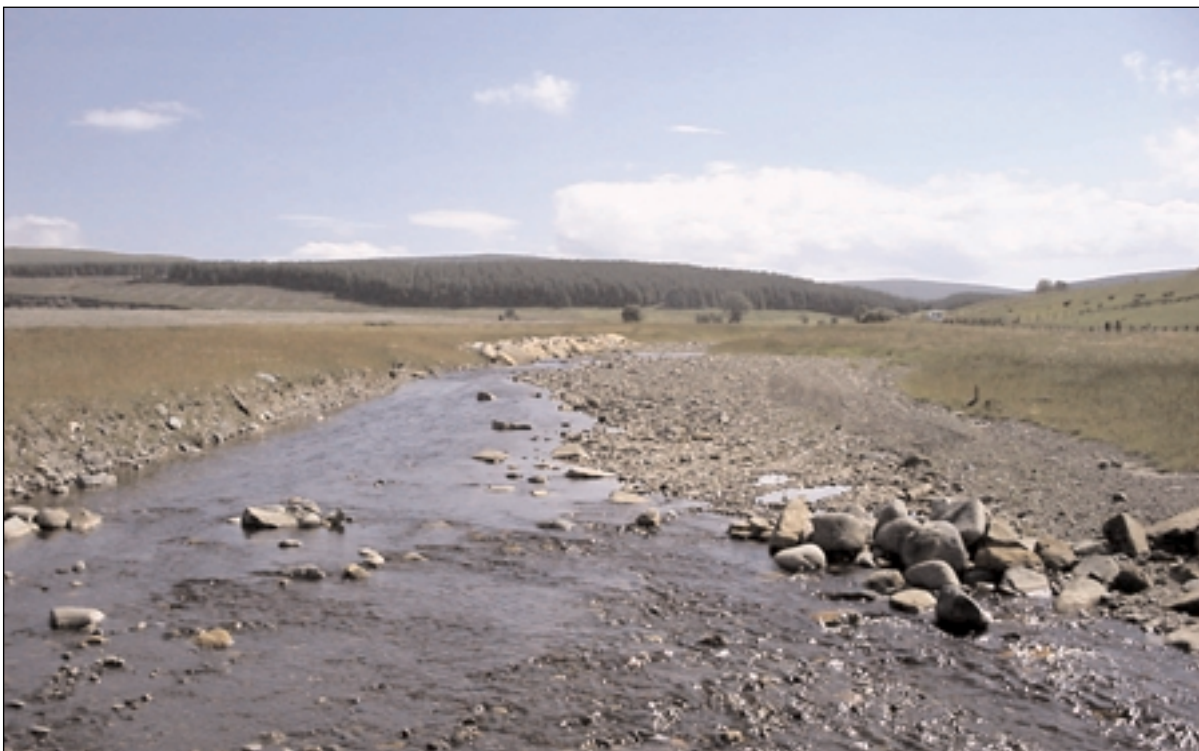
The overwide channel and plentiful bedload gives the river scope to shape its bed

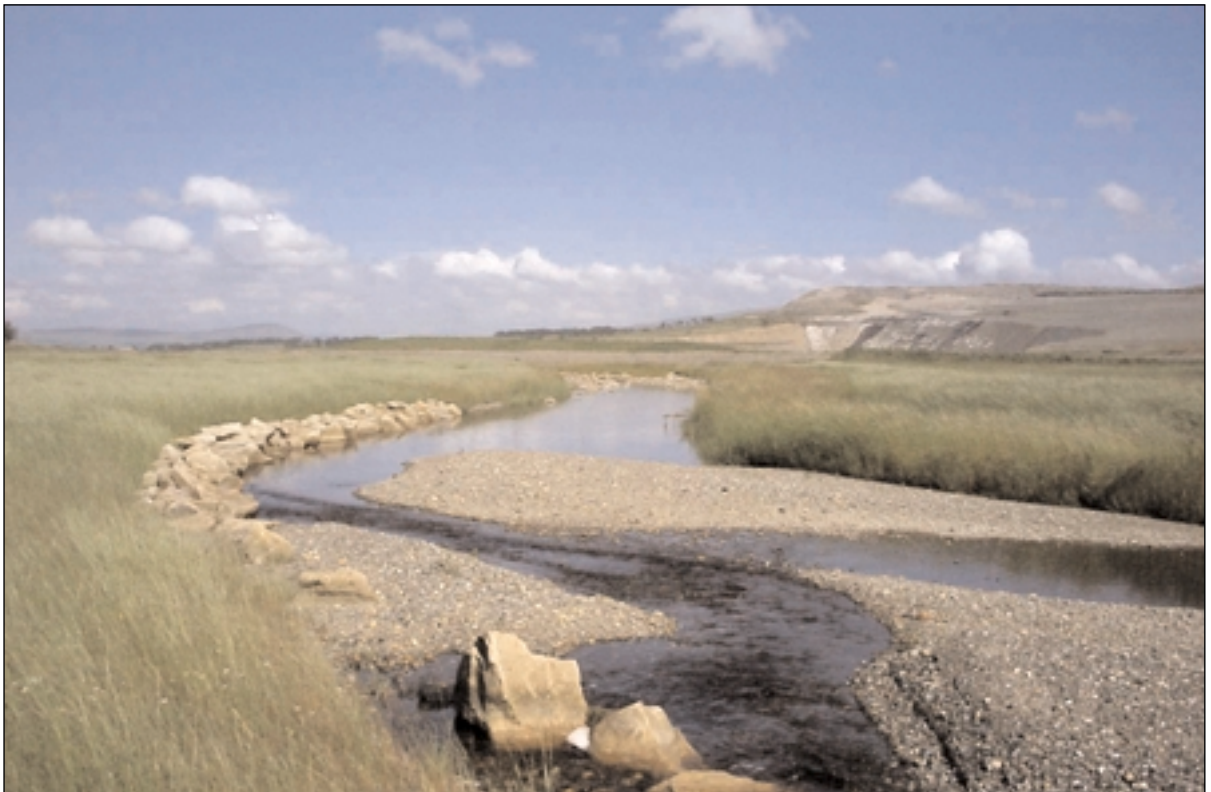
The rip-rap is still very evident but the in-river form is developing well

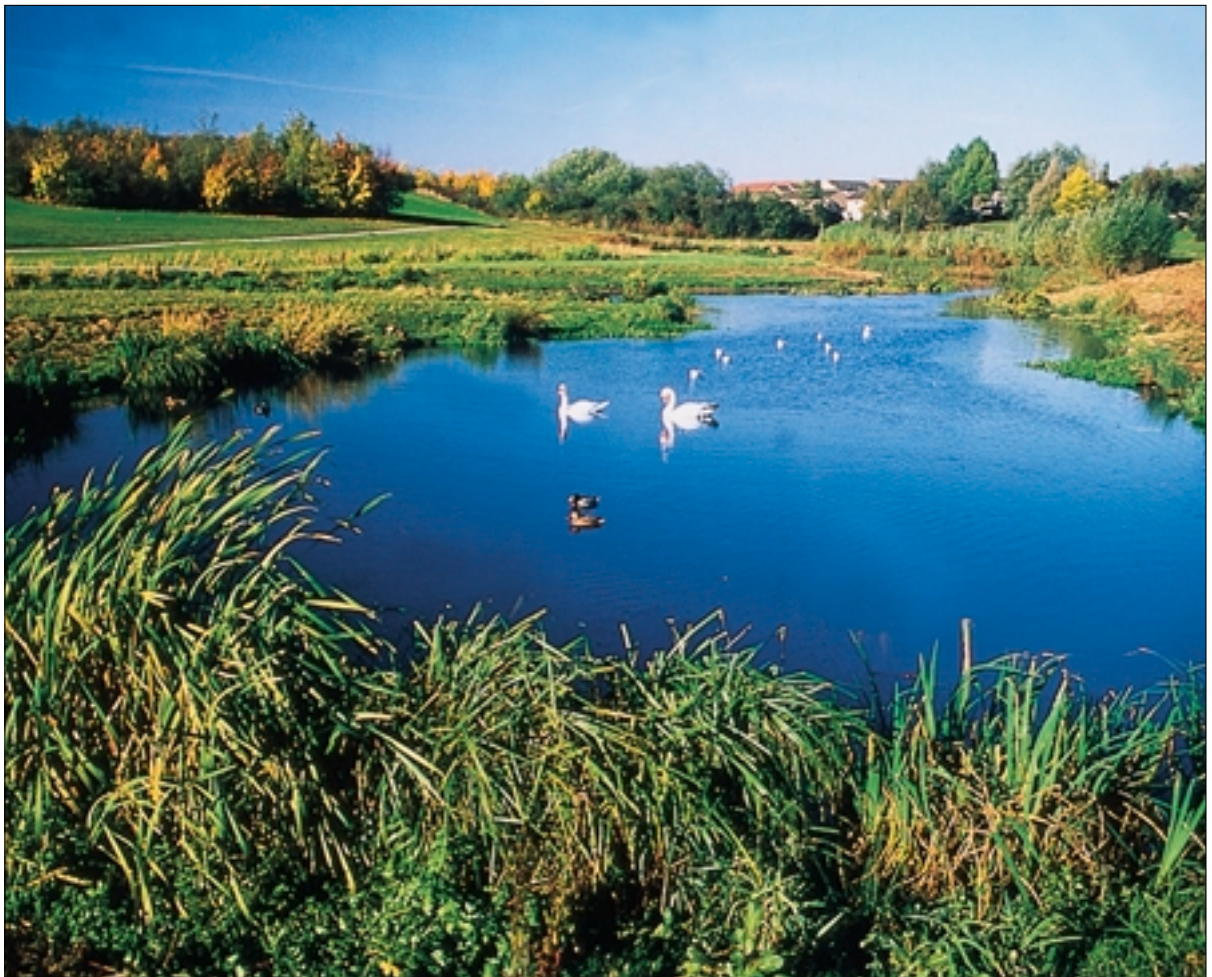
Large Backwater – November 1996

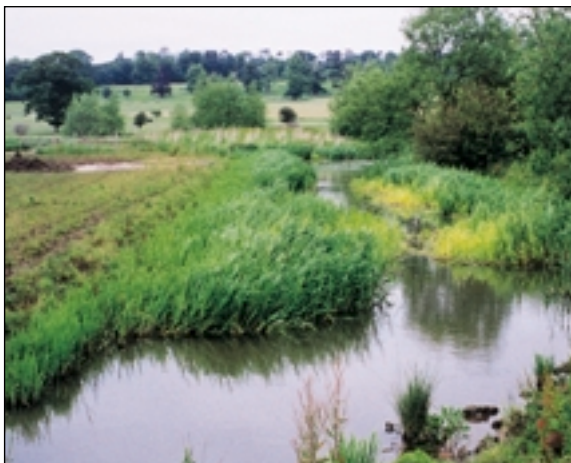
Backwater 1

Backwater 1 was created after excavating a new meander in the leat (see 1.3). It is an unfilled length of the old leat which was enhanced by removing the embankment from the left side so that rising floodwater could overspill to merge with floodwaters in the new river channel adjacent to it.

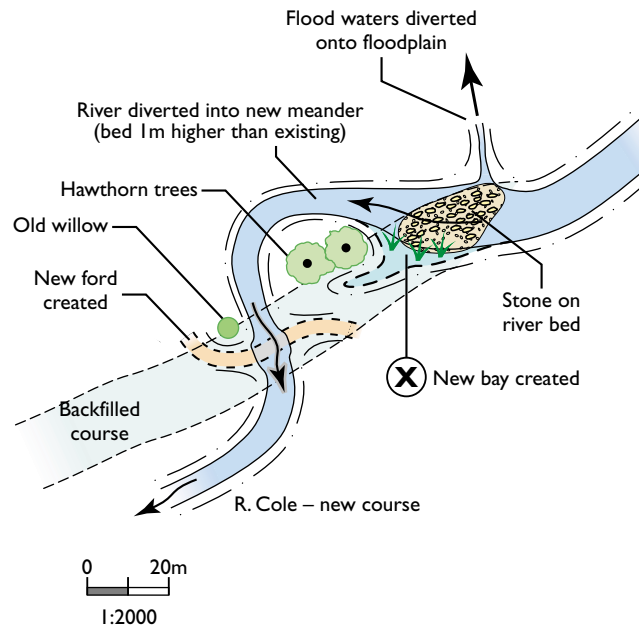
Figure 2.2.2
NEW BAY AT START OF LOWER MEANDERS
(For location see Figure 1.2.1)

New bay at start of lower meanders (fig. 2.2.2)

The new meandering channel is smaller than the existing channel upstream and its bed is elevated c. 1m higher. As a result, water in the upstream channel is impounded and slow moving which contrasts with a marked increase in velocities within the new channel. The design of the junction of the old and new channels reflects these hydraulic conditions. The risk of downward scour of the new bed was alleviated by backfilling the existing channel bed where it abuts the new and adding a layer of stone to create a secure transition. To complete the diversion, the old channel was backfilled in a manner that created a small marshy bay within which the slower moving floodwaters approaching the new meander can eddy freely before entering it. This was preferable to complete backfilling and having torevet the fill to resist erosion.

Opposite the bay, an old drainage ditch entered the river. This was incorporated and enlarged to enable floodwaters to pass freely from the river out onto the lowest part of the floodplain, remote from the main river course. As a further safeguard against downward erosion of the new river bed, a stone ford was created 80m downstream where the new channel crosses over the line of the original (see Part 8). This ford acts like a small weir and therefore 'fixes' both bed and normal water levels upstream.

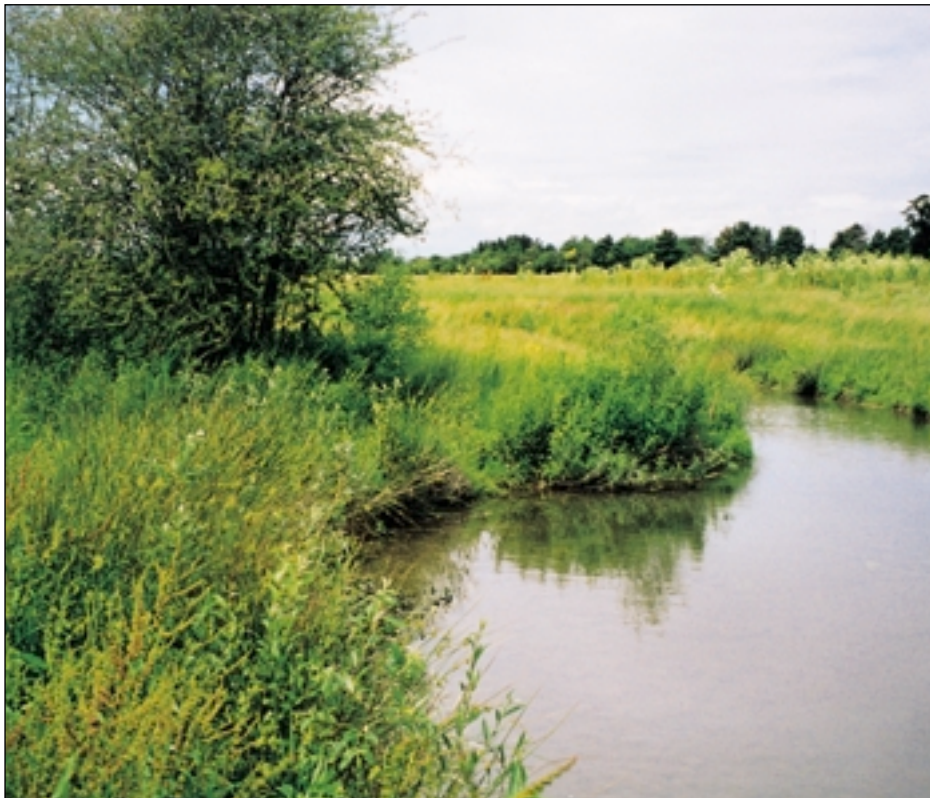
View of shallow bay X

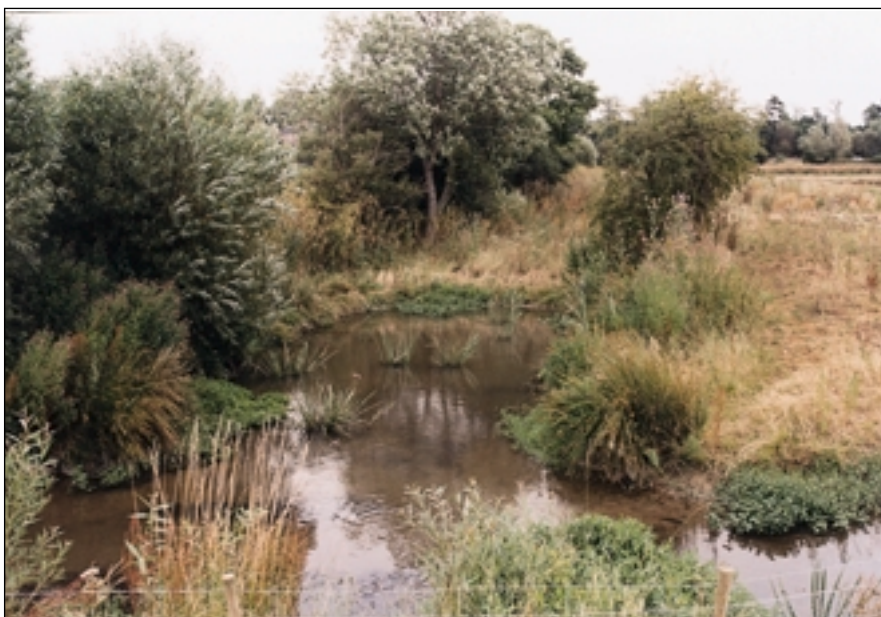
Small backwater A

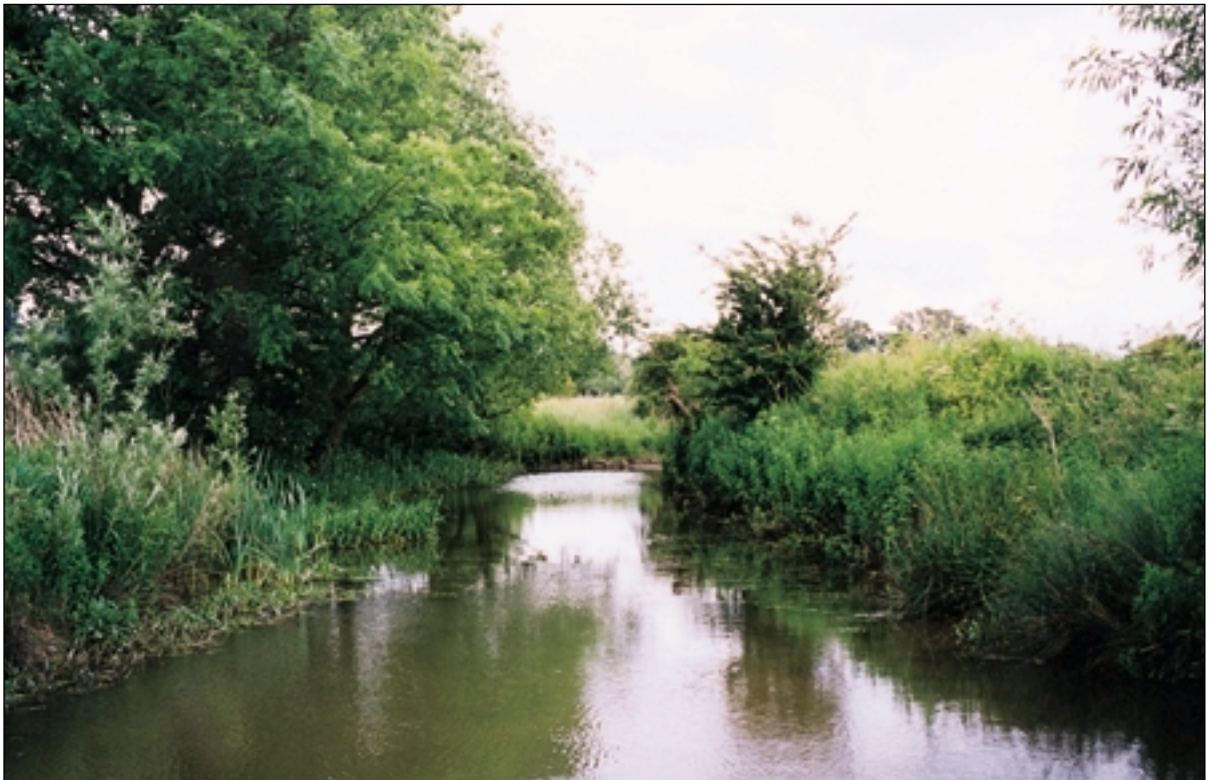
Large backwater **B**

Backwater B contrasts with A in that the retained trees along the old course all overhang open water and the new channel approaches from behind the trees rather than towards them. The hydraulics are entirely different as a result. The old river bank, behind the trees, remains at a high level preventing any floodwater from passing into the backwater save for small volumes that occasionally pass over the infilled length of channel. The backwater is thus a quiet refuge of still water, and hydraulic interaction with the river is limited to rise and fall of water levels.

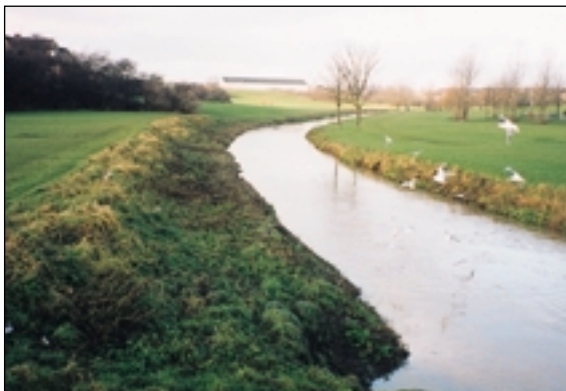
View downstream before deflectors constructed

The river had been straightened and enlarged to carry floodwaters safely through an urban area. A gas main runs parallel to one bank and contaminated landfill lies close to the other. The channel was uniformly trapezoidal although bank toes had been eroded. No diversity in the shape of the bed or banks, or of flow currents, existed and the ecological and visual amenity was poor.

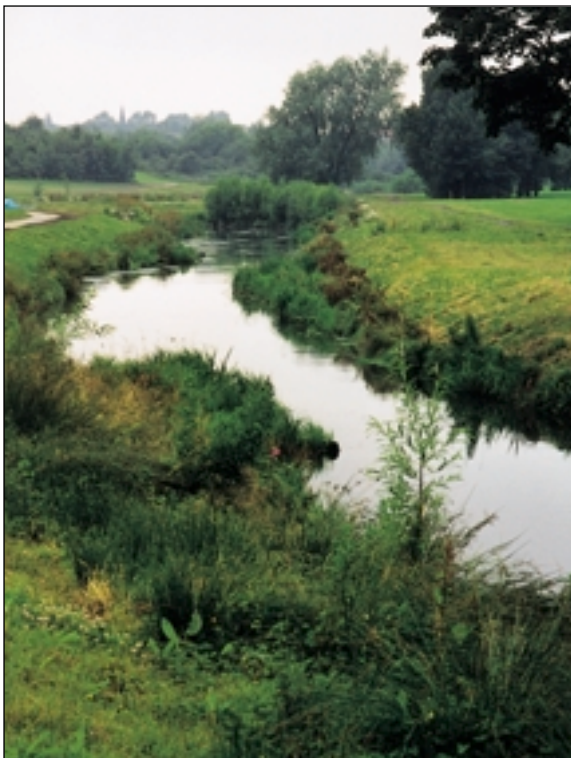
Type A deflector
– vegetation established

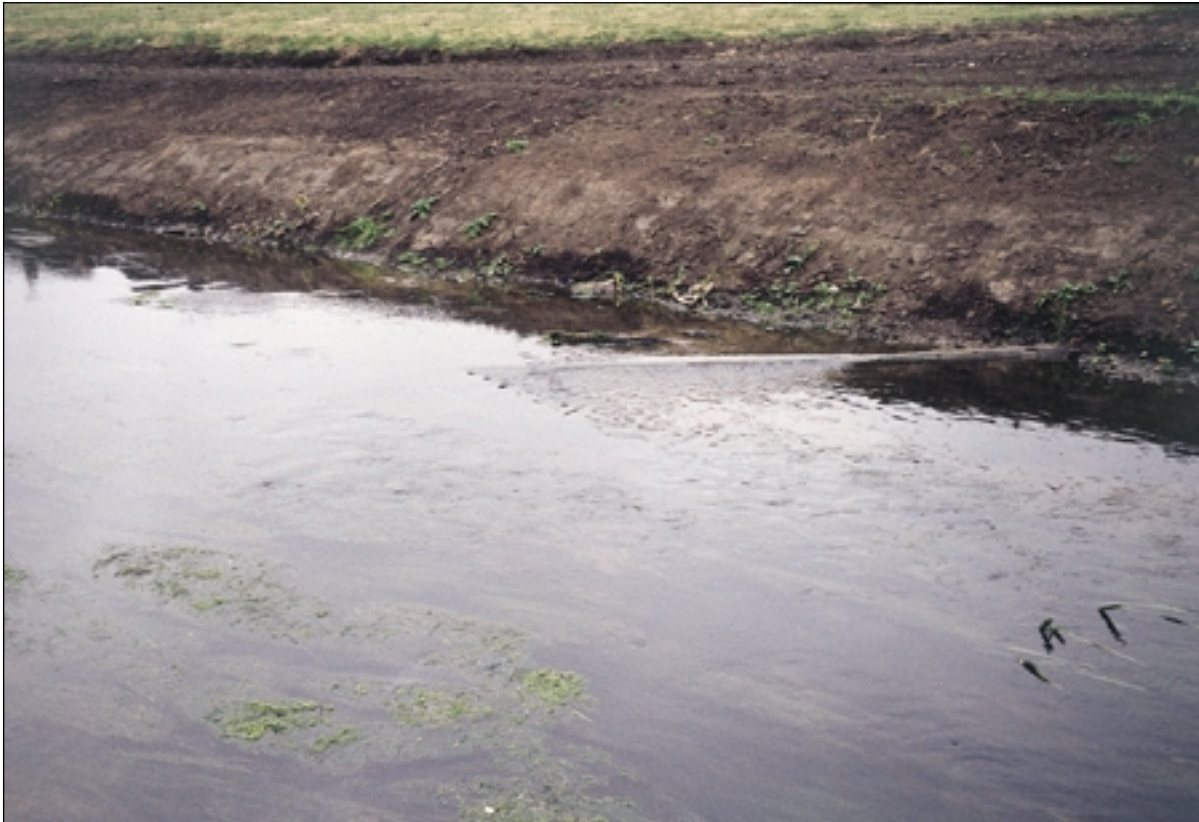
Type B deflector before planting

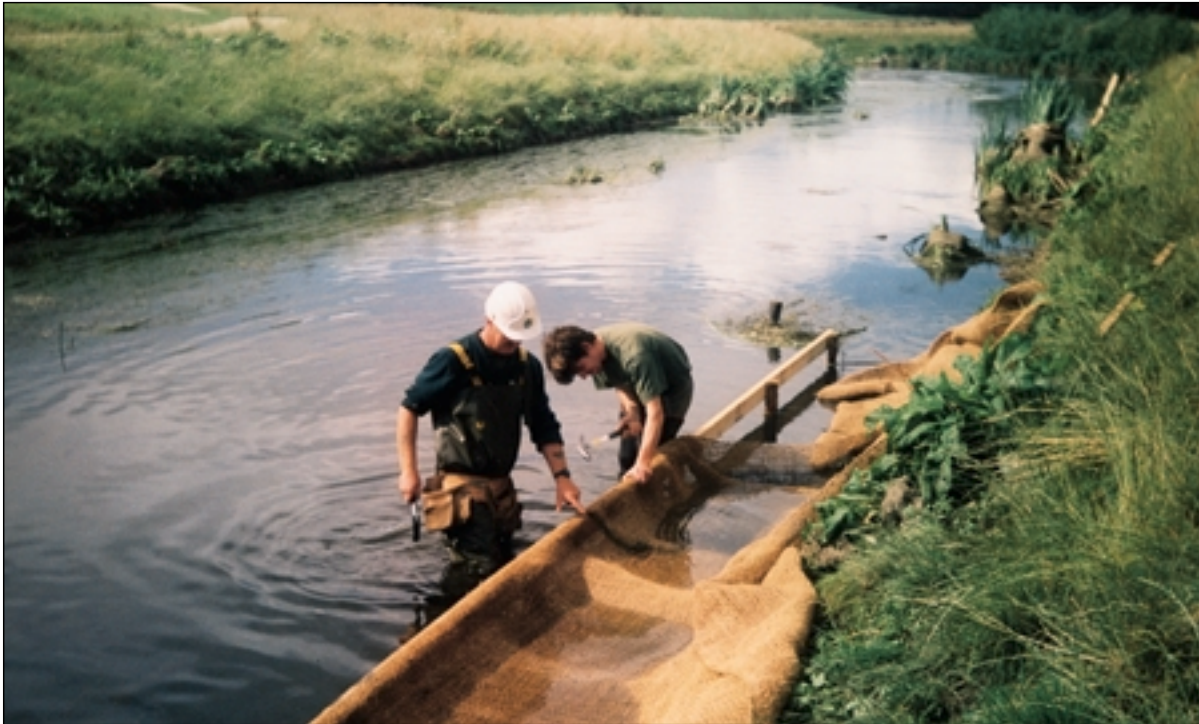
Attaching coir matting to create Type A ledges on River Skerne

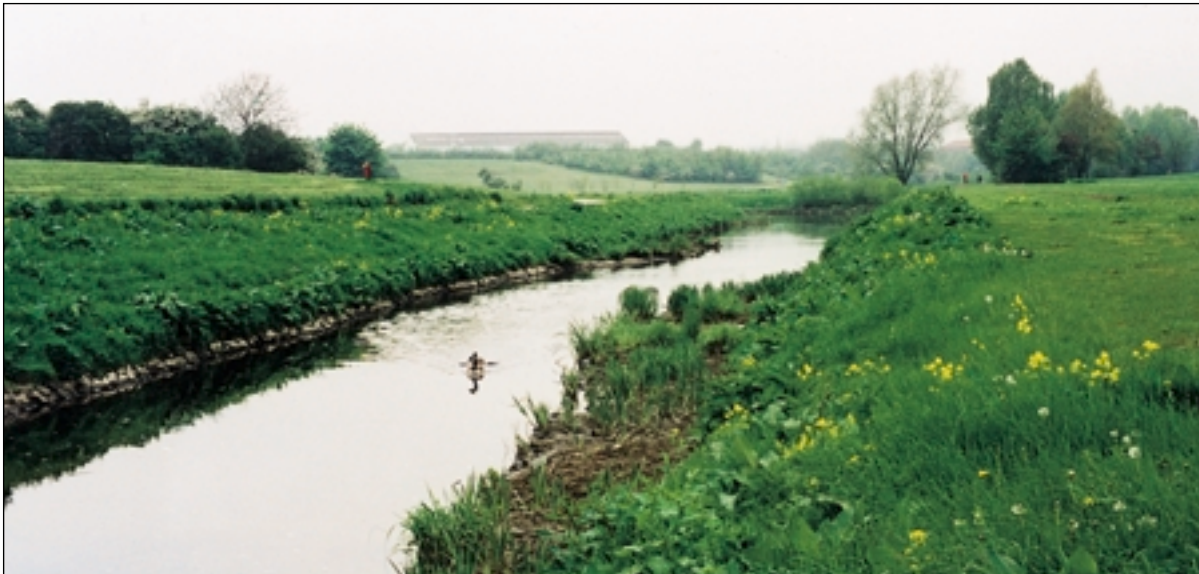
Type A Ledge on the Skerne – May 1998

Type A margins using plant pallets were installed downstream of the footbridge in the autumn of 1997 and overwintered satisfactorily in dormant conditions after several floods. Early summer 1998 growth was patchy with some silt banks smothering pallets. Growth was sufficient to ensure the spread of species to generate the dense cover required. Notable species that survived include occasional purple loosestrife and meadowsweet.

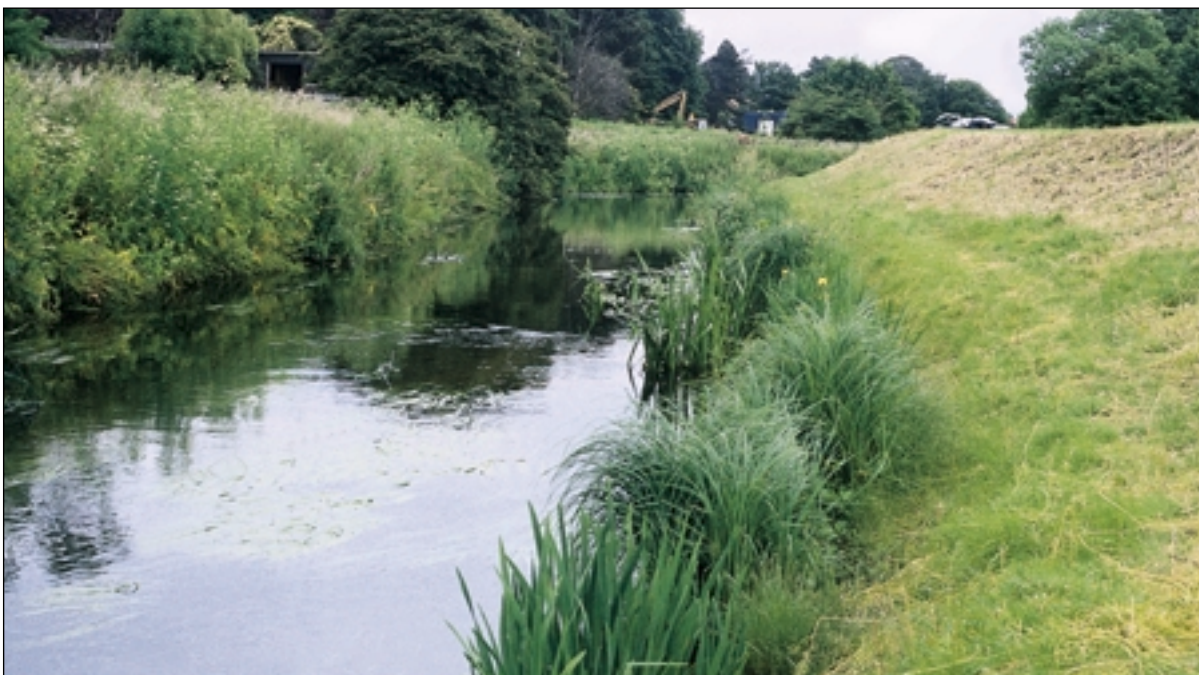
Type B Ledge on the Skerne after 2 years

Type B margins utilising plant rolls were installed upstream of the footbridge in August 1996. In 1998 they are attractive features much favoured by resident ducks that have created some bare patches between well established runs of lesser pond-sedge, yellow flag and reed canary-grass. The attraction of silt within the overwinter dormant vegetation along the ledges is significant; ledges have built up by as much as 300mm in places before being assimilated within new spring growth.

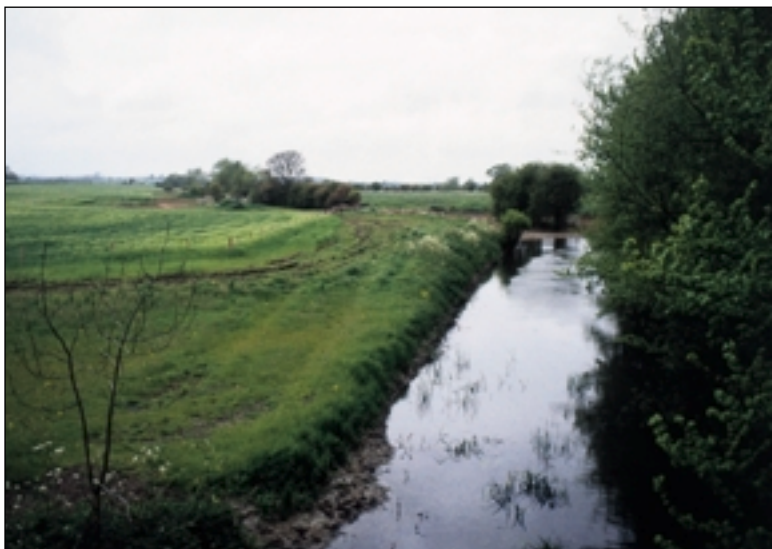
Prior to re-profiling and ledge construction – May 1996

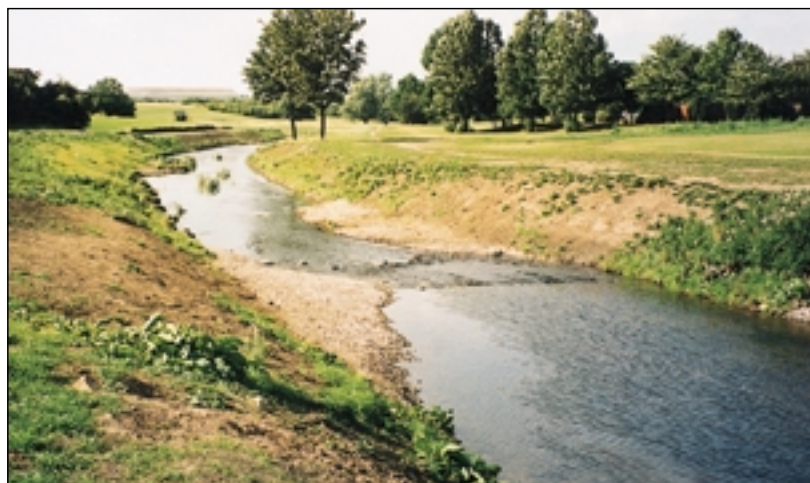
Stone Riffle downstream of Hutton Avenue footbridge

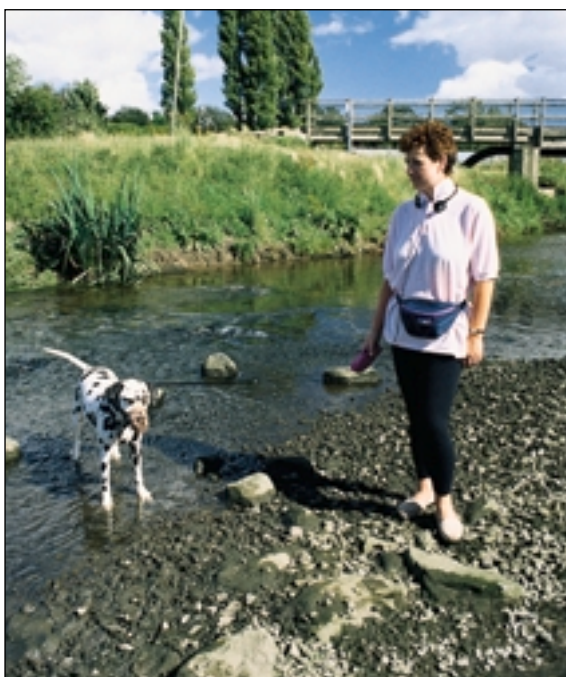
The riffle allows easy access down to the river – November 1996

Of particular note is the popularity of this spot with children who can gain safe access to the river and paddle in the shallow water, where the bed is firm and stoney.

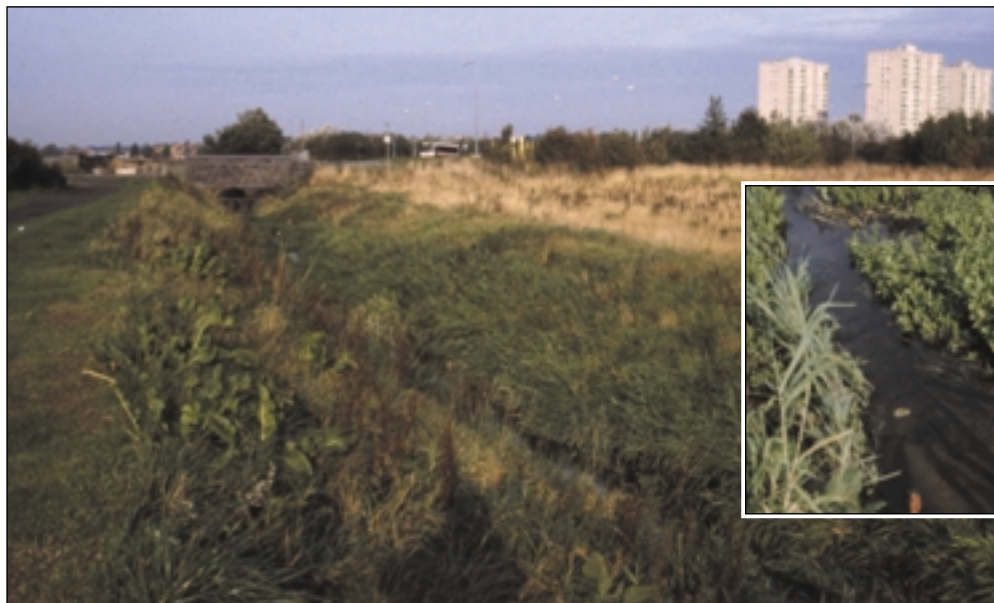
Before:
The Alt, straight and steep sided

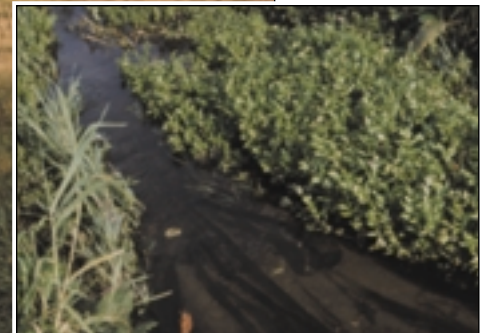
Bed dominated by silt

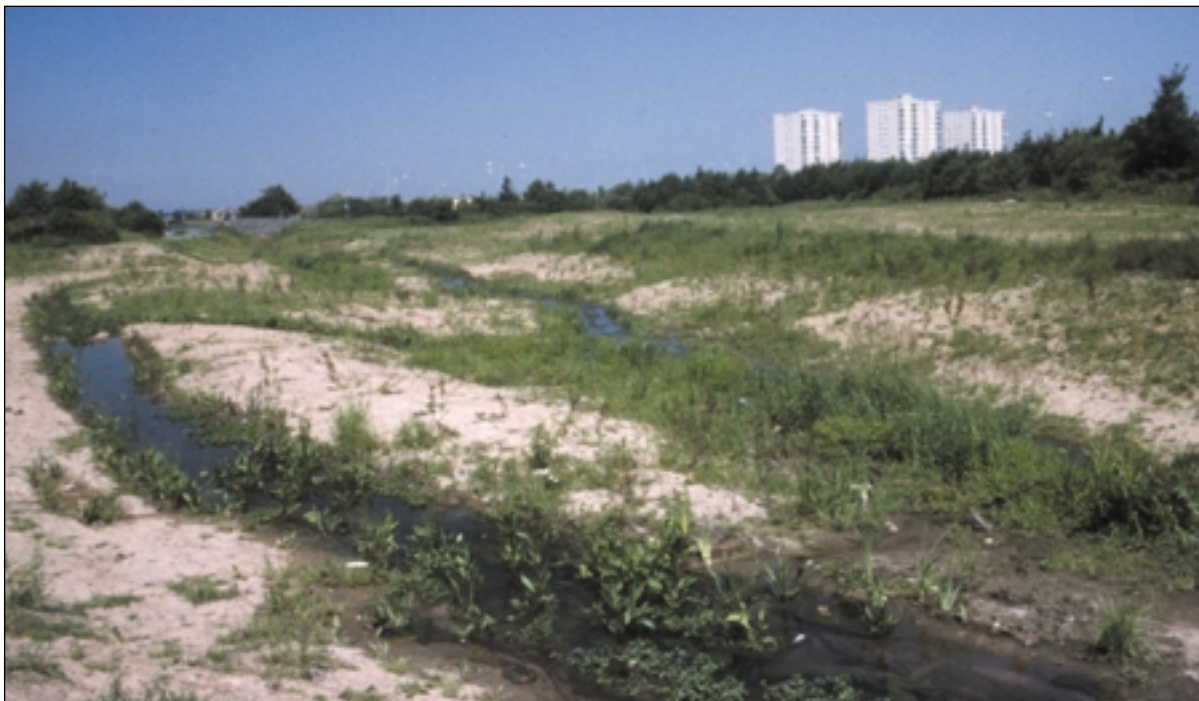
The excavated 'floodplain' area

Spoil disposal had to be addressed at an early stage to permit such a large (9000m³) 'floodplain' excavation. The nearby school planned to build an earth bank to prevent illicit vehicle access to its playing fields. By using 6000m³ from the enhancement works to help the school achieve this, the project avoided a potential doubling of costs.
