INTRODUCTION TO THE MANUAL *For the Web*

Manual of River Restoration Techniques

RESTORING MEANDERS TO
STRAIGHTENED RIVERS

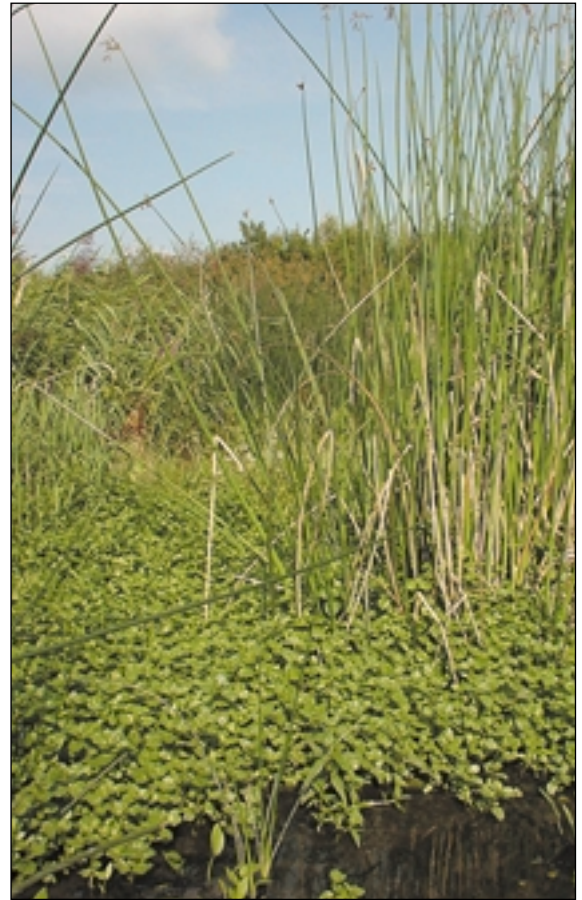
A good diverse vegetation structure has developed along and between the channel threads

The planting has been successful, with the exception of some of the shrubs on the riverbank which were removed.

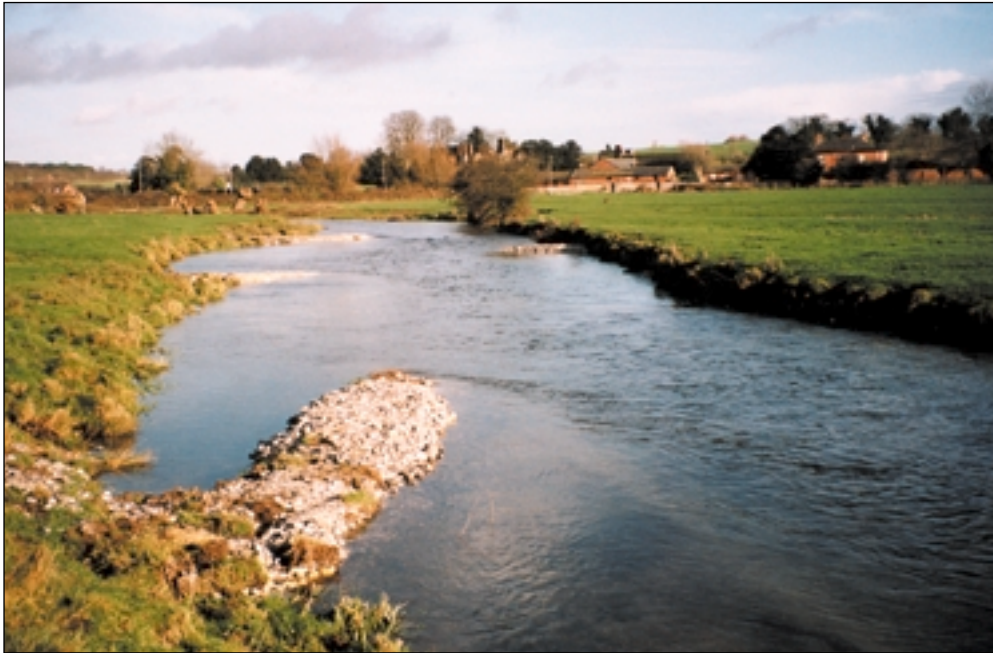
Completed chalk groynes

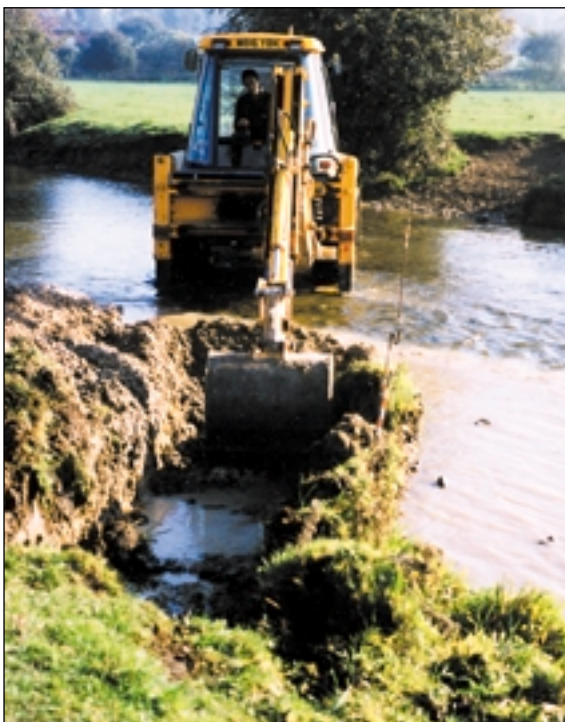
Digging the groyne trench

After marking out the area with pegs a JCB dug a trench 0.5m deep and 1-2m wide, with the excavated bed and bank material placed to one side. The trench was cut into the existing bank to anchor the completed groyne. The trench was then filled with either chalk or faggot bundles to provide reinforcement and stability and the excavated material from the original trench replaced on top.

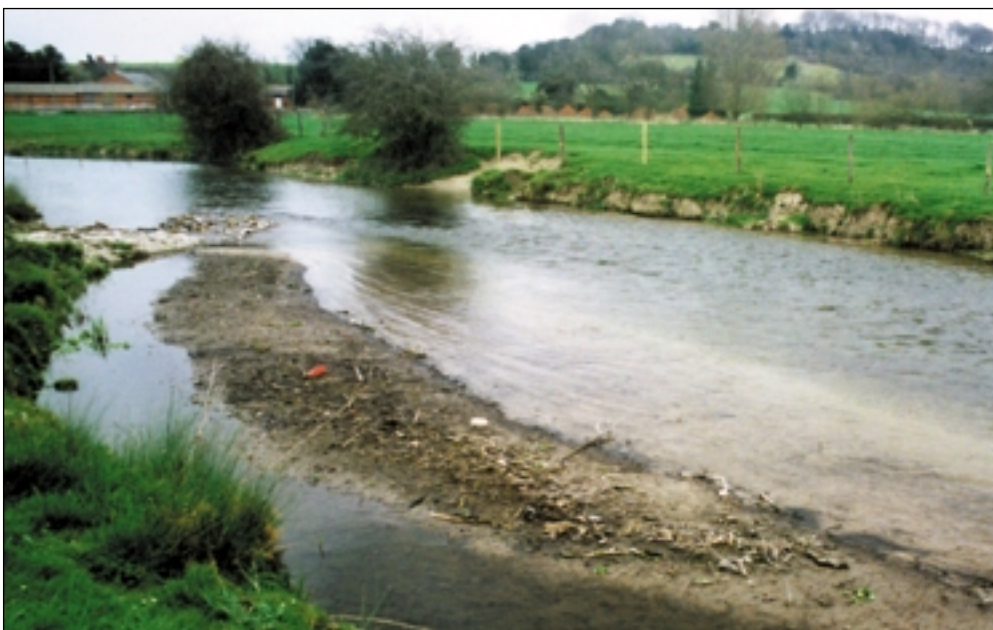
Six months of siltation

An initial concern, visual intrusion of the groynes, has been negated by the rapid siltation and colonisation by marginal plants naturalising the structures and stabilising the banks. There was no significant difference in the performance and stability of the chalk filled groyne compared with the faggot filled structures: the chalk groynes were however 37% cheaper to construct.

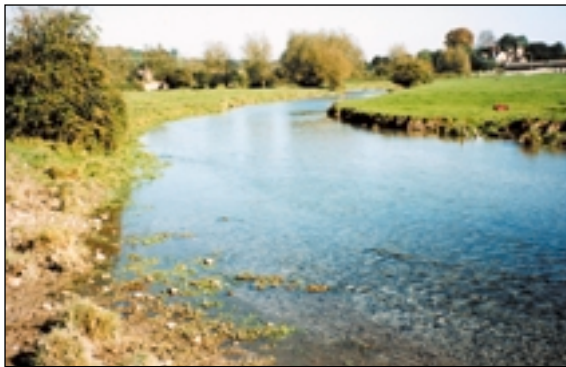
Cattle poached, wide and shallow

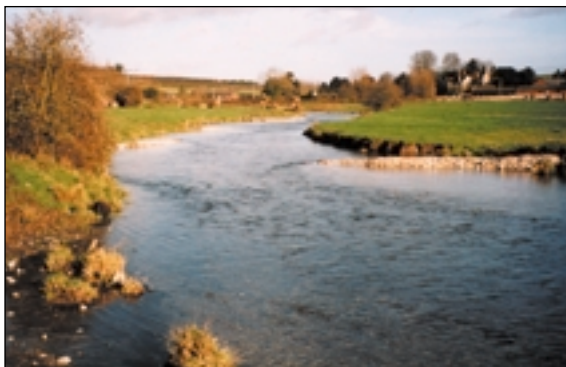
Groynes in place already increasing flow diversity

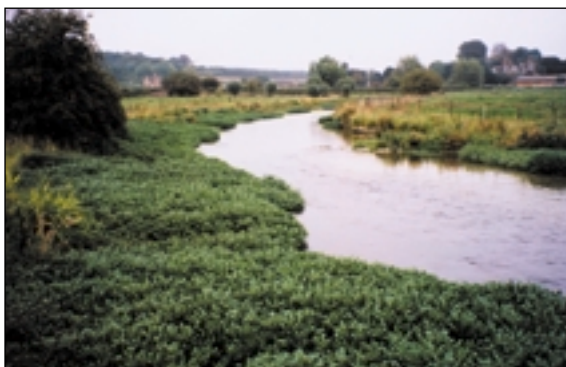
Silt deposits were quickly colonised and the river narrowed

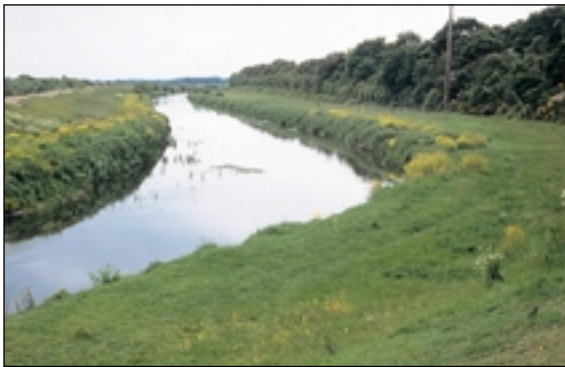
River Dearne. Wide and straight, choked in summer

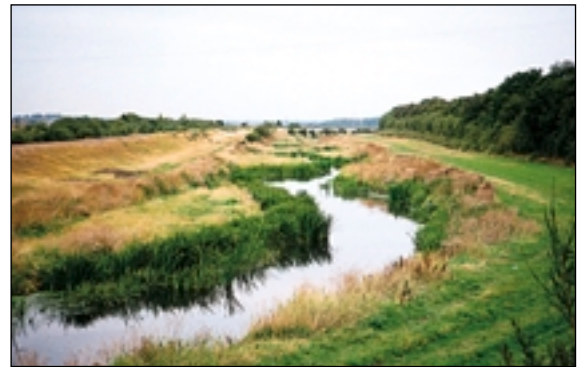
New sinuous reed-fringed course

The sinuous low-flow channel was defined by placing stone in the river to form the 'inside' of each bend.

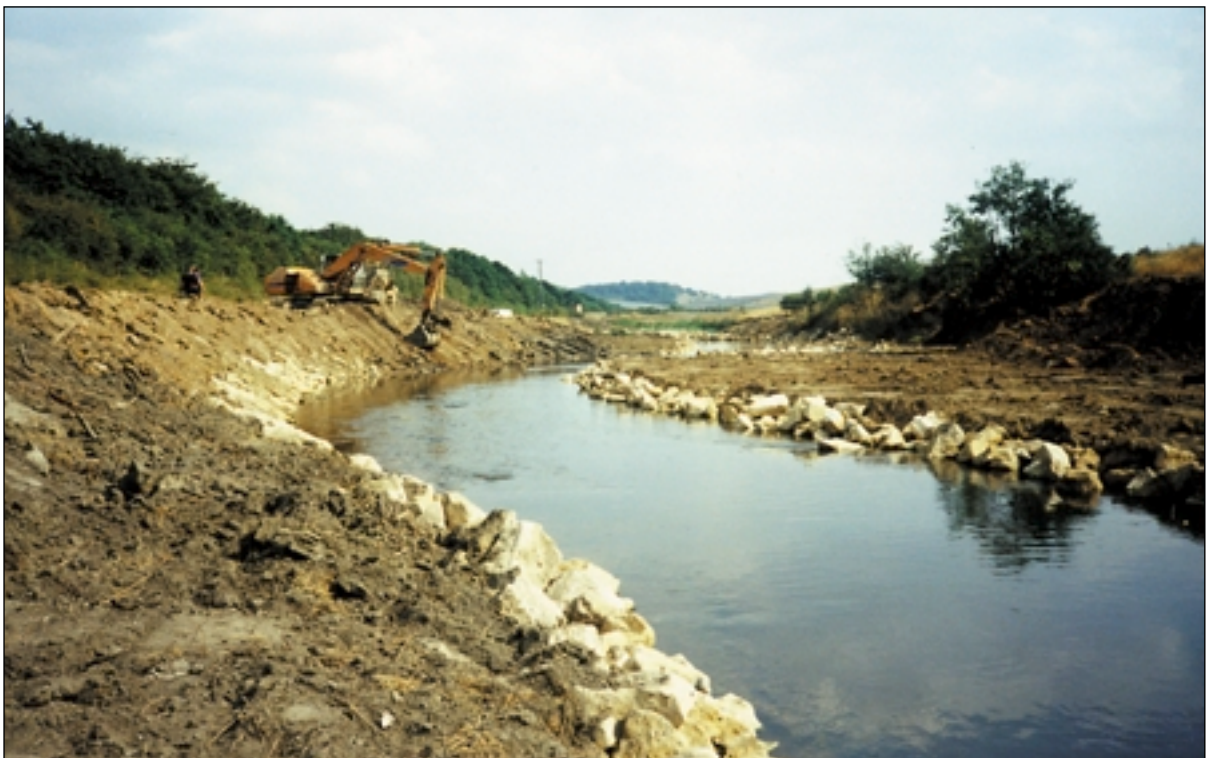
Placement of limestone boulders and berm back-filling

Placement was carried out by an excavator from within the channel as water levels only varied between 300 and 700mm. Work started upstream and looked initially to increase velocities in the first two bends to 0.5 m/s, reducing the increase to near existing flows (approx. 0.2m/s) at the final bend.

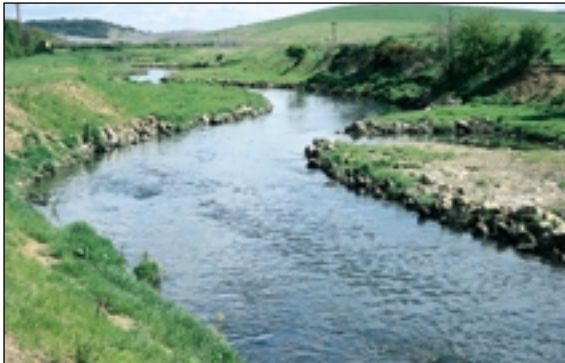
Narrowing increased velocities and created riffles used for fish spawning

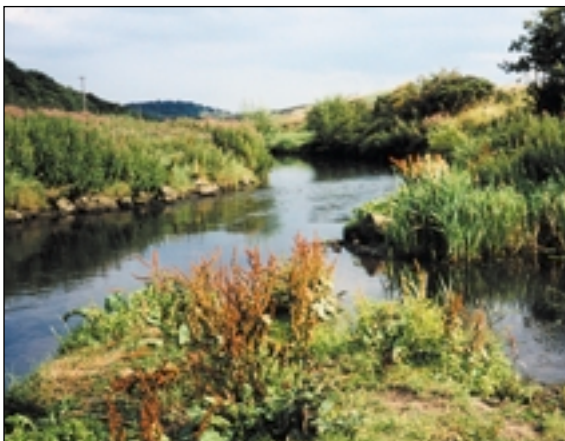
Main channel and backwater
5 years on, Summer 2000

The two unconnected backwater pools dried out due to the hydraulic draw of the river through the loosely compacted fill material. To mitigate this effect upstream connections were made using 100mm dia. plastic pipes.

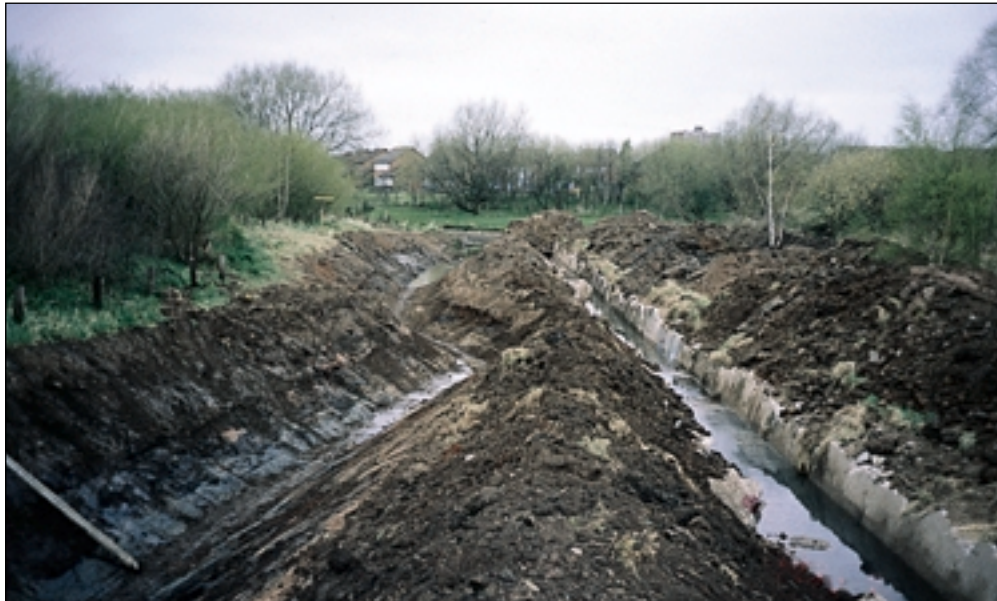
The 'new' Brook being excavated adjacent to the old channel. Spoil stockpiled

the opposite bank of the old channel. This maintained the flow through the old drain and allowed all work to be carried out in the dry. Once completed flow was diverted through the new course, and the old channel was filled using the spoil from the new.

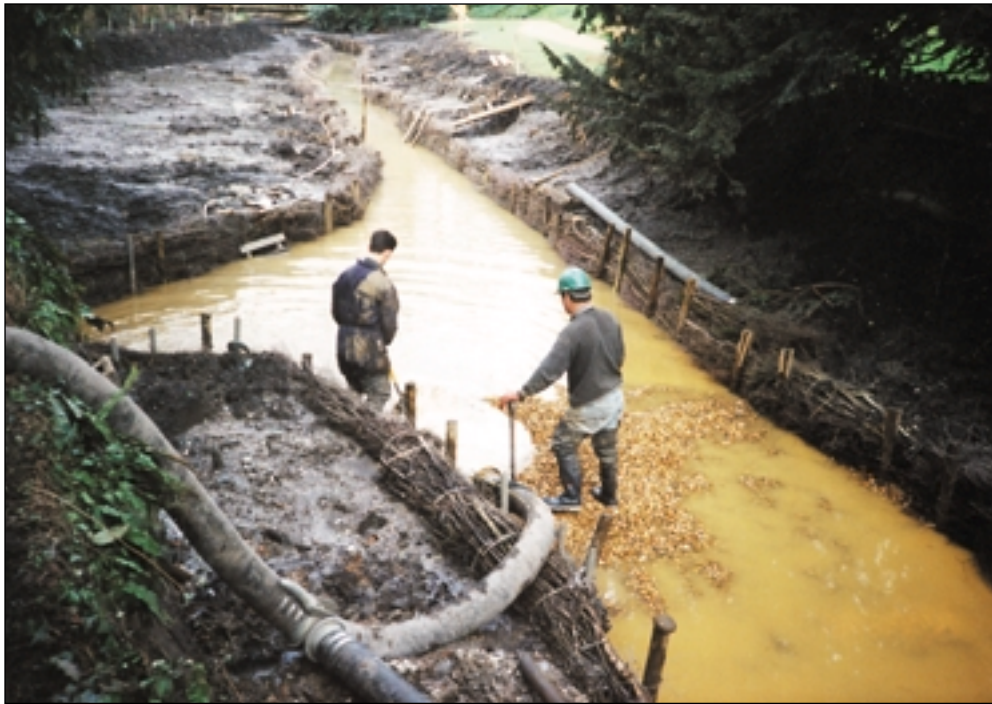
View of the wide dredged section, gravel being placed within the low-flow channel

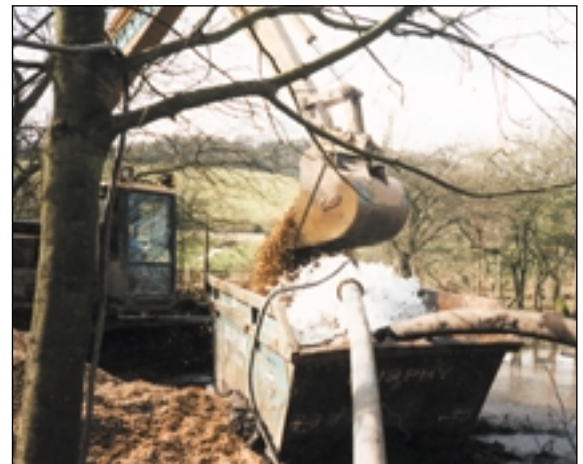
Pumping apparatus in operation

- At the site compound a submersible pump powered by a diesel generator was placed in a skip located near to the river.

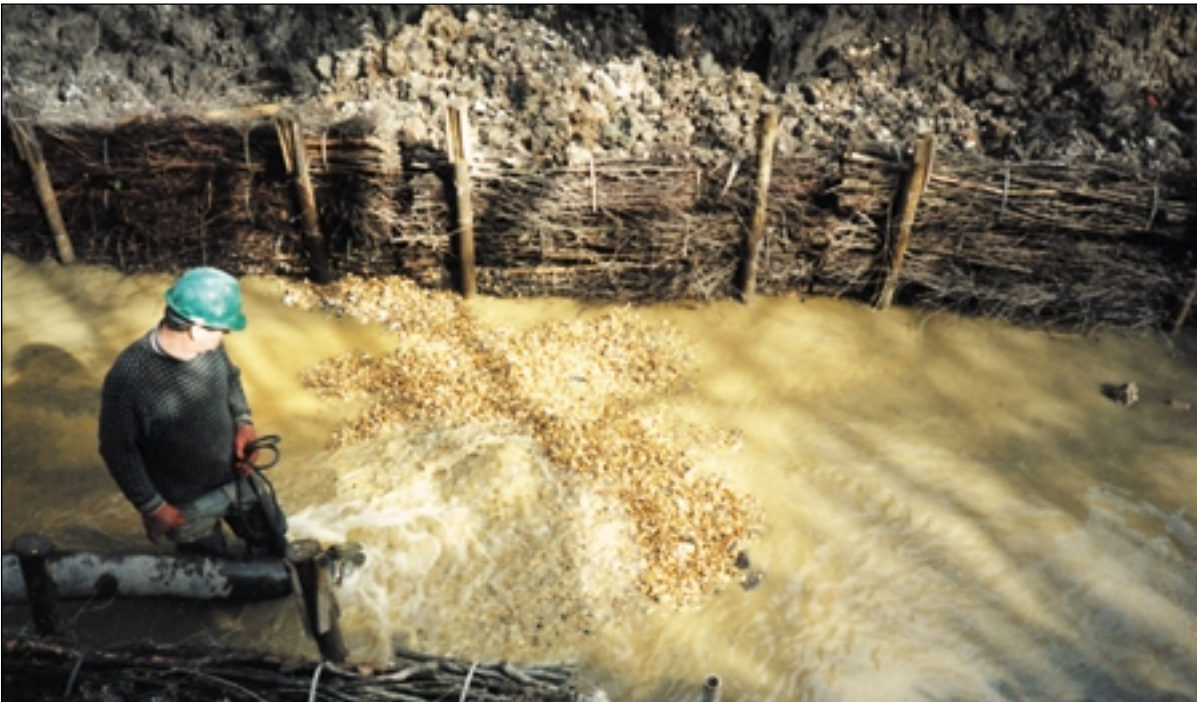
Gravel pumping in operation

Using this approach the contractor was able to place the gravels economically and without having to remove existing valuable trees and shrubs. By introducing the gravel it was possible to shape the bed, recreating pools on the bends and riffles on the straight sections (*see 5.5 for more detail on bed raising*).

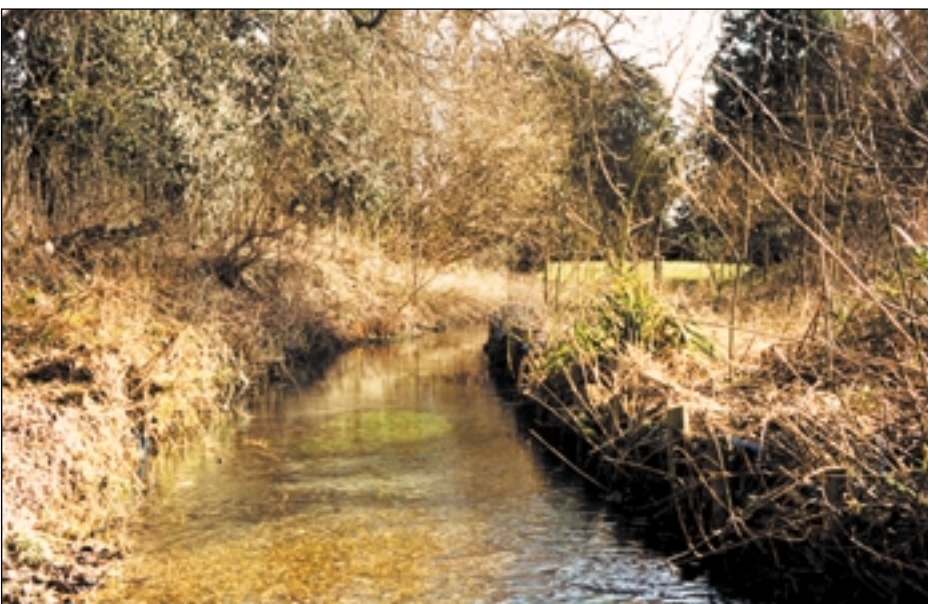
Four years on – gravel shoals and deeper hollows remain

Some redistribution of gravel has occurred locally, forming deeper hollows and bars.

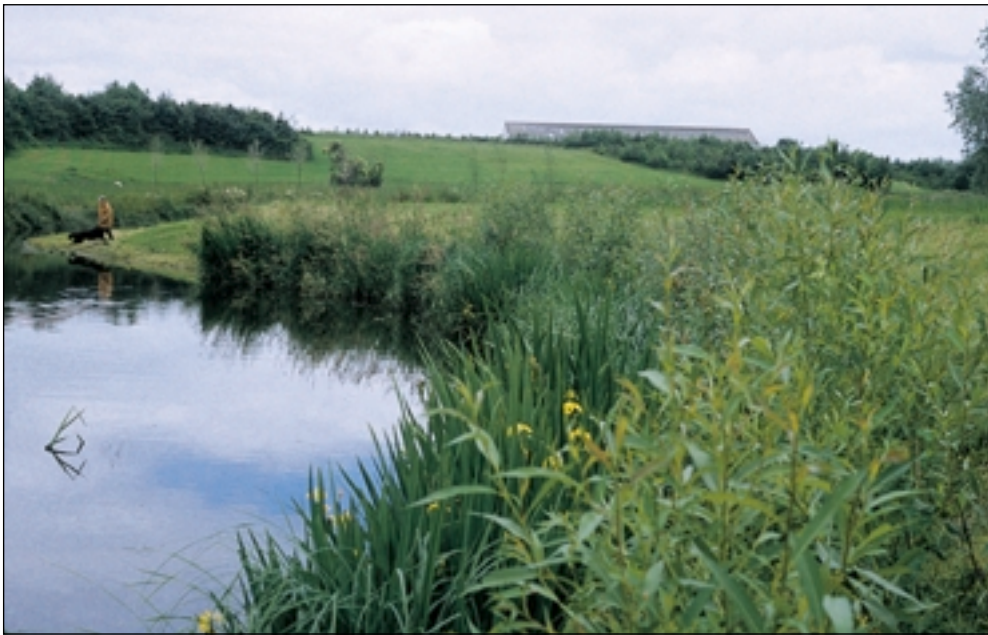
Willow spiling 2 years after construction

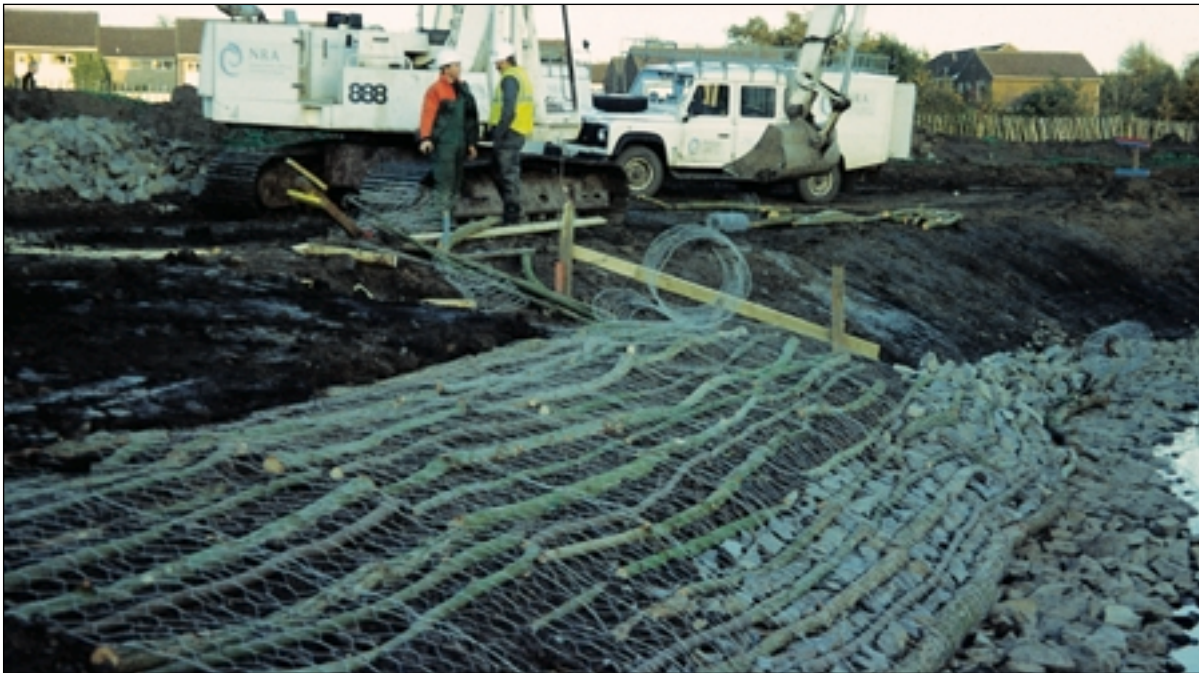
Mattress revetment under construction – October 1995

NOTE: Additional poles inserted to close up spacing after photo taken

Selected live crack and white willow poles, 50-100 diameter, were then laid horizontally all along the face of the fill and pressed into it. Finally the free ends of the netting were drawn tightly over the poles and secured to stakes driven well back in the fill. Due to the shortage of willow locally, up to 30 % non-regenerative sycamore was incorporated intermittently. The netting was stapled to the poles to create a structurally integral unit.

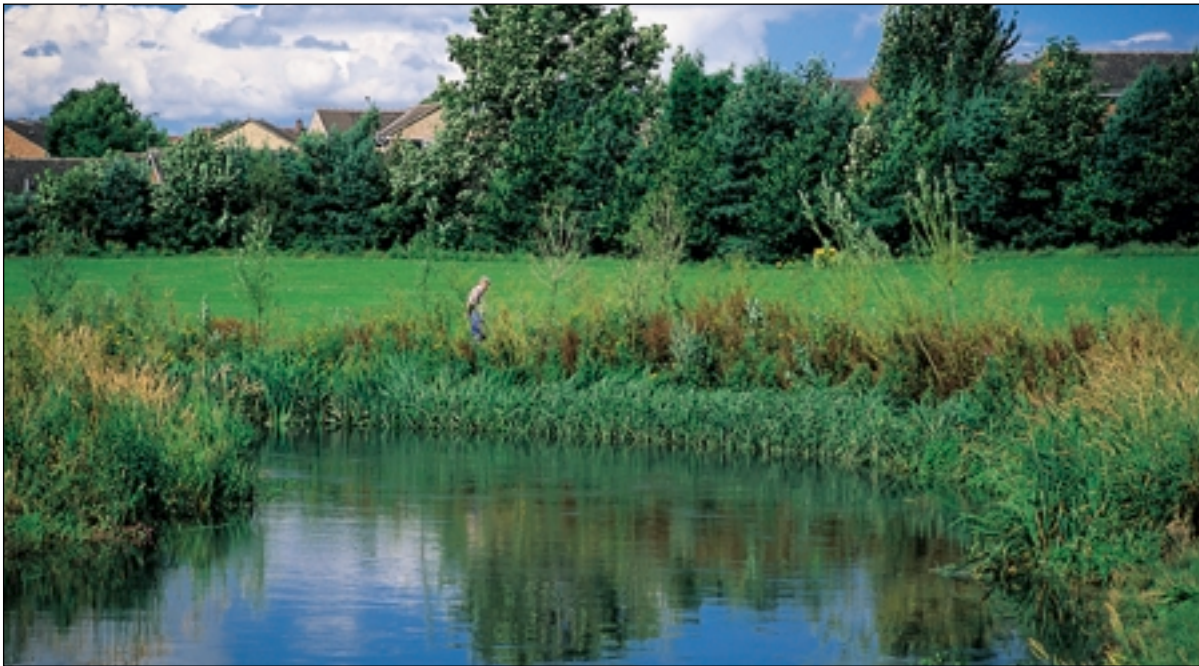
Log toe revetment three years after construction

This technique demonstrates revetment using tree trunks or large boughs along the water's edge to stabilise the toe of reformed banks. Proprietary nylon geotextile is used torevet the bank above the logs so that willow plants can safely be established within it. Revetment was needed to protect a gas main in the bank and loose backfill closing off a length of redundant channel.

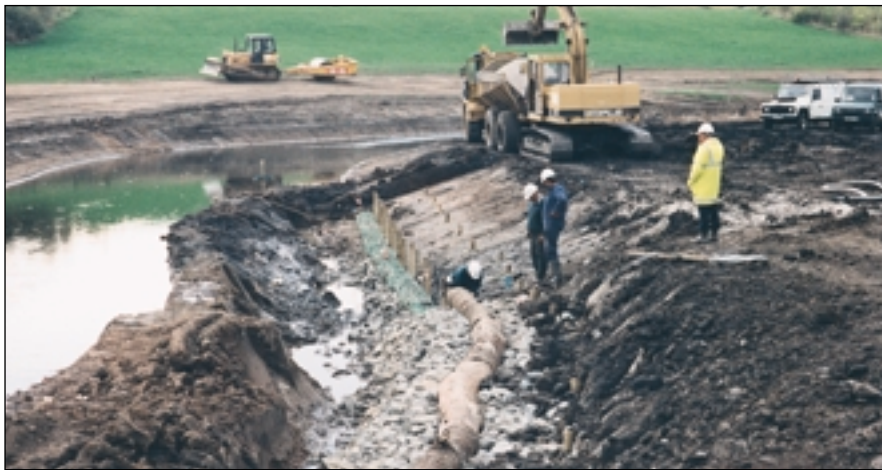
Log toe revetment during construction

This technique was used in two locations and both have performed well with dense willow growth up to 2m high along the bank and a thick margin of plants along the water's edge, all of which are accreting river silts in successive floods. Rooted willow plants established much more strongly than unrooted slips, but this is not uncommon with the grey/goat species selected. Other willow varieties are known to strike readily from slips. Species that are indigenous to the site are always preferable. Brushwood containing willow cut locally can be built into the lower banks as an alternative to the geotextile utilised at the Darlington site which was virtually barren of trees.

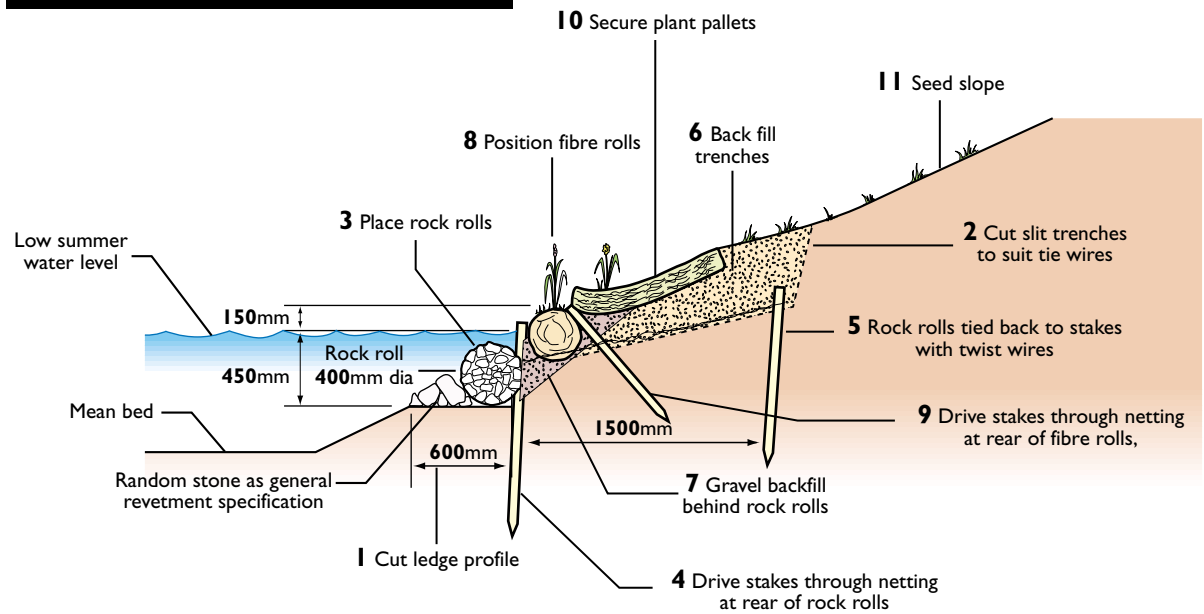
Figure 4.4.1
PROFILE OF TRANSITIONAL REVETMENT

This technique demonstrates the use of proprietary revetment materials in a situation where the potential for erosion is not severe. A flexible revetment is provided within the water's edge zone at the toe of the bank utilising rock rolls and plant rolls to resist undercutting. At this site, it is used to form a smooth transition between the un-reveted river banks and the fully reveted banks described in 4.1 to 4.3.

Children walking along the bank toe, behind the plant rolls, have created ledged paths, which are stable, and are accreting significant amounts of silt due to eddy currents set up as floods pass over the stands of reed grass. This desirable situation contrasts with the erosion of river bank toes that typified pre-works conditions in the straight trapezoidal river.

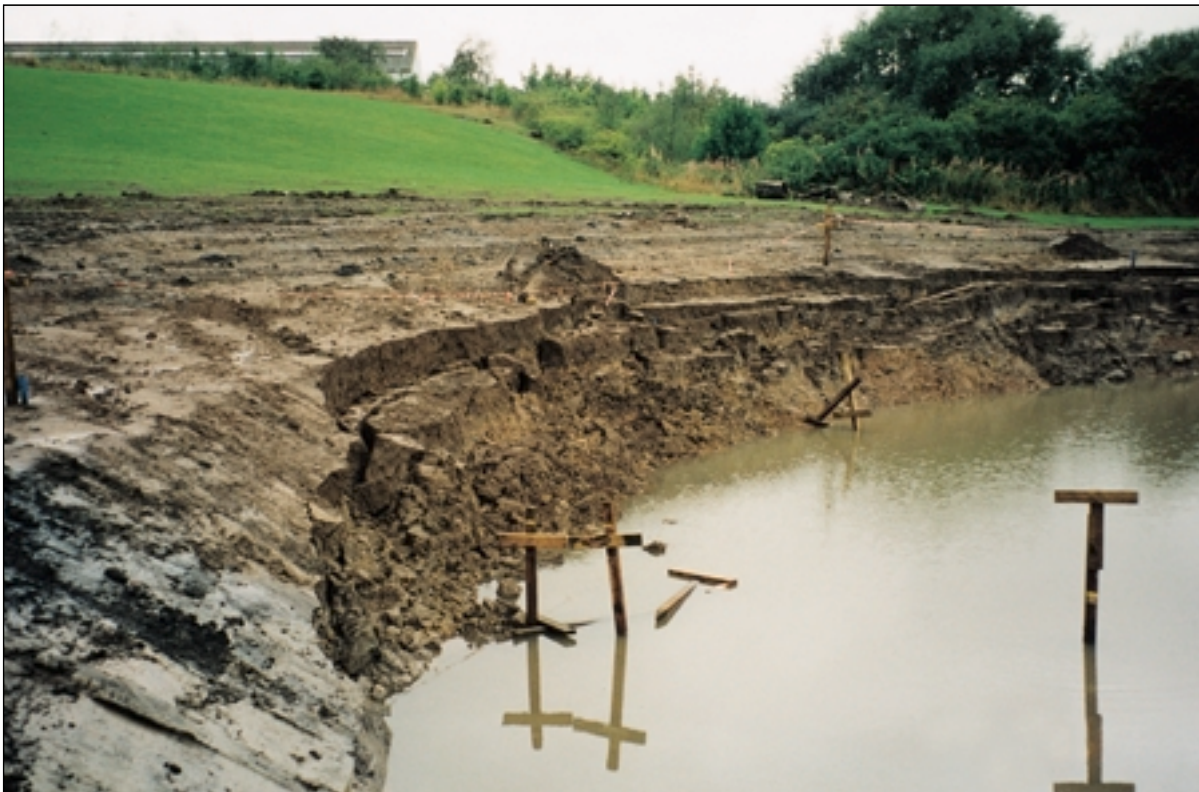
Slipped slope during work – September 1995

During works, water seepage from gravel at the bottom of a newly excavated river bank caused it to slip. As the bank was close to banded industrial fill, repair was necessary. The route of a proposed footpath was also at risk if this bank remained unstable.

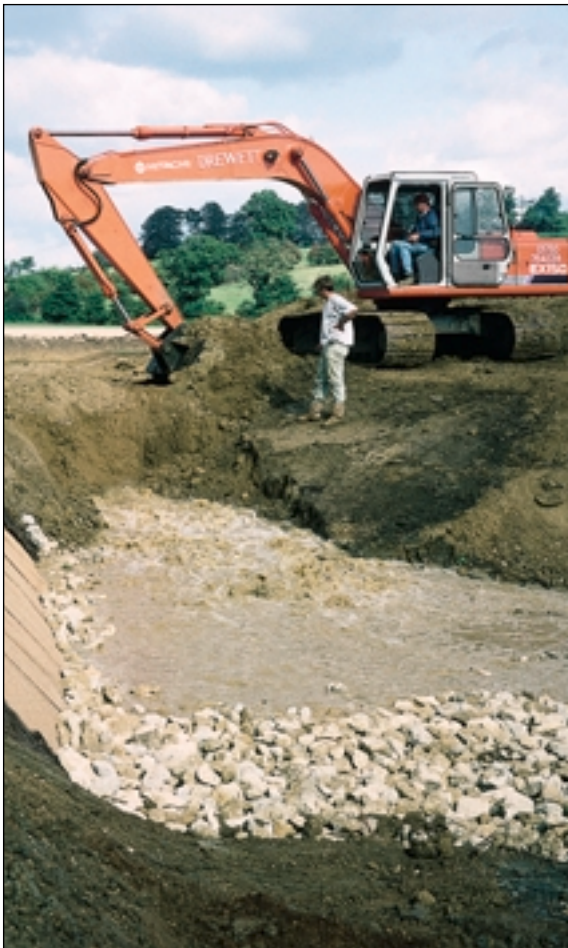
Construction of coir matting revetment
– river being released

Coir was installed on both banks at the crossing located mid way between the ford (ch. 280m) and the stock bay (ch. 100m), as well as opposite the large backwater. Hurdles were installed opposite the small backwater. A plan of the reach can be found in 1.2.

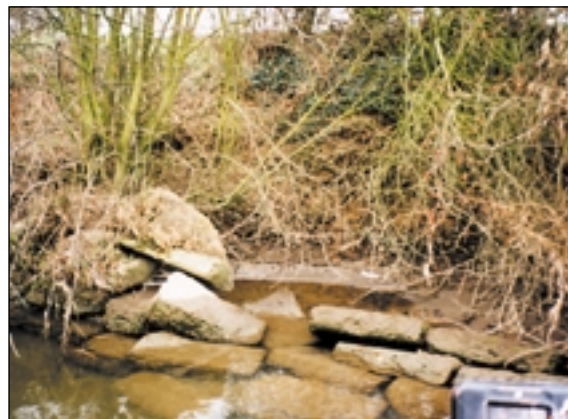
Failed section of bagwork at Clifton Lock Cut

At Clifton lock cut the old concrete bagwork revetment was beginning to disintegrate and allow wash-out of the unprotected bank back towards the

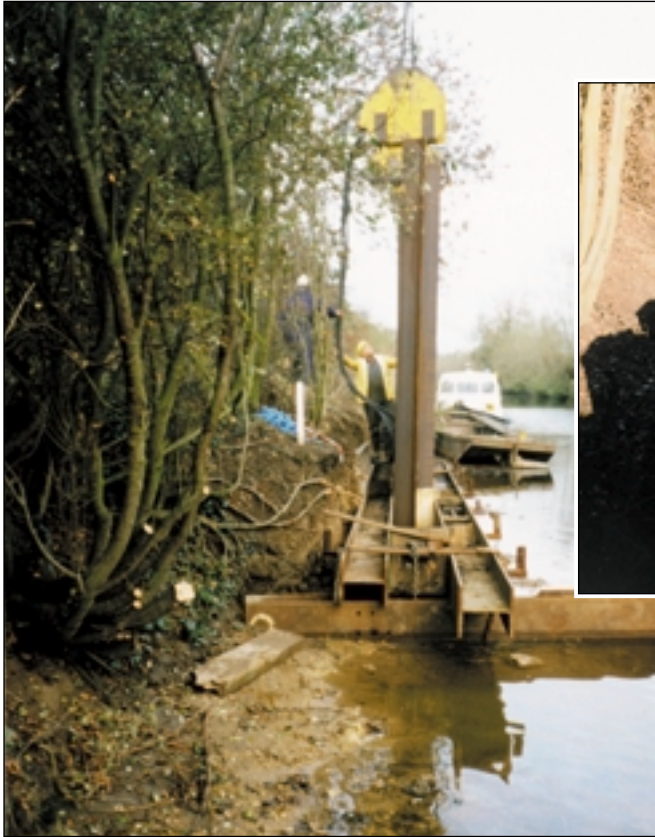
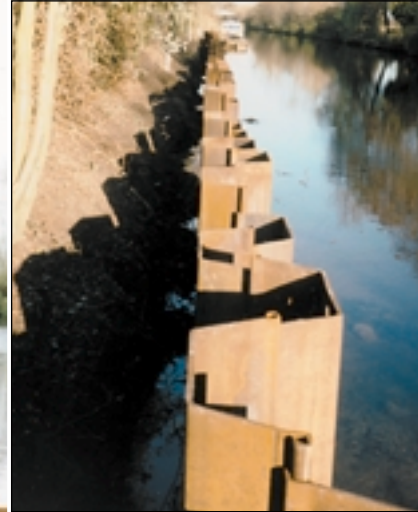
Initial sheet piling after bagwork removal, over existing trees

of sheet piling (to allow continued maintenance dredging) with an above-water 'soft' approach promoting vegetation growth. The sheet piling was carried out using a land based crane with floating pontoon to support the piling frame, thus reducing the degree of trimming and removal of existing bankside vegetation.

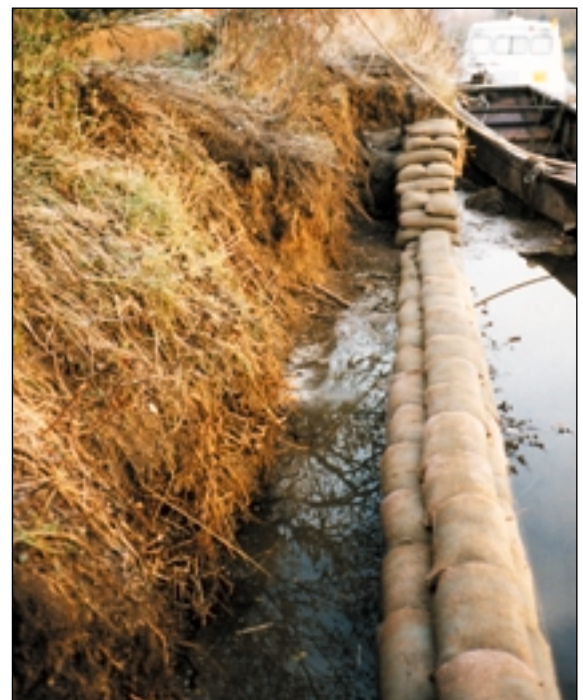
2 layer capping bagwork and tie-in to existing sheet piling

Transition from the existing high sheet piling and bagwork wall is achieved by stepping down the bagwork to tie into the new 2 layer system. At the upstream end the return piling runs 1200mm into the bank.

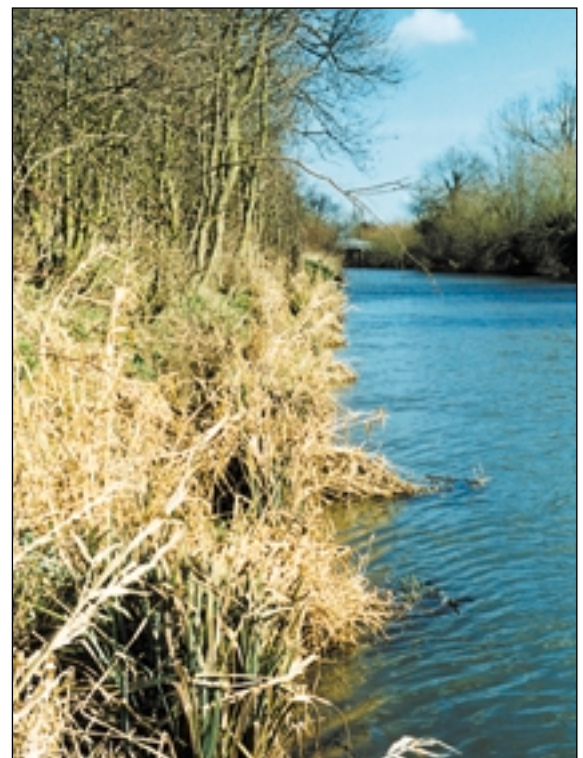
Vegetation establishment after 18 months

The fibre matting protected the slope well and has since almost completely degraded allowing re-vegetation of the upper slope. In areas this has taken a number of years, possibly due to the steepness of some sections and a dry summer after completion. The growing root system of the retained shrubby vegetation will be helping to bind the backfilled bank and provide extra stability.

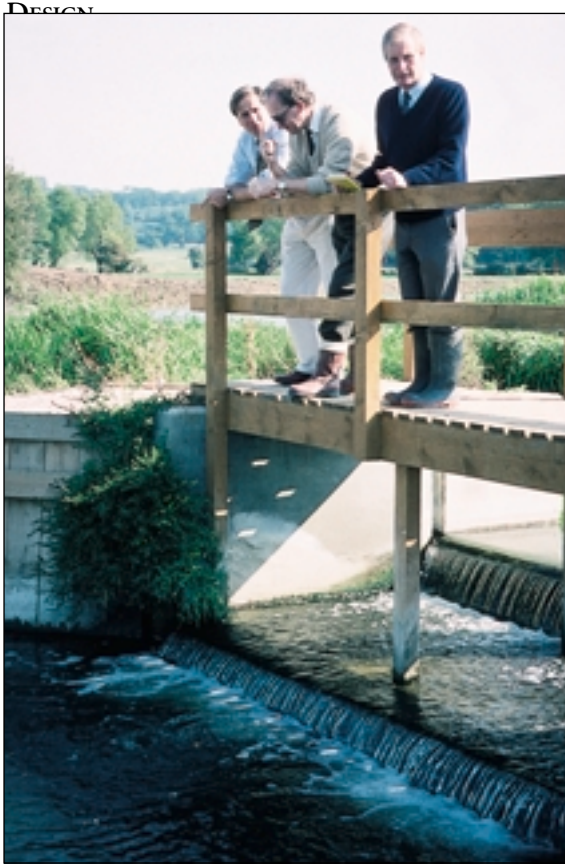
Control weir (location ① on plan)

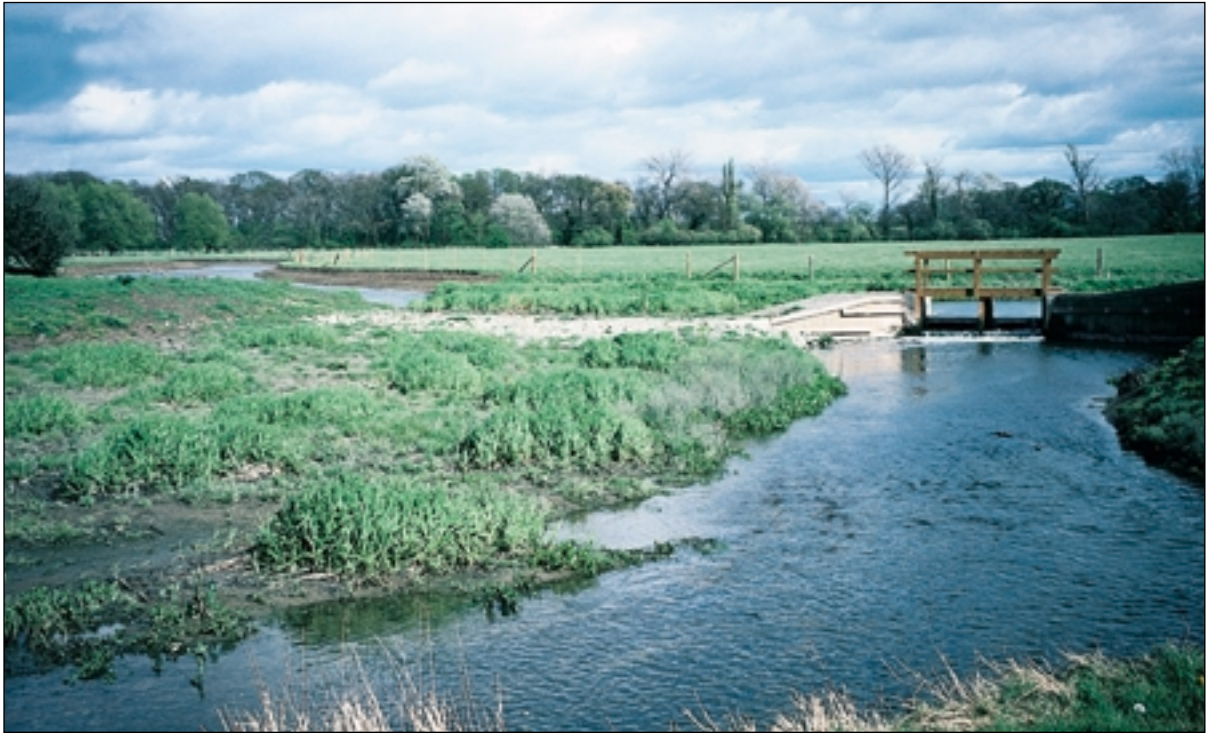
Spillway alongside bifurcation weir
– April 1997

The hydraulic capacity of the flume is small (to suit base flows) so a 10m wide spillway is incorporated alongside to feed sufficient floodwater to fill the new channel. The crest level is only 0.1m above the normal water level in the leat so it operates frequently. Below the spillway, a large area of land is gently graded out towards the new channel which sustains marshy conditions around its inner margins. This low lying area is largely flooded before overspill occurs, ensuring a fairly smooth combining of floodwaters passing downstream. Water in the new channel rises quickly, ensuring the overspill is completely submerged (drowned) at an early stage of a rising flood, thereby further reducing scour potential.

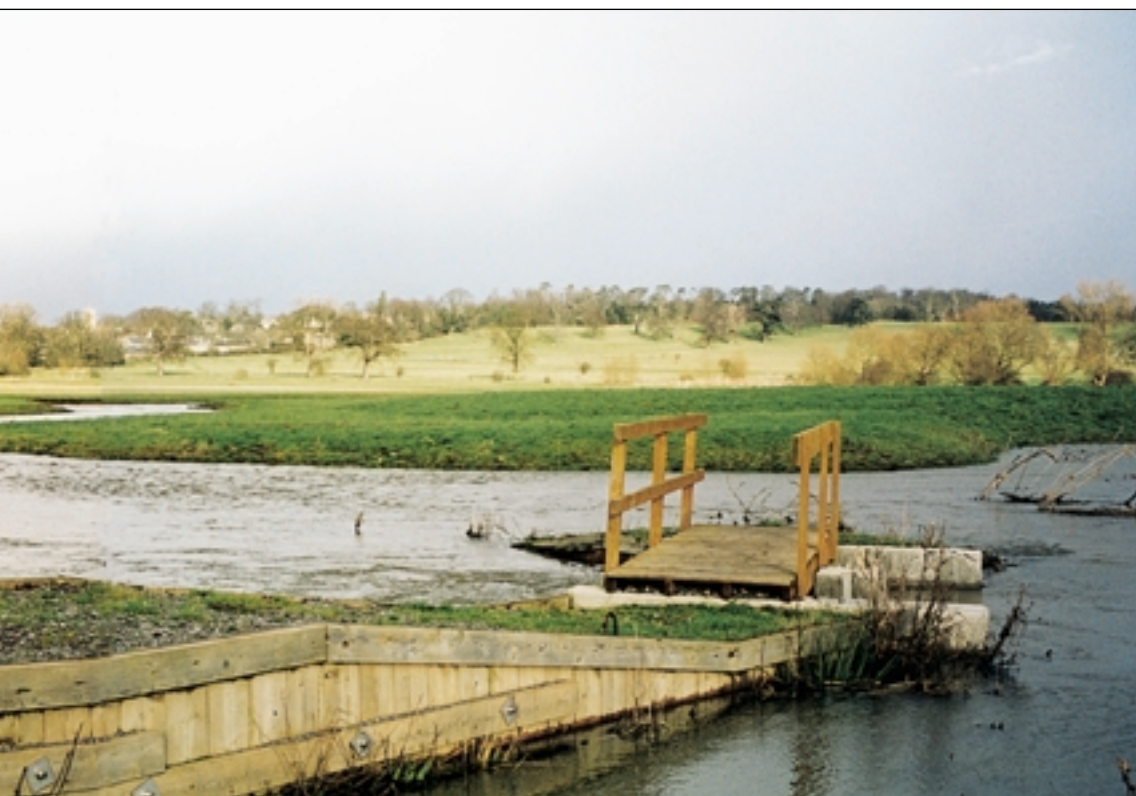
Flood filled channel
downstream of
bifurcation weir

The structure has functioned exceptionally well and fulfils all design criteria. The complex configuration of channel and landforms combine with diverse patterns of flow currents to sustain a variety of habitat niches as well as an overall feature of landscape interest. Snipe are commonly seen probing the marshy areas intrinsic to the design. The National Trust (owners) plan to undertake landscape planting, and to provide a permanent bridge to further enhance the location. The abundance of fish in the new channel suggest that migration is occurring satisfactorily.

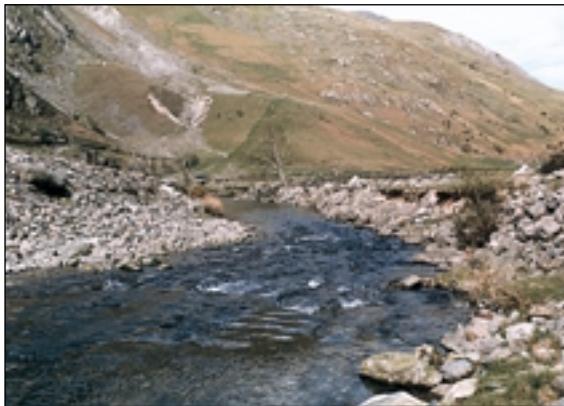
Deep channel and dredgings on bank at Blaen-y-Nant confluence

Over the succeeding 30 years the river responded to the channel deepening by flushing through virtually all of the finer river bed gravels and scouring both river bed and bank soils in many places. The reach became severely denuded of any stable habitat for flora and fauna and a once thriving salmon fishery declined. Flooding was still troublesome to farmers. An appraisal of the problem concluded that far too

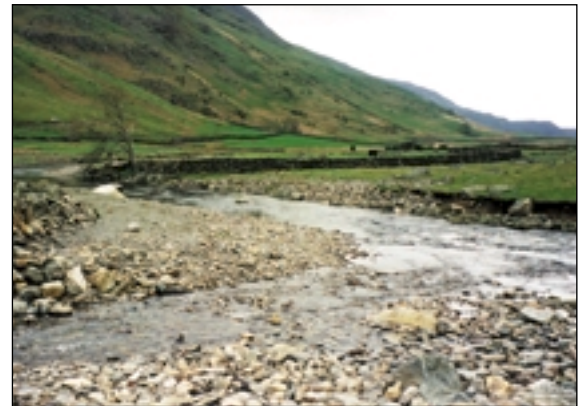
Restored bed levels and bank profile

much floodwater was being conveyed in the enlarged channel and that it would be necessary to restore pre-works river bed profiles to correct this imbalance. Re-routing of more frequent floods over the floodplain fields would result from this, helping to sustain other desirable habitats.

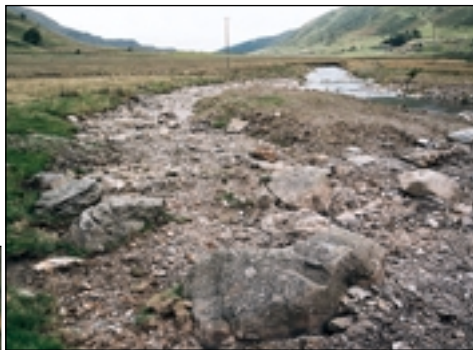
Restored island

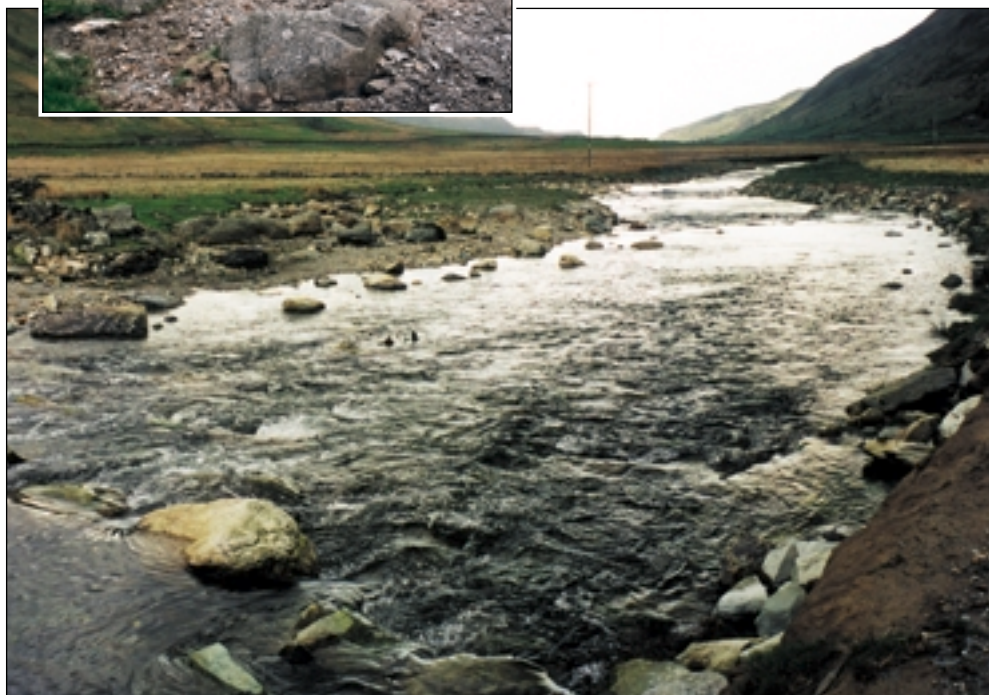
Restoration of boulder cascade, stepping stones and braided channel

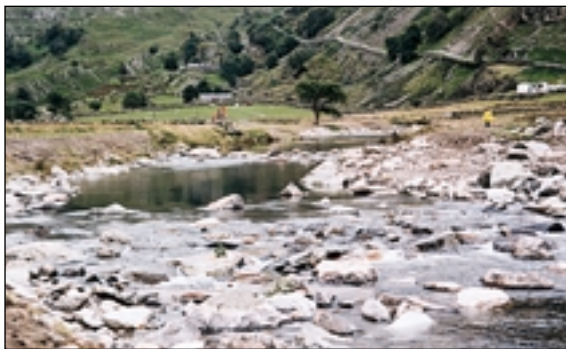
Lower 'stepping stone' cascade

The lower cascade was the smallest of the four so was readily adapted to restore a series of large stepping stones recorded on O.S. maps. The effect of restoring the cascade was to impound the upstream reach of river to a water depth of 2m. Ideally this upper reach would have been completely backfilled to the 1 in 600 gradient shown on figure 5.3.2. but insufficient material was available for this because dredged gravels had been removed from site.

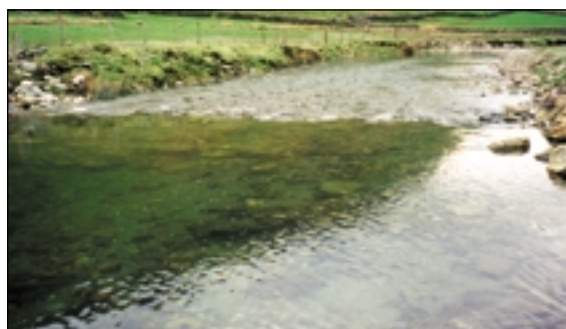
Flatter 'riffle' cascade with upstream pool

The practical alternative to full bed restoration was to concentrate the material available into a series of individual cascades along the upstream reach. These took a similar form to the main cascade but the downstream slopes were much flatter to simulate 'riffle' characteristics rather than true cascades. The upper of these 'riffles' at chainage 700m took the form of a long diagonal ford which restored a feature recorded on old O.S. maps – (see 8.4 for details of this ford).

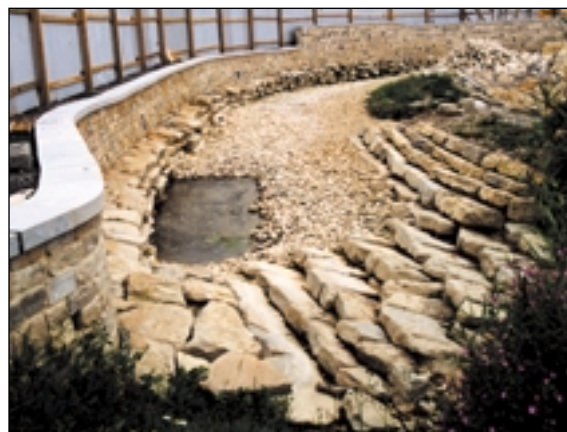
Simulated rock outcrop with downstream pool

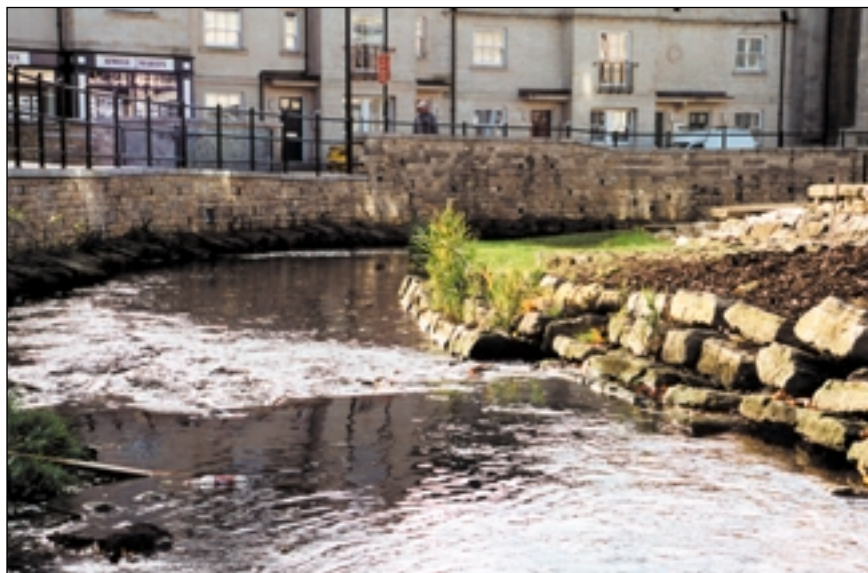
The outcrops provide stability to the bed and banks as well as aesthetic interest

Flat slabs of Purbeck limestone had been selected for a variety of purposes throughout the site and for use in the two outcrops. The slabs needed to be laid with a constant angle of dip and needed to provide a gently sloping face over which the water would tumble down to the lower level. A practical method of arranging the slabs needed to be developed; the outcome is shown in figures 5.4.1 and 5.4.2

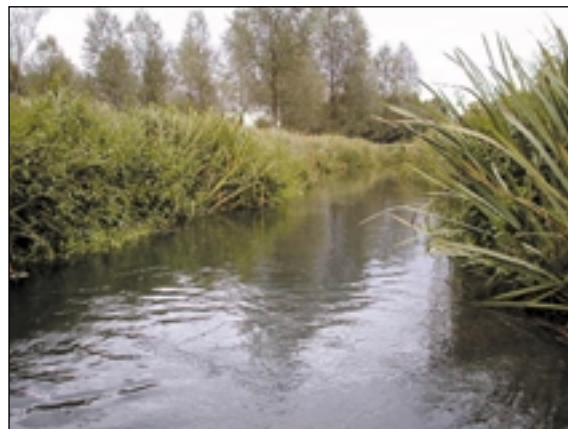
Before: sluggish deep water with encroaching sedge

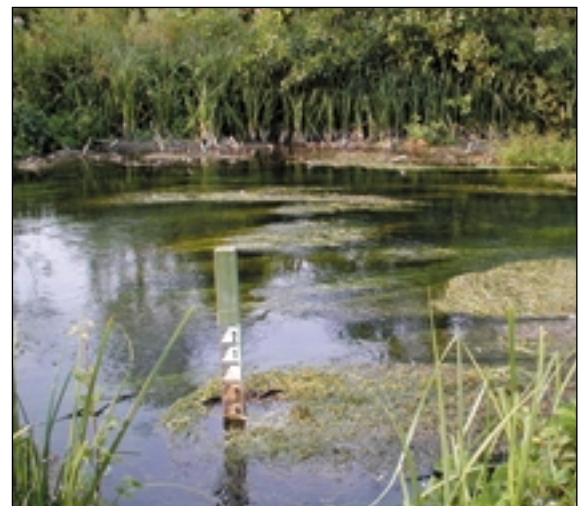
Gravel placement may influence or be influenced by fluctuating water levels

Work was scheduled to commence in early October when river flows are usually at an annual low, approximating to Q90. Prior to undertaking work, stakes were placed in the river to mark this level as a guide to the contractor during the gravel placement process. This was especially important since water levels would change if silt entrapment measures had needed to be installed downstream (on standby but not needed).
