INTRODUCTION TO THE MANUAL *For the Web*

Manual of River Restoration Techniques

RESTORING MEANDERS TO
STRAIGHTENED RIVERS

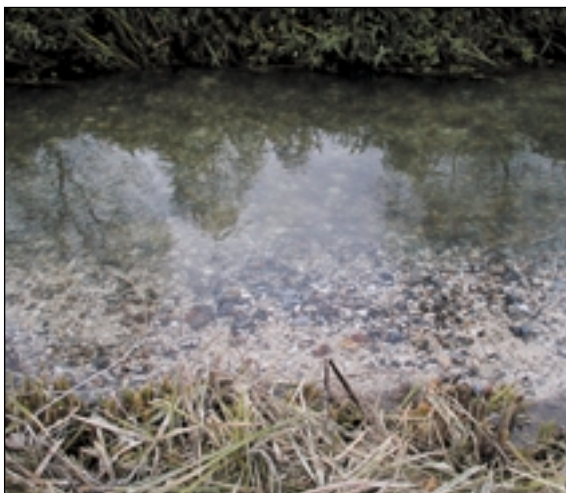
Flinty gravel used to narrow and raise the river bed

The material used to shallow the channel depth was chalky and gravel flints. Where possible it is advisable to use material from the immediate area to reflect the type of bed that would have been present under natural conditions. Here the gravel fill was excavated from the floodplain by the creation of an adjacent pond on the right bank. The suitability of the material was checked beforehand by the inspection of machine-excavated trial pits. Infill material was predominantly a mixture of gravels and flints varying in size from 20 to 10mm, with <5% coarse sand and minimal silt. A few larger flints were also present.

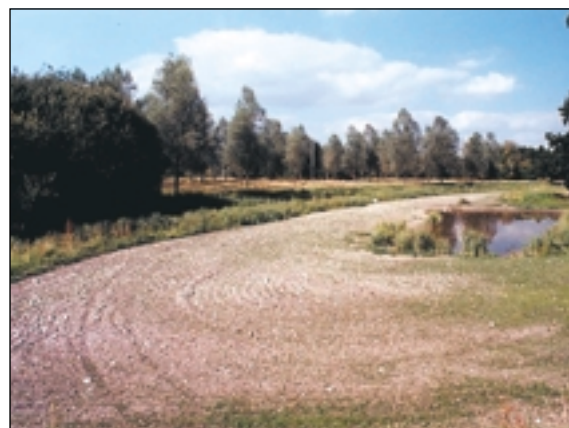
New pond with early growth, showing the gravelly nature of the floodplain material

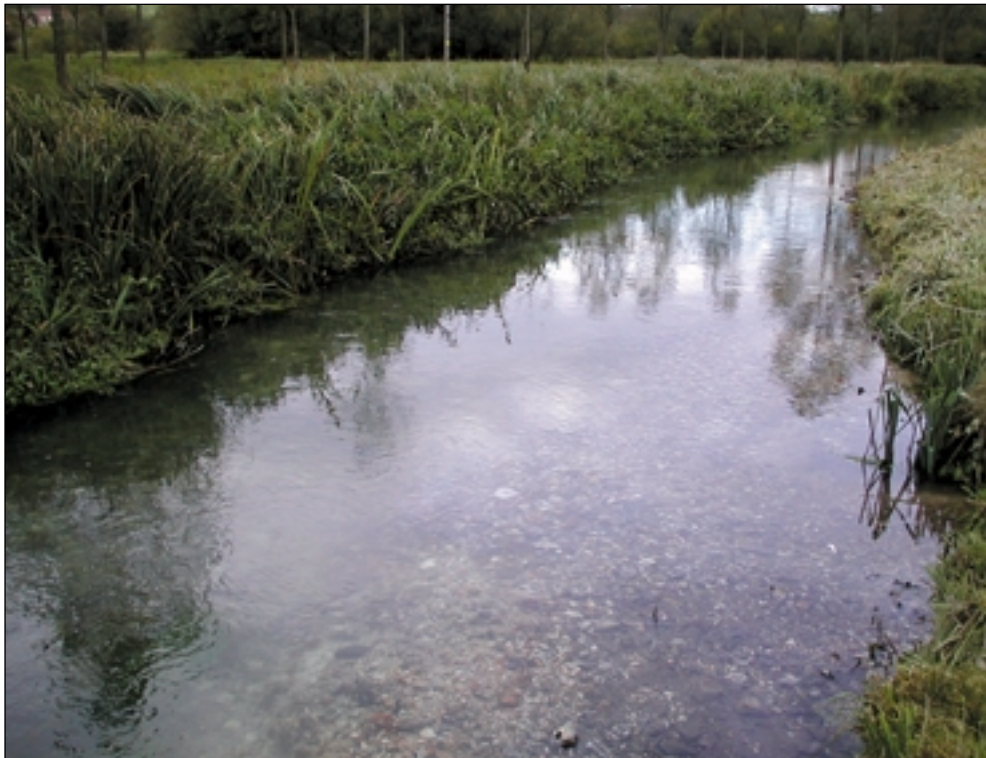
A few months after completion, the raised bed evident

Gravel has been used to shallow and narrow the remaining open water channel by up to a half, with the shallower margins finishing just below the Q90 level. The remaining low-flow channel is raised to within 500mm of the Q90 surface.

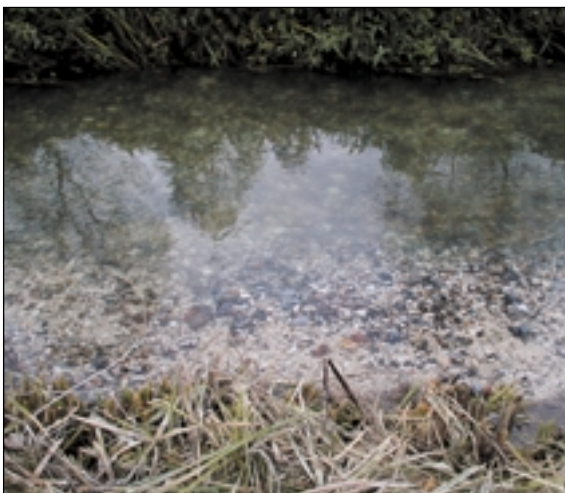
Flinty gravel used to narrow and raise the river bed

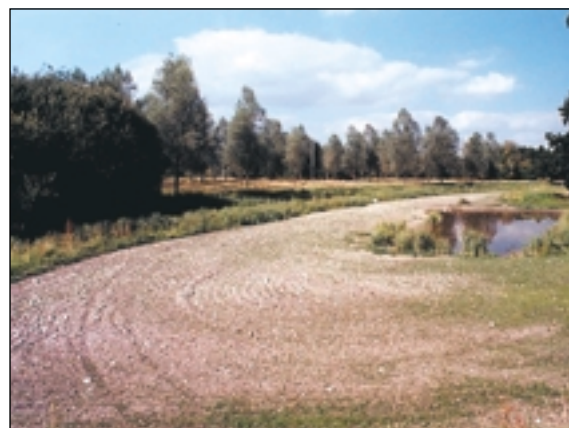
New pond with early growth, showing the gravelly nature of the floodplain material

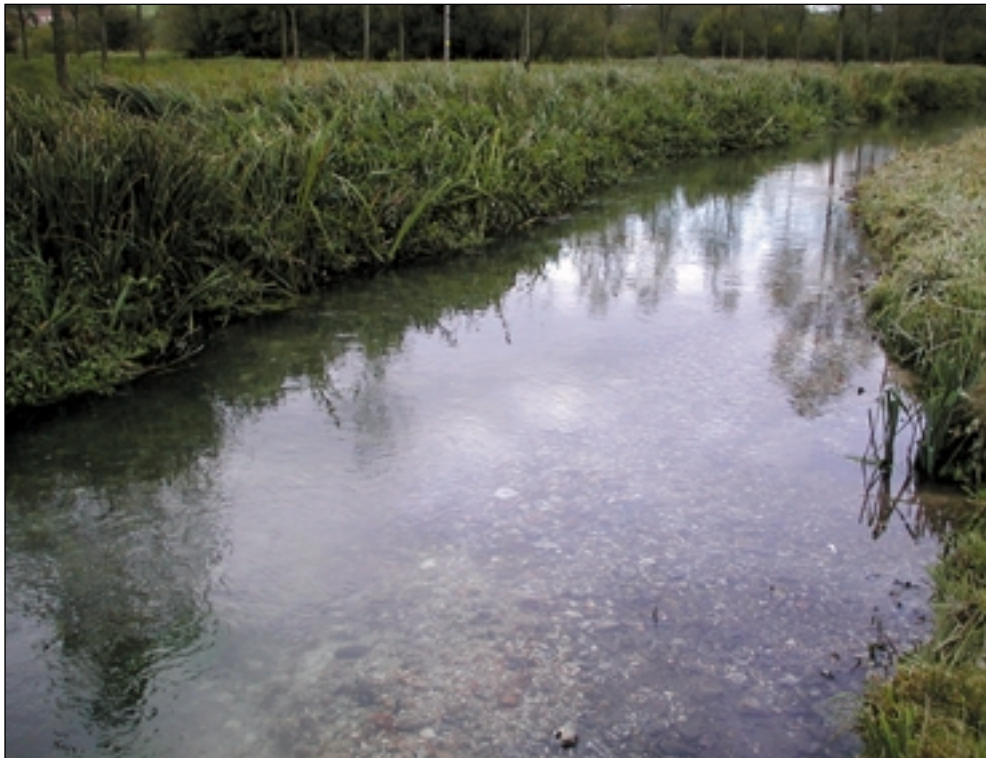
A few months after completion, the raised bed evident

Gravel has been used to shallow and narrow the remaining open water channel by up to a half, with the shallower margins finishing just below the Q90 level. The remaining low-flow channel is raised to within 500mm of the Q90 surface.

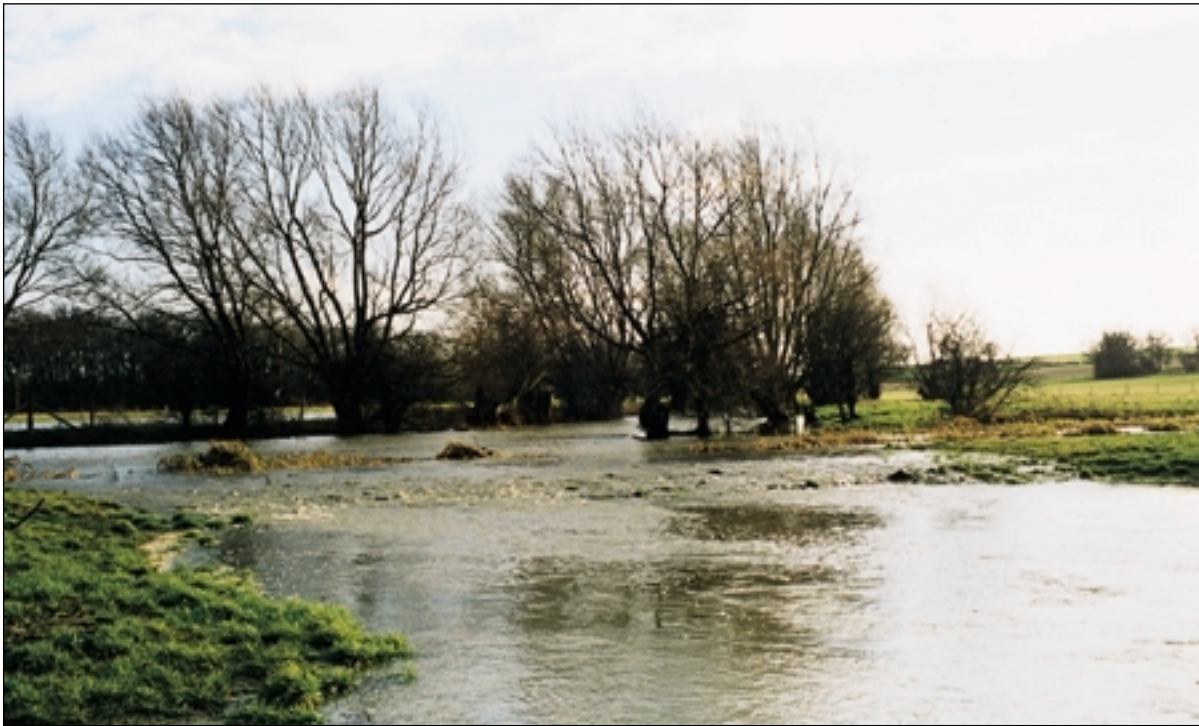
Spillway **S2** in flood

Spillway S2 begins to operate only after S1 has filled the new channel with water. Water spilling over S2 passes directly into the new channel causing it to overflow its banks and initiate field flooding. Scour of the overspill is minimal because this design ensures floodwaters from both S1 and S2 merge without excessive turbulence.

The level at which S2 is set is critical; it is 300mm lower than the floor of the mill further down river, to ensure floodwater is diverted away from the mill. In practice, S2 replaced an unsightly concrete cascade weir built at the mill to protect it from flooding. The cascade has been boarded off and will be infilled once the performance of S2 is proven to be satisfactory.

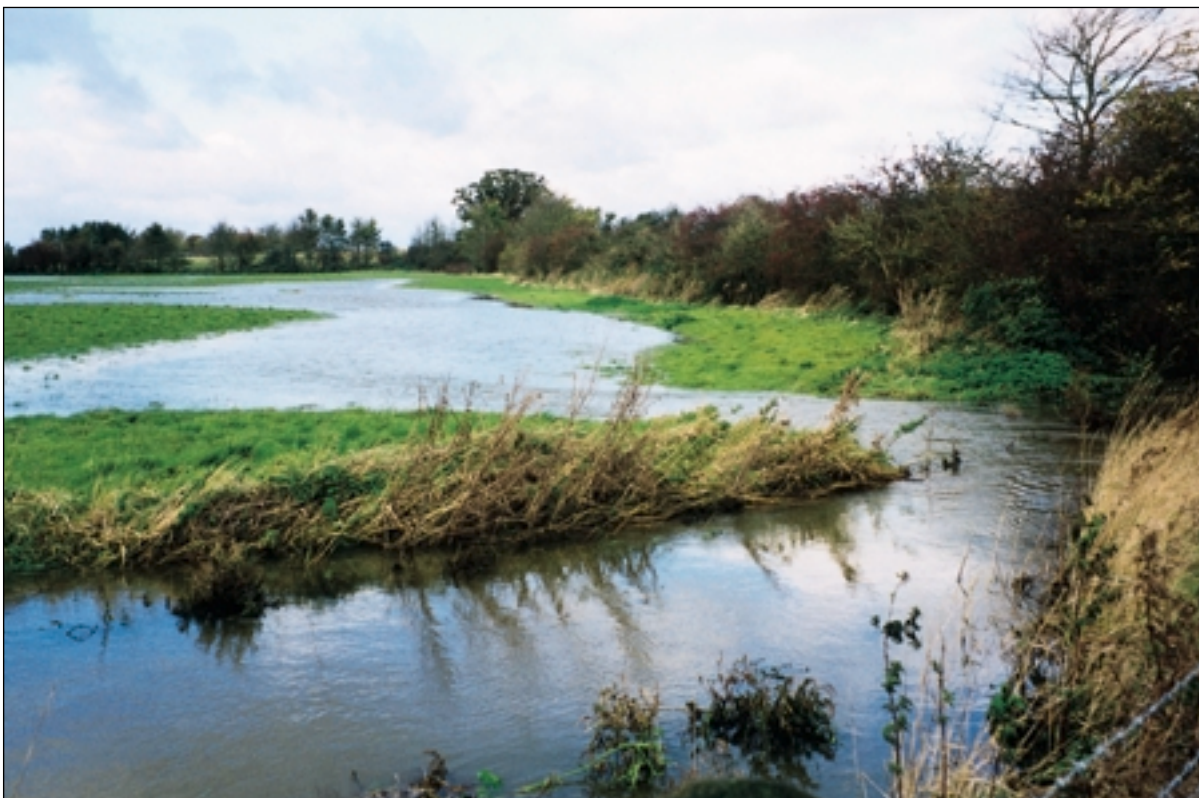
Spillway **S4**. Floodwaters spilling into field gully.

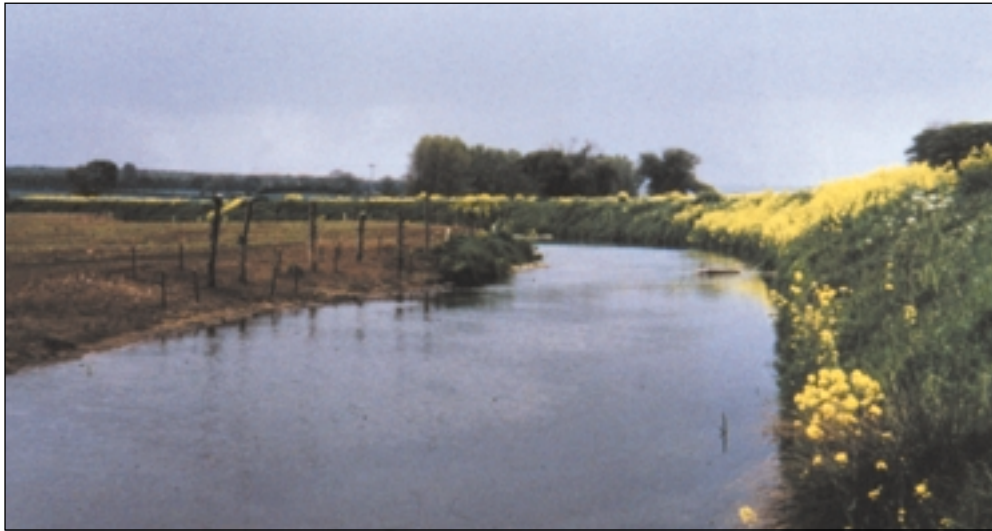
Removal of the left floodbank and marginal berm creation on the Great Eau at Withern

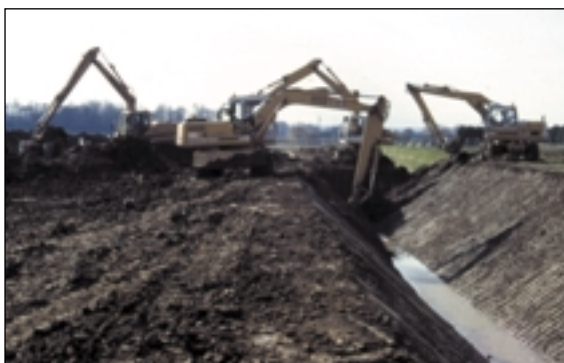
Relocating the IDB drain and set-back floodbank

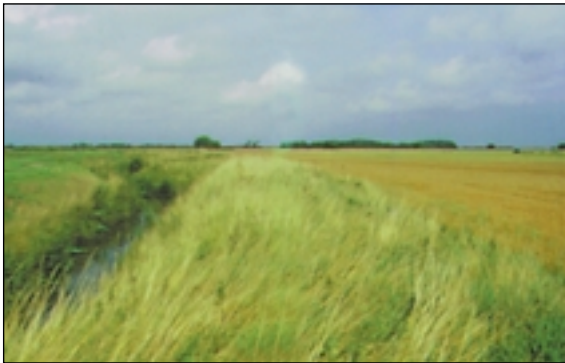
View along the trapezoidal right bank of the Long Eau

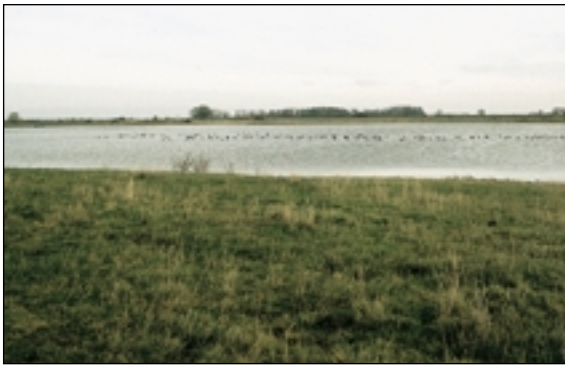
View from the new embankment across the restored floodplain. Showing wintering wildfowl, January 1999

Water is designed to spill onto the 16ha site from the Long Eau when levels reach 2.6m above OD, just 0.3m over their normal retained level. This floods progressively outwards from the old course of the IDB drain, which represents the lowest levels within the area. This low spot remains damp for much of the year, the downstream end forming a permanent wet scrape/shallow pool.

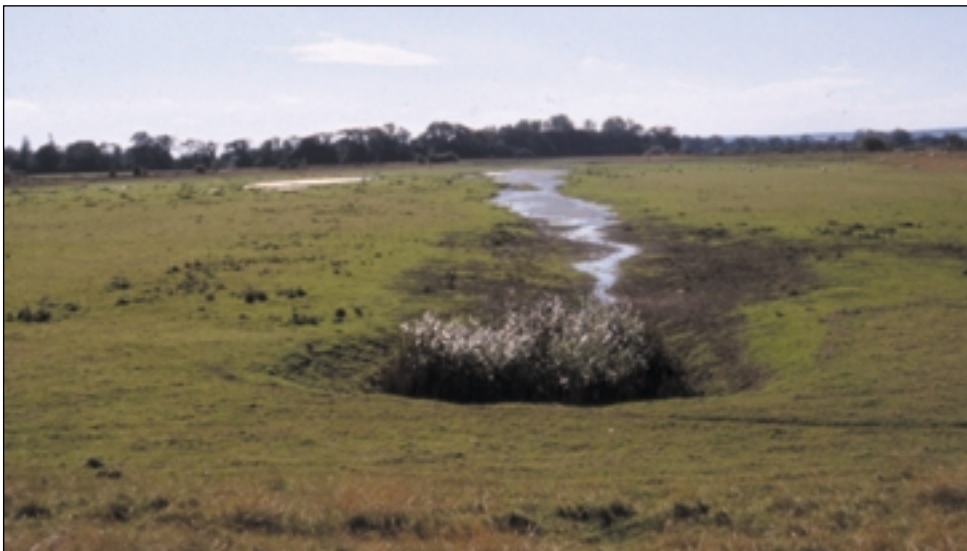
Floodplain, penstock and permanent wetland area, October 2001

Water will spill onto the site from the Long Eau when levels reach 2.6m above OD and has reached a maximum of 4m above OD. Levels are then reliant on conditions in the Eau subsiding and, depending on the intensity of the event, have been retained for two or three days. Below the Eau level of 2.6m, 75% of the washland will retain water to a depth of up to about 0.5m. This can remain for 3-4 months providing ideal conditions over the winter months for dabbling and grazing ducks such as widgeon, teal, gadwall and mallard.

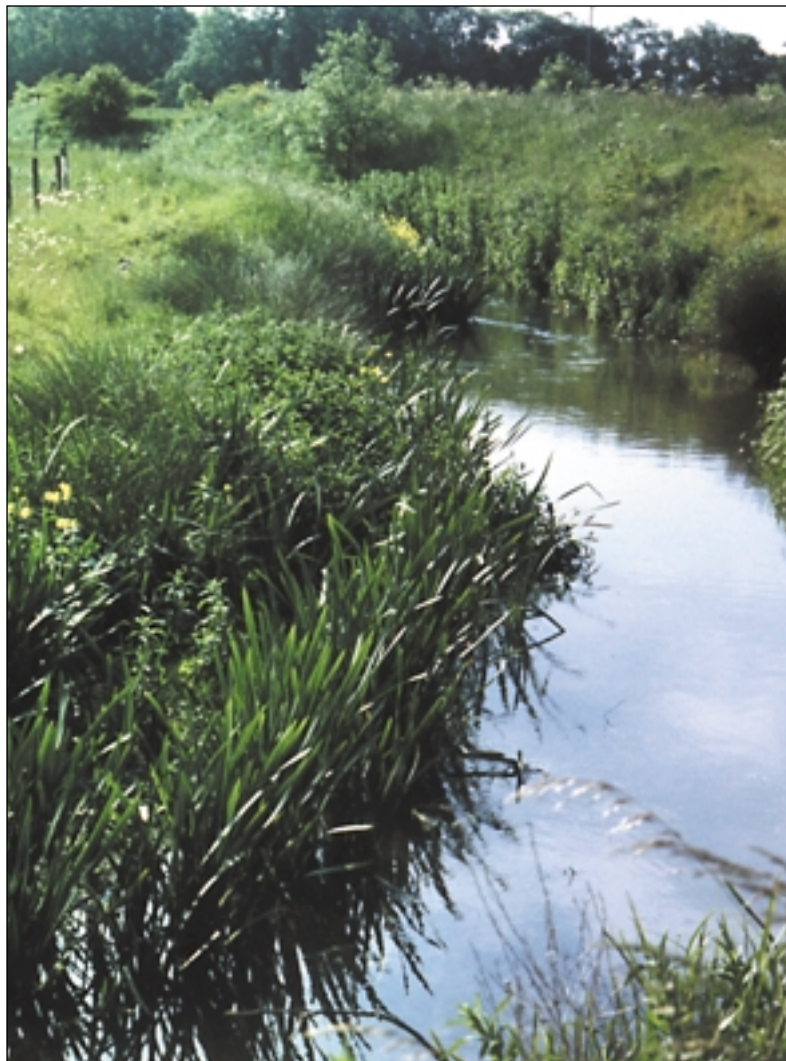
Berm at section A after 4 years

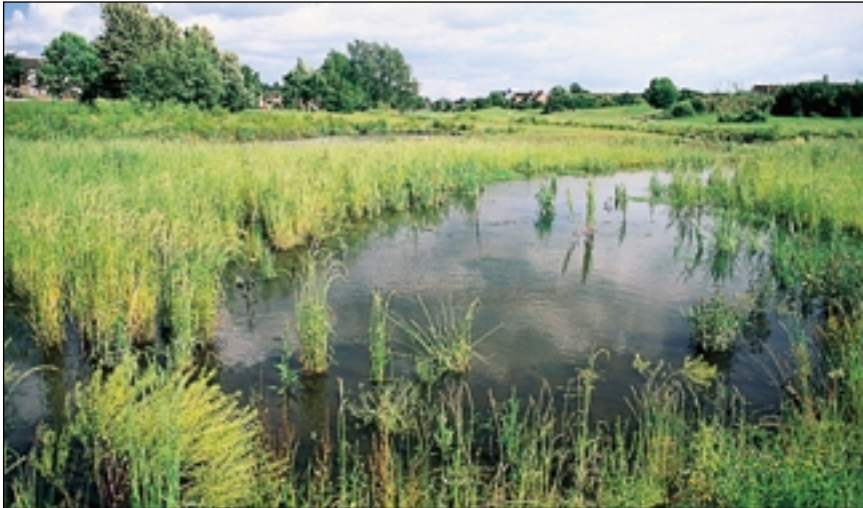
Completed spring-fed scrape

The south side of the floodplain is partially overfilled with industrial waste contained within a clay bund. Clean water was observed to be seeping from the toe and to be sustaining a lush growth of grass (mown) all year round. A scrape was excavated within this area of low artesian water pressure so that full advantage could be taken of the opportunity to introduce a significant wetland feature to the floodplain (*fig. 7.1.1*).

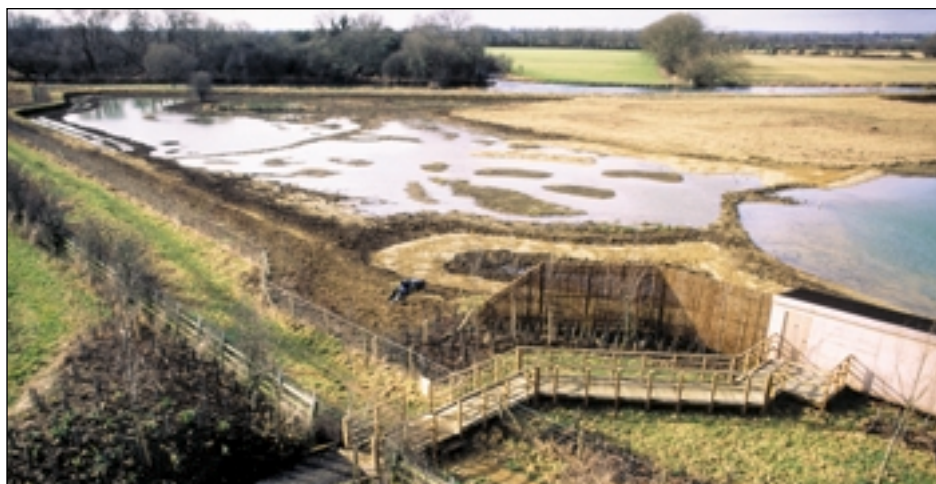
Wader scrapes
(February 1992)

These areas were designed to be between 300mm below and 100mm above normal water levels. As the main pond level will fluctuate by about 300mm, reflecting groundwater levels, these areas are important to retain shallow slopes at the water's edge.

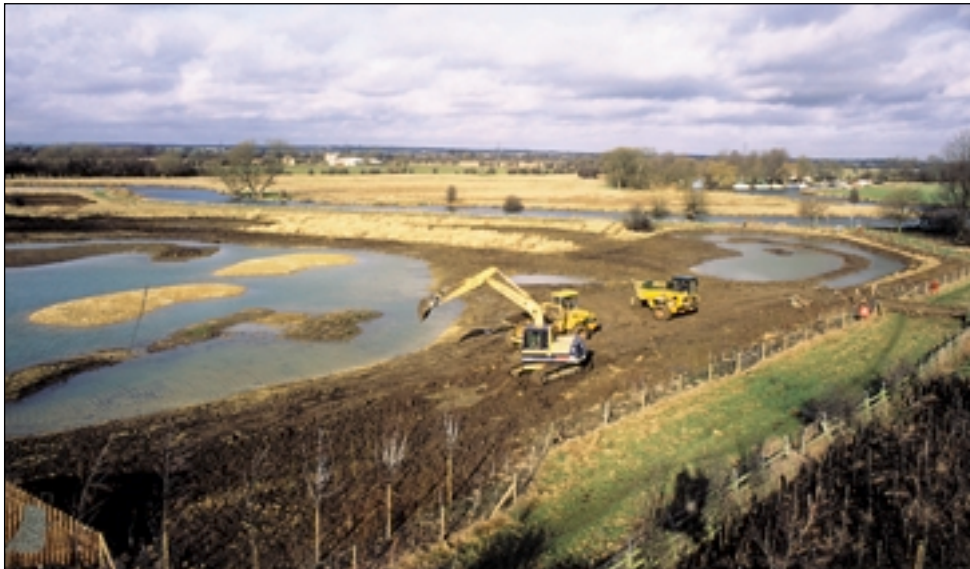
Main pond, pool and reedbed creation (February 1992)

The mosaic of over 40 ponds and pools was designed to maximise the topographical, hydrological, biological and visual diversity of the site. This included specific creation of individual waterbodies with a wide range of maximum depths and permeability, and low angle, undulating drawdown zone areas to encourage both wetland plant diversity and wading bird habitat.

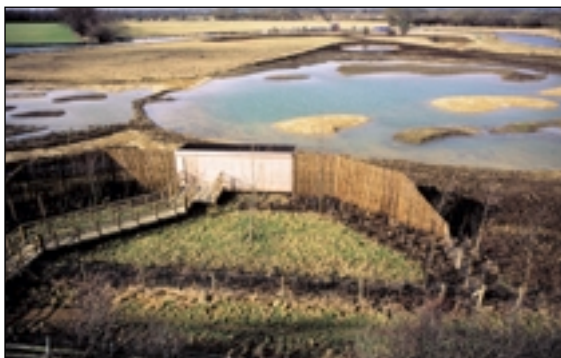
Aerial view of site

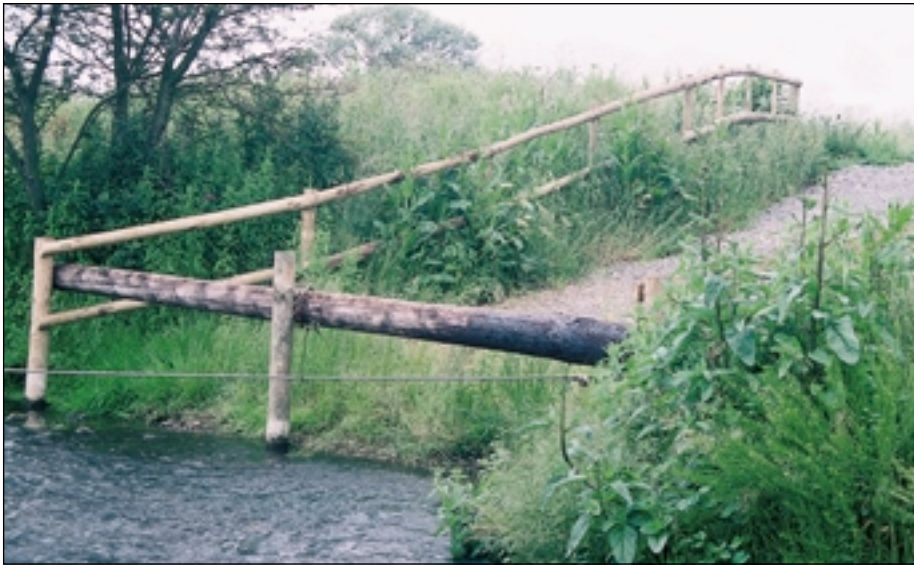
Stock watering point at ch. 100m

Located at ch. 100m just downstream of a sharp bend in the new river course where a fast flowing riffle of gravel was expected to form. This hydraulic condition, combined with the careful contouring of the adjacent river banks, helps to avoid the risk of siltation that all too often renders watering points useless. The post and rail fencing around the ramp is tied into bank top fencing on either side, as well as across the river, to form a secure field boundary point.

The river fencing comprises a single heavy wire cable strained tightly across on a diagonal line (see photograph). The extra length of the diagonal renders the cable less likely to form a complete blockage of the river if floating debris becomes snagged on it. The angle of the diagonal is aligned to direct turbulence caused by its presence towards the mouth of the watering point, further reducing the risk of siltation.

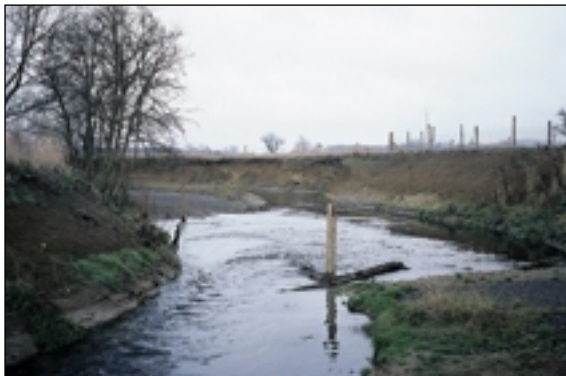
Ford at ch. 280m

The ford at ch. 280m (fig.8.1.2)

Most of the ford is formed within the old backfilled river channel, which is carefully contoured to create smooth transitions with undisturbed ground on both sides of the river, as well as with the root levels of the three trees and with the newly excavated channel. The river bed and ramps are surfaced with stone over a filter fabric to suit livestock rather than heavy vehicles.

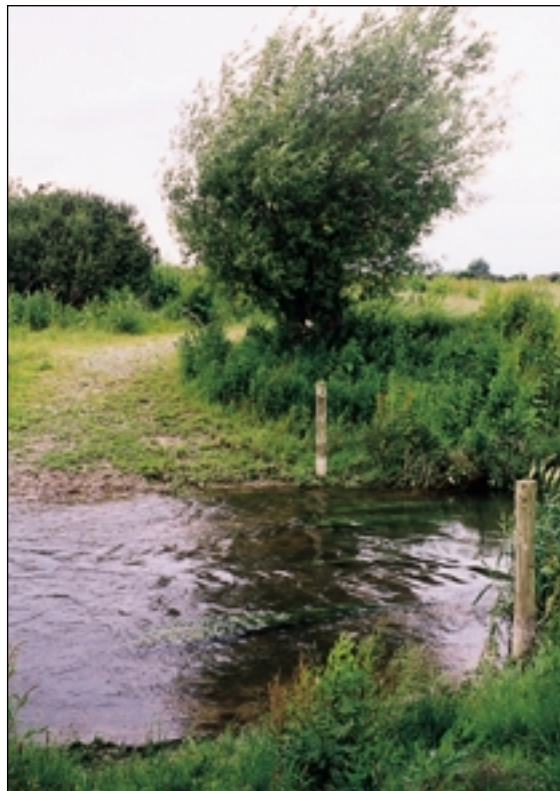
Equestrian ford at ch 620m

Despite the commonality of the design concept, each is individually configured to take advantage of local conditions and this is evident in the variety of visual interest and habitat diversity that has resulted. Of particular note, water crowfoot is thriving in the tailstone of the equestrian ford and ch. 620m.

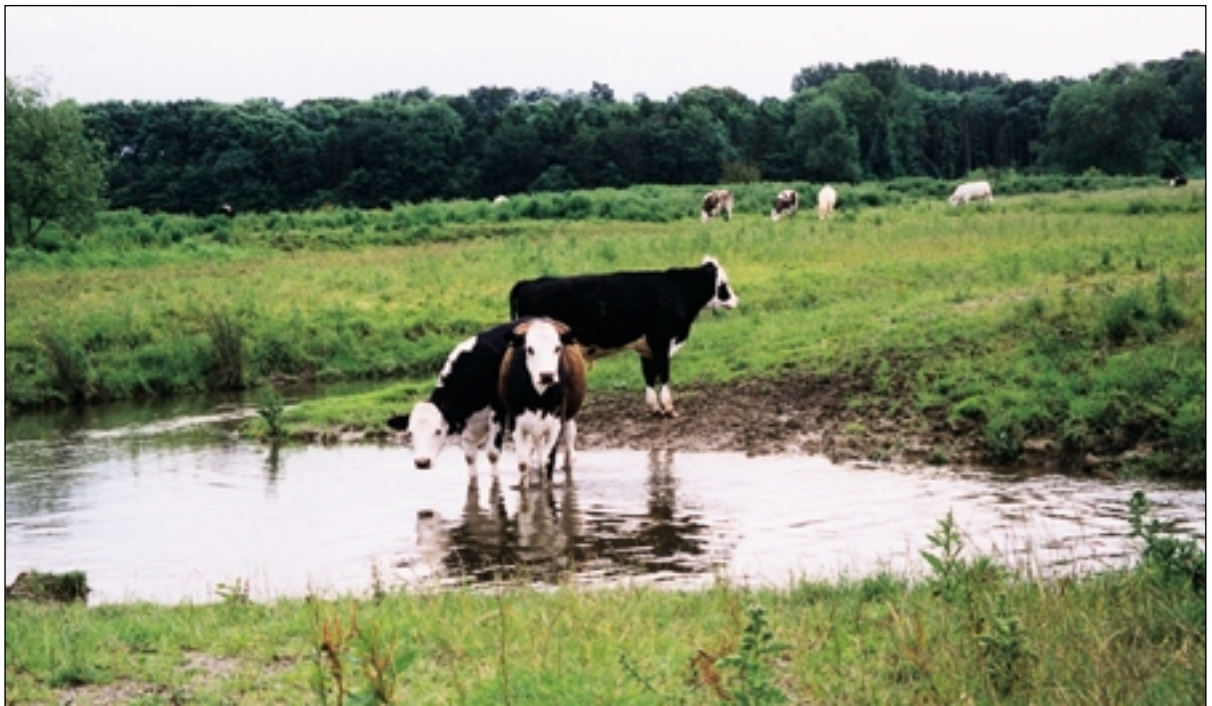
Vehicular ford upstream of mill at ch. 250m

The ford is shown diagrammatically in 2.2, Figure 2.2.1. Its purpose is to provide vehicular access across the river in conjunction with the nearby crossing over the mill leat (see 8.2). The ford is configured as a point bar located downstream of a sharp bend in the river. It crosses the river diagonally such that the ramp on the inside of the bend could take the form of a natural shoal of gravel that gently rises up to field level, mimicking the geomorphology of upland rivers where point bars and shoals of gravel often serve as crossing points. Because there is no significant bed load of gravel in the River Cole, the bar and shoal had to be artificially created using crushed stone and aggregate.

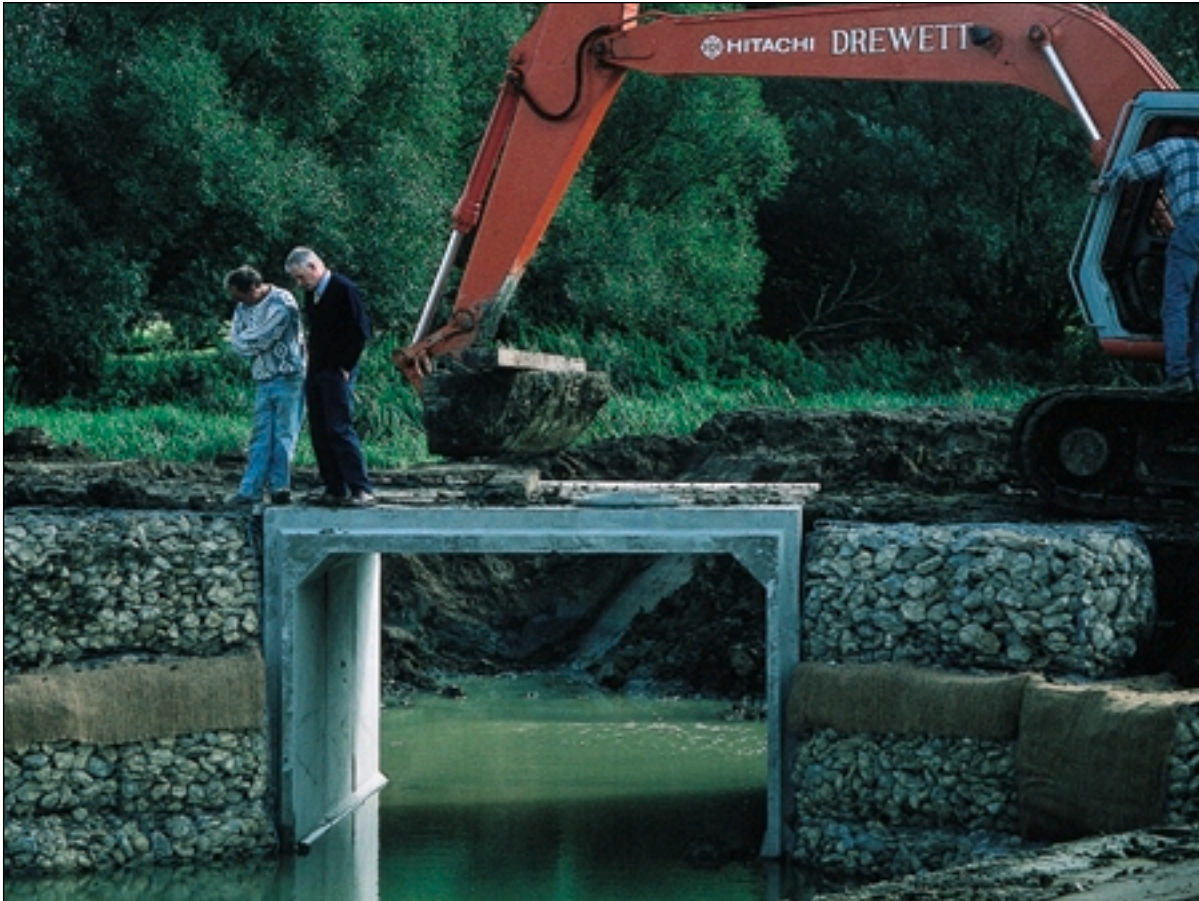
New concrete culvert crossing under construction

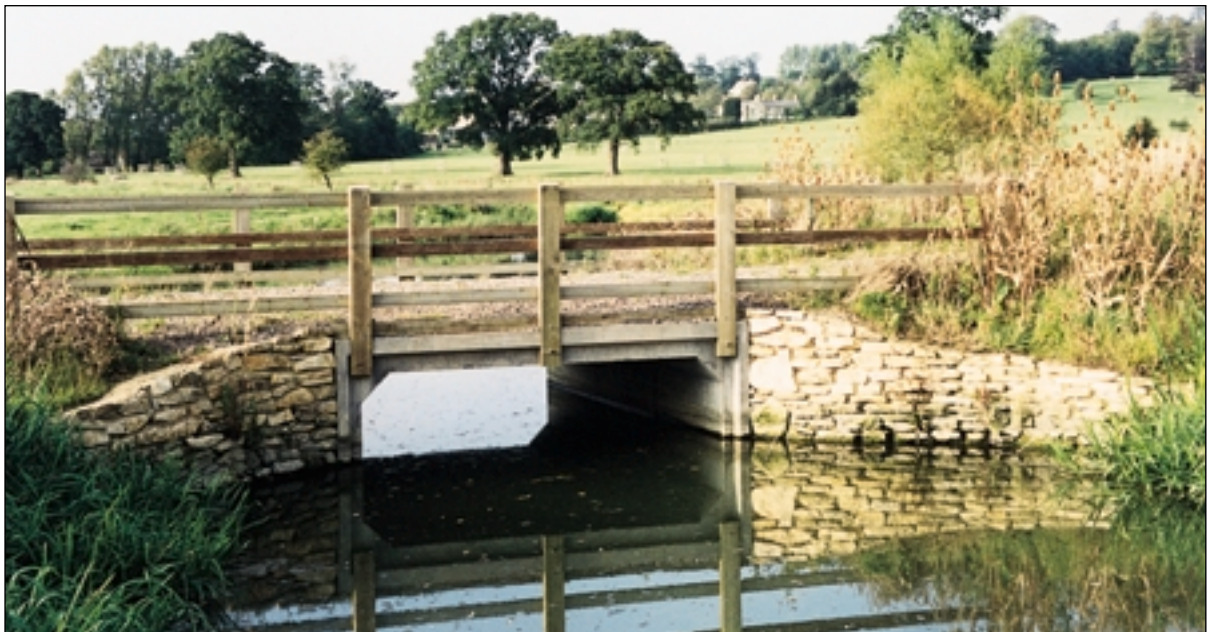
Completed 'bridge'

and stone walling are intended to draw the eye away from the concrete box which is a relatively minor feature of the overall visual aspect evident in the photo.

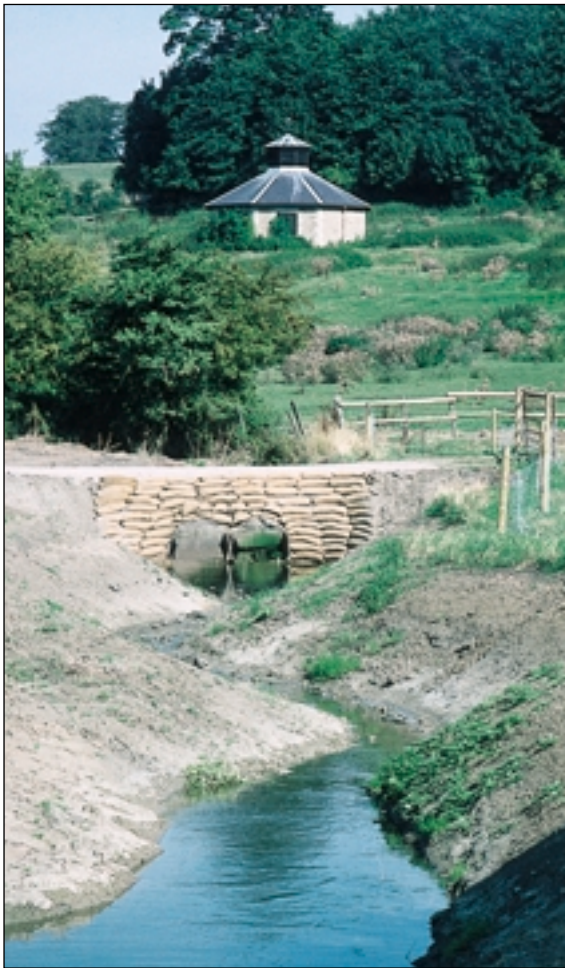
Flood drain crossing seen from bank of R. Cole.
(bagwork wing walls incomplete)

Concrete filled hessian sandbags were used to achieve this complex geometry. Another consideration was that the pressure of floodwaters passing through the pipes might produce high velocities and turbulence on exit. A distinct scour pool was excavated that was

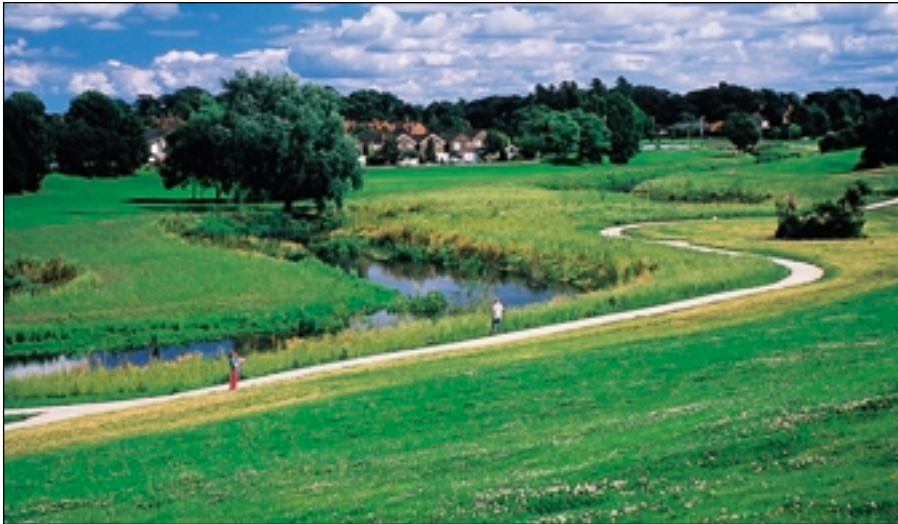
Concrete footpath and meanders

Prior to the restoration project formal paved access alongside the river was very limited but was found by survey to be high on local peoples priorities for improvements. Two separate paths were included at the locations indicated on the project plan that precedes the techniques section of this manual.

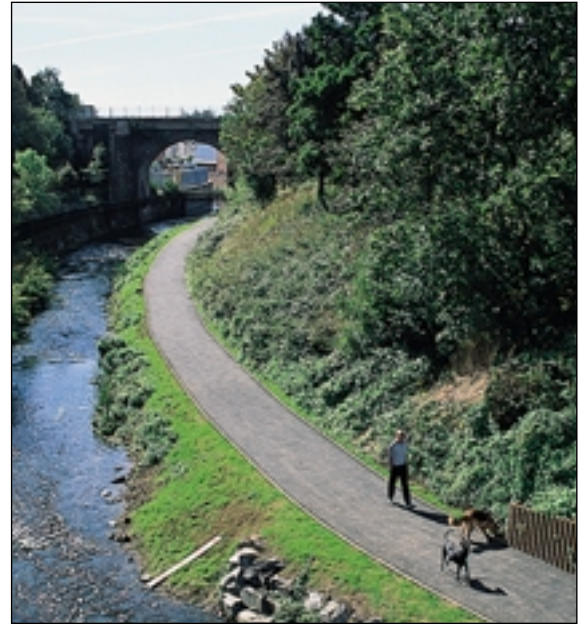
Bitmac footpath towards Skerne Railway Bridge

Drainage of rain water from adjacent slopes proved critical and some remedial works were needed to clear occasional puddles and associated silts that mudded the path.

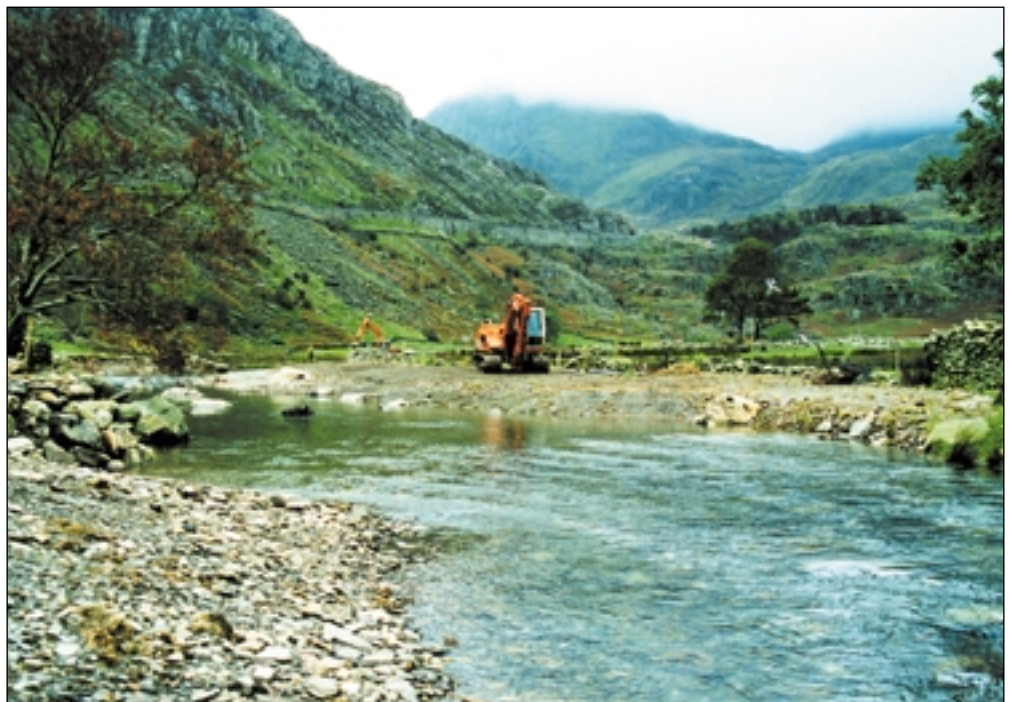
The restored ford, shoals and riverbed

The ford is located between two opposing bends in the river alignment such that shoals of gravel naturally accumulate on the inside of each. The two shoals would typically be joined by an underwater bar of gravel aligned diagonally across the channel. The natural cross-section of the river, drawn across this diagonal bar and up the flat shoal profiles each side, would roughly match the ford profile needed. The sustainability of the shoals and the bar of gravel would depend upon continuing inputs of material to

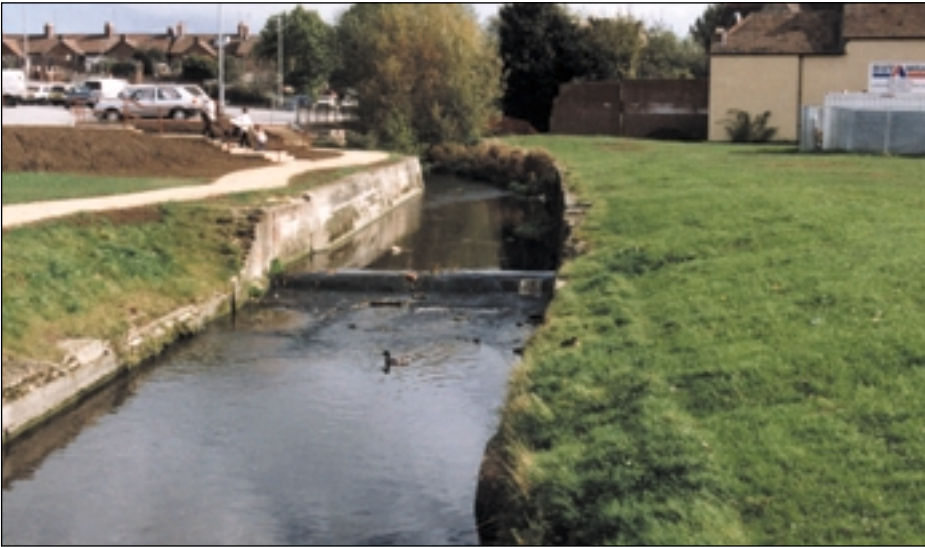
The river and weirs before construction

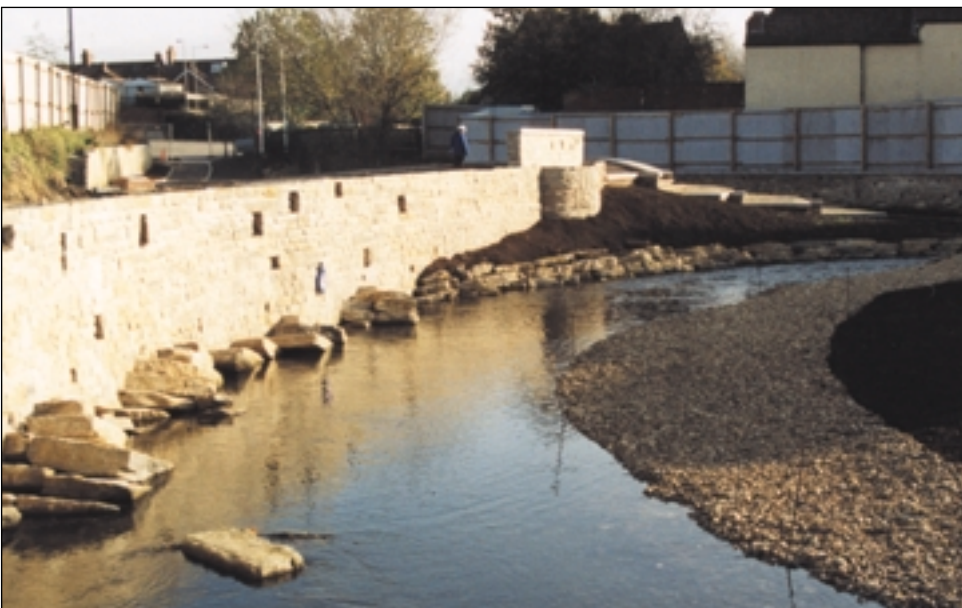
Gravel margins and seeded soil form the shallow banks opposite 'rocky' walls

The inner part of each meander is configured as a gravel shoal. People enjoy being close to the river

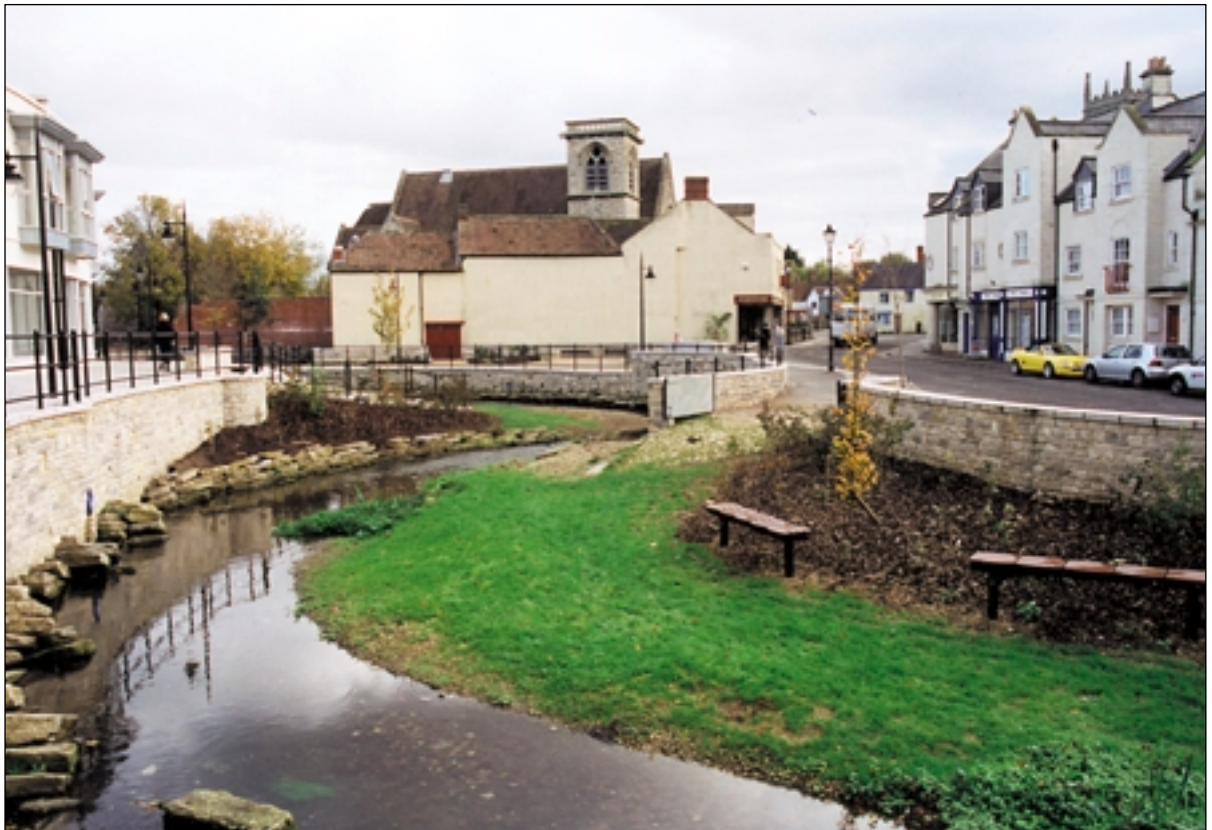
View of the accessible new river course, November 2001

A gently sloping ramp was achieved by aligning this parallel to the course of the river channel thereby maximising the distance over which a drop of c1.5m could be incorporated. The ramp blends smoothly into the shoal and falls at 1 in 12.5 at its steepest. Figure 8.5.1 indicates the profile of the inner bend and shoal. The upper part of the ramp is reinforced against wear and tear with limestone block paving. Purbeck limestone was used extensively throughout the project (see 1.5). Grass is seeded between the paving blocks ensuring a good blend with the grassed areas around the shoal.

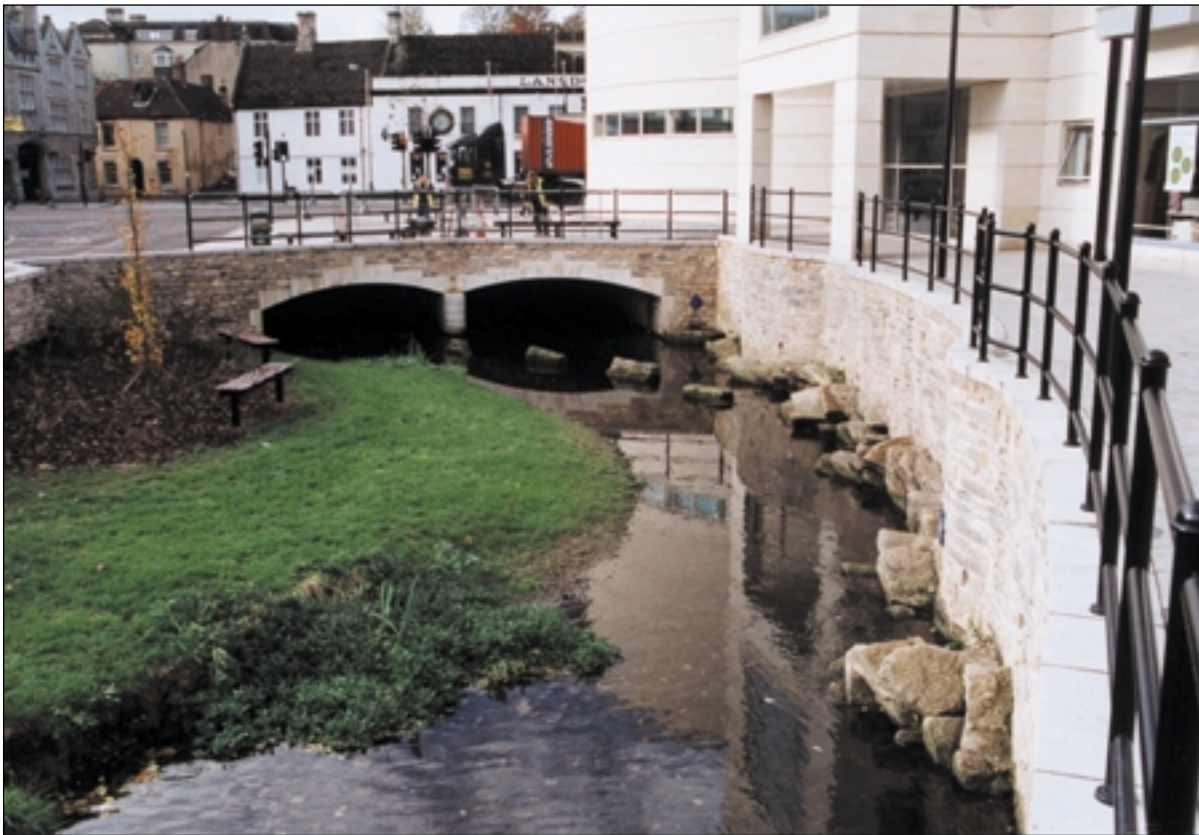
Seating and gentle grass and gravel slope to waters' edge

but the overall appearance of the access provision is inviting and safe during normal river conditions.

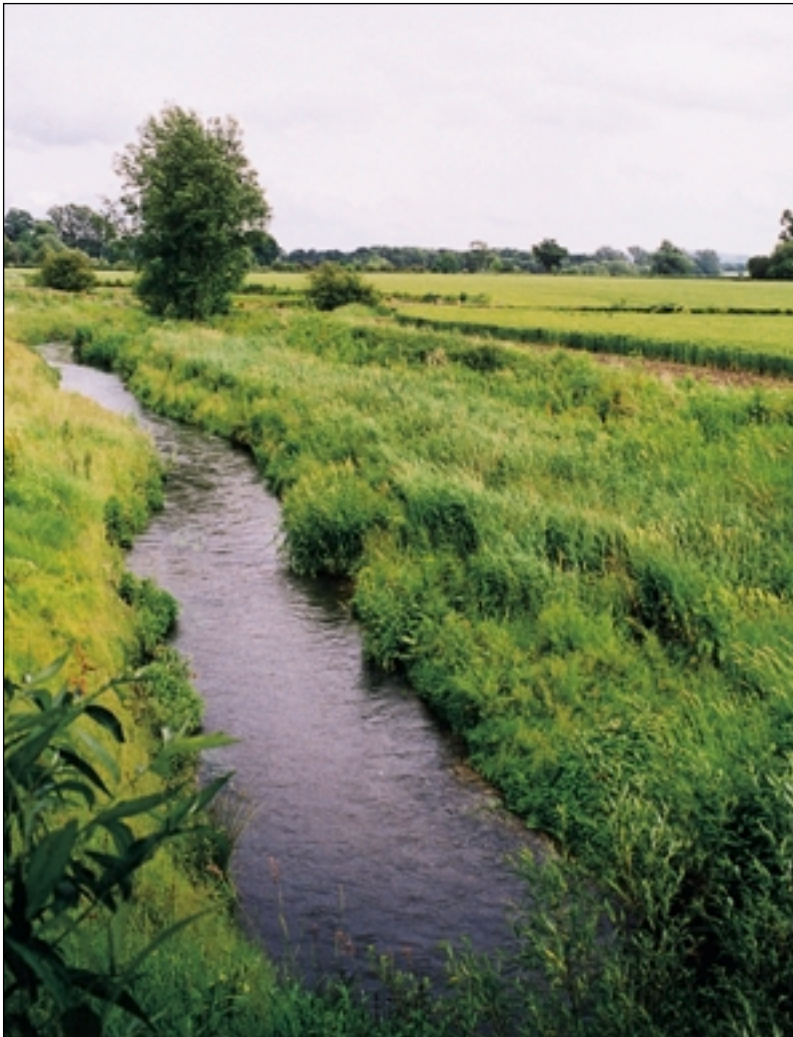
Reedbed established – Summer 1998

The reedbed established exceptionally well with 93% of seedlings surviving to maturity, although seed germination was perhaps only 50%, but still sufficient to achieve full colonisation within two growing seasons. Other aquatic species colonised the area naturally, including greater water plantain and soft rush. Concerns that the River Cole might damage the reedbed when in flood proved unfounded because the
