Korswagen, P., Gaggero, M. B., & Rots, J. G. (2025). Experimental Comparison of Cracking in Four Masonry Walls with Different Boundaries and Material. In G. Milani, & B. Ghiassi (Eds.), *18th International Brick and Block Masonry Conference: Proceedings of IB2MaC 2024—Volume 2* (Vol. 2, pp. 322-332). (Lecture Notes in Civil Engineering; Vol. 614). Springer. [https://doi.org/10.1007/978-3-031-73310-9\\_23](https://doi.org/10.1007/978-3-031-73310-9_23)

# Experimental Comparison of Cracking in Four Masonry Walls with Different Boundaries and Material

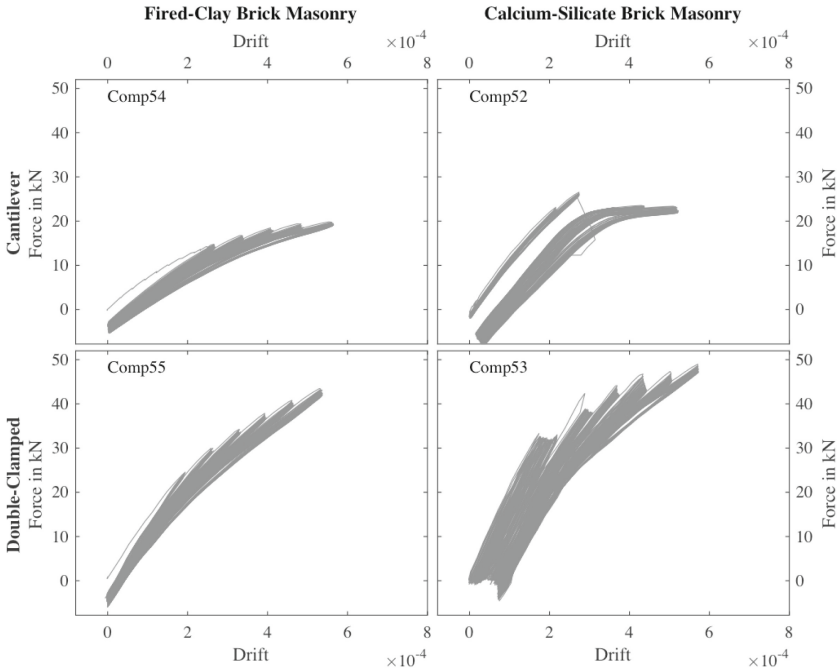
**Fig. 3.** Force-Drift curves for the four walls during the repetitive loading protocol.

The lateral force opposed by the walls when applying the prescribed displacements was recorded. When plotted against the enforced drift, a force-displacement curve can be drawn. Figure 3 compares the four walls for the repetitive part of the protocol (when the drift was applied only in one direction without reversal). The five or six incremental steps are visible. The curves reveal that the doubled-clamped tests reached a higher capacity—this is expected since the overburden was also higher. However, both walls, independent of the material, also achieved noticeable higher forces at each step while the cantilever tests quickly reached their capacity and present a more plastic force-drift envelope. In terms of hysteretic energy, no remarkable differences can be observed for all four walls, while the calcium-silicate walls do show slightly larger energy release.

The force-drift behaviour of the walls could be idealised with a bi-linear diagram. For the cantilever walls, the upper branch would be more horizontal, while the double-clamped walls display a steeper branch. Beyond light-damage, a tri-linear diagram could be used; see next section (Fig. 4).

In Fig. 8, the comparison is first conducted in terms of force. The behaviour observed in Figs. 3 and 4 is here emphasised: the cantilever tests display a lower capacity. It is also clear that the fired-clay specimen shows a lower capacity for the cantilever boundary and for the double-clamped tests. The force at each step degrades; in the positive direction, this occurs during the repetitive protocol, while for the cyclic protocol, this occurs only in the negative direction since the positive direction has already been damaged. The degradation is more consistent during the double-clamped tests. A hypothesis is that the predominantly shear behaviour, that follows from this boundary condition, is also linked to the observed reduction in force.

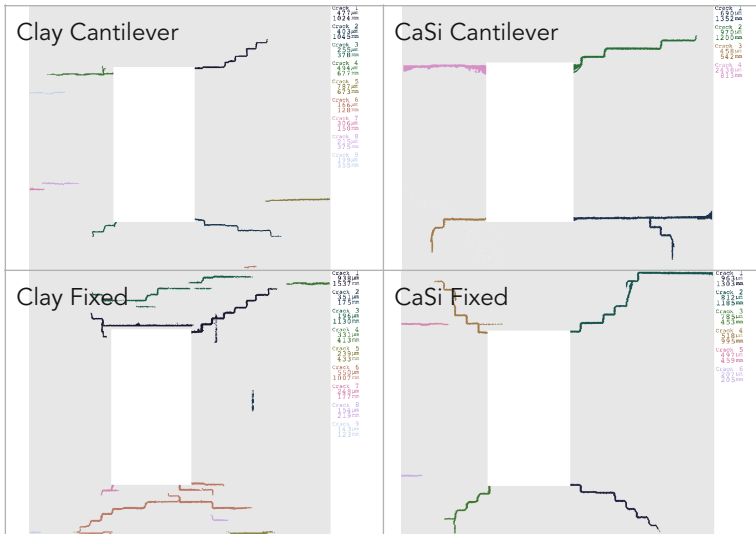
**Fig. 5.** Summative crack pattern at the end of the cyclic protocol.

At the end of the cyclic protocol, the summative crack pattern is gathered in Fig. 5. Clear differences can be observed for the two materials and the two boundary conditions. For the cantilever cases, cracks appeared more horizontal and followed a somewhat diagonal path. For the fixed-fixed condition, a steeper path is visible. Similarly, the CaSi walls display more diagonal and even vertical paths, cutting through the units. Moreover, the double-clamped cases seem to show more smeared cracks while the cantilever walls display more localised cracks directly propagating from the window corners. Nonetheless, the cracks for the fixed-fixed boundary are consistently wider, but not remarkably so.

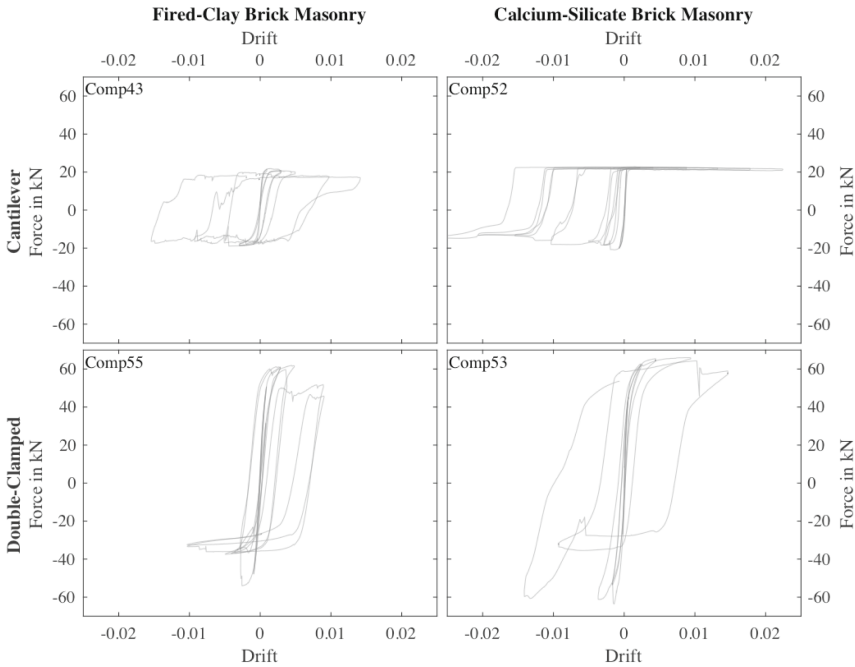
**Fig. 6.** Force-drift curves for the near-collapse protocol.

The shape of the force-drift curves are linked to the failure mechanism of each test. In general, pure rocking with crack opening and closing, and pure shear, with only sliding at the crack interface, can be distinguished. The various walls exhibited combinations of these mechanisms at different degrees on the two possible directions. For example, Comp43 displays mostly sliding in both directions; Comp52 in contrast, shows sliding only in the negative drift direction while the positive direction is associated with pure rocking. The other two walls, in doubled-clamped configuration, present a mixed mechanism. The boundary motivates sliding but is also accompanied by Mode I crack opening and closing. For Comp55, the negative direction sees little sliding while the positive direction sees little sliding while Comp53, after clear failures, starts to slide (Fig. 6).

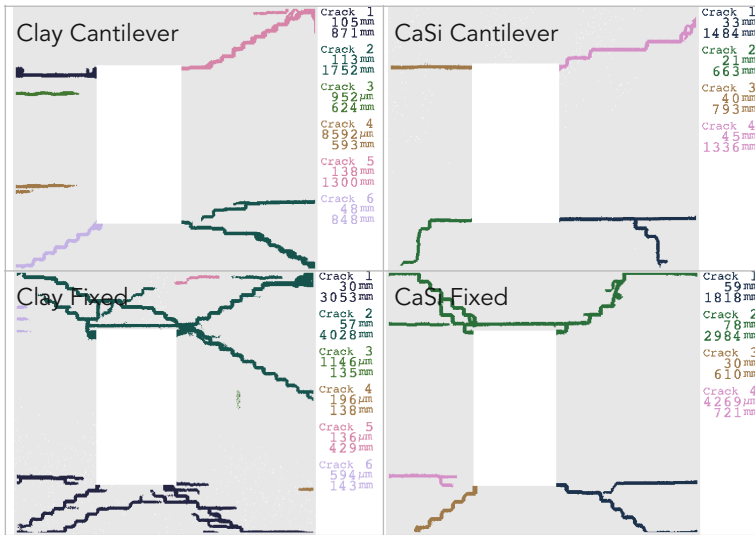
Fig. 7. Summative crack pattern at the end of the near-collapse test.

This can also be inferred from the final crack patterns, presented in Fig. 7, at the end of the tests. Here, the earlier cracks have been aggravated and depict walls that have separated into rigid bodies; these slide or rotate against each other.
