Case Study: Wenduine, Belgium
Vulnerability of buildings on a coastal dike

CASE STUDY: WENDUINE, BELGIUM

VULNERABILITY OF BUILDINGS ON A COASTAL DIKE

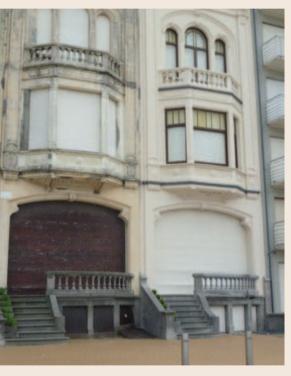
Figure 3 (top right). Basement with flood protective window shutters (Photo courtesy Koen Trougy)
