ter Meulen, D. W. B., Cabboi, A., Brownjohn, J. M. W., & Antonini, A. (2025). Vibration-Based Monitoring of the Historic Quay Walls of Amsterdam. In A. Cunha, & E. Caetano (Eds.), *Experimental Vibration Analysis for Civil Engineering Structures, EVACES 2025 - Volume 3* (pp. 74-83). (Lecture Notes in Civil Engineering; Vol. 676 LNCE). Springer. [https://doi.org/10.1007/978-3-031-96114-4\\_9](https://doi.org/10.1007/978-3-031-96114-4_9)

**Abstract.** More than 1700 km of historic quay walls exist in the Netherlands, of which many approach the end of their lifespan. Collapses of the structures have already occurred, such as the failure of the Grimburgwal in Amsterdam, which stresses the urgency of assessing these structures. The application of vibration-based monitoring (identifying and tracking modal properties over time) to assess quay wall structures is investigated in this paper by executing a vibration-based monitoring campaign at a historic quay wall in Amsterdam. Based on the preliminary results of this monitoring campaign, this study shows that vibration-based monitoring is a promising field to explore further for quay wall assessment.

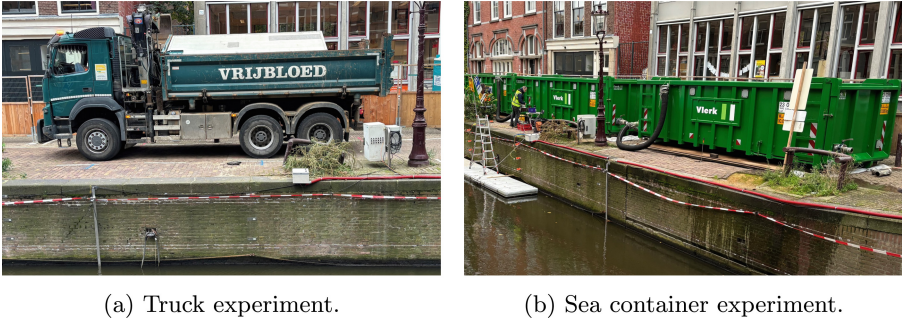
Fig. 4. Execution of the proof load test.

The proof load test conducted by Deltares was a modified version of the full-scale proof load experiment at Amsterdam Overamstel executed by Hemel [15]. A heavy load was applied on segment RBS0101-A1 by means of a truck first (see Fig. 4a) and second by sea containers gradually filled with water (see Fig. 4b). The truck and the sea containers induced a maximum pressure of 20 kPa, which aimed to initiate the early stages of the common quay wall failure mechanism *lateral failure of the quay wall foundation* [15, 17, 18, 22]. During the proof load test, the maximal horizontal displacement provoked by the applied load was limited to 10 mm to prevent a collapse of the quay wall. Eventually, the Municipality of Amsterdam can use the proof load test results to improve strength estimations of the historic quay walls and to update the predictions of their residual lifespan.
