The Importance of a Safe Construction in the Fight Against Terrorism

A historical analysis of buildings subjected to terrorist attacks and the changes in structural and safety design

ARA011 Architectural History Thesis

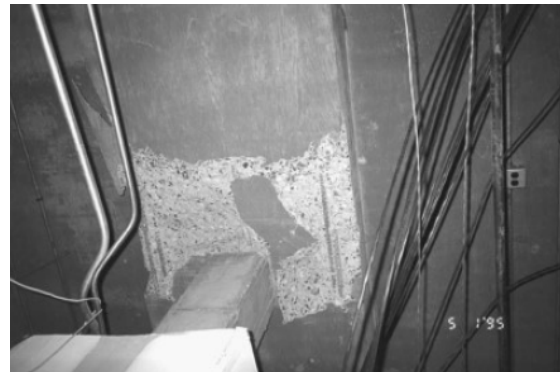
Fig.12 Damaged connection between beam and column (Osteraas, 2006)

Once the initial blast wave had passed the upward force dropped leaving its own weight as the only force on the slabs. As the slabs are proceeding to return to their original bend it fails to transfer its force to the columns due to the damaged connection. The gravitational downwards force start to bend the slabs further downwards then its original state. At first the fourth and fifth floors collapsed onto the third floor. The added weight was too much for the floor to be supported following to its collapse and along with it causing 10 constructive areas to fail along the northern half of the structure. (Figure 13). The

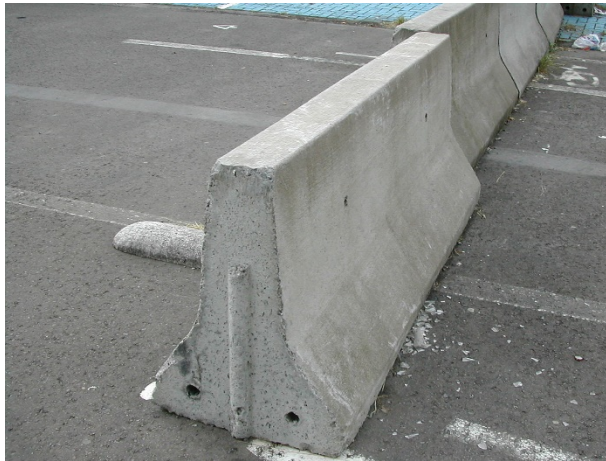
During the time of the investigation the jersey barriers (Figure 16) were placed in front of federal buildings as a temporary measurement to prevent vehicles from getting too close to these buildings, which were later on replaced by more integral designed elements to protect the buildings while also look esthetically appealing. However, this measurement has only limited effect when buildings are relatively close to the streets. To protect these building modifications to the buildings itself should be considered such as erecting walls to compartmentalize the building, adding supplemental support frames and reinforcing existing columns with steel and concrete (Corle et al,1998).

Fig.16 Jersey barrier (CorreiaPM -Wikipedia, 2008).

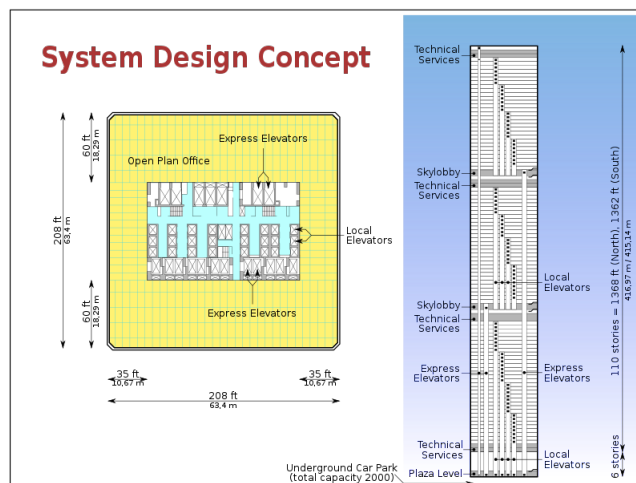
On September 1962 architect Minoru Yamasaki was selected to design part of the WTC complex. In his design, 2 near identical 80-stories tall towers sit in the center of the complex and provide most of the required office space. These towers later became known as the Twin Towers. However, to fulfill the requirements of the Port Authority to accommodate 930.000m² throughout the WTC complex of office space, the Twin Towers would have to be 110-stories tall with a square floorplan of 63,4m wide (NIST, 2005). One of the major problems during the design of the towers was its height. At that time a building of 80-stories was considered the limit from an economical and logistics point of view, since more stories means more elevators which means less rentable space. To counter this problem, they introduced a new system with the concept of sky lobbies which acted as central hubs where people would switch from express elevators to local elevators to get to the desired floor (Figure 17). The benefits of such a system are that multiple elevators can make use of the same elevator shaft thus reducing the required amount of shaft needed and making the additional 30 floors economically feasible (NIST, 2005).

Fig.17 Elevator system design with use of sky lobbies in the Twin Towers (MacRudi- Wikipedia, 2008)

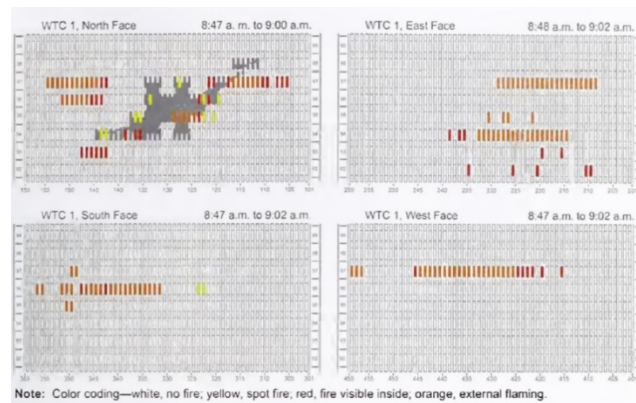
On impact, the fuel tanks of the airplane were cut open by the exterior columns which resulted in the fuel spewing in all directions. As the jet fuel used in the plane is highly flammable, some of it ignited on contact with both the hot debris and electrical devices (NIST, 2005). Combined with the dust from damaged walls and floors the ignition resulted in fireballs and an extreme overpressure in the building which blew out windows in the east and south side of the tower. After the fireballs had disappeared over half of the fuel was still inside the building and caught on fire upon ignition (Figure 22). Due to the blown-out windows the fire was fed with fresh air and continued to intensify over time. There was no way to fight against the fires as the sprinkler system was inoperable and there was no access to the floors. Even if the sprinkler system was operable, it would have been activated immediately at triple capacity within the first 13 minutes to overcome the fires. Any later would have been too late.

Fig.22 Exterior view of the fire development in the North Tower between 8:47a.m. and 9:02a.m. (NIST, 2005).

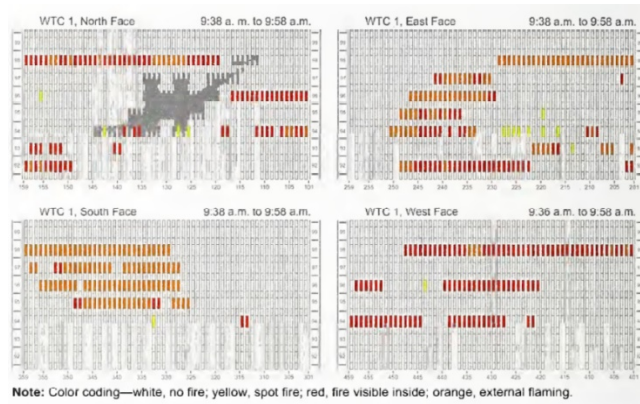
As the fires continued to burn in the North Tower the aluminum frames from the windows started to weaken and were either push outward or suck inwards to supply more fresh air to the fire and provide a path for the hot gasses and smoke (Figure 23).

Fig.23 Exterior view of the fire development in the North Tower between 9:38a.m. and 9:58a.m. (NIST, 2005).

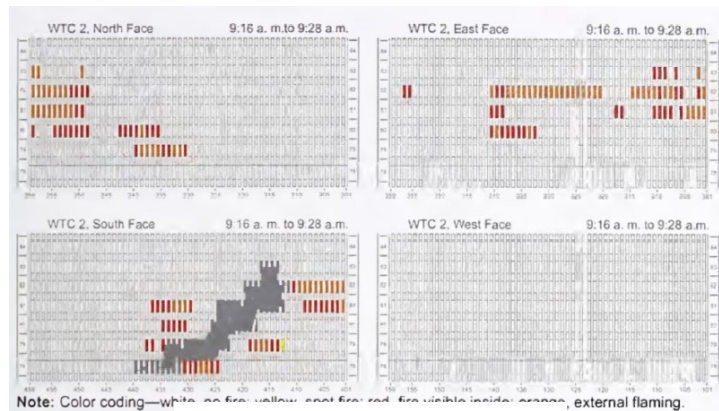
Fig.26 Exterior view of the fire development in the South Tower between 9:16a.m. and 9:28a.m. (NIST, 2005).

As the fuel was scattered around, several fireballs could be seen bursting out of the windows which supplied the starting fires with air (Figure 26). For the following 30 minutes the small fires intensified around the debris and started to spread and grow. As the southeast corner of the core structure was severed, this load had to be absorbed by the exterior columns on the east and south façade and the east wall of the core structure. The affected floors on the east side of the building started to increase in temperature and sag. This led to the exterior columns in the east façade to be pulled inwards one by one over time and losing their loadbearing abilities with each displacement. With the exterior columns at the east façade unable to provide loadbearing capacity, the already weakened core system was unable to provide support and the top of the building started to lean to the south east after which the South Tower collapsed.

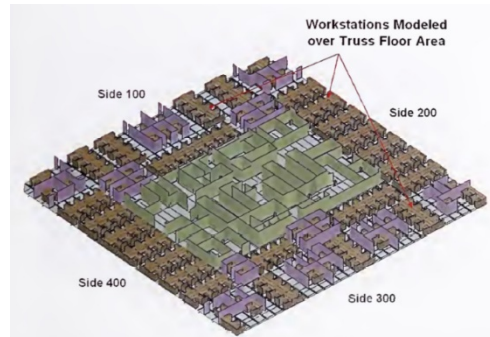
Fig.29 Model of the 96th floor of WTC 1, including interior. (NIST, 2005).

Based on photographs, media footage, eyewitnesses, debris analyses and reports from the NYPD and FDNY, Leslie E. Robertson Associates (LERA) was contracted to construct a reference model (Figure

28 to 31) with use of the SAP2000 v8 software. This reference model was used to perform computer simulation in order to establish the capacity of the buildings to simulate what would happen if an airplane impacted the building and to reconstruct the mechanics of the airplane impact damage, heat from fires and to construct a timeframe of local failures resulting in the building collapse (NIST, 2005).

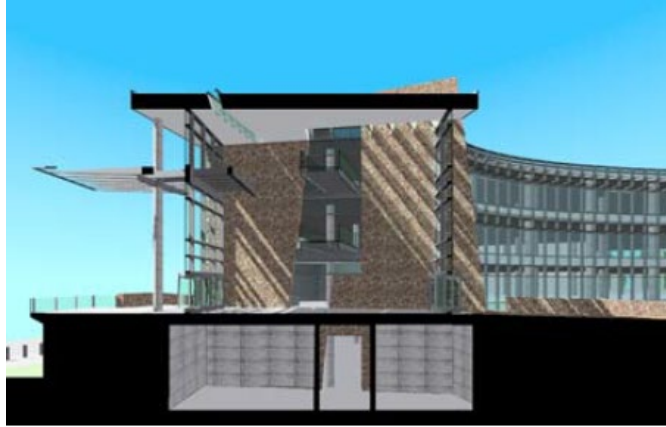
Fig.34 Section of the lobby showing a blast-resistant wall between the lobby and the office space (Pollalis, 2006).

The lobby, on the south side of the building, is open to the public and allows people to access the open space at the north of the building without going to security. In order to guarantee the safety of the users, the two blast-resistant walls between the lobby and the workplaces are designed to minimize damage by sending the blast upward instead of further into the building towards the office spaces (Pollalis, 2006)(Figure 34).

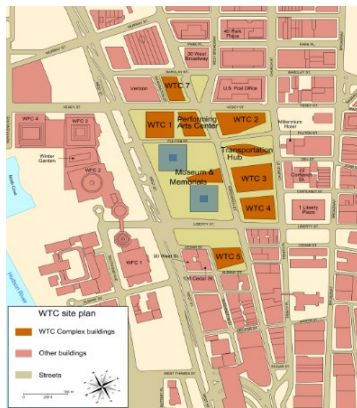
Fig.35 New WTC floorplan with 9/11 memorial (Mamgommann88-Wikipedia, 2011).

Following the 9/11 tragedy in 2001 proposals for the site’s reconstruction started almost immediately in 2002 with a design competition held by the Lower Manhattan Development Corporation. These proposals led to the design as seen in Figure 35 where the new complex would be constructed around the old site of the Twin Towers which was to become a memorial. The WTC 1 building of the new complex was envisioned to be the replacement of the Twin Towers and to become the new icon of the complex. Over a 3-year period several designs were proposed resulting in a merger of the designs from Studio Daniel Libeskind and Skidmore, Owings & Merrill (SOM) in 2005 (Figure 36) which was later refer to as the One World Trade Center or One WTC. The final changes in design were to ensure the building was especially designed to withstand attacks such as the '93 bombing and the 9/11 attacks because the One WTC will most likely to become a target for such attacks in the future (Jester, 2016).
