# Assessing Structural Integrity of Concrete Half-joints Using Sensor Data

A Case Study of the Naardertrekvaart Bridge

to obtain the degree of Master of Science

at the Delft University of Technology,

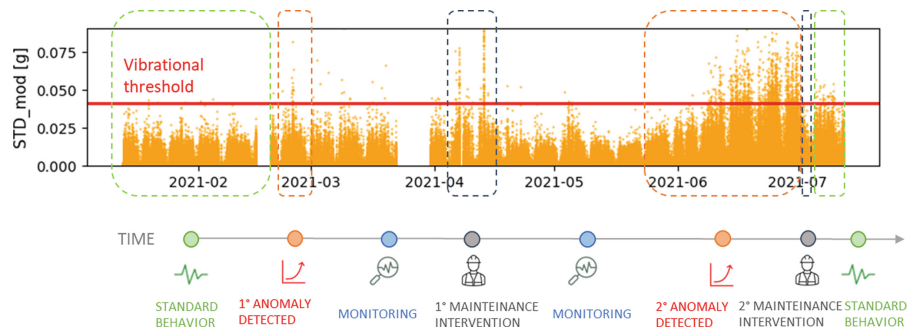
**Figure 2.7:** Timeline of the standard deviation values of a single accelerometer [21]

The analysis of the measurement data is split into two parts. The first part consists of real-time anomaly detection based on the standard deviation of the acceleration data. This system proved to be useful in detecting and localising damage to the bridge, as previous indications of damage were confirmed by visual inspections and were followed up by appropriate maintenance interventions, which reduced the standard deviation back to normal values. This process can be seen in Figure 2.7.

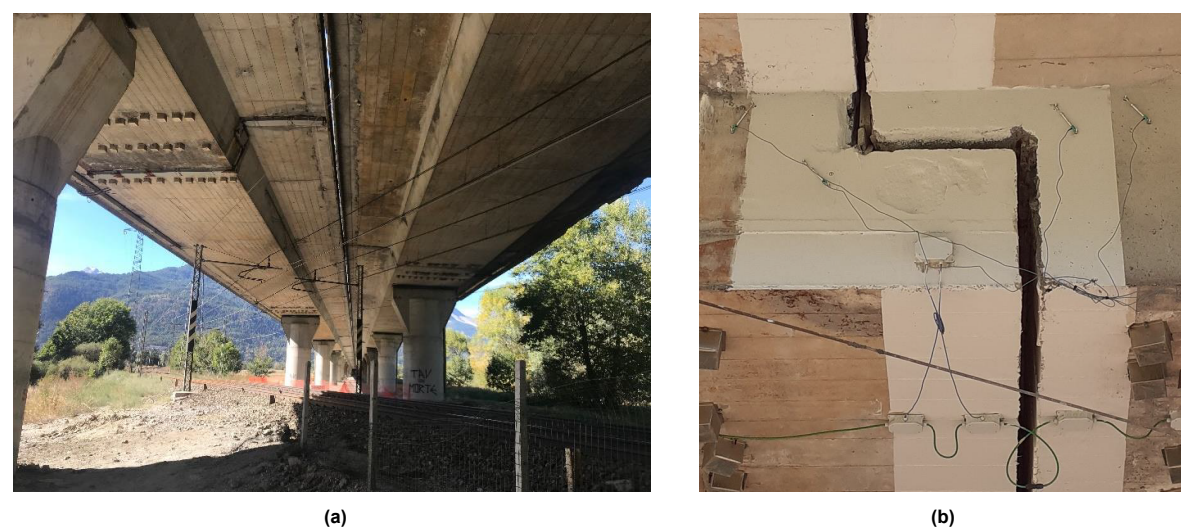
**Figure 2.8:** SHM system on the GAD bridge with (a) a deck view of the overpass and (b) the installed tiltmeters and crackmeters [22].

The GAD bridge is a prestressed reinforced concrete plate bridge in northern Italy constructed in 1983, which uses the half-joint system. It was constructed in 1983 and it facilitates highway traffic. As the half-joints showed insufficient resistance to shear, due to insufficient shear reinforcement, the half-joint was strengthened using prestressed transversal bars [47]. To monitor the behaviour of the half-joints until scheduled deck replacement, an SHM system was installed in 2019. As part of the SHM system, multiple half-joints were equipped with clinometers, measuring the rotation at each side of the half-joint, crack meters, measuring the crack opening of the visible cracks, and temperature sensors. The SHM system can be found in Figure 2.8. The measured data are continuously analysed by algorithms measuring sudden variations exceeding predefined thresholds, which have been pre-defined based on regular variations of the measured variables. Thereby, this system is mostly data-driven. If no anomalies are found, the data are uploaded to the cloud to be used for long-term data analysis [22].

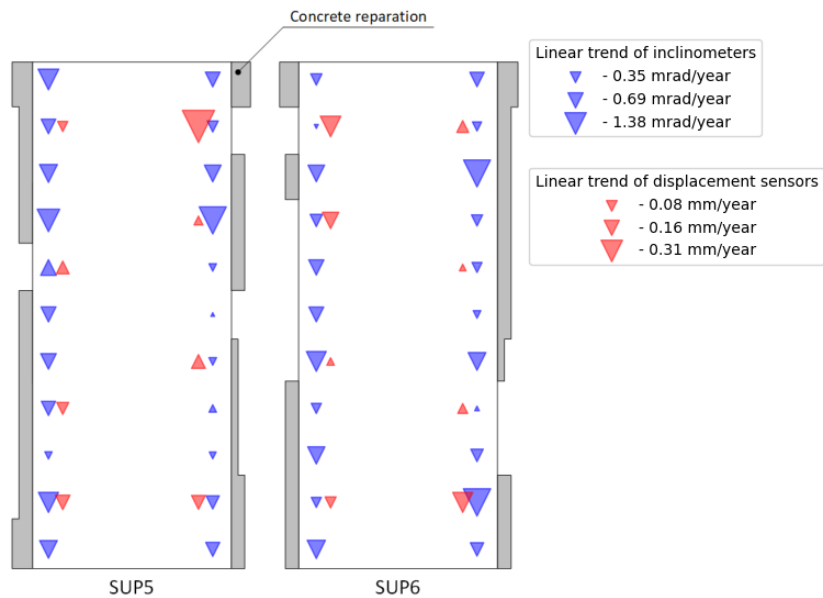
Figure 4.2: Linear trend observed by the measurement sensors, plotted on different locations along the support platforms. The linear trends are calculated using a least squared estimate of a straight line between 01-04-2022 and 01-04-2024.

Analysis of the measurement data of the inclinometers and displacement sensors reveals the presence of a significant linear trend in multiple sensors. The magnitude and direction of the trends is depicted in Figure 4.2 for the measurement sensors at different locations along the support platforms.

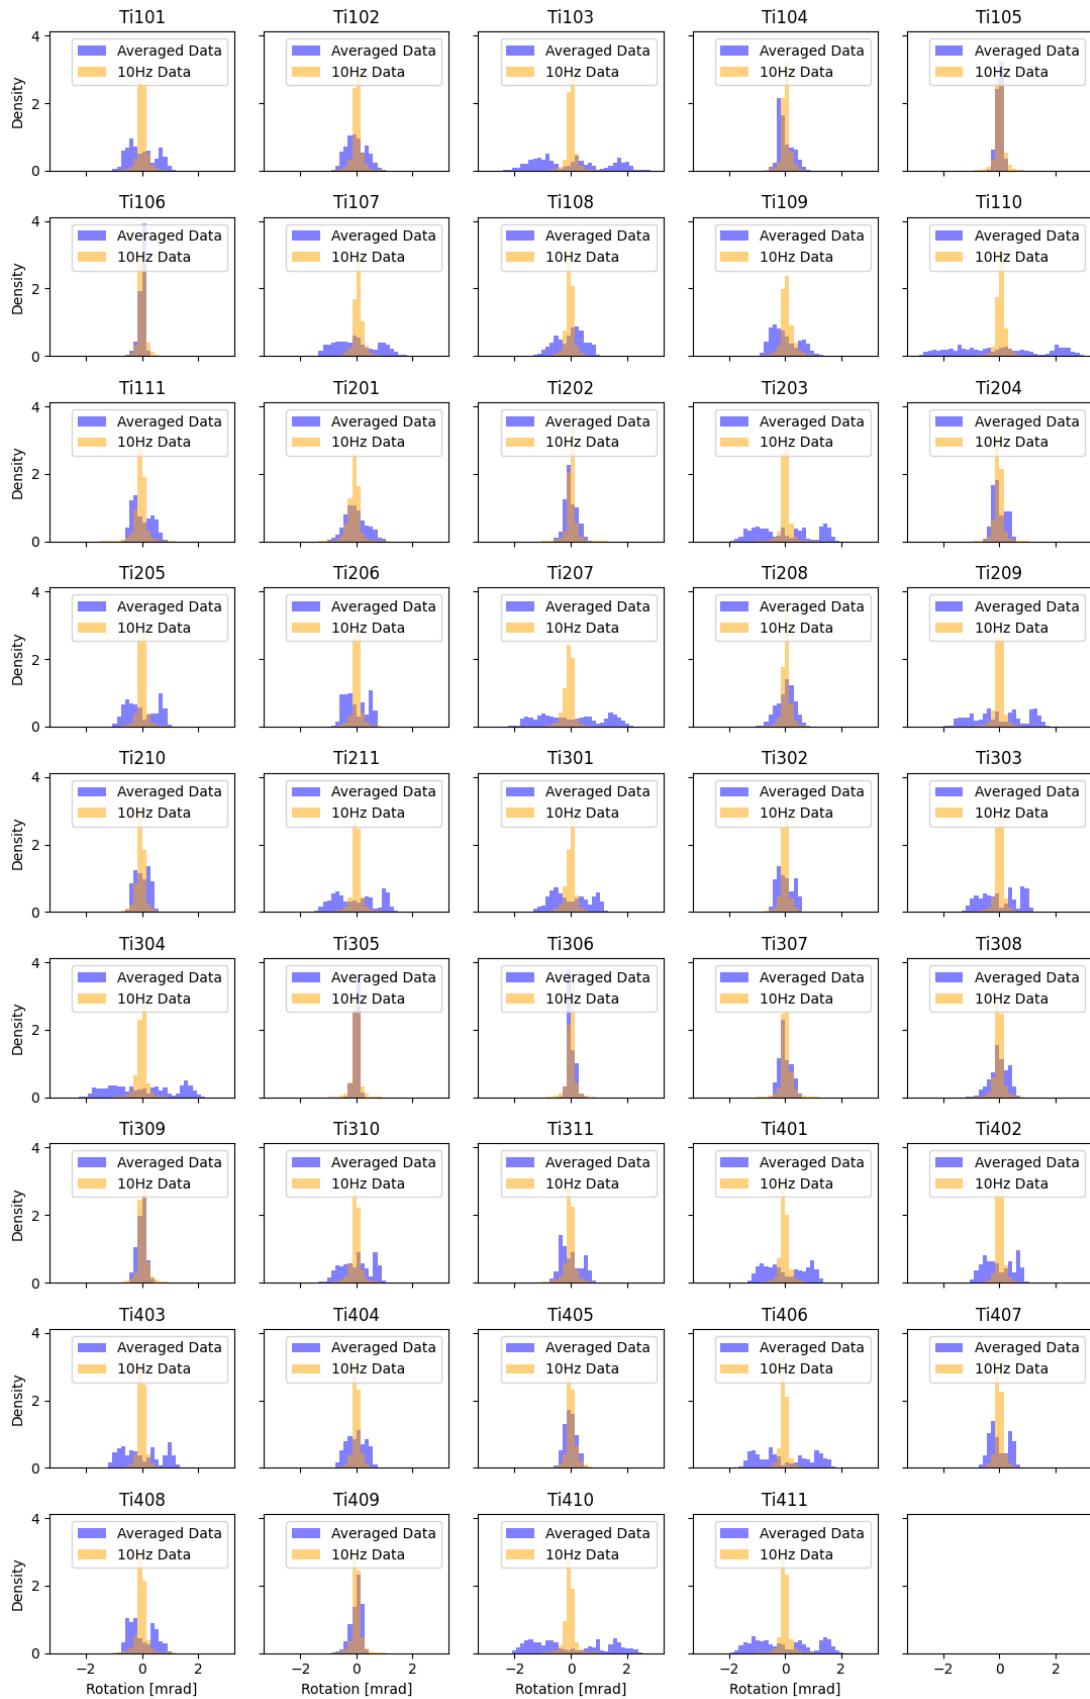
**Figure C.2:** Histograms of the historical and high-frequency measurement data of every inclinometer

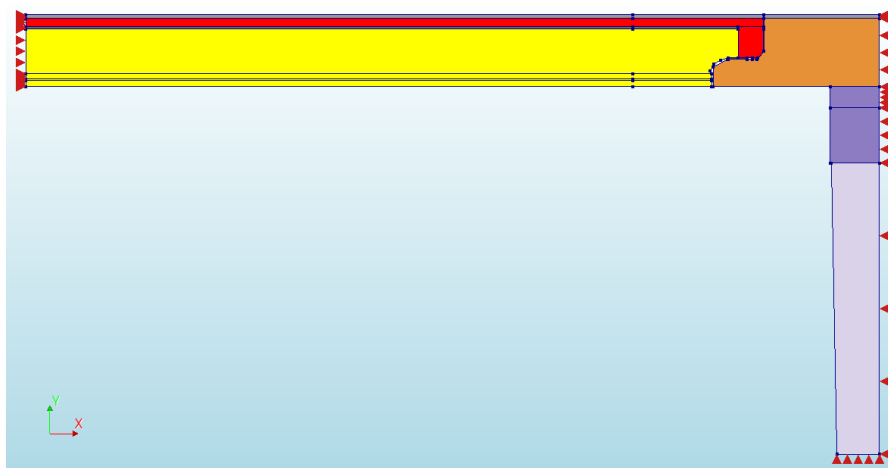
**Figure D.1:** 2D model of half a standard span of the Naardertrekvaart bridge

A 2D plane stress model of half a standard span of the Naardertrekvaart bridge is developed to investigate the local effect of thermal expansion. The magnitude of this effect depends on the stiffness of the material in the half-joint gap. The model is shown in Figure D.1. The geometrical components of the model are discussed in Section D.1.1, its supports in Section D.1.2, and its mesh in Section D.1.3. The ability of the model to simulate the behaviour of the physical structure, and thereby the validity of the assumptions taken in the model, is confirmed in Appendix E.1.
