Thermoplastic composite stiffened structures in post-buckling

van Dooren, K.S.

Dissertation

Keywords: Thermoplastic composite, post-buckling, skin-stringer separation, stiffened panels, welding, butt-joint, testing, damage tolerance, finite element, virtual crack closure technique

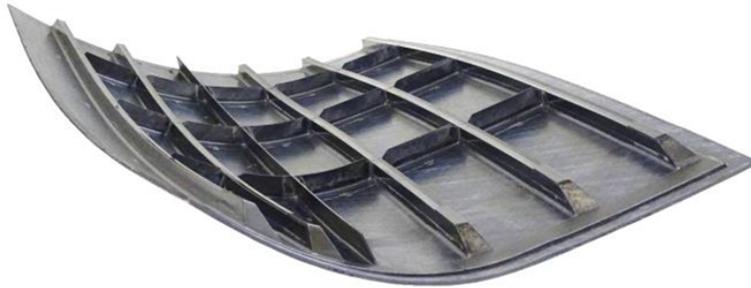
Figure 1.1: Orthogrid double curvature fuselage panel [5].

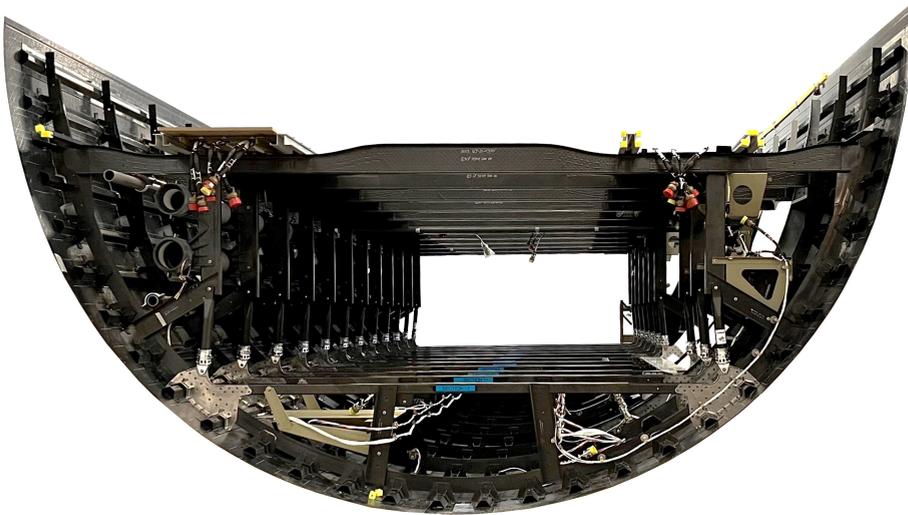
Figure 1.2: Lower half of the STUNNING fuselage [8].

tory (NLR) utilising Automatic Fibre Placement (AFP), to which continuous compression moulded omega stringers from Xelis were conduction welded by GKN Fokker. GKN Fokker also manufactured the frame and floor beam sub-assemblies and was responsible for assembling the fuselage, which was executed at Smart Advanced Manufacturing XL (SAM XL) in Delft. The sub-assemblies were joined to the stiffened skin with injection-moulded clips of ECO-CLIP, for which ultrasonic welding was used in cooperation with Delft University of Technology. SAM XL developed also an industry-ready assembly process, by integrating robotics for ultrasonic welding and pick and place of stringers, and developed smart control and programming methods.

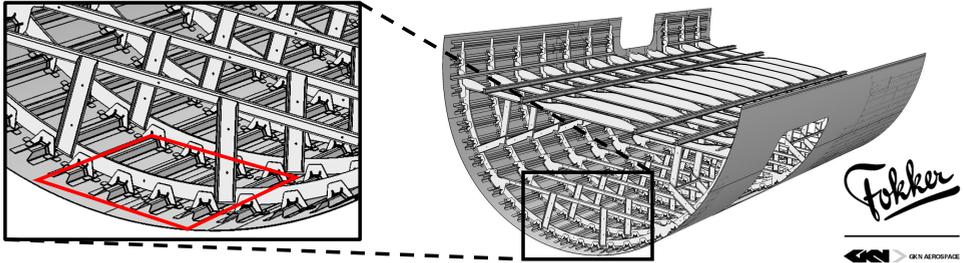
Figure 2.1: Lower half of the STUNNING Multifunctional Fuselage Demonstrator, with the keel section highlighted [6, 7].

The lower half of the fuselage of the STUNNING project is shown in Figure 2.1. The keel section is considered as the area of interest, due to its low skin thickness, and is highlighted in red. A fuselage section approximating the keel section is modelled and shown in Figure 2.2. The fuselage section is modelled up to the cargo beams and includes the vertical beams, frames and clips. The geometries and joining methods used for the beams, frames, brackets and clips are simplified to lower the complexity of the models, and because these parts are not of interest in this research. The total length of the section is 2005 mm, the total width is 2664 mm, the outer radius is 1926 mm, the stringer pitch is 212 mm, and the frame spacing is 635 mm. The omega stringer geometry is reported in Figure 2.3.

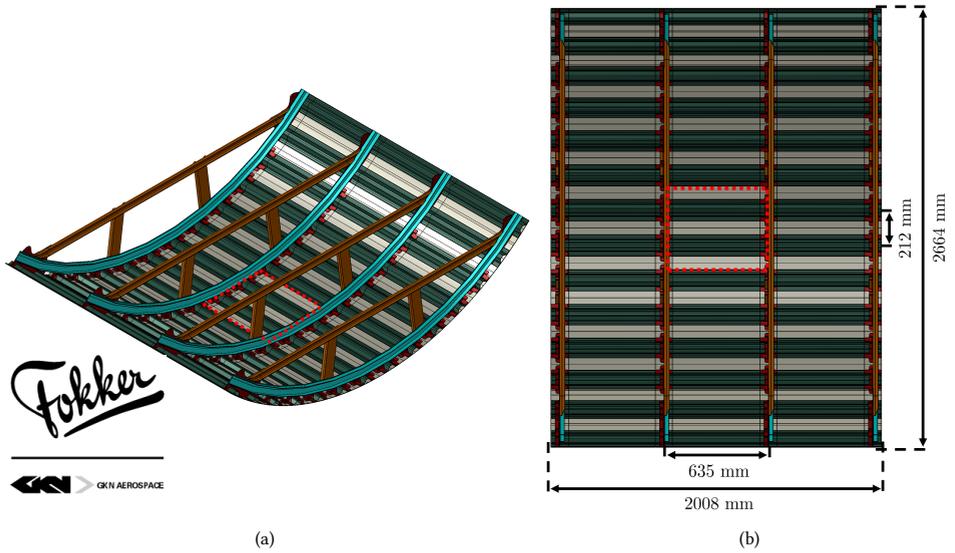
Figure 2.2: Fuselage section with highlighted area of interest: (a): iso-view; (b): top-view.

The area of interest of the fuselage section is in between the two middle frames and includes the middle three bays, as shown in Figure 2.2. The area of interest has a mesh size of 2.5 mm, while the adjacent areas are meshed coarser when feasible with a mesh size of

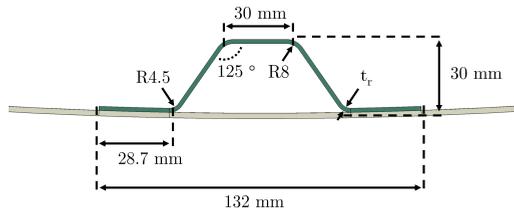
Figure 2.3: Omega stringer geometry.

The thickness of the skin and stringers are measured with a micrometer. The skin is found to be thinner compared to the nominal, with an average thickness of 2.14 mm. The flat sections of the stringers have an average thickness of 1.66 mm which is approximately the nominal thickness. It is however seen that in the middle of the radius from stringer flange to web, the thickness is lower, shown as t_r in Figure 2.3, with an approximate minimum thickness of 1.15-1.20 mm.

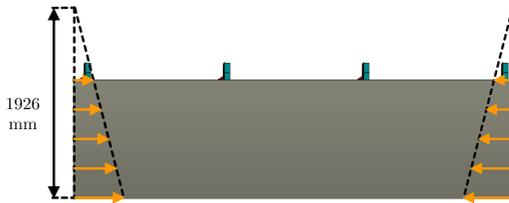
Figure 2.4: Side-view of fuselage section model showing bending load-case.

The fuselage is loaded in bending using a linear displacement field that applies compression to the fuselage section, with the bottom of the section in maximum compression, as illustrated in Figure 2.4. Boundary conditions applied to the free edges of the fuselage section, which are the edges of the skin and frame ends, constrain the circumferential degree of freedom, as illustrated in Figure 2.5, and leave the radial degree of freedom unconstrained.

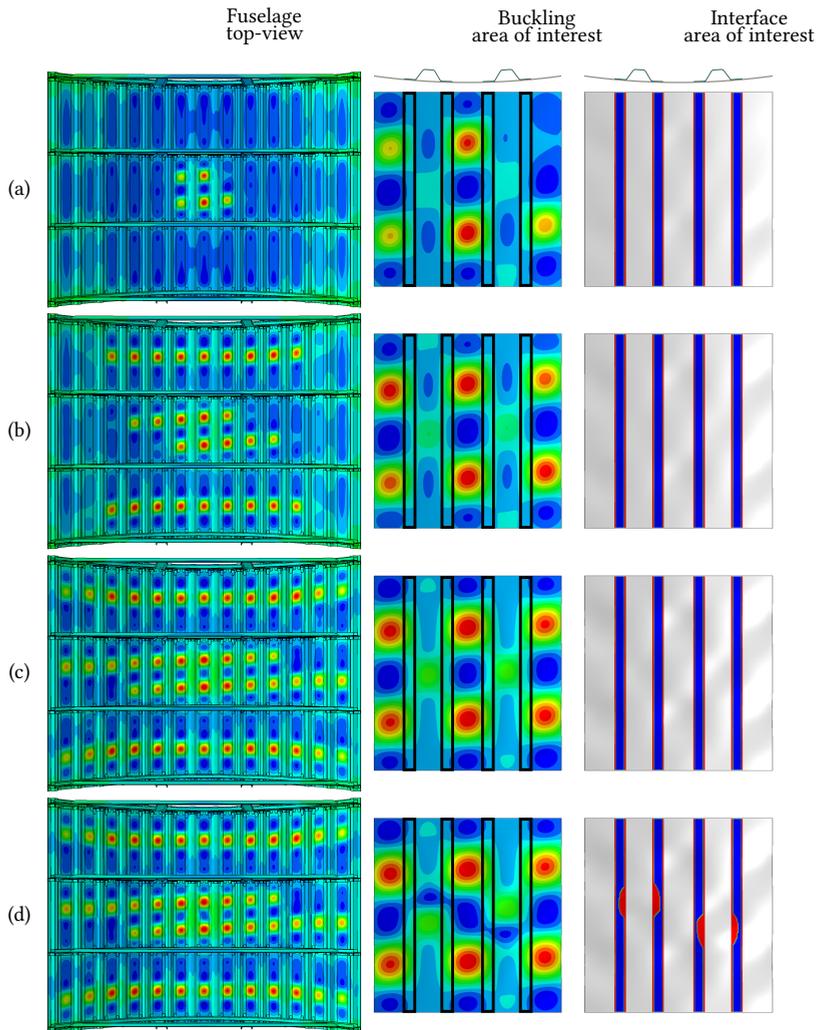
Figure 2.7: Radial displacement of fuselage section, radial displacement and interface state of area of interest, at different levels of bending with a longitudinal displacement of: (a) 5.36 mm; (b) 6.27 mm; (c) 8.23 mm; (d) 8.24 mm.

The buckling shape of the fuselage section is investigated. Contour plots of the out-of-plane displacement are shown at different levels of longitudinal bending, and consequentially different maximum longitudinal displacement, in Figure 2.7. The contour plots show the out-of-plane radial displacement of the fuselage section and a close-up of the area of interest, and the interface state of the two stringers in the area of interest. The area of interest consists of the middle three bays and two stringers in between the two middle frames and has the highest level of compression. This area also limits itself to the two stringers and adjacent bays where skin-stringer separation is modelled with VCCT. In the contour plots of the area of interest, the interface state of the welded flange is blue for the intact interface and red for the pre-crack and separation. The stringers are hidden, and an outline of the stringer flanges is shown in black, to allow seeing the radial displacement in the bay and underneath the stringer.

At a maximum applied longitudinal displacement of 5.36 mm, the skin in the middle of the section in between the two middle frames starts to buckle with a five half-wave buckling shape (Figure 2.7(a)). The half-waves in the bay have a much higher radial displacement compared to the half-waves underneath the stringer, with the half-waves at the top and bottom barely visible. The half-wave length underneath the stringer and in the bay is similar, but the sign of the radial displacement is inverted for the adjacent waves in the circumferential direction. The buckling shape continuously evolves, with the remaining bays in between the middle frames displaying an initial three half-wave buckling shapes followed by a five half-wave buckling shape (Figure 2.7(b)). At a maximum longitudinal displacement of 8.23 mm (Figure 2.7(c)) all bays have buckled, with the top and middle

At a maximum displacement of 8.24 mm (Figure 2.7(d)), failure due to skin-stringer separation starts, with separation developing from underneath the stringer. It is seen that the outward half-waves in the radial direction in the bay and underneath the stringer start to connect, which is called tunnelling. Separation starts almost simultaneously in two stringers, with similar elliptical crack front shapes. Once separation starts, it is unstable, and the stringer totally separates in one separation event.

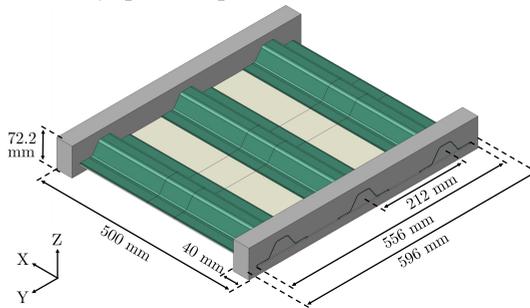
Figure 2.8: Three-stringer panel.

The panels have the same stringer pitch and nominal stringer geometry as the STUNNING fuselage lower half, shown in Figure 2.2 and Figure 2.3, respectively. The nominal width and length of the panels are equal to 556 mm and 500 mm, respectively. The panel length corresponds to the maximum possible welding length available at the time of the design. The geometry of the three-stringer panel is shown in Figure 2.8.

The geometrical imperfections of panels 1 and 2 are shown in Figure 2.15, with the imperfection aligned with the z-axis of the axis system reported in Figure 2.8. The panels show a similar curved imperfection in the transverse direction, with the edges of the panel curved inwards. The total magnitude of the imperfections is 11.76 mm. The imperfection has a slight skew, rotated anti-clockwise. The orientation of the skew is likely caused by the outer -45 ply of the layup. When inspecting the imperfection of the panels more closely, it can be seen that the largest curvature is in the welding region. The curvature of the panels is most likely caused by the local heating during welding, leading to thermal stresses.

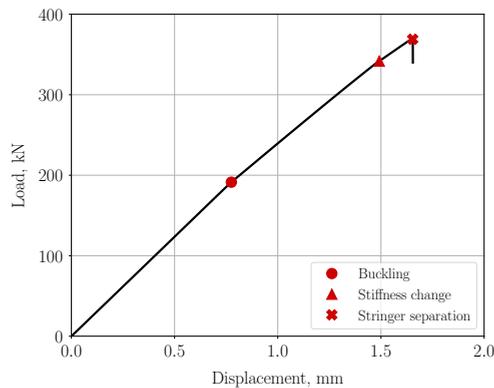
Figure 2.9: Load-displacement curve of the panel preliminary analysis.

The load-displacement graph of the three-stringer panel is shown in Figure 2.9. The linear stiffness before buckling is 248.2 kN/mm. Local buckling occurs at an approximate load of 192 kN and displacement of 0.78 mm. At 338 kN the panel presents a small buckling shape change. Panel failure occurs at a load of 370 kN and displacement of 1.65 mm due to skin-stringer separation.

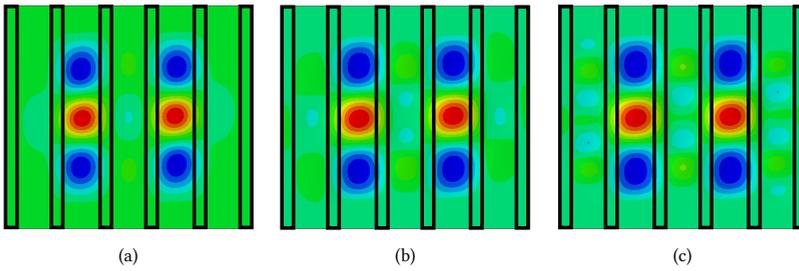
Figure 2.10: Buckling shapes of the panel preliminary analysis: (a) 0.78 mm / 191 kN; (b) 1.48 mm / 338 kN; (c) 1.65 mm / 370 kN.

The panel displays a three half-wave buckling shape, as reported in Figure 2.10(a), with one half-wave in an inwards direction and two half-waves in an outwards direction. The average half-wave length of the panel and the fuselage section is very similar. At a load of 338 kN, the buckling shape changes underneath the stringer, as shown in Figure 2.10(b).

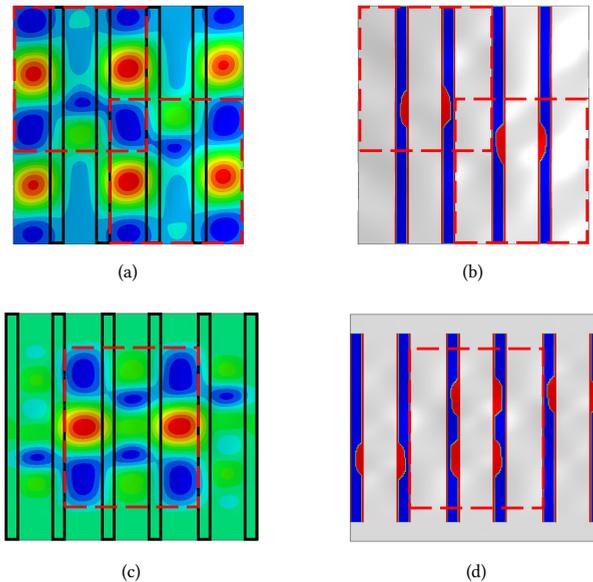
Figure 2.11: Comparison of skin-stringer separation behaviour from the analyses: (a) buckling shape of fuselage section; (b) welded skin-stringer interface state of fuselage section; (c) buckling shape of the panel; (d) welded skin-stringer interface state of the panel.

Two main aspects of the skin-stringer separation behaviour of the fuselage section and of the three-stringer panel are compared. The first aspect is the out-of-plane deformation when skin-stringer separation occurs, shown in Figure 2.11(a) and Figure 2.11(c) for the fuselage and the panel, respectively. The second aspect is the shape and location of the crack front, shown in Figure 2.11(b) and Figure 2.11(d) for the fuselage section and the panel, respectively. To compare the structural behaviour of the fuselage section and the panel, an area with a similar size and similar buckling shape is selected on each structure and highlighted with red dashed squares. During separation, both structures show a similar tunnelling behaviour underneath the stringer between inwards half-waves, within the highlighted area. The panel displays two tunnels per highlighted area, while the fuselage section displays one tunnel per highlighted area. The weld interface shows the same difference in the number of failure locations, that can be caused by the difference in boundary conditions. In any case, both the fuselage section and the panel show similar separation behaviour, starting from underneath the stringer and presenting an elliptical crack front.

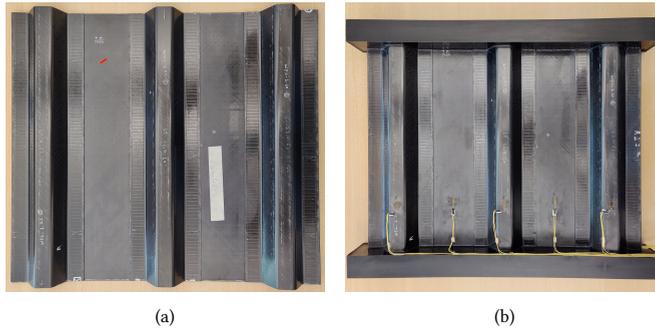
Figure 2.12: Test panels: (a) as received; (b) with potting and strain gauges.

Two nominally identical three-stringer panels are then manufactured. Project partner NLR - Netherlands Aerospace Centre manufactured the skin by automatic tape laying followed by autoclave consolidation. Project partner GKN Fokker uses conduction welding to join the stringers to the skin. Conduction welding makes use of a heating element, that is pressed on the stringer flange to apply pressure and heat, and weld the stringer flange to the skin. A panel as received is shown in Figure 2.12(a). The panels are then prepared for the tests. The first step consists of casting epoxy potting onto both ends of the panels for load introduction, and then the loading faces are trimmed in a milling machine to minimize loading imperfections. This is followed by attaching strain gauges and wiring. A panel with potting and strain gauges is shown in Figure 2.12(b).

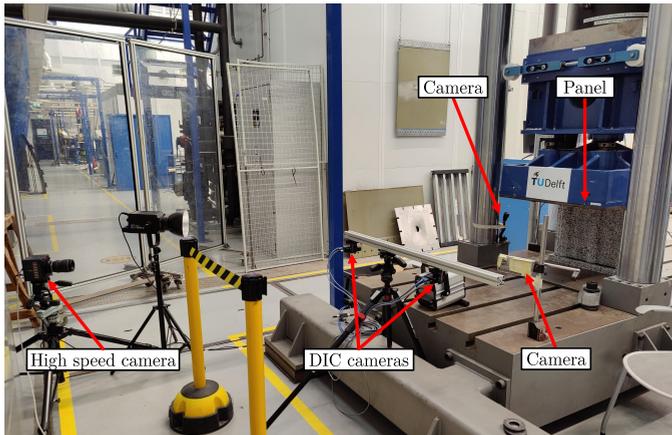
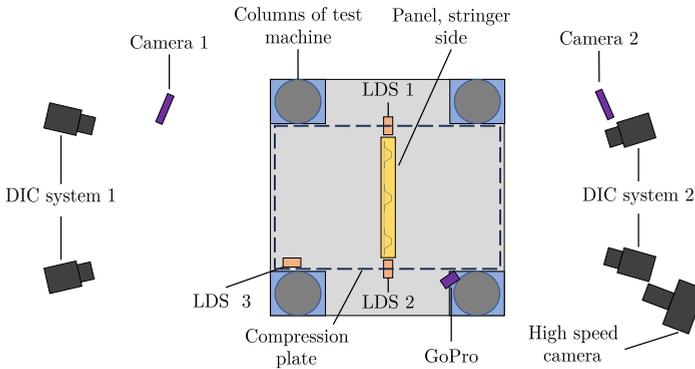
Figure 2.14: Test setup: (a) test setup photo stringer side; (b) test setup schematic top-view.

The test panels are placed in between the compression plate and the base, and a pre-load of 2 kN is applied. The loading rate is 0.1 mm/min until final failure, after which the loading stops automatically. The test setup is shown from the stringer-side of the panel in Figure 2.14(a) and a top-view illustration of the test setup is shown in Figure 2.14(b).

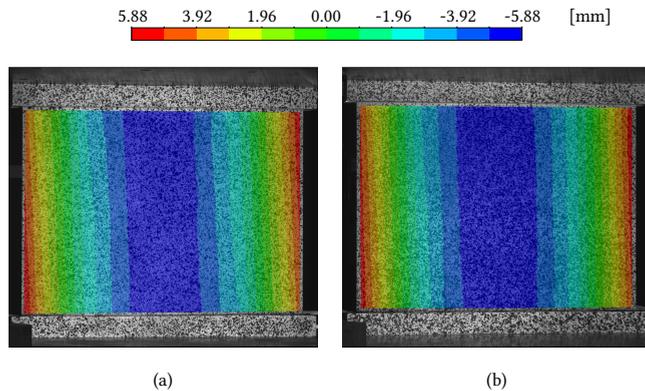
Figure 2.15: Out-of-plane imperfections: (a) panel 1; (b) panel 2.

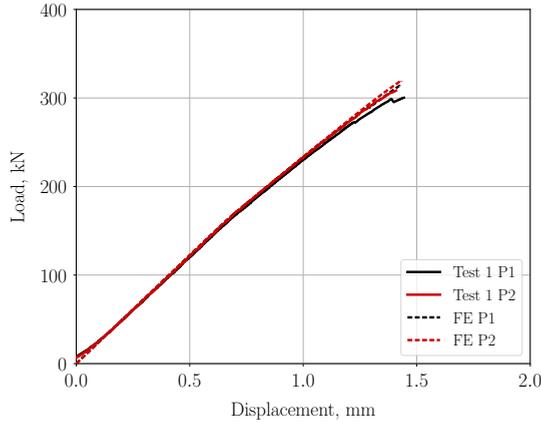
Figure 2.16: Load-displacement curves from tests and numerical analysis.

The load measured by the load cell of the testing machine is reported in Figure 2.16, as a function of the average displacement measured by the two LDS. The panels show settling behaviour till approximately 30 kN after which they present a linear stiffness of approximately 240.2 kN/mm and 244.1 kN/mm for panels 1 and 2, respectively, until buckling. Panel 1 starts to locally buckle at an approximate load of 155 kN and panel 2 at a load of 165 kN. In the post-buckling field, panel 1 shows a higher reduction of stiffness compared to panel 2. This is caused by a buckling shape change, which starts gradually at 245 kN and shows a small load drop at 275 kN due to a sudden shape change. Panel 2 does not show any load drops before failure. The panels fail due to skin-stringer separation at a load of 301 kN and 309 kN for panels 1 and 2, respectively, as reported in Table 2.5.

The numerical analyses conducted using dynamic implicit analysis show a stiffness of 244.6 kN/mm and 244.9 kN/mm for panels 1 and 2, respectively. This is a 1.8% and 0.3% difference in comparison with the test results. The numerical analysis of both panels shows buckling at approximately 160 kN, which is a difference of 3.2% and 3.0% for panels 1 and 2, respectively. In comparison to the test results the initial post-buckling stiffness is similar, but at higher loads, the stiffness is over-predicted. The higher over-prediction for panel 1 is caused by smaller load drops due to buckling shape changes that occur at 245 kN and 285 kN. The numerical analysis predicts panel collapse due to skin-stringer separation at a load of 314 kN and 320 kN for panels 1 and 2 respectively, as reported in Table 2.5. This is an over-prediction of 4.3% for panel 1 and 3.6% for panel 2 in comparison to the test results. The difference between the experimental and numerical results can be caused by not taking into account the loading imperfections, the difference in material properties and the slight skew of the middle stringer of panel 1 in the numerical models.

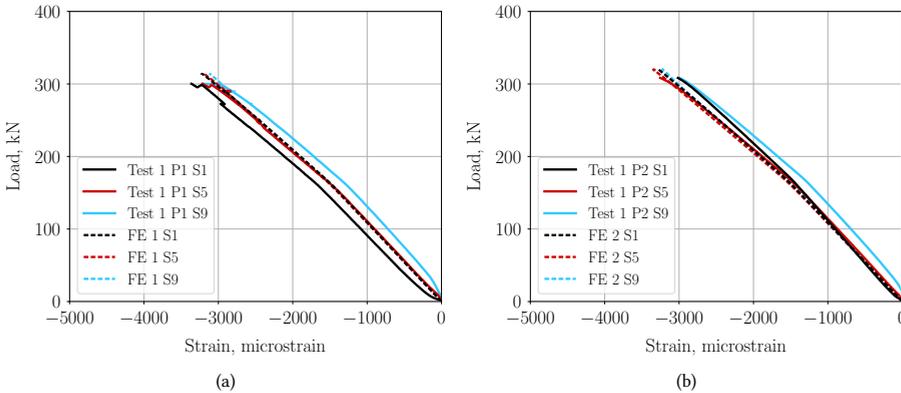
Figure 2.17: Experimental and numerical compressive strains in stringer caps: (a) panel 1; (b) panel 2.

The strains measured on the caps of panels 1 and 2 are shown in Figure 2.17(a) and Figure 2.17(b), respectively. On panel 1 they show diverging behaviour initially, most likely due to loading imperfections, and a similar gradient until the buckling shape changes and the skin and stringer separate. The strains in the caps of panel 2 diverge less in comparison to panel 1, with stringers 1 and 2 showing similar strains in pre-buckling and stringer 3 showing lower strains. In post-buckling, it is seen that the strains in stringers 2 and 3 show similar gradients, while the strains in stringer 1 show a higher gradient. The numerical analysis predicts the strains in the stringers reasonably well, with the main difference being the initial loading.

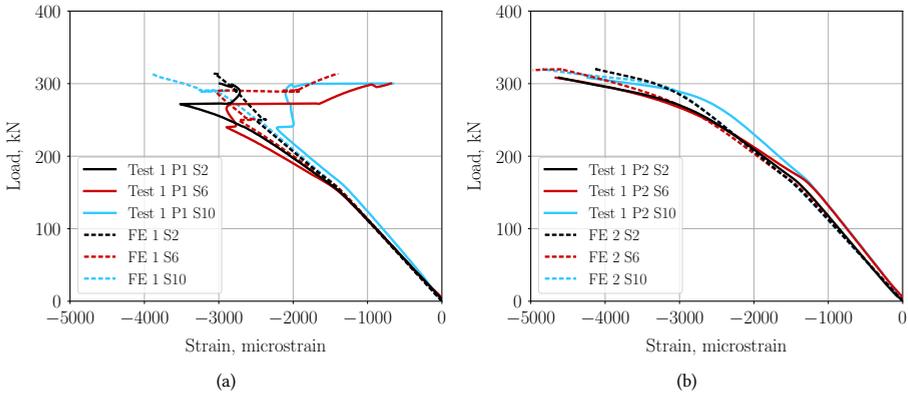
Figure 2.18: Experimental and numerical compressive strains in the skin below stringer: (a) panel 1; (b) panel 2.

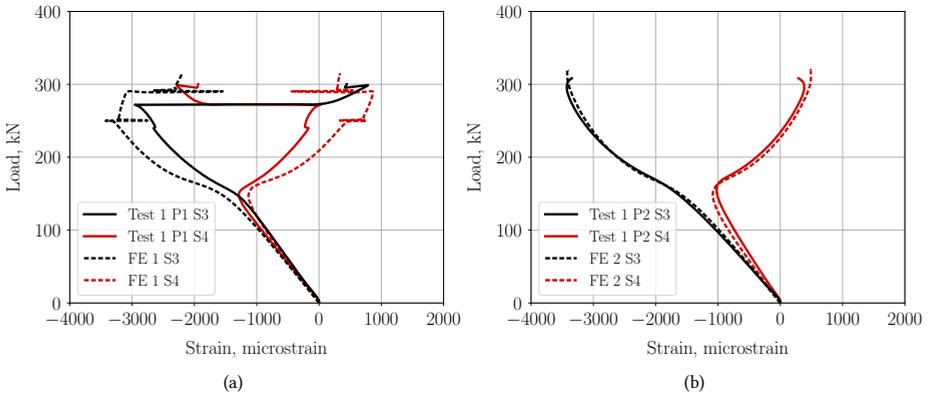
Figure 2.19: Experimental and numerical compressive strains in the skin of bay 1: (a) panel 1; (b) panel 2.

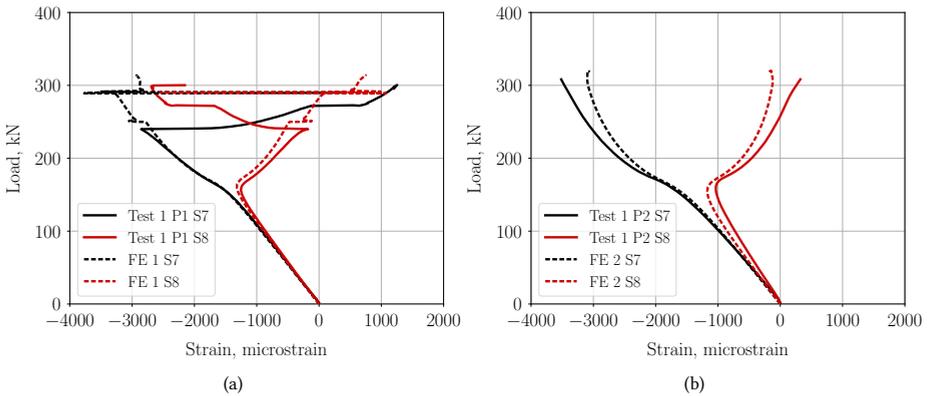
Figure 2.20: Experimental and numerical compressive strains in the skin of bay 2: (a) panel 1; (b) panel 2.

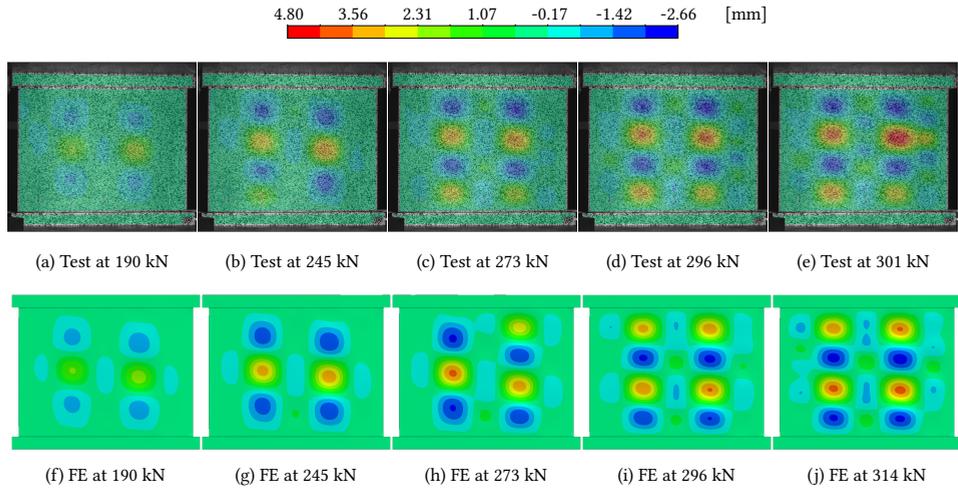
Figure 2.21: Experimental and numerical out-of-plane displacement of panel 1.

The out-of-plane displacement from the DIC measurement and the numerical analysis of panels 1 and 2 are reported in Figure 2.21 and Figure 2.22, respectively, highlighting the buckling shape and the evolution of the shape in the post-buckling field. Positive displacement corresponds to inwards direction, and negative displacement corresponds to outwards direction, in line with the axis system reported in Figure 2.8.

Panel 2 shows a three half-wave buckling shape with no buckling shape change in the bays, and at higher loads the number of half-waves increases underneath the stringer. The three half-wave buckling shape does not show a skew in vertical position of the half-waves as panel 1, which might be due to differences in imperfections. The maximum inwards out-of-plane displacement is similar between panels 1 and 2, but the maximum outwards displacement of panel 2 is higher. The difference in final buckling shape might lead to the small difference in failure load and it can indicate that the four half-wave buckling shape is slightly more critical. Both panels showed an increase in the number of half-waves underneath the stringer, and these half-waves become more prominent in terms of out-of-plane displacement close to the failure load.

The numerical analysis predicts the initial three half-wave buckling shape of both panels 1 and 2. The numerical analysis of panel 1 also shows buckling shape changes in the bay to four half-waves, but the changes occur at higher loads and the fourth half-waves form at the top of the panel. This difference can be caused due to the fact that the stringer alignment imperfections are not taken into account. The numerical analysis of panel 2 is able to predict the post-buckling behaviour well, with the evolution of the half-waves underneath the stringer and no shape changes in the bay. The maximum inwards displacement of panel 1 is lower in the numerical analysis, while the maximum outwards displacement shows good agreement. The maximum inwards and outwards displacement of panel 2 is predicted well, with the outwards displacement being slightly over-predicted.

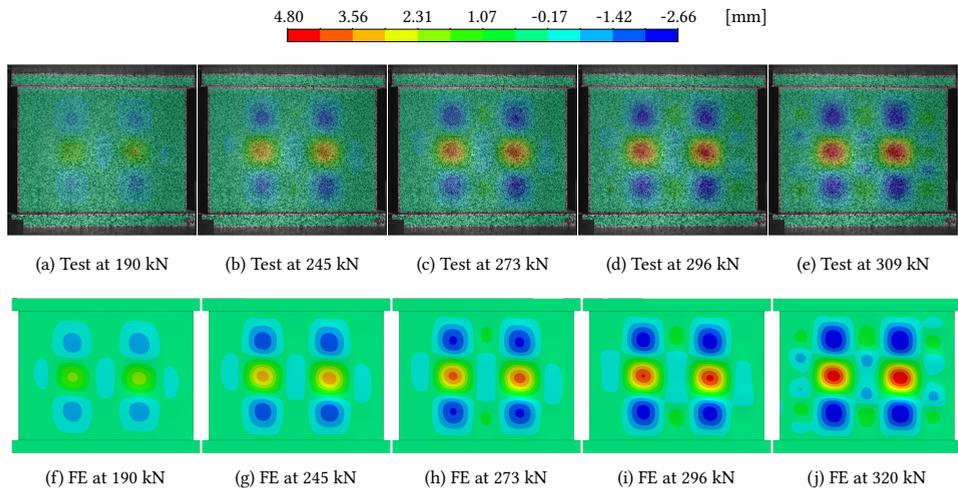
Figure 2.22: Experimental and numerical out-of-plane displacement of panel 2.

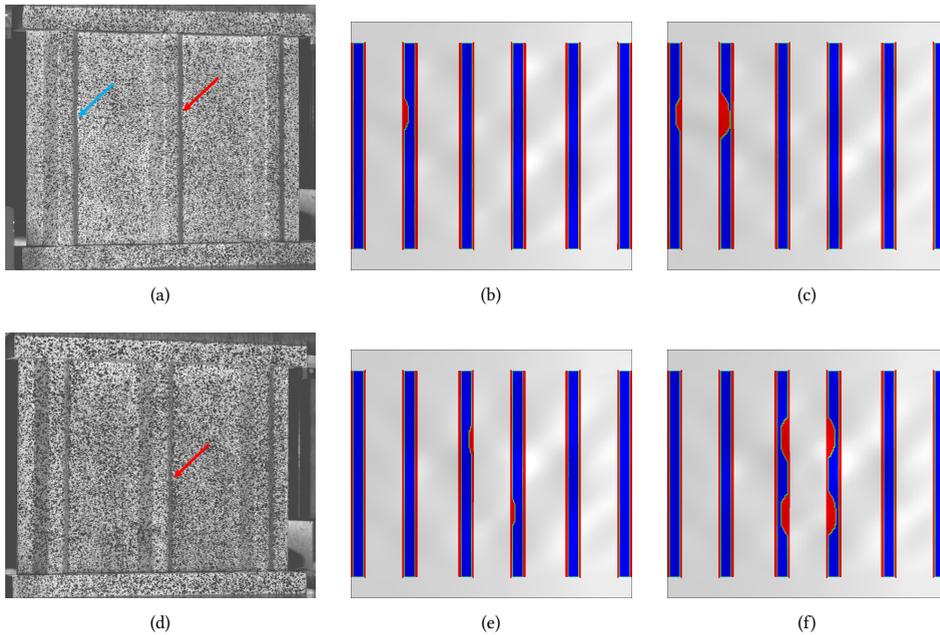
Figure 2.23: Comparison of failure behaviour: (a) start of failure of panel 1 during test; (b) start of failure of panel 1 analysis; (c) propagation of panel 1 analysis; (d) start of failure of panel 2 during test; (e) start of failure of panel 2 analysis; (f) propagation of panel 2 analysis.

The final failure of panels 1 and 2 is captured by the high-speed camera at 10000 fps. Panel 1 shows a skin-stringer separation event in stringer 1 which did not lead to final failure. The location of this separation event is indicated by the blue arrow in Figure 2.23(a). It occurs at a load of 299 kN and causes a load drop to 295 kN. It is visible from the deformation of the flange and web of the stringer, which causes a change in the shadow on the web. The event could also be heard and seen on the normal camera footage and causes a sudden increase in the out-of-plane displacement measured by the DIC. From the camera footage, it appears that the separation starts from underneath the stringer and stops approximately halfway through the stringer flange.

The test is then continued until a load of 301 kN where the panel fails due to skin-stringer separation. Final failure starts by separation of the middle stringer, with the first separation location shown by the red arrow in Figure 2.23(a). This separation appears to start from underneath the stringer and grows both in longitudinal direction and width direction towards the bay.

Panel 2 shows final failure at a load of 309 kN due to skin-stringer separation of the middle stringer, as reported in Figure 2.23(d). Separation starts at a different location than panel 1, most likely caused by the different buckling shape, but grows in a similar manner from underneath the stringer.

The numerical results are shown in Figure 2.23(b-c) and Figure 2.23(e-f) for panels 1 and

2, respectively. The figures report the skin of the panels with contour plots of the interface states, where blue means intact interface and red means separation or unwelded regions next to the weld. The numerical analysis predicts that the final failure of panel 1 starts with skin-stringer separation of stringer 1 as shown in Figure 2.23(b-c). The separation grows in longitudinal and width directions with an elliptical crack front. The failure location is similar to the location of the first skin-stringer separation event in the test of panel 1. The numerical analysis of panel 2 predicts that final failure starts with skin-stringer separation of the middle stringer as shown in Figure 2.23(e-f). Separation starts in two locations simultaneously, shortly followed by two other locations, all in the middle stringer with elliptical crack fronts. The failure locations are slightly different compared to what is seen in the test, which can be caused by differences in buckling shape and imperfections.

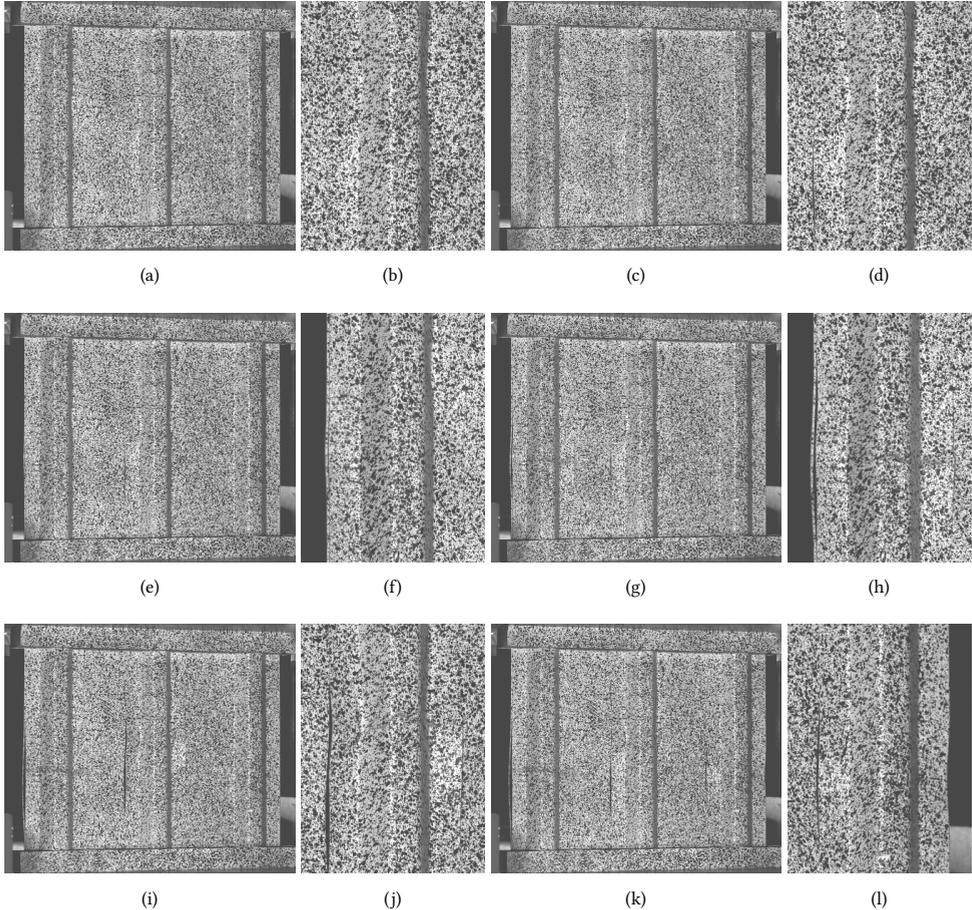
Figure 2.24: Failure sequence of panel 1: (a) separation in middle stringer; (b) close-up of middle stringer; (c) propagation of separation in middle stringer; (d) close-up of middle stringer; (e) separation in left stringer; (f) close-up of left stringer; (g) fracture of left stringer; (h) close-up of left stringer; (i) fracture of middle stringer; (j) close-up of fracture of middle stringer; (k) separation in right stringer; (l) close-up of right stringer.

The final failure sequence of panel 1 is shown in Figure 2.24. It starts with skin-stringer separation in the right flange of the middle stringer, Figure 2.24(a-b). The separation propagates in outward direction towards the bay, and the left flange also separates with similar behaviour, Figure 2.24(c-d). Separation then starts in the left stringer, first in the right flange, followed by the left flange, Figure 2.24(e-f). This is followed by the fracture of the left stringer, Figure 2.24(g-h), and then of the middle stringer, Figure 2.24(i-j). Lastly, the right stringer separates, Figure 2.24(k-l). The failure sequences occur within approximately 3 ms.

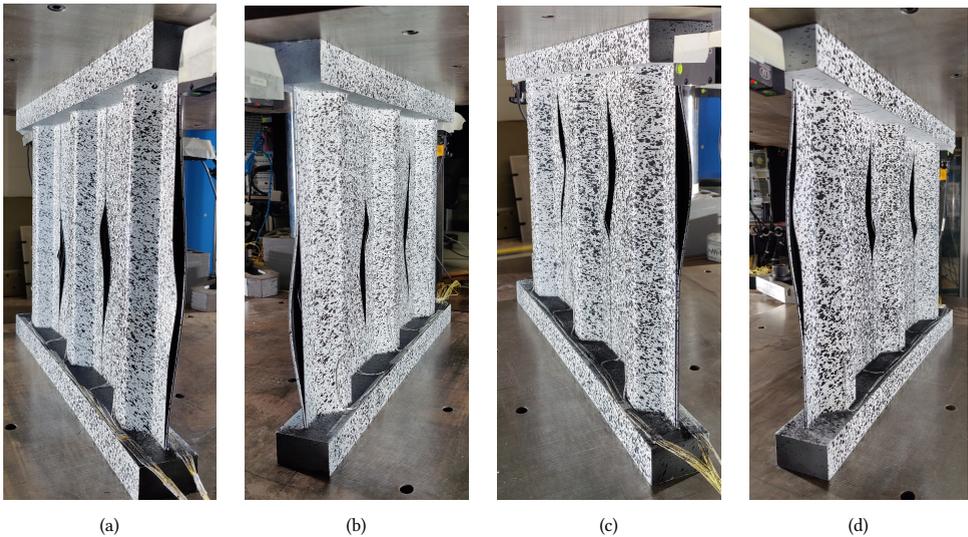
Figure 2.25: Post-failure photos: (a) panel 1 right side; (b) panel 1 left side; (c) panel 2 right side; (d) panel 2 left side.

Photos of panel 1 after failure are shown in Figure 2.25(a-b). The panel shows large separated areas and large outward deformation of the skin. The left and middle stringer are fractured approximately in the middle of the panel, and several stringer flanges have delaminations. The skin appears to be mostly intact, with only minor damage close to the failed welds. These findings are supported by the c-scan results reported in Figure 2.26(a), where it is possible to note that the left and middle stringers have partial separations from

Photos of panel 2 after failure are shown in Figure 2.25(c-d). The panel has large separated areas towards the top, with large outward skin deformation. It can be noted that the large separated areas are in the opposite direction compared to panel 1, which has more separation in the downward direction. The middle and right stringer are fractured approximately in the middle of the panel, and the stringer flanges show delaminations. The skin seems to be mostly intact, judging from both visual inspection and the c-scan results reported in Figure 2.26(b). From the c-scan, it can also be seen that the interface at the bottom of the middle stringer shows separations in both flanges with elliptical crack fronts.

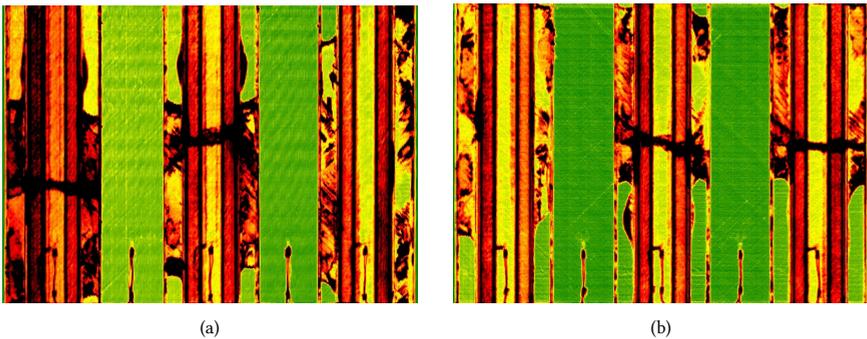
Figure 2.26: Post-failure c-scan: (a) panel 1; (b) panel 2.

underneath the stringer at the top of the panel, with elliptical crack fronts, while the right stringer has almost no intact interface left.

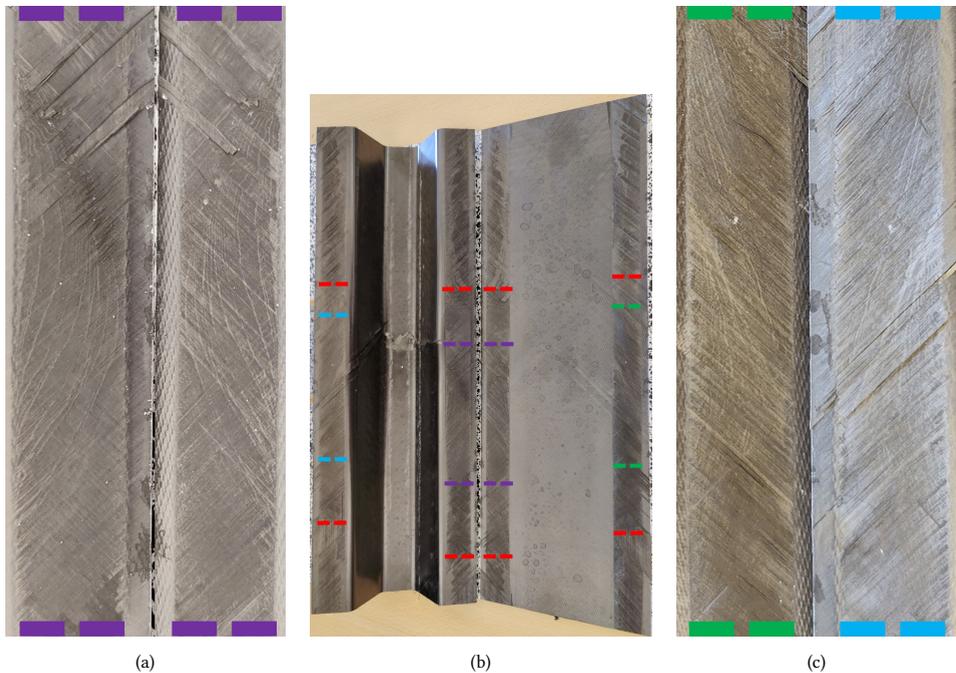
Figure 2.27: Weld fracture surfaces of panel 1 middle stringer: (a) close-up of the left weld, with the area between purple dashes; (b) welds middle stringer, with the area in between red dashes corresponding to the separated area in the test; (c) close-up of the right weld, with the area between blue and green dashes.

The middle stringer of panel 1 is removed after the test to investigate the weld fracture surface, which is shown in Figure 2.27. The area in between the red dashes is separated during the test, while the areas outside of the red dashes are separated after the test when the stringer is removed from the panel. The weld fracture surface can be identified by the darker and rough surface in comparison to the surrounding areas. It can be seen that there is limited damage to the skin-side of the interface, with only small amounts of fibres delaminated from the skin. The stringer flanges have several areas where the top ply has delaminated. There are also fibres fractured off the stringer, which remain attached on the skin-side of the interface. On both the left and right weld Figure 2.27(a+c), light grey marks indicate an elliptical crack front during propagation. The width of the weld varies slightly along the length, ranging from approximately 17 to 19 mm. However, the weld might seem wider than it actually is, due to the possibility of the adjacent surfaces being damaged by the separation of the weld.

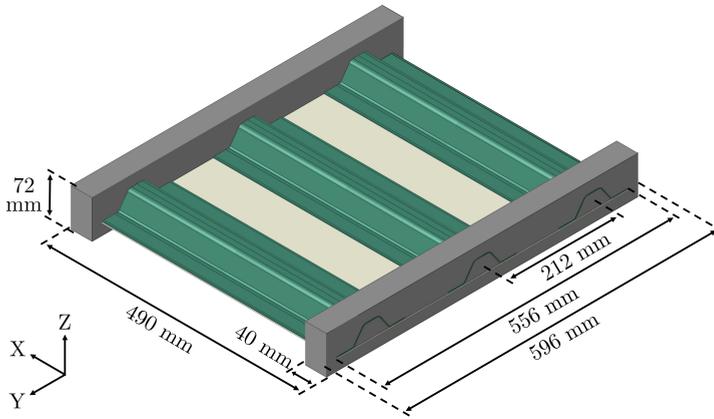
Figure 3.1: Welded omega-stiffened thermoplastic panel.

The welded omega-stiffened thermoplastic panels are designed to show structural behaviour similar to the STUNNING fuselage [38]. They have three stringers, to allow for bay buckling on both sides of the middle stringer and achieve a deformation and loading similar to a fuselage section. The stringer pitch is equal to the stringer pitch of the keel section of the STUNNING fuselage, 212 mm, which results in a total width of 556 mm, as reported in Figure 3.1. The panels are 490 mm long, which is the maximum welding length at the time of production, with the panel's loading edges trimmed.

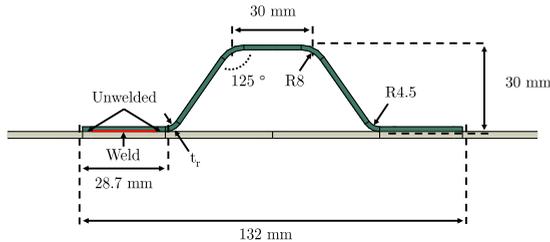
Figure 3.2: Omega stringer geometry and weld.

The omega stringer is 132 mm wide, 30 mm in height and has a web-cap angle of 125°, as reported in Figure 3.2. The flange width is 28.7 mm, and the cap width is 30 mm. The panels are made of CF/LM-PAEK material, and the properties used are reported in Table 3.1 [33]. The nominal ply thickness is 0.184 mm, and the layups of the skin and stringer are reported in Table 3.2.

regions on both sides of the weld, as shown in Figure 3.2, allowing VCCT to be used for pristine welded joints. This results in a relatively efficient analysis for a panel-level structure due to the courser mesh allowance of VCCT compared to other methods. In this model, skin-stringer separation can only occur at the interface between skin and stringer, and can't grow into the laminates, to limit the complexity of the model and analysis. Also, due to the unwelded region on both sides, it is less likely that separation will migrate.

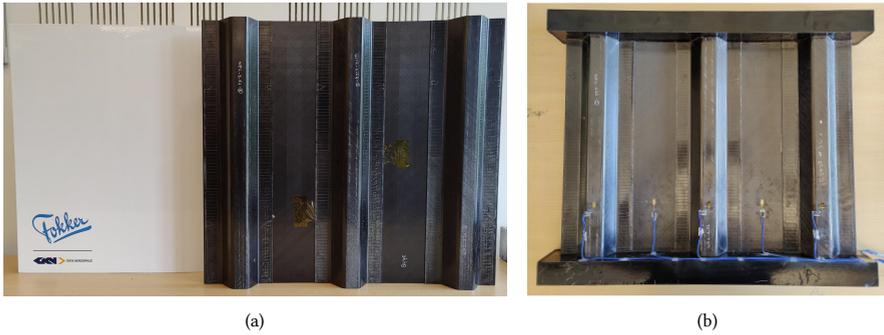
Figure 3.3: Omega-stiffened panels: (a) as received; (b) with potting and strain gauges.

The panels are received from the project partners as reported in Figure 3.3 (a). The panels are then prepared for testing in several steps. They are trimmed, followed by the casting of potting to both ends of the panel for load introduction. Then the loading faces of the panels are machined to minimise loading imperfections. The following steps are to attach strain gauges and wiring, as shown in Figure 3.3 (b). The panels have 10 strain gauges attached, of which the locations are reported in Figure 3.4, 135 mm from the bottom loading plane. The strain gauges are on top of the cap and the bottom of the skin underneath each stringer. There are two strain gauges attached back-to-back in the bays. The strain measurements are used for load distribution and redistribution due to phenomena such as buckling and failure, and also for loading imperfections. The last step is to paint the panels in matt white, followed by black speckles, for digital image correlation.

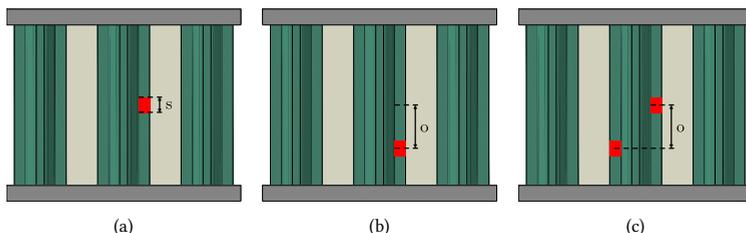
Figure 3.5: Panel illustrations of three sensitivity parameters: (a) damage size; (b) damage 1 offset; (c) damage 2 offset.

This section focuses on the analysis of panels with different damage sizes and damage locations. The first study considers the damage size of an initial damage in the centre of the panel, as shown in Figure 3.5 (a). The considered damage sizes are reported in Table 3.4. The results of the study are reported in terms of the initiation load and the final failure load. Initiation is considered the start of skin-stringer separation, and final failure is considered when unstable separation leads to panel collapse.

The second study considers the location of the initial damage, for a panel with one initial damage and a panel with two initial damages, both for a damage size of 40 mm. The location is defined as the offset between the panel’s centre and the damage’s centre, as reported in Figure 3.5 (b-c). The study considers one initial damage (Figure 3.5 (b)) and two initial damages, where the first damage in the right flange will remain in the centre, and the second damage in the left flange will be offset (Figure 3.5 (c)). The damage offset range of the study is reported in Table 3.4.

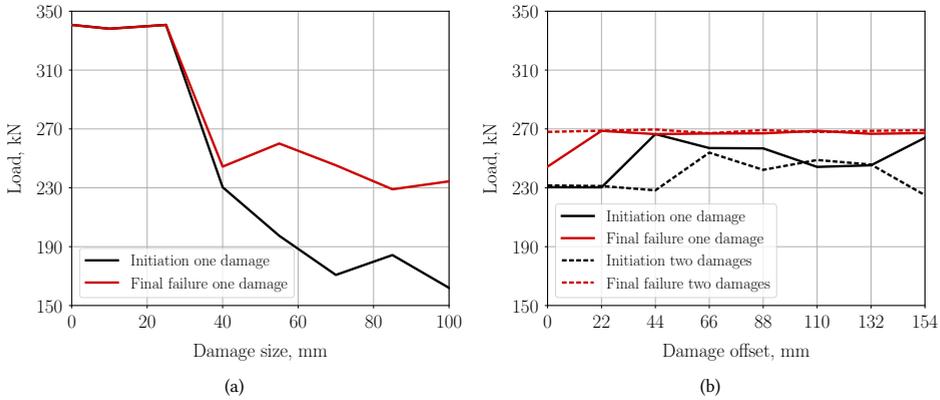
Figure 3.6: Sensitivity study of: (a) damage size; (b) damage offset.

The initiation load and failure load for a panel with one initial damage of different sizes are reported in Figure 3.6 (a). The panel has a low sensitivity to initial damage sizes of 10 and 25 mm, and for a damage size of 40 mm both the initiation and final failure load drop considerably. A buckling shape change most likely causes this drop. The panel starts out with three half-waves in the bays, reported in Figure 3.7 (a), and the panel with a damage size of 40 mm presents a gradual shape change to four half-waves, reported in Figure 3.7 (c). A damage size of 25 mm and below did not show this buckling shape change. The initiation load drops further for larger damage sizes, while the failure load does not go

The initiation load and failure load for a panel with one and two initial damages at different locations are reported in Figure 3.6 (b). For panels with one initial damage, the initiation load is similar for offsets of 0 and 22 mm, and then for higher offsets the initiation load increases. This is caused by differences in the buckling shape evolution. The panels have an initial three half-wave buckling shape, as reported in Figure 3.7 (a), that changes to four half-waves in one bay for 0 and 22 mm offset, as reported in Figure 3.7 (b). Higher offsets do not exhibit this buckling shape change. The initiation load does go down between 44 and 110 mm offset, which seems to be caused by the relative position of the damage w.r.t. the outward half-wave being more critical for separation. The failure load is lowest

for 0 mm offset, for higher offsets it plateaus at approximately 270 kN. An offset of 0 mm is chosen for the test panel with one initial damage, which is reported in Figure 3.8 (a).

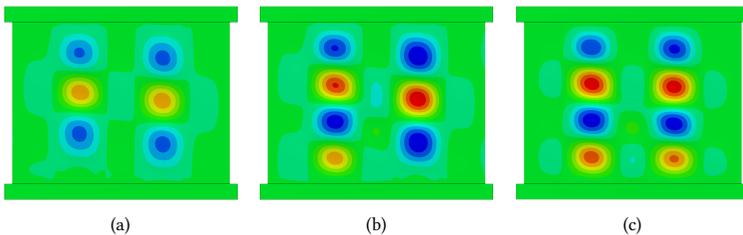
Figure 3.7: Buckling shapes: (a) three half-waves; (b) three and four half-waves; (c) four half-waves.

The panel with two initial damages shows an initiation load of approximately 230 kN for 0, 22 and 44 mm of offset, and increases to approximately 255 kN know for an offset of 66 mm. This difference is caused by the change in buckling shape from three to four half-waves in both bays, as reported in Figure 3.7 (c), and four half-waves seems to be more critical. The failure load is approximately 270 kN for all cases, which seems to be dominated by a certain amount of separated area after which separation becomes unstable and the panels collapse. Offsets of 88, 110 and 132 mm present similar behaviour in terms of initiation load, but the case of 110 mm is deemed to be most interesting, as the separation starts at the damage in the middle, while the opposite flange also starts to separate in the middle of the panel which grows towards the second initial damage. This interaction is considered interesting, while it has a low risk of the initial damages quickly causing tunnelling behaviour, and far enough from the potting to minimise the influence of boundary conditions. Therefore, an offset of 110 mm is chosen for the panel with two initial damages, as reported in Figure 3.8 (b).

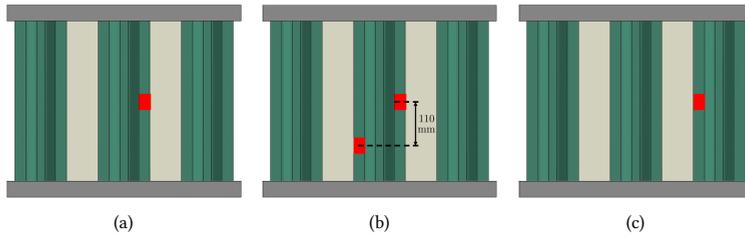
Figure 3.8: Panels with initial damage of 40 mm: (a) panel 2; (b) panel 3; (c) panel 4.

below 230 kN for the damage sizes in this study. Based on these results, it is chosen to use a 40 mm damage size for the test panels, as reported in Figure 3.8(a). This damage size presents a considerable drop in final failure load, while there is still a margin between the buckling load of approximately 170 kN and the initiation load of 230 kN. Since the strength of the welded joint is unknown at the time of the design, a conservative damage size is deemed best.

The last configuration has one initial damage of 40 mm in the side stringer, as reported in Figure 3.8 (c). This allows to study the effect of initial damage in different stringers.

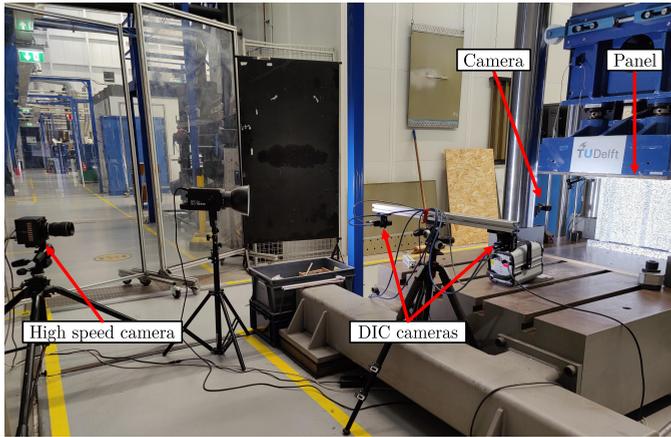
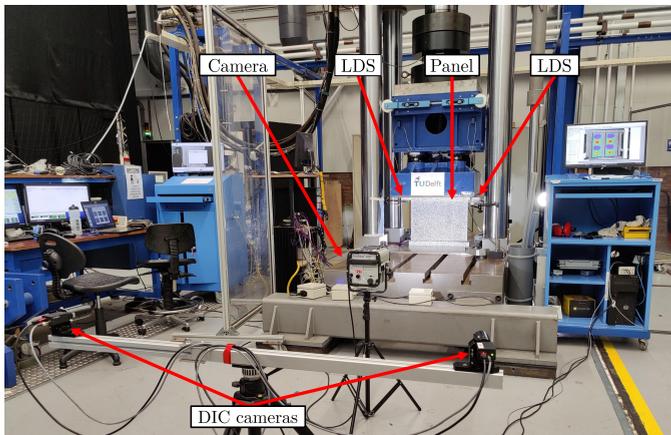
Figure 3.9: Test setup seen from: (a) stringer side; (b) skin side.

The test setup is reported in Figure 3.9 from the (a) stringer side and (b) skin side of the panel. The panels are positioned in the test machine and a preload of 2 kN is applied to keep the panel in place. The test is then executed with a loading rate of 0.1 mm/min. and the loading stops automatically after failure.

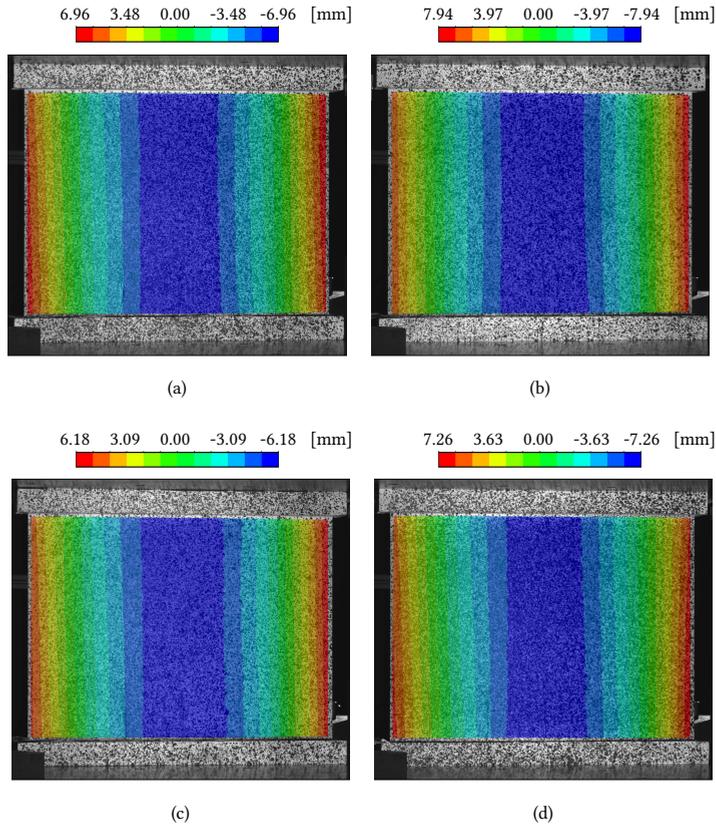
Figure 3.10: Out-of-plane imperfection of test panels: (a) panel 1; (b) panel 2; (c) panel 3; (d) panel 4.

The first imperfection that is measured is the out-of-plane imperfection of the skin, for which DIC is used. The nominal design has a flat skin, and the imperfection is the deviation of the skin w.r.t. a flat plane. The out-of-plane imperfections of all four panels are reported in Figure 3.10, with the imperfection aligned with the z-axis of the axis system reported in Figure 3.1. All four panels have a similar curved imperfection in the width direction, with a total magnitude of the imperfection ranging from 12.36 mm to 15.88 mm. The imperfection has a counterclockwise skew, probably caused by the layup and the outer -45 ply. The panels are also slightly curved in the longitudinal direction, but it is minimal compared to the imperfection in the width direction. The highest curvature in the width direction is in the welded area, as the imperfection is mostly caused by the local heating of the conduction welding process, which results in thermal stresses.

This study considers the interaction between the damage location and size for different geometrical imperfections. The study is executed for different imperfection amplitudes, as reported in Table 3.5. The damage size sensitivity study will be done for both panel 1 and 2 imperfections, which are reported in Figure 3.10(a) and (b), respectively, and the damage location sensitivity study for the panel 2 imperfection.
