Thermoplastic composite stiffened structures in post-buckling

van Dooren, K.S.

Dissertation

Keywords: Thermoplastic composite, post-buckling, skin-stringer separation, stiffened panels, welding, butt-joint, testing, damage tolerance, finite element, virtual crack closure technique

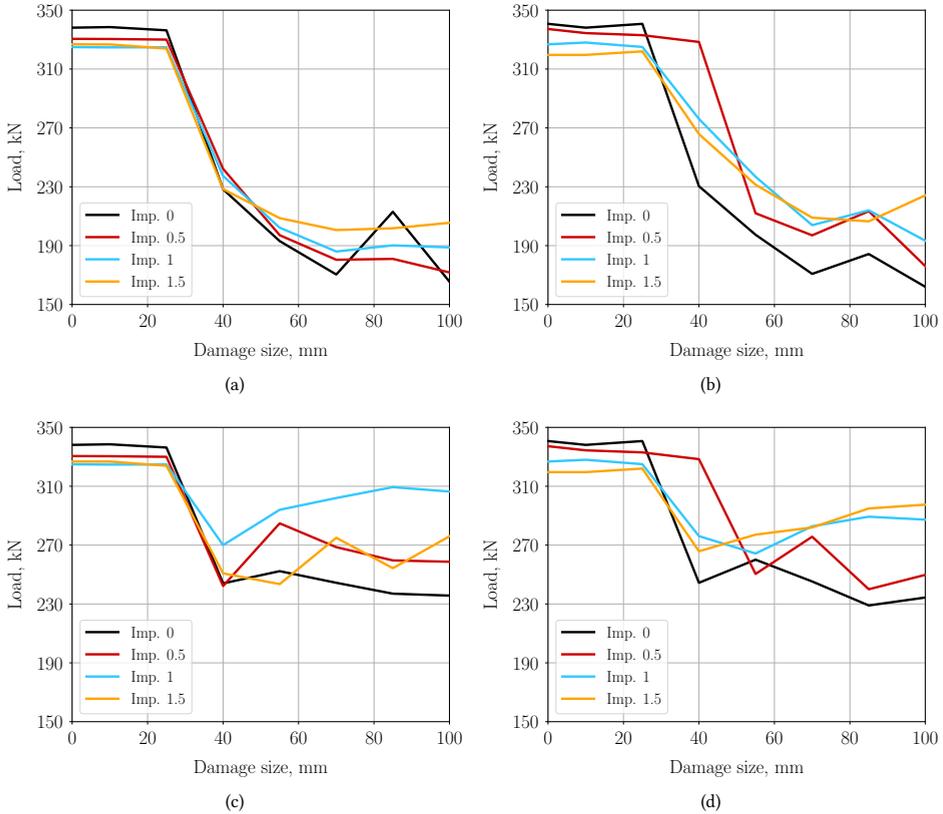
Figure 3.11: Damage size sensitivity study results for different imperfection amplitudes: (a) initiation panel 1 imperfection; (b) initiation panel 2 imperfection; (c) final failure panel 1 imperfection ; (d) final failure panel 2 imperfection.

The initiation loads for the damage size sensitivity study with panels 1 and 2 geometrical imperfections are reported in Figure 3.11 (a) and (b), respectively. For small damage sizes, a higher imperfection amplitude lowers the initiation load, especially for the imperfection of panel 2. At a damage size of 40 mm and larger, the initiation load drops considerably for most cases, except for an imperfection amplitude of 0.5 of panel 2. The average initiation load for a damage size of 40 mm is 275 kN for the imperfection of panel 2, while it's 234 kN for the imperfection of panel 1. This is a decrease in the failure load compared to a pristine panel of 30% and 17% for panels 1 and 2, respectively. The initiation loads drop further for larger damages, with the case of no imperfection presenting the highest sensitivity to the damage.

The failure loads of the damage size sensitivity study are reported in Figure 3.11 (c) and (d), for panels 1 and 2, respectively. When comparing the results to the initiation loads in Figure 3.11 (a) and (b), it can be concluded that for damage sizes of 40 mm and smaller, the panels show final failure at or shortly after the initiation of skin-stringer separation. At larger damage sizes, the failure load increases for the imperfection of panel 2 and an amplitude of 1 and 1.5. This is also seen for the imperfection amplitude of 1 of panel 1, while imperfection amplitudes of 0.5 and 1.5 have varying results. At damage sizes of 40 mm and larger, the panels without imperfection have the lowest failure loads, and the geometrical imperfection seems to lower the sensitivity to damage for skin-stringer separation. At damage sizes of 55 mm and above, the lower bound for the failure load is between 230 and 250 kN, which is a reduction of 26-32 % of the failure load compared to a pristine panel.

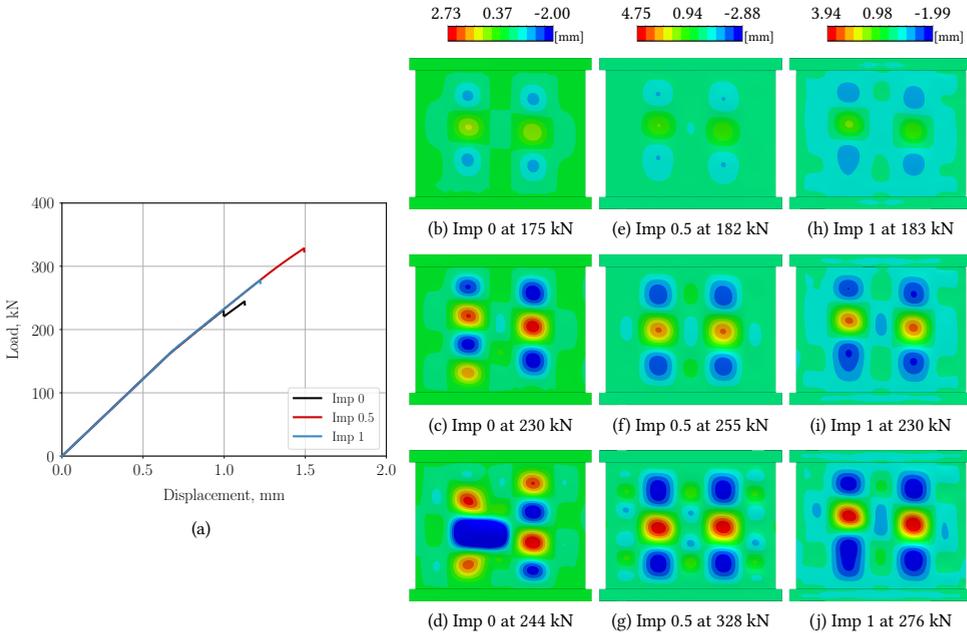
Figure 3.12: Panels with 40 mm damage and panel 2 imperfection: (a) load-displacement; (b-g) out-of-plane displacement contour plots.

The first investigation focuses on the damage size of 40 mm for different imperfection amplitudes of panel 2, as both the initiation load and failure load are highly affected. The load-displacement behaviour for the three imperfection amplitudes of 0, 0.5 and 1 is reported in Figure 3.12 (a). For no imperfection, a small load drop is seen at 230 kN, due to the opening of the initial damage and the start of separation, and final failure occurs at 244 kN. The imperfection amplitudes of 0.5 and 1 have a failure load of 328 and 276 kN, respectively, and experience no load drop before final failure. Out-of-plane contour plots are reported in Figure 3.12 (b-d), (e-g) and (h-j) for imperfection amplitudes 0, 0.5 and 1, respectively. The initial damage of 40 mm is on the left side of the panel. All three cases start initially with three half-wave buckling shapes with a clockwise skew regarding half-wave

placement. At higher loads, a fourth half-wave appears in the bay with the initial damage for no imperfection, while the other two cases present no additional half-waves in the bays. For an imperfection amplitude of 0.5 the skew of the half-waves rotates anti-clockwise with increased load, and additional half-waves appear underneath the stringers.

The effect of the different buckling shapes, caused by different imperfections, on the skin-stringer separation behaviour and failure load is considerable. This seems to be related to the relative position of an outward half-wave w.r.t. to the initial damage, which can cause opening of the initial damage and start separation. The four half-wave buckling shape is most critical, where an outward half-wave with a shorter half-wave length is positioned close to the initial damage location. In this case separation starts at 230 kN, with a small load drop, followed by stable separation growth until a load of 244 kN. Then the middle stringer weld, opposite to the initial damage, starts to separate. The least critical case is with an imperfection amplitude of 0.5, where there is no outward half-wave close to the initial damage. At higher loads, the outward half-wave only moves further away, with the buckling shape having an anti-clockwise skew. Also, the curvature of the imperfection

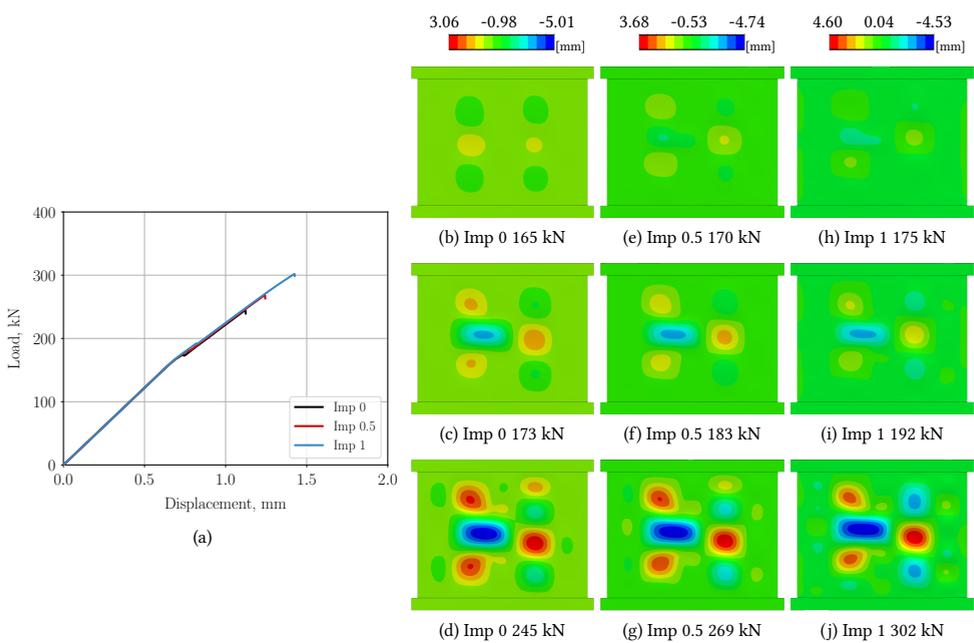
Figure 3.13: Panels with 70 mm damage and panel 1 imperfection: (a) load-displacement; (b-g) out-of-plane displacement contour plots.

The second investigation is on the damage size of 70 mm for different imperfection amplitudes of panel 1. The load-displacement behaviour for the three imperfection amplitudes of 0, 0.5 and 1 is reported in Figure 3.13 (a), which present higher failure loads for a larger imperfection. After buckling, all three imperfection amplitudes experience a small load drop, which is caused by a small separation event at the initial damage location. Out-of-plane contour plots are reported in Figure 3.13 (b-d), (e-g) and (h-j) for imperfection amplitudes 0, 0.5 and 1, respectively. For no imperfection, the initial buckling shape has three half-waves (b), and the initial damage opens shortly after a small load increase which results in an anti-symmetric buckling shape (c). The imperfection amplitudes of 0.5 and 1 present opening of the initial damage at the start of buckling (e-h), with an anti-symmetric buckling shape. All three amplitudes show stable separation growth of the initial damage after the first separation event, until final failure. The final failure of imperfection amplitudes 0 and 0.5 starts with the right bay switching buckling shape to four half-waves (d-g). This buckling shape change is not seen for an imperfection amplitude of 1.

At final failure, all three imperfection amplitudes show a similar amount of separation growth, with the separation length growing from 40 mm to approximately 162 mm. It is therefore difficult to judge how much the buckling shape change of imperfection amplitude 0 and 0.5 contributes to the start of final failure, and the separation length might be the main contributor. The imperfection amplitudes and resulting buckling shape differences do contribute to the differences in final failure, but indirectly by influencing the separation

A larger imperfection delays the start of separation at 173, 183 and 192 kN for imperfection amplitude 0, 0.5 and 1, respectively. Also, for larger imperfections, this separation event caused less growth while occurring at higher loads. This can be considered counter-intuitive, as one could expect that a higher load leads to more separation. This might be caused by the relatively high curvature of the imperfection in the weld region. The larger imperfection increases the curvature of the welded interface, which might increase the initiation and the failure load.

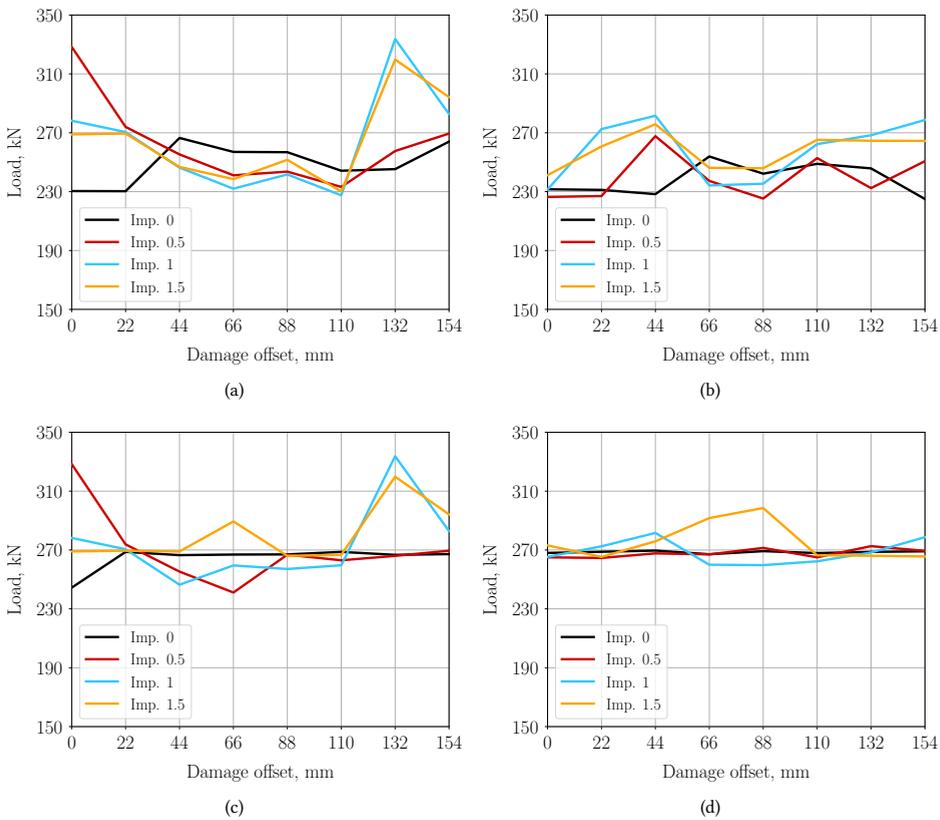
Figure 3.14: Damage offset sensitivity study results with Panel 2 imperfection: (a) initiation damage 1; (b) initiation damage 2; (c) final failure damage 1 ; (d) final failure damage 2.

The initiation loads for single damage have a lower bound of approximately 230 kN, as reported in Figure 3.14 (a). For an offset of 0 mm, the initiation load is highly influenced by the imperfection amplitude, with the imperfection amplitude initially increasing the initiation load considerably and then converging to an intermediate load level between 230 and 270 kN. The results from different imperfection amplitudes converge for offsets between 44 and 110 mm, with the highest initiation load for no imperfection. The results diverge at offsets above 110 mm, with larger imperfections leading to higher initiation loads. This effect is caused by all cases between 44 and 110 mm offset presenting similar three half-wave buckling shapes, and more varying buckling shapes below 44 mm and above 110 mm offset. The higher sensitivity to the damage location between 44 and 110 mm offset is most likely caused by the relative location of the damage w.r.t. an outward

buckling half-wave. The lower sensitivity at 132 mm for imperfection amplitudes 1 and 1.5 are caused by a buckling shape change underneath the stringers, and results at 154 mm offset are most likely starting to get affected by the proximity of the potting.

The final failure loads for single damage show less variance than the initiation loads, as reported in Figure 3.14 (c), with a lower bound of approximately 250 kN. The largest difference is seen at 0 mm offset, where the highest failure load is for the imperfection amplitude of 0.5. At high offsets of 132 mm and 154 mm, the imperfection amplitude of 1 and 1.5 shows the highest failure loads, where final failure occurs after the first initiation of skin-stringer separation. Most cases that present initiation above approximately 270 kN, collapse after initiation, while cases that experience initiation below 270 kN continue to carry load until approximately 270 kN.

The results of the sensitivity study with two initial damages shows initiation loads between 230 and 280 kN, as reported in Figure 3.14 (b). Imperfection amplitudes 1 and 1.5 result in similar behaviour over the whole offset range, while imperfection amplitudes 0 and 0.5 result in varying behaviour. There are three different ways in which initiation starts. Firstly, the damage at the middle of the panel starts, followed by the second damage. Secondly, the second damage with the offset starts, followed by the damage in the middle of the panel. Lastly, both damages experience initiation simultaneously. Offsets of 0 and 22 mm always experience simultaneous initiation, while 66 mm always initiates at the second damage. The remaining cases have varying behaviour, due to differences in buckling shapes and buckling shape evolution. One of the common factors seems the proximity of an outward half-wave, which increases the criticality of a damage location.

The failure load present little variation for the offset of the second damage, as reported in Figure 3.14 (d), with most failure loads at approximately 270 kN. Most cases show that after the initiation of the two damage locations, one tunnel (or one half-wave) is formed between the two locations, and final failure occurs after one of the side stringers exhibits skin-stringer separation. An exception is for an imperfection amplitude of 1.5 for an offset of 55 and 88 mm, which have a higher failure load, and there are two separate tunnels underneath the middle stringer.

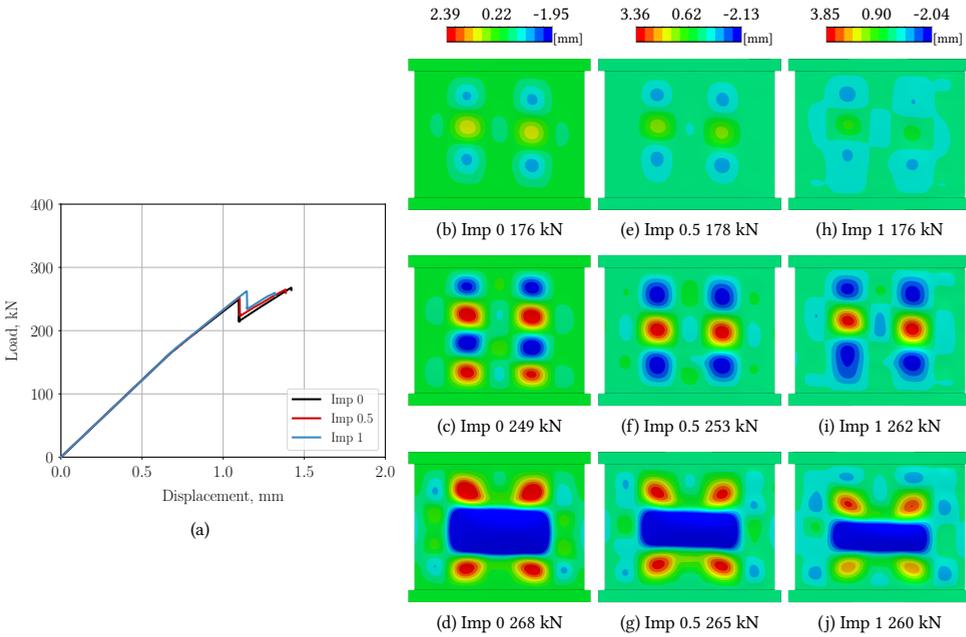
Figure 3.15: Panels with two 40 mm damages with a 110mm offset, and panel 2 imperfection: (a) load-displacement; (b-g) out-of-plane displacement contour plots.

The effect of the imperfection amplitude is investigated in more detail for an offset of 110 mm, as this offset is chosen for one of the test panels. The load-displacement behaviour for the three imperfection amplitudes of 0, 0.5 and 1 is reported in Figure 3.15 (a), which shows higher initiation load and a lower failure load for higher imperfection amplitudes. Out-of-plane contour plots are reported in Figure 3.13 (b-d), (e-g) and (h-j) for imperfection amplitudes 0, 0.5 and 1, respectively. All three imperfection amplitudes start with a three half-wave buckling shape (b-e-h). The case of no imperfection presents a buckling shape change to four half-waves in both bays (c). The buckling shape evolution between imperfection amplitudes 0.5 and 1 shows differences in half-wave lengths and skew of the half-wave positions (f-i). After initiation, all three cases experience tunnelling behaviour underneath the middle stringer (d-g-j). For the case of no imperfection, initiation starts at the damage in the middle of the panel, while for the cases with an imperfection amplitude of 0.5 and 1, initiation starts at the second damage at an offset of 110 mm. After the initiation of skin-stringer separation, it presents a load-drop, followed by stable separation growth until final failure when one of the side-stringer starts to separate. The lower imperfection amplitudes have a lower initiation load, and more separation growth after the separation event, which seems to lead to a higher final failure load.

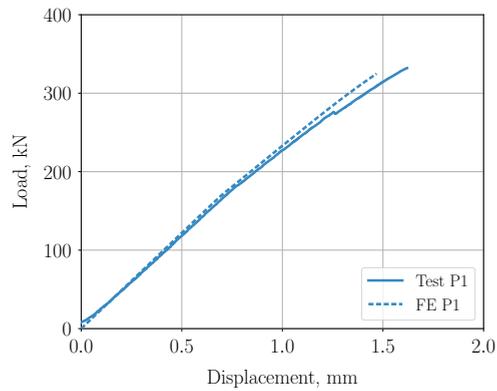
Figure 3.16: Load-displacement curves from tests and numerical analysis of pristine panel.

The load, as measured by the load cell and the average of the LDS displacement measurement, is analysed. The load-displacement behaviour of the pristine panel is reported in Figure 3.16. The panel has an approximate stiffness of 236 kN/mm, buckles at a load of 172 kN and fails at a load of 332 kN. At approximately 275 kN a small load drop is seen due to a sudden change in buckling shape. The numerical analysis is able to predict the overall structural behaviour well, but it does not predict the buckling shape change and resulting small load drop. This also leads to a larger difference in post-buckling stiffness, as the buckling shape change seen during the test also reduces stiffness.

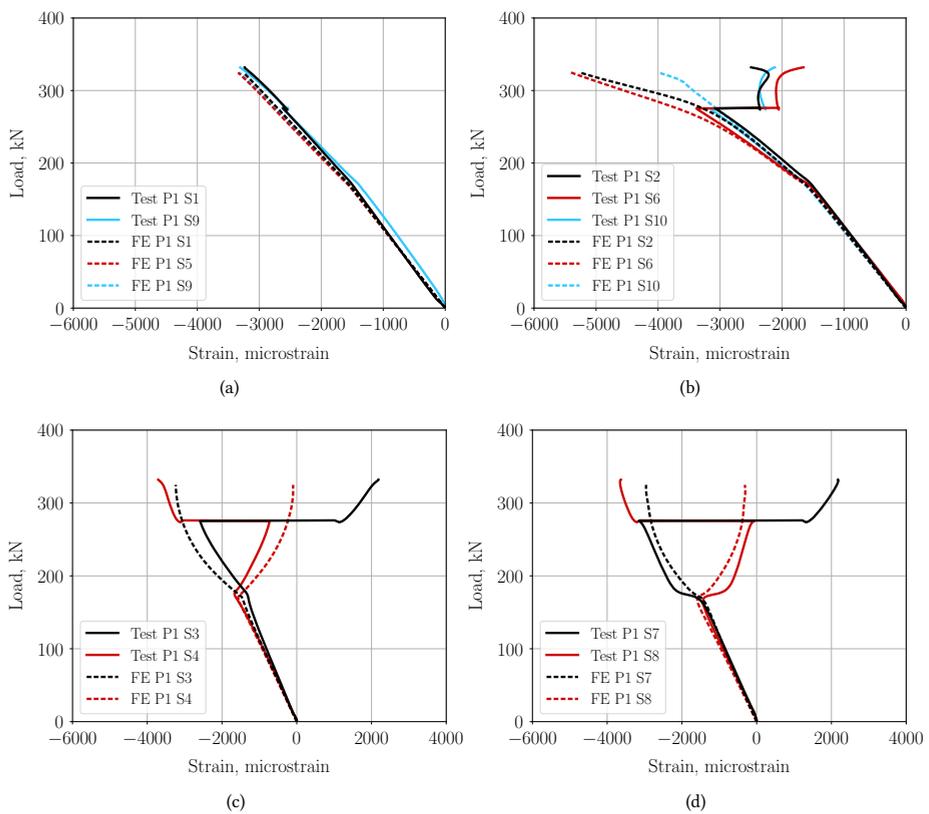
Figure 3.17: Experimental and numerical compressive strains of the pristine panel: (a) caps; (b) skin under stringer; (c) bay 1; (d) bay 2.

The strains of the stringer cap are reported in Figure 3.17(a). The loading imperfection is small, and in the post-buckling range, there is a small jump in strains which is caused by the sudden buckling shape change. The strains under the stringers are reported in Figure 3.17(b). The strains underneath the stringer show equal loading and a drop in stiffness after buckling. The strains only diverge slightly and experience a sudden jump in strain due to a buckling-shape change.

The strains in bay 1 show a large jump due to the buckling-shape change, as reported in Figure 3.17(c). This jump in strain is not seen in the numerical results, due to the lack of a buckling-shape change. The strains in bay 2, as reported in Figure 3.17(d), show a higher bending component compared to bay 1, with a similar jump in strains due to the buckling shape change. The strains, as predicted by the numerical analysis, are very similar but lack the jump in strain due to buckling shape change.

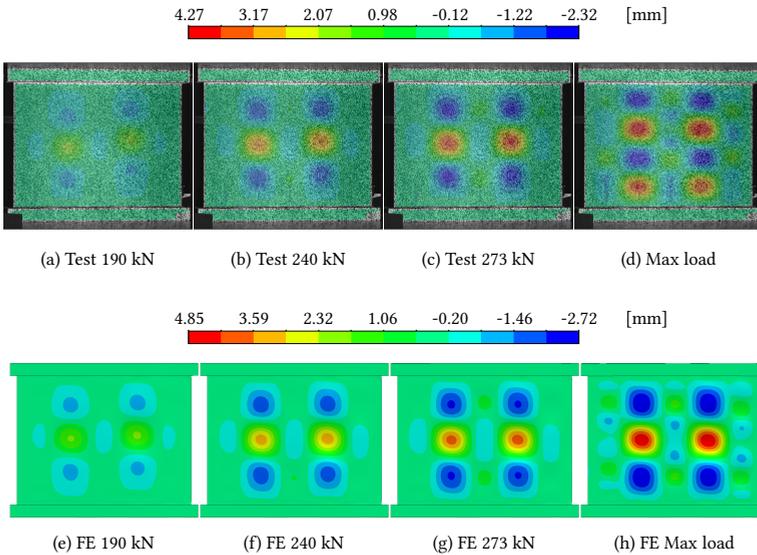
Figure 3.18: Experimental (a-d) and numerical (e-h) out-of-plane displacement of the pristine panel.

The post-buckling shape and evolution of the panels are determined from the DIC measurement and compared to the results from the numerical analysis. The displacement is positive for inwards direction and negative for outwards direction, in line with the axis system reported in Figure 3.1. The panel presents an initial three half-wave buckling shape until approximately 275 kN, after which a sudden buckling shape change occurs with a four half-wave buckling shape, as reported in Figure 3.18. The numerical analysis predicts a three half-wave buckling shape. The number of half-waves underneath the stringer increases in the post-buckling field, similar to the test, but the buckling shape does not change.

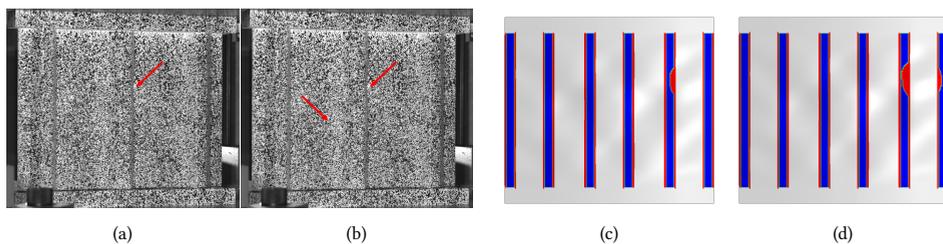
Figure 3.19: Comparison of failure behaviour of pristine panel: (a) start of failure during test; (b) propagation of failure during test; (c) start of failure in analysis; (d) propagation of failure in analysis.

The start of final failure is captured at 10000 fps by a highspeed camera. It starts with skin-stringer separation in the right flange of the middle stringer, which is followed by separation in the left flange of the middle stringer, as reported in Figure 3.19(a-b). Before final failure occurs, small ticking sounds can be heard on the GoPro footage, indicating possible stable separation. The numerical analysis predicts the start of failure in the right stringer, as reported in Figure 3.19(c-d). This difference can be caused by the differences in imperfection and buckling shape.

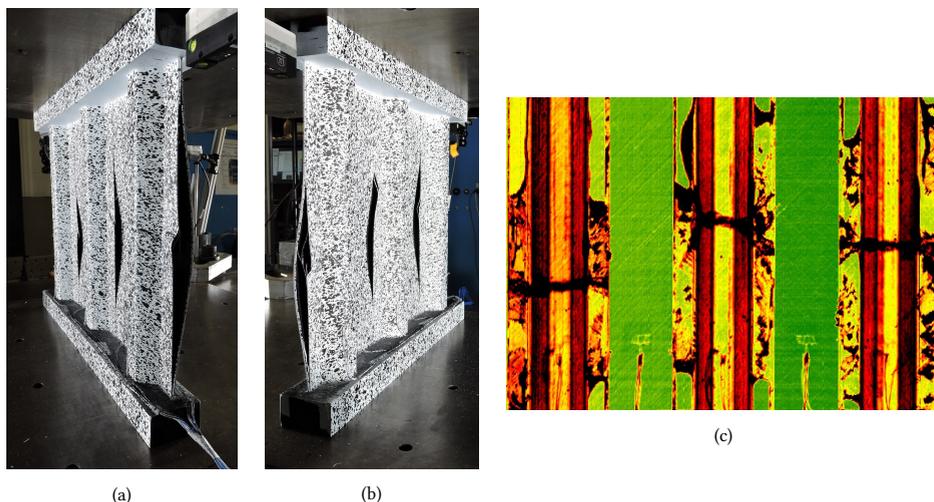
Figure 3.20: Post-failure of pristine panel: (a) photo from right side; (b) photo from left side; (c) c-scan.

The post-failure state is reported in Figure 3.20(a-b-c). All stringers have large separated areas, with more separation on the right-hand side of the panel. All stringers have fractures across the whole stringer width, and the flanges have large delaminations. The areas of the weld at the top of the panel have elliptical crack fronts.

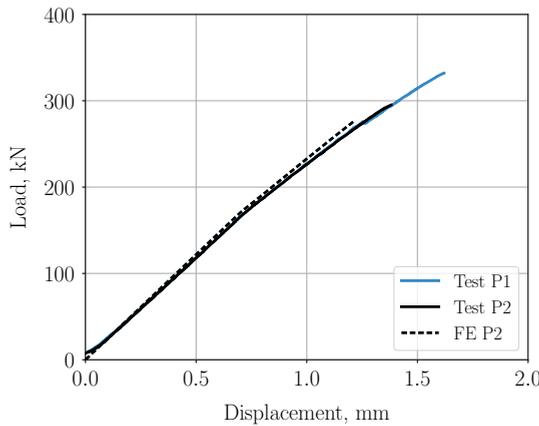
Figure 3.21: Load-displacement curves from tests and numerical analysis of panel 2.

The load-displacement behaviour of the panel with one initial damage in the middle stringer is reported in Figure 3.21, in a comparison with the pristine panel. The panel has a stiffness of approximately 237 kN/mm and buckles at a load of 168 kN. Panel 2 fails due to skin-stringer separation at a load of 295 kN, while the pristine panel fails at a load of 332 kN. This is a reduction of the failure load of 11.2 % due to the damage in the flange of the middle stringer. The numerical analysis of panel 2 is able to predict the overall structural behaviour well. The biggest difference is seen for the failure load, which is conservative with a 6.4 % lower failure load compared to the test.

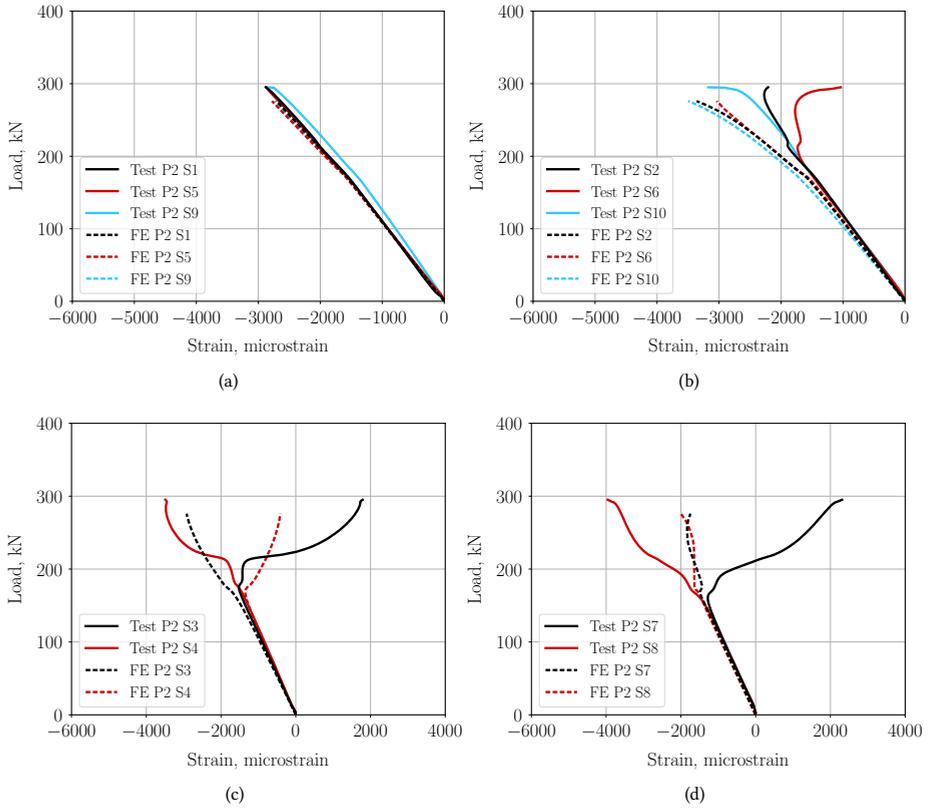
Figure 3.22: Experimental and numerical compressive strains of the panel 2: (a) caps; (b) skin under stringer; (c) bay 1; (d) bay 2.

The strains on the cap of the panel are reported in Figure 3.22(a), where it is seen that S9 shows lower strains compared to S1 and S5. A small loading imperfection can cause this difference. The strains under the stringers are equal, and there is no sign of unequal loading of the skin Figure 3.22(b). A slight drop in stiffness can be seen initially when buckling occurs after which the strains diverge, probably due to the different half-wave positions underneath each stringer, with more divergent behaviour close to the failure load.

The strains in bay 1 present slight divergent behaviour initially after buckling, as reported in Figure 3.22(c). When the buckling-shape further develops, the strains diverge more and experience a large bending component. The numerical prediction shows less divergent strains and in opposite direction, due to differences in buckling shape. The strains in bay 2 are reported in Figure 3.22(d). There is comparable behaviour to the strains in bay one, with slightly more divergent behaviour. The numerical prediction, however, predicts almost linear strains, with only a small bending component which switches sign several times.

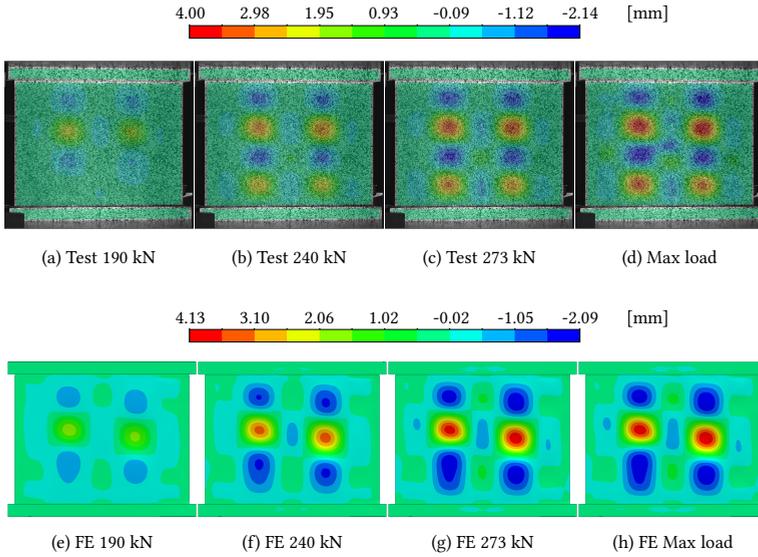
Figure 3.23: Experimental (a-d) and numerical (e-h) out-of-plane displacement of panel 2.

The panel shows an initial three half-wave buckling shape, with the half-waves positioned towards the top of the panel, as reported in Figure 3.23. The buckling shape evolves to a four half-wave buckling shape, and just before final failure, the outwards half-waves in the bay and underneath the stringer start to connect. The numerical analysis predicts a three half-wave buckling shape, which evolves in terms of out-of-plane displacement magnitude and half-wave length. The difference in buckling shape compared to the test can be due to the differences in geometrical imperfection and loading imperfection.

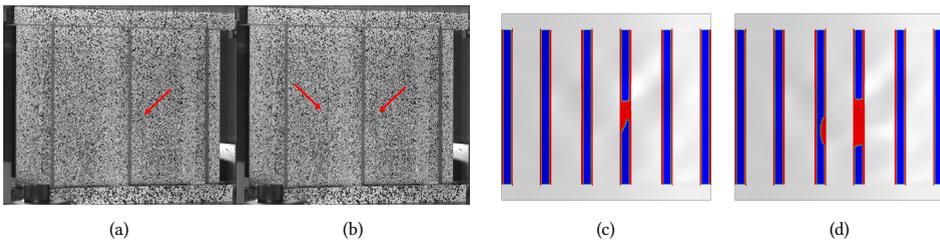
Figure 3.24: Comparison of failure behaviour of panel 2: (a) start of failure during test; (b) propagation of failure during test; (c) start of failure in analysis; (d) propagation of failure in analysis.

The start of failure is reported in Figure 3.24(a), which is captured by a high-speed camera at 10000 fps. Separation starts in the right flange of the middle stringer, at the initial damage location. This is followed by separation of the left flange, as reported in Figure 3.24(b), and then the stringer further separates in upwards and downward directions. The numerical analysis also predicts this behaviour, as reported in Figure 3.24(c-d). There is an elliptical crack front shape for the separation at the initial damaged location and in the opposing flange.

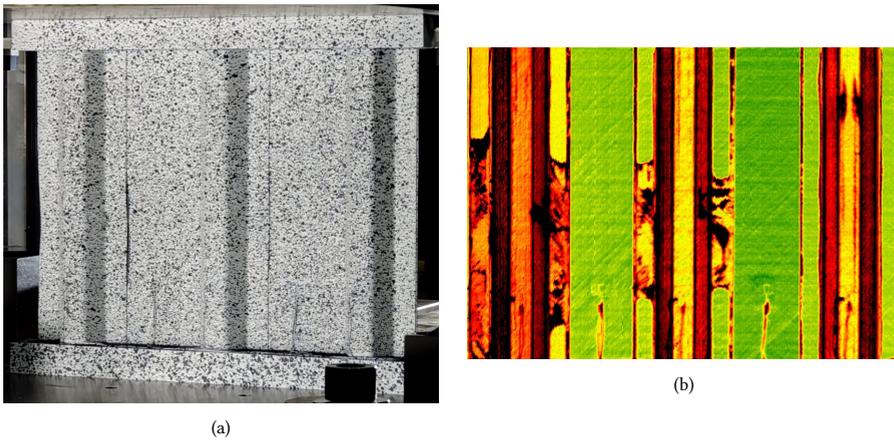
Figure 3.25: Post-failure of panel 2: (a) photo; (b) c-scan.

The post-failure state of panel 2 is reported in Figure 3.25(a-b). It is seen that both the left and middle stringer have large separations. The left stringer has a larger separated area compared to the middle stringer, while the middle stringer had initial damage in the right flange. Final failure started with separation at the damaged location, which caused further large separations in the left-hand side of the panel. The right stringer's interface has some small separated areas, and the weld presents small elliptical fronts. The right flange of the left stringer shows material damage, with a fracture that starts from the lower radius to the flange edge.

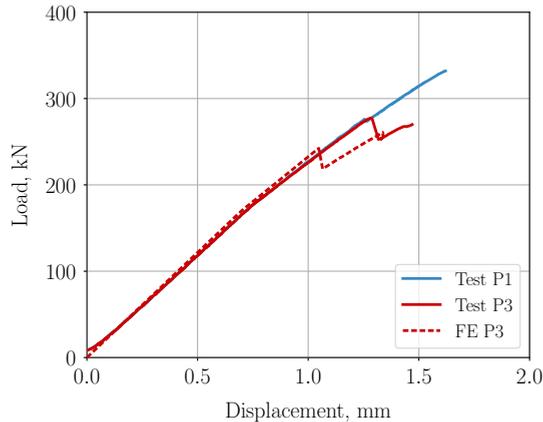
Figure 3.26: Load-displacement curves from tests and numerical analysis of panel 3.

The load-displacement behaviour of panel 3 is reported in Figure 3.26. Panel 3 has a stiffness of approximately 236 kN/mm, and it buckles at a load of 173 kN. The panel experiences a maximum load of 277 kN at 1.29 mm of displacement, after which a load drop occurs. The panel fails at a load of 270 kN and 1.48 mm of displacement. This maximum load is 16.6 % lower compared to the pristine panel. The numerical analysis predicts similar behaviour with a load drop due to a skin-stringer separation event before final failure. It is, however, seen that this load-drop occurs at a lower load, and the maximum load is 5.8% lower compared to the test.

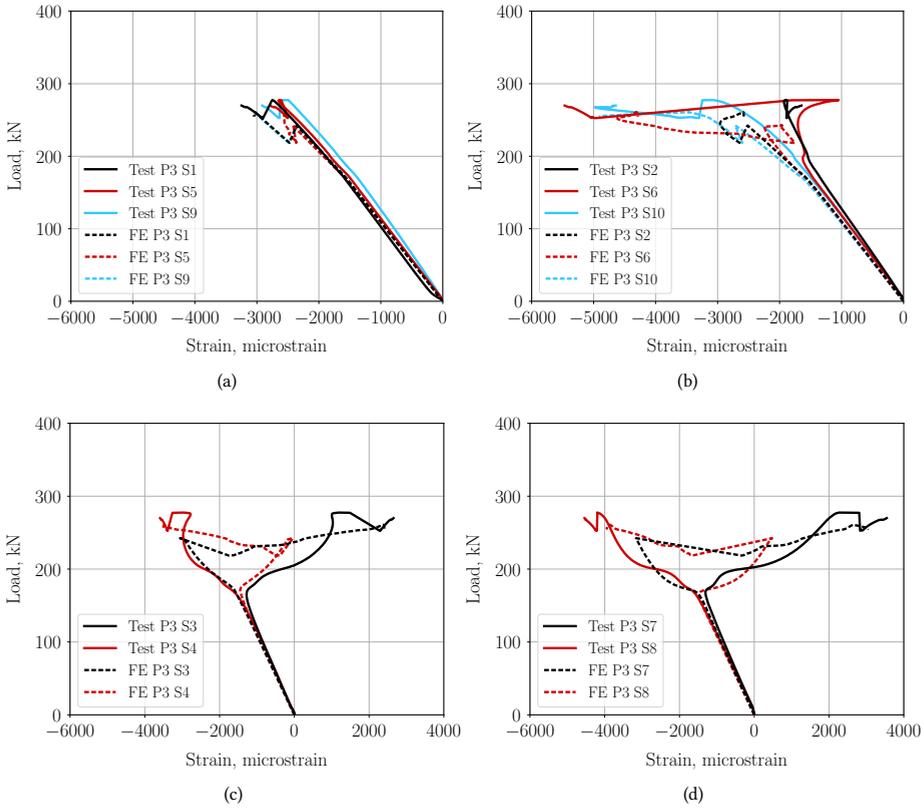
Figure 3.27: Experimental and numerical compressive strains of the panel 3: (a) caps; (b) skin under stringer; (c) bay 1; (d) bay 2.

The strains on the caps of the panels are reported in Figure 3.27(a). It is seen that there might be a small loading imperfection, and a load drop due to a skin-stringer separation event. The strains underneath the stringer are reported in Figure 3.27(b). Before buckling a minor difference in strains can be seen in the skin, indicating a small loading imperfection. After buckling the strains diverge, with large strain changes in the post-buckling field. These large changes are caused by the skin-stringer separation event, which also leads to a load drop.

The strains in bay 1 start to diverge immediately after buckling, and show jumps in strain due to the skin-stringer separation event, as reported in Figure 3.27(c). The numerical analysis predicts similar behaviour initially, although with opposite bending component, and larger jumps in strain in the post-buckling field. The strains in bay 2 present a high bending component in the post-buckling field, as reported in Figure 3.27(d). A strain jump occurs due to the skin-stringer separation event, with S7 also presenting an increase in strains just before the separation event. The numerical analysis predicts an opposite bending component with larger jumps of strain in the post-buckling field due to the skin-stringer separation event.

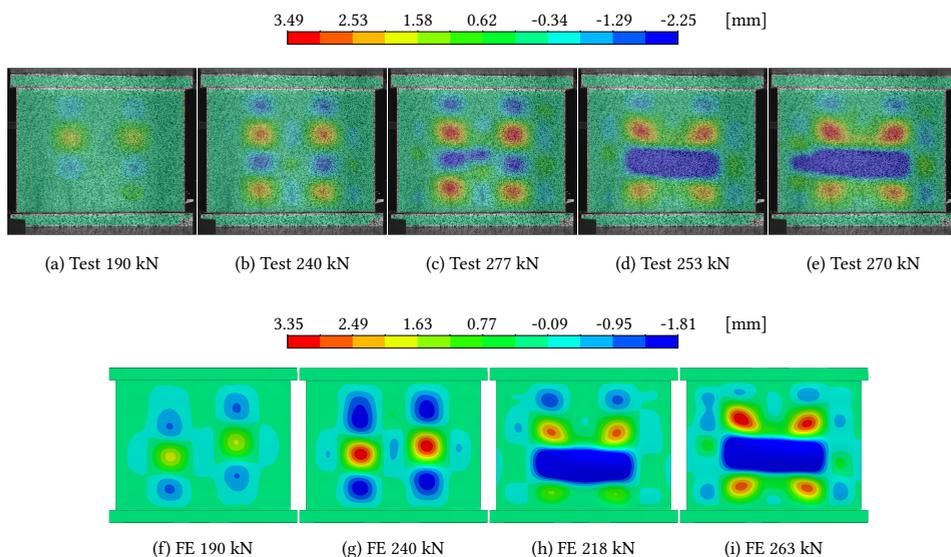
Figure 3.28: Experimental (a-e) and numerical (f-i) out-of-plane displacement of panel 3.

Panel 3 shows a four half-wave initial buckling shape, with the fourth half-wave barely visible in bay two, as reported in Figure 3.28. At higher load levels the fourth half-waves become more prominent. At 277 kN the initial damage opens, with the outward half-waves in the bay and underneath the stringer connecting. After the skin-stringer separation event there is large out-of-plane displacement in the middle of the panel, due to the separation between skin and stringer. At 270 kN, just before final failure, the large half-wave in the middle of the panel grows towards the side of the panel. The numerical analysis predicts a three half-wave buckling shape, with an anti-clock-wise skew in terms of half-wave position. At 218 kN, after the skin-stringer separation event, a large area of high out-of-plane displacement is seen, similar to the test results. At 263 kN the area of high out-of-plane displacement has moved upwards, indicating separation growth in an upwards direction.

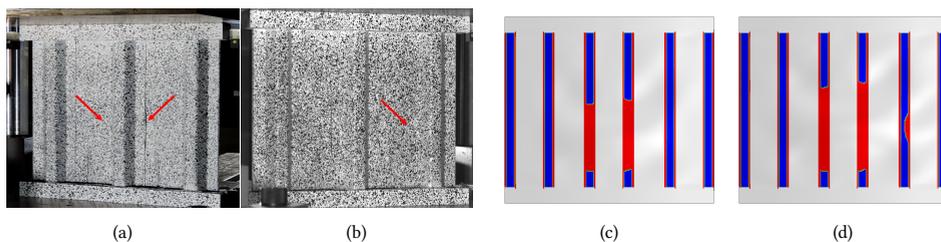
Figure 3.29: Comparison of failure behaviour of panel 3: (a) start of failure during test; (b) propagation of failure during test; (c) start of failure in analysis; (d) propagation of failure in analysis.

Panel 3 endured a skin-stringer separation event of the middle stringer, which did not lead to panel collapse, as reported in Figure 3.29(a). The event started with stable crack growth, heard on the GoPro camera footage, for approximately 15 seconds. This stable crack growth seems to occur at the initial damage in the middle of the panel, as DIC measured an increase in out-of-plane displacement at this location. The stable crack growth is followed by unstable crack growth that results in a large separated area. After loading continued, final failure occurred with further separation of the middle stringer, followed by separation of the right stringer, as reported in Figure 3.29(b). Similar behaviour is predicted by the numerical analysis, as reported in Figure 3.29(c-d). Both flanges of the middle stringer separate initially, and final failure starts by separation of the right stringer.

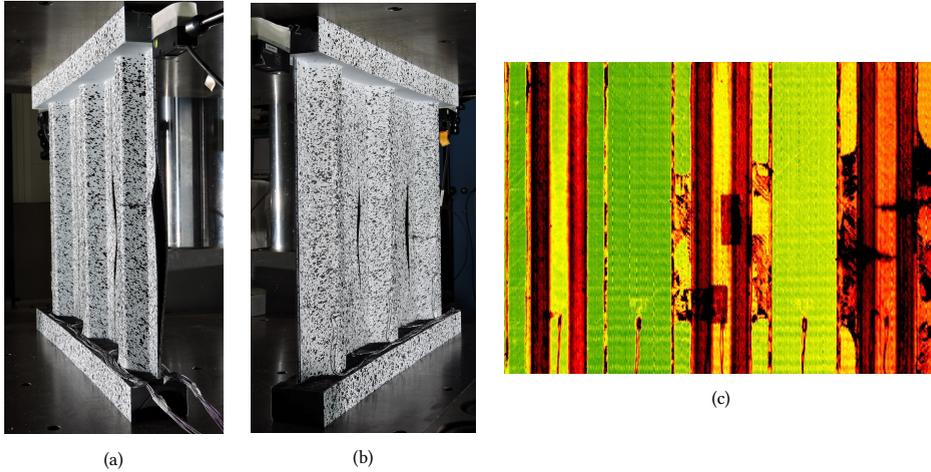
Figure 3.30: Post-failure of panel 3: (a) photo right side; (b) photo left side; (c) c-scan.

The post-failure state of panel 3 is reported in Figure 3.30(a-b-c). The middle and right stringer present large separated areas, with the right stringer having the largest separated area. The right stringer also presents two fractures across the stringer, in the middle of the

panel. All flanges which have separated also have delaminations of the stringer flanges. The left stringer has no visible separations and no material damage.

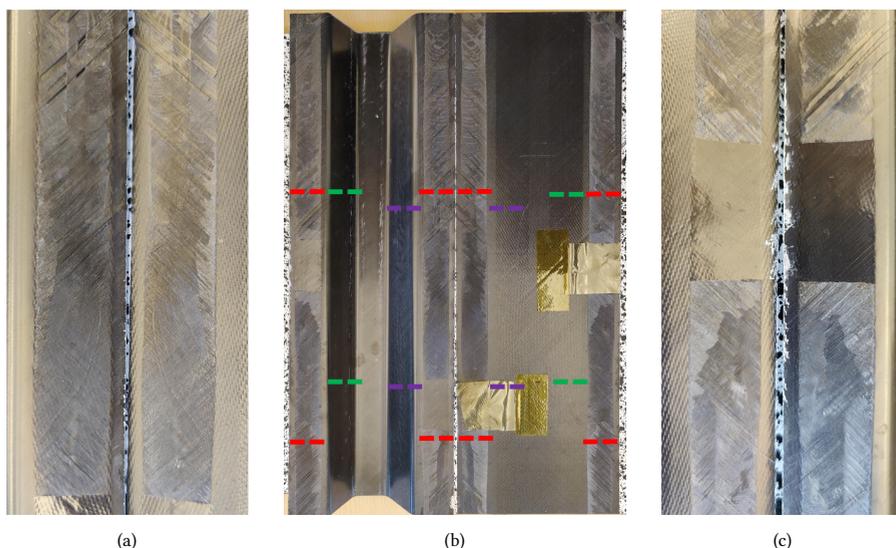
Figure 3.31: Fracture surface of welds of middle stringer of panel 3; (a) close-up of the area between purple dashes; (b) fracture surfaces of middle stringer, with the stringer and skin on the left and right side respectively, with red dashes indicating the area that separated in the test; (c) close-up of the area between green dashes.

After the test, the middle stringer of panel 3 is removed to investigate the fracture surfaces of the failed welds. The weld can be distinguished by the rough surface with visible fibres Figure 3.31 (b). The area in between the red dashes corresponds to the area that separated during the test. The two yellow foils of the initial damage are visible on the skin, while on the stringer two smooth areas can be seen that correspond to the same initial damage locations. The areas in between the purple and green dashes are highlighted in Figure 3.31 (a) and (c), respectively. The skin is mostly intact in the area that separated in the test, with limited fibre pullout and no obvious delaminations. The stringer has a few locations with delaminations, and small pieces of the stringer ply remain on the skin. The bottom 0 ply of the stringer is visible in a few small areas where the bottom 45 ply has delaminated.

On the fracture surfaces, lighter and darker areas can be identified. There are lighter areas around the middle initial damage and the opposite weld, with an elliptical shape. These areas correspond to the location where DIC measured higher out-of-plane displacement before the first separation event. This might indicate that the lighter areas are caused by stable crack growth, while the darker areas are due to unstable crack growth.

On the fracture surface on the opposite side of the middle initial damage, next to the elliptical lighter area associated with the stable crack growth, dark elliptical marks can be seen. These markings indicate crack growth with an elliptical crack front shape. The crack growth seems to go in a sideways direction towards the bay and a downward direction towards the second initial damage location.

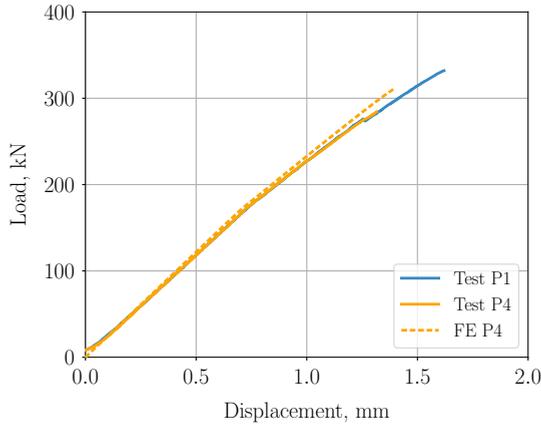
Figure 3.32: Load-displacement curves from tests and numerical analysis of panel 4.

The load-displacement behaviour of panel 4 is reported in Figure 3.32. Panel 4 has an approximate stiffness of 236 kN/mm before buckling. It buckles at a load of 177 kN and fails at a load of 284 kN. This is a reduction of 14.5 % in comparison to the pristine panel failure load. The numerical analysis over-predicts the failure load by 9.3 %, which is the largest difference between numerical results and test results of all panels. This might be due to the location of the damage, which is in one of the side stringers.

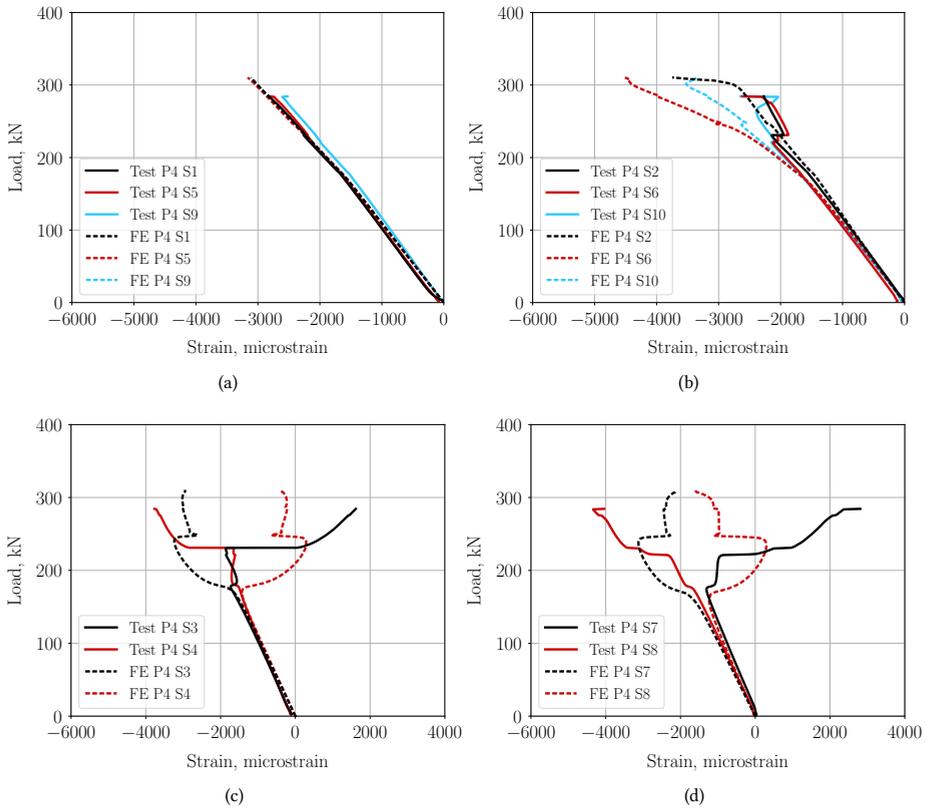
Figure 3.33: Experimental and numerical compressive strains of the panel 4: (a) caps; (b) skin under stringer; (c) bay 1; (d) bay 2.

The strains of the stringer caps are reported in Figure 3.33(a). They are comparable to the previous panels, with a small reduction in strains of S9 just before final failure. The strains under the stringers are reported in Figure 3.33(b). In post-buckling they present jumps and divergent behaviour due to buckling shape changes, and a sudden increase just before final failure.

The strains in bay 1 show convergent behaviour initially after buckling, as reported in Figure 3.33(c). Then they suddenly diverge considerably with a large bending component. The numerical analysis predicts diverging strains immediately after buckling, with a jump in the post-buckling field.

The strains in bay 2 present similar behaviour to bay 1, as reported in Figure 3.33(d). In post-buckling, they present an initial small bending component, after which the strains diverge due to high bending levels. The numerical analysis predicts divergent strains at a lower load, indicating buckling in the bay starts at a lower load than the test.

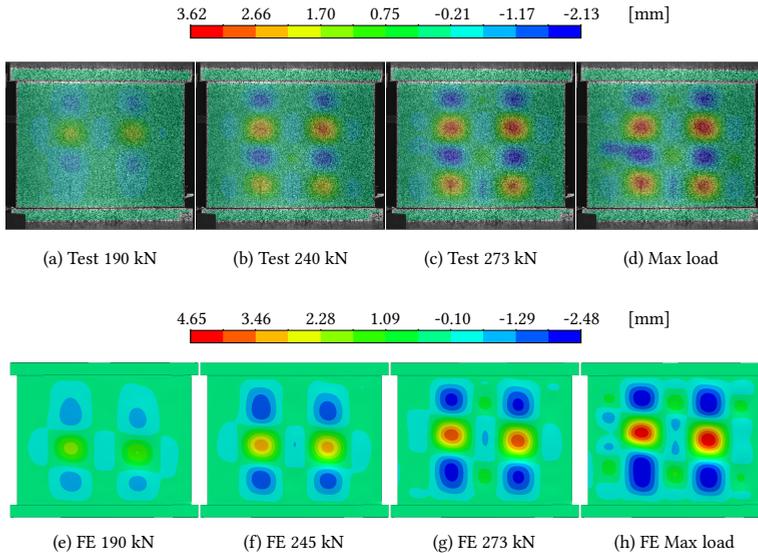
Figure 3.34: Experimental (a-d) and numerical (e-h) out-of-plane displacement of panel 4.

The panel has an initial three half-wave buckling shape, with the half-waves positioned towards the top of the panel, as reported in Figure 3.34. The bottom inwards half-waves have a higher half-wave length, and at higher loads the fourth half-waves appear at this position. At the maximum load the damage in the stringer opens, with inward half-waves connecting between the bay and underneath the stringer. The numerical analysis predicts a three half-wave buckling shape, with the half-waves initially positioned towards the bottom of the panel. At higher load levels, the half-waves evolve towards the top of the panel, and the number of half-waves underneath the stringer increases.

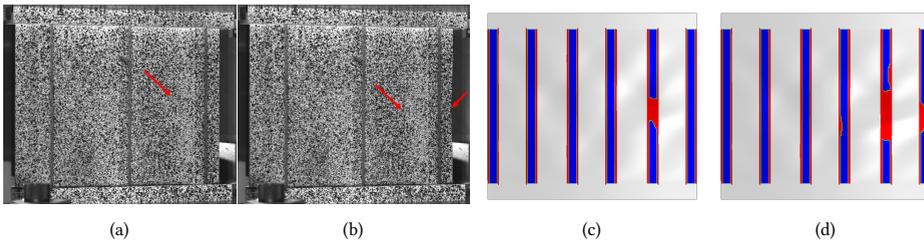
Figure 3.35: Comparison of failure behaviour of panel 4: (a) start of failure during test; (b) propagation of failure during test; (c) start of failure in analysis; (d) propagation of failure in analysis.

The final failure is captured by the high-speed camera and starts in the left flange of the right stringer, where the initial damage is located, as reported in Figure 3.35(a). This is followed by the separation of the right flange of the same stringer, Figure 3.35(b). Before final failure occurs, a ticking sound can be heard on the GoPro footage, indicating stable separation. The numerical analysis predicts the same start location at the initial damage, Figure 3.35(c). Then separation starts in the right flange of the right stringer and in the middle stringer’s left flange, as reported in Figure 3.35(d). This behaviour was not seen during the test.

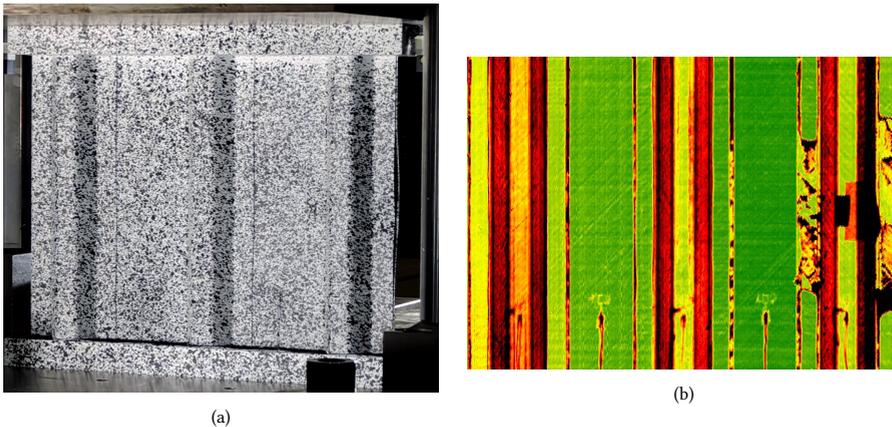
Figure 3.36: Post-failure of panel 4: (a) photo; (b) c-scan.

The post-failure state of panel 4 is reported in Figure 3.36(a-b). Only the right stringer has large separated areas, with a fracture in the right flange. The middle stringer welds present small separations at the inner weld edge, as the weld becomes slightly narrower in some areas.

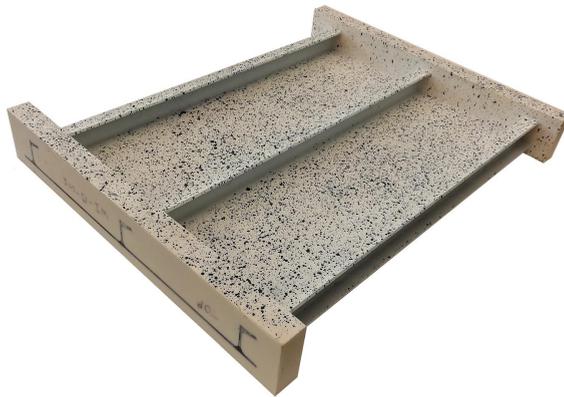
Figure 4.1: Thermoplastic composite stiffened panel.

The thermoplastic composite stiffened panels investigated in this work are representative of a business jet fuselage section [5]. The panels have three stringers, with each stringer consisting of a vertical web and an angled side cap, and are joined to the skin with a butt-joint. The panels have two potting tabs, moulded to each end of the panel for load introduction during testing. One of the panels is shown in Figure 4.1.
