Thermoplastic composite stiffened structures in post-buckling

van Dooren, K.S.

Dissertation

Keywords: Thermoplastic composite, post-buckling, skin-stringer separation, stiffened panels, welding, butt-joint, testing, damage tolerance, finite element, virtual crack closure technique

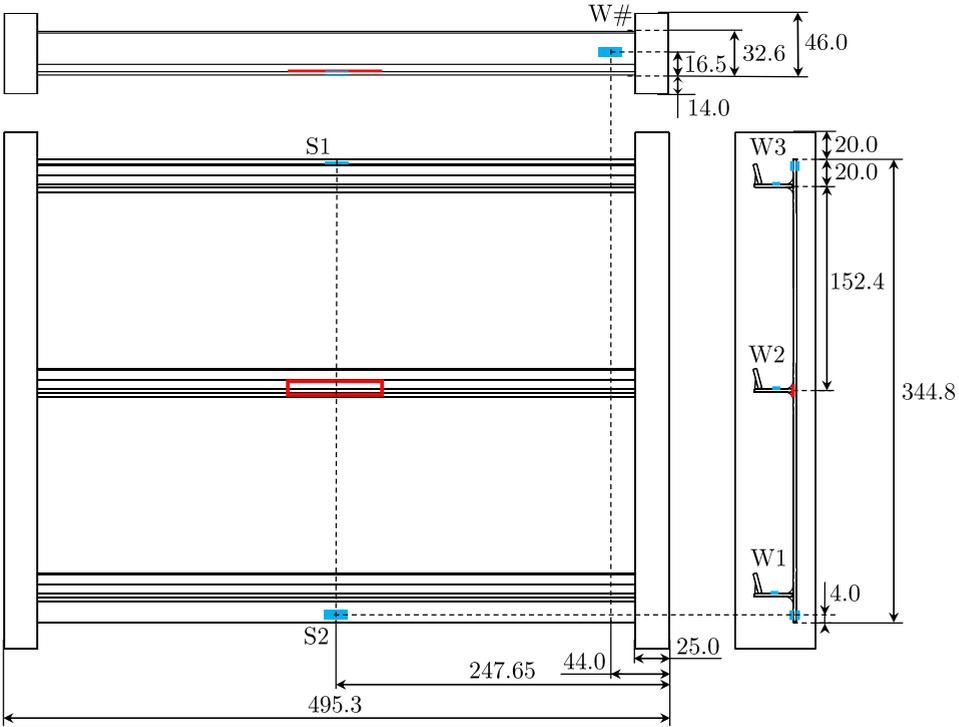
Figure 4.2: Geometry of thermoplastic composite stiffened panel (dimensions in mm), with initial damage location and strain gauges highlighted in red and blue, respectively.

The panels are 495.3 mm long including the potting, 445.3 mm long in between the potting, 344.8 mm in width and the stringer spacing is 152.4 mm, as shown in Figure 4.2. The web is 28 mm in height, the cap is 15 mm wide and is angled upwards at 105 degrees w.r.t. the web, as shown in Figure 4.3. Short fibre filler material joins the laminates of the stringer and skin, to constitute the so-called butt-joint. The panels have an initial damage in between the bottom of the filler and the top of the skin at the middle stringer, as highlighted by the red area. The initial damage is approximately 70 mm long and is considered a typical damage size to represent BVID for this design. To determine the BVID size, impact tests were performed by GKN Fokker on a larger structure using an indenter with a diameter of 1/2 inch to obtain an initial indent depth of 1 mm, which is assumed to be at least 0.3 mm after material relaxation [58]. For the larger structure with 15 ply skin, an impact from the inside with a dent depth of 1 mm resulted in a 70 mm crack. Consequently, the initial damage for these three-stringer panels is created by inserting a 40

A total of 7 strain gauges are attached to each panel to measure strains. A strain gauge is attached to each web under the cap towards the bottom of the panel, while the other strain gauges are attached back-to-back on the free edges of the skin. The locations of the strain gauges are shown in Figure 4.2 and Figure 4.3, with the strain gauges on the web and on the skin named W# and S#, respectively. The locations are chosen according to the results of the numerical predictions, such that the strain gradient is low at each location. The strain gauges on each web show if each stringer is equally loaded in pre-buckling, and how the load distribution changes in post-buckling due to the growth of the skin-stringer separation. The strain gauges on the skin are used to determine loading imperfections due to bending.

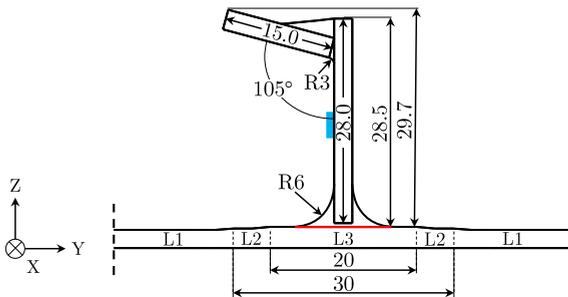
Figure 4.3: Stringer cross-section (dimensions in mm), with initial damage location and strain gauges highlighted in red and blue, respectively.

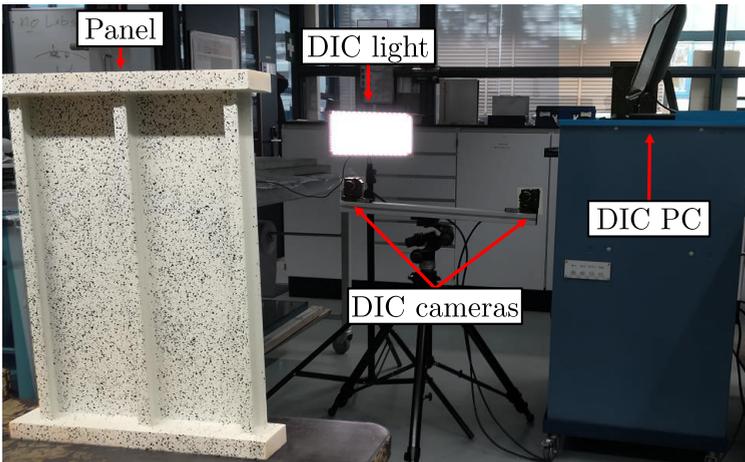
Figure 4.4: DIC measurement setup.

The geometrical imperfections are measured by DIC. The nominal design of the skin is flat, and the geometrical imperfections are therefore measured as the out-of-plane deviation of the skin of the panels with respect to the flat plane. The DIC measurement setup uses two stereo camera and additional lighting, and is shown in Figure 4.4.

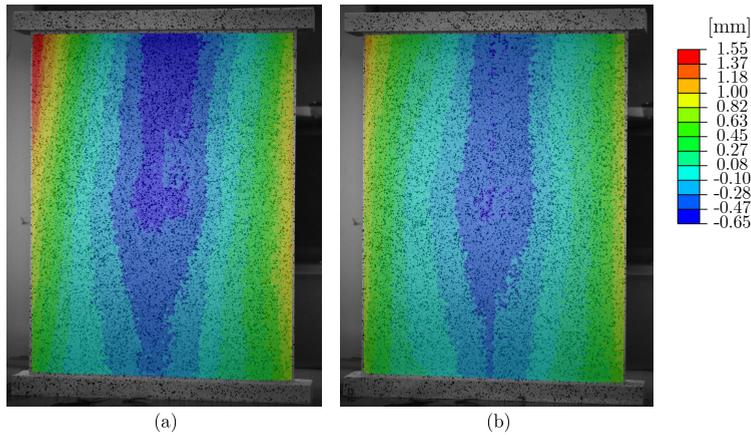
Figure 4.5: Out-of-plane geometrical imperfection of skin-side: (a) panel 1; (b) panel 2.

The measured skin-side imperfections are reported in Figure 4.5, where the out-of-plane deviation is projected onto each panel as a contour plot, and the imperfection is aligned with the z-axis of the axis system reported in Figure 4.3. The measurements show a maximum out-of-plane imperfection of 0.65 and 0.56 mm in the outwards direction, and a maximum of 1.55 and 1.08 mm in the inwards direction, respectively for the two panels. It is possible to note a slightly V-curved shape in the transverse direction and a slight curvature in the longitudinal direction. The curvature in the transverse direction is most likely caused by internal stresses due to the potting curing process and by the mismatch in stiffness of the potting material and composite laminates.

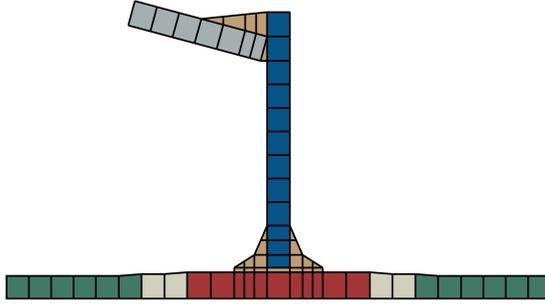
Figure 4.6: FE mesh of the stringer cross-section.

The modelling approach makes use of shared nodes to connect the different sections, as shown in the stringer cross-section in Figure 4.6. Shared nodes instead of ties shows better computational efficiency and more consistent mesh convergence. The interface between the filler and the skin of the middle stringer is partially bonded by a contact pair definition with VCCT. This area, which is the length of the stringer between the potting, is 445.3 mm long and 9.7 mm wide and has an initial damage of approximately 70 mm in the middle. It is assumed that the pre-crack is present only between the filler and the skin, and that it also only grows in this interface. The possible crack growth into the filler is neglected to lower the complexity of the model. This assumption is based on failure behaviour seen during internal tests by GKN Fokker and three-point bending tests by Baran et al. [55]. It is chosen to use VCCT as it shows good results for a relatively course mesh [26, 35, 56], needed for large structures as in this work, which was also shown by Bertolini et al [14] in a direct comparison between VCCT and CZM. Furthermore, VCCT requires a pre-crack, and this requirement is automatically fulfilled due to the initial damage in the skin-stringer interface.

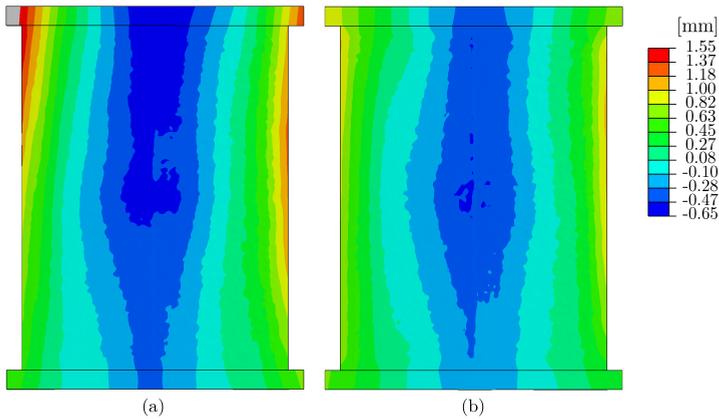
Figure 4.7: FE out-of-plane geometrical imperfection of skin-side: (a) panel 1; (b) panel 2.

The geometrical imperfections are included in the FE model, as buckling behaviour of thin-walled structures is known to be sensitive to imperfections. Any residual stresses, for example from the manufacturing process, are neglected. The geometrical imperfections are applied to the nominal mesh by means of a FE linear analysis. The out-of-plane coordinates of the DIC imperfection are translated into boundary conditions for the linear analysis using python. This linear analysis outputs a nodefile that only includes the deformation field. The nodefile can be used to apply the imperfection in the non-linear analysis, without transferring the stress state of the previous linear analysis. The resulting out-of-plane displacement fields of the linear analysis for both panels, which are the geometrical imperfection used for further analysis, are shown in Figure 4.7.

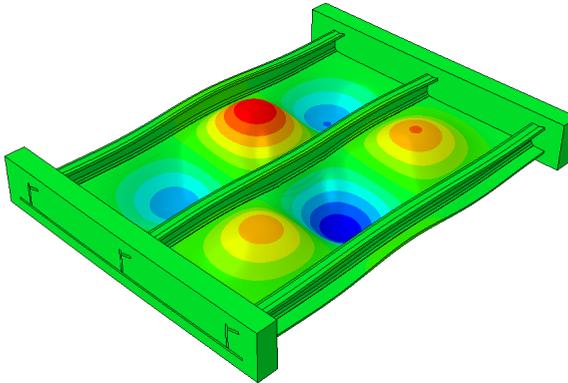
Figure 4.8: FE eigenvalue buckling shape.

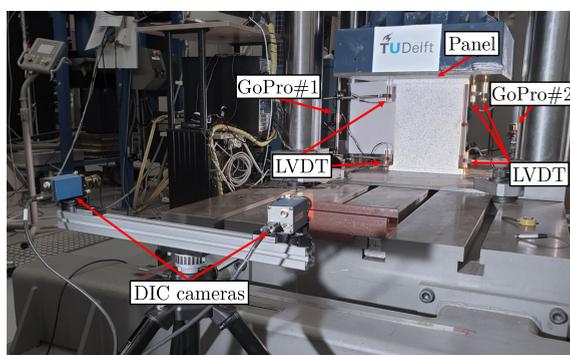
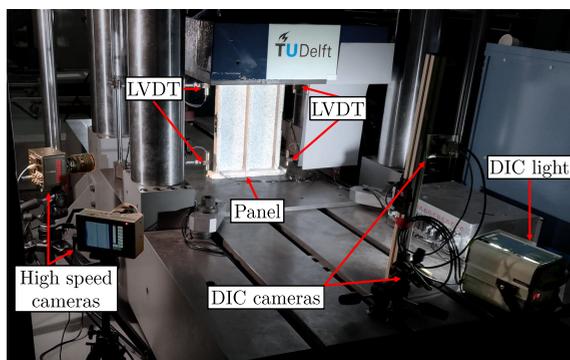
(a)

(b)

Figure 4.9: Test setup: (a) skin-side; (b) stringer-side.

The experimental test setup is shown from the skin-side and stringer-side of the panel in Figure 4.9. The panel is placed between the base and the compression plate of the test machine, after which a low preload of 0.5 kN is applied to keep the panel in place. The tests are performed at a loading rate of 0.1 mm/min until final failure of the panel. The loading automatically stops when the drop in force is measured.

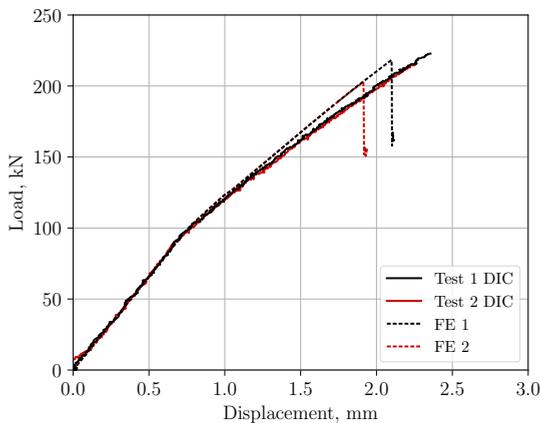
Figure 4.10: Load-displacement curves from tests and numerical predictions.

The load measured from the load cell of the test machine and the longitudinal displacement measured by DIC is used for obtaining the load-displacement curves. The longitudinal displacement by DIC is determined by the difference in displacement from the top and bottom potting. The curves are shown together with the prediction from the numerical analysis in Figure 4.10 for panel 1 and 2.

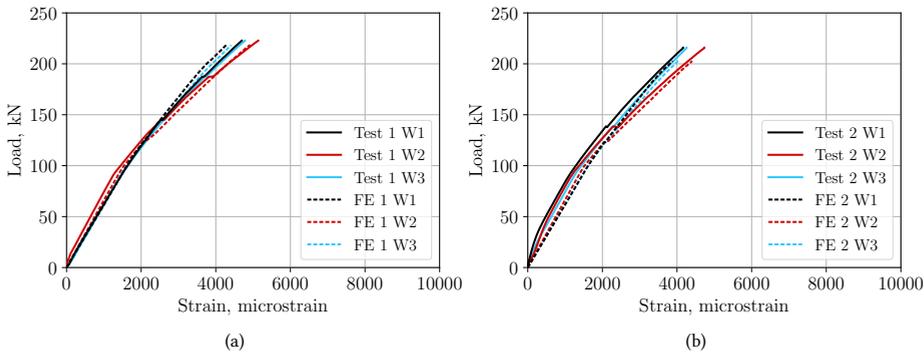
Figure 4.11: Experimental and numerically predicted compressive strains in stringer webs: (a) panel 1; (b) panel 2.

The strains measured by the strain gauges on the webs of panel 1 are shown in Figure 4.11(a). It can be seen that initially the pre-buckling strains in the outside webs are slightly higher compared to the middle web, indicating that there is a small loading imperfection. Then, all three webs show the same stiffness until buckling. In the post-buckling field the strains show a decrease in stiffness. At 145 kN and 187 kN small load drops are seen indicating crack growth events. The strains of the webs of panel 2 are shown in Figure 4.11(b). It can be seen that there is more settling compared to panel 1, most likely due to a slightly larger loading imperfection, and there is one load drop indicating a crack growth event at 138 kN.

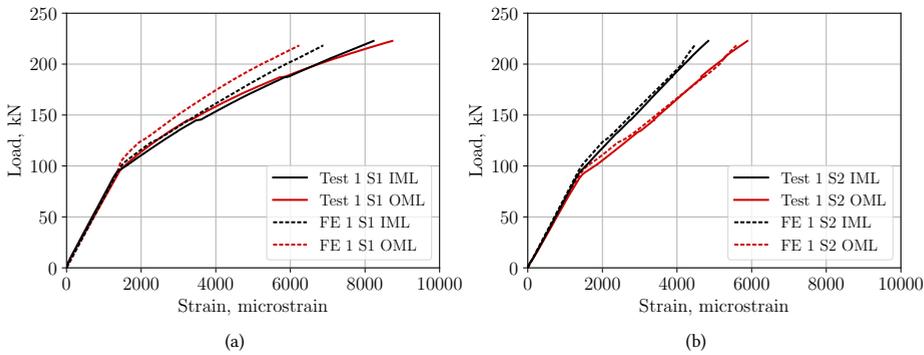
Figure 4.12: Experimental and numerically predicted compressive strains of panel 1: (a) S1; (b) S2.

The strains in the skin of panel 1 are shown in Figure 4.12(a) and Figure 4.12(b) for location S1 and S2, respectively, with notation IML and OML for inner and outer mould line. At location S1 the measured strains show a small difference between inner and outer mould line indicating a small bending component. At location S2 the influence of bending is more clear, with a larger difference between IML and OML in the post-buckling field. The measured strains at location S1 are considerably higher compared to location S2 in

The numerical analysis accurately predicts the strain in pre-buckling for both location S1 and S2. A small difference is seen for panel 2 location S2, due to bending in the measured strains in the pre-buckling field. In post-buckling the strains are under predicted at location S1, while the strains at location S2 are accurately predicted for both panel 1 and 2 in post-buckling.

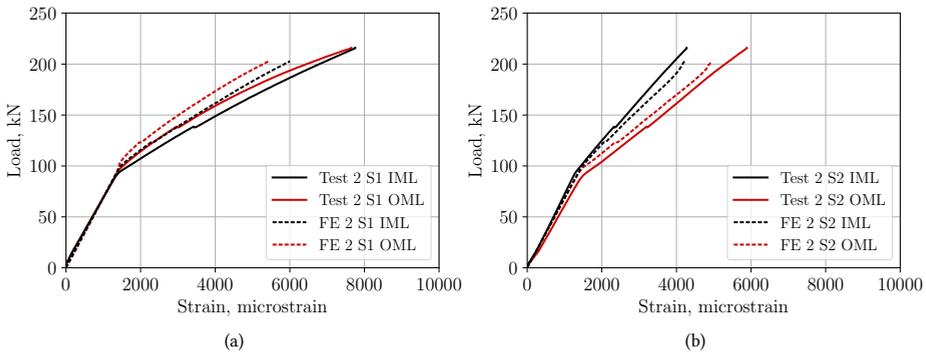
Figure 4.13: Experimental and numerically predicted compressive strains of panel 2: (a) S1; (b) S2.

The strains of the skin of panel 2 are shown in Figure 4.13(a) and Figure 4.13(b) for location S1 and S2 respectively. In pre-buckling, location S2 shows a minor bending component, which is not seen for panel 1. This is most likely caused by a small loading imperfection. For both location S1 and S2 the measured strains of panel 2 show more bending compared to panel 1.

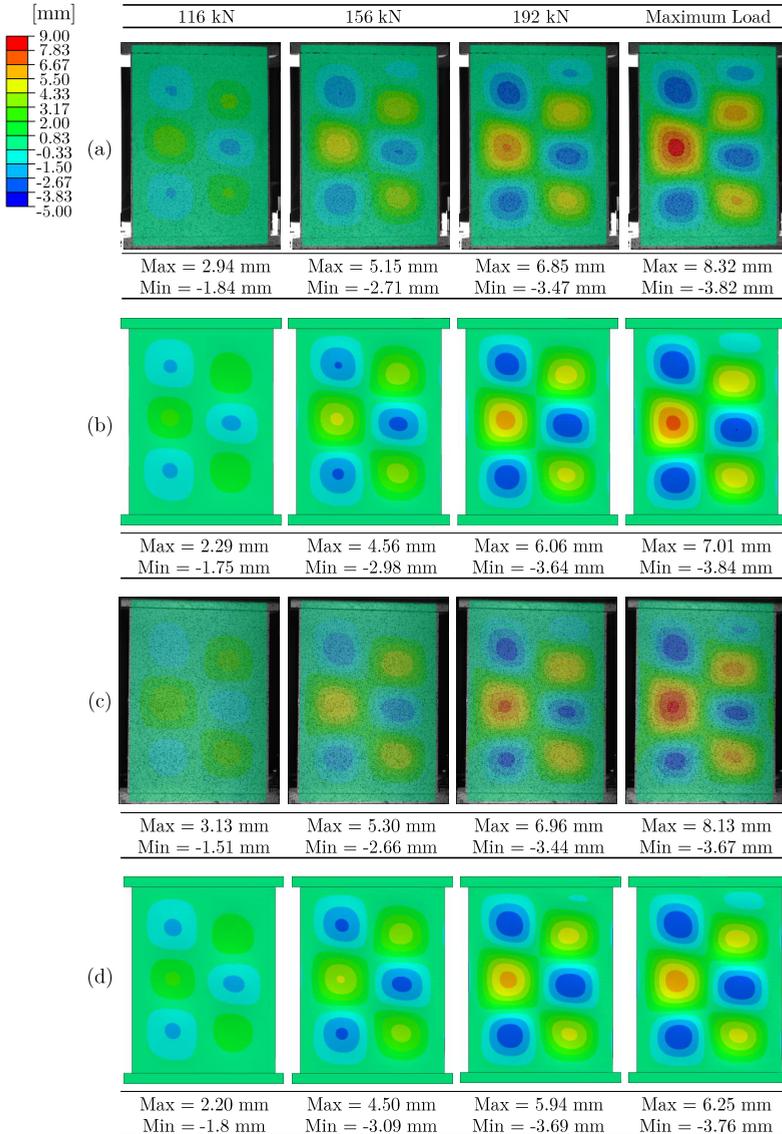
Figure 4.14: Out-of-plane displacement: (a) panel 1 test; (b) panel 1 FE; (c) panel 2 test; (d) panel 2 FE.

The out-of-plane displacements of the two panels captured by the DIC system are reported in Figure 4.14 by contour plots at four load levels, to show the evolution of the deformation in the post-buckling field. For each contour plot the maximum and minimum out-of-plane displacement are reported. A positive sign is for displacement in inwards direction towards the stringer, and a negative sign is for outwards direction away from the stringer, in line with the axis system reported in Figure 4.3. The contour plots for both tests are compared with the results of the numerical analysis.

while the outwards displacements are initially larger. The outwards out-of-plane displacements at the maximum load is accurately predicted for both panels, indicating that the amount of crack opening due to the outwards displacements might be the dominating factor for final failure.

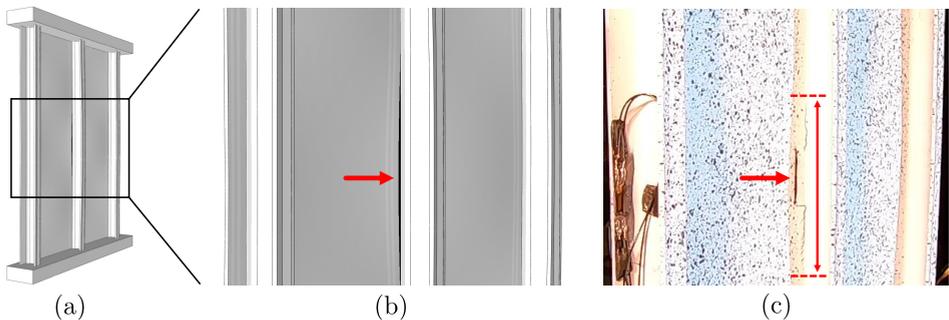
Figure 4.15: Crack opening seen from left side of panel 1 at 156 kN: (a) full view of panel; (b) close-up FE; (c) close-up camera footage with visual separation length marked in red.

As panel 1 and panel 2 show very similar behaviour, only camera footage of panel 1 is here reported. At 156 kN, approximately between buckling and final failure, crack opening can be well distinguished, as shown in Figure 4.15. The crack has opened and grown, with more crack growth in downwards direction compared to upwards direction. The cap-side of panel 1 is shown Figure 4.15(c). The opposite side of panel 1, corresponding to the side of the stringer without cap, is shown in Figure 4.16, where no crack opening can be seen. The one-sided crack opening is due to the buckling shape, where the outwards half-wave on the cap-side opens the crack, while the inwards half-wave on the opposite side of the cap tends to close it.

The numerical analysis accurately predicts the combination of stable crack growth and crack growth events. The corresponding views are shown in Figure 4.15(a-b) and Figure 4.16(a-b) for the cap and the opposite side, respectively, for a comparison with the camera footage.

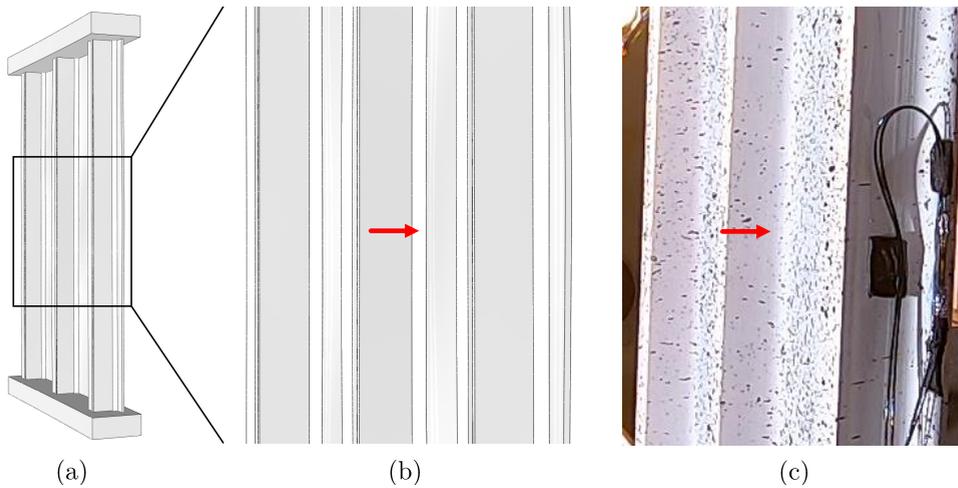
Figure 4.16: Closed crack seen from right side of panel 1 at 156 kN: (a) full view of panel; (b) close-up FE; (c) close-up camera footage.

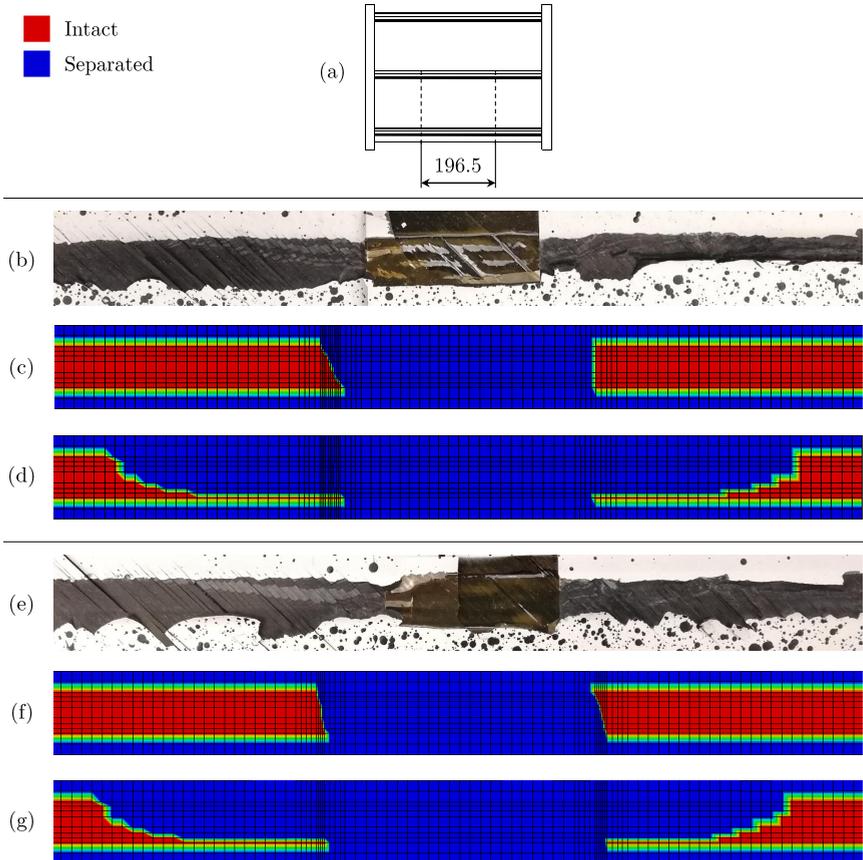
Figure 4.17: Top view skin-stringer interface: (a) interface area of interest; (b) test panel 1 fracture surface; (c) FE panel 1 initial damage; (d) FE panel 1 at 156 kN; (e) test panel 2 fracture surface; (f) FE panel 2 initial damage; (g) FE panel 2 at 156 kN.

To further investigate the skin-stringer separation, the fracture surface is analysed. It is shown over a length of 196.5 mm, as highlighted in Figure 4.17(a), which corresponds to the area that is separated before the final failure. The fracture surface of panel 1 is shown in Figure 4.17(b), where the foil inserted in the joint for the initial damage can be noted. The grey marks close to the foil are considered to be caused by the extension process of the initial damage, as the distance between the markings match the initial damage length. Larger grey marks can be seen further away from the foil, with a slight elliptical shape. The shape of these marks is most likely caused by the one-sided crack growth in the post-buckling field.

The fracture surface of panel 2 is shown in Figure 4.17(e). The fracture surface is very similar to panel 1, but it shows less grey marks. This might be due to the single unstable crack growth event in post-buckling compared to panel 1. Also, more filler material remains attached to the skin, and delaminations can be seen on both sides of the foil.

The skin-stringer interface of the numerical analysis for panel 1 is shown for the initial damage and at the load of 156 kN in Figure 4.17(c) and Figure 4.17(d), respectively, where red indicates intact interface, and blue indicates separated interface. The numerical prediction at 156 kN shows a quasi-elliptical crack front shape, with a narrow horizontal line of intact interface.

The skin-stringer interface of the numerical analysis for panel 2 for the initial damage and at the load of 156 kN are shown in Figure 4.17(f) and Figure 4.17(g), respectively. The initial damage is similar to panel 1, but is slightly longer. The interface at 156 kN shows slightly more crack growth compared to panel 1, which might have led to the lower final failure load of panel 2.

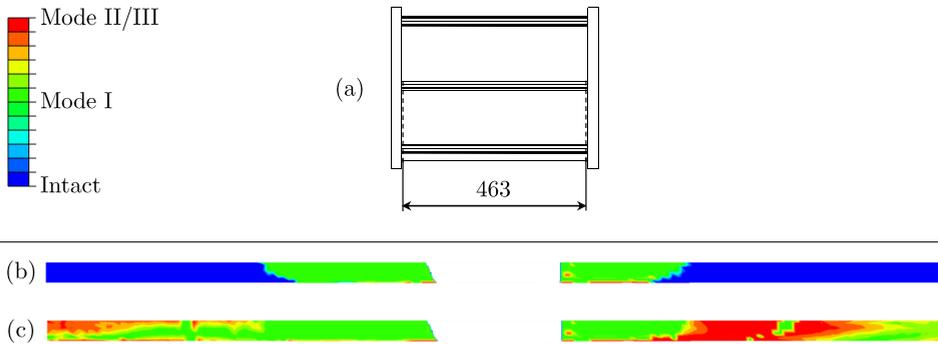
Figure 4.18: Panel 1 mode-mixity: (a) interface area of interest; (b) mode-mixity at start of final failure; (c) mode-mixity after final failure.

III as shown in Equation 4.4, resulting in a value of 0 for pure mode I and a value of 1 for pure mode II/III. In case of an intact interface, a value of -1 is assigned. The interfaces are analysed over a length of 463 mm, as reported in Figure 4.18(a). The mode-mixity of the fracture surface at the start of final failure is shown in Figure 4.18(b). The one-sided crack growth before failure is mode I dominated, with final failure being initiated by a narrow line of mode II/III fracture. The fracture surface after the final failure of the panel is shown in Figure 4.18(c). The crack growth towards the left is mode I dominated while the crack growth towards the right is mode II/III dominated. The majority of the fracture surface is either dominated by mode I or mode II/III, with only small areas of mixed-mode loading.

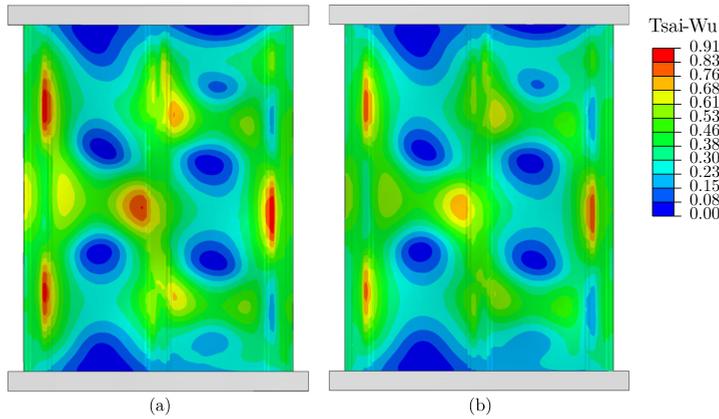
Figure 4.19: Tsai-Wu failure criterion of the skin bottom zero ply from the numerical prediction at maximum load: (a) panel 1; (b) panel 2.

Four first ply failure criteria are included in the numerical analysis to determine if material failure occurs before skin-stringer separation. The values of the most critical ply for each criterion at the maximum load are reported in Table 4.8 for both panels. It is possible to see that none of the criteria show first ply failure before final failure, with the Tsai-Wu criterion reporting the highest value for both panels. The most critical ply according to the Tsai-Wu criterion is the bottom zero ply in the skin, for which the contour plots of both panels are shown in Figure 4.19. It can be noted that the most critical locations are underneath the outer stringers, approximately coinciding with the longitudinal location of outwards half-waves of each corresponding bay.

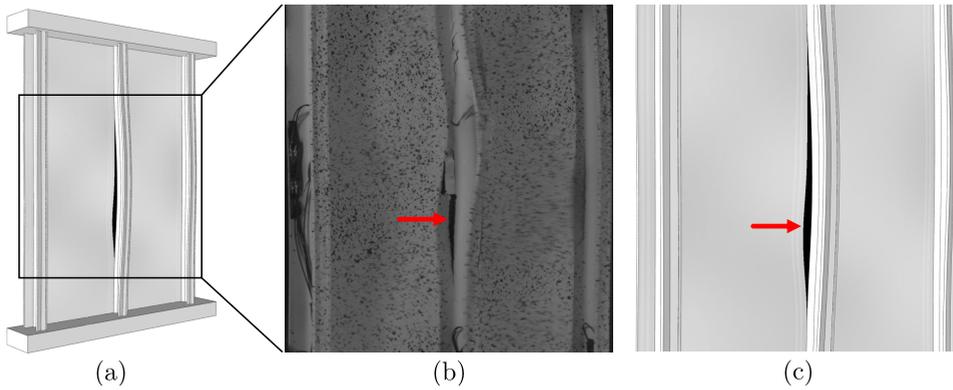
Figure 4.20: Crack opening of panel 1 during final failure: (a) full view of panel; (b) high speed camera; (c) close-up FE.

The final failure mode is captured by two high speed cameras. The area that is recorded by high speed camera 1 is shown on the FE model in Figure 4.20(a). A frame of the 3000 fps high speed footage of panel 1 is shown in Figure 4.20(b). It highlights the behaviour during separation of the middle stringer. The crack in the butt-joint grows in downwards direction and a tunnel forms between two outwards buckling half-waves. Due to the separation of the stringer from the skin, the cap and the web of the stringer also start to show failure, and consequently load carrying capabilities are lost. The numerical prediction of the final failure of the panel is shown in Figure 4.20(c). The analysis also reveals crack growth in downwards direction, with a tunnel between two outwards buckling half-waves, similarly to the failure behaviour seen in the tests.

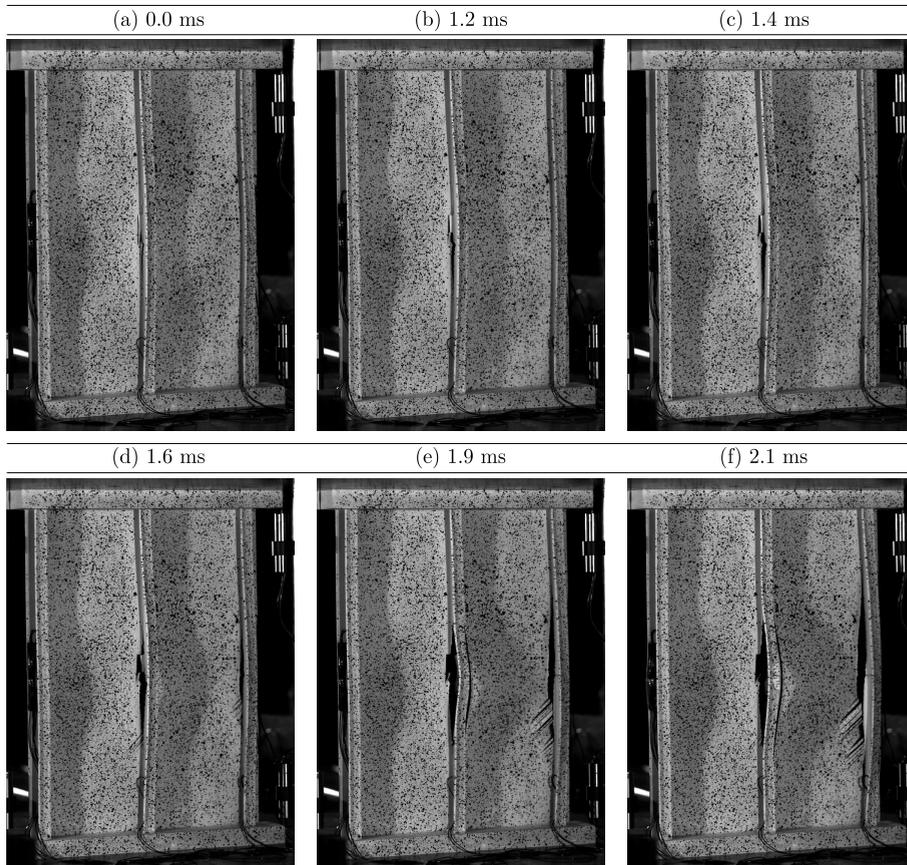
Figure 4.21: Sequence of final failure of panel 2 captured by high speed camera: (a) crack opening of middle stringer; (b) crack propagation of middle stringer; (c) separation of right stringer; (d) separation of middle cap; (e) failure of middle cap; (f) separation of left stringer and separation of right cap.

The sequence of the final failure over the full length of panel 2 is captured by the second high speed camera at 10000 fps, as shown in Figure 4.21. Final failure starts with the crack opening (a). Then the crack grows between the web of the middle stringer and the skin (b), after which the separation between the web of the right stringer and the skin occurs (c). This is followed by the separation between cap and web of the middle stringer (d) and failure of the middle cap (e). Then, the web of the left stringer starts to separate from the skin simultaneously with the separation between cap and web of the right stringer (f). This sequence occurs within 2.1 ms, and shows that the skin-stringer separation is the critical failure mode leading to the final failure of the panel.

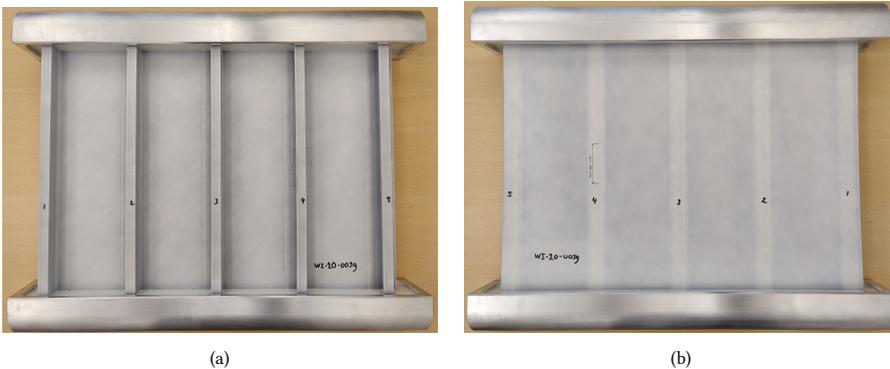
Figure 5.1: Panel: (a) stringer-side; (b) skin-side.

The curved multi-stringer panels are representative of the fuselage section of a business jet. The panels are manufactured and potted to the rollers by GKN Fokker and are received as shown in Figure 5.1. The rollers are made of aluminium, and the panels are attached to the rollers with epoxy potting. The panels have an approximate curvature and length of 6277 and 497 mm, respectively, and the total length including rollers is 585 mm, as reported in Figure 5.2(a). The rollers have a radius of 45 mm, and the loading edge and bending neutral axis of the panels coincide with the rollers' centre of curvature. The panels have five stringers, with a stringer spacing of 152.4 mm, which results in a total width of 650 mm, as reported in Figure 5.2(c).

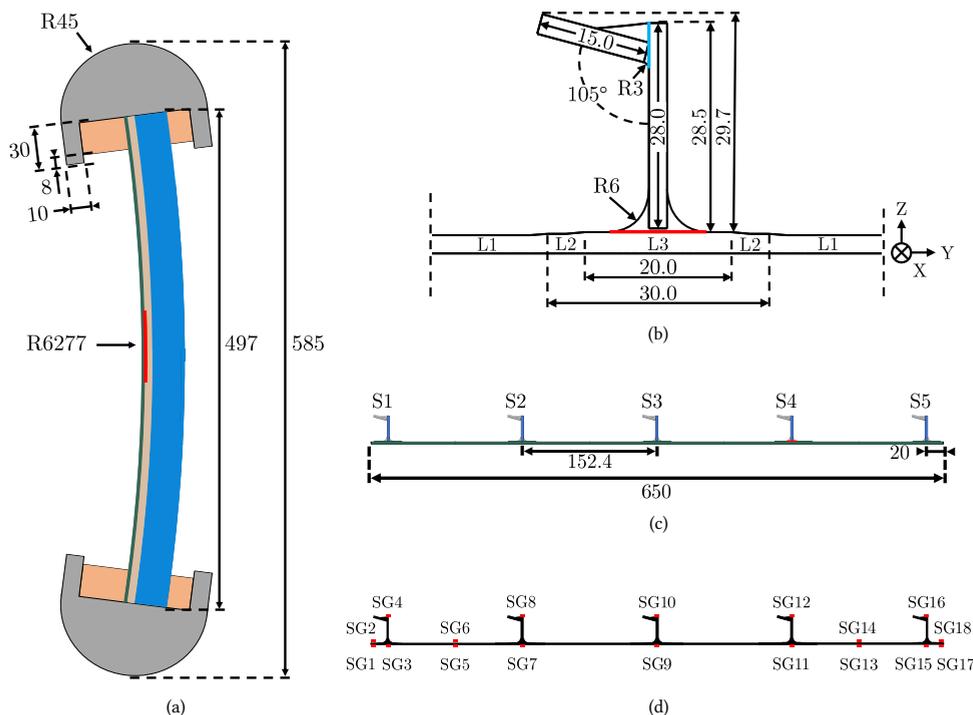
Figure 5.2: Panel geometry: (a) side-view illustration ; (b) stringer cross-section; (c) panel cross-section; (d) strain gauge positions.

The butt-joint technique is used to join the stringer to the skin. The stringer consists of a web and an angled side cap. The cap is 15 mm wide, angled at an angle of 105 degrees w.r.t. the web, which is 28 mm in height, as reported in Figure 5.2(b). The skin-web joint, which is called the butt-joint, and the web-cap joint consist of carbon Short Fibre Reinforced Plastic (SFRP) filler PolyEtherKetoneKetone (PEKK) extrusion profiles, of which the material properties are reported in Table 5.1. One of the panels has initial damage at the skin-stringer interface that represents a BVID. The location of this BVID is highlighted in red in Figure 5.2(a, b). The BVID is created by including a 40 mm foil at the skin-stringer interface during co-consolidation, after which the BVID is extended to 70 mm by applying out-of-plane displacement to the skin in a test machine [16, 74].

The panels are instrumented with 18 strain gauges at the positions reported in Figure 5.2(d), in the middle of the panel along the longitudinal direction. Strain gauges are attached back-to-back on the skin on the free edges, in the middle of the outer bays,

The out-of-plane displacement of the skin is measured during the tests by DIC, and is reported in Figure 5.13. Negative displacement corresponds to an outward direction, and positive displacement corresponds to an inward direction, in line with the axis system reported in Figure 5.2(b). The scale of the contour plot is based on the out-of-plane displacement of the skin at the maximum load. For each plot, an offset is applied to the displacement field, such that the scale's maximum is at the maximum out-of-plane displacement point of the panel. This eliminates the contribution of the rolling motion of the panels to the out-of-plane displacement and results in a clearer comparison.

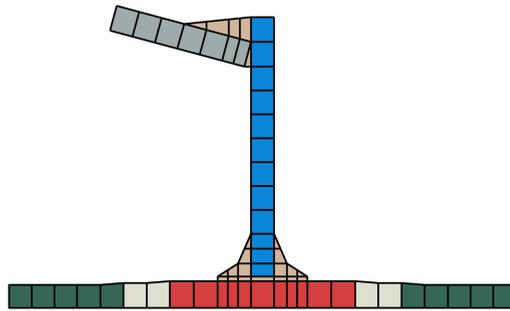
Figure 5.3: Mesh of the stringer cross-section.

The model utilizes continuum shell elements (SC8R) for the composite laminates, while solid brick and wedge elements (C3D8I, C3D6) are used for the short fibre filler material. The epoxy potting and aluminium rollers consist of solid brick elements with reduced integration (C3D8R) for better computational efficiency. The mesh of the stringer and skin cross-section is reported in Figure 5.3. Figure 5.3.

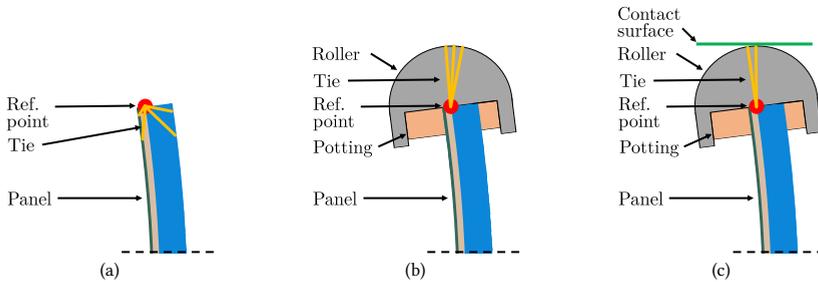
Figure 5.4: Comparison of the three approximations of the roller boundary conditions: (a) method 1, panel only; (b) method 2, roller; (c) method 3, roller with contact.

The roller boundary condition is approximated in three ways, as shown in Figure 5.4.

The first method utilises a reference point in the centre of the roller radius, as shown in Figure 5.4(a). This reference point is tied to the region of the panel that is inside the potting material, but no actual potting material is modelled. The reference point is constrained in all degrees of freedom except for rotation of the axis in the centre of the roller radius, and compression is applied in the longitudinal direction.

The second method models the potting and roller as shown in Figure 5.4(b). The panel, potting and roller are connected with shared nodes. There is a reference point in the centre of the roller radius, which is tied to a small region on the outside of the roller radius. This region is kept small to approximate a contact area. The reference point is free to rotate around the axis in the centre of the roller radius, compression is applied in the longitudinal direction, and the remaining degrees of freedom are constrained. The load is transferred from the reference point to the contact area through the rigid body ties. This method aims to approximate the application of compression through contact without the need for a contact definition and improves computational efficiency.

The third method adds contact between the roller and a contact surface to apply compression, as shown in Figure 5.4(c). This method still uses a reference point in the centre of the roller radius, which is tied to a region on the outside of the roller. This region is to the left of the initial contact point of the roller with the contact surface. It does

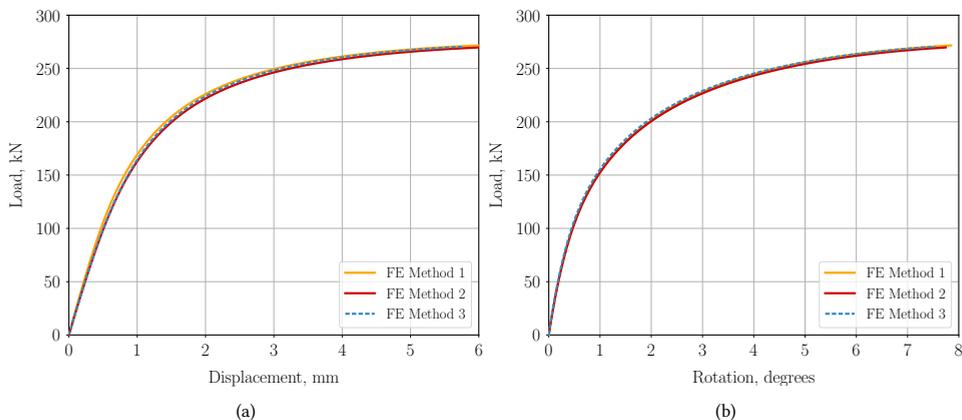
Figure 5.5: Load displacement (a) and rotation (b) curves of the analyses with different boundary conditions.

The load-displacement graph of the three analyses is reported in Figure 5.5(a). The difference in load-displacement behaviour is minimal between the three different boundary condition methods. Method 1 shows an initial higher stiffness compared to methods 2 and 3, but converges with method 3 at higher displacements. Method 2 matches with method 3 initially but shows a slightly lower load at higher displacements. The roller load-rotation of the three analyses is reported in Figure 5.5(b). Only the top roller rotation is reported for conciseness, as the rotation of both rollers is indistinguishable in the analysis. All analyses show similar behaviour, with method 3 initially presenting a higher rotational stiffness and method 2 a lower overall stiffness. The two outer stringers, stringers 1 and 5, displace in the lateral direction during loading, as illustrated in Figure 5.6(a). The maximum lateral displacement of stringer 1 and minimum of stringer 5 are reported in Figure 5.6(b) and (c), respectively. Method 2 and 3 have very similar behaviour, while method 1 has a higher stiffness, especially for stringer 1. This is most likely caused by the rigid body tie in the potting region of method 1, instead of the physical modelling of the potting for method 2 and 3.

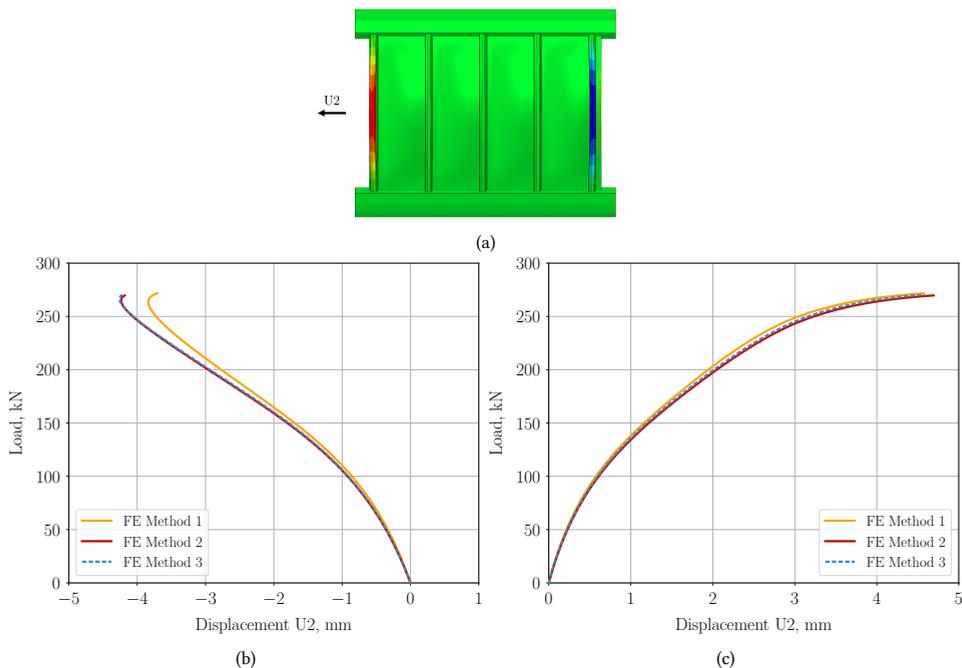
Figure 5.6: Load versus lateral displacement of the analyses with different boundary conditions: (a) contour plot FE method 2; (b) negative displacement; (c) positive displacement.

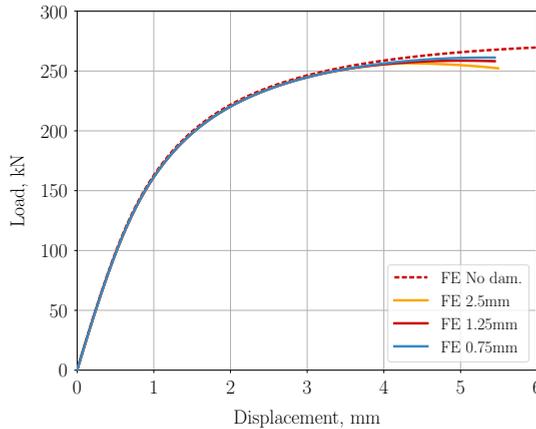
Figure 5.7: Load displacement curves of mesh-size sensitivity study of damage.

The load-displacement results are reported in Figure 5.7. The analyses with damage evolution start to show material softening at 2.56 mm of displacement for a mesh size of 2.50 mm, and at 2.50 mm of displacement for a mesh size of 1.25 and 0.75 mm, which can also be partially attributed to increment timing. At higher displacements, however, there is a sensitivity to mesh size, with a larger mesh size leading to more softening. The difference is more pronounced between the analysis with a mesh size of 1.25 and 2.5 mm, above an applied displacement of 4 mm. Consequently, the analysis results in the following sections are obtained using a mesh size of 1.25 mm.

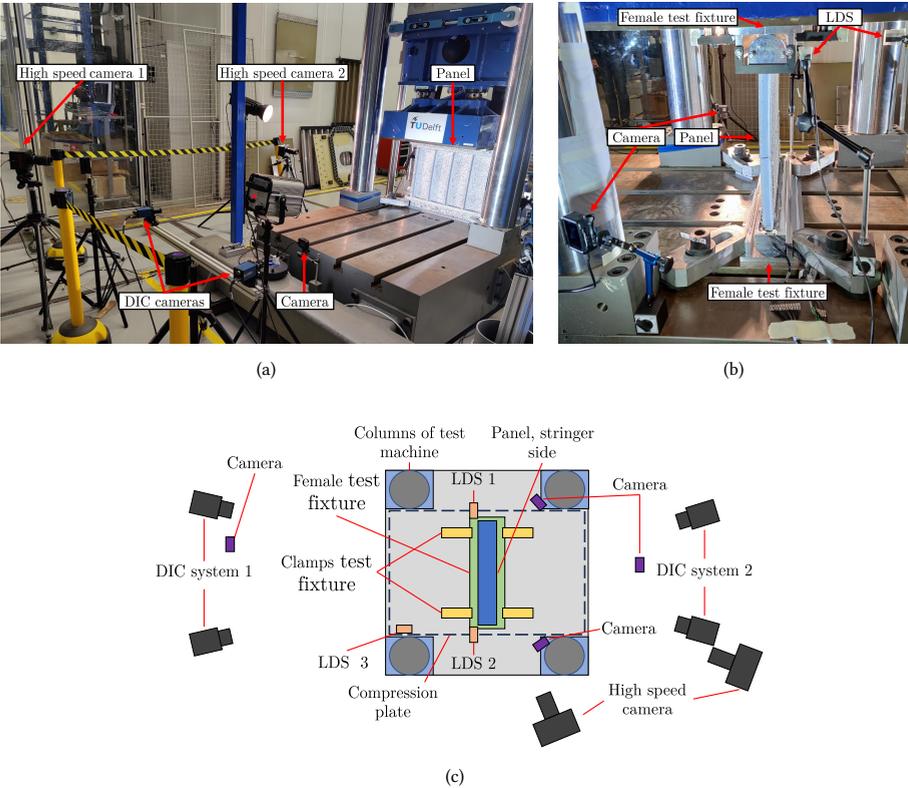
Figure 5.8: Test setup: (a) stringer side; (b) side-view; (c) top-view illustration.

The experimental test setup is shown in Figure 5.8 from the stringer-side of the panel (a), from the skin side (b) and with a top-view illustration (c). A female test fixture is clamped to the top compression plate and base of the test machine. The female test fixture is a machined aluminium profile with vertical uprights to limit the movement of the rollers, and to which white paint and black speckles are applied for Digital Image Correlation (DIC). The top and bottom female text fixtures are aligned such that the uprights on the right side, as seen in Figure 5.8(b), can be used to align the panel at the start of the test. The top fixture has hangers mounted to the side to catch the top roller in case of panel collapse. When compression is applied, the panel rolls to the left. When the panel fails, the female test fixtures are able to keep the panel in place. After panel alignment, a preload of approximately 2kN is applied to keep the panel in place.

The tests of panel 1 and panel 2 are executed at a loading rate of 0.25 mm/min. The force is measured by the load-cell of the MTS test machine and the displacement of the compression plate is measured by three Linear Displacement Sensors (LDS). Two LDS are placed next to the panel and one LDS is placed on the corner of the compression plate. The different locations allow to determine load imperfections, as shown in Figure 5.8(c). The displacement field of the panels is measured by two DIC systems, one system on the

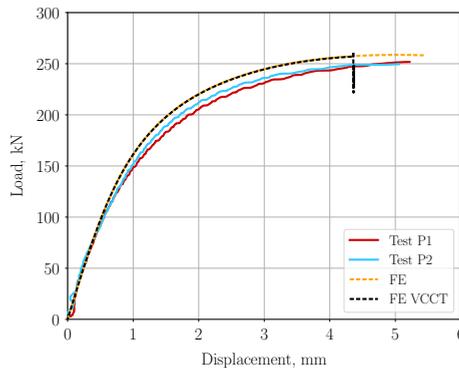
Figure 5.9: Load-displacement curves from tests and numerical analysis.

The load-displacement curves of the tests and numerical analysis are reported in Figure 5.9. The panels show a decreasing stiffness due to the curved geometry and roller boundary condition, clearly seen at loads above approximately 120 kN. At higher loads close to failure, the load-displacement behaviour starts to plateau. The stiffness of panel 1 and panel 2 are similar. The stiffness of panel 1 is slightly lower between approximately 1 and 4 mm of displacement, which can be caused by material softening due to the pretest. Panel 1, with BVID, fails at a load of 251 kN and 5.22 mm of displacement, while panel 2 fails at a load of 249 kN and 5.06 mm of displacement. Unexpectedly, the panel with BVID shows a slightly higher failure load and displacement, which indicates that the BVID is not critical for the failure mode that causes the collapse.

The numerical analysis predicts the initial stiffness well, but above 100 kN it starts to over-predict the stiffness. However, the plateau behaviour at higher loads is predicted well. The analysis with VCCT is conservative in predicting failure due to skin-stringer separation, which did not appear to be the critical failure mode in the test. The following sections, therefore, only show results from the analysis without VCCT.

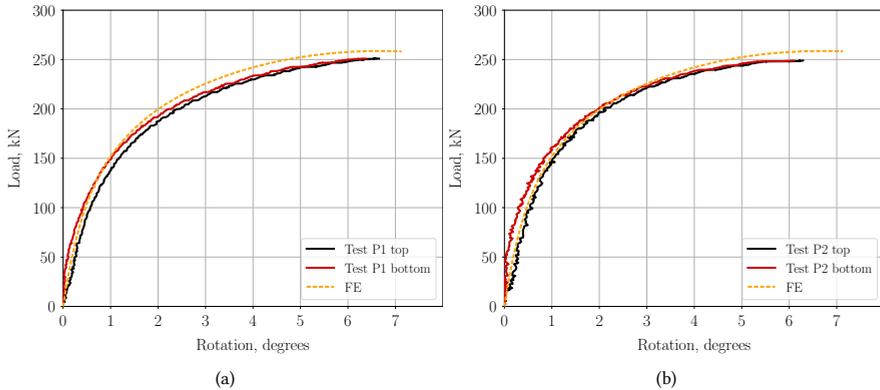
Figure 5.10: Load-rotation curves from tests and numerical analysis: (a) panel 1; (b) panel 2.

tests, which stays constant after settling. Panel 1 seems to have a slightly lower amount of rotation than panel 2, indicating a higher bending stiffness.

The numerical analysis predicts the rotation of the rollers well, with an under-prediction of the rotation at higher loads, above approximately 1.5 and 3 degrees of rotation for panels 1 and 2, respectively.

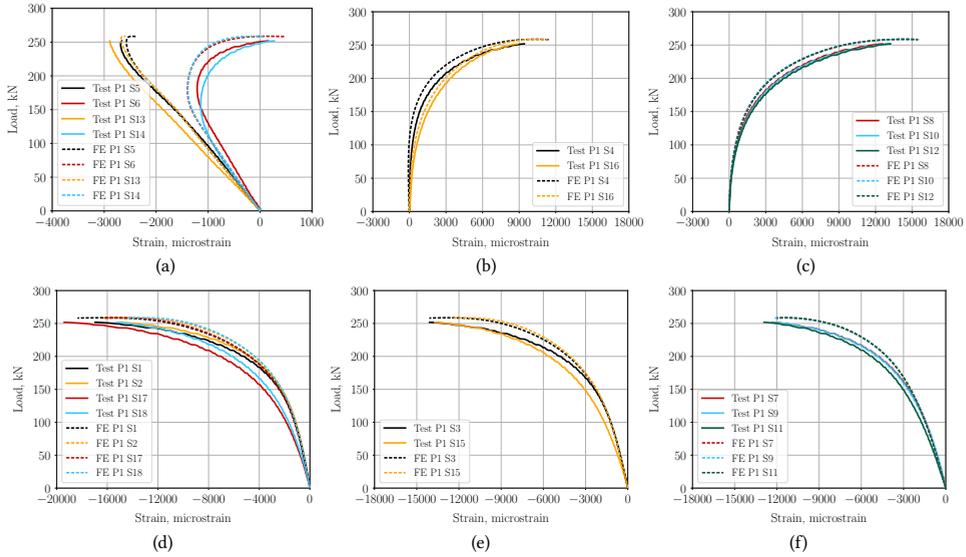
Figure 5.11: Experimental and numerical compressive strains of panel 1 with initial damage: (a) bays; (b) top of side stringers; (c) top of middle three stringers; (d) free edges; (e) bottom of side stringers; (f) bottom of middle three stringers.

The measured strains of the test till failure of panel 1 are reported in Figure 5.11. The strains measured by the skin strain gauges show negative strains, indicating compression, and the strain gauges on top of the stringer webs show positive strains, indicating tension. This is due to the combined compression and bending loading. The strains also reach higher values than the more typical compression tests, with strains up to 19400 microstrain. The strains show a slight loading imperfection in the skin, while the stringers are equally loaded. The outer stringers, strain gauges 4 and 16, do show differences, but this can also be caused by geometric differences instead of a loading imperfection. The highest strains are in the stringer area and free edges, with lower strains in the middle of the bay.

The numerical analysis predicts the overall behaviour well, with a similar over-prediction of stiffness, and thus under-prediction of strain, at higher loads as for the load-displacement curves. The analysis does not consider loading imperfections, which is most noticeable for strain gauges 17 and 18. The strains in the stringer region seem slightly better predicted than in the skin region.

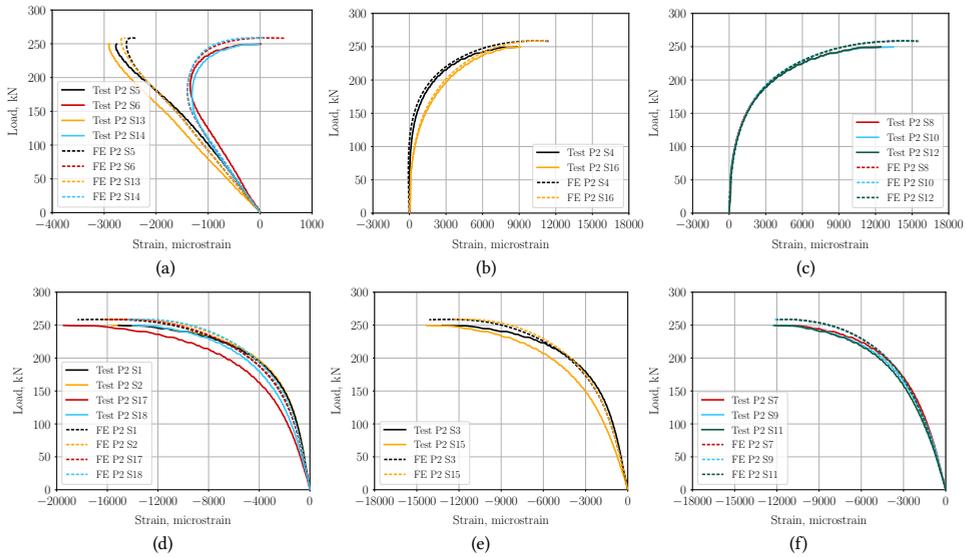
Figure 5.12: Experimental and numerical compressive strains of panel 2 in pristine condition: (a) bays; (b) top of side stringers; (c) top of middle three stringers; (d) free edges; (e) bottom of side stringers; (f) bottom of middle three stringers.

The measured strains of the test till failure of panel 2 are reported in Figure 5.12. The behaviour is very similar to panel 1. When the results of strain gauge 10 and 11 are compared between panel 1 and 2, no clear influence of the BVID of panel 1 can be distinguished.
