Thermoplastic composite stiffened structures in post-buckling

van Dooren, K.S.

Dissertation

Keywords: Thermoplastic composite, post-buckling, skin-stringer separation, stiffened panels, welding, butt-joint, testing, damage tolerance, finite element, virtual crack closure technique

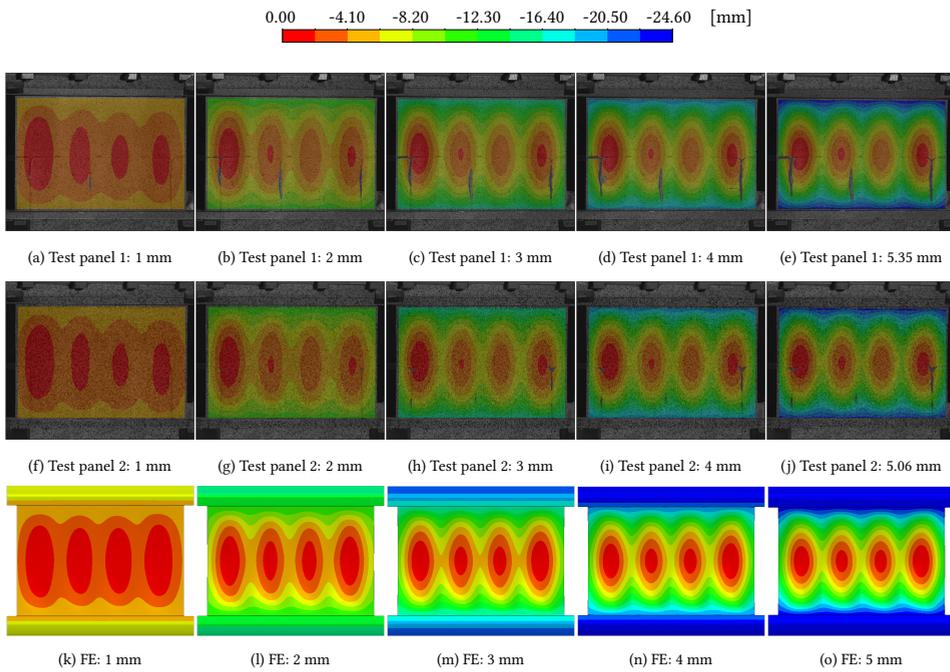
Figure 5.13: Out-of-plane displacement: (a-e) test panel 1; (f-j) test panel 2; (k-o) FE.

The out-of-plane displacement of the skin is measured during the tests by DIC, and is reported in Figure 5.13. Negative displacement corresponds to an outward direction, and positive displacement corresponds to an inward direction, in line with the axis system reported in Figure 5.2(b). The scale of the contour plot is based on the out-of-plane displacement of the skin at the maximum load. For each plot, an offset is applied to the displacement field, such that the scale's maximum is at the maximum out-of-plane displacement point of the panel. This eliminates the contribution of the rolling motion of the panels to the out-of-plane displacement and results in a clearer comparison.

The out-of-plane displacement of the test of panel 1 is plotted in Figure 5.13(a-e) in steps of 1 mm of longitudinal applied displacement and at the maximum applied displacement. The panel shows a single half-wave in each bay, with the highest out-of-plane displacement at the left side of the panel. The evolution of the out-of-plane displacement is gradual, with an exponential increase of displacement w.r.t. the load. The three bays on the right initially have similar out-of-plane displacement, but at higher applied displacement, the bay on the rightmost side starts to have higher displacement than the middle two bays. At the maximum applied displacement, the difference in out-of-plane displacement is 2-2.5 mm between the middle two bays and most left bay, and a 1 mm difference between the most left and right bay. These differences can be due to loading imperfections but are also due to geometric differences. The middle two bays are stiffer due to the adjacent bays, while the two outside bays have a free edge nearby. The difference between the most left and right bay is partly due to the anti-symmetric stringer, which provides more stiffness when the cap is pointed towards the bay. In terms of loading imperfections, the differences can be due to both the difference in applied compression between left and right, in terms of roller rotation and the resulting out-of-plane displacement of the roller itself. With only a 1 mm difference in out-of-plane displacement between the most left and right bay, and considering the geometric differences, the loading imperfections are estimated to be small.

The out-of-plane displacement of the test of panel 2 till failure is plotted in Figure 5.13(f-j). The out-of-plane displacement behaviour of panel 2 is similar to panel 1, in terms of total out-of-plane displacement and the differences between the four bays. There is no visible difference in the out-of-plane displacement of panel 1 and 2 due to the BVID of panel 1.

The out-of-plane displacement of the numerical prediction is reported in Figure 5.13(k-o). The numerical analysis accurately predicts the out-of-plane displacement behaviour, with only minimal differences due to loading and geometric imperfections not considered in the analysis. The differences between the bays are lower than what is measured in the tests, with the most left and right bay having a 0.3 mm difference in out-of-plane displacement at 5 mm of applied displacement, and the middle two bays a 1 mm difference compared to the outer bays.

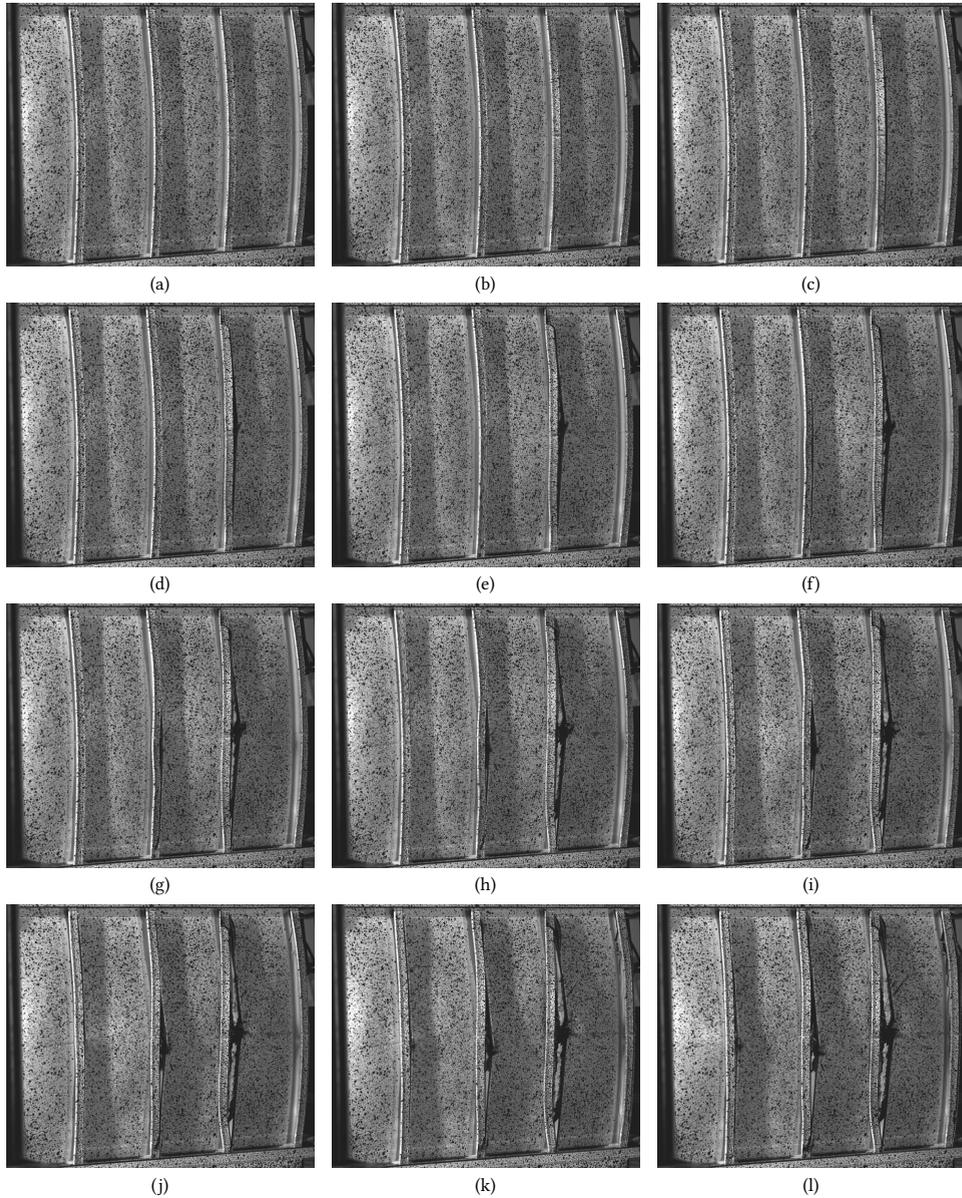
Figure 5.14: High-speed footage panel 1: (a-b-c) stringer 4 cap separation; (d) stringer 4 web fracture; (e-f) stringer 4 cap separation; (g) stringer 3 web fracture; (h) stringer 2 cap separation; (i) stringer 5 butt-joint failure; (j-k) stringer 2 web fracture, stringer 5 cap separation; (l) stringer 5 web failure.

The panel collapse sequence of panel 1 is reported in Figure 5.14 over a total time period of 1.1 ms. Panel collapse starts with the cap separating from the web of stringer 4 (a), the stringer with a BVID in the butt-joint skin-stringer interface. The cap completely separates in the following two frames and fractures at the top of the panel (b-c), followed by failure of the web (d). Then, the cap of stringer 3 separates from the web (e), and the cap fractures at the bottom of the panel (f). The web of stringer 3 fails next, and the web of stringer 2 shows delaminated plies at the web-cap interface (g). The cap of stringer 2 then separates almost completely from the web within one frame (h). The butt-joint of stringer 5 is the first visible skin-stringer interface that shows failure (i), with the failure occurring at the top of the panel. Due to the separation of the caps from the webs, most butt-joints can no longer be seen. After the butt-joint failure, the cap of stringer 5 separates from the web, simultaneously with the web fracture of stringer 2 (j-k). Lastly, the web of stringer 5 fails (l).

The frames of the high-speed footage are further analysed. When the caps separate from the web, the caps displace towards the skin in the middle of the panel. The caps hit the skin once or multiple times, with the skin also displacing out-of-plane in waves. When web fracture occurs, a few caps detach further and pull partially out of the potting material. After failure is completed, the caps return close to their initial position.

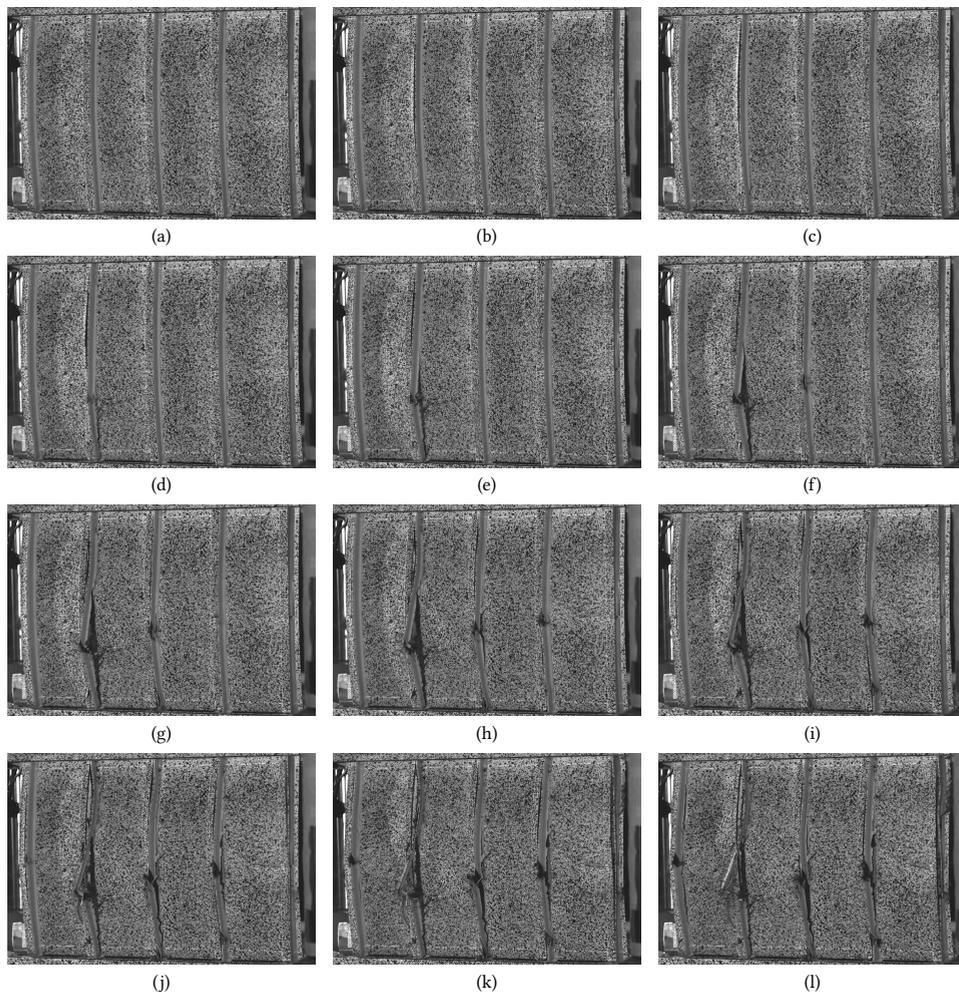
Figure 5.15: High-speed footage panel 2: (a-b) stringer 2 cap separation; (c) stringer 2 butt-joint failure; (d) stringer 2 web fracture; (e) stringer 3 cap separation; (f) stringer 3 butt-joint and web failure, stringer 4 cap separation; (g) stringer 4 butt-joint failure; (h-i) stringer 4 fracture, stringer 1 cap separation; (j) stringer 5 cap separation, stringer 1 web fracture; (k) stringer 1 and 5 butt-joint failure; (l) stringer 5 web fracture.

The panel collapse sequence of panel 2 is reported in Figure 5.15 over a total time period of 2.3 ms, as every 2nd frame is reported. Panel collapse starts with the separation of the cap of stringer 2 in the middle of the panel (a-b), with a fracture in the cap at the bottom of the panel. The butt-joint of stringer 2 then separates from the skin at the bottom of the panel (c), which grows in an upward direction and is followed by fracture of the web (d). The cap of stringer 2 then separates from the web and fractures at the bottom of the panel (e). The butt-joint of stringer 2 fails at two locations, in the middle and bottom of the panel, and the web fractures (f). In the same frame, the cap of stringer 4 starts to separate, followed by further separation and fracture of the cap and failure in the butt-joint (g). The web of stringer 4 then separates, while the cap of stringer 1 also separates from the web (h-i). The web of stringer 1 then fails and the cap of stringer 5 separates from the web (j). The butt-joint of both stringer 1 and 5 then fails (k), and lastly, the web of stringer 5 fractures (l).

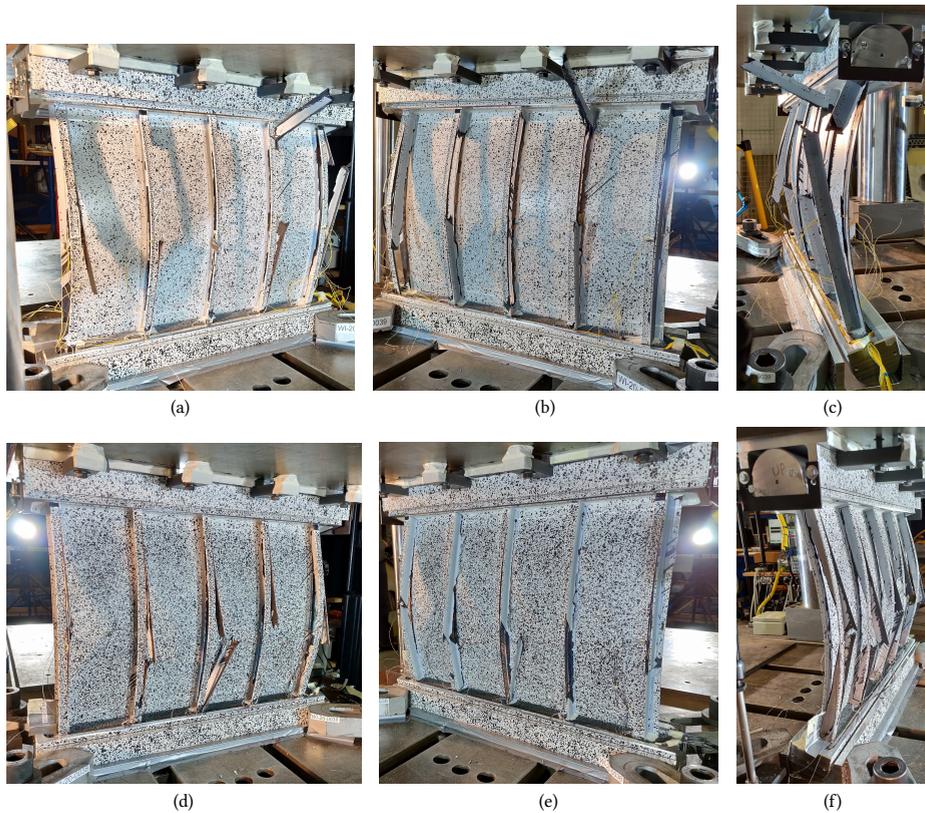
Figure 5.16: Post-failure photos: (a) panel 1 left-view; (b) panel 1 right-view; (c) panel 1 side-view; (d) panel 2 left-view; (e) panel 2 right-view; (f) panel 2 side-view.

Photos of panel 1 after failure are reported in Figure 5.16(a-c). The caps, once separated from the webs, show fractures in several locations. The caps of stringers 1, 2 and 5 are also partially pulled out from the potting material. The failure between cap and web seems to occur in two different ways, with the top ply of the web being delaminated and pulled off partially, and with separation between web and the short fibre filler. In the middle of the panel, it seems that failure and delamination of the web plies is more common, with small pieces of the ply still attached to the cap, while towards the top and bottom of the panel, failure occurs at the interface between the web and short fibre filler. All the webs separated from the skin at the butt-joint. The webs present one or more fractures in each web and parts of the web are no longer attached to the panel. The failure in the web and skin region is mostly in the butt-joint. Stringer 1 has a part of the ply delaminated from the skin at the bottom of the panel, and the remaining butt-joints only show minimal pulled-off fibres. Failure in the butt-joint can be roughly divided into three types of failure: failure at the interface between skin and butt-joint, failure in the short fibre filler and failure at the interface between web and butt-joint. There are no visible fractures in the skin, but there is likely damage inside the laminate. There are indications of damage at the back of the skin, with paint chipped off.

Photos of panel 2 after failure are reported in Figure 5.16(d-f). The failure modes, that are initially visible, are similar to panel 1. Stringer 2 fails first and has considerable amounts of fibre pullout from the skin, especially towards the top of the panel. The biggest difference, however, is that the edge of the skin, on the side of stringer 5, shows a large fracture. A close-up picture of this fracture is reported in Figure 5.17. The skin is fractured across the thickness of the laminate and has a visible length of approximately 60 mm as seen from the stringer-side of the panel. Further propagation is visible on the back side of the skin, with propagation in a downward direction, leading to a total visible length of approximately 100 mm.

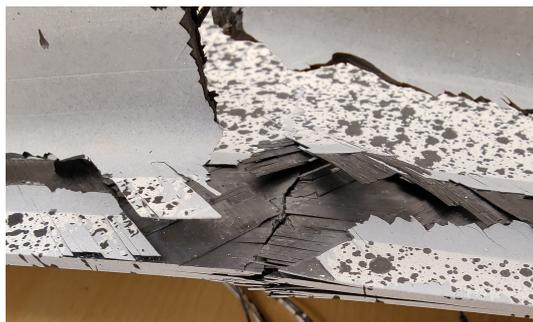
Figure 5.17: Skin fracture of panel 2.

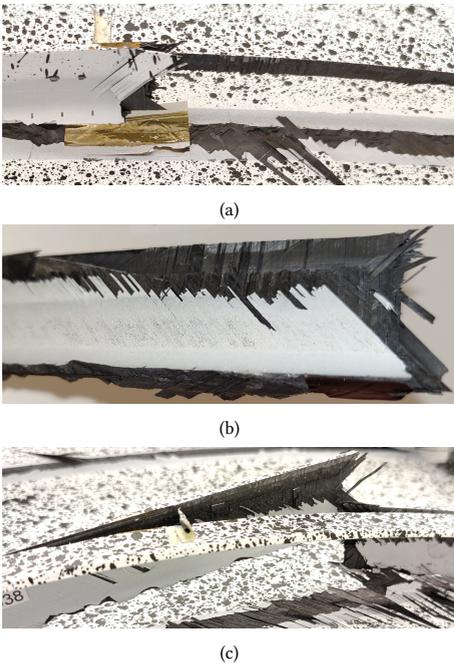
Figure 5.18: Fracture photos: (a) panel 1 web and stringer; (b) panel 1 web; (c) panel 2 web and cap.

Both panels show failure first in the web-cap joint area. The cap-web failure of panel 1 occurs in the stringer with a BVID in the butt-joint, but the BVID itself is not necessarily critical, with no indication of crack growth before panel collapse. From panel 1, a close-up of the stringer 4 cap and of the web is reported in Figure 5.18(a-b). There are web plies still attached to the cap, both the -45 ply and parts of the 90 ply, which indicate that the critical failure mode is a combination of both the failure of these plies and delamination. Panel 2 fails in stringer 2, and the criticality of this stringer out of the three middle stringers is most likely due to imperfections. The stringer 2 web of panel 2, as reported in Figure 5.18(c), shows similar damage as stringer 4 of panel 1. The 45 ply is visible at the top of the web, as the -45 ply and 90 ply present failure as well as delamination, indicating the same failure mode as panel 1.

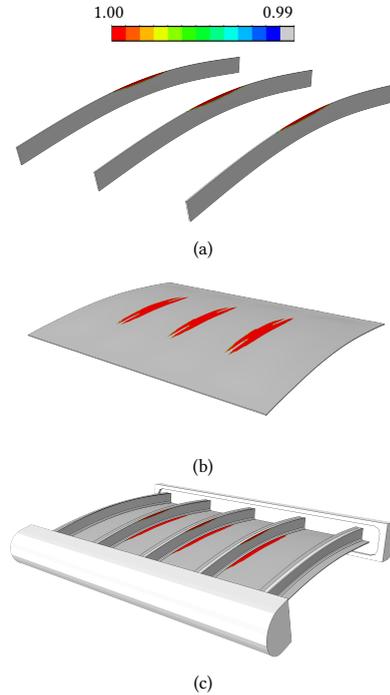
Figure 5.19: Matrix tensile damage variable contour plot, at 5.26 mm of displacement: (a) middle three webs; (b) skin; (c) panel.

Although the numerical model is not able to predict the sudden failure of the panel, as it does not take into account delamination between each ply, it is able to correctly identify the critical plies. Contour plots of the Hashin matrix tensile damage variable are reported in Figure 5.19 for the middle three webs (a), the skin (b) and the full panel (c). The top -45 ply is most critical in the web, closely followed by the 45 ply. At 5.26 mm of displacement, the area with a damage variable higher than 0.99 for the -45 ply reaches the bottom of the cap-web joint. This means that the short fibre filler joint is locally connected only to a failed ply, at the free edge of the web laminate.

The skin also has areas with a damage variable above 0.99, and the top 45 ply is the most critical. However, this can be considered less critical than the web, as the top skin plies are in tension, with no free edge and continuous fibres underneath the joint, making it less likely for this ply to delaminate compared to the web plies.
