de Jong, A., Yang, Y., & Fennis, S. A. A. M. (2025). Assessing the Structural Integrity of Concrete Half-joints Using Sensor Data. In D. Leonetti, H. H. Snijder, B. De Pauw, & S. van Alphen (Eds.), *IABSE Congress Ghent 2025: The Essence of Structural Engineering for Society* (pp. 99-107). International Association for Bridge and Structural Engineering (IABSE).

Half-joints in concrete bridges are known to exhibit an increased rate of degradation. Their main vulnerability is situated in the re-entrant corner, buried deep inside the joint. This makes visual inspection nearly impossible. A Structural Health Monitoring (SHM) system offers a promising alternative, but interpretation of the half-joint status from SHM data is not straightforward. The study presented in this paper is a case study of the SHM system on the Naardertrekvaart bridge in the Netherlands. Analysis of SHM data revealed a dependence of the movement of the bridge on a seasonal temperature cycle, presumably caused by hindered thermal contraction of the half-joints. This phenomenon offered no reliable estimation of the half-joint status. In addition, from the movement of the lower half-joint nibs under traffic loads,

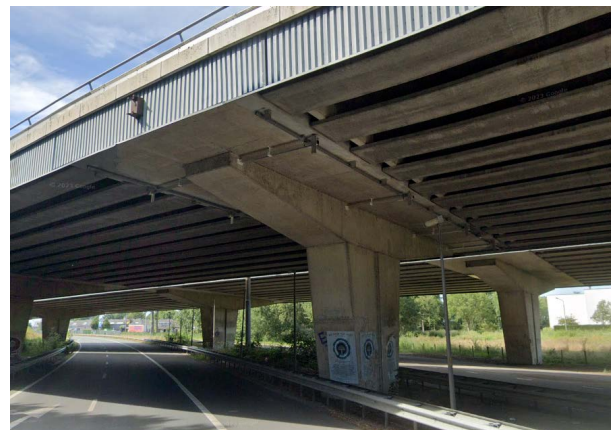
Figure 3: Street view image of support 5 of the southern Naardertrekvaart bridge (Google Maps)

bridges contain 11 supports and 10 spans, of which 9 standard spans and 1 divergent span between support 3 and 4. Both bridges are slightly slanted [3]. Each span of the bridge is composed of 11 prefabricated, prestressed longitudinal girders, which are connected to the supports using half-joints. The supports are composed of a column and a platform, as can be seen in Figure 3.
