de Jong, A., Yang, Y., & Fennis, S. A. A. M. (2025). Assessing the Structural Integrity of Concrete Half-joints Using Sensor Data. In D. Leonetti, H. H. Snijder, B. De Pauw, & S. van Alphen (Eds.), *IABSE Congress Ghent 2025: The Essence of Structural Engineering for Society* (pp. 99-107). International Association for Bridge and Structural Engineering (IABSE).

Half-joints in concrete bridges are known to exhibit an increased rate of degradation. Their main vulnerability is situated in the re-entrant corner, buried deep inside the joint. This makes visual inspection nearly impossible. A Structural Health Monitoring (SHM) system offers a promising alternative, but interpretation of the half-joint status from SHM data is not straightforward. The study presented in this paper is a case study of the SHM system on the Naardertrekvaart bridge in the Netherlands. Analysis of SHM data revealed a dependence of the movement of the bridge on a seasonal temperature cycle, presumably caused by hindered thermal contraction of the half-joints. This phenomenon offered no reliable estimation of the half-joint status. In addition, from the movement of the lower half-joint nibs under traffic loads,

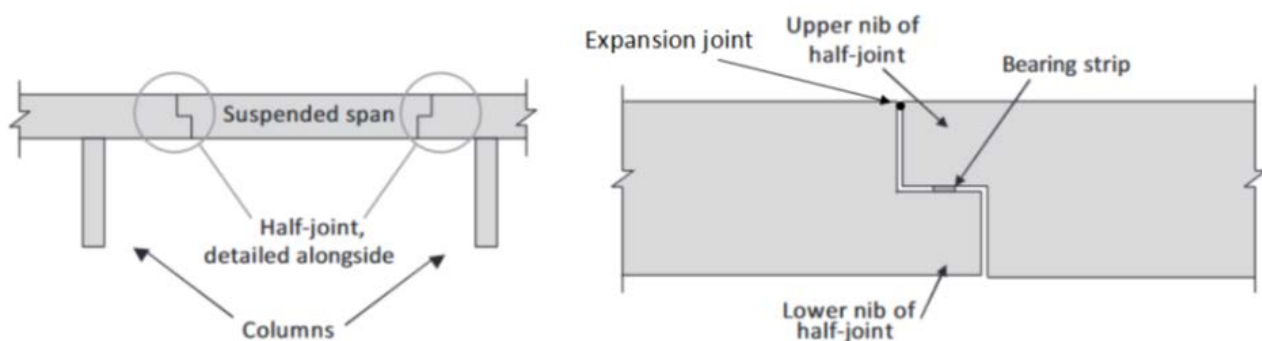
The half-joint, also known as the Gerber saddle or Gerber joint, was first introduced by Heinrich Gottfried Gerber, a German Engineer [1,2]. It is a type of joint that can frequently be found in concrete bridges. This type of joint consists of a lower nib connected to the support, and an upper

nib connected to the span, as shown in Figure 1. Loads are generally transferred from the upper nib to the lower nib. This type of joint gained some popularity between 1960 and 1970, mainly due to its ability to facilitate a more slender design of the superstructure. Currently, over 100 of the bridges in the Netherlands in possession of Rijkswaterstaat contain half-joints [3].

Figure 1: Half-joint principle for reinforced concrete bridges, edited [15]

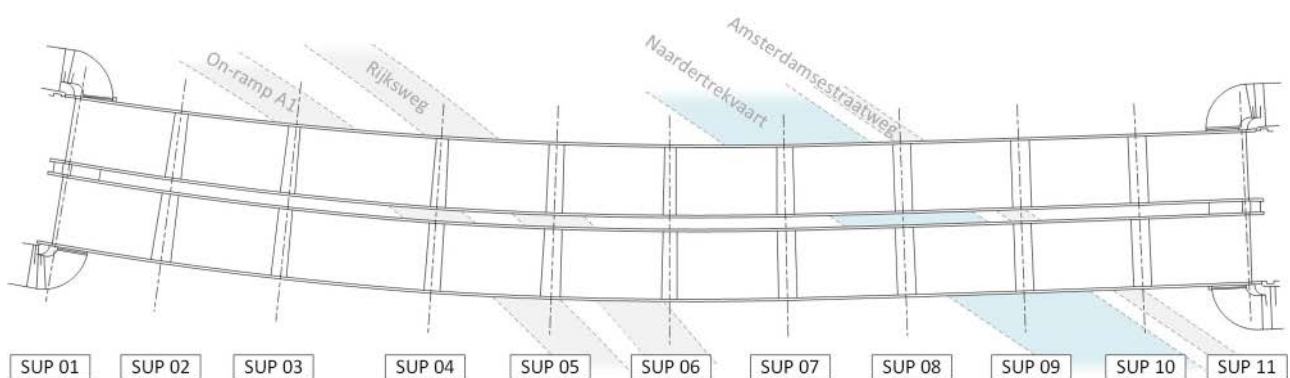
Figure 2: Top view schematic of the Naardertrekvaart bridge

The Naardertrekvaart bridge was constructed in 1969, and is part of the A1 highway in the Netherlands. It consists of two separate bridges, a northern and a southern bridge. A schematic top view of the bridge can be found in Figure 2. Both

bridges contain 11 supports and 10 spans, of which 9 standard spans and 1 divergent span between support 3 and 4. Both bridges are slightly slanted [3]. Each span of the bridge is composed of 11 prefabricated, prestressed longitudinal girders, which are connected to the supports using half-joints. The supports are composed of a column and a platform, as can be seen in Figure 3.

The uncertainty of the state of the half-joints led to the placement of an SHM system in 2022. This monitoring system takes measurements of the rotation and vertical displacement of the lower nib of the four half-joints at support 5 and 6, visible in Figure 2. Measurements are taken at multiple locations along the width of the bridge. The measurement sensors are intrinsically thermally compensated. It also takes temperature measurements to enable filtering out the thermal influences on the measurement data. Figure 4 shows the SHM setup at one measurement location. The inclinometers are mounted directly onto the concrete, while the displacement sensors are installed on a metal rod, mounted to the support column. The thermometers measure the temperature of the metal rod, and the temperature of the concrete on the sides of the bridge. The total setup of the SHM system can be found in Figure 5.

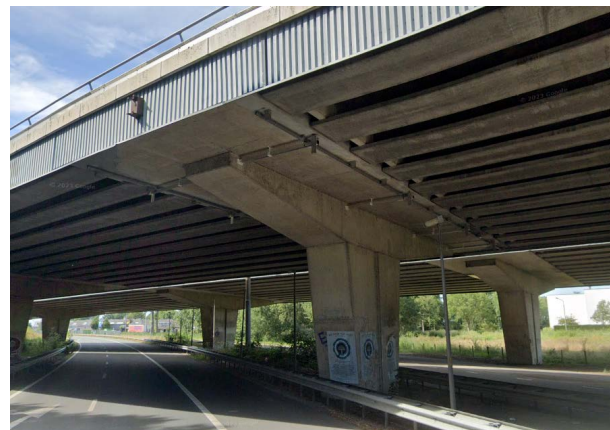
Figure 3: Street view image of support 5 of the southern Naardertrekvaart bridge (Google Maps)

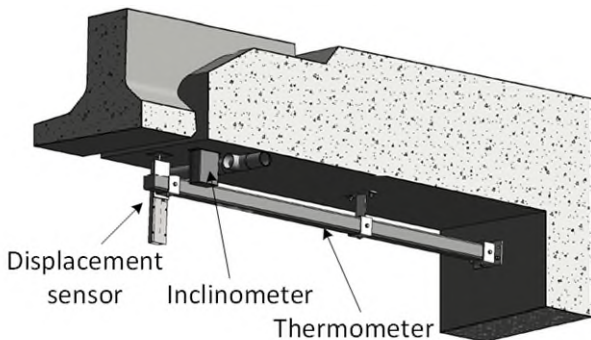
Figure 4: Sensor setup at a measurement location [16]

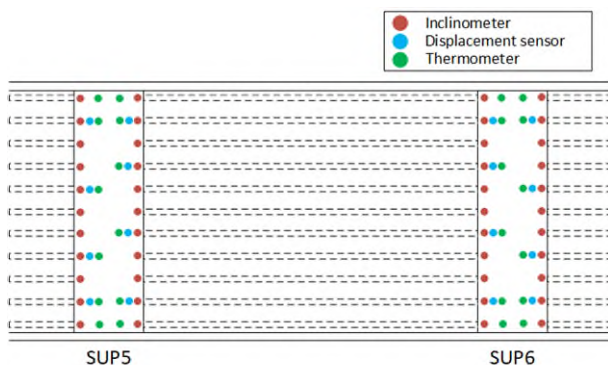
Figure 5: Locations of the sensors of the SHM system

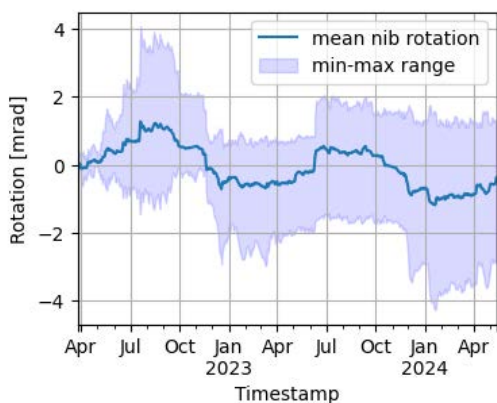
The graph in Figure 6 shows the long-term rotation of the lower half-joint nibs. The measurement data exhibit a slight downward trend. The cause of this downward trend is likely related to the inaccuracy of the measurement system. In addition to the downward trend, the measurement data exhibit a noticeable annual fluctuation. Analysis of the correlation plot in Figure 7 reveals a clear positive correlation between the outside temperature and the observed rotation of the lower half-joint nibs.

Figure 6: Overall rotational behaviour observed by the inclinometers

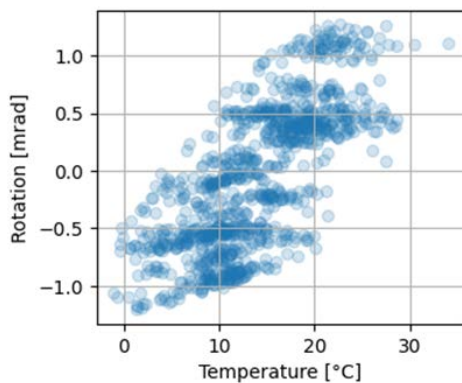
Figure 7: Correlation plot of the rotation and temperature data

This observation suggests that the lower nibs of the half-joints rotate upwards during periods of high temperatures, and rotate downwards during periods of low temperatures. The inference of the status of the half-joints from the dependence of the nib rotation on temperature is described in the following section.

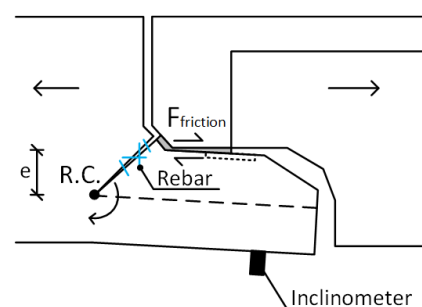
To explain the fluctuating behaviour of the rotation of the lower half-joint, multiple phenomena were investigated. Only one of these phenomena seemed promising in doing so [3]. This phenomenon is characterised by the presence of a contact surface inside of the half-joint. In a conventionally designed half-joint bridge, elastomeric bearings are placed between the girders and the support platforms. These bearings are implemented to facilitate free horizontal movement between the two structural components and should therefore be the only point of contact between the spans and the supports. However, inspections of the physical structure have indicated that there is insufficient vertical space between the transversal end-beams and the lower half-joint nib. A schematic of the situation is shown in Figure 8. Direct contact between the elements can result in the buildup of a horizontal friction force between them when temperature changes cause thermal expansion or contraction. This friction force would result in a downward bending moment on the lower half-joint nib during times of low temperatures. The magnitude of the developed friction force is difficult to accurately estimate due to simultaneous dependence on vertical load on the joint, conditions of the contact surfaces and state of the reinforcement bars close to the re-entrant corner.

Figure 8: Schematic of nib rotation as a result of hindered thermal contraction of the structural elements

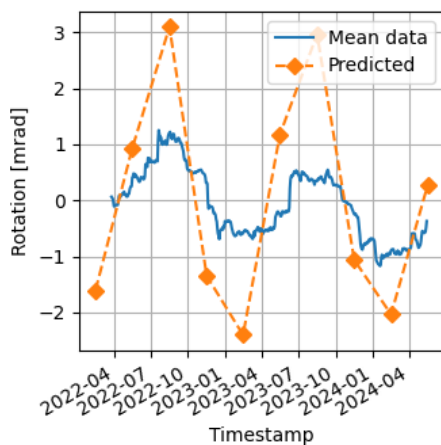
An estimation of the effect of this horizontal friction force on the rotation of the lower half-joint nib can be acquired by using a very simplified model of the half-joint system. The model simulates the connection between the lower half-joint nib and the platform as a linear elastic

rotational spring. Its stiffness is estimated based on a previously conducted FEM calculation by Ingenieursbureau Kok & Van den Heuvel [14]. It was assumed that the horizontal contact faces between the lower half-joint nib and the transversal beam do not slip. The predicted effect of friction force development on the rotation of the lower half-joint nibs in combination with the average rotation observed by the inclinometers can be found in Figure 9. Comparison of the observed and predicted effect shows that the prediction is an overestimation, but follows the same pattern. Although this is an indication that this phenomenon is taking place in the half-joints, the simplicity of the model of the half-joint makes it unfitting as an indicator of the structural integrity of the half-joints.

Figure 9: Predicted effect of hindered thermal contraction of the structural elements on rotation measurements, compared to the observed rotation

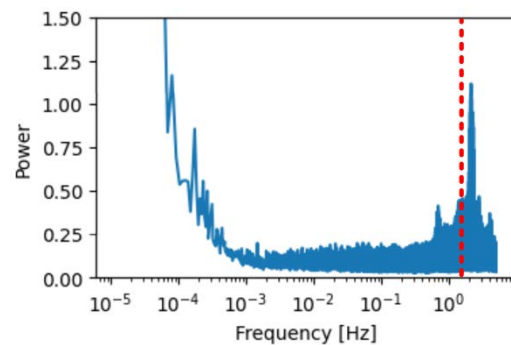
The high-frequency measurement data of the Naardertrekvaart contains the dynamic behaviour of the bridge, which the long-term dataset filtered out. The dynamic behaviour can be characterised by its power spectral density (PSD), which reveals the dominant vibration frequencies. The average PSD of all inclinometers is displayed in Figure 10. A clear peak can be observed at a frequency of approximately 2.2Hz. Repetitive traffic loading at a constant frequency could cause a visible peak in the PSD. However, as the average frequency of passing traffic during rush hour does not exceed 1.4Hz, the peak is likely to be caused by vibrations of the bridge system in one of its natural frequencies.

Figure 10: Average power spectral density of all inclinometers

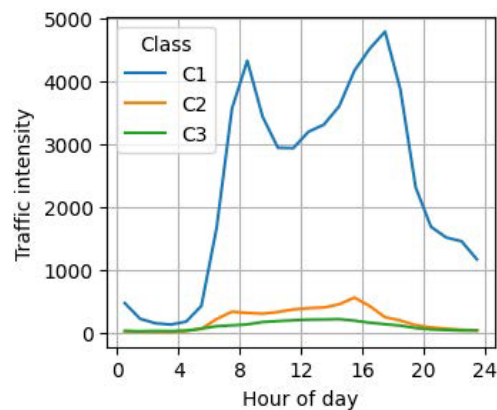
The weight of the vehicles crossing the bridge is unknown. Therefore, an estimation must be made of the average load on the lower half-joint nib per hour of the day. To make this estimation, a simulation is run using Python. This simulation pushes realistic axle loads over an influence line, representing the portion of the load on a bridge span that is being transferred to one of the half-joints. Realistic traffic loads are sampled from the database of the Bridge Weigh-in-Motion (WIM) system on the Moerdijkbrug, which is part of the A16 highway in the Netherlands. The amount of sampled vehicles is based on average hourly traffic intensity measurements by Rijkswaterstaat. The hourly traffic intensity measurements are shown in Figure 12, split up into three different weight classes. The definition of the three weight classes can be found in Table 1.

Figure 12: Average hourly traffic intensity on the Naardertrekvaart bridge
