THE TRAIL TOWARDS A MORE SUSTAINABLE ALPINE HUT.

A RENOVATION PROJECT FOR RIFUGIO CARDUCCI, 2297 MT., ALTA VAL GIRALBA, DOLOMITI.

P5 Drawing-set | 13-09-2021

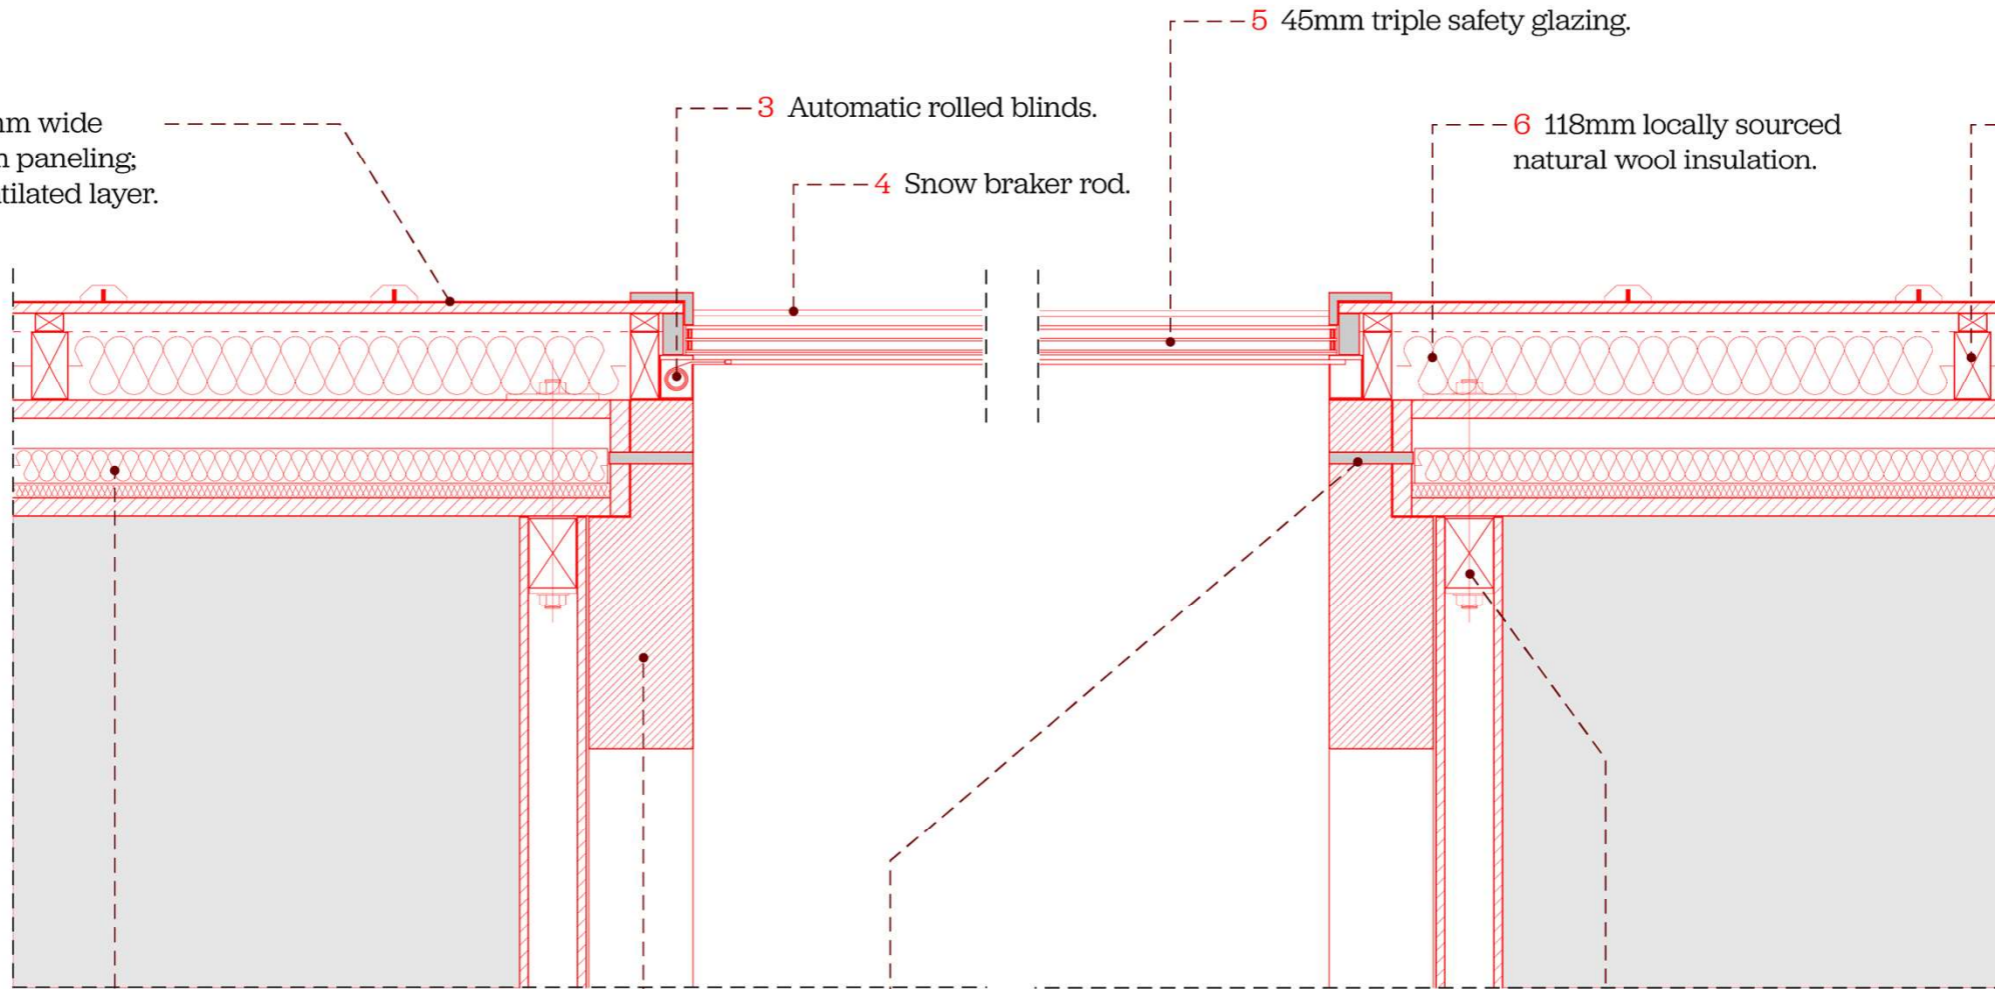
Roof-Superstructure-Corridor Glazing-Interior
boxes Detail.

1 Standing seam metal roofing 500mm wide panels; waterproof membrane; 18mm paneling; 50x30mm larch battens (85mm) ventilated layer.

3 Automatic rolled blinds.

4 Snow braker rod.

5 45mm triple safety glazing.

6 118mm locally sourced natural wool insulation.

7 118x60mm larch battens. 950mm spacing.

8 200mm Lignatur Surface element.

9 Superstructure:500x180mm Larch GLT Truss Frame.

10 20mm diameter larch dowel. Locking airlifted boxes to GLT timber frame.

11 Through bolted box structure.
