SHARED HERITAGE BANDUNG

TRANSFORMATION FRAMEWORK

HERITAGE & ARCHITECTURE

ANALYSIS OF HERITAGE & DESIGN

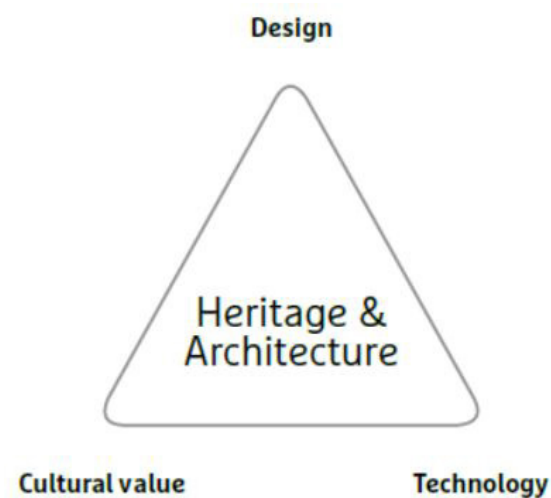
Figure 2. The heritage triangle (Kuipers & de Jonge, 2017)

Within the heritage framework, the project is assessed by three chairs, which work in close collaboration with each other; design, technology & cultural value, as shown in figure 2. From within these three angles, the basis for the continuity and preservation of the use of historical buildings is laid (Kuipers & de Jonge, 2017).

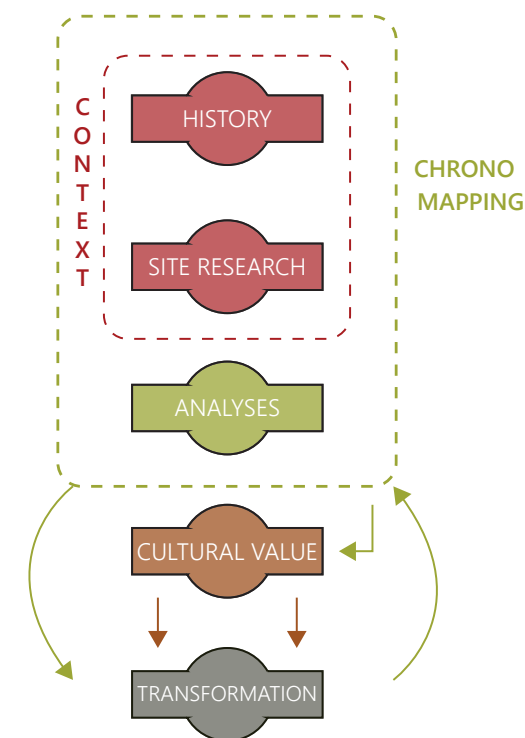
Figure 11. Diagram showing the iterative process between the different assets (own illustration)

The illustration below shows the process, from researching the context, to analyzing the different findings, leading to a problem statement and finally researching a suitable transformation as a solution for the problem statement. Even though I am already designing, it necessary to get feedback through research and analysis. This shows an iterative process between the 5 phases.¹

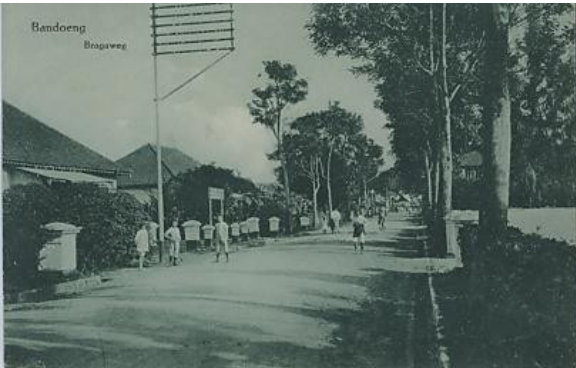
1902
Early buildings mainly from wood-
en constructions, in the center of
a large courtyard with protective
trees along this pad.

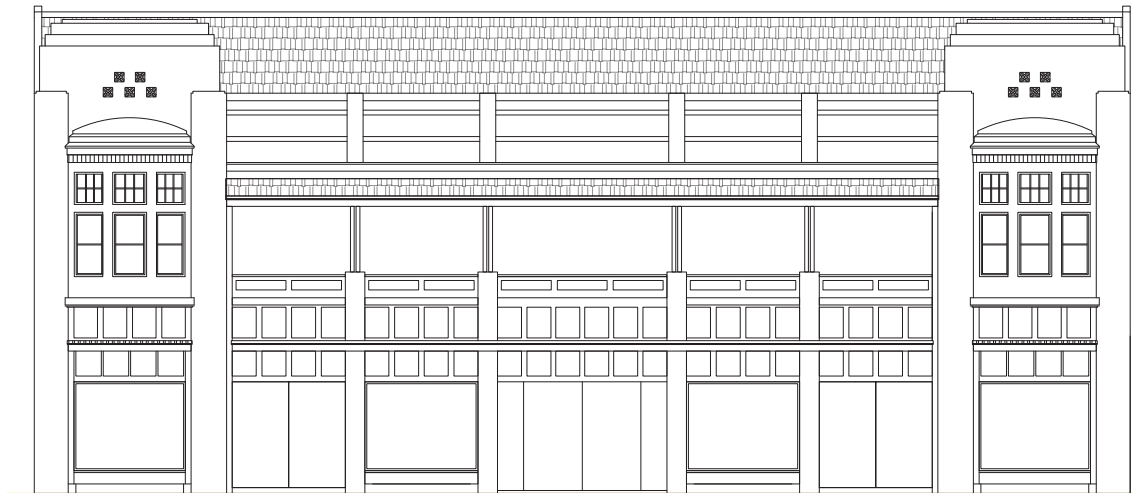
1920
A great deal of the original facade
had changed over time.

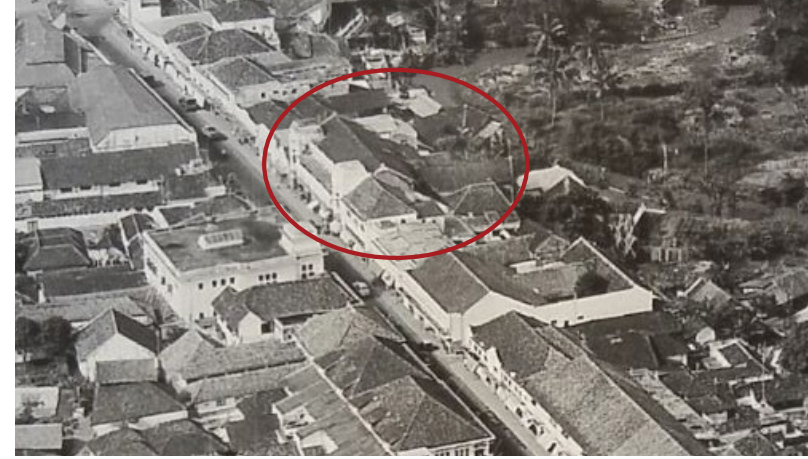
1946

It seems that the buildings in the back of Hellerman shop were there since a long time already. The question is if it was there from the start.

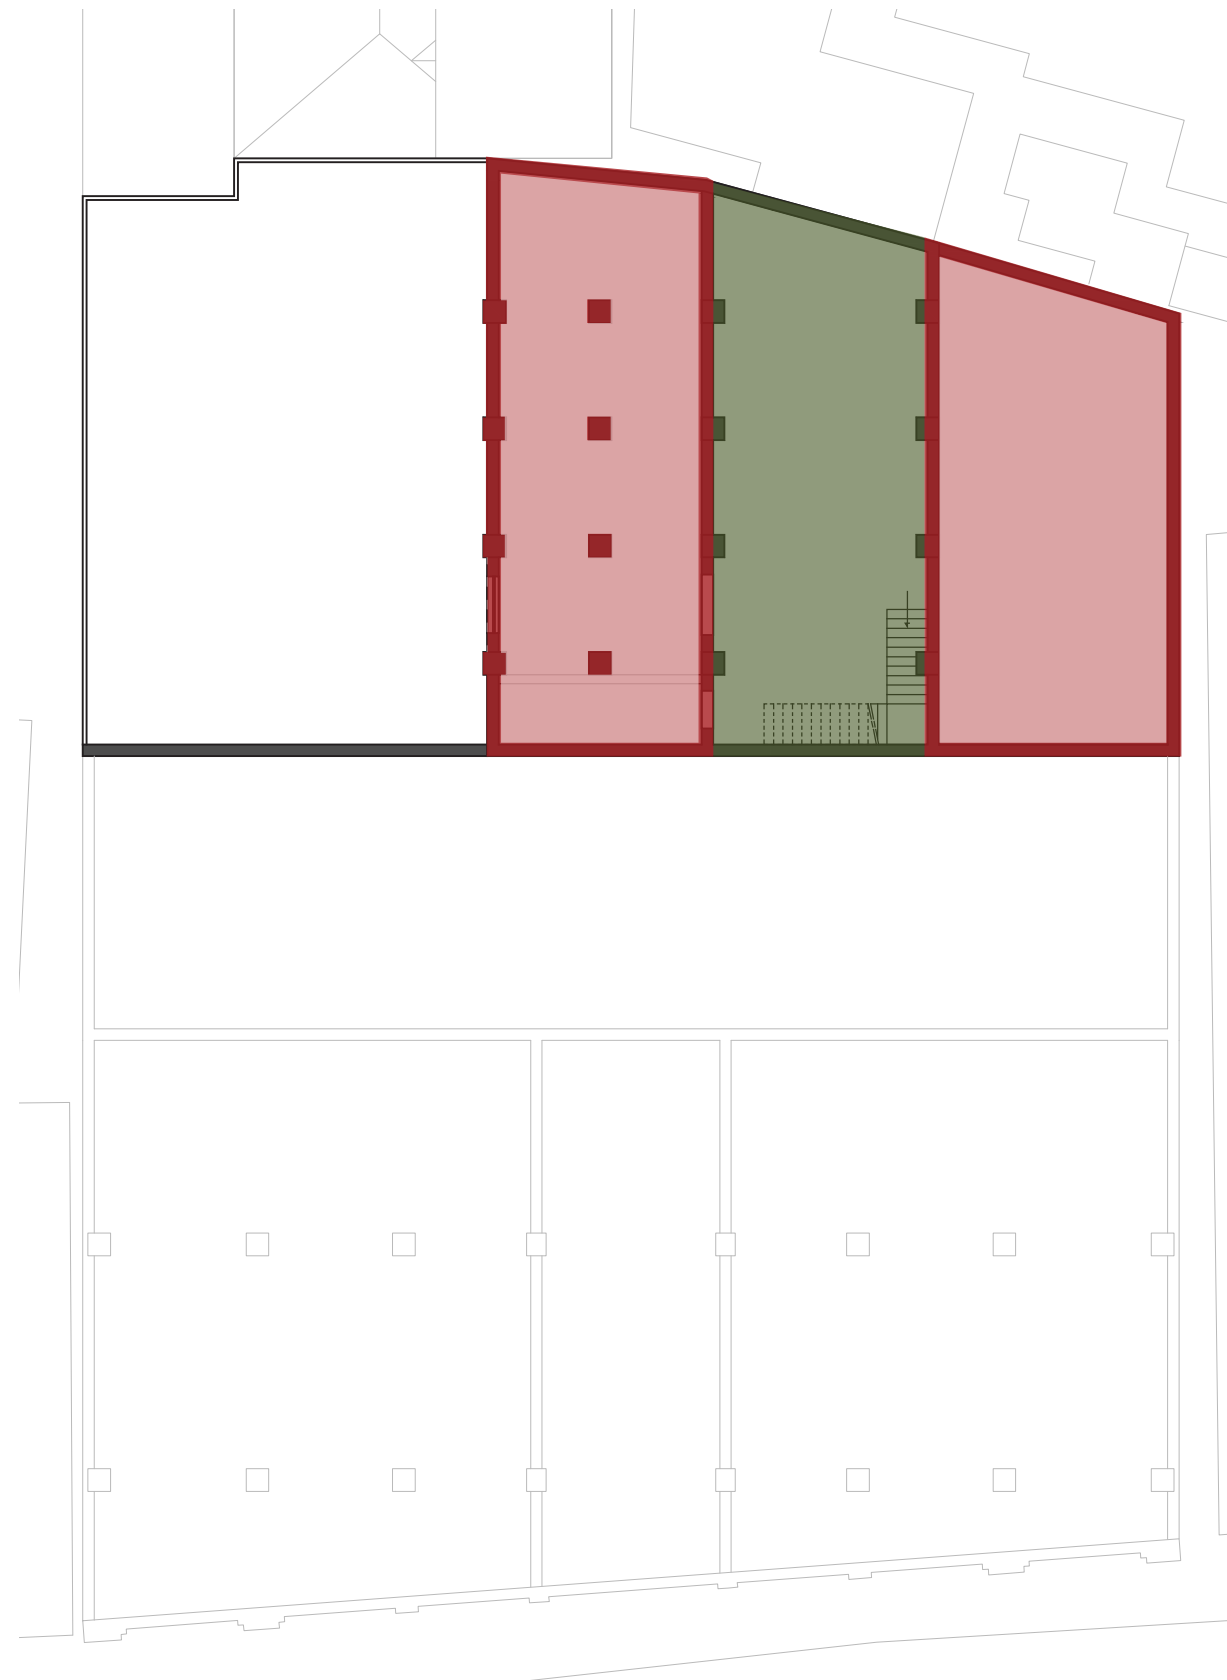
Semi-Basement

BUILDING DESIGN CHRONOMAP

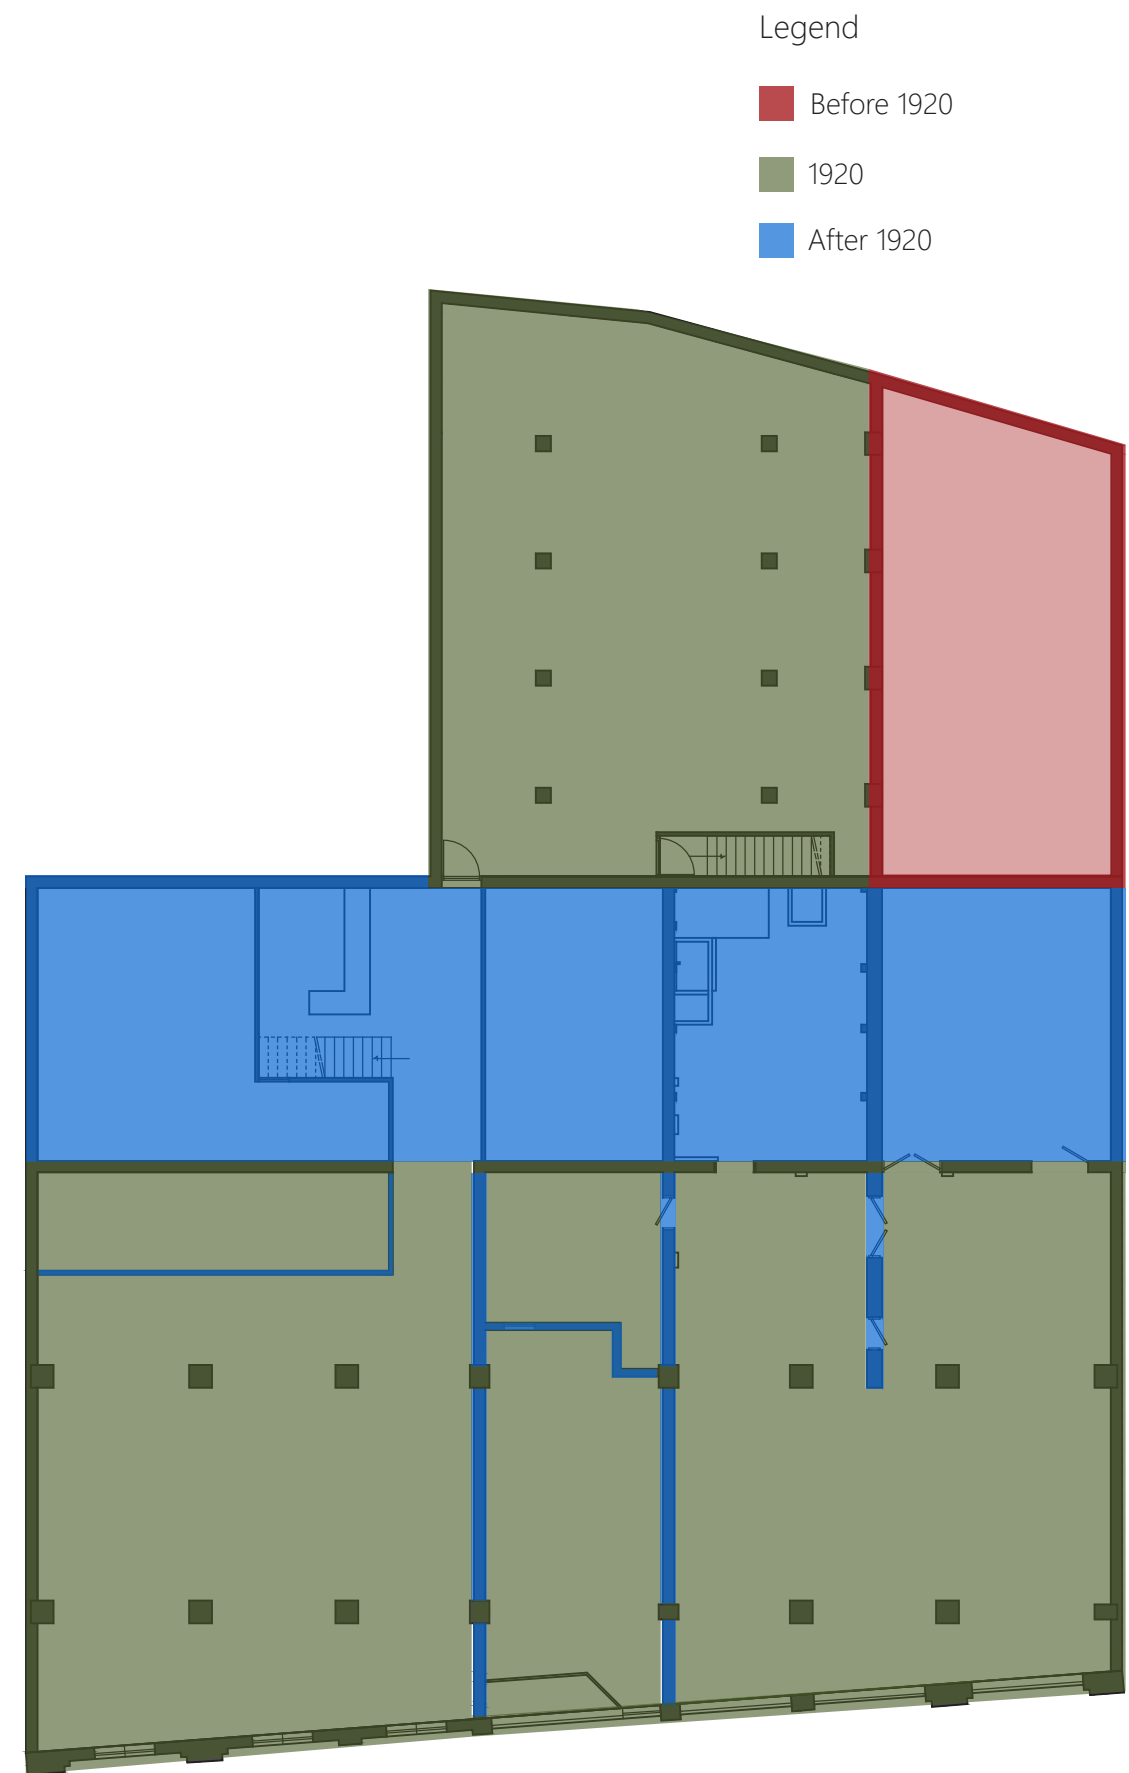
Ground floor

- Legend
- Before 1920
 - 1920
 - After 1920

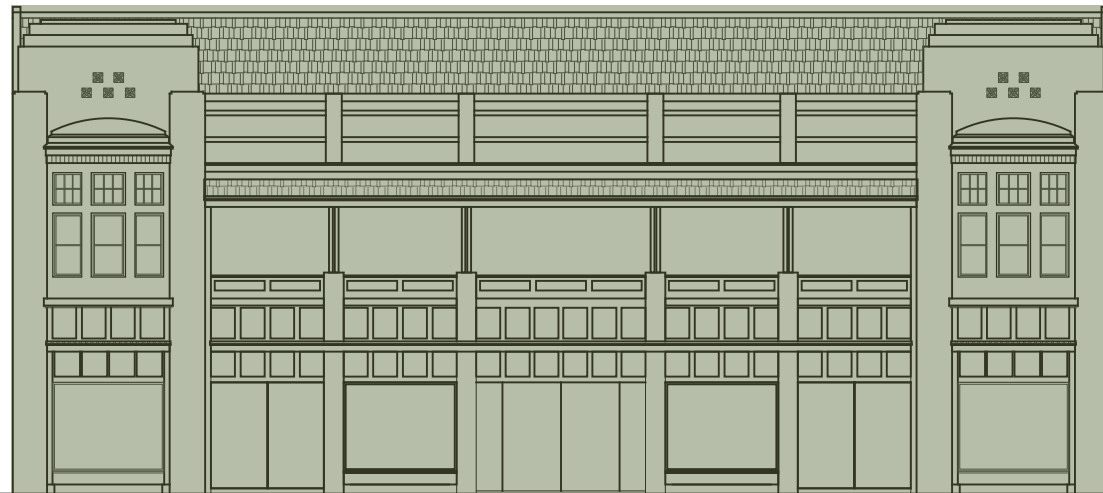
1920

CHRONOMAP FRONT FACADE

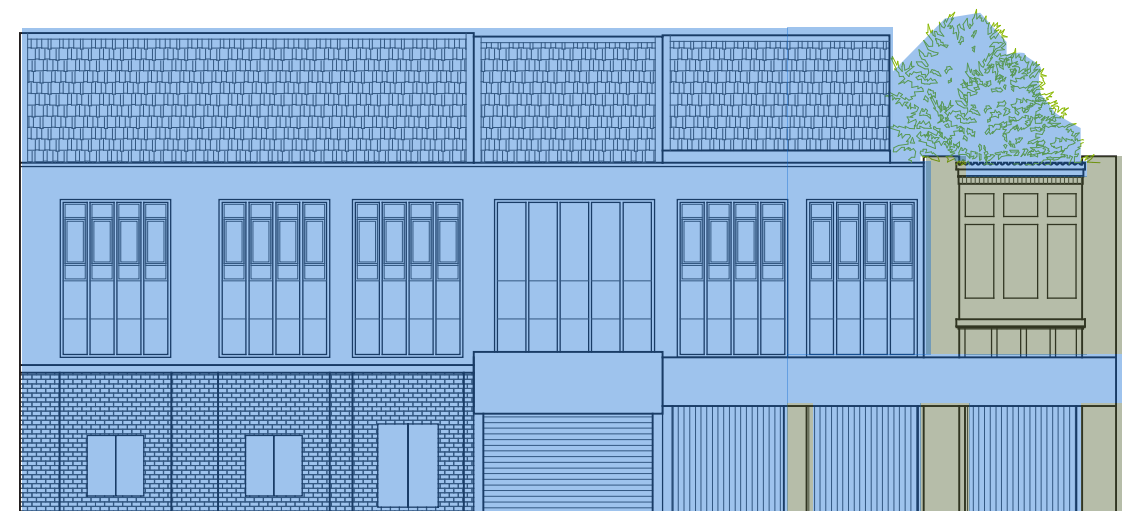
Current situation

Structure

On the left side of the front facade, when we look at the two columns on the ground floor, they are much bigger than the middle ones. They are as big as the ones all the way on the right side of the building. This is because in the past they had to carry a tower on the first floor. It can therefore be concluded that only the first floor has been rebuilt, because you still have the big columns on the ground floor.

If they would have rebuilt the ground floor, they wouldn't have to rebuild it that big because currently it doesn't have a tower to carry. But another theory might be that it could be for aesthetic reasons, so it could be symmetrical with the right side, but then for that concept to work they would also have had to rebuild the tower. So that theory can be scrapped away.

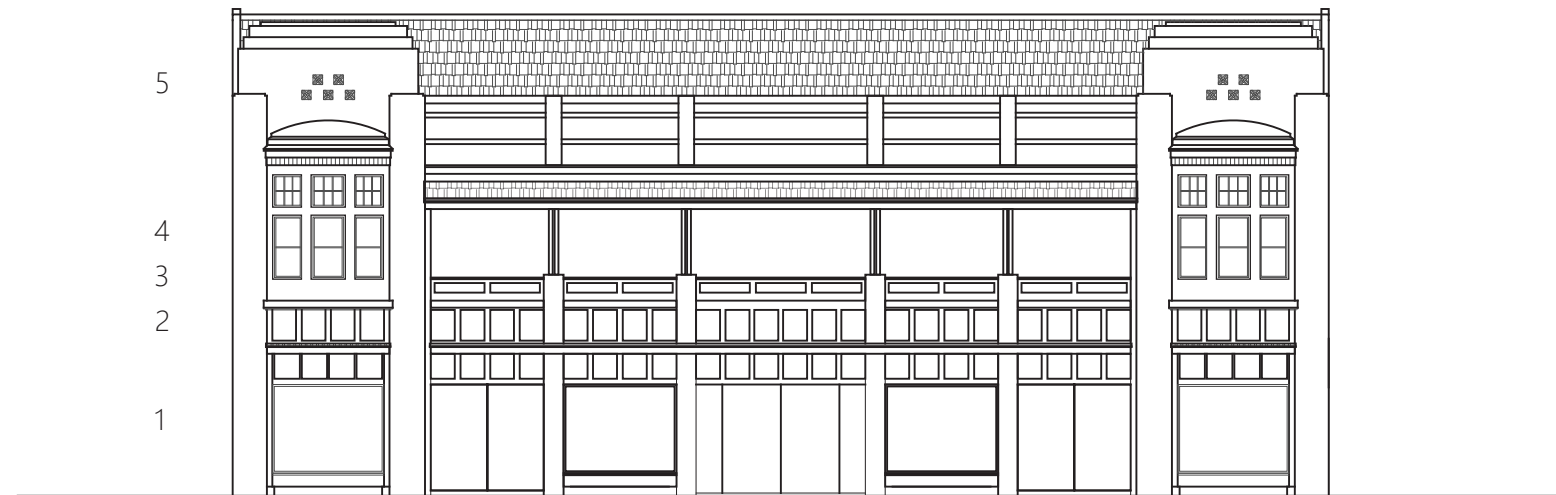
FRONT FACADE ANALYSES

1. Show-window and entrance
2. Clerestories
3. Parapet
4. Second-floor window
5. Ventilation-outlet/inlet

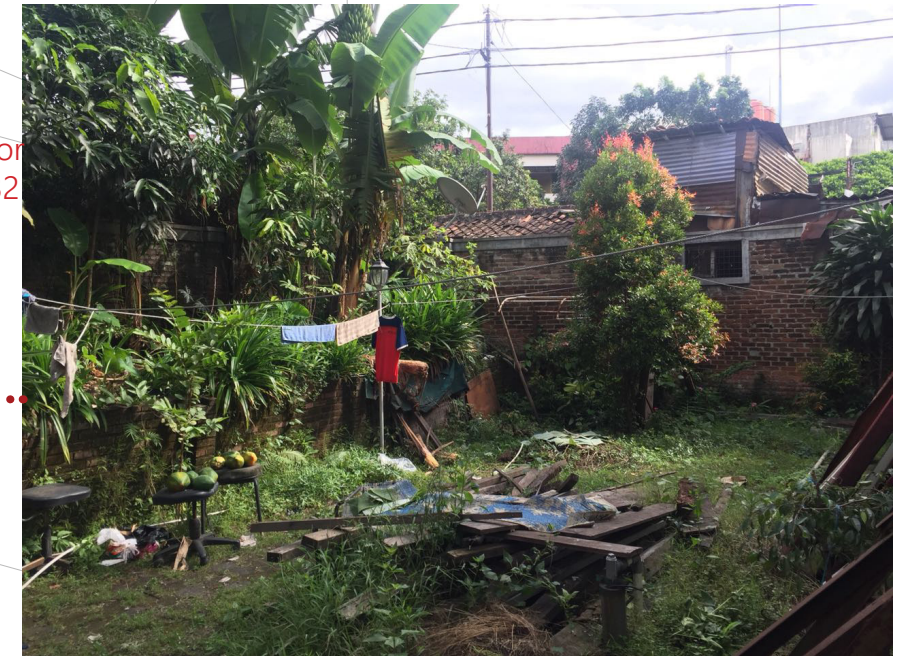
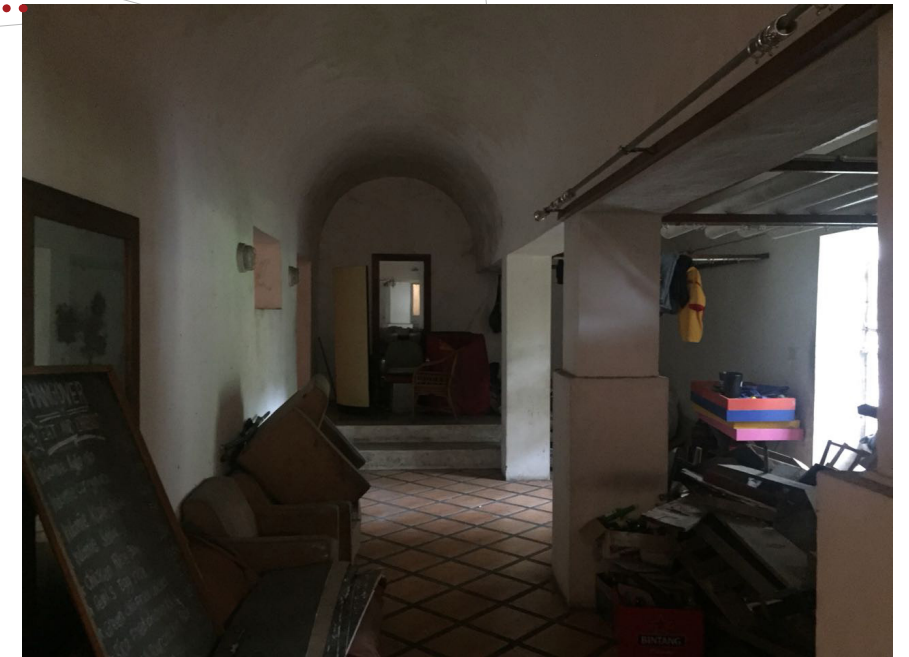
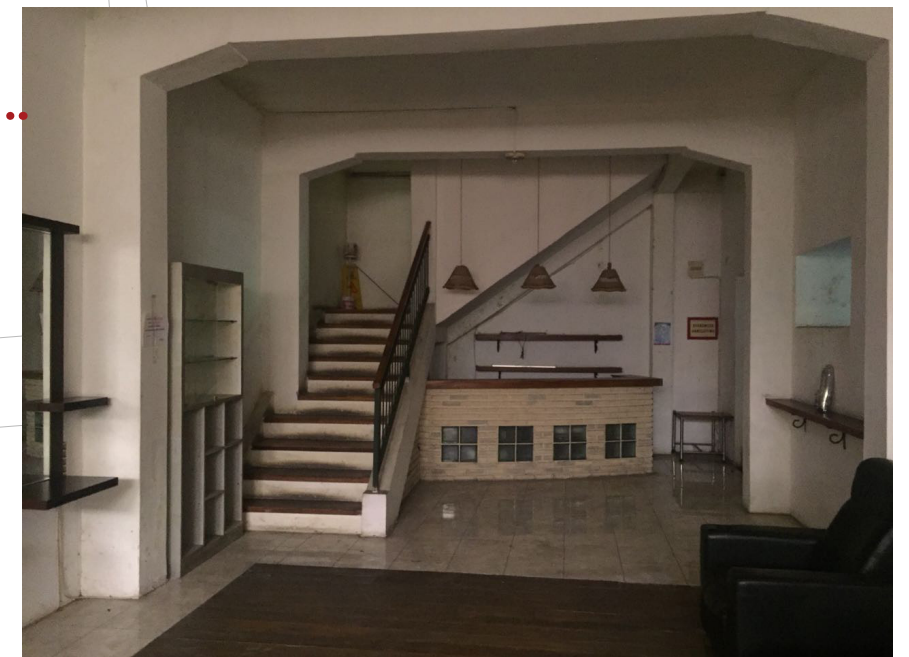
HELLERMAN BUILDING | HANGOVER SEMI-BASEMENT

In the picture of the backyard, the ground seems to be higher then when looked at the backyard of my neighbor Jip. This needs to be adjusted in the section. See page 32 'Sections' for more evidence of the elevated semi-basement.

Picture of back facade, showing the foundation of the building, meaning that the semi-basement floor of back building 2 might be much higher then shown in the longitudinal section drawing, but not sure if this applies for back building 1.

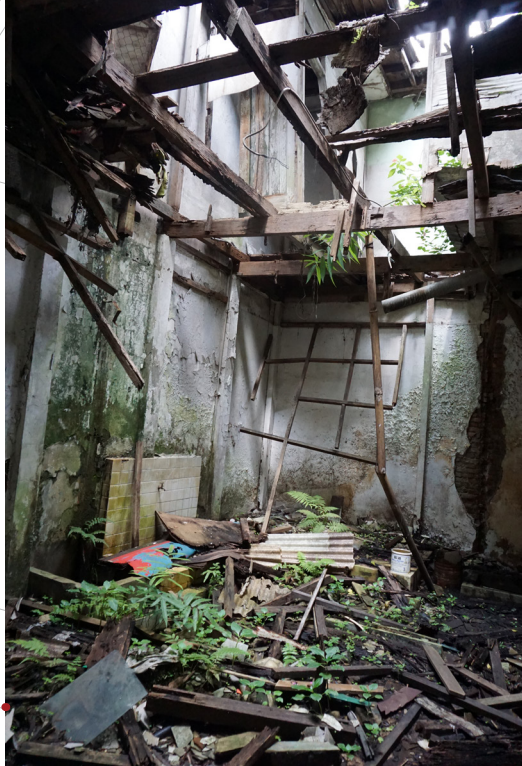
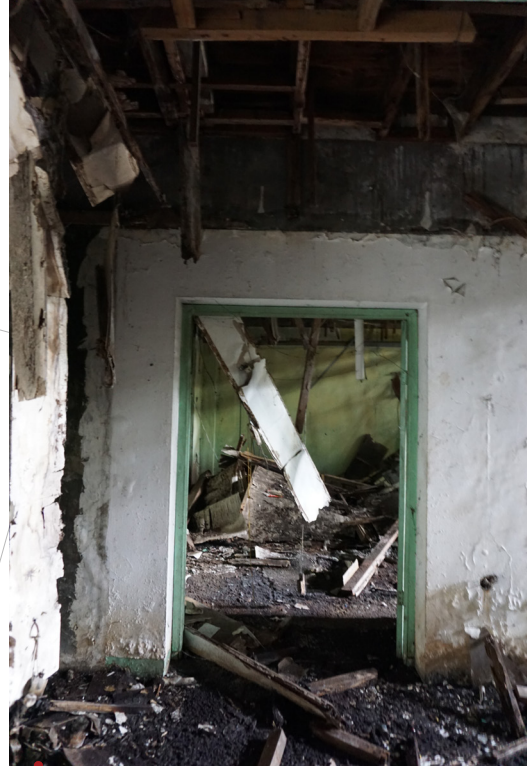
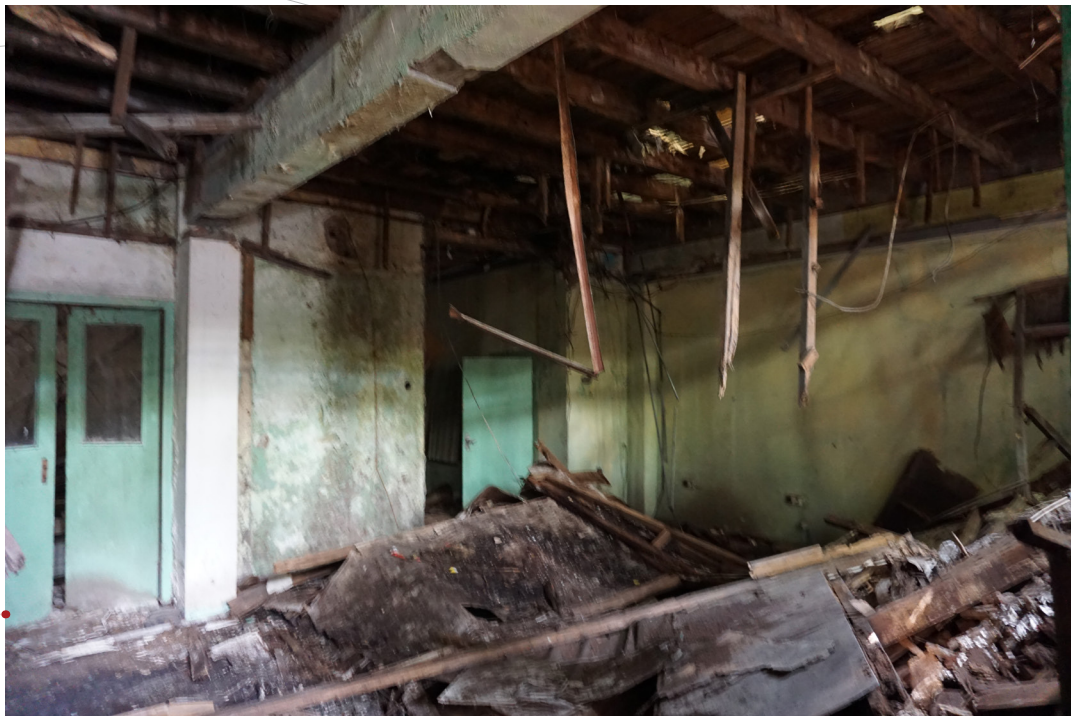
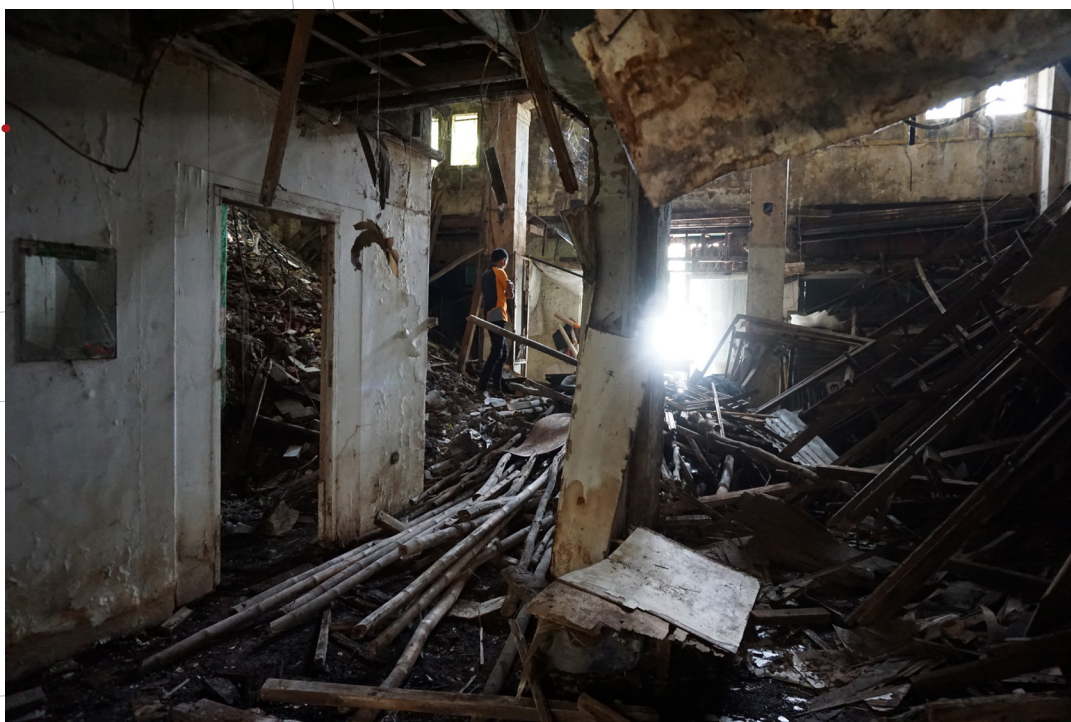
HELLERMAN BUILDING | VACANT

GROUND FLOOR

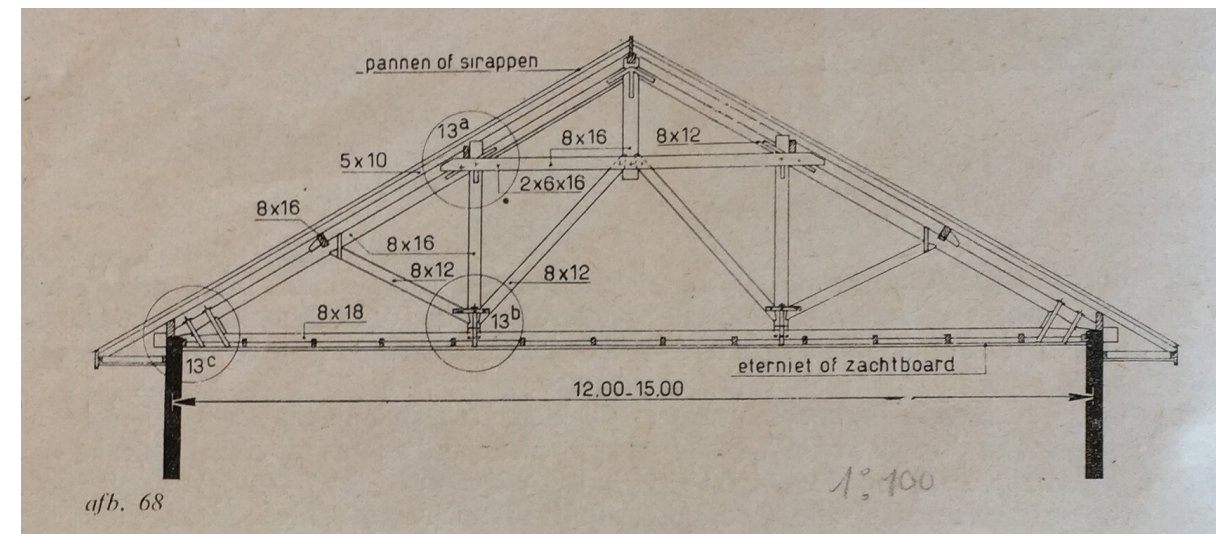
ROOF COVER

Pannenbedekking / Pans covering: these cheap and sustainable for the humid warm weather. Pannen zonder sluiting zijn de Hollandse of Vlaamse pan

De aansluiting van het pannendak tegen een loodrecht op de nok staande muur geschiedt met een strook lood of lodorite. Deze strook wordt gemetseld in een in de muur gehakte sleuf en door de pleisterlaag van de muur aan de bovenzijde afgedekt.¹

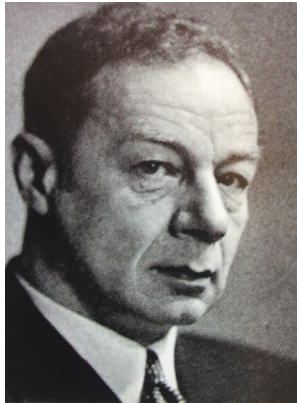
<p>HISTORICAL Value</p> <p>It is very likely that the architect of the building could have been R. A. L. Schoemaker. This adds even more value on the narrative and design of the building.</p>

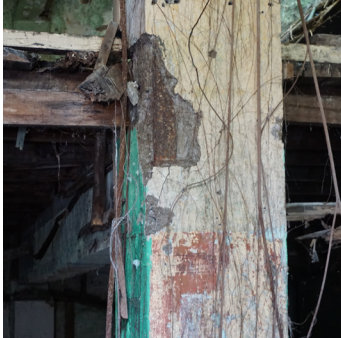
<p>AGE Value & HISTORICAL Value</p> <p>The exposed iron in the concrete beam expresses the building engineering in the 1890s, as being one of the first buildings in the Braga street. These values are of high importance.</p>

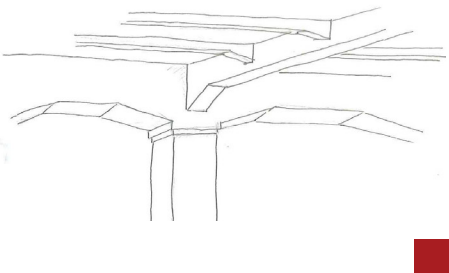
<p>HISTORICAL Value</p> <p>This type of construction, with the oblique part at the beginning, expresses high historical value to the history of building engineering. Current building constructions are not built in this manner anymore.</p>

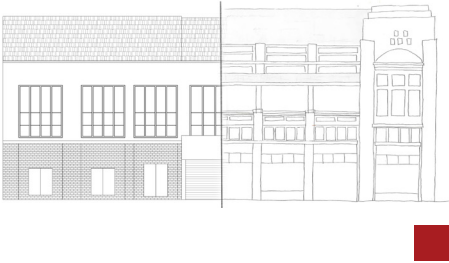
<p>HISTORICAL Value</p> <p>The original facade (on the right side) shows another type of proportion, that was common for the colonial buildings, whereby the ground floor seems a lot higher than the upper floor. In the renovated facade the upper floor seems much higher than the ground floor.</p>

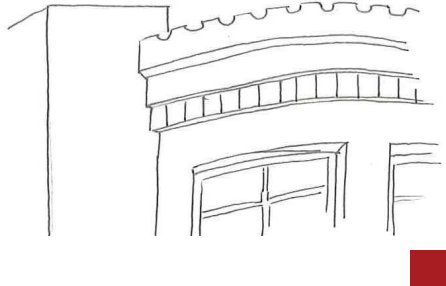
<p>RELATIVE ART Value</p> <p>The stucco placed on top of the tower. Even though this is not part of the original design, this component is of high value for the ornamentation and aesthetic value of the building.</p>

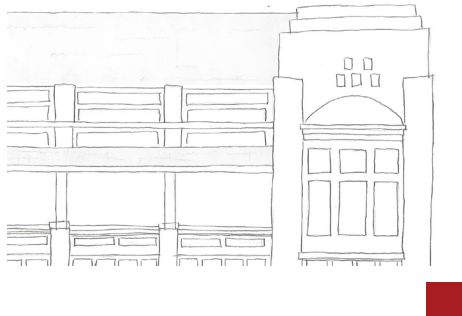
<p>RELATIVE ART Value</p> <p>The original design consisted of a balcony, which contained a railing and a top part of the facade (thereby hiding the roof). These elements illustrated horizontal-ism is the facade in contrast with the vertical-ism which the towers showed.</p>

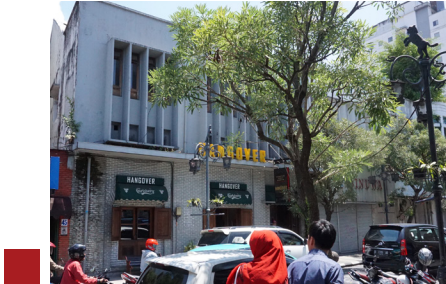
<p>NEWNESS Value</p> <p>Even though the renovated facade looks completely different from the original one, it kept certain characteristics such as the vertical-ism of the windows and the hidden roofs. However, it is not seen as restoration of the building, but as transformation and will thus be given an indifferent value in relation to its authenticity.</p>

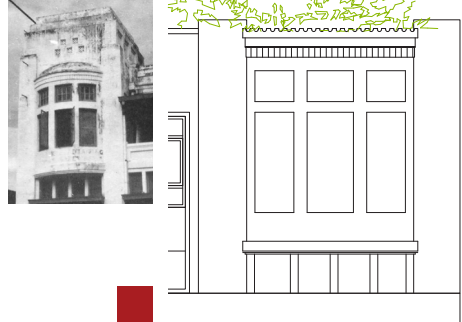
<p>RARITY Value</p> <p>The last tower of the building, which is still standing. It is of great importance as a result of not only aesthetic qualities of the design, but also uniqueness within its direct context in the Braga street.</p>

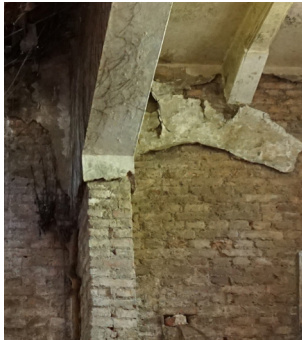
<p>AGE Value</p> <p>The broken-off plaster and the exposed bricks of the interior wall reveal the authenticity of the building and has remained unspoil</p>
