IMPACT Project Field Tests Data Analysis

Report Number T04-08-04
Revision Number 3_3_P01

Task Leader Mark Morris
Partner HR Wallingford

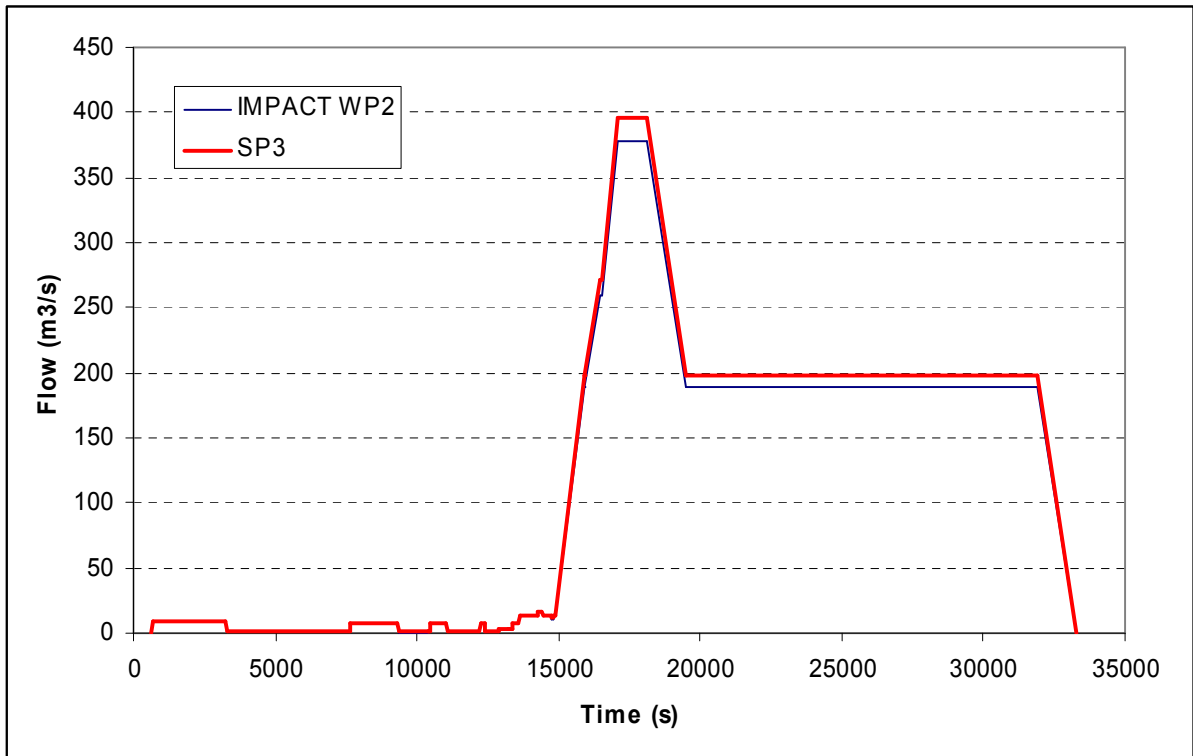
Figure 2: Inflow to the reservoir

Figure 2 shows the reservoir inflow data presented in the SP3 and the IMPACT WP2 reports. Data comparisons show a difference of an approximately 5% increase in the peak inflow value and also along the constant inflow that follows the peak. It is unclear why the inflow hydrograph has changed whilst the water levels which were used to obtain the hydrograph have not changed (See below) – no guidance has been given in response to questions on this point. Therefore, in the absence of a response from Norway, it is recommended to use the water levels data, rather than flow data, for this test case as an upstream boundary condition. Where a flow boundary condition is required modellers should undertake two runs using the two different inflow hydrographs and compare the model outflow output with the corresponding outflow hydrographs.

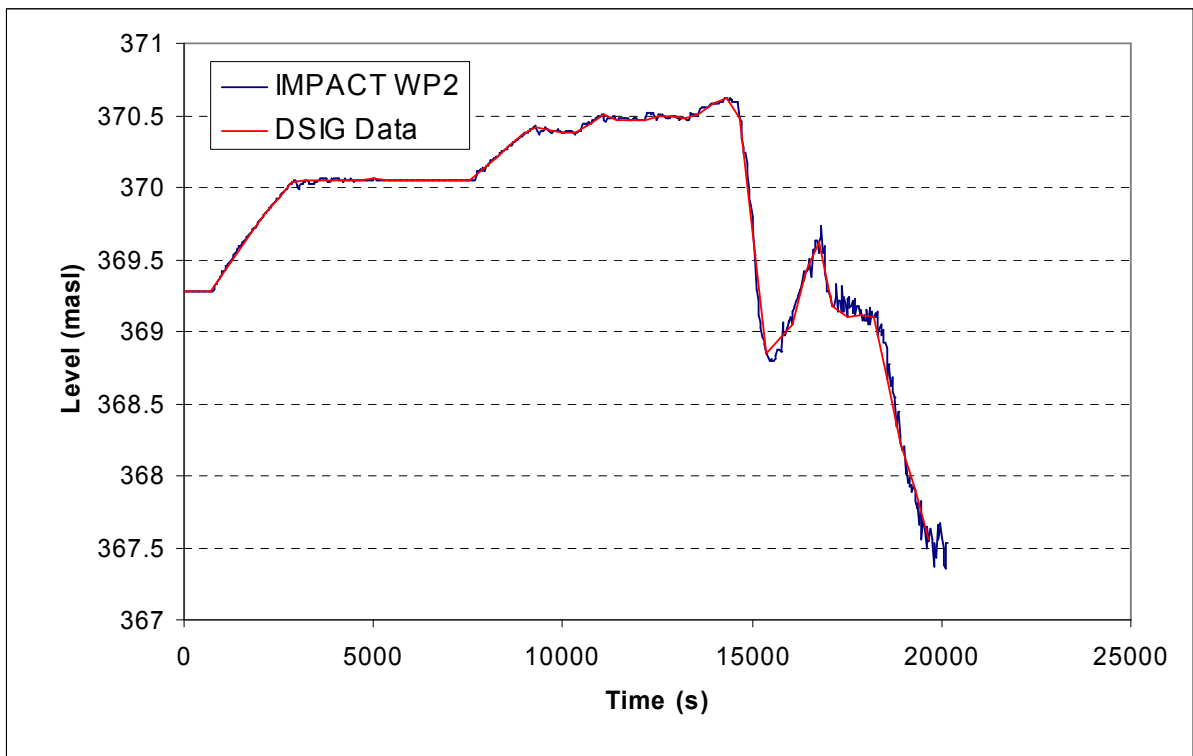
Figure 3: Test 1-02 water level.

For this test, data comparisons show that the water level data is identical in both the SP3 and IMPACT WP2 reports. However it should be noted that water level data provided in the DSIG file for this test case is only a sample of the complete data set, as shown in Figure 3 below. The full data set is available via the original IMPACT project data if it has not been provided to the DSIG as part of the SP3 report.

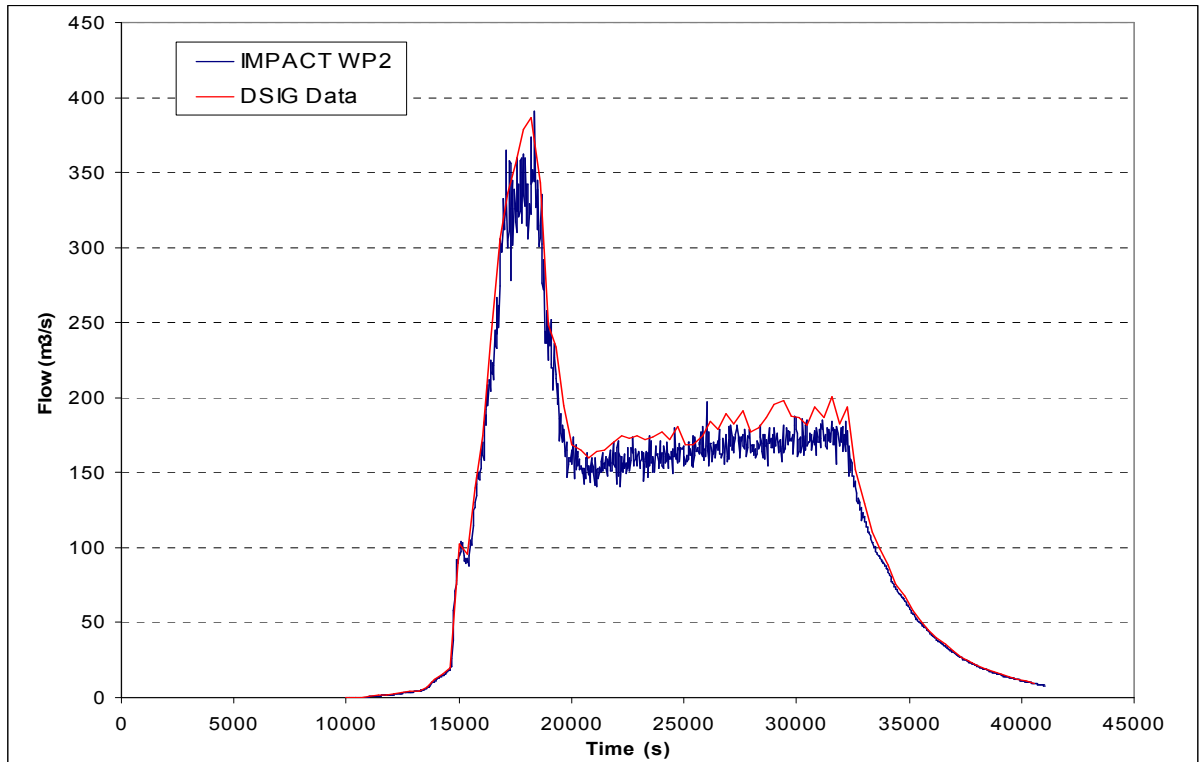
Figure 4: Test 1-02 outflow hydrograph

A visual comparison of the reservoir outflow data presented in the SP3 and IMPACT WP2 reports shows an increase in the peak outflow value and also along the hydrograph from a time approximately equal to 20,000 seconds until the end of the hydrograph. This is probably due to the observed increase in the inflow hydrograph (see above). The full data set used in the SP3 report was not available in suitable digital format therefore Figure 4 shows a comparison between the IMPACT WP2 data set against the data provided from the DSIG modelling data, which is a sub set of the data shown in the SP3 report. The data can be visually compared with Figure 5 which shows the data presented in the SP3 report. Similar to the inflow issue, and in the absence of any clarification from Norway, modellers are asked to follow the same recommendation given for using the inflow data above.

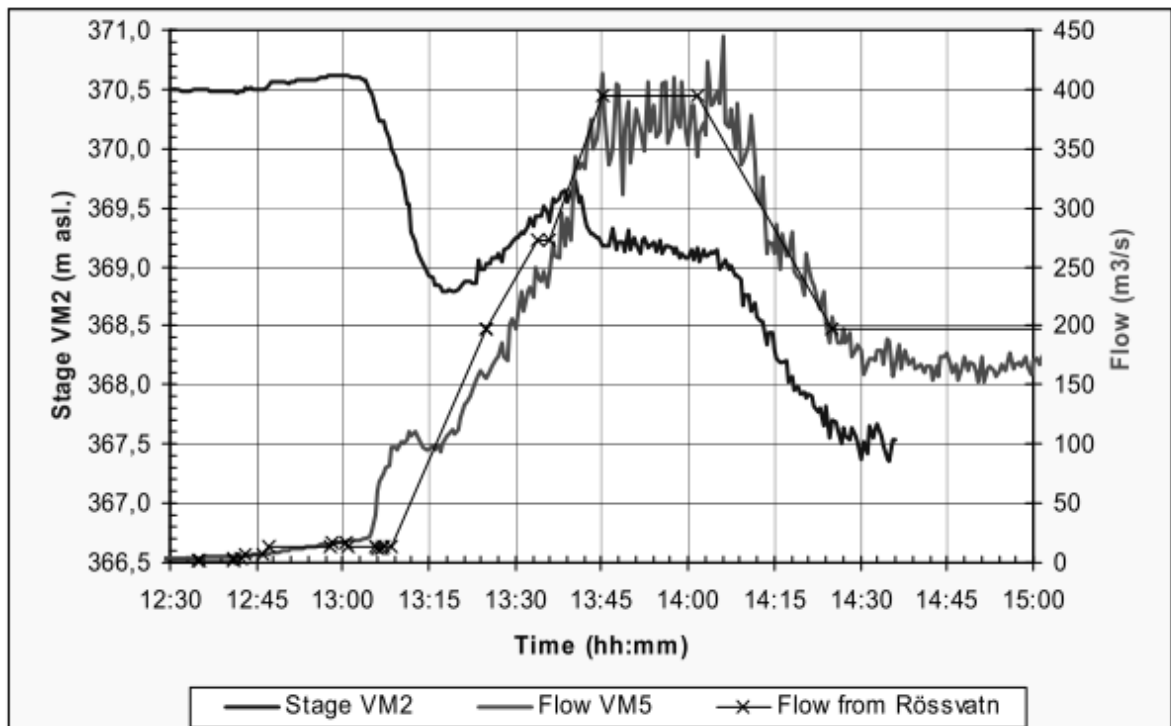
Figure 5: Test 1-02 outflow hydrograph from the SP3 report (called flow VM5 in the legend)

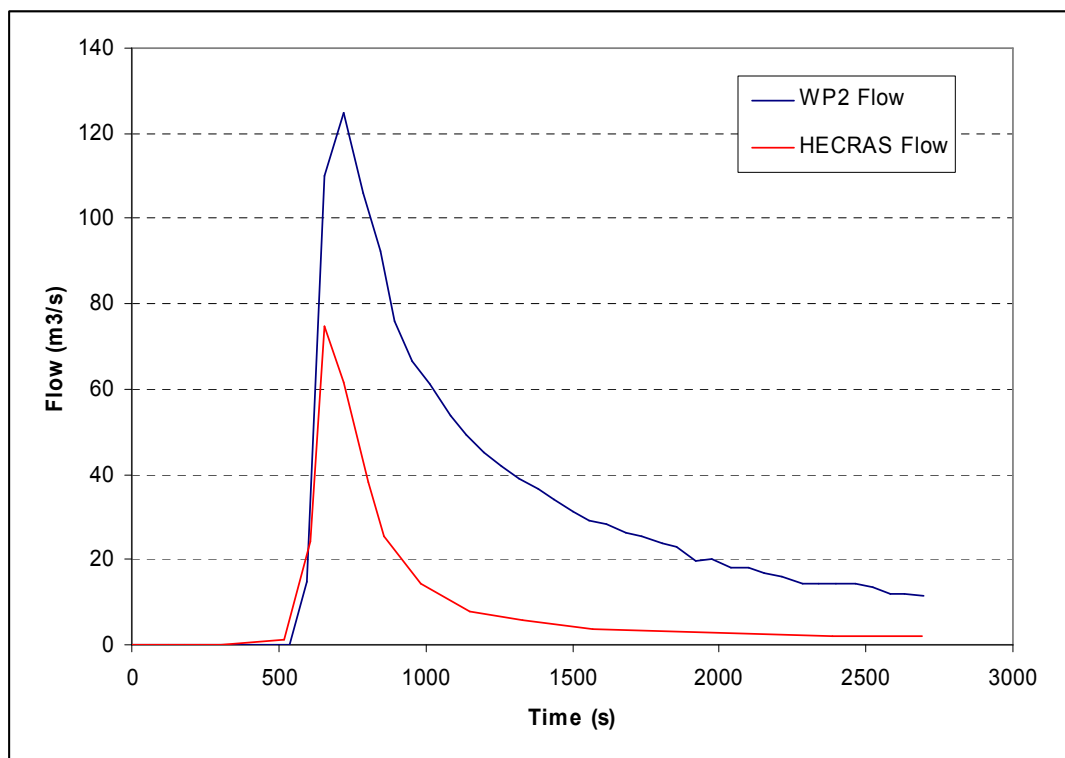
Figure 7: Test 2C-02 outflow hydrograph.

Data comparisons show a significant difference between the data reported in the SP3 and IMPACT WP2 reports (See Figure 7). SP3 shows data calculated using HECRAS. This suggests a recalculation of breach flow in some form. It is stated in the SP3 report that errors were found in the volume balance calculation for this test case which is probably due to ice build up at the location of the flow measurement downstream of the dam. However, email records show that corrections to data were made during the IMPACT project and that modified data was correct at that time. .

Recent volume calculations undertaken by HR Wallingford show that neither of the hydrographs shown in Figure 7 satisfy the volume balance equation. Based upon the hydrographs shown in Figure 7, the volume of water under the SP3 and WP2 hydrographs is 23,478 and 81,227 m³ respectively starting from time T=0 to T=2690 seconds. The inflow volume for this period of time is approximately 1,100 m³. The reservoir water level at T=0 was 369.808 (m.a.s.l.) which translates to a volume equals 31,920 m³. Based upon the information presented in the SP3 report, the reservoir was empty at the end of the test. Using the above figures for both data sets does not satisfy the following volume balance equation:

It is therefore recommended that modellers use the two hydrographs for purpose of comparison, knowing that their outflow results should lie between the two given outflow hydrographs (Figure 7) and probably closer to the one calculated by HECRAS.

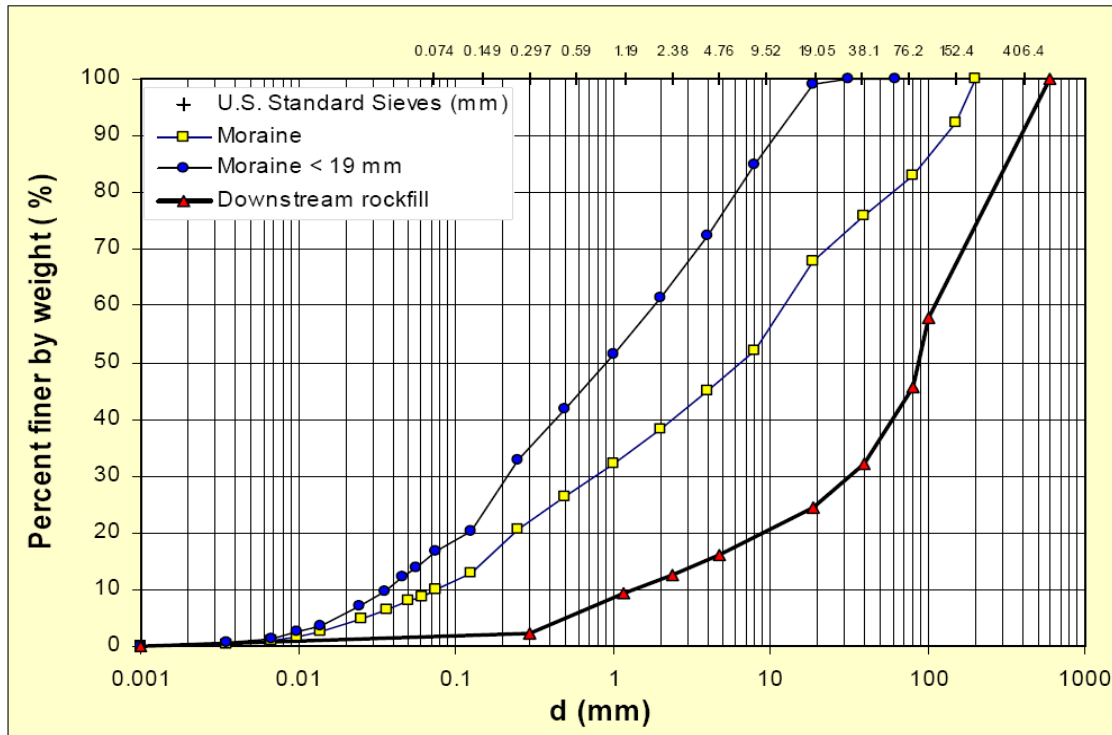
Figure 9: Grading curves for moraine and rock fill used in test 1-03

1. Point No.1 above is correct. The same curves are used in the SP3 and the IMPACT WP2 reports. However, by using that curve (See Figure 9) it can be concluded that the D_{50} is between 6 and 7 mm and a value equals 7 mm was used. (It is hard to see how using this curve provides a D_{50} equal to 5.5 mm).
2. Point No. 2 contradicts information emailed to HR Wallingford during the IMPACT project in which laboratory data is given for the moraine and rockfill material for all the tests undertaken in 2003.
3. Point No 3 may be true but was not previously advised.
