## The use of acoustic emission and composite peel tests to detect weak adhesion in composite structures

Teixeira De Freitas, Sofia; Zarouchas, Dimitrios; Poulis, Hans

The Journal of Adhesion

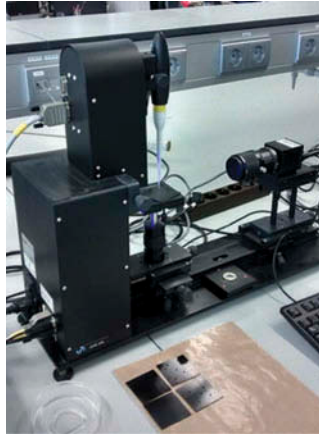
**Figure 1.** Contact angle measurement instrument (KSV CAM 200).

In order to characterise the effect of different surface pre-treatments and of a contamination agent on the CFRP surface, contact angle measurements with distilled water were performed using a Tensiometer (KSV instrument CAM 200, Helsinki, Finland) shown in [Figure 1](#). The lower the contact angle between the drop and the surface, the better the wettability of the surface. This set of experiments was performed on small CFRP specimens (50x50 mm, layup  $[0^\circ]_5$ ). Five specimens were used for each configuration and five contact angle measurements were taken for each specimen at distinctive places of the samples, as shown in [Figure 2](#).

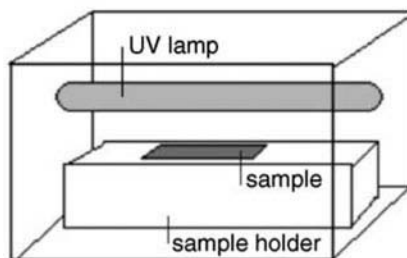
**Figure 3.** Schematic representation of the UV/Ozone surface treatment apparatus. [48]

the removal of very thin layers organic contaminants. [45] This process works by decomposing the organic compounds into volatile substances (i.e. water and carbon dioxide) with the use of ultraviolet rays and by strong oxidations during the formation and decomposition of the ozone. [46,47] The treatment was performed at atmospheric condition. The samples were treated for seven minutes at a distance of approximately 40 mm away from the UV-lamps. Figure 3 shows a schematic representation of the UV/Ozone surface treatment apparatus.

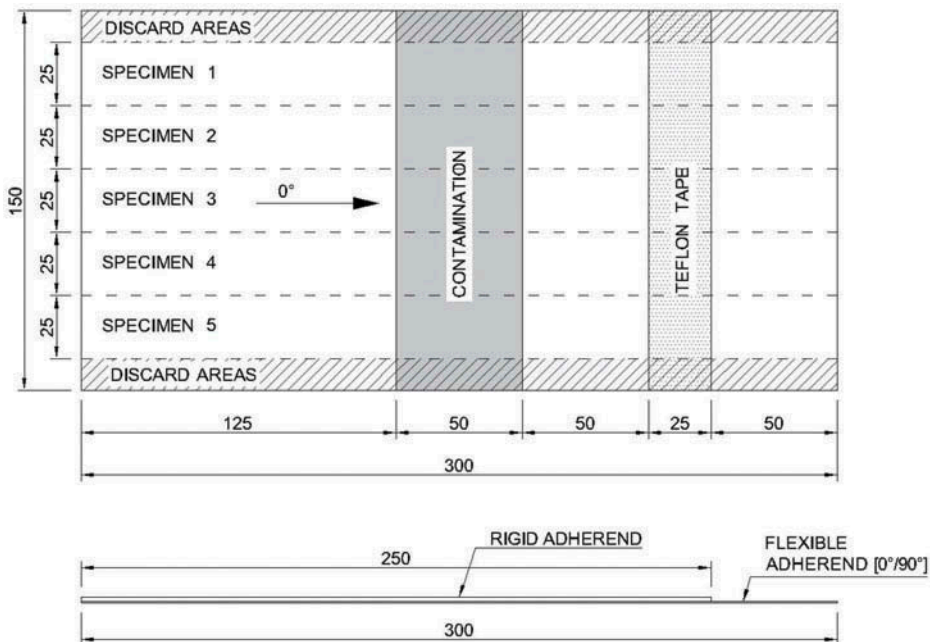
Figure 4. CBP test panels with the contamination strip (dimensions in mm).

The contamination was applied along 50 mm of the 300 mm length of the flexible adherend, as shown in Figure 4.

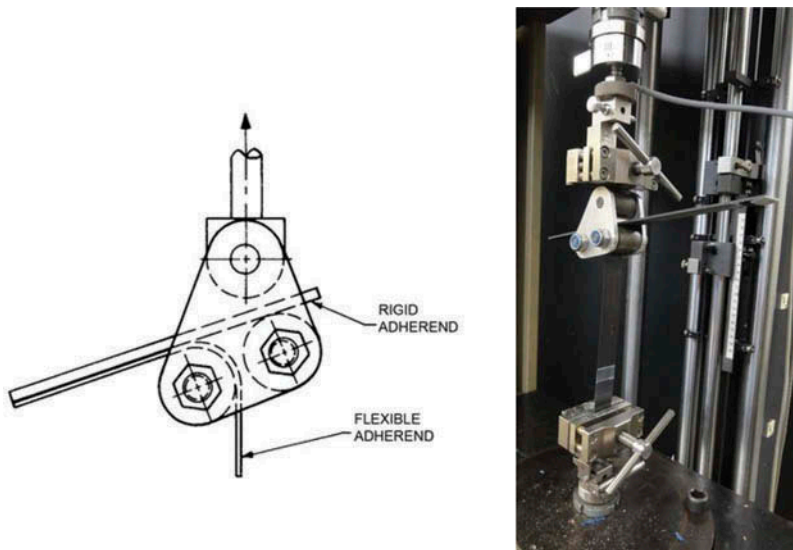
Figure 5. CBP test set up. [39]

Figure 5 shows the test setup of the CBP tests. During testing, the flexible adherend is peeled off from the rigid adherend. Testing was carried out using an electro mechanic Zwick machine with a maximum capacity of 10 kN. The testing speed was 125 mm/min. A total of five specimens were tested in each test condition. During tests, the load and the crosshead displacement were recorded.

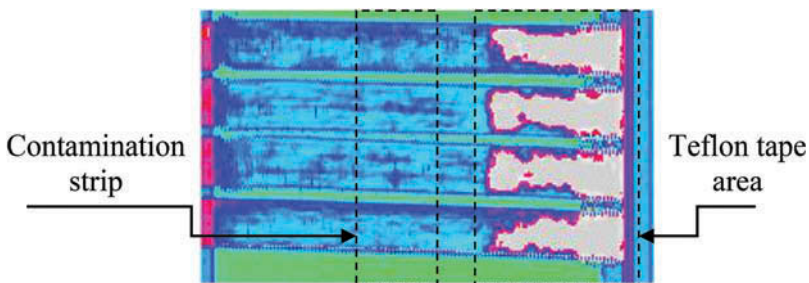
Figure 7. Ultrasonic C-scan of the DCB contaminated specimens.

Prior to testing, the specimens were inspected using Ultrasonic C-scan. Figure 7 shows a representative example of the C-scan of the contaminated specimens (squitter C-scan, 10 MHz frequency, crystal diameter 10 mm, water nozzle 8 mm

diameter, scanned every 1 mm, 10 dB damping, no filters). As it can be observed, the contamination area cannot be detected by the C-scan, which proves the existence of a “weak bond” or a “kissing bonds” in the specimens. Unfortunately, C-scans of the CBP specimens prior to testing are not available, but since the contamination and manufacturing procedure was exactly the same, one can assume that also “weak bonds” are present in the CBP specimens.

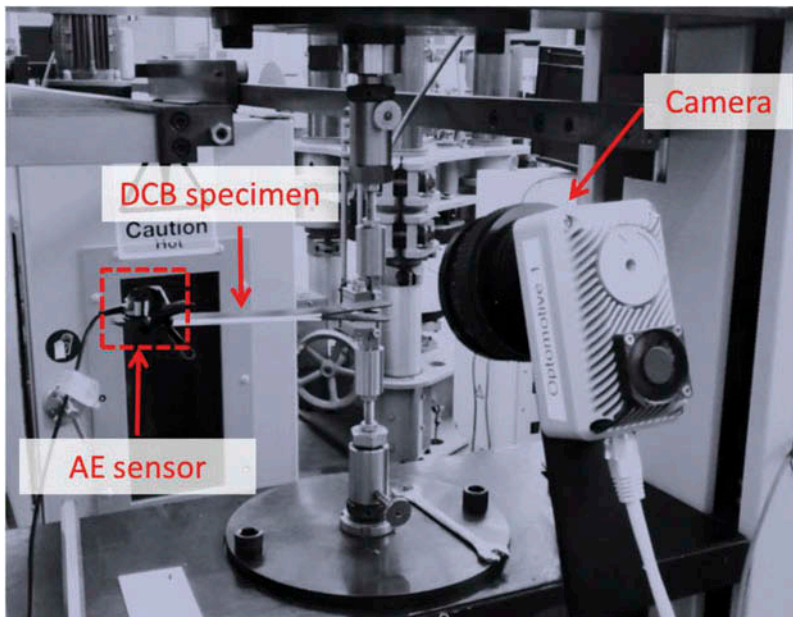
Figure 8. DCB test set up.

Figure 8 shows the test set up of the DCB. The tests were carried out at the same machine as the CBP tests. The testing speed was 4 mm/min. The tests were stopped when the desired crack length was reached. A camera is placed near the specimen to monitor the crack length throughout the tests.

An AMSY-6 (Vallen Systeme GmbH, Icking, Germany), 8 channel AE system, was used in order to perform the AE measurements. One wide-band piezoelectric sensor AE1045S-VS900M, with external 34 dB pre-amplifier and a band pass filter of 20–1200 kHz, was attached on the surface of the coupon using a special clamping device. The sampling rate is 2 MHz. Ultrasonic gel coupling was applied on the sensor surface in order to maximize the conductivity between the sensor and the specimen. The AE system was continuously recording AE activity until the failure of the specimen. The sensor was positioned at the end of the specimen as shown in Figure 8. A threshold of 55dB was selected and the AE data set for each AE hit contained the duration (sec), rise time (sec), peak amplitude (dB), energy (eu), the number of threshold crossings and ratio rise time to amplitude. It should be mentioned that within the purpose of this study, AE was used to identify differences between AE activities from coupons with different surface treatments and evaluate the capability of AE technique to detect the weak bonds. Localisation of the crack tip during the testing was performed with a camera, and thus only one AE sensor was used. During tests, the load and the cross head displacement were also recorded.

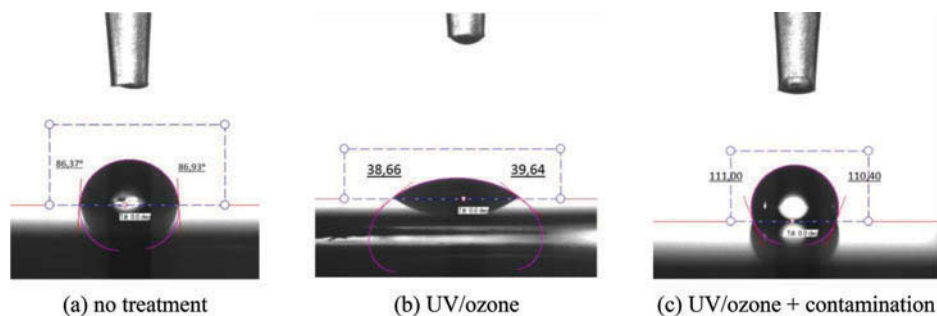
**Figure 9.** Water drop at the surface of the CFRP and contact angle measurement.

Table 1 presents the average contact angles measured for each surface treatment. Figure 9 shows an example of the contact angle measurements as found after the three surface treatments (no treatment, UV/ozone and contaminated).

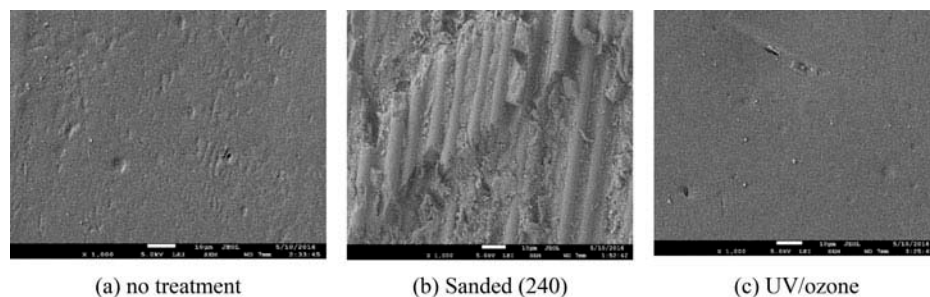
**Figure 10.** SEM pictures of the CFRP surface after treatment (scale 1000x).

Figure 10 shows SEM pictures of the surfaces after the pretreatment (5.0 kV acceleration voltage, Low angle secondary electron detector – LEI). While the UV/ozone treatment seems not to change the morphology of the CFRP

surface, sanding results in an increase of the surface roughness but also significant fiber break. This fiber damage is undesirable on the CFRP adherends since it may decrease the adherends performance and facilitate intralaminar failure of the composite.

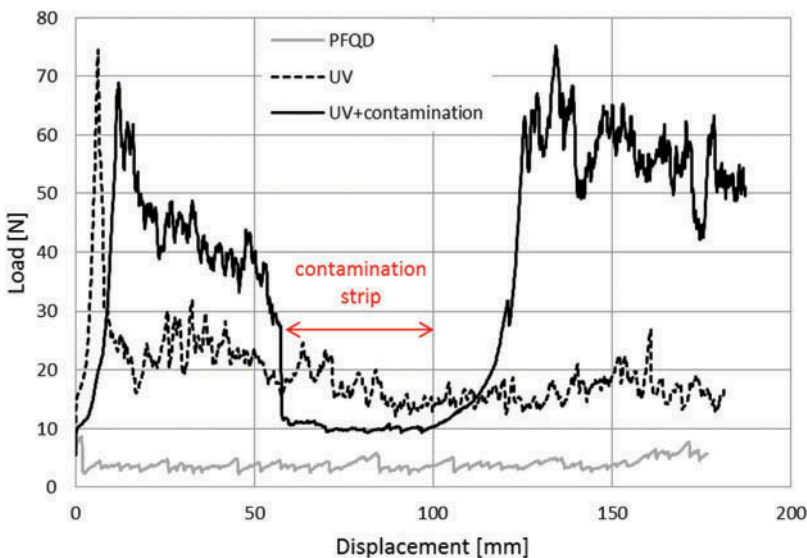
**Figure 11.** Representative load displacement graphs from the CBP tests.

Figure 11 shows examples of load displacement graphs recorded while testing specimens treated with PFQD and treated with UV/ozone with and without contamination strip. Figure 12 shows representative fracture surfaces corresponding to each load displacement graph.

The lowest peel load occurs for the specimens cleaned only with PFQD. This is the result of the crack growing at the interface resulting in 100% adhesive failure as it can be observed in Figure 12.

The second lowest peel load occurs for the specimens treated with PFQD +UV/Ozone. The final fracture surface is predominantly intralaminar failure of the composite (ILFC) - flexible adherend, with the exception of the begging of the peel length where cohesive failure is mixed with ILFC.

For the contaminated specimens (UV+contamination), a sudden drop in the peel load is observed when the crack reaches the contaminated area (weak bond) where the failure is predominantly adhesive failure, with a very low percentage of ILFC. In the non-contaminated area, the fracture

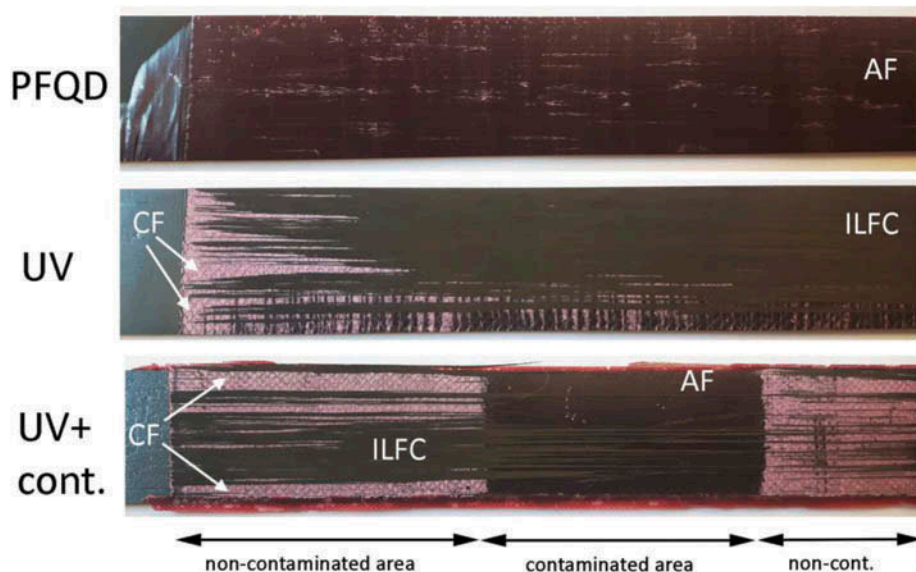
**Figure 12.** Typical fracture surfaces of the rigid adherend after CBP tests (CF – cohesive failure, AF – adhesive failure; ILFC – Intralaminar failure of the composite).

shows cohesive failure in the adhesive layer and ILFC. The contaminated area (weak bond) can be clearly detected by visual observation of the fracture surface and by a drop in the load.

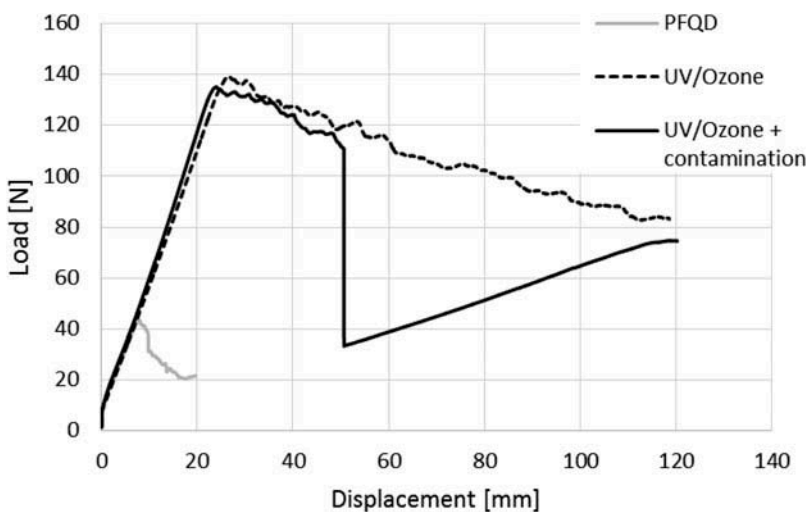
Figure 13. Examples of load displacement graphs from the DCB tests.

Figure 13 shows typical examples of the load displacement curves obtained from the DCB tests for the three different types of specimens. The corresponding final fracture surfaces are shown in Figure 14, with details on typical areas of fracture surfaces taken using optical microscope.

The results are in accordance with the CBP test results. Surfaces treated with PFQD present 100% adhesive failure, indicating bad adhesion. Surfaces treated with UV/Ozone present nearly 100% cohesive failure, indicating good adhesion. The contamination strip–weak bond–is also clearly detected by the DCB load-displacement curve where a sudden load drop is observed, and by a change in failure mode, from cohesive failure to adhesive failure. In the DCB tests, there is no intralaminar failure of the composite adherend. This is

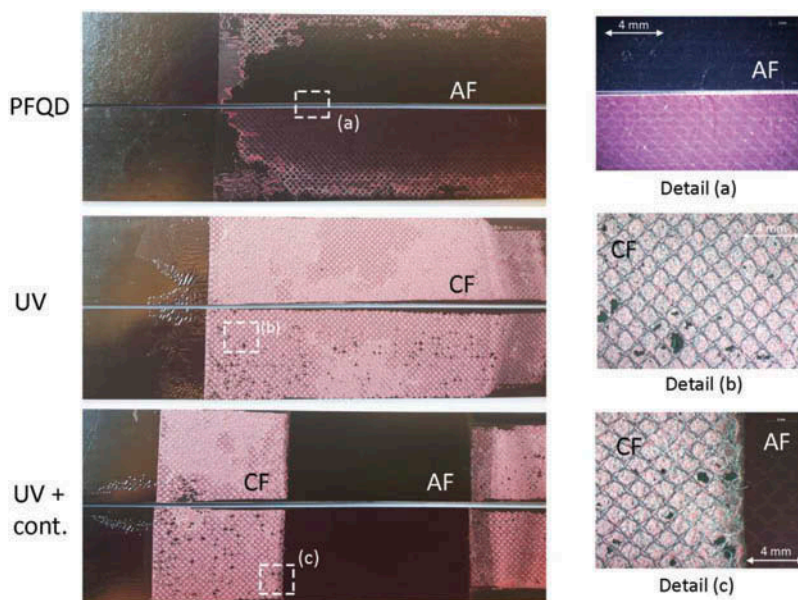
**Figure 14.** Typical fracture surfaces after DCB tests (CF – cohesive failure, AF – adhesive failure).

During DCB tests, AE sensors were attached to the DCB specimens. Figures 15 and 16 shows representative examples of the AE activity obtained for specimens treated with PFQD and UV/Ozone. The different sets of AE signals are compared with their corresponding failure mechanism, as shown in Figure 14. The AE activity was similar between specimens of the same test series/surface-treatment.

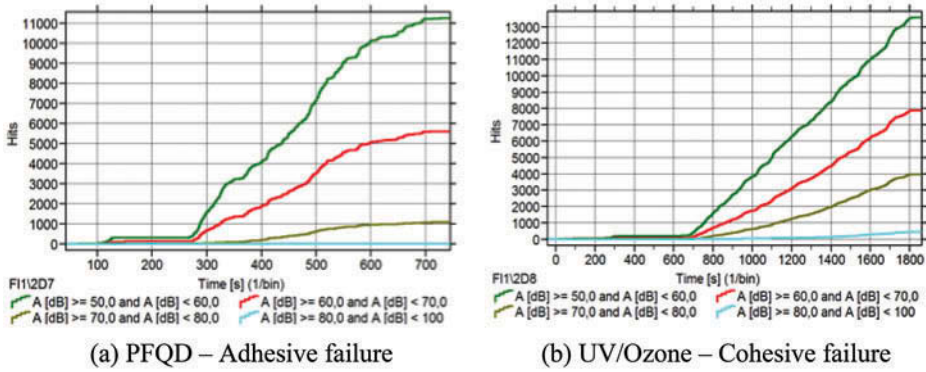
Figure 15. Number of hits for specimens treated with PFQD and UV/Ozone.

The hits were clustered in four groups with respective peak amplitude: Group (1) 50–60 dB, Group (2) 60–70 dB, Group (3) 70–80 dB, Group (4) 80–100dB. As can be seen in Figure 15, for both specimens, the majority of the hits were found in Group (1). The results show that there is less AE activity, in terms of number of AE events, when adhesive failure occurs (PFQD – Figure 15(a)) in comparison with cohesive failure (UV/ozone – Figure 15(b)).

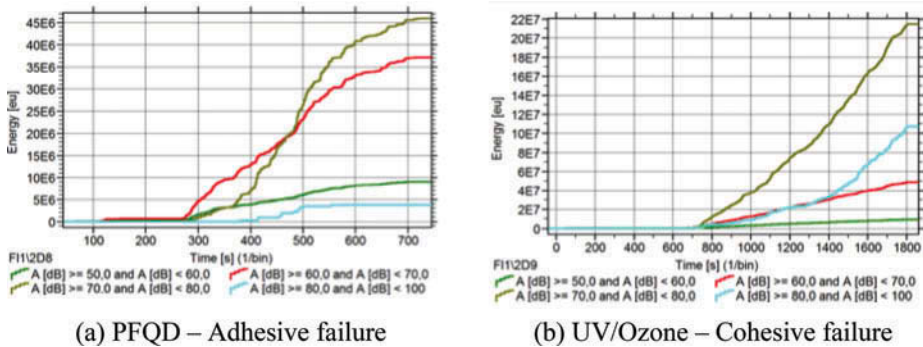
Figure 16. Cumulative energy for specimens treated with PFQD and UV/Ozone.

Figure 16 shows the cumulative energy of the AE activity for both specimens. For the case of the cohesive failure inside the adhesive layer, the cumulative AE energy is significantly higher than the case of the adhesive failure. These results are in a good agreement with the fracture toughness values presented in Table 3. The largest amount of energy was attributed to the AE hits of Group (3) and (4), in contrast to the specimens treated with PFQD for which the largest amount of energy was carried by the AE hits of group (2) and (3). As it was expected, Group (1) contains AE hits with very low energy, since the peak amplitudes are lower.

This means that, the cohesive failure process releases larger amounts of energy in comparison with the adhesive failure. The characteristic of different amounts of energy recordings is of great value and can be used as a reference, for example, during the in-service monitoring of adhesive bonded joints where the adhesion quality of the bonded joint might be unknown, and an early detection of poor adhesion can thus be achieved.

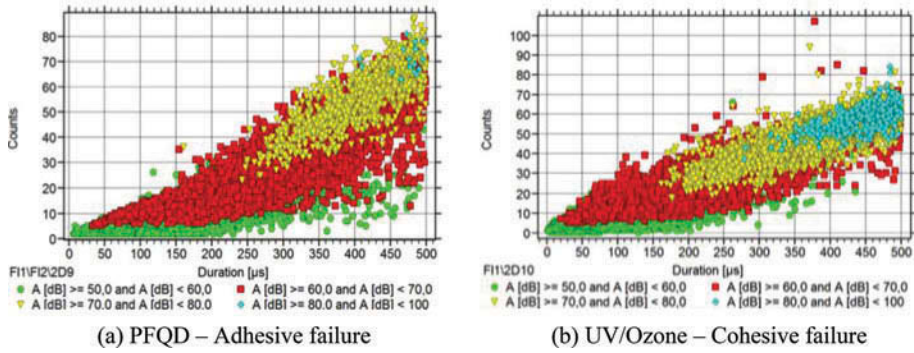
**Figure 17.** The typical number of counts in respect to the duration of measurement for each hit for the specimens treated with PFQD (a) and the specimens treated with UV/Ozone (b).

Furthermore, Figure 17 presents the number of counts of each AE hit in respect to their duration, for the two different specimens. The AE hits of Groups (1) and (2) (highlighted with green and red) show very similar characteristics for

both specimens. However, different trends were observed for the hits of Group (3); the hits of specimens treated with PFQD range between 20 and 80 counts with duration between 250  $\mu\text{s}$  and 500  $\mu\text{s}$  while the hits of specimens treated with UV/Ozone range between 20 and 70 counts with duration 150  $\mu\text{s}$  and 500  $\mu\text{s}$ .

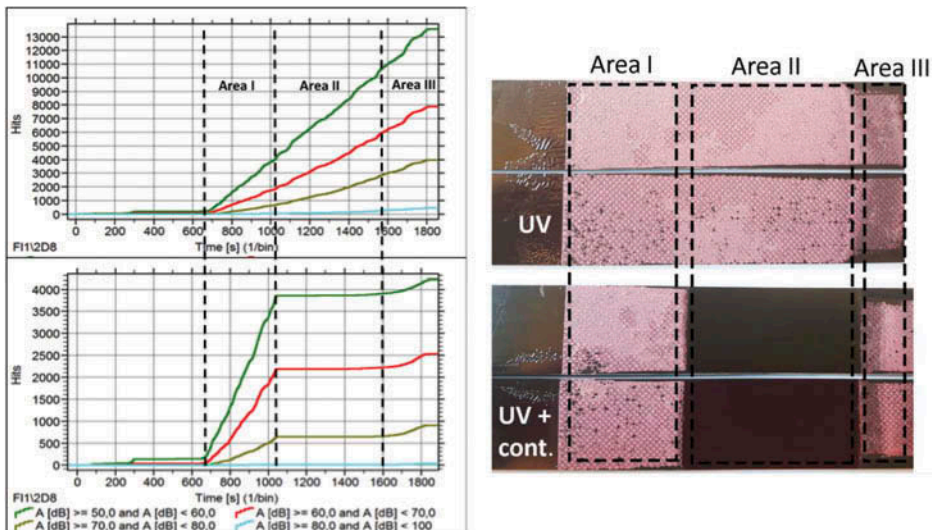
**Figure 18.** The cumulative number of hits during the tests for specimen without and with contamination respectively.

Finally, Figure 18 presents the cumulative hits during the DCB tests for two specimens without and with contamination, respectively. At time  $t=1000$  s, the crack reached a length of  $a=25$  mm of the bondline (start of contamination area) and, in contrast to the specimens without contamination where AE activity continues with the same rate, the AE activity is zero for a time period of 600 sec which corresponds to the time that the crack needed to reach the end of the contaminated area. Therefore the AE activity drops significantly in the contaminated area, following the trend of the load drop.

Such information can be used for detecting contaminated areas or “weak bonds” during in-service where the crack may grow without AE activity.
