Structural integrity assessment of a full-scale adhesively-bonded bi-material joint for maritime applications

Thin-Walled Structures

The present study proposes a comprehensive integrity assessment approach for a full-scale adhesively-bonded bi-material joint for maritime applications. The joint represents a cross-section of the bond-line connection of a ship with a steel hull and a sandwich composite superstructure. The full-scale joint consists of a sandwich composite core adhesively bonded to two U-shaped steel brackets. The joint was subjected to a quasi-static loading profile including 6 load cycles up to the final failure. Each load cycle was followed by a dwell segment holding the joint at the maximum displacement for 30 s and then unloading to 50% of the maximum displacement. Three Structural Health Monitoring (SHM) techniques including Acoustic Emission (AE), Fiber Optic Sensor (FOS), and Digital Image Correlation (DIC) were employed during the test to assess the damage state of the joint. Moreover, a Finite Element Model (FEM) was developed to simulate the evolution behavior of different damage mechanisms in the joint and the FE results were compared against the experime

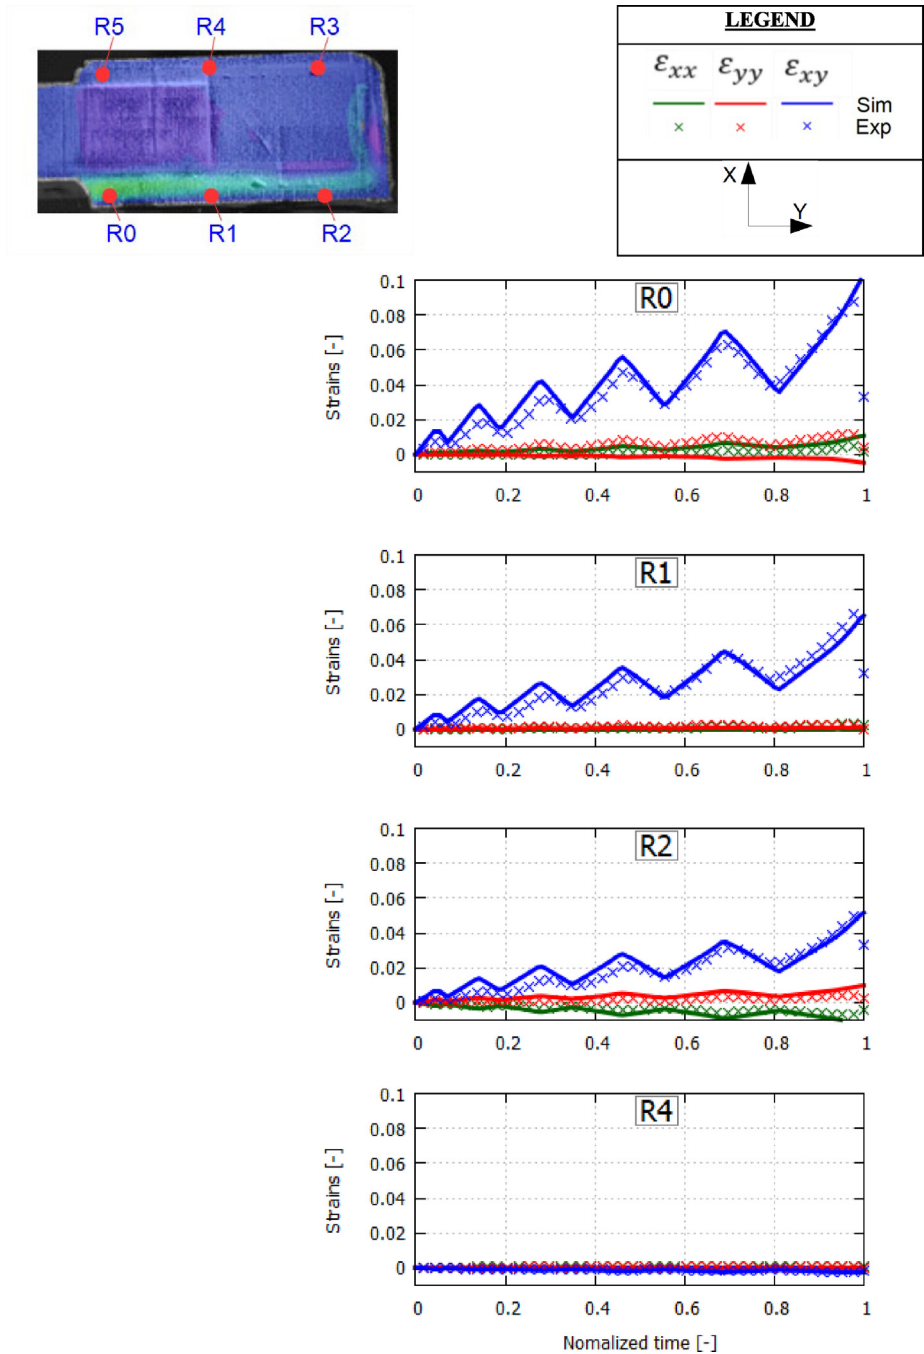
Besides comparing the global strain of the joint, local strains measurements in the adhesive section obtained from the DIC are compared to the predicted strains at this section by the FE model (see Fig. 17). The comparison is done for eight points on the adhesive part of the joint, as depicted in Fig. 17. A good correlation between the experimental measurements and the FE predictions is obtained. The majority of the load seems to be carried out by one side of the joint, because of its

asymmetric geometry and the loading conditions imposed. The results show that the dominant strains in the adhesive are shear strains.

Fig. 17. Comparison between the predicted strains by the FE simulations and the experimental measurement obtained by DIC for the joint.

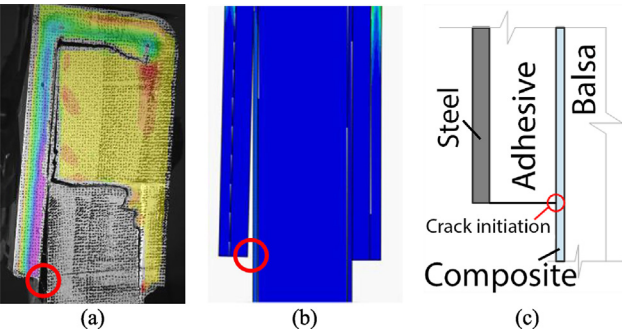
According to the dominant damage modes indicated by the AE results (see Figs. 12 and 14) and the visual inspection and DIC (see Figs. 8 and 13), the failure of the composite skin in contact with the adhesive part, which experiences high shear stress, is the main failure mechanism. The location of the crack initiation was also confirmed by the FE simulations as showed in Fig. 18.

Fig. 18. Location of the crack initiation leading to the final failure of the joint. (a) the experimental test, (b) FE simulation prediction, and (c) graphical illustration.
