Experimental investigation of fatigue after impact damage growth in CFRP

Biagini, D.; Pascoe, J. A.; Alderliesten, R. C.

23rd European Conference on Fracture, ECF 2022

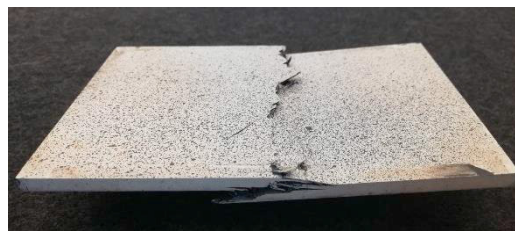
Fig. 4. Failed fatigue specimen showing the presence of delamination and kinking in transverse direction

To a visual examination, in both tests the failure mode appears to be similar to the one observed in static CAI tests, with a transverse fracture starting at the impact location and propagating towards the lateral edges (Fig.4). The local failure modes observed were delamination and fibre kinking.

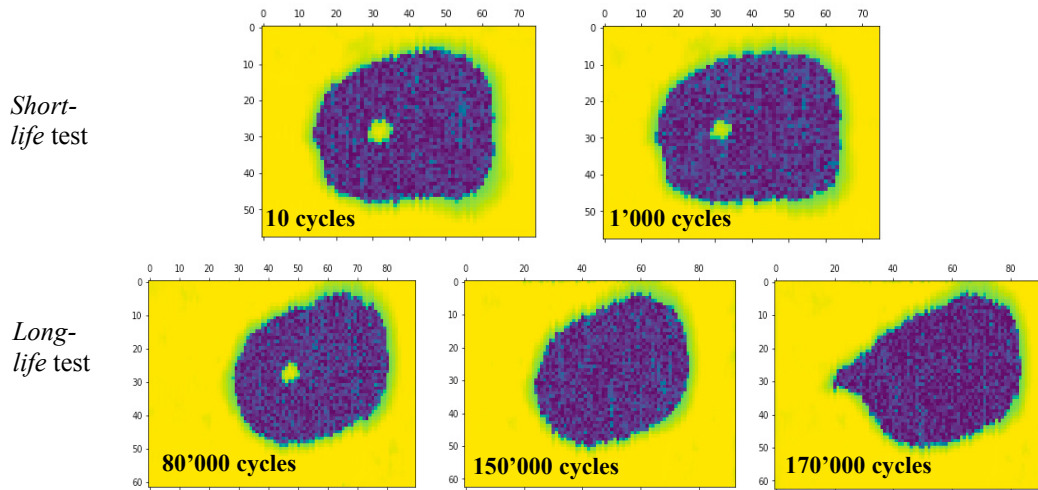
Fig.5. Ultrasound inspection results for *short-life* and *long-life* fatigue test

Impact tests resulted in BVID (impact dent < 0.3 mm) comprising multiple delaminations at different interfaces as documented in previous experimental works (Bull et al. (2014), Ellison et al. (2020)). From Fig.5, it's evident that a non-delaminated area can be detected in the impact location. The presence of this feature was observed by other authors in the literature both in LVI (Bull et al. (2014), and quasi static indentation (Abisset et al. (2016)) and can be attributed to the out of plane compression originating in the contact region between the impactor and the composite plate.

Periodic ultrasound scan was performed at interrupted fatigue test (Fig.6). In *short-life* fatigue, three scans were performed after 10, 100 and 1000 cycles. In the scans almost no delamination growth was observed and the specimen reached failure at 2500 cycles. In *long-life* fatigue instead, a total of 21 scans were performed following the intervals explained in section 2.4. For large part of the fatigue life no apparent growth was observed. After 140'000 cycles, delamination growth in the initial non-delaminated cone was observable. Only after that, a large delamination growth started in the transverse direction until reaching final failure. As previously explained, the short-life fatigue test showed only little growth. However in this case, due to the short duration of the test and the adopted inspection intervals, the last scan was performed at less than 40% of total fatigue life. For this reason the authors cannot exclude that adopting a shorter inspection interval, a delamination propagation similar to the *long-life* fatigue could be seen in the *short-life* fatigue.
