**Interface adhesion assessment of composite-to-metal bonded joints under salt spray conditions using peel tests**

Teixeira de Freitas, S.; Banea, M.D.; Budhe, S.; de Barros, S.

Composite Structures

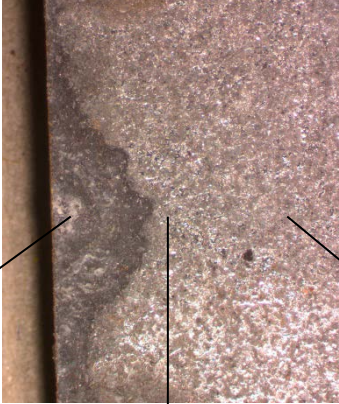
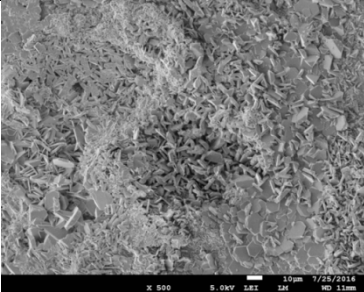
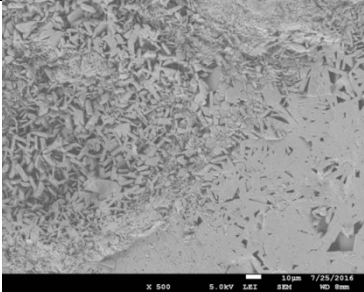
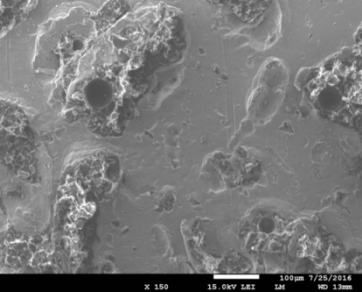
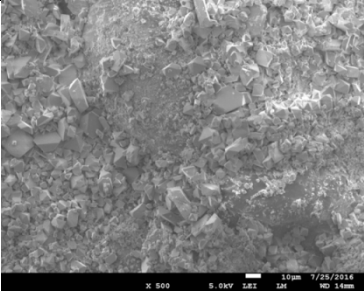
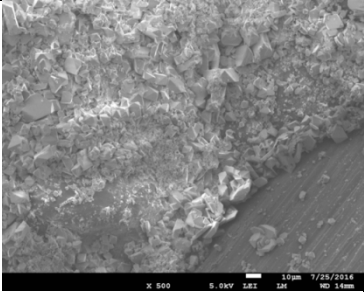
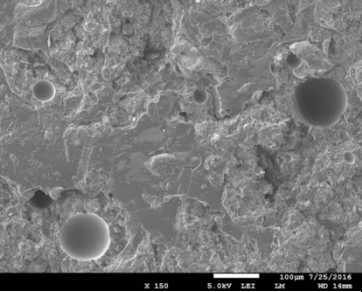
Table 3 – SEM pictures of typical fracture surfaces of the peel specimens.

Table 3 shows pictures taken from an area at one of the edges of the specimen where moisture ingress can be visually observed. The optical microscopic images (top) show the typical failure modes: adhesive failure (AF) and cohesive failure (CF), and a “flower-like” pattern of the moisture ingress from the edge to the center of the specimen’s width. SEM pictures were taken from three spots: (1) at the very edge of the specimen (AF), (2) farther from the edge, but still in the degraded area (AF) and (3) a non-degraded area with cohesive failure. SEM pictures were taken both at the steel side and correspondent CFRP side (2<sup>nd</sup> and 3<sup>rd</sup> row, respectively).

The fracture surfaces at the edge of the specimen –spot (1), 1<sup>st</sup> column, present a very rough fracture surface and particularly at the steel side, the surface texture suggest a deposition of salt crystals. At spot (2) – 2<sup>nd</sup> column, one can observe the same rough surface as in spot (1) with a transition to a smoother surface at the right bottom corner of both pictures (flexible and rigid adherends). Finally, on the cohesive failure area – spot (3), 3<sup>rd</sup> column, on the flexible adherend (steel side), there are areas of smooth surfaces and areas of rough surfaces. The rougher surfaces include also air voids which suggest that, adhesive is present on those areas. The smoother surfaces can indicate an area of the interface with steel. On the rigid

adherend side the air voids can also be observed on the adhesive. Smoother and rougher surfaces can also be identified.

<sup>1</sup>shown also in Figure 6; chemical characterization in Figure 7(a)

<sup>2</sup>chemical characterization in Figure 7(b)
