IMPACT PROOF CHILE

MULTIDISCIPLINARY PROJECT - 2016/2017

IMPACT PROOF PRELIMINARY DESIGN FOR THE MARINE BIOLOGY STATION IN DICHATO

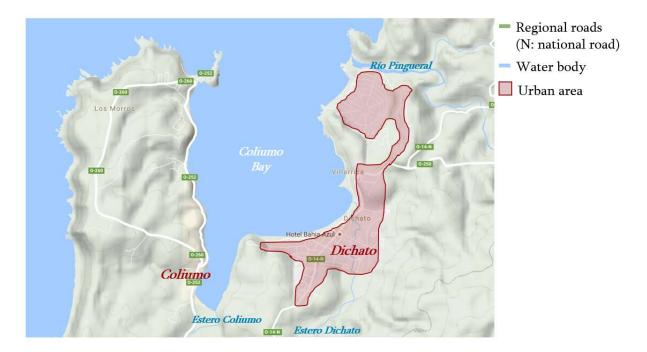
Figure 1-2: Topography, land use and infrastructure around Coliumo Bay

Figure 1-2 maps the urban areas, water bodies and infrastructure in and around Coliumo Bay, with height contours to indicate the elevation in the area. The bay has width of approximately 2.7 km and a maximum depth 20 m with respect to mean sea level.

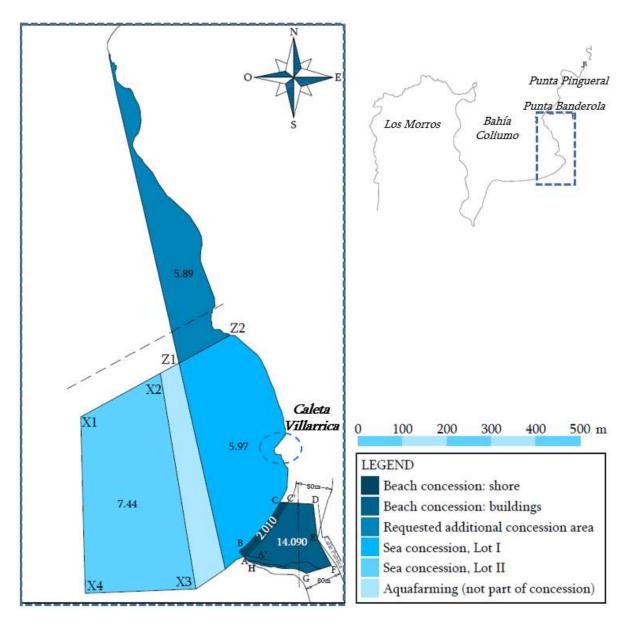
Figure 1-3: UdeC marine concession in Coliumo Bay

The University of Concepción (UdeC) owns a marine concession in Coliumo Bay, which includes a section of the beach, the shore and the sea. The marine concession and its location within the bay is shown is in Figure 1-3. Within the Lot II of the concession lies the Marine Biology Station (EBMD), which belongs to the Faculty of Natural and Oceanographic Sciences of UdeC. The objective of the EBMD is to provide research and educational support in the field of marine sciences (UdeC, 2003).

Caleta Villarrica is also marked in Figure 1-3. At this coastal protrusion, the EBMD concession included a jetty for the docking of a Marine Biology vessel called Kay Kay II. This vessel served as a floating laboratory and as storage space for breeding programs of marine species. However, in the 2010 Maule earthquake this jetty was destroyed.

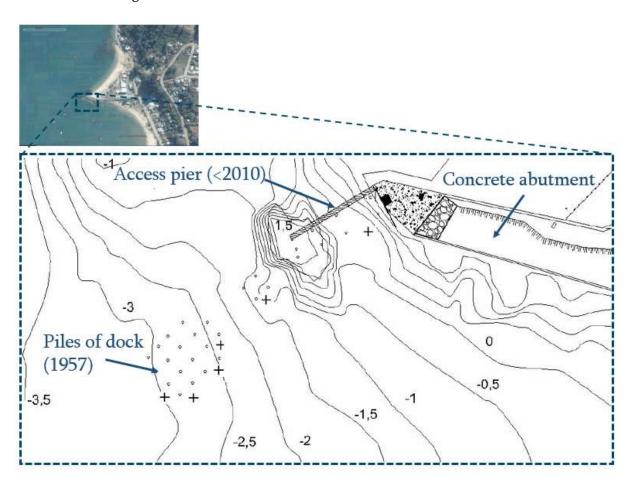
Figure 1-4: Historical maritime elements at Villarrica site

Table 1-1 gives an overview of the changes in the appearance and features of the Villarrica harbour in the period April 2004 to January 2016. In 1957 a dock was built on steel piles embedded in concrete foundations, with a wooden platform of 340 m². Currently, only the piles remain, which are heavily corroded. This dock was registered in the name of the Internal Tax Services. The EBMD was inaugurated by UdeC in November of 1978. Since 2003, the UdeC marine concession exists as shown in Figure 1-3. Several projects were constructed, namely an access pier for the docking of the Kay Kay II vessel (Figure 1-4); a storage facility also serving as laboratory (green-roofed building in Figure 1-4); a concrete defence wall north of the pier; and a southern defence wall, made of masonry, which deteriorated quickly due to the severity of the elements -waves and tides in particular. Figure 1-4 shows some of these key features of the Villarrica harbour site, together with elevation contours and crosses marking SPT locations.

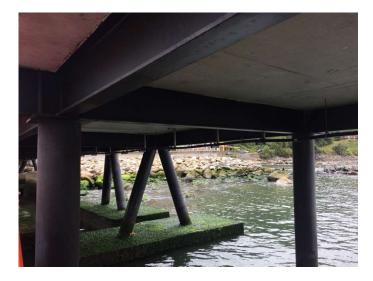
Figure 1-8: Construction detail of the deck, piles, beams and foundation slabs of the Coliumo jetty

The jetty is made in an L-shape, the concrete deck is poured in-situ, on steal H-beams. The beams are supported by steal piles, placed both straight and inclined, to absorb horizontal forces. The piles are founded on concrete slabs on the rocky seabed. A clear view of the construction discussed is given in figure Figure 1-8.

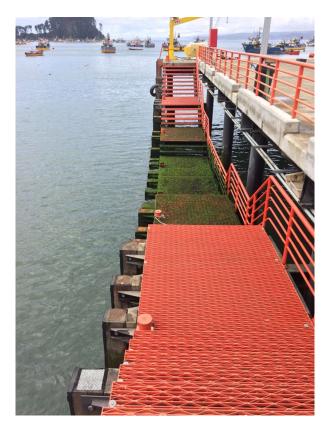
Figure 1-9: Levelled steel staircase at Coliumo jetty

Alongside the L-shaped deck there are several staircases in order to serve the ships at different tidal water levels. In Figure 1-9 an example at Coliumo is given. The total length of the stairs can be adjusted to the design, as well as the height to the tidal difference. Wooden piles are placed in front to serve as fenders and foundation to the seabed. Small bollards have been placed on the steel stairs, whereas bigger ones are placed on the deck. A crane to assist the ship has been placed on the deck next to the stairs.

In and around Coliumo not much sea defence is present as it is situated on the lea-side of the bay, in the shadow of a peninsula. In Figure 1-9 the peninsula is on the left side. The opening to the open sea is at the right of it, facing in North direction. In comparison to the marine biology harbour complex, Coliumo is much more sheltered from wave impact. A traditional jetty like this would need an additional sea defence in Dichato, on the opposite side of the bay.

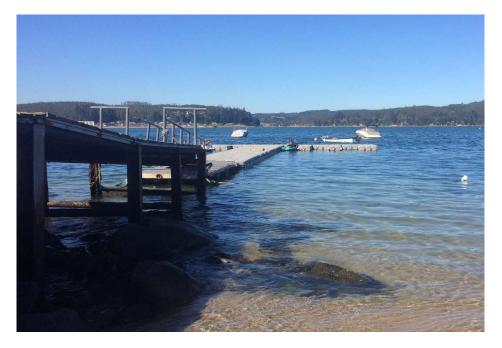
Figure 1-10: Jet ski floating jetty

Although offshore sea defences are rarely seen in Chile, breakwaters are placed on occasion in smallsize applications. In Dichato, for example, a breakwater has been placed on the windward side of a floating jet ski jetty, see Figure 1-10 and Figure 1-11. The original jetty (pre-2010) consisted of an extended dock of wooden piles and a concrete deck, of which only the first few metres withstood the 2010 tsunami and remain today as can be seen in Figure 1-10. The rest of the jetty has been replaced with a temporary floating one.

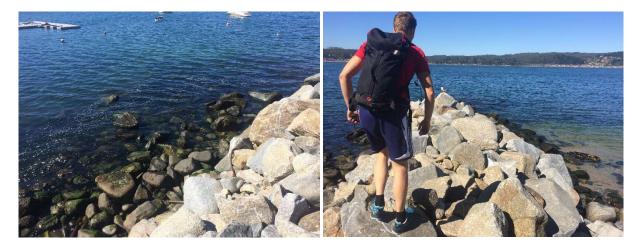
Figure 1-11: Breakwater to the North of jet ski jetty

The breakwater, too, was destroyed by the tsunami wave, see the rubble of previous armourstone on the leeward side of the breakwater in Figure 1-11. The breakwater was reconstructed shortly after the tsunami simply by placing back the removed stones. No re-design of any of the elements in this jet ski docking facility was considered, as designing against tsunami impact is considered futile¹.

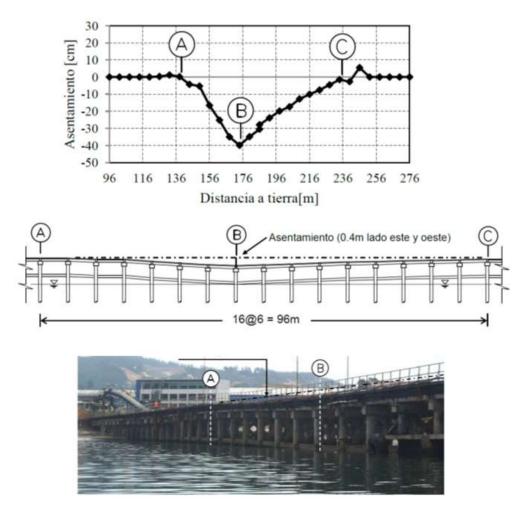
Figure 1-12: Liquefaction-induced differential settlements at Puerto Lirquén

The following images show jetties and other harbour facilities in Chile that were affected by the Maule 2010 earthquake and ensuing tsunami. Several failure mechanisms may be inferred from the photographs, as well as structural mitigation measures. These examples stem from a presentation given by Dr. Dechent of UdeC, on December 6th 2016.

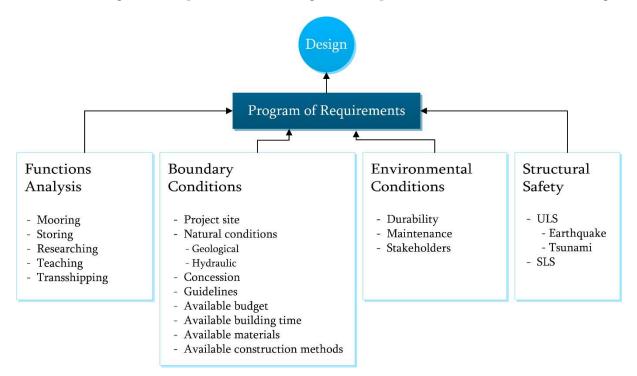
Figure 2-1: Method to achieve the Program of Requirements

To make sure the final design fulfils the needs of the EBMD, an extensive program of requirements is compiled. To achieve a complete program of requirements a method as depicted in Figure 2-1 is used. Analyses of the functions, boundary conditions, sustainability and safety requirements are carried out to make sure all needs and interests are included in the Program of Requirements. The different analyses are elaborated in the following chapter. Finally, the analyses are put together and result in the Program of Requirements. The Program of Requirements is used as basis to for design.

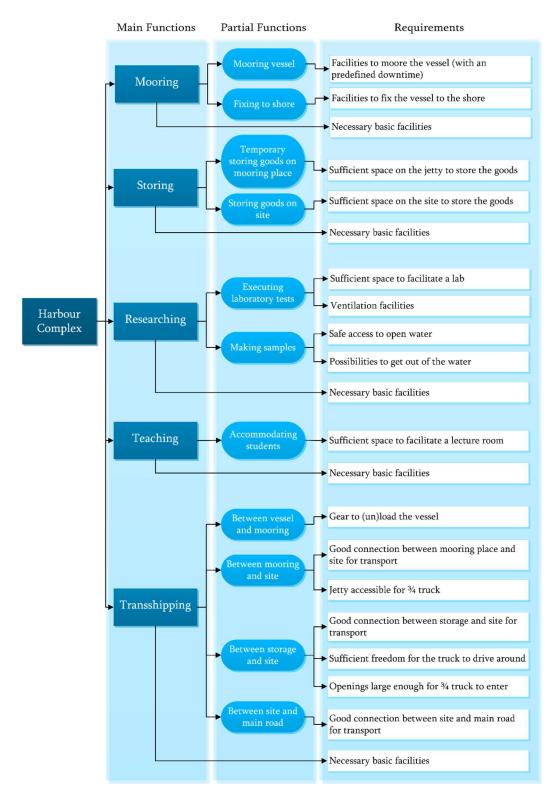
Figure 2-2: Function analysis diagram

The main functions of the Harbour Complex are: mooring; storing; researching; teaching; and transhipping. These main functions are divided into partial functions which result in the requirements to be fulfilled, as shown in *Figure 2-2*. A short elaboration of each main function follows.

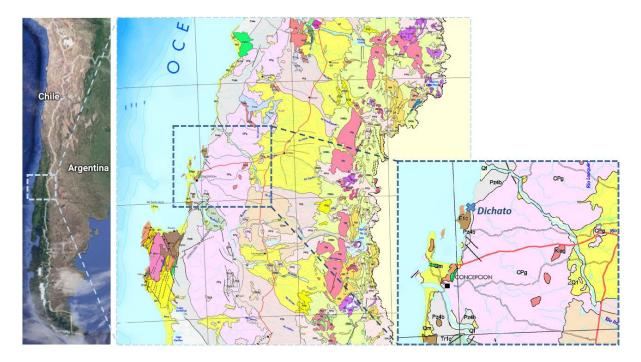
Figure 2-3: Location of scope area and geologic map (scale 1 : 100 000) (SERNAGEOMIN, 2009)

The geologic map in Figure 2-3 shows the regional geology. A rock and soil type description of the geologic units relevant to the region around the Dichato harbour and Coliumo bay. Figure 2-3 also depicts the presence of two faults to the South of Dichato, running diagonally NW to SE. For the geologic history of the region, consult Appendix B.1

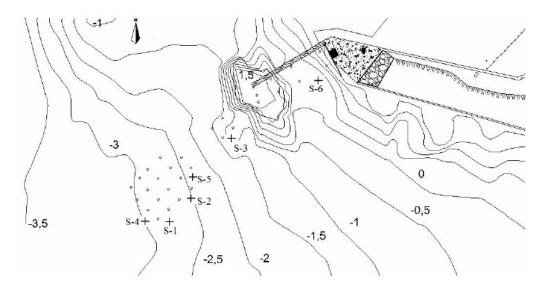
Figure 2-4: Locations of SPTs performed in February 2010. MLW (Mean Low Water level case, see Figure 2-12)

In February 2010 the Soil Mechanics Laboratory carried out 6 Standard Penetration Tests (SPTs) off the coast of Caleta Villarrica, as marked by the crosses in Figure 2-4. The SPTs were performed using an ACKER MC-2 model, mounted on a raft, with 1.75 inch inside diameter tubes. Records of the SPT penetration indices, water levels, determination of index properties and the USCS classifications tests of the recovered samples are given in Appendix B.4, as well as photographs of retrieved samples. A second test was carried out onshore in November 2016: a geophysical survey using geophones and a Nakamura set-up. Please consult Appendix B.4.3 for an explanation of the survey and the results, which give an indication of the stratigraphy of the subsurface at the Marine Biology Station up to 70 m depth.

Another consideration is the location of the existing pile remains, which are steel piles with concrete 'shoes', see Figure 2-4 for locations. The old piles will be cut for construction of a new jetty, but the concrete shoes which remain at the sea floor ought to be avoided when driving new piles.

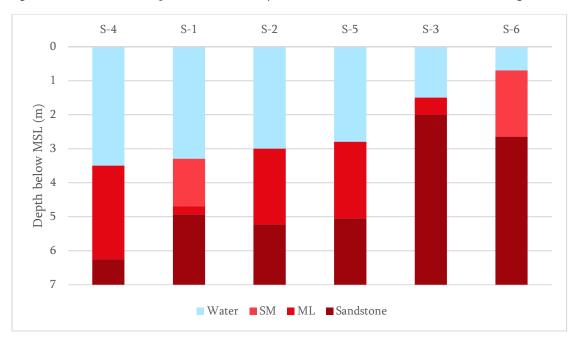
Figure 2-5: SPT results (arranged in SW-NE direction)

Figure 2-5 illustrates the results of the SPT, where a distinction is made between three soil or rock types according to USCS standards: SM (silty sand); ML (inorganic silt of low plasticity); and, at the rejection point of the penetration cone, rock (sandstone with silty matrix). It may be noted that the depth of the sandstone increases irregularly towards the shore, with a rock outcrop between S-3 and S-6. Also, the presence of silty sand is limited to the locations of S-1 and S-6.

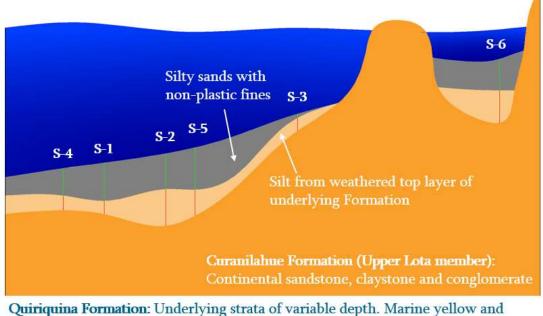
Figure 2-6: Geological cross-section at Caleta Villarrica (not to scale)

green conglomerate sandstones, fine and medium sandstones and mudstones.

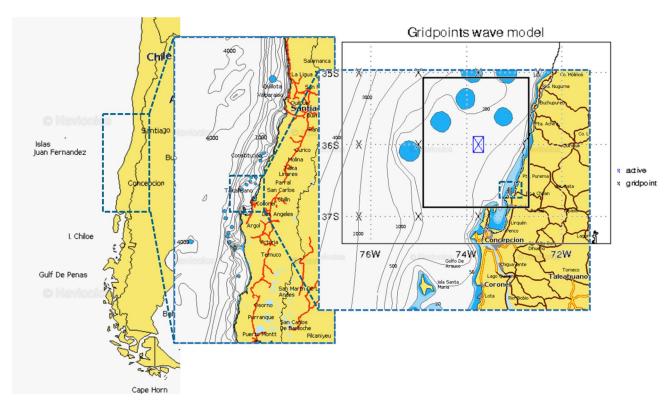
Figure 2-7: Bathymetry. Source: Navionics & WaveClimate.org

A good insight in the bathymetry is of major importance as it serves as input for the modelling of the forces on construction. A detailed zoom-in is given in Figure 2-7, as also the greater depths further off from the shore are significant in making a good translation of offshore wave conditions to the nearshore wave properties. Figure 2-7 also gives the grid point where the wave and wind data were measured.

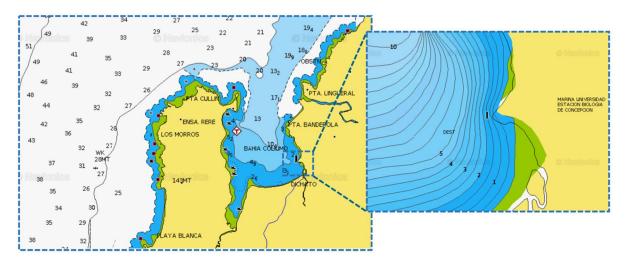
Figure 2-8: Seabed profile. Source: Navionics

The detailed bathymetry of the Coliumo Bay is relevant for the structural design as well, as it has to be suitable for the normative vessel.

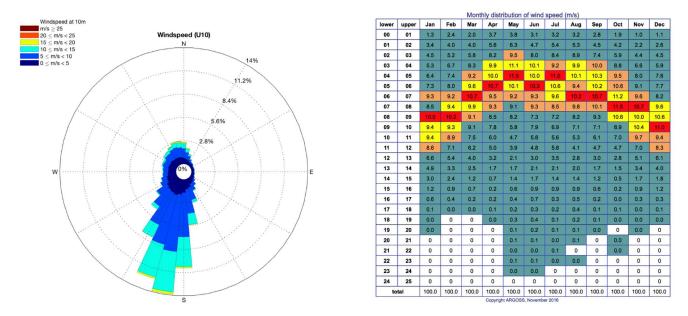
Figure 2-9: Wind directions/ percentage of occurrence and intensity

The climate in this region is mostly influenced by anticyclone wind caused by a high pressure cell in the central pacific. In this particular area, the prevailing wind directions are south to south-south-west during summer. During winter, northern winds are more frequently occurring. This can be seen in Figure 2-9. The figure on the left describes the origin of the winds. A big peak at the bottom means from the south. The longer a line is, the more often it occurs. The colours describe the

magnitude of the wind. The average maximum winds in Dichato are in the order of 15-20 m/s, both from the north and south. In the figure on the right, it is made clear that the summer winds (from the south) have a higher average value than the winter (northern) winds. Nevertheless, the storms in the winter can be of great importance for the design. The highest wind speeds will originate from the north, as occurred in August 2015. A storm with wind speeds of 35 m/s left great damage at the coast of middle Chile (Winckler, 2016).

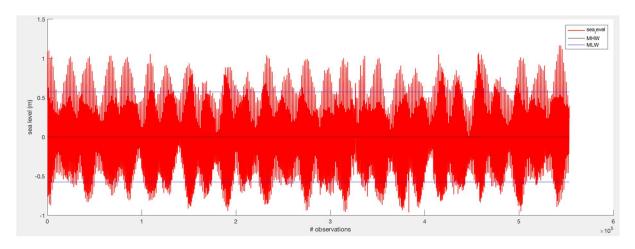
Figure 2-10: Tidal observations of 1 year from the Talcahuano buoy

After removing some odd values the result is displayed in Figure 2-10. Clearly the semi-diurnal character of the tide can be observed, as the higher peaks and lower peaks are separated. In a more detailed plot this becomes even more clear, Figure 2-11, these are the observations of one month.

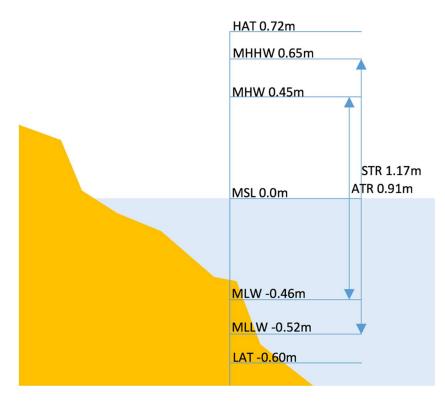
From the data, a mean high water level is calculated, by calculating the maxima per tidal cycle. Those values are averaged and represent the MHW. The same is done for the mean low water. The highest all time (HAT) and lowest all time (LAT) is obtained from the data as well. In *Figure 2-12* a summary of the values is displayed. An average tidal range (ATR) of 1.15m is the result of the mean high and low water tide.

HAT = Highest All Time; MHHW= Mean Highest High Water level; MHW = Mean High Water level; MSL = Mean Sea Level; MLW = Mean Low Water level; MLLW = Meanest Lowest Low Water level; and LAT = Lowest All Time.

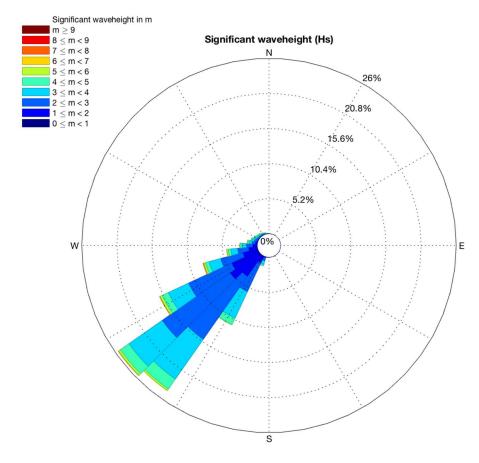
Figure 2-13: Wave heights and directions offshore at Coliumo Bay. Clearly the main direction, the SW, is visible. Note that the NW winter storms are of importance for the design as well.

The waves from the south-west are the prevailing waves, as can clearly be seen in *Figure 2-13*. These are mainly swell waves with their origin around the 'roaring forties' above Antarctica. The significant wave heights (H_s) are around 7 m offshore and have a peak period (T_p) of 14.5s (BMT Argoss, 2016). This is without the storm conditions from the south-west, where significant wave heights are in the order of 9m (T_p 15.5 s).

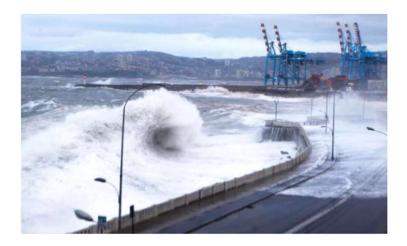
Figure 2-14: Winterstorm August 2015, at the port side of Valparaíso (Winckler, 2016).

The second important direction of waves is from the north-north-west. These waves are wind waves, originated from storms (mainly during the southern hemisphere winter) off the coast off Chile. A very destructive storm from this particular direction occurred in August 2015. Wind speeds (v_{10}) of 35m/s and offshore wave heights of 10.23m with a peak period (T_p) of 7s where measured along the coast. The storm is very well documented and analysed (Winckler, 2016). To give an indication of the force of the NNW storm, a picture at Valparaíso is displayed in Figure 2-14.

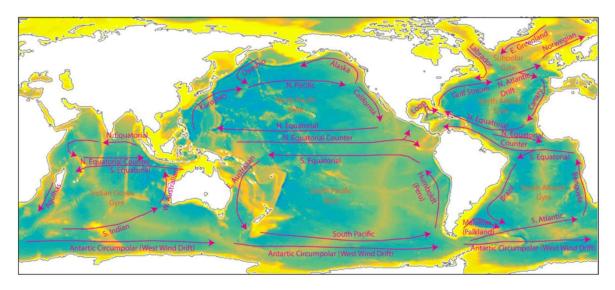
Figure 2-15: Main ocean currents. Figure generated by James Salmon using the WOCE data base.

To get an insight in currents along the Coliumo bay, two different views can be taken. The first one is a world view, the second is on the level of the bay. The Peru-Humboldt current is the large-scale eastern boundary current, driven by the global wind patterns, more specifically, driven by the Antarctic Circumpolar current (West Wind Drift) and the trade winds in the Hadley cell. This current has an average speed of maximum 10 km/day, has a width of approximately 1000km and goes up to a depth of 500m. Figure 2-15 gives a view of the origin of the current and its position in the world circulation (Pietrzak, 2011).

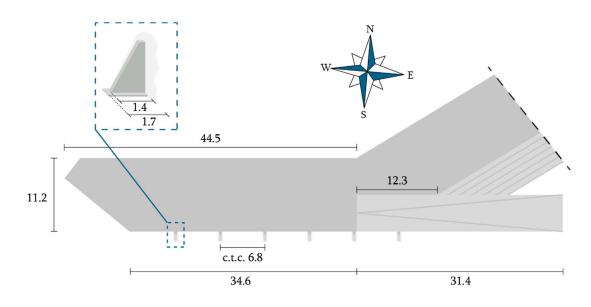
Figure 2-16: Concrete abutment (dimensions in m)

Another structural aspect to be taken into account for the jetty design is the concrete abutment as mentioned in Chapter 1.1.3. This part of the previous harbour still solidly remains and could be used as an integrated part in the design of the harbour complex. Its dimensions are indicated in Figure 2-16. The concrete abutment is strengthened on its southern side by protruding concrete elements.

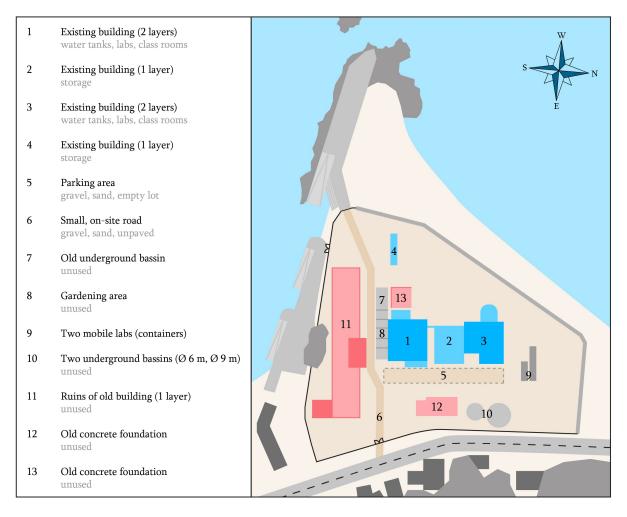
Figure 2-17: Current situation Marine Biology Station

Figure 2-17 shows the current situation of the Marine Biology Station, focusing on the onshore facilities. The buildings marked 1, 2, 3 are currently in a good condition. They have been developed after the tsunami of February 17, 2010, and are therefore in no need of structural attention. On the ground floor level, some attention should be paid to the parking area (number 5) and the small on-site road (number 6). From a structural point of view, redevelopment of the structures 11, 12 and 13 is of interest.

- a) The remains of the large building (number 11, see Figure 2-17) shall be reused and it shall be redeveloped in a similar manner to the new buildings that have already been constructed on site, as was suggested in the Traditional Alternative (see paragraph 3.3). This option is most in line with the interests expressed by the on-site operator during our location visit of 1 December 2016.

- b) The foundations of the old sleeping cabin (number 12, see Figure 2-17) shall be redeveloped in order to restore the original function there, as was also suggested in the Traditional Alternative (see paragraph 3.3), in agreement with the interests expressed.

- c) The other on-site foundational remains (number 13, see Figure 2-17) will not be redeveloped at this point, as no need has been expressed to do so at this point. We do suggest to refurbish and maintain this foundation to make it suitable for future expansion.

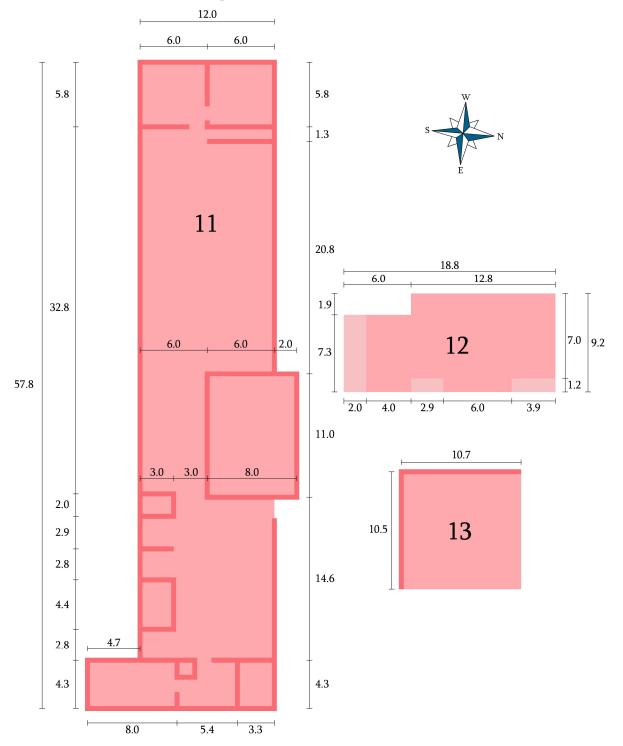
Figure 2-18: Onshore structures suited for potential structural redevelopment (dimensions in m)

The remains of the old on-shore structures numbered 11, 12, 13 have potential to be structurally redeveloped (see Figure 2-18). The largest structure, building 11, has no ceiling. Only walls remain up to a height of one building layer. The on-site operator who was spoken with during a site visit on December 1, 2016, said that building 11 requires similar use as building 1 and 3 of Figure 2-17.

Structure 12 only has concrete foundations remaining, used for a small cabin in the past, with a few units for nightly stays. The building has been wiped away and its original function has not been restored in the current building stock. It would be preferable if sleeping units yet again became a part of the on-site complex.

In the last structure, numbered 13, only the concrete foundations remain as well as low walls on two of the four sides. The previous function of this structure remains unknown, but it could prove a good site for additional functions as the foundations are already in-place.

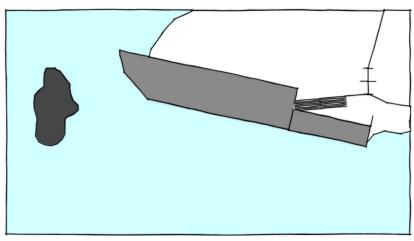
Figure 3-2: Null option (Alternative A)

For this option, the status quo is maintained. No jetty or wave protection is applied and transhipment continues to take place using a transitional smaller vessel.

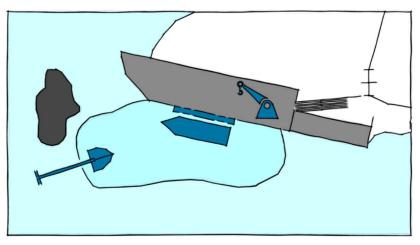
Figure 3-3: Simple option (Alternative B)

The construction time and costs are minimized for this option through the employment of the existing concrete abutment as a mooring facility. A staircase is built in front of the abutment in concrete or steel and a crane is installed on top. An area around the abutment is dredged to create sufficient depth for the vessel. Considering the mooring location at the lee-side of the Caleta Villarrica no additional wave defence system is applied. The rock outcrop as shown in Figure 3-3 might have to be removed for manoeuvrability purposes. Also, the quality of the concrete abutment needs checking and, potentially, upgrading.

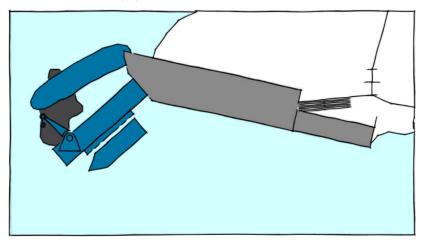
Figure 3-4: Traditional option (Alternative C)

As part of the Coastal Reconstruction Plan of 2011-2013, a new jetty was built in Coliumo, across the bay from Dichato, for docking and transhipping purposes for local fishermen. A similar concept may be applied for the EBMD jetty: a concrete deck on steel piles which are alternately inclined to resist horizontal forces from seismic or vessel impact loads. As in option B), a steel or concrete staircase is built on the lee-side of the structure and a crane is installed on the concrete deck. A rubble mount breakwater is erected on the windward side of the jetty. As in Coliumo and other harbour towns, a concrete slab road runs from the existing abutment to the onshore storage structure.

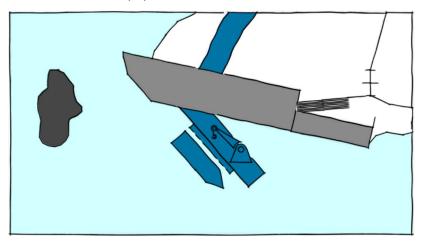
Figure 3-5: Impact proof option (Alternative D)

Considering the exceptional natural conditions to which the harbour complex may be subjected, it is important to consider a design which is as resistant as possible to seismic and tsunami loading. Taking into account the fact that the existing concrete abutment withstood the 2010 tsunami without significant damage, a second concrete abutment is constructed pointing southwards from the existing one to avoid the wave impacts of highest intensity. This second abutment serves as the

mooring facility. On the windward (northern) side, an armourstone wall is erected as coastal protection.

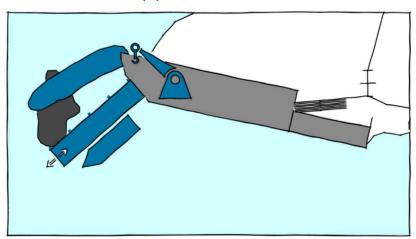
Figure 3-6: Future flexible option (Alternative E)

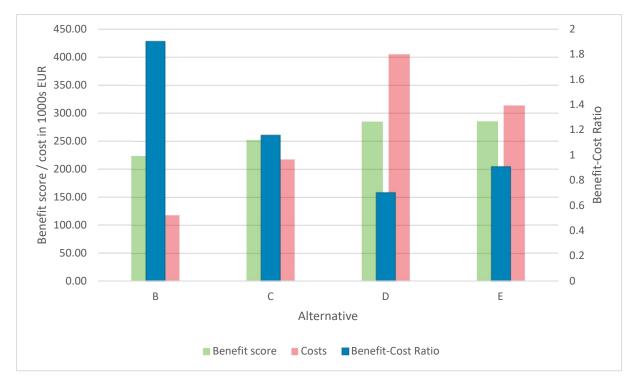
Figure 4-1: Results Cost-Benefit Analysis

The outcomes for the different alternatives are shown in Table 4-6 and depicted in Figure 4-1. It appears that option (B) Simple, is the optimal option to ensure the performance of the required tasks of the Marine Biology Station. Its costs are very low, and the benefit score is as high as other options.

From Figure 4-1 option (B) Simple emerges as the optimal design alternative. Whilst options (D) Impact Proof and option (E) Future Flexible have a higher benefit score, this is offset by the costs involved. Option (B) scores well despite having the lowest benefit score due to the limited costs involved in constructing this mooring facility.
