Zhang, Y., Pal, S. K., Ragni, D., Groves, R. M., & Watson, S. J. (2026). Remote detection of internal and subsurface damage in wind turbine blades using acoustic beamforming and infrared thermography. *Structural Health Monitoring*. <https://doi.org/10.1177/14759217261446879>

Remote detection of internal and subsurface damage in wind turbine blades using acoustic beamforming and infrared thermography

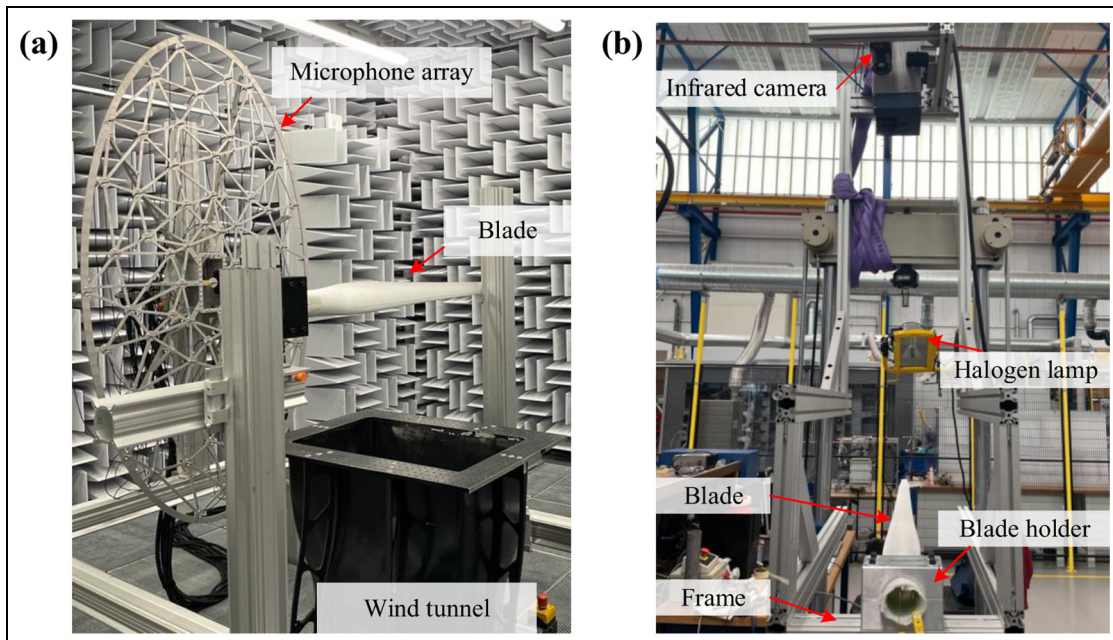
Figure 5. Experimental setup for non-rotating tests: (a) wind tunnel measurements and (b) static thermal measurements.

Non-rotating tests for acoustic measurements were conducted in the Anechoic vertical open-jet tunnel (A-tunnel) of TU Delft.⁵⁸ The experimental setup is shown in Figure 5(a). The wind tunnel has a 0.4×0.7 m rectangular test section at the outlet. It can operate at free-stream velocities up to 45 m/s, maintaining a turbulence intensity below 0.1% across the full velocity range. The uniformity of free-stream velocity in the test section is within 0.5% relative to the velocity at the nozzle center. The blade was mounted horizontally above the wind tunnel nozzle using two clamps at the two ends of the blade to ensure its stability. This configuration minimizes unwanted vibrations, which may introduce a change in the geometry of the blade, for example, the angle of the attack, under aerodynamic load during measurement. The trailing edge at mid-span was fixed at 500 mm from the nozzle, with the chord line at mid-span aligned with the nozzle centerline. During the measurements, the wind tunnel operated at a free-stream velocity of 30 m/s. The boundary layer was tripped using 0.4 mm thickness zigzag strips at 20% on both pressure and suction sides. Due to setup constraints, a different microphone array,

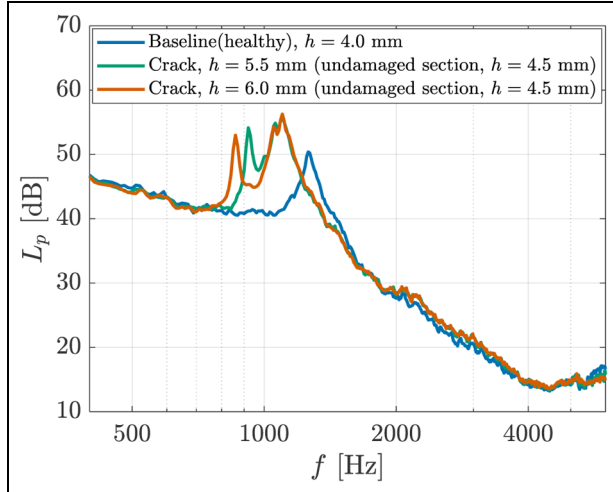
Figure 6. Noise spectra for the baseline and different cracked cases.

The crack-induced increase in trailing edge thickness can alter the coherent vortex shedding process and, consequently, shift the associated tonal noise.^{26,28} Figure 6 presents the noise spectra for the baseline and for different crack sizes under non-rotating conditions with a clean inflow. Table 2 summarizes the trailing edge thickness and the corresponding tonal frequency for each case, together with the trailing-edge-thickness-based Strouhal number, $St_{h, \text{peak}} = \frac{f_{\text{peak}} h}{U}$ (f_{peak} , h , and U are the tonal frequency, trailing edge thickness, and inflow velocity, respectively). The crack size was increased by introducing a small insert into the original cracked trailing edge.

For the baseline case, as shown in Figure 6, only a single spectral peak associated with blunt trailing edge noise is observed, since the trailing edge thickness is uniform along the span. This peak is located at $St_{h, \text{peak}} = 0.168$, which agrees with the results reported in the study by Brooks et al.⁵³ When a crack appears at the trailing edge, two distinct peaks emerge in the noise spectrum. For the cracked blade, manufacturing differences lead to a slightly larger trailing edge thickness in the undamaged section compared to the healthy blade, causing the higher-frequency peak to shift toward a lower frequency relative to the baseline case. In addition, the presence of the crack further increases the trailing edge thickness at the damaged section, giving rise to an additional peak at a lower frequency. As the crack size increases, from a thickness of 5.5 to 6.0 mm, this low-frequency peak shifts further toward lower frequencies. A qualitative analysis shows that the corresponding trailing-edge-thickness-based Strouhal

numbers, $St_{h, \text{peak}}$, listed in Table 2, vary between 0.168 and 0.172. Moreover, as the crack size increases, the Strouhal number, $St_{h, \text{peak}}$, tends to increase, which is consistent with the findings reported in the authors' previous work.²⁸

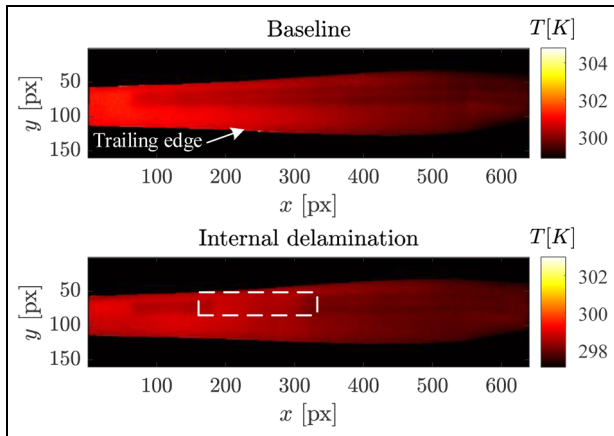
Figure 7. Instantaneous thermal image when the blade is heated for around 120 s for baseline and different damaged cases. The dashed box indicates the damaged location.

To evaluate the capability of IRT in detecting structural damage, especially for the internal defects, the thermal responses for baseline and damaged blades were compared. Figure 7 shows the instantaneous thermal images when the blades were heated for

approximately 120 s for the baseline and internal delamination cases. The region with internal shear webs for

both blades exhibits a slightly lower temperature compared to the surrounding area. In the case of internal delamination, the damaged region appears to exhibit less contrast with the surrounding area than the non-damaged location and at the same location as the baseline case. This behavior can be attributed to the disruption of heat conduction caused by the delamination, which introduces an additional thermal resistance. As a result, the heat flux is partially impeded, leading to localized temperature accumulation.

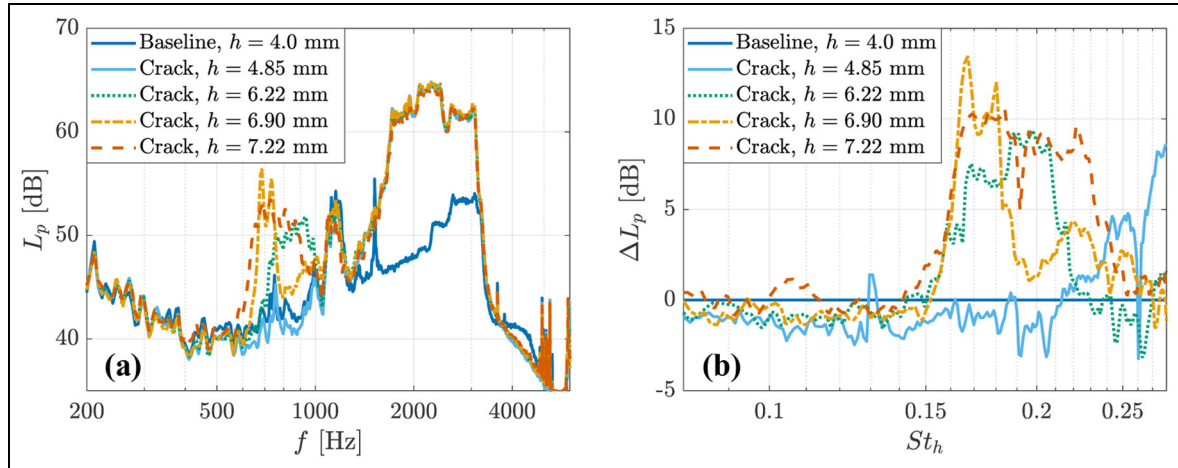
Figure 11. The sound pressure level and the relative sound pressure level for baseline and trailing edge crack of different crack sizes: (a) noise spectra and (b) relative spectra compared to the baseline case.

Trailing edge crack detection. A crack at the trailing edge can lead to an increase in the local effective thickness, as the crack opening introduces a geometric modification³ that affects aerodynamic noise. In this work, the damage size was adjusted by adding different layers of tape to the damaged section, thus increasing the total thickness of the trailing edge. Experiments were conducted at a rotational speed of 420 rpm and a wind speed of 7 m/s. All the blades were tripped using 0.4 mm thickness zigzag strips on both the suction and pressure sides at 20% of the chord. Figure 11 shows the noise spectra for the baseline and the various cracked configurations. It should be noted that, since the experiments in the A-tunnel and OJF were performed in different seasons, the trailing edge thickness of the original crack slightly changed from 5.5 mm, as shown in Table 2, to 4.85 mm. As shown in Figure 11, the noise spectra of the baseline case and the 4.85 mm cracked case are very close below 1300 Hz, where the damage-induced features are not clear. A noticeable difference between the two configurations appears in

the 1700–3000 Hz range, where the noise spectrum of the cracked blade exhibits a higher-level broadband hump compared to the baseline. Figure 12 shows the beamforming maps for these two cases at a one-third octave frequency of $f_{1/3} = 2500$ Hz with the same dynamic range (60–75 dB). The cracked configuration exhibits a markedly higher sound pressure level near the blade tip, which may be attributed to a slight tip deformation after manufacturing, leading to a small twist that generates increased noise in this region. However, this change does not affect the detection of the trailing edge crack, as the crack-induced spectral variations are present at lower frequencies.

For a larger crack, the trailing edge thicknesses were set to $h = 6.22, 6.90,$ and 7.22 mm. Strong tonal components appear in the corresponding noise spectra, as shown in Figure 11(a). As the crack size (trailing edge thickness) increases, the tonal components shift to lower frequencies, consistent with the expected effect of the blunter trailing edge. Figure 11(b) shows the relative sound pressure level compared to the baseline case, $\Delta L_p = L_p - L_{p, \text{Baseline}}$. The frequency is scaled by the trailing-edge-thickness-based Strouhal number, $St_h = fh/U$, where U is the resultant flow speed at the damaged section. The resultant flow speed, U , is obtained from BEMT, as shown in Table 3. The humps induced by damage are located in the range of St_h between 0.15 and 0.25, which agrees with the results reported in previous studies.^{26,53}

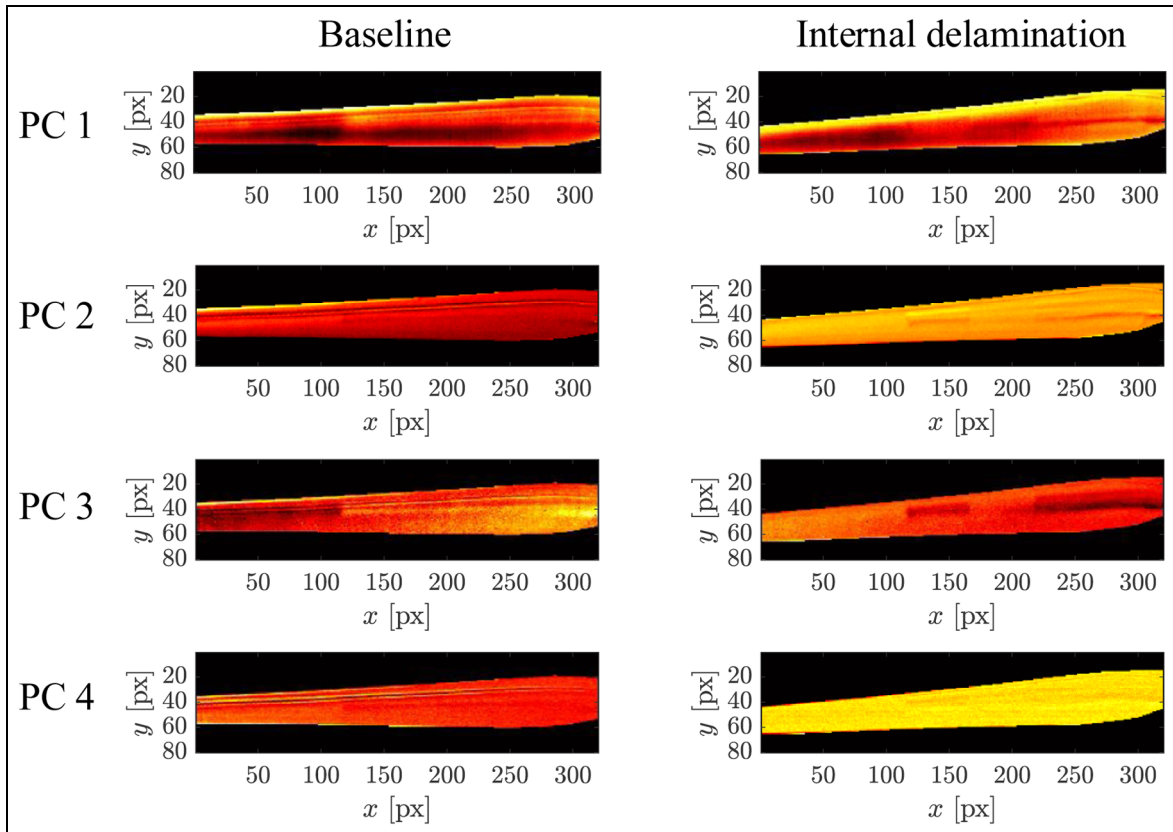
Figure 15. The first four PCs of PCT for the baseline case and the case with internal delamination. PC: principal component; PCT: principal component thermography.

PC thermography. To further enhance the visibility of temperature features associated with internal structures and defects, PCT is applied to the thermal image sequences. In this study, 500 thermal images were used for the PCT analysis. Figure 15 shows the first four PCs for the baseline and internal delamination cases. For the baseline case, the first three PCs clearly show the internal shear webs (at 26.0% and 42.5% of the chord length) together with the surface zigzag tripping strip (at 20% chord), while the fourth PC shows only the tripping strip. In contrast, for the internal delamination case, discontinuities in the internal shear web patterns are evident in PCs 2 and 3, indicating the presence of internal delamination.

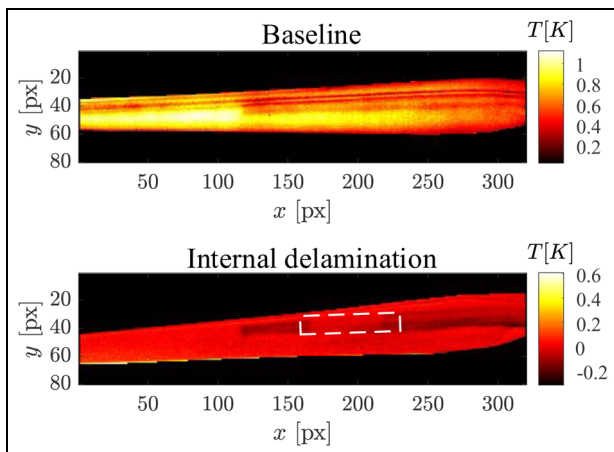
Figure 16. The reconstructed thermal images for the baseline case (using PCs 1–3) and the case with internal delamination (using PCs 2 and 3). PC: principal component.

The thermal images are reconstructed using only the PCs associated with internal features to ensure consistency with the analysis framework used for the non-rotating blades discussed in the third section. Figure 16 shows the reconstructed instantaneous thermal images for the baseline and internal delamination cases. For the baseline blade, the reconstruction is performed using PCs 1–3, whereas for the internal delamination case, only PCs 2 and 3 are used. After reconstruction, the thermal features associated with the internal structures become more pronounced than in the original images shown in Figure 14. The internal delamination is more clearly visualized, appearing as a higher-temperature discontinuity at the damaged location. This behavior is attributed to the reduced effective thermal conductivity at the delaminated section, which impedes heat transfer and leads to localized heat accumulation, as discussed previously.
