NET-ZERO ENERGY REFURBISHMENT
WITH CIRCULAR BUILDING MATERIALS
AT THE TU DELFT

P5 - Iris Snijders Blok – 03-11-2017

Master Building Technology

The graduation project result in an energy neutral refurbishment of the Low Speed Lab and provides the TU Delft with a method to refurbish its building portfolio

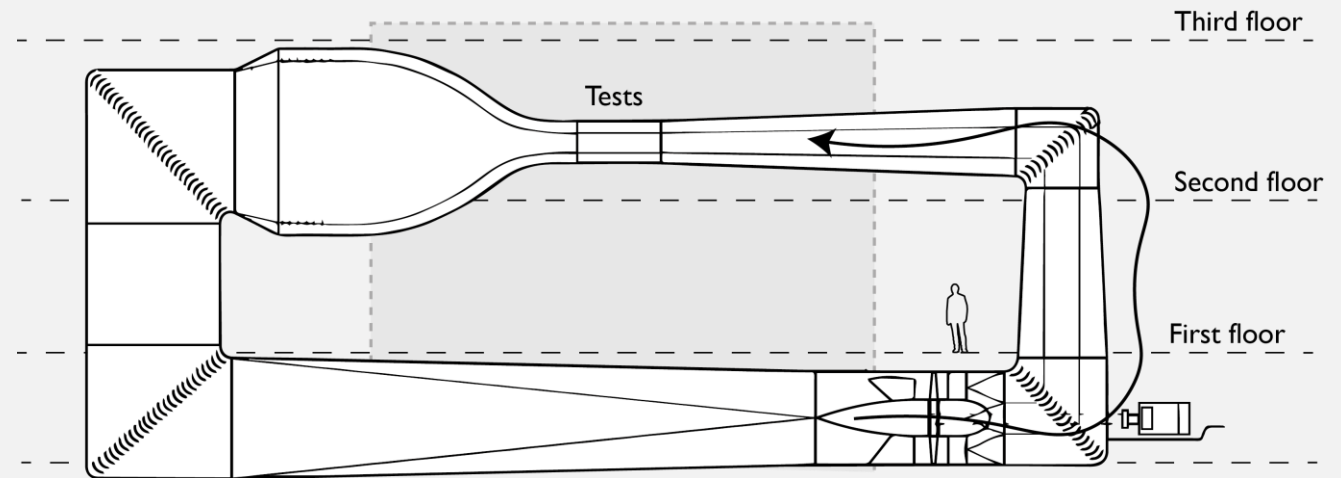
Section of the Low Speed Low Velocity wind tunnel

THE BUILDING HOUSES A THREE-STOREY HIGH WIND TUNNEL

Key information on the chosen building

- Low Speed Low Velocity wind tunnel
 - Built in 1952. Addition in 1977
- Increase of users groups to nine
 - Morphology does not suit many users
- High energy consumption
 - Lack of thermal insulation
 - Many machines
- Area is being redeveloped
 - New parking garage
 - New park

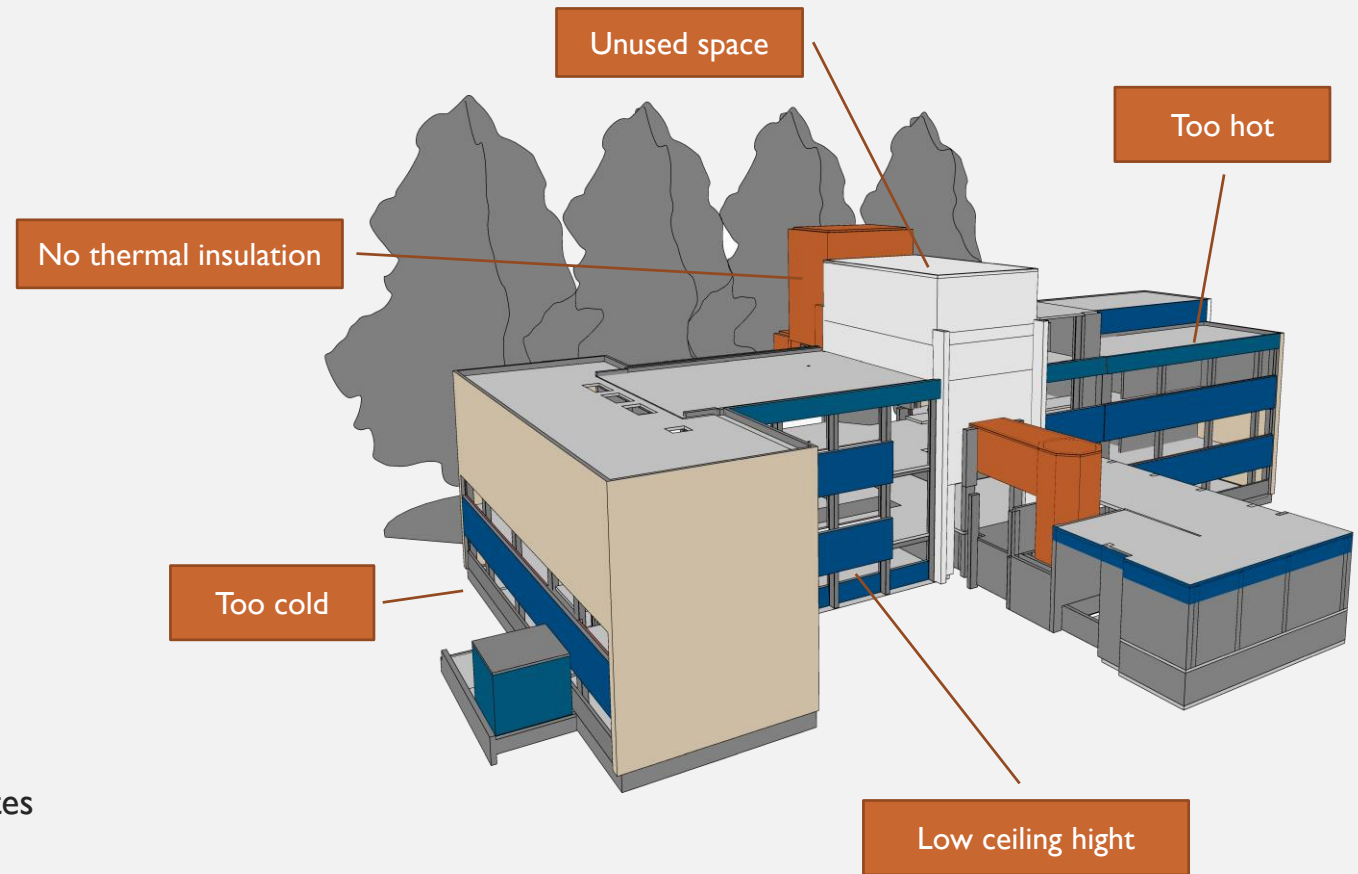
PROBLEMS

1. Comfort

- Too cold/warm
- Lack of thermal insulation
- Lack of daylight

2. Morphology

- Defect routing
- Dead end routes
- Chaotic
- No focus point
- Many materials, volumes, colours and routes

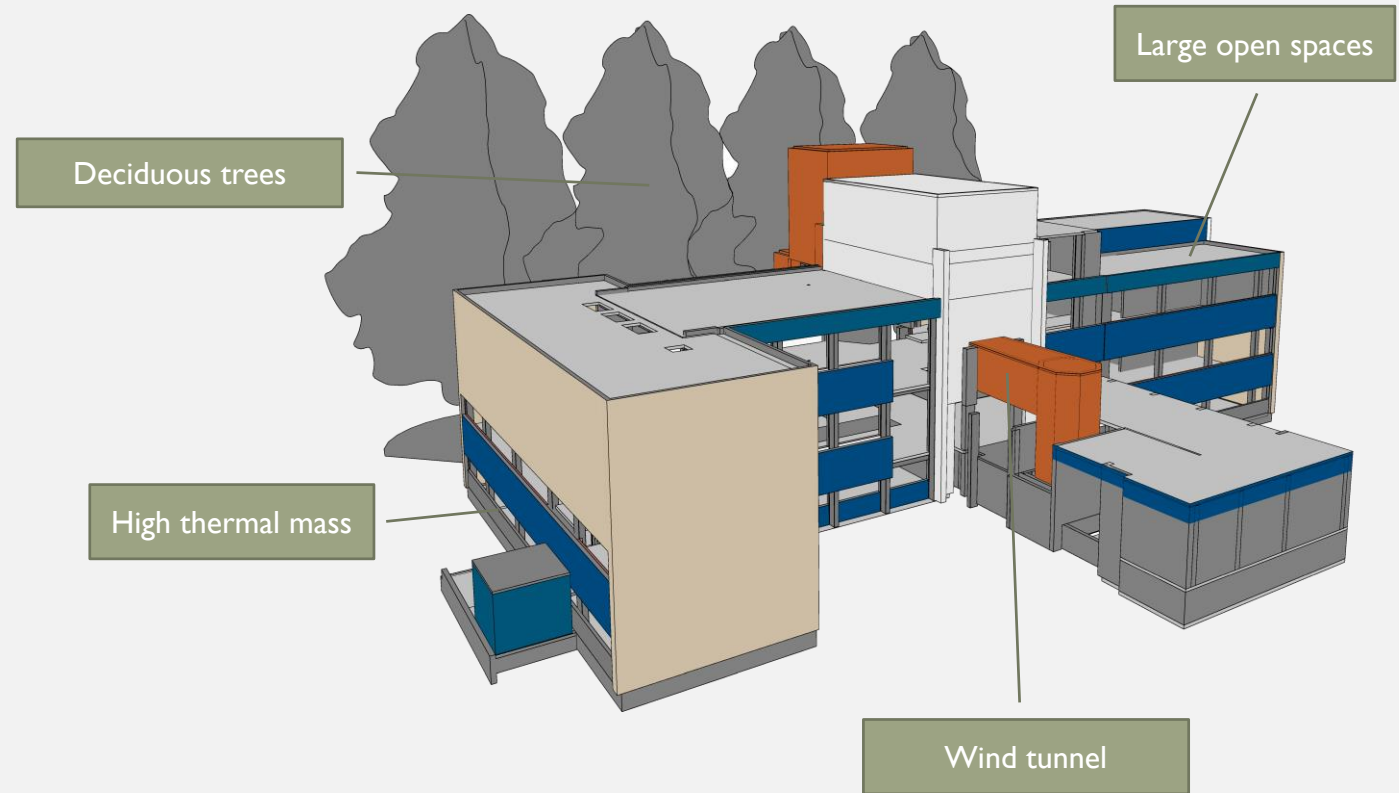
ASSETS

1. Structure

- Large open spaces
- High floors

2. Architecture

- Wind tunnel
- Open spaces

3. Climate

- High thermal mass
- Deciduous trees

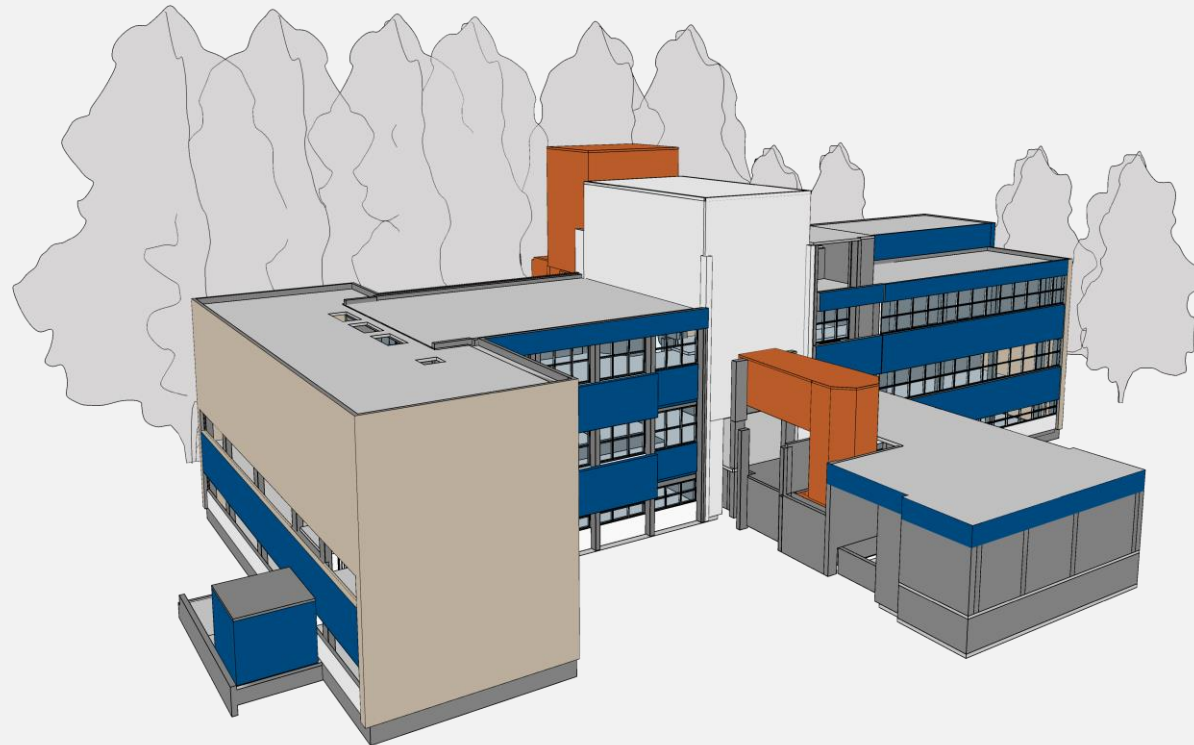
0. CURRENT BUILDING

Current volume (14000 m³)

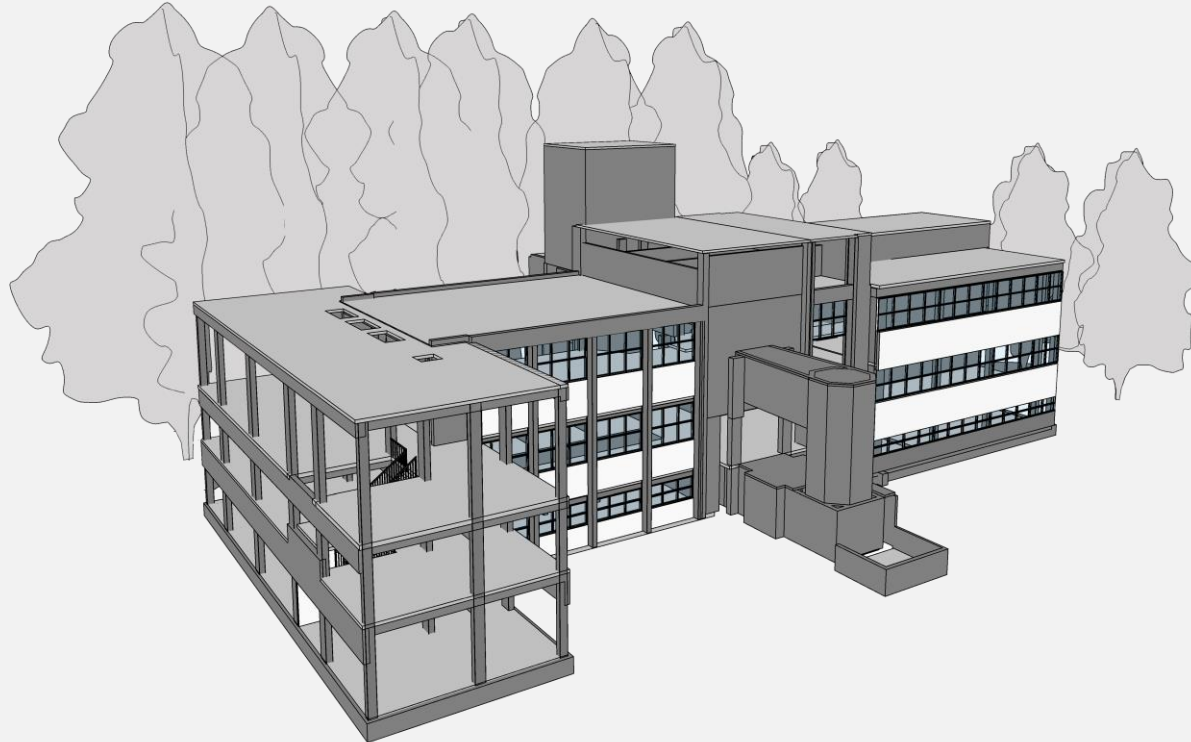
I. STRIPPED

Demolition of (uninsulated) machine hall (1110 m³)

Demolition of (uninsulated) top floor (338 m³)

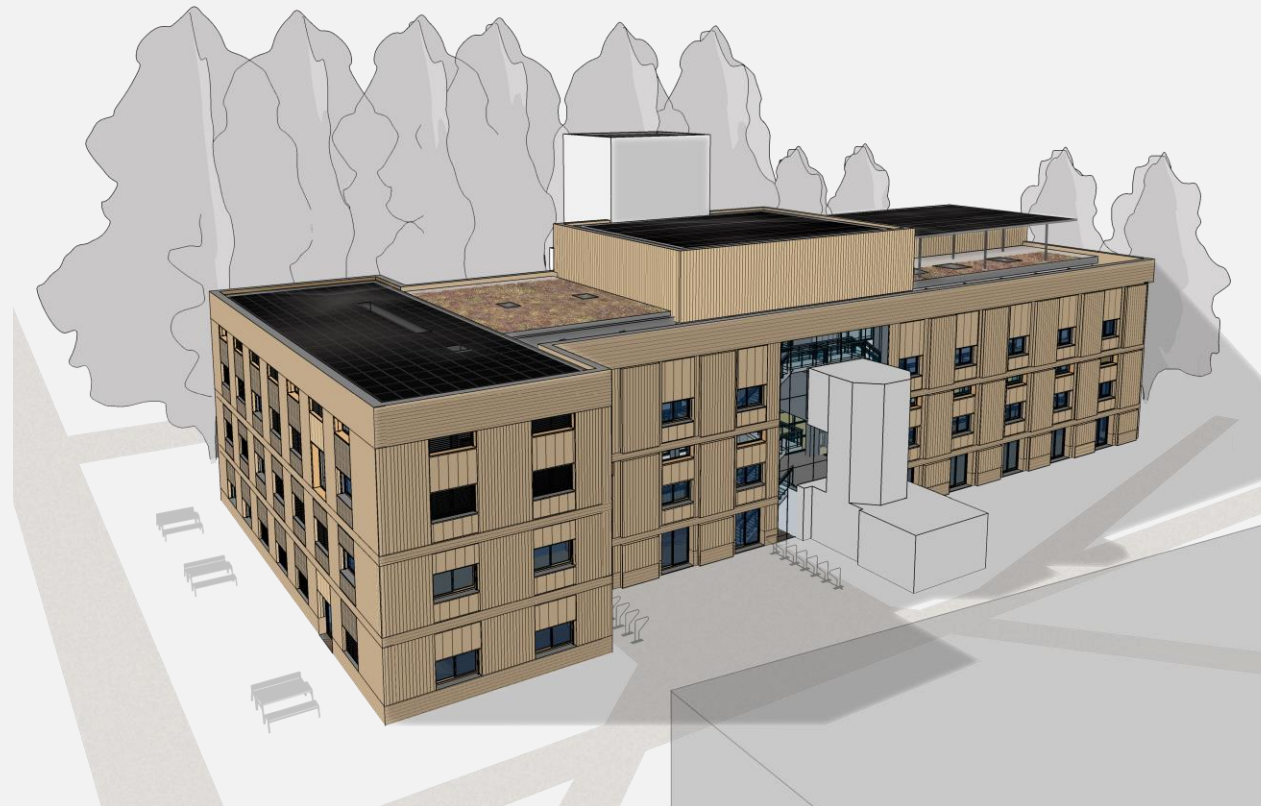
2. NEW DESIGN

The new design consists of an add-on and a new facade

Addition of 4,5 m wide volume (2740 m³)
Total (15302 m³)

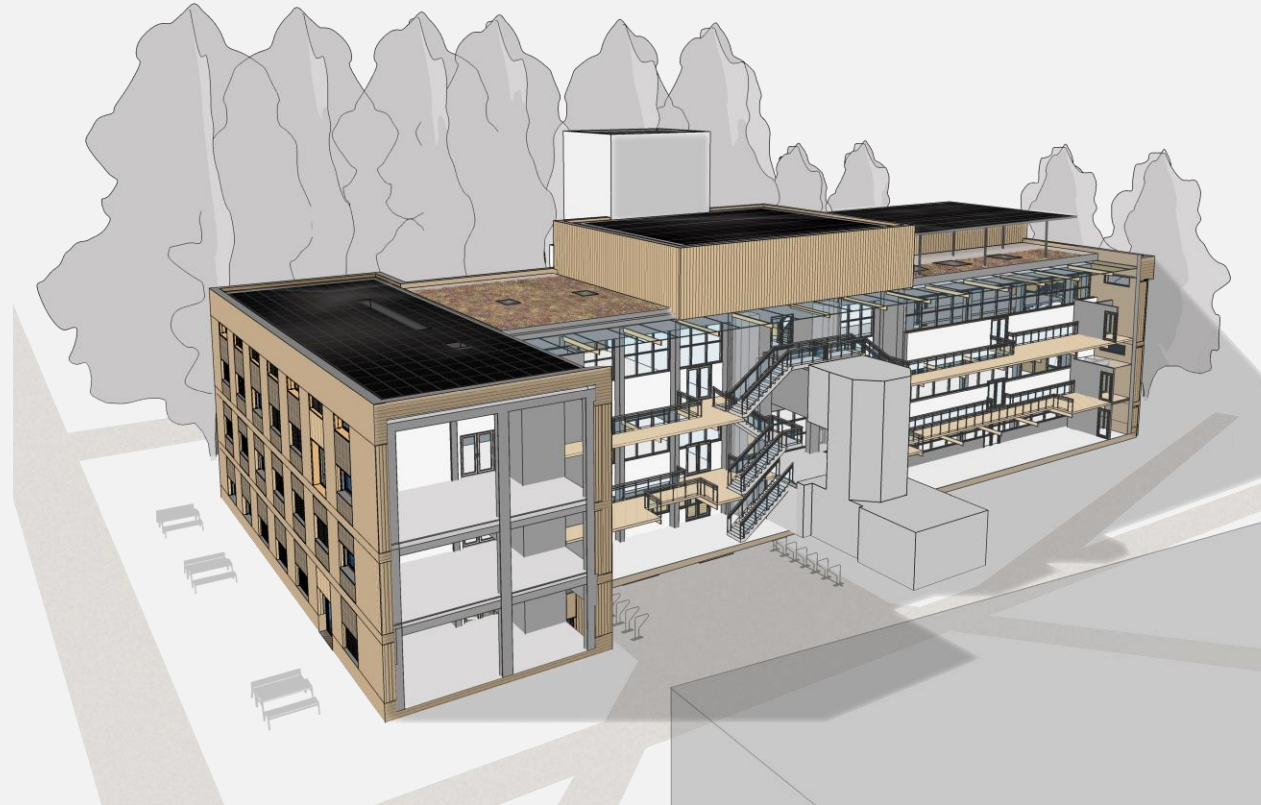
THE FLEXIBILITY IS IMPROVED BY DIVIDING THE BUILDING IN FOUR
