## Compression after impact fatigue damage growth in CFRP – what does no-growth really mean?

Biagini, D.; Pascoe, J.A.; Alderliesten, R.C.

Proceedings of the 31st symposium of ICAF - the International Committee on Aeronautical Fatigue and Structural Integrity

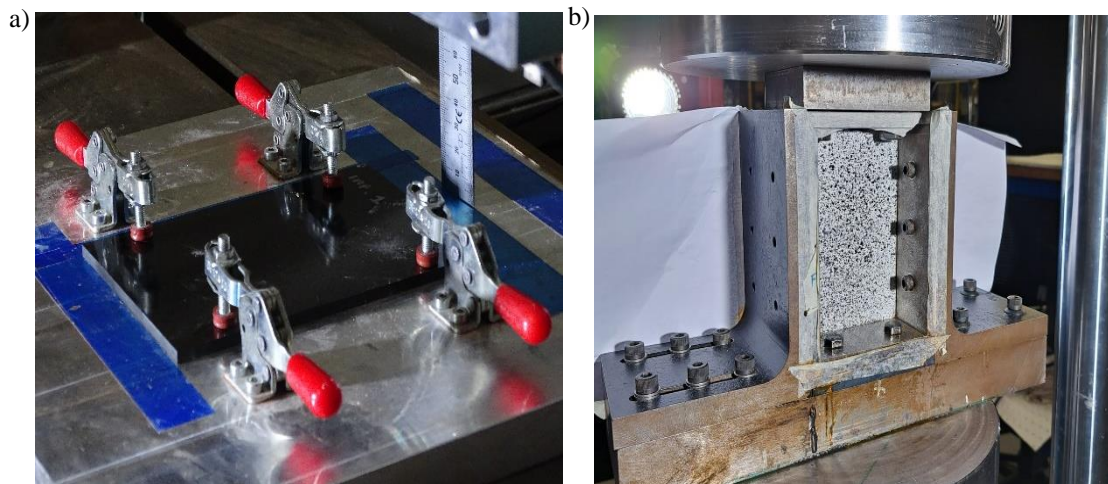
Figure 1: a) Impact test fixture and b) CAI fatigue test fixture.

Impact testing was conducted using a drop-weight tower according to ASTM D7136. The support fixture has a cut-out of  $125 \pm 1$  mm in the length direction and  $75 \pm 1$  mm in the width direction (Fig1.a). To obtain single impacts, the impact tower was equipped with a catcher triggered by optical sensors. A hemi-spherical impactor with a diameter of 16 mm and a mass of 4.8 kg was used. A target impact energy of 34 J was used in all the impacts. This condition can be classified as low velocity impact (LVI).

To estimate the static CAI strength, 3 specimens were tested following the ASTM D7137 standard for static CAI tests [13]. Next, since there is no standard for fatigue CAI, testing was conducted using the same setup as for the static CAI tests (Fig.1.b). Two series of two specimens were loaded in compression - compression under force control at different load levels. A frequency of 3 Hz was used to avoid specimen self-heating. The crosshead displacement and the applied force were recorded using a 100 kN load-cell on an MTS hydraulic testing machine. The test was periodically stopped to allow the ultrasound inspections.

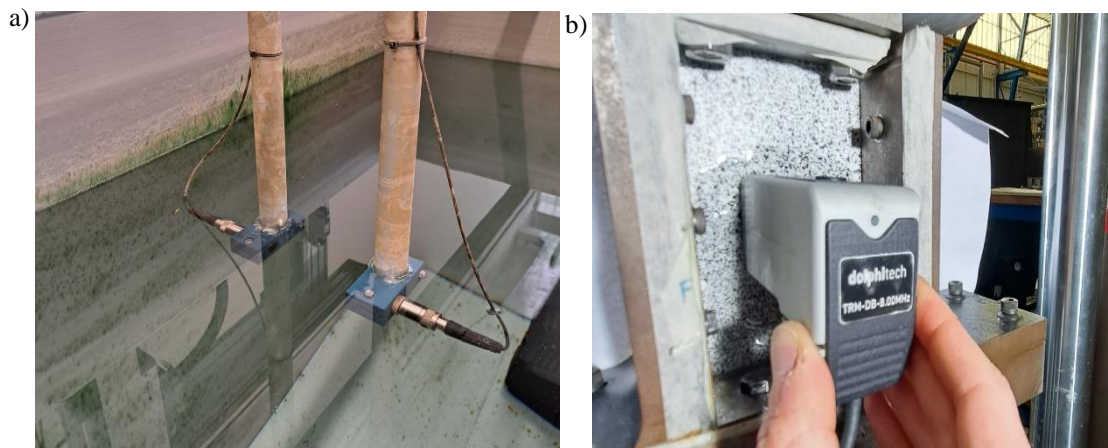
Figure 2: a) Through thickness ultrasonic scan system immersed in water tank and b) Echo pulse ultrasonic scan inspected in loco.

To evaluate delamination size, two different ultrasound systems were used: **system 1** is a through thickness attenuation scan immersed in a water tank (Fig.2.a) and **system 2** is echo pulse Dolphicam 2 system (Fig.2.b). In system 1, a probe of 8 MHz was used to emit ultrasound towards the receiver placed at 100 mm distance. Scanning speed was set to 100 mm/s and a definition of 1 mm was achieved. In system 2 a scanning probe of 5 MHz was used.

Inspection using through thickness scan was performed in a water tank located close to the test location (Fig.2.a). The procedure of removing, scanning and repositioning the specimens took on average 10 minutes. Inspection using an echo-pulse system was performed directly in loco without removing the specimen from the fixture (Fig.2.b).

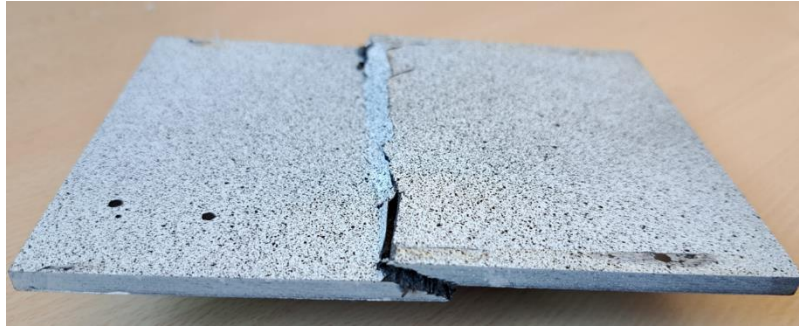
Figure 4: Failed specimen after CAI fatigue test.

In all specimens final failure was characterized by unstable delamination propagation in multiple interfaces and fiber kinking. The fractured specimen appears very similar to static CAI tests previously conducted by the authors [13], showing a final fracture that runs in the centre of the specimen, perpendicular to the loading direction (Fig.4).

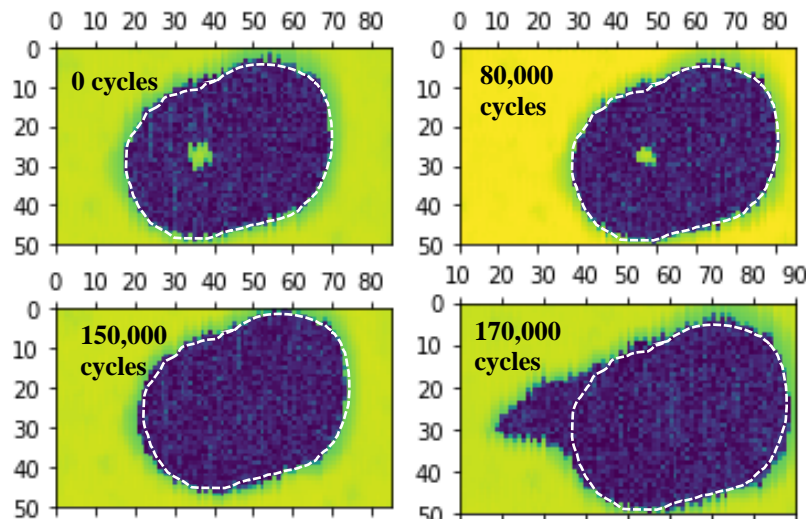
Figure 5: Delamination monitoring in fatigue using through thickness attenuation [12]

Some common trends were observed in the fatigue damage propagation and failure of the four specimens. In *series 1 – specimen 1*, no growth was captured with the through thickness scan. This because failure happened after 2,600 cycles and only three inspections were performed at 10, 100 and 1,000 cycles. In all the remaining specimens, a macroscopic and relatively fast delamination growth happened in the perpendicular to loading direction, proceeding from impact damage towards the lateral edges of the specimen (Fig.5 and Fig.6). This observation is consistent with several tests in literature [17] [18].

The first observation presented is the growth monitored in specimen 1 of series 1. In this case we used through thickness attenuation scan to evaluate growth below the impact contact point. As explained in previous sections, there is an area below the impact point, where little or no delamination is present. Because of the impact dent curvature reflection, it was difficult to evaluate this area using the echo-pulse system. For that reason we adopted through thickness transmission scan. The results clearly show how the delamination propagation firstly happened in the central area, and only after that, a single delamination started growing towards the lateral edges (Fig.5). If only the outer projected external area is taken into account, this growth in the central area is *not* considered.

At the starting point of Fig.5, if a central non delaminated area is present, the laminate is forced to deform locally in two half buckle shapes. Delamination growth in the central area may join two half delaminations into a single larger one. This would result into a single buckle, a sudden increase in the strain energy release rates at the external edges of delaminations and a reduction of the buckling load.

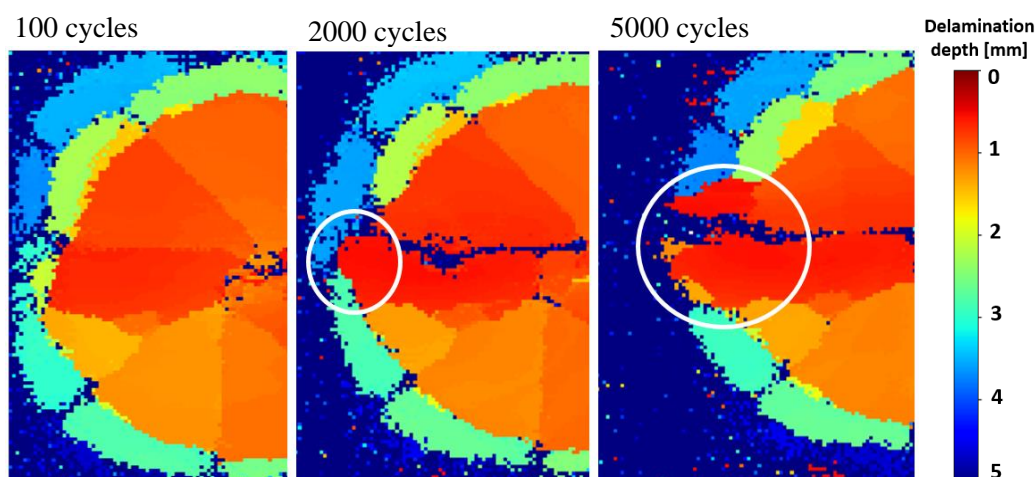
Figure 6: Delamination monitoring in fatigue using echo-pulse system.

The second observation presented is the growth observed in specimen 2 of series 2 ( Fig.5). A short delamination, located in the first interfaces close to impact surface, started growing in the transverse direction. It is interesting to notice that all this growth phase took place inside the projected delamination area, hence would not have been captured by only considering the projected area as metric to describe growth.

As shown in Fig.3, BVID is composed of multiple delaminations located in different interfaces. Short delaminations will most likely be present also in the shadowed area. Based on this observation we cannot exclude that the faster growth of short delamination can happen in certain cases, without being noticed. Pascoe [11] hypothesised that the no growth observed in certain tests could be a misconception generated by the limit in the observation we can perform using ultrasound inspections. The present observation (Fig. 6) supports that hypothesis.
