# Urban Facades

**Integration of  $\text{TiO}_2$  coating into facade elements of historical buildings in Athens for air purification purposes**

**Main objective:** to develop a **framework/roadmap** regarding the different ways a **TiO<sub>2</sub>** coating can be applied on the various components of existing facades of **historical buildings** in Athens, in order to contribute to the **NOx** removal in the proximity of its application

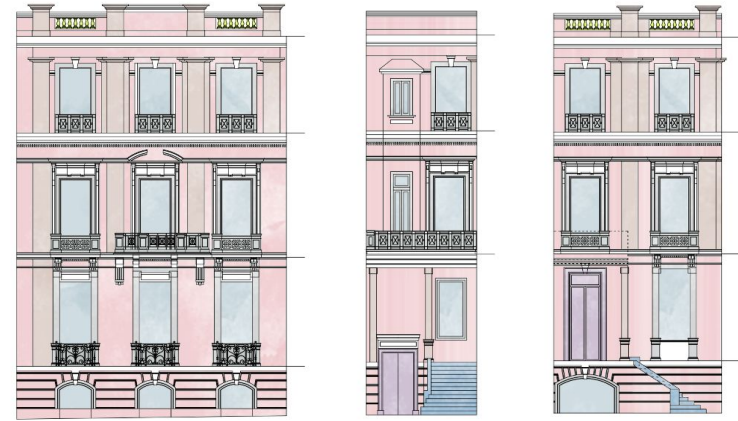
\_East facade 1

\_East facade 2

\_South facade 1

- It represents the **majority of the existing building stock**
- It is representative in terms of **style** (repetitive rhythm of windows, decorative elements, color palette)
- It is an apt example of the most common used **materials** (concrete, bricks + mortar, wood, plaster)
- It also has extra **unique elements** (outdoor staircases, ornate decor)
- It is more likely for a **residential building** to turn into offices and not the other way around
- It is already **renovated once** (approved alterations)
- No need for **radical** renovation works (preserved)
- It is a **feasible** choice, given the fact that the building is **currently in use**
- It is a **corner building** with both East and South facades
