Non-destructive inspection technologies for repair assessment in materials and structures

Developments in the Built Environment

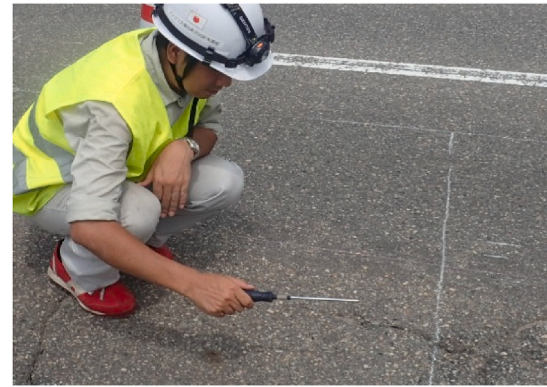
Fig. 11. (a) Analysis model for AE tomography, (b) steel-ball tapping (Okude et al., 2018).

Fig. 11(a) shows the model of AE tomography analysis and the positions of the sensors. The shaded part at the top of the model indicates the asphalt layer with thickness of 50 mm. As elements for AE tomography analysis, the applicable region was divided in 16×8 , which gives a total of 128 elements. In this study, elastic waves were excited by steel-ball tapping. A steel-ball of 5 mm diameter was tapped at several locations on the asphalt surface, ensuring that the distribution of impact points was as uniform as possible at the target area. The steel-ball tapping is illustrated in Fig. 11(b) (Okude et al., 2018).

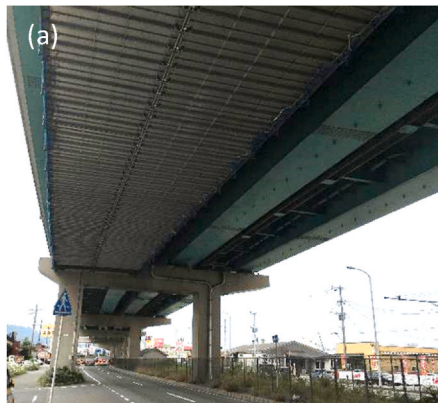
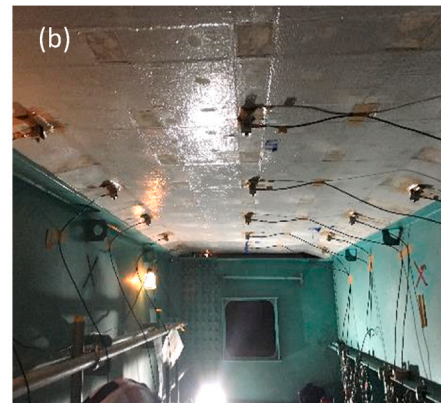
Fig. 13. (a) Tested highway bridge, (b) sensor arrangement for the measurement before repair.

The effect of repair by epoxy injection on an RC slab of a highway bridge was visualized (Takamine et al., 2018). The results before and after repair were compared to visualize the soundness based on the elastic wave source distribution by measuring the elastic waves generated by the traffic. Fig. 13 shows an overview of the measurement. The bridge of interest is a highway bridge in service, and elastic waves generated by vehicle traffic were measured for the RC slab. The target panel had cracks which were visible from the underside and was reinforced with CFRP sheets. Eighteen AE sensors were installed in a grid pattern of 3×6 on the underside of the deck. The sensor spacing was 780 mm in the bridge axis direction and 700 mm in the direction perpendicular to the bridge axis.
