**The development of short pitch rail corrugation
Extensive field monitoring and validation of numerical predictions**

Tribology International

The development of short pitch rail corrugation: Extensive field monitoring and validation of numerical predictions

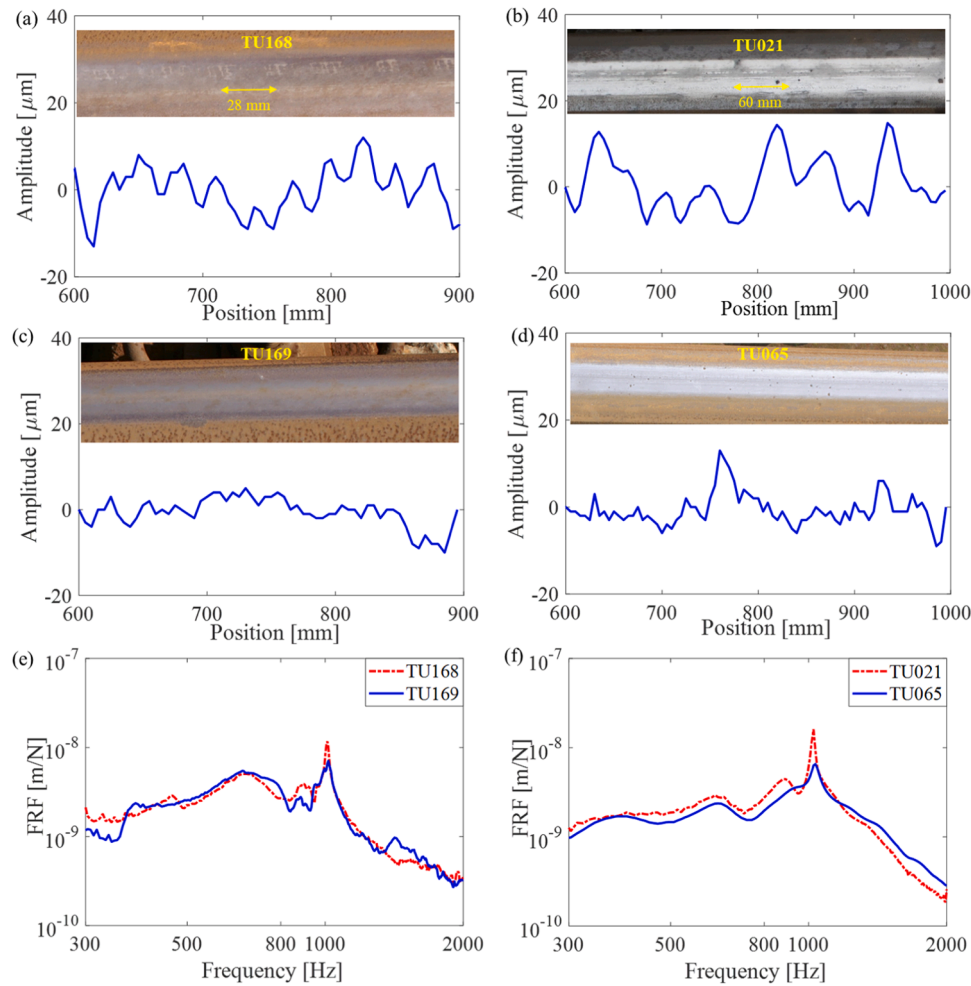
Fig. 4. Field observations of tracks with and without corrugations. (a) TU168 with corrugation on Track 2 at Assen; (b) TU021 with corrugation on Track 4 at Weert; (c) TU169 without corrugation on Track 2 at Assen; (d) TU065 without corrugation on Track 4 at Weert; (e) the vertical FRFs at TU168 and TU169; (f) the vertical FRFs at TU021 and TU065.

Observations from the four monitored tracks reveal that corrugation is not everywhere on the rail but occurs at particular locations, see some examples in Fig. 4. TU168 (Fig. 4a) and TU169 (Fig. 4c) were both located on Track 2 at Assen, about 40 m apart, and TU021 (Fig. 4b) and TU065 (Fig. 4d) were on Track 4 at Weert, around 400 m apart. Corrugations were observed and measured at TU168 and TU021, but not at TU169 and TU065. Besides, it was worth noting that the rails on Track 1 at Steenwijk, laid in place in 1987, were not ground until November 2009. Similar observations in the Dutch railway were reported in [18, 53], showing that rail corrugation was not found everywhere after about 20 years of service without grinding. These observations are consistent with the numerical simulation, suggesting that initial excitation is necessary for corrugation formation. The hypothesis in the literature, proposing that the initial stochastic rail surface roughness alone excites the so-called corrugation ‘wavelength-fixing’ mechanism [18,54], seems insufficient to explain corrugation, as the monitored rails on the same

The initial excitation that induces corrugation will change the track dynamic behaviours from the nominal states [34], which could thus be identified from the track FRFs measured by hammer tests. Figs. 4e and 4f compare the vertical FRFs of the tracks with and without corrugation during the first observation. It can be seen that the peaks in FRFs of corrugated tracks are sharper than those of non-corrugated tracks, despite similar peak frequencies. These peaks correspond to different track resonance modes [42], with their frequencies and sharpness primarily determined by vertical stiffness and damping of fastenings [55], respectively. The results in Figs. 4e and 4f indicate that the fastenings of the corrugated tracks were degraded by providing less damping, making track resonance modes more predominant. This agrees with the numerical simulations [33] that fastening degradations serve as necessary initial excitation for corrugation formation. Besides, corrugation formation seems not determined by fastening vertical stiffness, which is similar for both corrugated and non-corrugated tracks. Comparison of longitudinal FRFs for tracks with and without corrugation reveals that initial excitation releases the rail longitudinal vibration mode, which is decisive to corrugation formation. A more detailed analysis of this comparison is provided in 3.4. Overall, the field observations validate the numerical simulations, indicating that initial excitation is necessary for corrugation formation. Although numerical simulations in [36] and laboratory experiments in [35,37] offer preliminary insights into the quantitative relationship between fastening degradation and rail

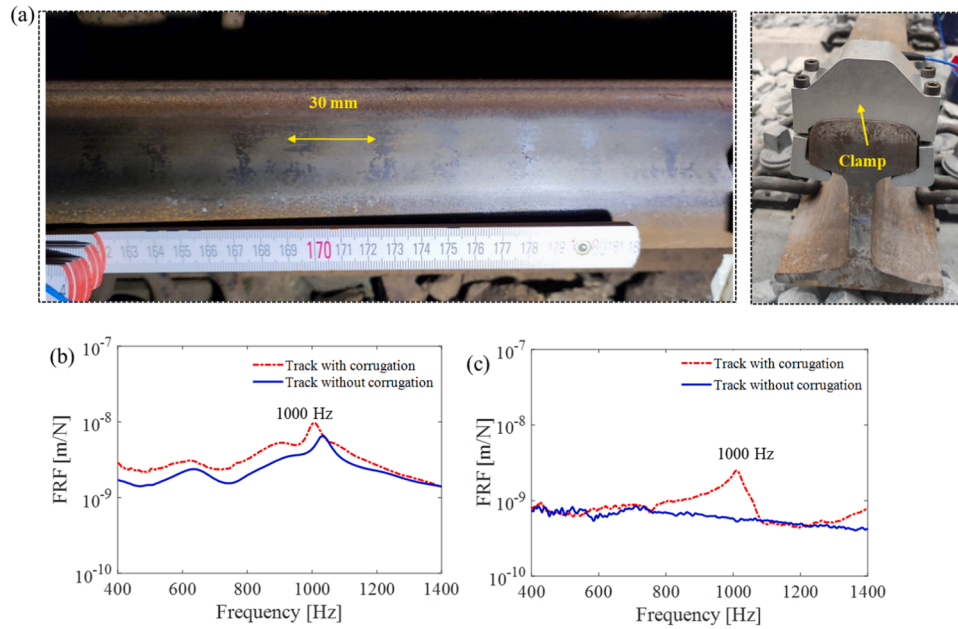
Fig. 9. Validation of the dominance of rail longitudinal mode on corrugation formation. (a) Corrugation on the track near Zoetermeer station, the Netherlands, and a clamp was made for the rail longitudinal excitation; (b) vertical FRFs of tracks with and without corrugation; (c) longitudinal FRFs of tracks with and without corrugation.

Figs. 9b and 9c show that both the longitudinal and vertical FRFs have a predominant resonance peak at around 1000 Hz, supporting the numerical prediction that the consistency between the vertical and longitudinal modes determines corrugation growth. Moreover, when comparing with FRFs of tracks without corrugation, the vertical resonance peak at 1000 Hz, corresponding to the vertical pinned–pinned resonance mode, occurs at both corrugated and non-corrugated tracks. However, the longitudinal mode at 1000 Hz only appears in the track with corrugation. This indicates that the longitudinal vibration mode is decisive in the corrugation formation. Corrugation can thus be mitigated or even eliminated. Corrugation can thus be mitigated or even eliminated by designing new rail constraints with high longitudinal stiffness [34]. In future research, more field validation on the dominant role of rail longitudinal modes can be conducted at other corrugation sites.

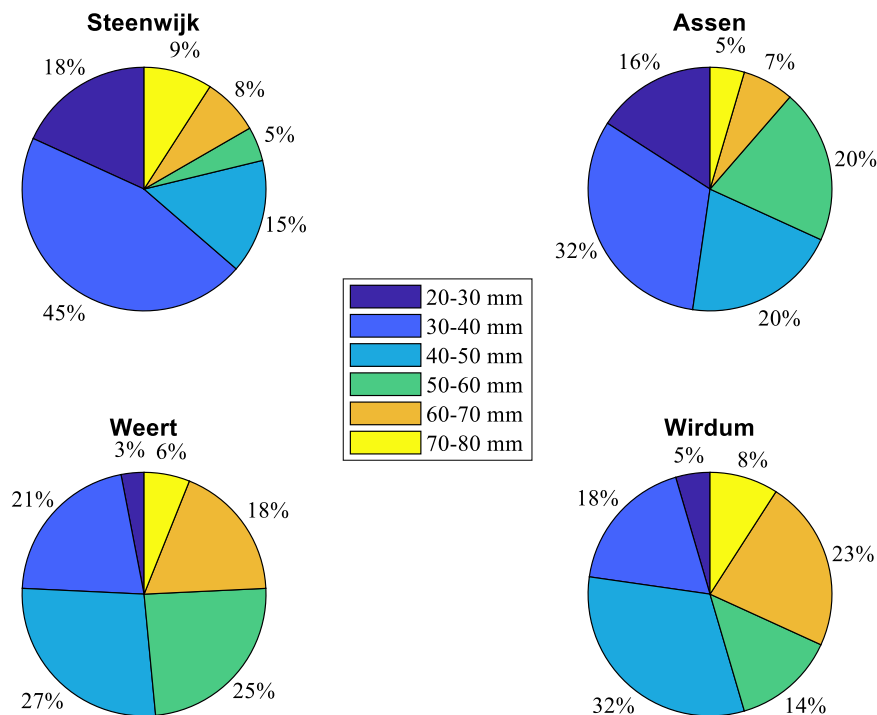
Fig. 10. The statistical data of corrugation wavelength components in the four monitored tracks. Track 1 was at Steenwijk, Track 2 at Assen, Track 3 at Weert, and Track 4 at Wirdum.

To validate this prediction, statistical data on corrugation wavelength components were collected from the four monitored tracks, as shown in Fig. 10. It can be seen that the corrugation wavelengths indeed have multiple components ranging from 20 to 80 mm at speeds of about 130–140 km/h. The majority (over 64 %) of the corrugation wavelengths in all the four tracks fall within the 30–60 mm range. Moreover, it is noted that in Track 1 and Track 2, about 70 % of the corrugation wavelengths are within a shorter range of 20–50 mm, whereas in Track 3 and 4, about 70 % are within a longer range of 40–70 mm. The main

difference between them is the sleeper types used: Track 1 and 2 used bi-block sleepers while Track 3 and 4 used monoblock sleepers. The possible reason is that monoblock sleepers provide greater flexibility to the track than bi-block ones due to bending, resulting in lower eigen-frequencies of the tracks and thus longer wavelengths. Furthermore, a comparison between Track 1 and Track 2 reveals that Track 1 has more corrugation wavelengths in the 30–40 mm range and fewer in the 50–60 mm range. This difference is likely caused by different fastening types, which can influence corrugation characteristics [36]. Besides, the effective track length engaged in the dynamic vehicle–track interaction, which could be influenced by, e.g., rail joints or defective welds, may also affect the corrugation wavelength feature. It is observed that Track 3 has wavelength components similar to those of Track 4, possibly suggesting that corrugation is insensitive to sleeper materials, as also reported in [57].

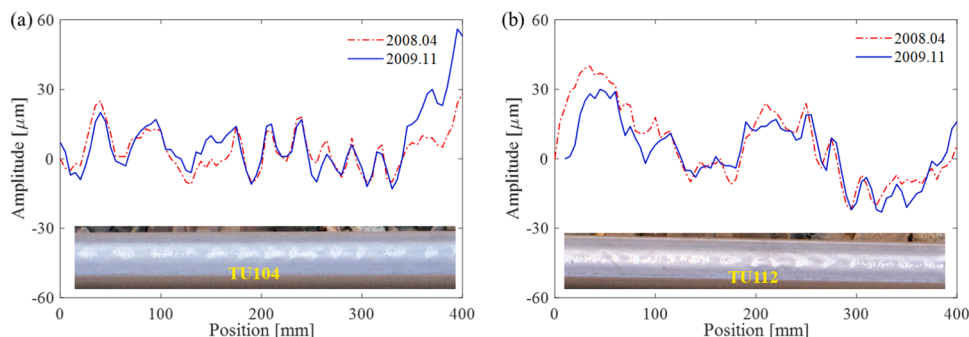
Fig. 11. Validation of the existence of the corrugation limiting amplitude. (a) TU104 on Track 1 at Steenwijk; (b) TU112 on Track 1 at Steenwijk.

Fig. 5a in 3.2.1 shows that the corrugation at TU101 grew little in about two years, with a maximum peak-to-trough distance of 22 μm . Fig. 11 presents two more corrugations at TU104 and TU112 on Track 1, which barely grew in 1.5 years, with maximum amplitudes of about 25 μm and 23 μm , respectively. These results validate the existence of a limiting amplitude for corrugation, which is around 22–25 μm on Track 1. The corrugations at TU193 (Fig. 5b) and TU064 (Fig. 5c) kept growing until grinding, making it impossible to determine their limiting amplitudes, which should exceed 51 μm and 49 μm , respectively. It is predicted in [36] that corrugation limiting amplitude depends on the intensity of the initial excitation, track degradation during the period of the corrugation, and the consistency between the longitudinal and vertical modes.

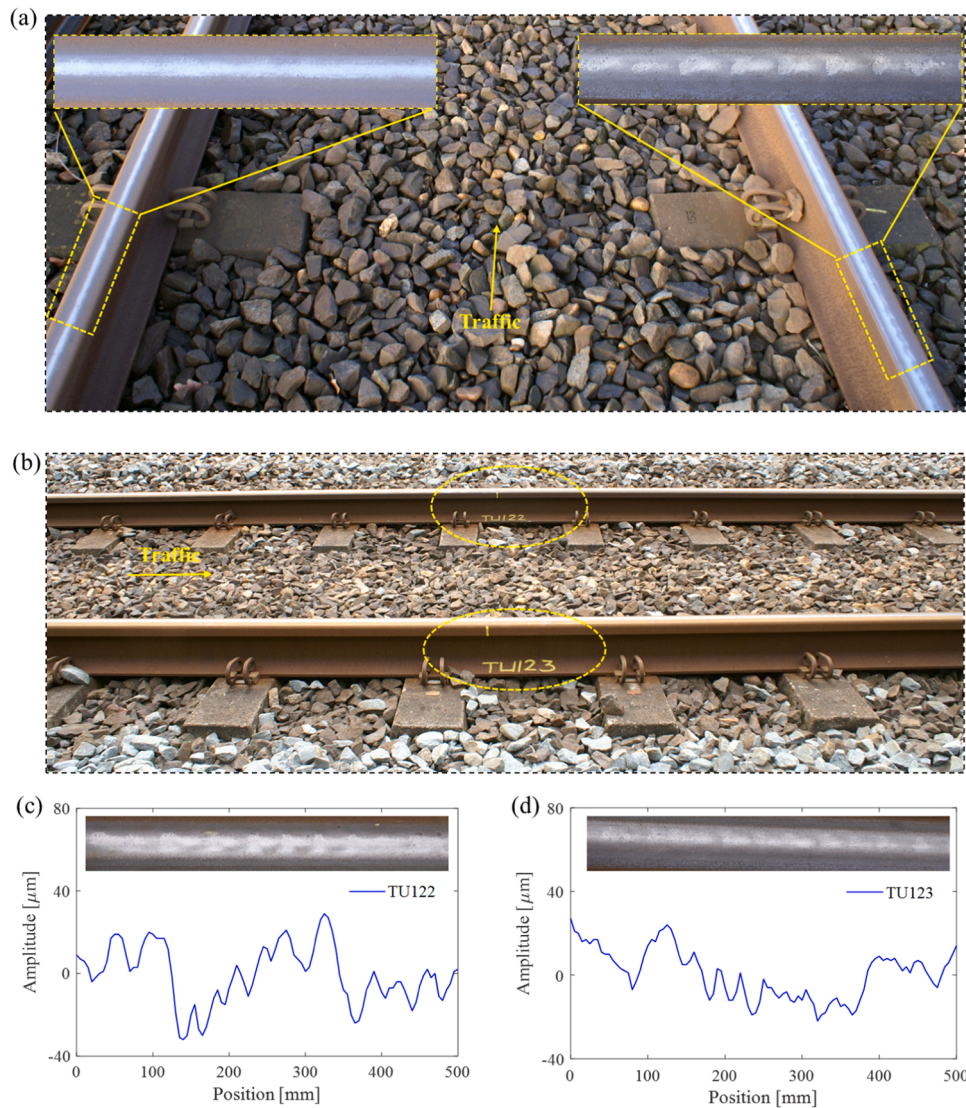
Fig. 13. Corrugation on the left and right rails. (a) One corrugation site on Track 1 at Steenwijk, and corrugation occurs on the right rail only; (b) TU122 and TU123 on Track 1 at Steenwijk, and corrugation occurs on both rails with different features; (c) the corrugation geometry at TU122; (d) the corrugation geometry at TU123.

Based on field observations in the four monitored tracks, there seems no direct correlation between the corrugation formation on the left and right rails of straight tracks. At some locations, rail corrugation occurs on one side (see Fig. 13a), whereas at other locations corrugation occurs on both rails (see Fig. 13b). Besides, corrugation on both rails often exhibit different features in terms of the wavelengths and severity, as shown in Fig. 13c and Fig. 13d. The possible reason is explained in [36] that the left and right tracks could have different dynamic behaviours because of various degradation modes, resulting in different characteristics of wheel-rail dynamic interactions, wear and corrugation.
