Skin-stringer separation in post-buckling of butt-joint stiffened thermoplastic composite panels

van Dooren, K. S.; Tijs, B. H.A.H.; Waleson, J. E.A.; Bisagni, C.

Composite Structures

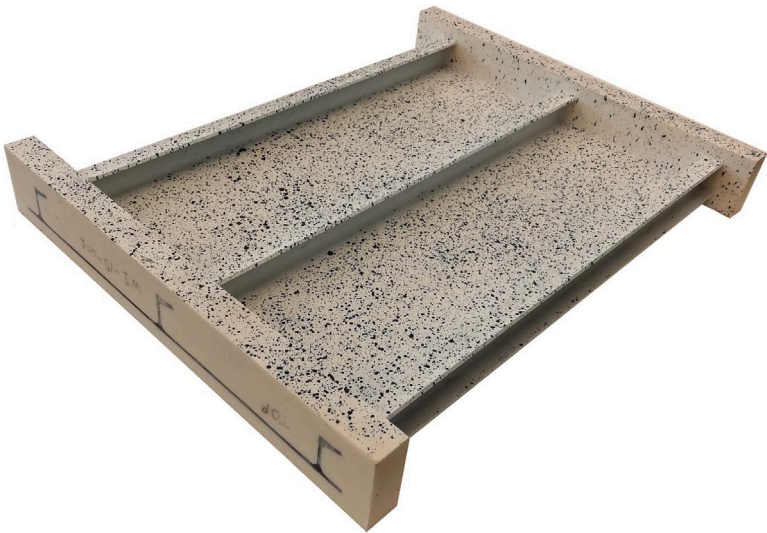
Fig. 1. Thermoplastic composite stiffened panel.

The skin is manufactured by advanced fibre placement and the stringer sections consist of pre-forms, which are cut by a waterjet from flat laminates. The stringer sections and filler profiles are assembled in an inner mould and held in place with tooling blocks. The skin is laid on top of the assembled mould with additional glass fibre fabric patches applied on the outer mould side of the skin at the joint locations to improve surface flatness of the skin after manufacturing. The whole section is then vacuum bagged, and co-consolidated in one step in an autoclave. The panels have an additional step purely for test preparation, where epoxy potting is applied to the end of the panels, by placing each end of the panel inside a female rectangular mould which is filled with epoxy.
