Interlaminar adhesion assessment of carbon-epoxy laminates under salt water ageing using peel tests

Moreira Arouche, Marcio; Budhe, Sandip; Banea, Mariana D.; Teixeira De Freitas, Sofia; de Barros, Silvio

Institution of Mechanical Engineers. Proceedings. Part L: Journal of Materials: Design and Applications

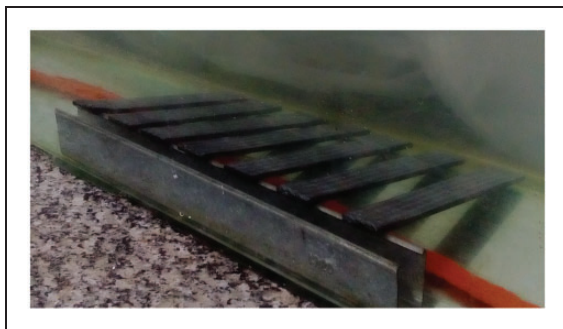
Figure 2. Specimens inside the salt water tank.

environmental exposure on the joint. Specimens were kept inside the salt water tank (5% NaCl) at room temperature for 60 days. The ageing process simulates the effect of environmental conditions wherein the materials are exposed to marine environment. Three reference specimens were tested without any ageing. Figure 2 shows the specimens inside the salt water tank.

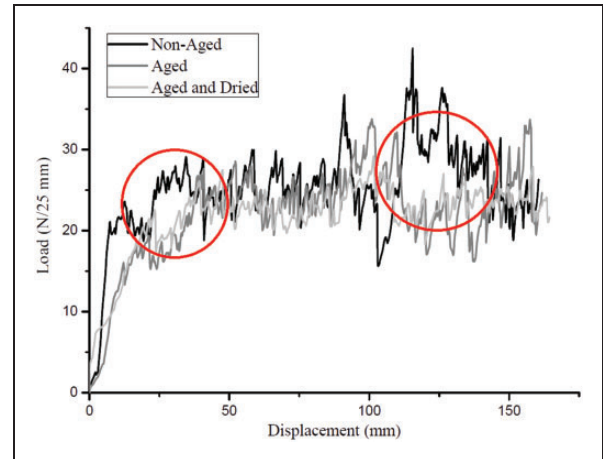
Figure 4. Representative load–displacement curves of the peel tests.

Specimens were tested in three different conditions: (1) non-aged; (2) immediately after 60 days ageing; and (3) after 60 days ageing and subsequent 280 days drying. Figure 4 shows the representative load–displacement curves of each test condition. Significant differences on the peel load are noted in the highlighted areas. This suggests a consequence of the ageing process. Previous work³⁰ showed that water ingress from the edge towards the centre of the interface and it has an irregular pattern. However, no relevant change on the peel strength is observed as consequence of the drying process.

It is observed a reduction of 22.4% on the average peel loads as consequence of the ageing process. No significant distinction is perceived on the peel loads after drying. This indicates that the damage caused by salt water ageing on the laminate interface is essentially irreversible.

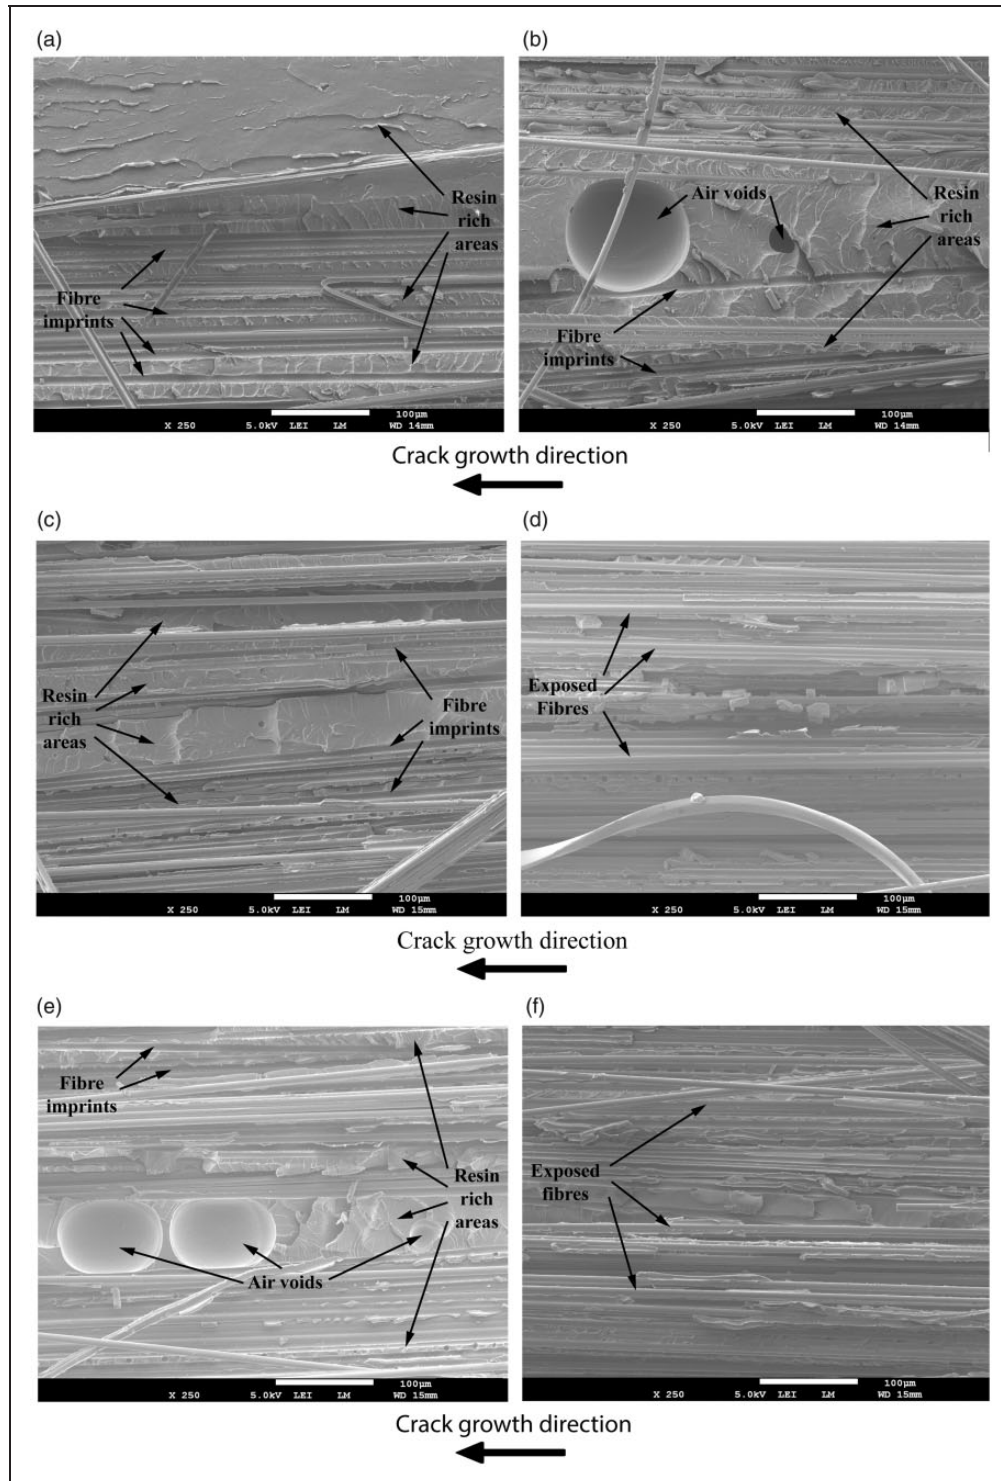
Figure 5. Fracture surfaces in low magnification: (a) non-aged – centre, (b) non-aged – edge, (c) aged – centre, (d) aged – edge, (e) aged and dried – centre, (f) aged and dried – edge.

Figure 5 shows the typical SEM fracture surfaces of samples taken from the rigid adherend in low magnification ($\times 250$, low-angle secondary electron image – LEI, 5.0 kV). The crack growth occurred from right to left direction of the images. Overall, the fracture surfaces show both resin-rich areas and exposed 0°

Considering the fracture surfaces of the non-aged specimens in Figure 5(a) and (b), significant resin rich areas are observed both at the centre (Figure 5(a)) of the specimens and at the edge (Figure 5(b)). The presence of considerable areas of resin together with the exposed fibres indicates that the failure occurred partially cohesive within the matrix and partially adhesive at the fibre/matrix interface.

Figure 5(c) to (f) shows the fracture surfaces of the aged specimens. The fracture surfaces at the centre locations (Figure 5(c) aged and Figure 5(e) aged and

dried) show similar features as for the non-aged specimens: a mixed of matrix failure (resin rich areas) and fibre/matrix interface failure (exposed fibres). However, at the edge of the conditioned specimens (Figure 5(d) aged and Figure 5(f) aged and dried), the resin rich areas disappear and the dominant fracture feature is the exposed carbon fibres, both at the aged specimens (Figure 5(d)) and aged and dried specimens (Figure 5(f)). The corrugated shape of the fracture surfaces typical of these areas indicates a poor fibre/matrix adhesion.

Results show that fracture mechanisms at the centre of the aged specimens remained unaffected by ageing, since at these areas the fracture surfaces are similar to the non-aged specimens. The typical fracture mechanism in this case is a mixture of matrix cohesive failure and fibre/matrix interface failure. These results indicate that the edges of the fracture surfaces were affected by ageing. In these cases, the prevailing fracture mechanism is fibre/matrix interface failure. According to the literature,^{16,20} this is the governing damage mechanism in polymer composites exposed to environmental ageing.

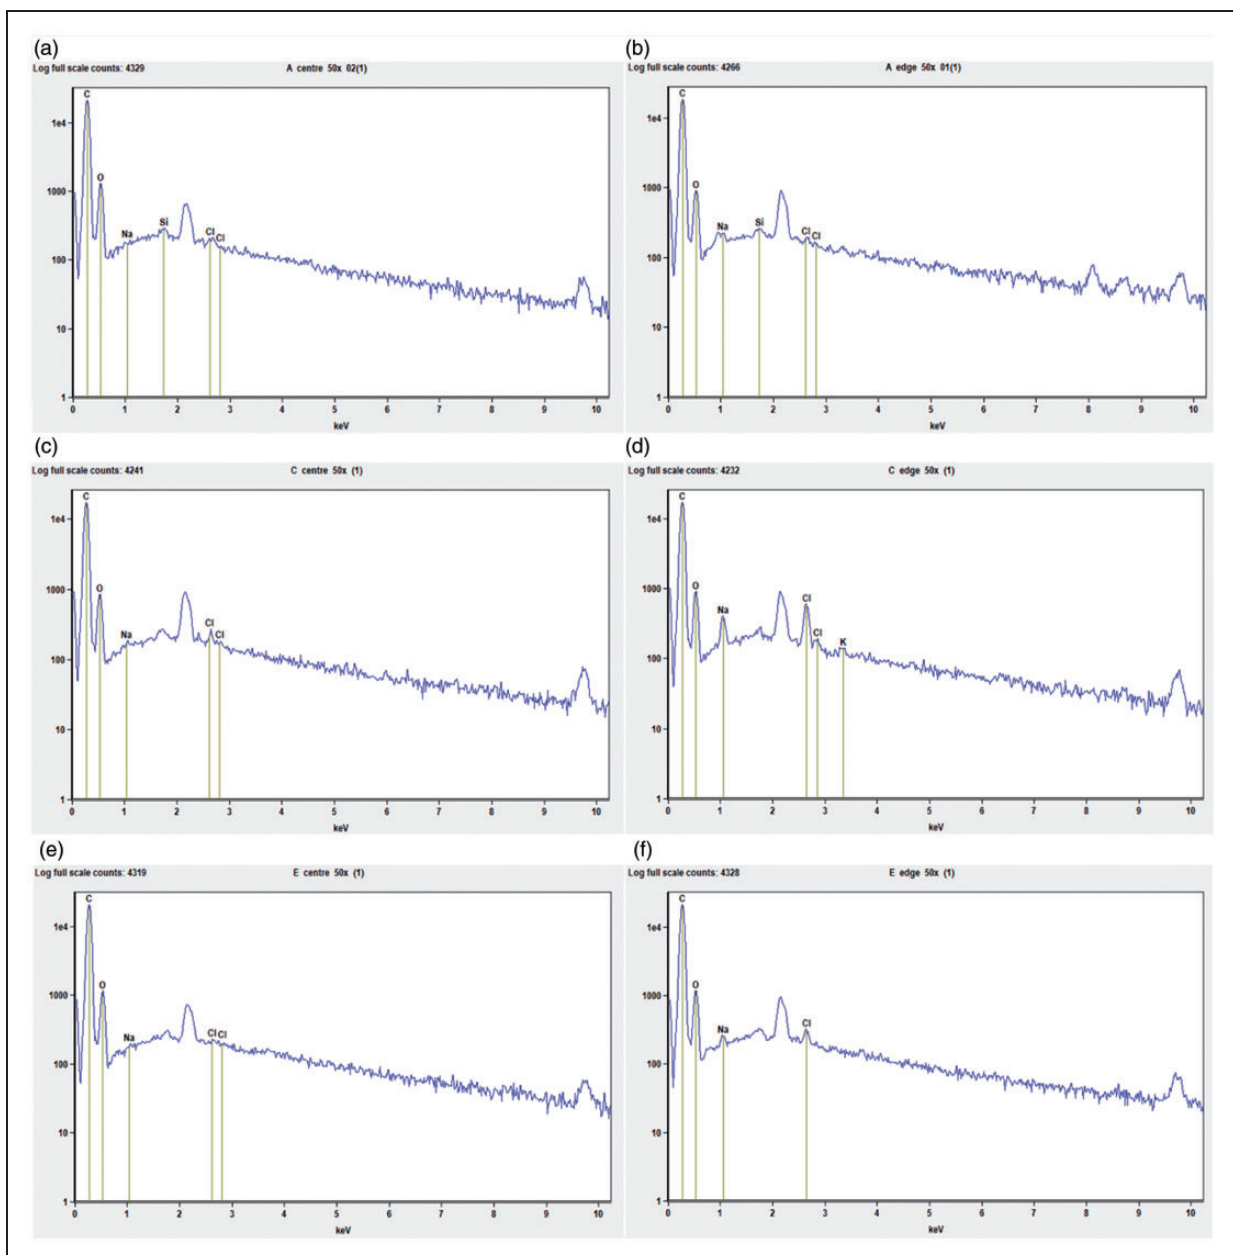
Figure 7. EDS spectrum of the fracture surfaces: (a) non-aged – centre, (b) non-aged – edge, (c) aged – centre, (d) aged – edge, (e) aged and dried - centre, (f) aged and dried – edge.

Figure 7 shows the results of the EDS analysis. The graphs display peaks that represent the occurrence of chemical elements on the fracture surface. Results revealed the presence of salt (Na and Cl elements) next to the edge of the fracture surface in aged specimen (Figure 7(d)) and in aged and dried specimen (Figure 7(f)). The incidence of these components is insignificant in both centre (Figure 7(a)) and edge (Figure 7(b)) of the non-aged specimen, as well as in the centre of the aged (Figure 7(c)) and aged and dried (Figure 7(e)) specimens. This confirms that the penetration of salt water occurred in the regions near the edge of the specimens and not at the centre. The other peaks represent the amount of carbon (C), oxygen (O) and the unnamed peaks represent gold and palladium sputtered for sample preparation. A comparative analysis of the salt content is presented in Figure 8. It is observed a decrease on the salt content at the edge of the specimen after drying. However, there was no difference between the peel loads (Figure 4 and Table 2). This reinforces the argument that the ageing process produced an unrecoverable damage on the interlaminar adhesion of the composite.

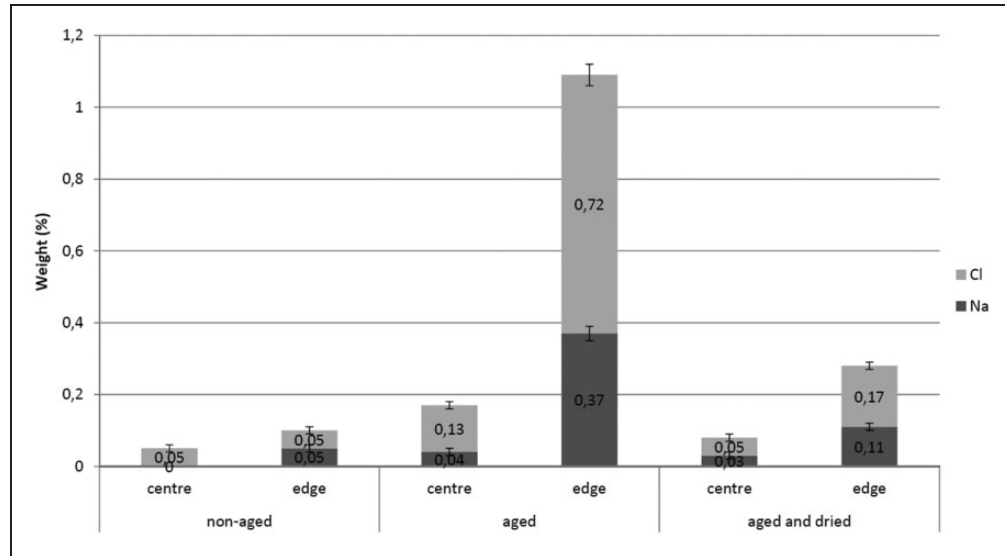
Figure 8. Salt content on the fracture surfaces.
