Assessing the Potential Danger of Hail Impacts on Stiffened Carbon Fiber Composite Panels in Aircraft Structures

to obtain the degree of Master of Science
at the Delft University of Technology,
to be defended publicly on Friday August 25, 2023 at 9:30 AM.

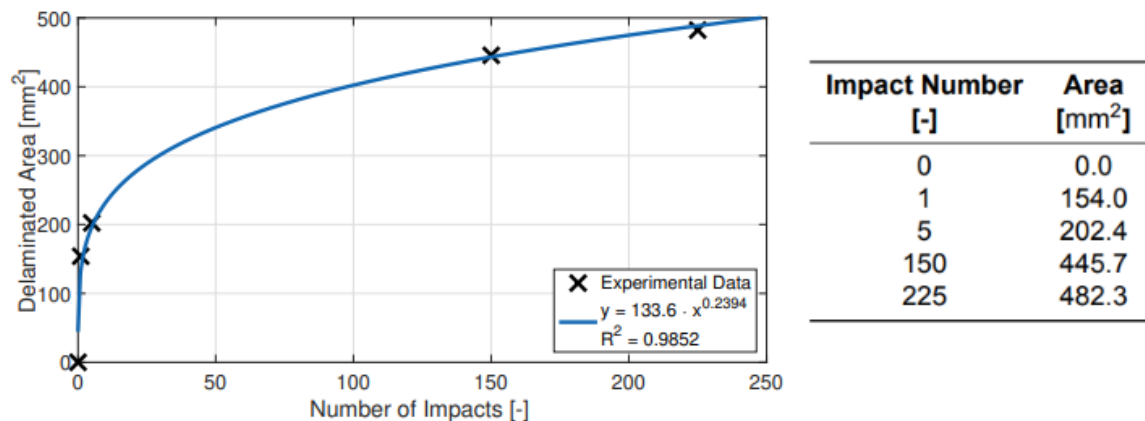
Figure 2.10: Fitted curve of the measured damage areas presented in the table [26]

These findings are similar to the conclusion found by Verstraeten [26]. The effect of impact fatigue was evaluated in the research by impacting a thin laminate on the same location with impacts of 6J. A total of 225 impacts were performed. The results are shown in Figure 2.10, with a fitted curve on the left and the measured data on the right in the table. Especially interesting in these findings is how fast the damage area growth rate decreases with repeated impacts. The first impact does three times as much damage area-wise than the next four impacts combined. Similar to the research by Liao et al.[4] the area increases quickly in the first impacts after which a plateau is approached.

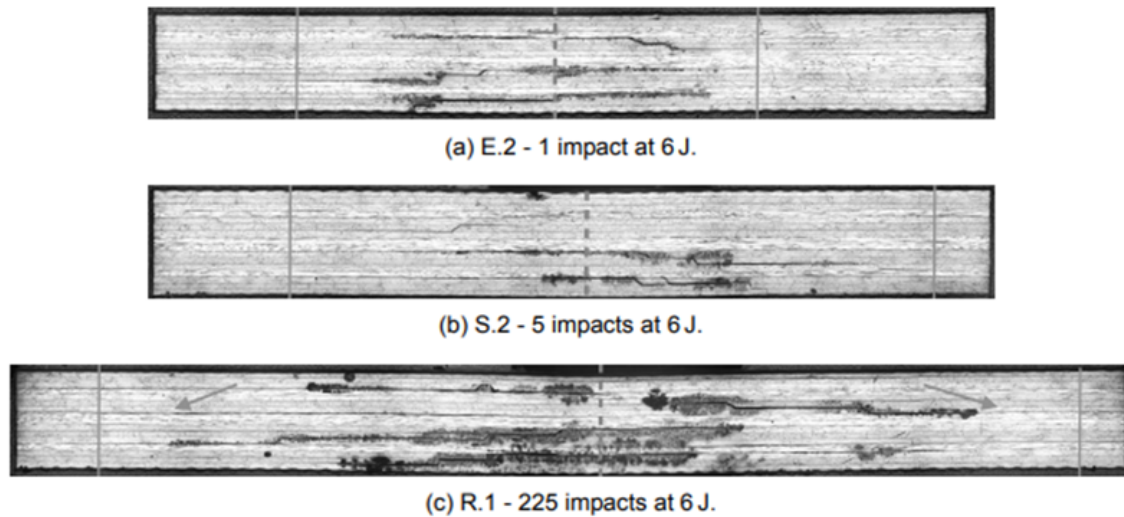
Figure 2.11: Microscopic images of the cross-section after repeated impacts [26]

In addition to the damage area, the cross-sections of panels subjected to repeated impacts have been observed to evaluate the damage through the thickness. Microscopic images of three cross-sections are presented in Figure 2.11. These are three different panels cut by hand through the impact location, hence the second panel was not cut perfectly through the damage which is why the damage is less after five impacts compared to one impact. The images show how the width of the damage grows with repeated impacts and how the delaminations leap between layers causing wide delaminations in those layers as well.

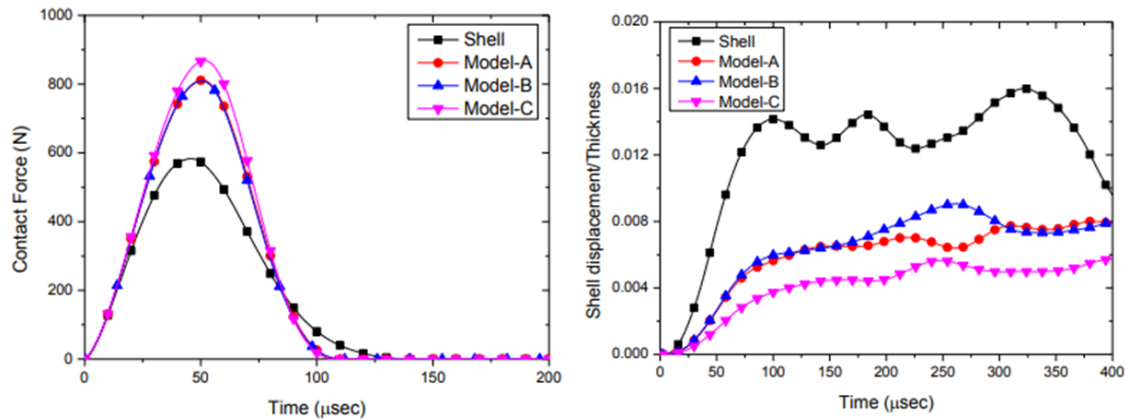
Figure 2.19: Contact force and lateral displacement against time for all models [23]

Another research on the effect of stiffeners is discussed of Rout and Karmakar [23]. An FEM is presented to assess the effect of stiffeners on the impact response of a composite shell panel. The unstiffened shell is compared to three models; (A) with stringers in the x-direction, (B) with stringers in the y-direction and (C) with stringers in both directions. The contact force and lateral displacements over time are presented in Figure 2.19. Similarly to what was seen for the curvature and thickness, stiffeners cause a higher contact force and lower lateral displacement as deformation is obstructed. Additionally, model C, with stringers in both direction, shows a slightly higher contact force and smaller displacements. So, as Le et al. [25] have shown, these smaller displacements can result in more damage at the locations of the constraints.

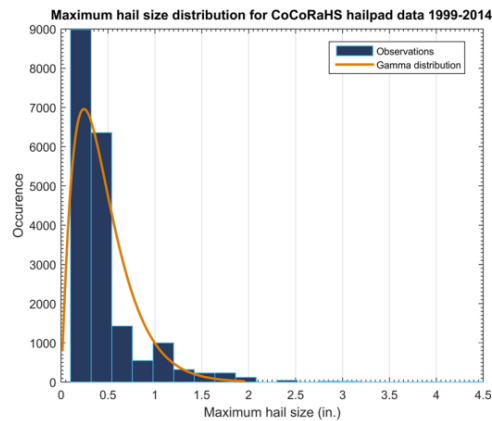
Figure 2.20: Maximum hail size distribution [11]

First, the size of the hail stones is discussed. A source for hail data is a program called the Community Collaborative Rain, Hail and Snow Network, or (CoCoRaHS). It is a volunteer program that collects hail data around the US. It was set up in 1999 and up until 2014 a total of 22,000 hail pad measurements were reported [11]. So, although the data is retrieved individually by many different people, causing some irregularities, the sheer number of data does give a great indication of hail characteristics in real life. The distribution of the maximum hail size for each of the hail pads is given in Figure 2.20. From the data it can be computed that around 80% of the hail stones were smaller than 12.7mm in diameter and 90% were smaller than 25.4mm. This means that around 10% of the hail pads have recorded

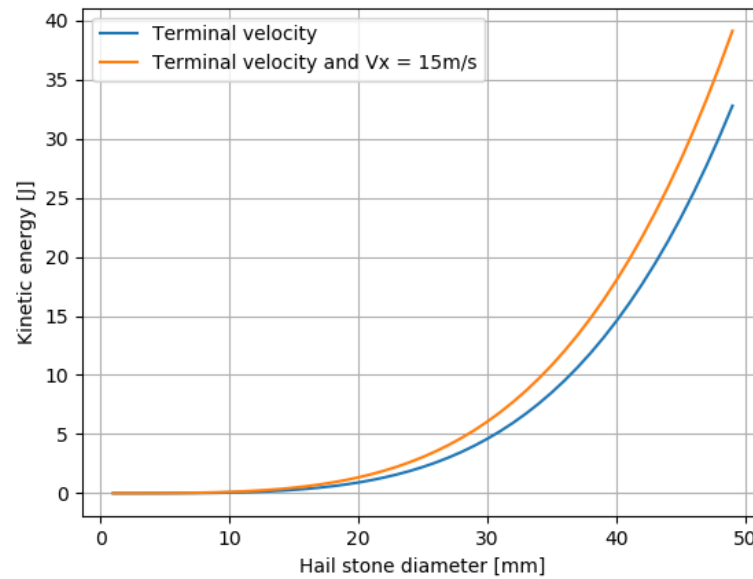
Figure 2.24: Relation between hailstone diameter and kinetic energy

With the size, density and fallspeed known of hail, the corresponding energy levels can be computed. This is done by evaluating the kinetic energy ($E = \frac{1}{2}mV^2$). Based on the findings of the previous sections, a relation between size and kinetic energy is given in Figure 2.24, with a drag coefficient of 0.5. Two curves are presented, one with only the terminal velocity taken into account and one where a horizontal velocity of 15m/s is added. It should be noted that smaller hailstones will gain more in speed than the larger hailstones from the same wind speeds due to their lower weights. However, it is still a good illustration how hail stones can get a significant increase in energy, over 30% increase at a diameter of 30mm. So, it can be seen that for small hail stones the kinetic energy is relatively low, but the energy increases rapidly with increasing size. Because of this rapid increase in energy it could be the case that the larger hail stones are the biggest threat, even though the majority of hail stones are much smaller.

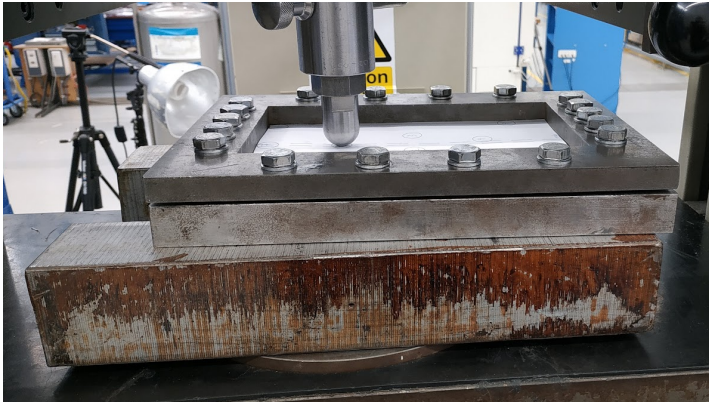
Figure 3.4: Indentation set-up

Most of the tests performed for the research are quasi-static indentation tests. These are done using a steel hemispherical indenter which is attached in a Zwick machine. The indenter is then lowered until a desired force, strain or work is reached. For the tests in this study mostly a desired work, or energy, was used as the parameter. The area under the force-strain curve was obtained automatically which equals to the total amount of work performed. The set-up is shown in Figure 3.4. A piece of paper can be seen on the panel which was used to identify where the indenter needed to be lined up. When the strain would increase there would have been a chance that the stiffener would be lowered onto the base of the set-up, so two metal blocks were placed under each side of the clamp to allow for this deformation without interfering with the test.

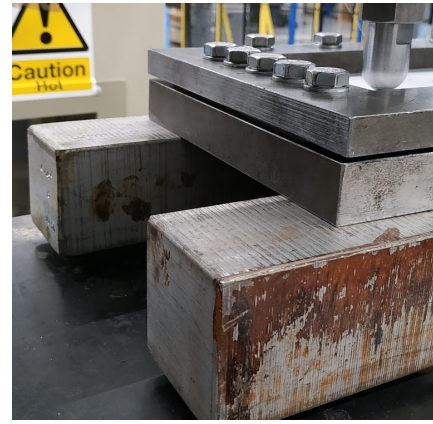
Figure 3.5: Metal blocks supporting the clamp

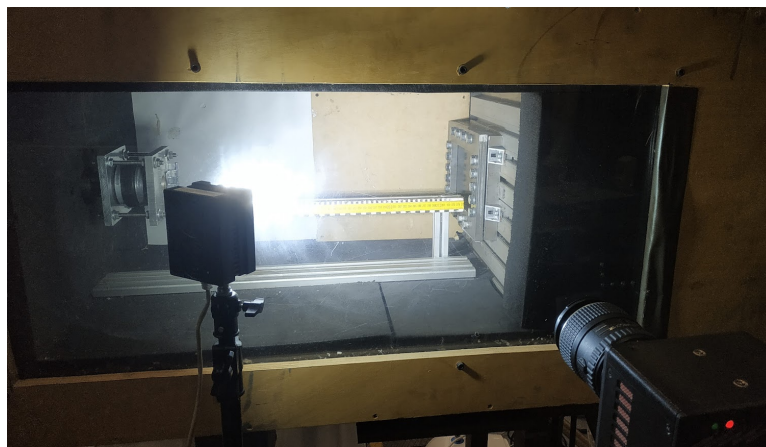
Figure 3.6: Ice impact set-up with high-speed camera and lighting

For the ice impacts a gas gun was used to obtain the required energy levels. The gun consists of a pressure tank attached to a barrel with a release valve in between. So, instead of a desired velocity, the pressure is set for each test. Subsequently, the resulting velocity is determined afterwards using a high-speed camera and a ruler within the set-up. The complete set-up is shown in Figure 3.6. The panel is placed on its side in the clamp on the right with the barrel of the gas gun on the left.
