Proceedings of the 31st symposium of ICAF - the International Committee on Aeronautical Fatigue and Structural Integrity

COMPRESSION AFTER IMPACT FATIGUE DAMAGE GROWTH IN CFRP – WHAT DOES NO-GROWTH REALLY MEAN?

Davide Biagini^{*1}, John-Alan Pascoe¹, René Alderliesten¹

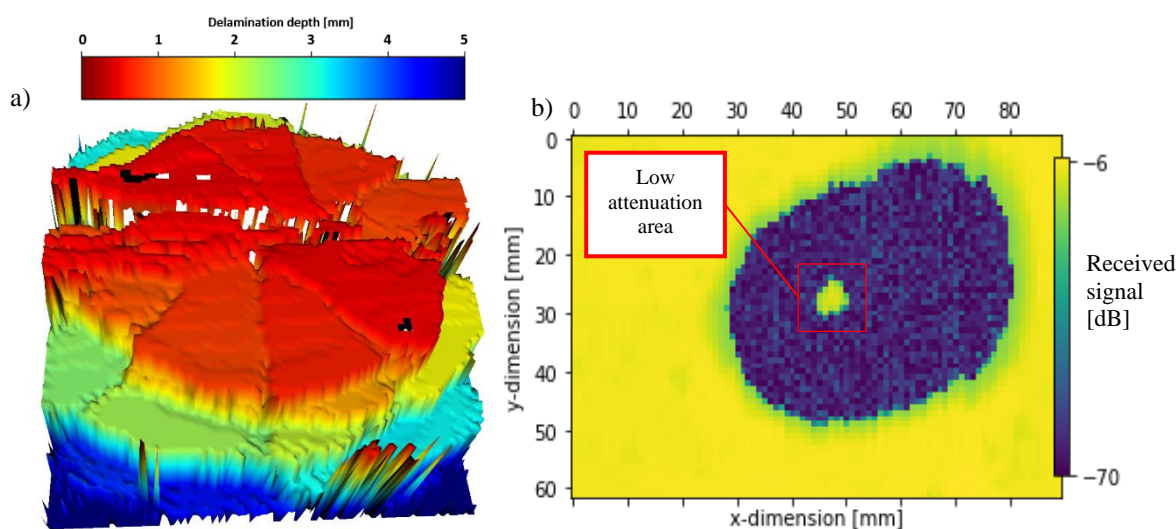
Figure 3: BVID reconstructed using a) echo pulse Dolphicam2 system, showing the 'spiral shape' delamination envelope and b) through thickness attenuation scan showing evidence of the non-delaminated area below the impact dent.

The low velocity impact tests resulted in an impact dent of < 0.3 mm depth, which falls in the BVID category. As can be seen from the three dimensional reconstruction of impact damage, created with Dolphicam 2 system (Fig.3.a), the impact damage structure comprises multiple delaminations located in different interfaces. As reported by previous literature, delaminations tend to grow in every interface, bounded by the orientations of the upper and lower plies. Considering this, if the mismatch angle between consecutive plies is kept constant at 45 degrees through the laminate's layup, the delamination envelope will appear like a spiral composed of triangular shapes, all characterized by the same 45 degrees angle. This feature was documented in previous literature [10][14] and can be clearly observed in the 3D reconstruction of delamination in Fig.3.a obtained with echo pulse ultrasonic scan.

Fig.3.b shows instead a through thickness scan of BVID. A central area with less attenuation can be observed, indicating that no delamination was formed during the impact in the area below the impact dent. The presence of this feature was observed by other authors in the literature both in LVI test [15], and quasi static indentation [16]. This non delaminated area can be attributed to the out of plane

It is important to notice here that, while the non-delaminated region is clearly visible from a through thickness scan, it is hard to detect this feature using an echo pulse system. This because of the strong echo generated by the surface of the impact dent. The impact contact area, being permanently deformed in the out of plane direction, appears to be at the same depth as the first interfaces of the non-deformed regions of the laminate. For this reason, to the authors' interpretation of the results, in the echo pulse scan the impact dent area appears in red colours (Fig.3.a), like it does in more external regions if a delamination is present within the first mm of depth.

As shown in Fig.3, BVID is composed of multiple delaminations located in different interfaces. Short delaminations will most likely be present also in the shadowed area. Based on this observation we cannot exclude that the faster growth of short delamination can happen in certain cases, without being noticed. Pascoe [11] hypothesised that the no growth observed in certain tests could be a misconception generated by the limit in the observation we can perform using ultrasound inspections. The present observation (Fig. 6) supports that hypothesis.
