Stability of a Sailing Yacht Floating Upside-down

Kensaku Nomoto

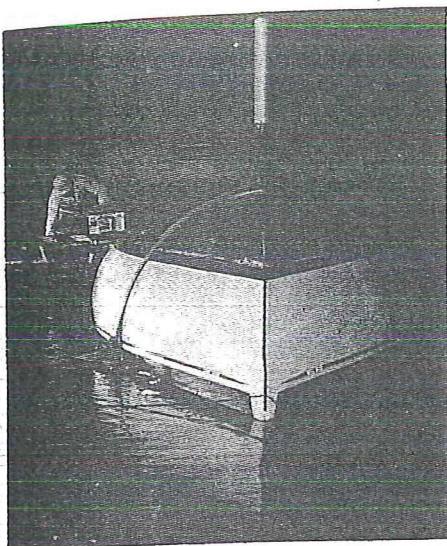
1. Just after turning-turtle
heel angle : 0

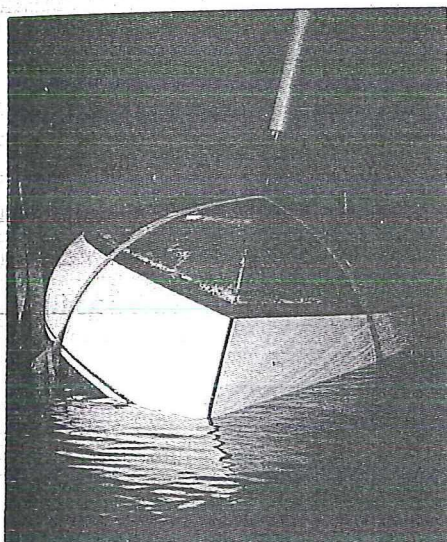
2. 8min.30sec. after
heel 15° ,uneasy attitude

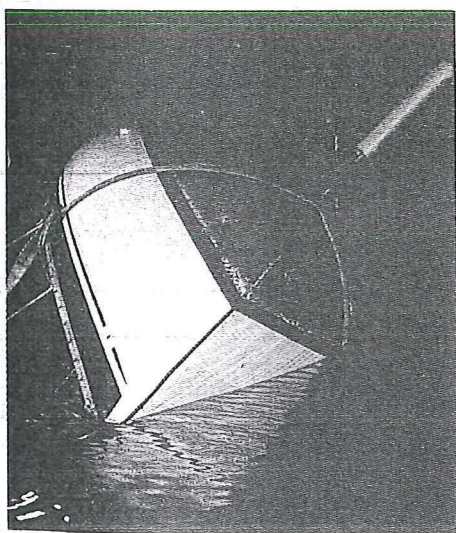
3. 9min.15sec. after
re-capsizing by herself

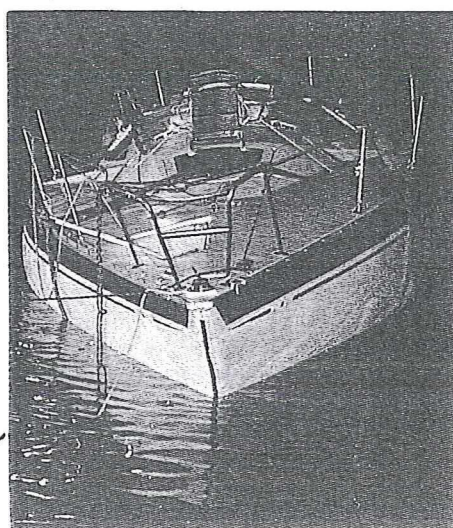
4. 9min.19sec. after
now righted up

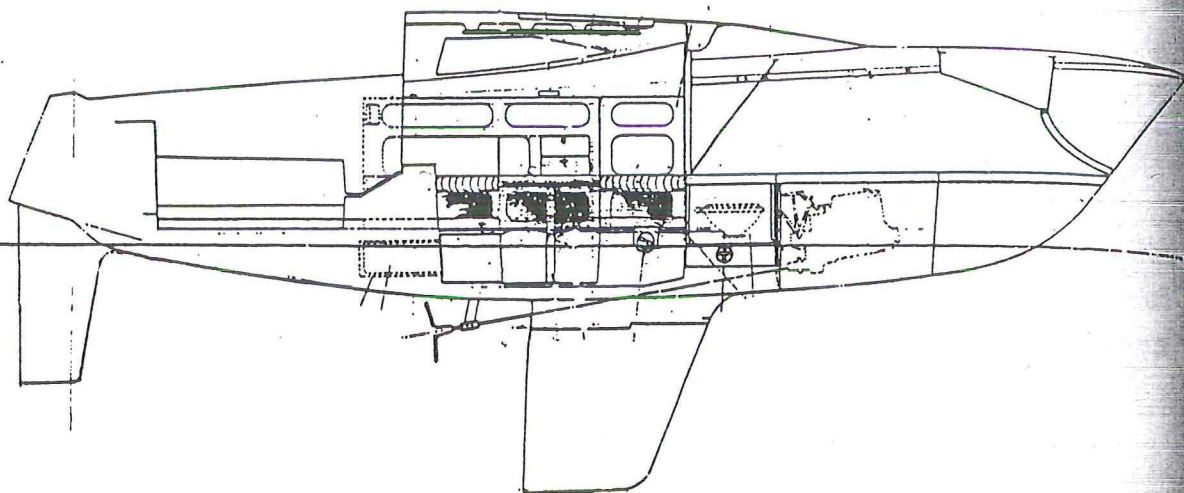
L_{OA} : 7.60 m	Δ : 1.95 ton	(test condition)
L_{DWL} : 6.00 m	GM : 0.86 m	(test condition)
B_{max} : 2.80 m	$GM_{INVERTED}$: 1.52 m	(test condition)

Fig.1 Arrangement Profile of Y-25 MarkII

1.1 Procedure and Results: A 25 foot cruiser/racer, YAMAHA Y-25 Mark II was employed to investigate what will happen after turn turtle capsize, her principal dimensions and rough drawings being shown in Figs. 1 and 2. The mast, rigging and auxiliary motor were removed before the experiment but the total weight and centre of gravity position remained unchanged by means of compensation weights. Difference in rolling moment of inertia does not matter as long as the static behaviour is

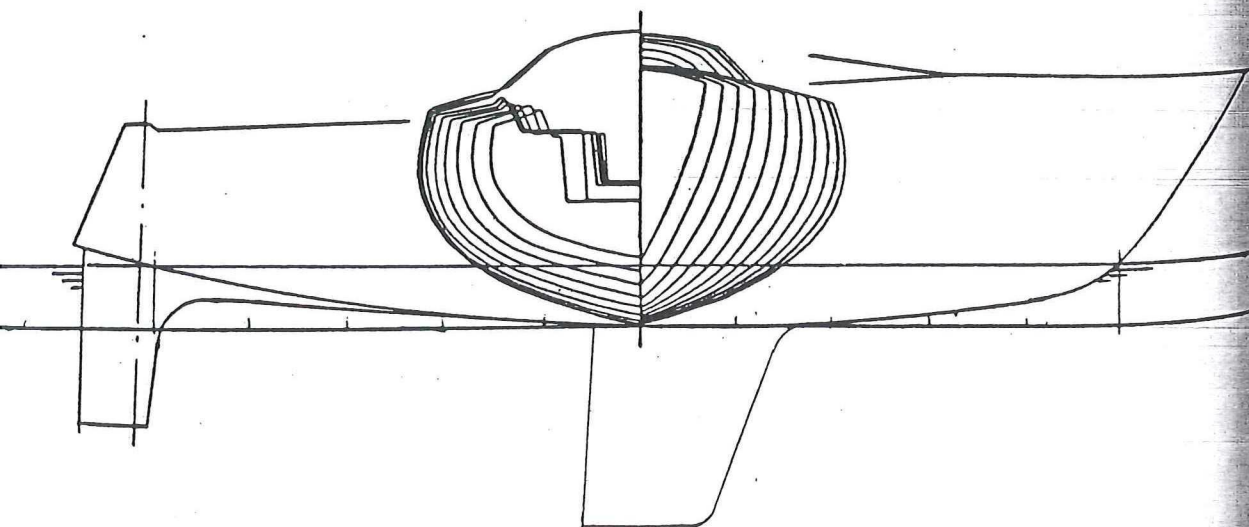
Fig.2 Rough Lines of Y-25 MarkII

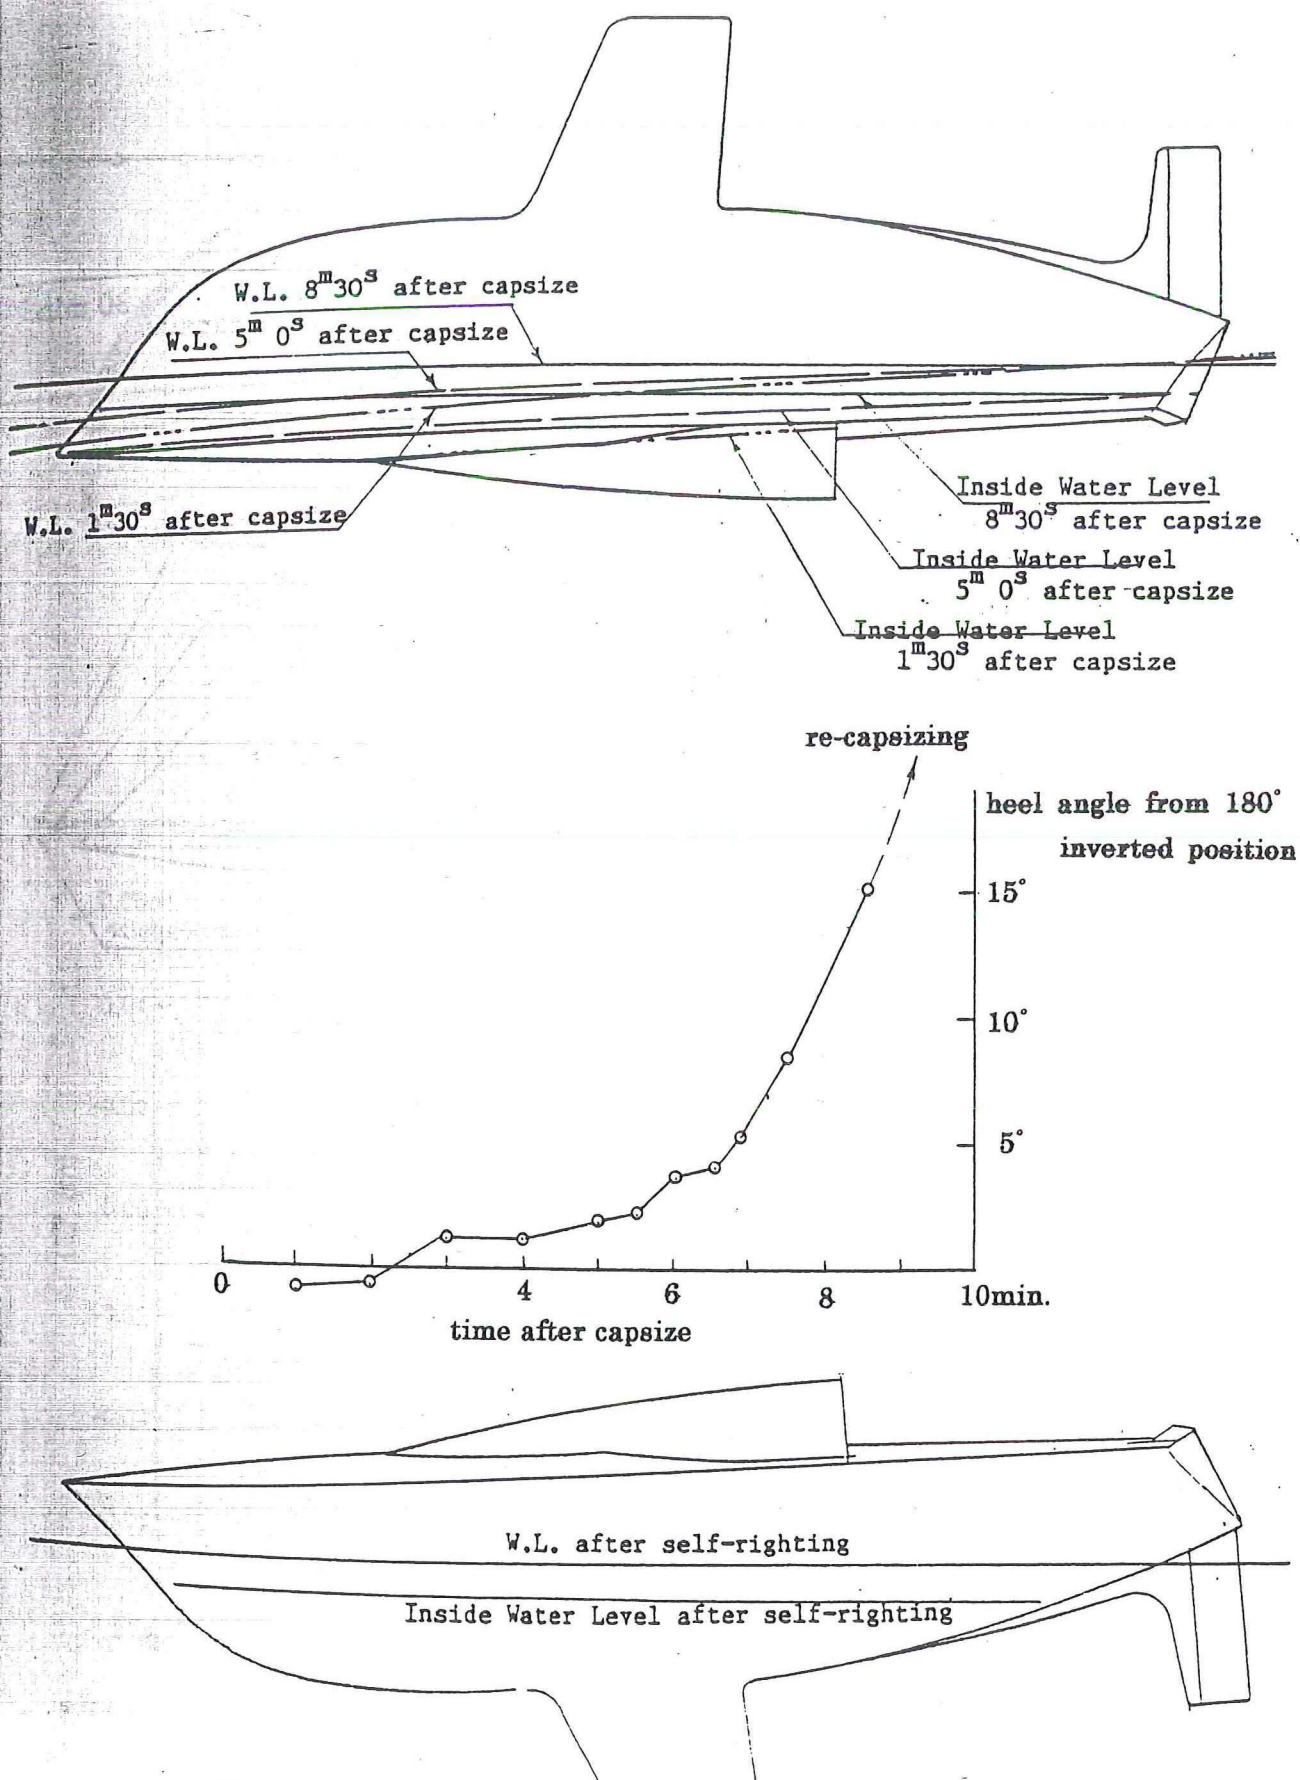
Fig.3 Full-scale Experiment of Inverted Stability, Test No.3.

In case of three tries out of four, the water inside tended to shift bowward to cause an appreciable trim by the bow at this stage as indicated in Fig. 3. At the same time in this situation the metacentric height GM (of course at the inverted attitude) had already become *negative*, which in turn created a certain amount of steady heel in spite of no asymmetric solid weight aboard. This loss of stability came from the reduced water-plane and free-water effect of flooded water. The steady heel gradually increased as shown in the inset graph in Fig.3 and finally the yacht did re-capsize by herself and righted (Photos.1 through 4). The time spent from turning over to re-righting was 11min.20sec., 4min.50sec. and 9min.19sec. respectively for the three tries above-mentioned. Meanwhile in the real world the re-capsize would supposedly take place considerably earlier encouraged by any external disturbance. The weight of flooded water estimated from the displacement after re-righting was about 2.5 tons which was some 25% over the yacht's intact displacement but still within such an amount that average crew could readily bail out (cf. Fig.3., bottom).

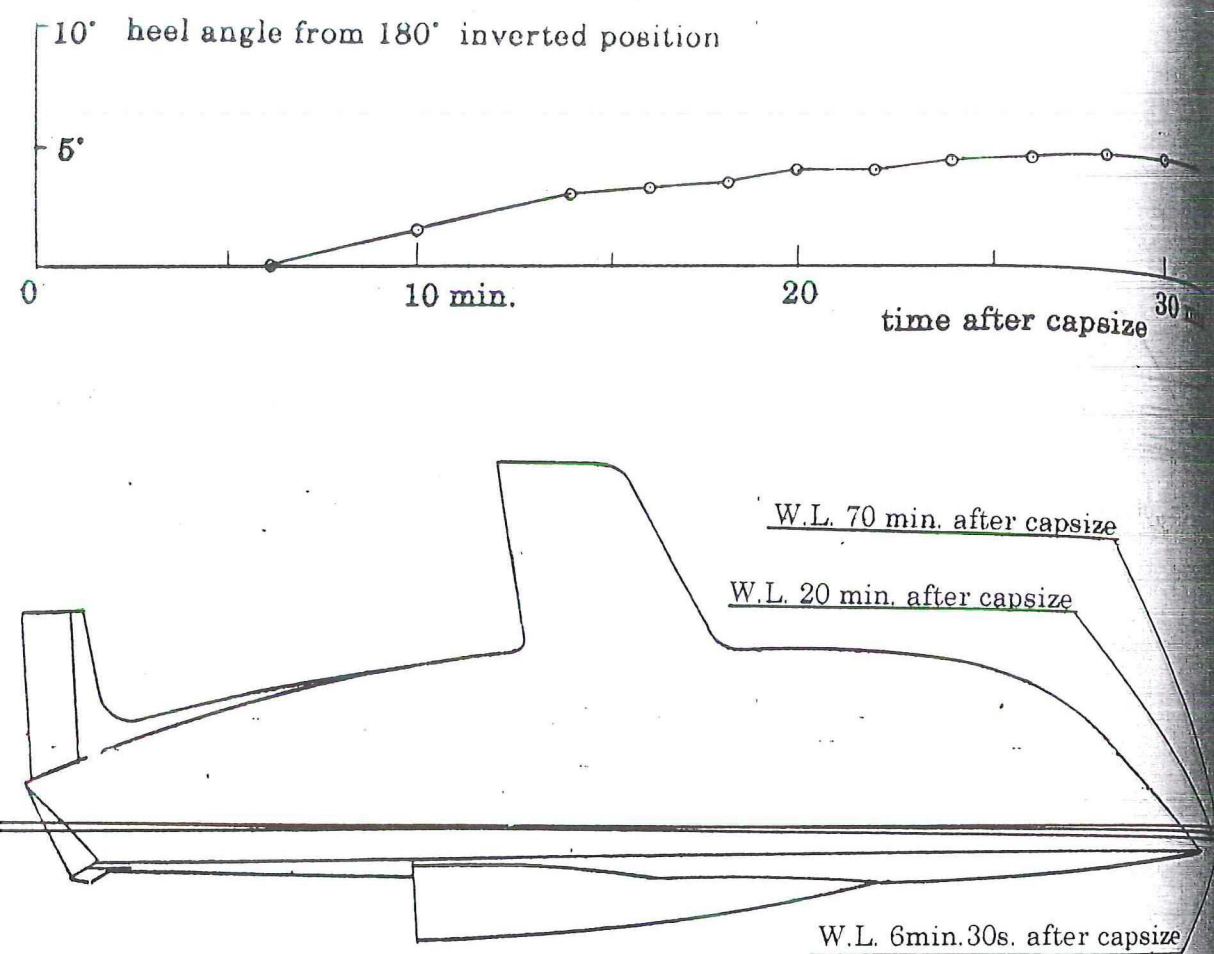
Fig. 4 Full-scale Experiment of Inverted Stability, Test No.4

Only one case out of four was somewhat different. In this case the flooded water apparently distributed itself evenly fore-and-aft for some reason and no appreciable trim was observed, as indicated in Fig.4. The reason for the difference is not very clear but the initial attitude given by turning-over operation might be related to. At any rate, in this case the yacht maintained her "turn turtle" position as long as 70 minutes after capsized, when we gave up to continue.

According to the inset graph in Fig.4, however, again in this particular case the heel angle began to gradually increase about 10 minutes after capsized in spite of no asymmetric solid weight aboard. It suggests presence of a negative GM also in this case due to the same cause as the other three and in real world external disturbance would force the yacht to re-capsize perhaps before very long.

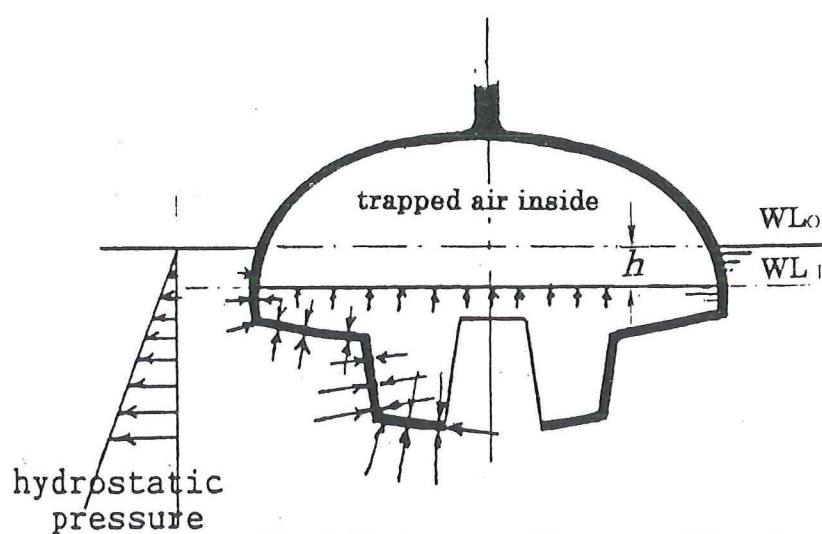
Fig.5 Hydrostatic Pressure Distribution when floating upside-down

Displacement volume enclosed by the two water-planes WL_0 and WL_1 and the shell surface supports most part of the yacht's weight.

Fig.5 illustrates this situation. Small arrows indicate the hydrostatic pressure. Interesting is the level difference between the outside and inside water. Denoting the level difference as h in metre, the static pressure on the inside surface is $1025 h \text{ kg/m}^2$ (in case of sea water).

2.2 Initial Stability at Inverted Mode: Now let us deal with stability at inverted mode indicated by Fig.5. , taking account of the trapped air and flooded water.

All these problems need repeated iteration process which the computers today are most good at. The program we developed at the Osaka Prefectural University, Dept. Naval Architecture is to integrate hydrostatic pressure over all the hull surface underwater plus the inside water-plane WL₁ as is illustrated in Fig.5. Through this program we can first obtain the sinkage, trim and level difference between the outer and inner water-planes, i.e. position of the two water-planes, at 180° inverted mode for a given hull configuration and a given volume of trapped air. Then the program provides the righting arm GZ for a given angle of heel, taking account of change in sinkage and trim.

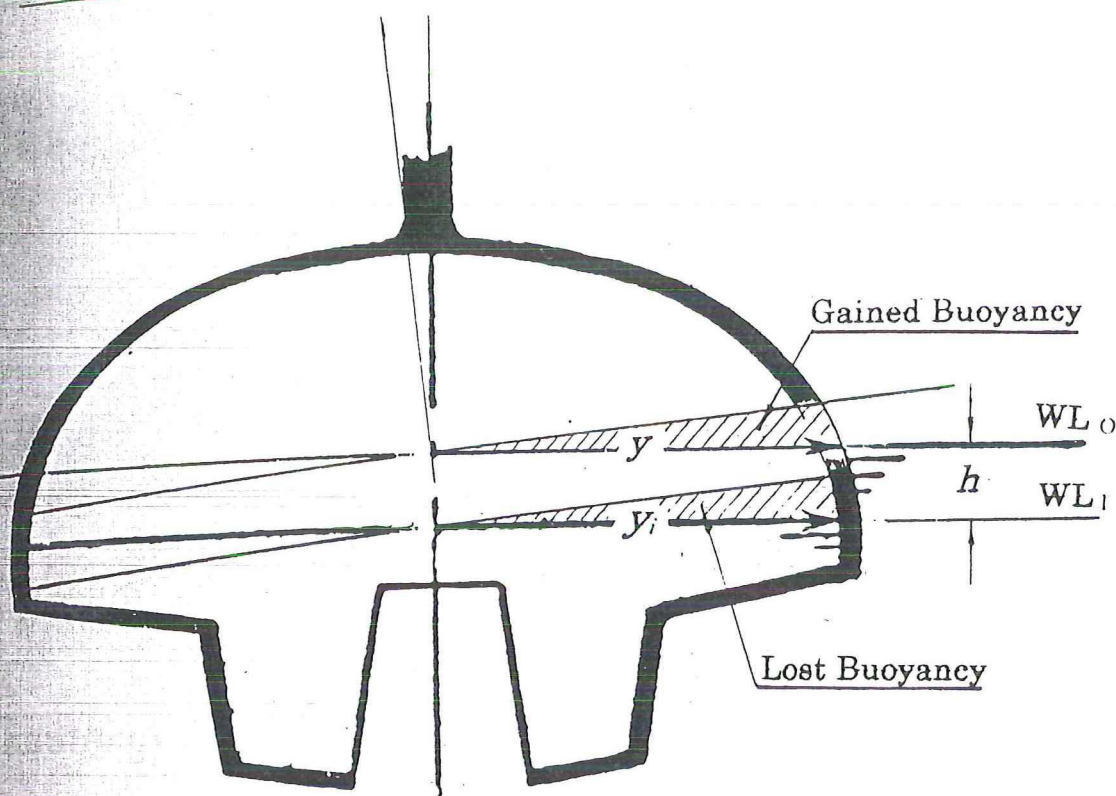
Fig.6 Effect of Flooded Water upon Inverted Stability;
buoyancy gained on the outside water-plane is much
cancelled by buoyancy lost on the inner water-plane

First take the initial stability at very small angle of heel. Referring to Fig.6 and following the usual mathematical reduction of metacentric radius BM, we get

$\int_L dx$ denotes an integration from bow to stern lengthwise. y and y_i are indicated in Fig.6.

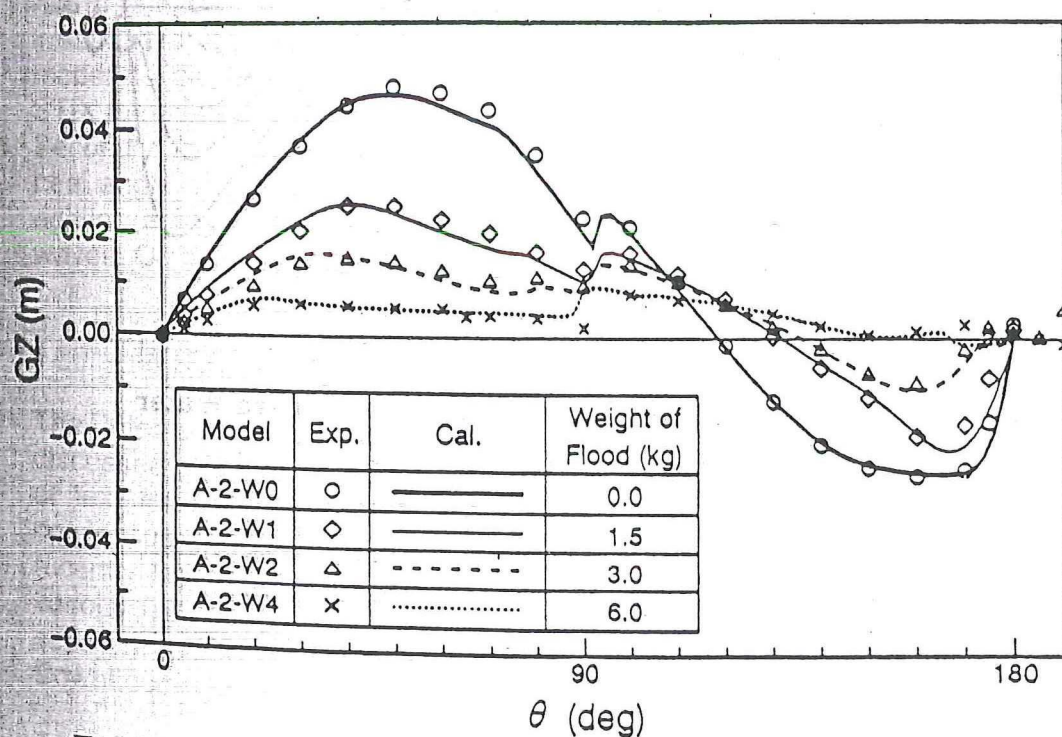
Fig.7 GZ Calculation with Experimental Data of
1/10-scale Model of an IOR Racer with Flooded Water
(SRI/JCI Report 1944)

$L_{OA} : 0.929 \text{ m}$ $B_{max} : 0.312 \text{ m}$ $\Delta : 3.03 \text{ kg(fresh water)}$ $GM : 0.088 \text{ m}$

Figs.7 and 8 indicate the two typical results, one for 1/10 scale model of a 31ft .IOR-type racer and the other the yacht employed at the previous full-scale experiment. Incidentally Fig.7 employed the latter program and Fig.8, the former.

3. Safety consideration after the re-capsize caused by flooding may be not exactly in the scope of the present work but let us have a few words upon it as a related crucial subject. Referring to Fig.7, the greater the flooded water the smaller the righting arm GZ gets in the whole range of angle of heel but at the same time the stability range becomes the greater. Since a large stability range is the decisive ability to avoid capsize, a yacht containing a great amount of flooded water is presumably quite safe in spite of her very low righting arm GZ, contrary to the common belief. A capsizing model experiments carried out with the same model as Fig.7 seem to assure this reasoning. On the other hand we should bear in mind the danger of total swamping and eventual sinking in this concern.

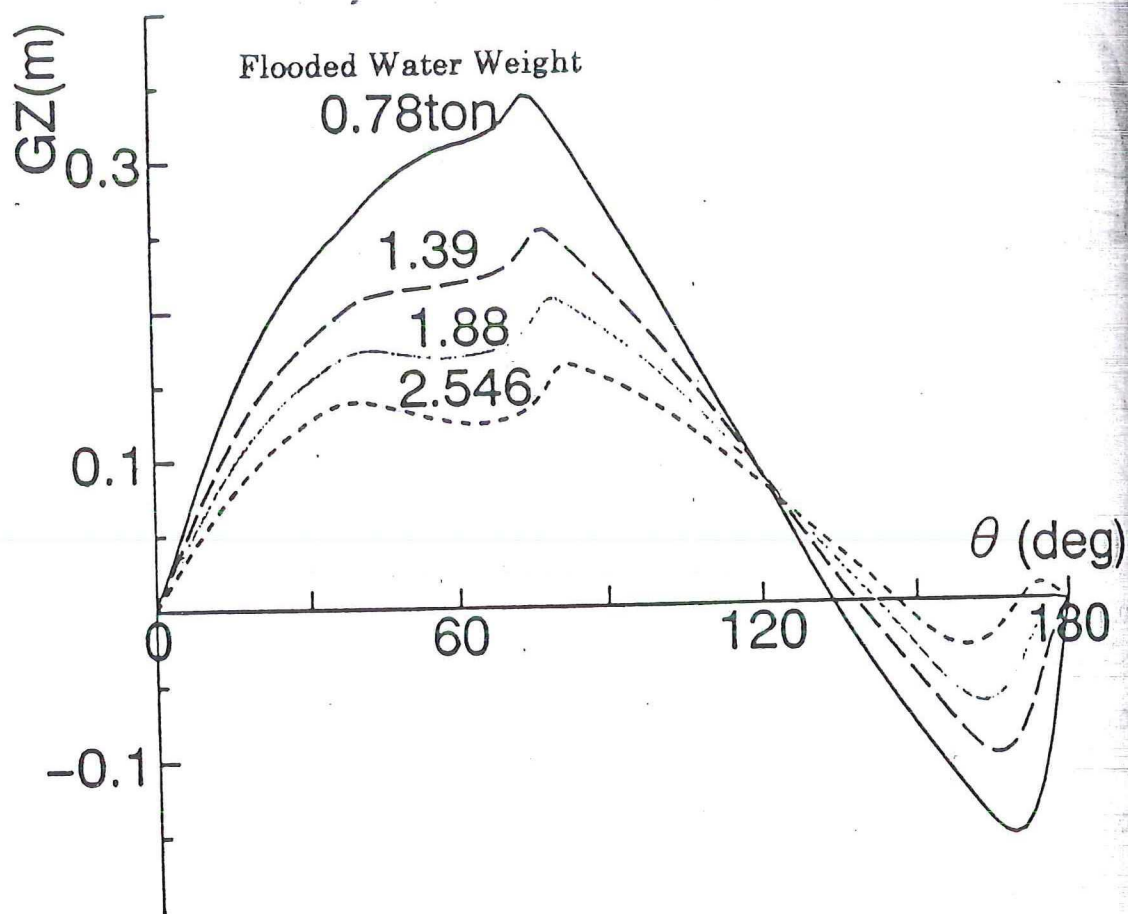
Fig. 8 G Z Calculation of Y-25 MarkII with Flooded Water
(JCI Report 1994)

L_{OA} : 7.60 m	Δ : 1.95 ton	(test condition)
L_{DWL} : 6.00 m	GM : 0.86 m	(test condition)
B_{max} : 2.80 m	GM _{INVERTED} : 1.52 m	(test condition)

inverted mode does recover its positive value at a small angle of heel from 180° by this reason. This is clearly seen in Fig.8 by the behaviour of GZ around 180° heel.
