To Plant or Not to Plant

When can Planting Facilitate Mangrove Restoration?

Published in Frontiers in Environmental Science

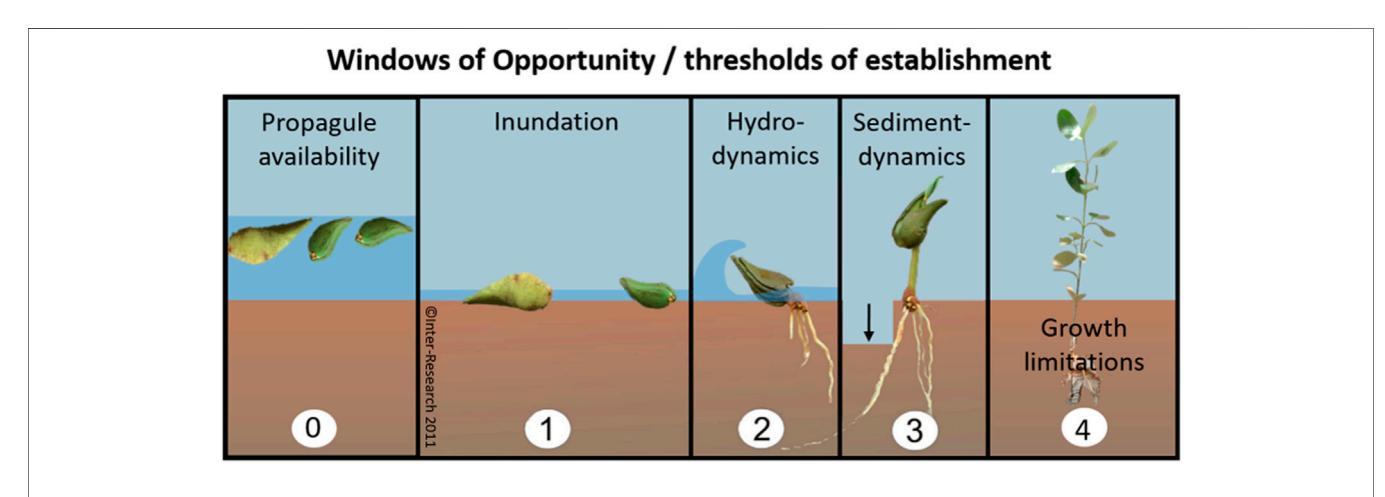
FIGURE 1 | Windows of opportunity that propagules should encounter (or threshold of establishment that propagules should overcome) before they can colonize a site. EMR makes use of measures that extend the window of opportunity for natural establishment (0–3). Mangrove planting is either aimed at overcoming propagule limitation (0) or at skipping the thresholds of propagule establishment (1–3) by using larger seedlings or saplings that would, to a certain extent, be able to withstand conditions that are too harsh for smaller seedlings. Finally, saplings need to overcome limitations of growth (4) such as predation, disease or other stressors to grow into reproductive young trees (panels 0 and 4 are additions to Balke et al. (2011)'s Windows of Opportunity figure).

To overcome plantation failure, interests have been shifting increasingly towards restoration of mangrove habitat to promote natural recruitment, rather than using active planting of mangrove propagules or seedlings (Balke and Friess, 2016; Lewis, 2005; Winterwerp et al., 2020, 2013). The focus of mangrove habitat restoration (i.e. EMR), lies in mitigating the establishment thresholds that limit natural propagule settlement and survival (Lewis and Brown, 2014). Lewis (2005) demonstrated the importance of addressing the first threshold, (i.e. limited propagule availability) (Figure 1, panel 0), by digging a creek, thus reestablishing aquatic connectivity at a propaguledeprived location and thereby initiating mangrove regeneration over the course of 6.5 years. At more exposed sites, propagules need to overcome additional thresholds to establish successfully for which they need to surpass three size-dependent windows of opportunity: 1) a flooding-free phase, 2) followed by a wave-free period and 3) an erosion-free period (Figure 1, panels 1-3) (Balke

et al., 2015, 2013, 2011). Van Cuong et al. (2015) demonstrated that these windows of opportunity can be extended along eroding shores by placing permeable fences parallel to the coastline. These fences both increased the bed level through sediment trapping (i.e. creating first window) and mitigated the wave stress (i.e. creating second window), allowing natural seedling recruitment to increase from zero to 24,000 seedlings ha⁻¹ over the course of 3 years. The examples provided by Lewis and Van Cuong et al. clearly show that informed mitigation of stressors restricting natural mangrove recruitment can be sufficient for successful restoration. It is noted that this approach requires proper understanding of the natural system, as the optimal method may differ depending on the specific abiotic and biotic constraints at the selected sites.

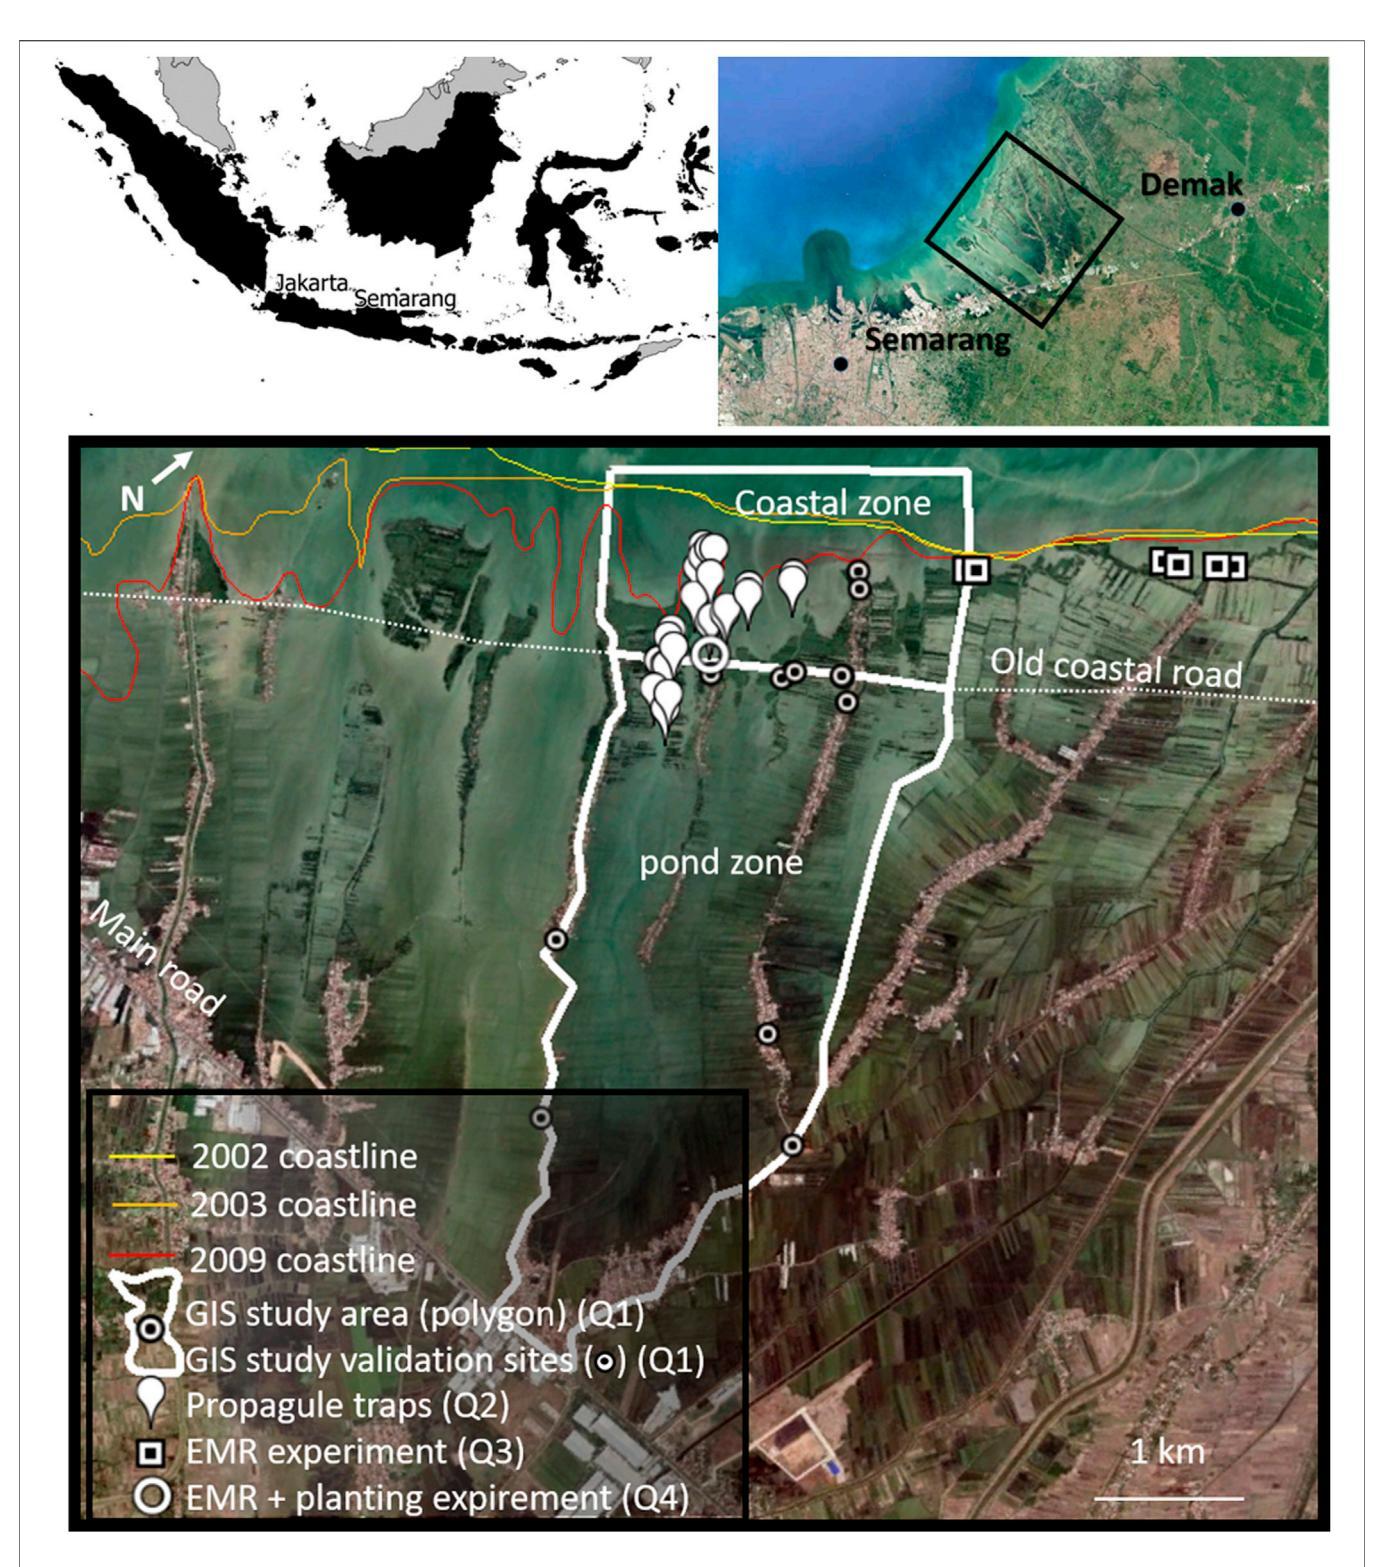
FIGURE 2 | The focus area of this paper, the coastline of Sayung subdistrict (black rectangle) in Demak, Indonesia. Historic coastlines are indicated (before, in between and after two major erosion events), as well as the old coastal road which became the last standing structure resisting coastal erosion, dividing the active aquaculture zone from the dynamic coastal zone. The locations of the four experiments linked to the four research questions are indicated with the marks displayed in the legend. Detailed location descriptions and overviews per experiment are shown in the method section.

The traps were placed across the creek and throughout the coastal bay. In total, 40 traps were placed throughout the basin, nine traps in the creek of the pond zone and 31 traps in the coastal zone (**Figure 2**, close-up in **Supplementary Figure S2B**) and they were emptied weekly throughout the year in 2017. Data from the wet season are partially missing as the coastal traps were continuously destroyed by waves, despite repeated efforts to replace them. In addition, the rough seas made it hard to reach and empty the remaining traps regularly.

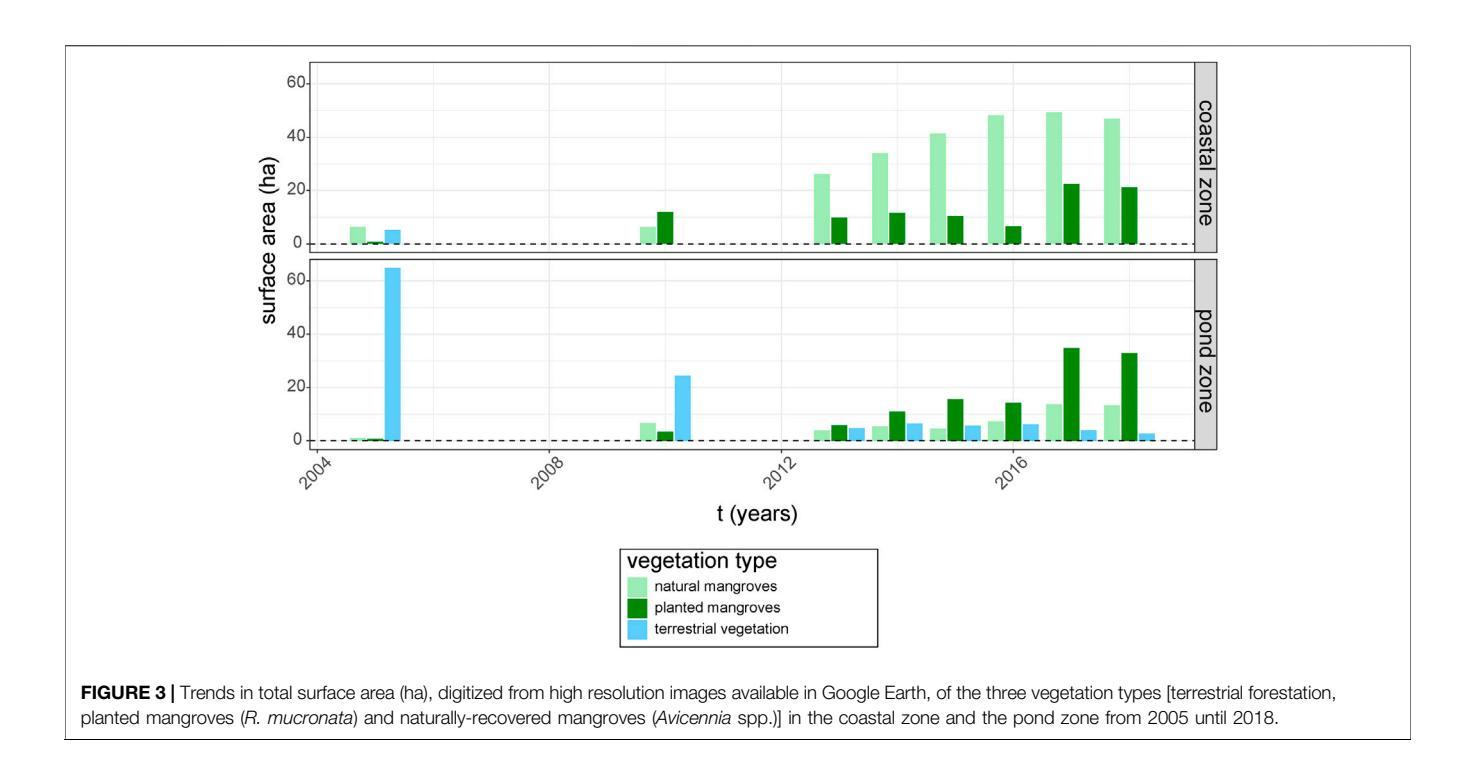
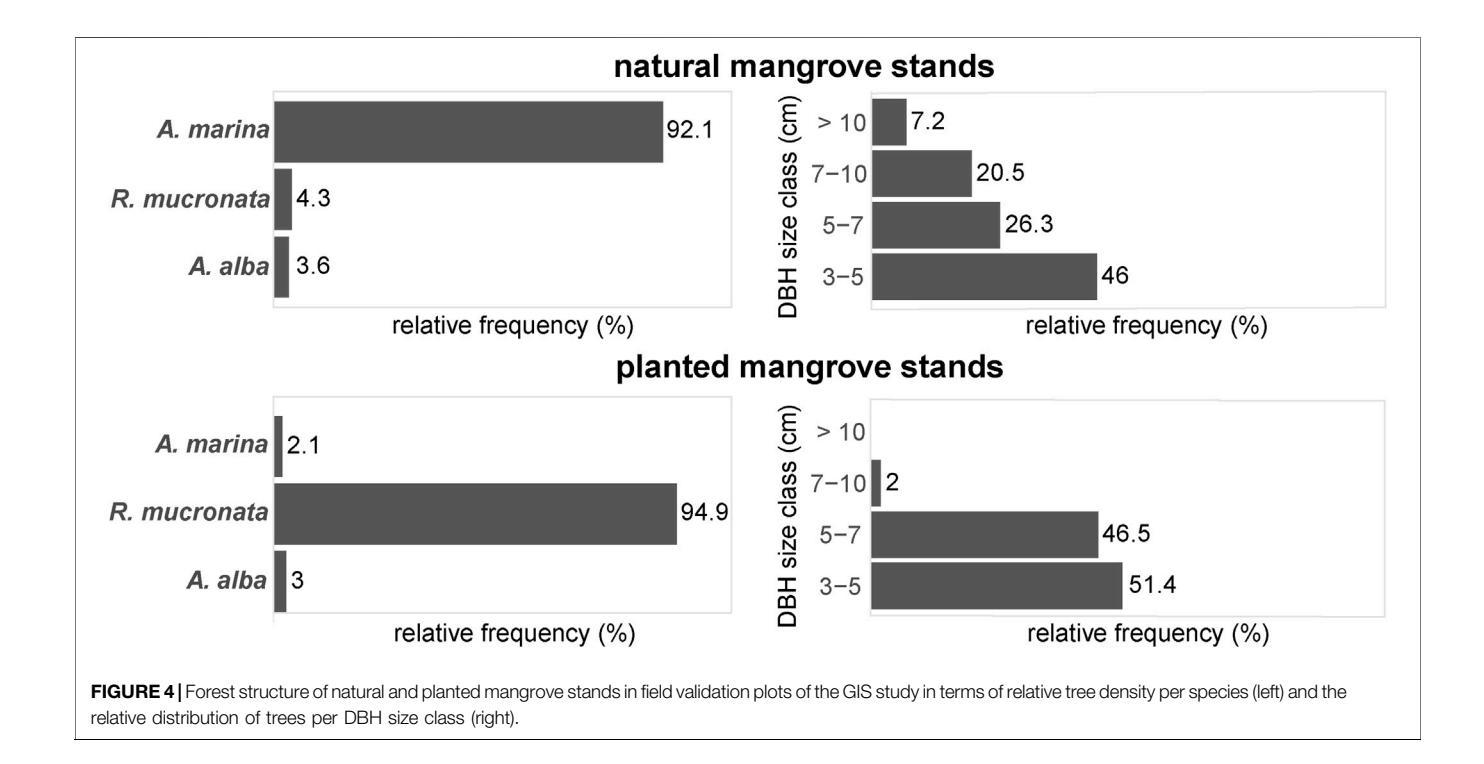
showed an average increase of 3.9 ha per year ($R^2 = 0.85$, p < 0.001), increasing from 6.3 ha in 2005 to 46.8 ha in 2018. Mangrove expansion through planting was significantly less rapid in the coastal zone (p < 0.01), with an average expansion rate of 1.3 ha per year ($R^2 = 0.56$, p = 0.03).

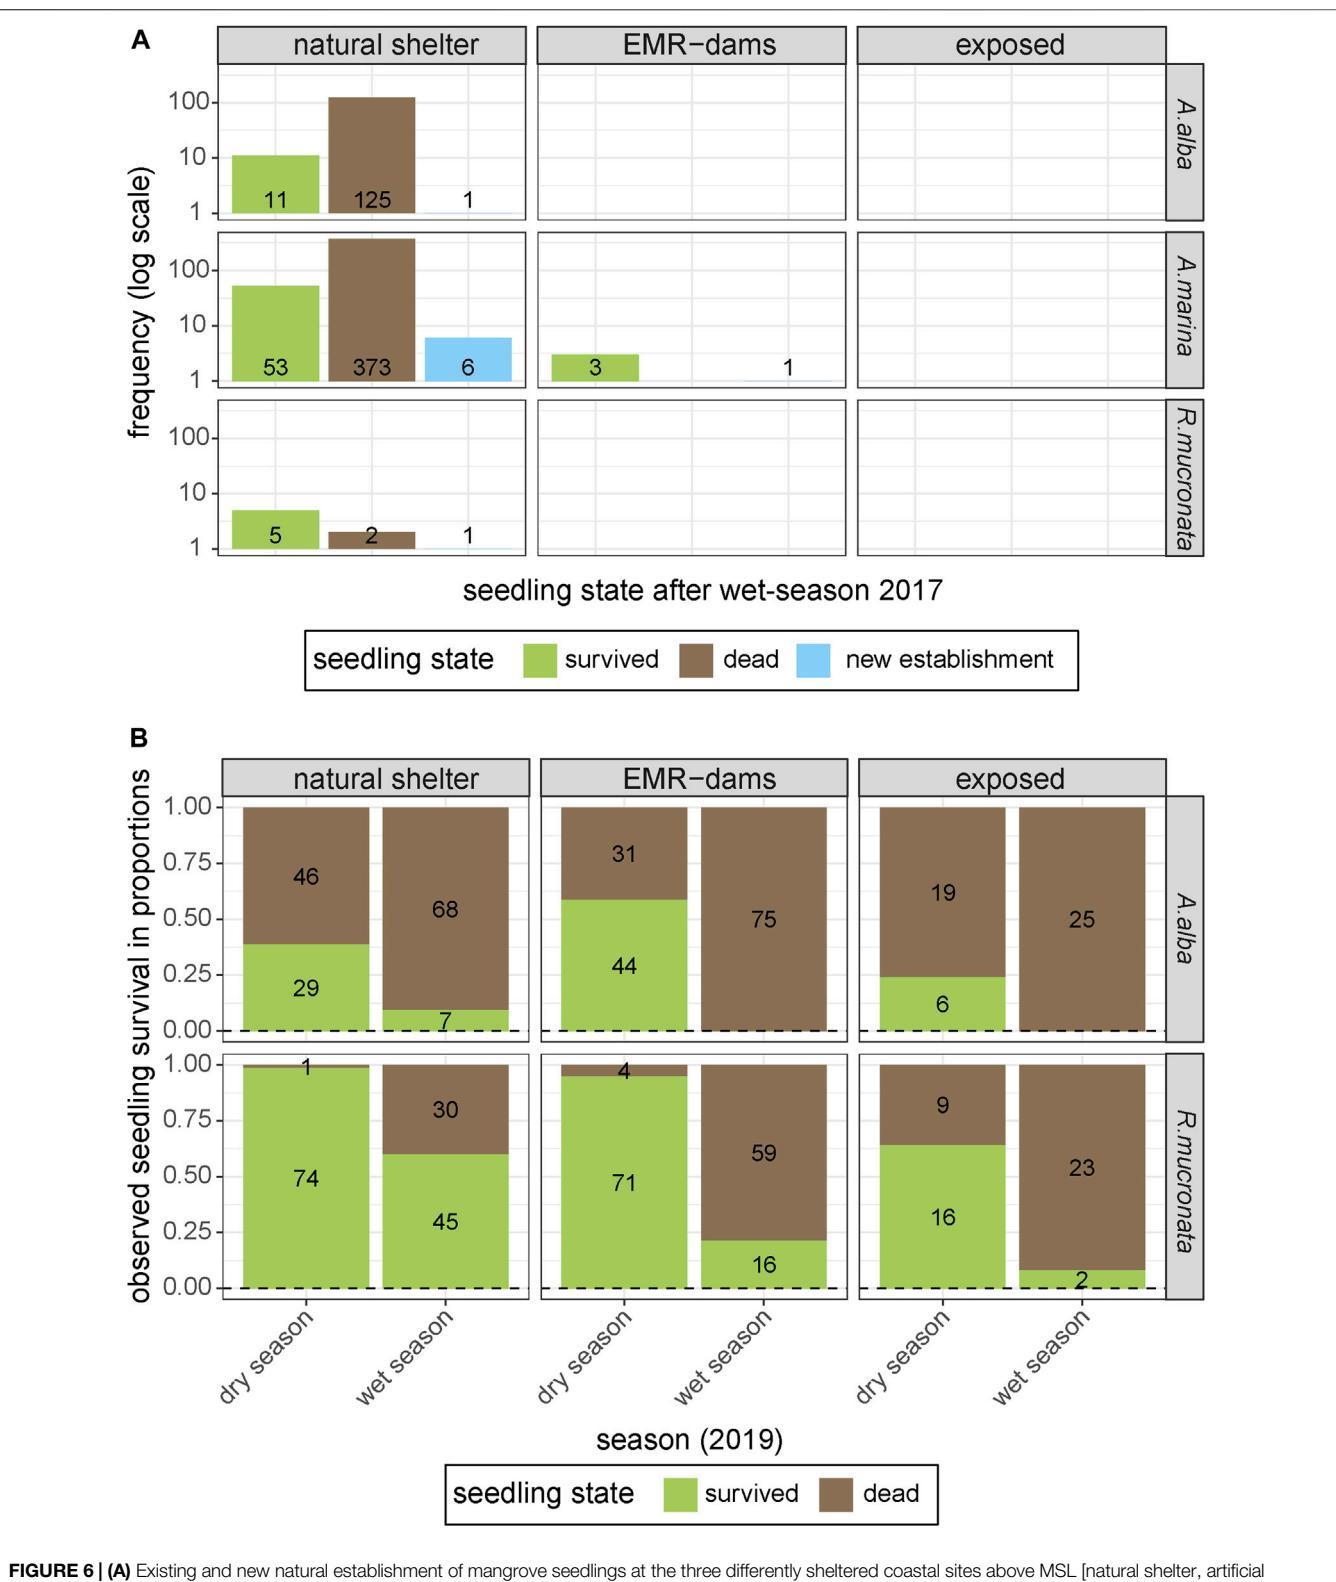
FIGURE 6 (A) Existing and new natural establishment of mangrove seedings at the three differently sheltered coastal sites above MSL (natural shelter, artificial shelter (EMR), and wave-exposed), and survival of existing natural recruits over the course of the experiment. (B) Survival of *A. alba* and *R. mucronata* seedlings that were planted at naturally sheltered sites, at habitat restoration sites behind an EMR-dam, and at an exposed site.

Despite the low success in natural recruitment at the EMR sites, EMR did increase the survival of established (planted) seedlings (Figure 6B), even at sites where natural recruitment behind the dams was not yet taking place (Figure 7A). This suggests that a combination of planting and EMR might be useful to overcome (temporary) thresholds of establishment and accelerate revegetation of challenging sites in the coastal zone. However, species choice appears an important factor in the development of the revegetated site after initial recruitment. R. mucronata, the species that is most often used in large-scale planting (Wodehouse and Rayment, 2019), proved to have the highest initial survival rate (Figure 7A), which might explain the popularity of these species in many voluntary planting projects (Primavera and Esteban, 2008; Wodehouse and Rayment, 2019). However, the slow growth rate of *R. mucronata*, such as observed at this muddy coast (Figure 7B), might lead to a mangrove stand that is, more stunted and/or less regenerative than when a pioneer species appropriate to this site would have been used. This outcome has indeed been observed in various studies (e.g. Barnuevo et al., 2017; Fickert, 2020; Proisy et al., 2018), as well as behind the breakwater in Demak (Figure 9). It should be noted that in carbonate systems, Rhizophora species have been observed as pioneers of the coastal zone [e.g. (McKee, 1993; Piou et al., 2006; Prabakaran et al., 2021)]. This illustrates that it is important to look at natural example sites with a similar biophysical typology as the restoration site [e.g. minerogenic versus organogenic soil (Worthington et al., 2020)], when selecting an appropriate pioneer species. The presence of a few fruiting pioneers can reportedly revegetate a site more efficiently than a planting effort with better surviving, but slower growing species (Fickert, 2020). Although we were not able to include formerly native pioneers such as Sonneratia alba and Aegialitis annulata (Balun, 2011; Ilman et al., 2016), our Q4 experiment indeed demonstrated that planting with pioneers can quickly lead

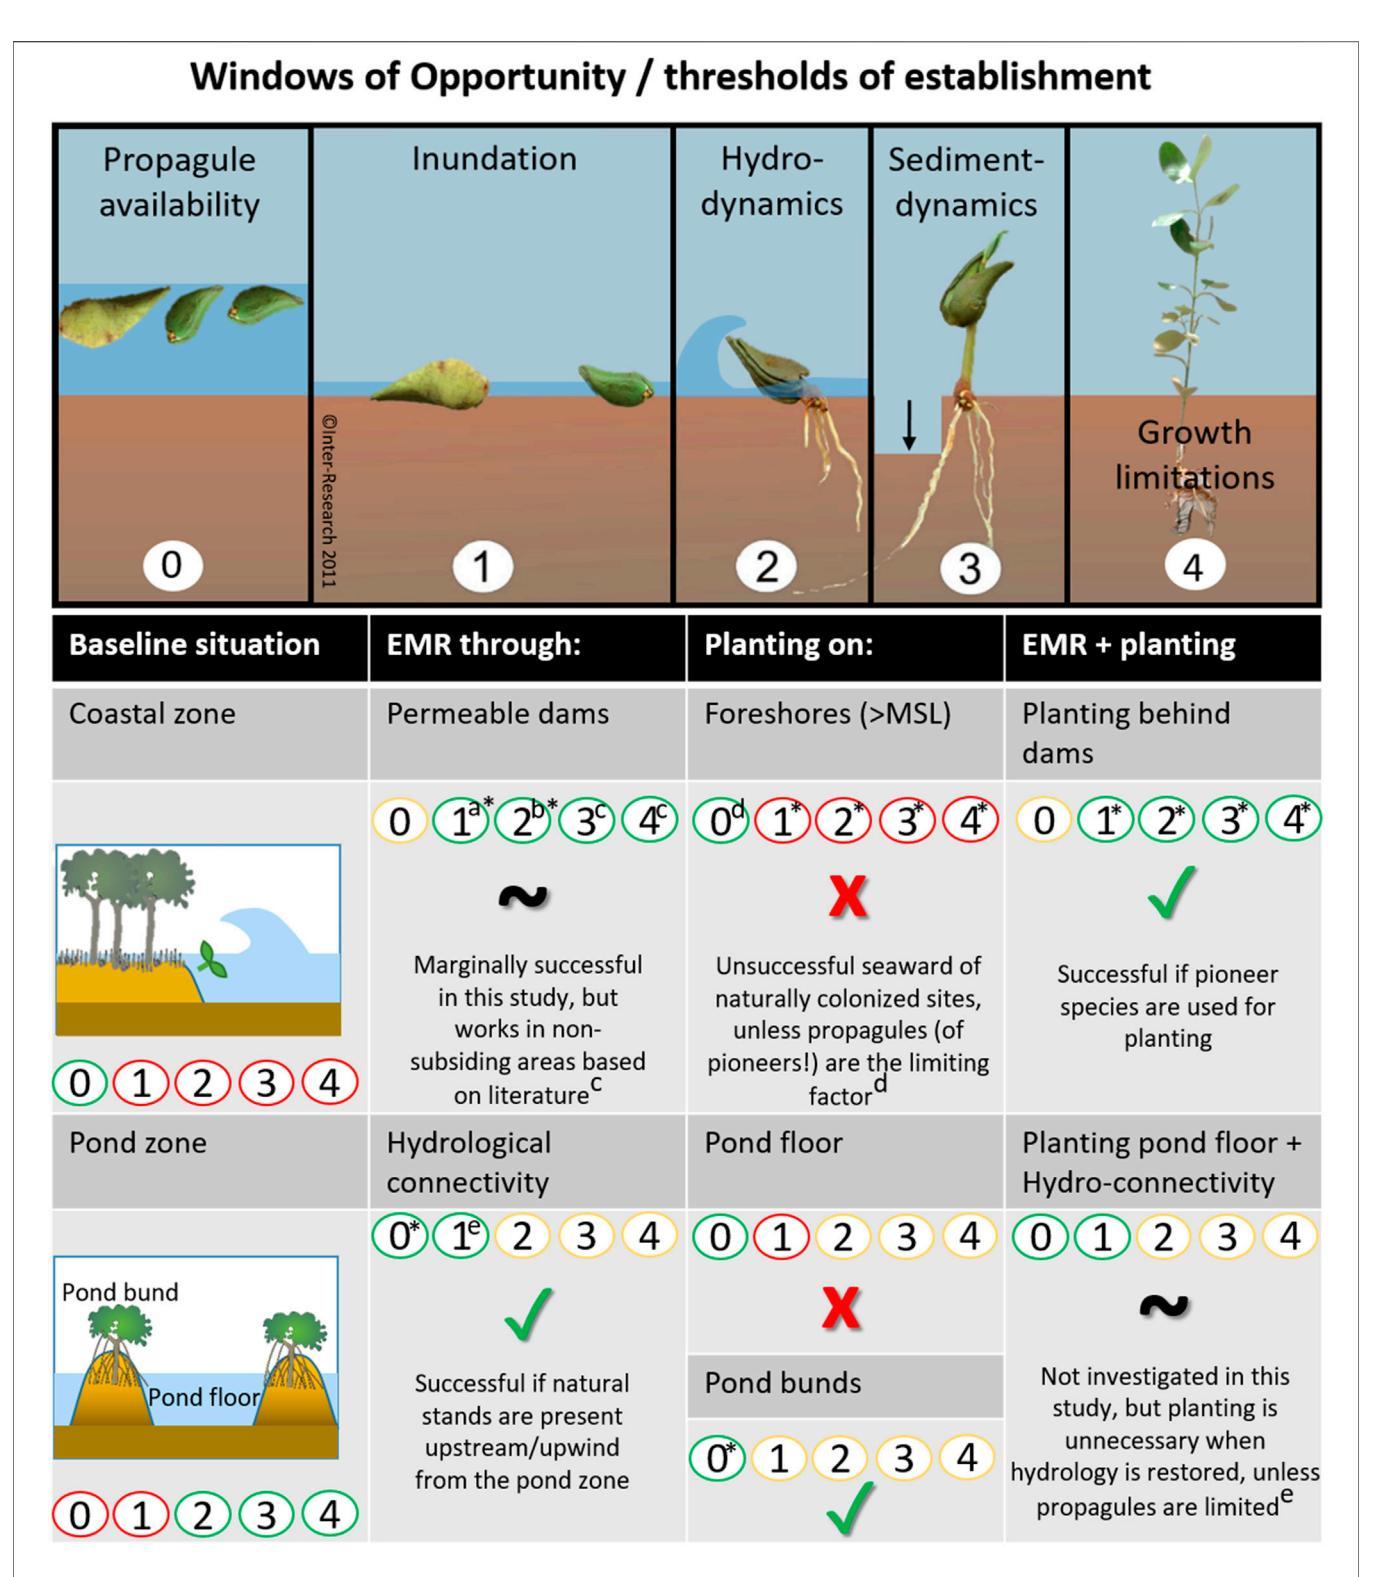
FIGURE 8 | Summary of the effectiveness of different restoration methods (EMR, planting, and a combination of both) to overcome thresholds of establishment in the coastal zone and the pond zone (red: ineffective, green: effective, yellow: condition already met in baseline situation), based on the findings of this study (*) and literature [a: (Cado et al., 2021), b: (Winterwerp et al., 2020), c: (Van Cuong et al., 2015), d: (Saenger and Siddiqi, 1993), e: e.g. (Lewis, 2005; Matsui et al., 2010; Proisy et al., 2018; van Bijsterveldt et al., 2020)]. The top panel of this figure was expanded from Balke et al. (2011)'s original Windows of Opportunity figure (panel 1-3).

mortality of planted seedlings (Brown et al., 2014). Also, in the case that natural colonizers can reach the site, additional planting often hampers the growth and succession of natural colonizers (Matsui et al., 2010; Proisy et al., 2018). Therefore, we conclude that planting may be a valuable measure in the pond zone but only when applied on pond bunds when aquaculture ponds are still active, bearing in mind that this will not result in a fully functional mangrove forest (**Figure 8**).

to the presence of a few reproductive young trees. This illustrates that the trade-off between a species' survival and growth rate should be taken into consideration when choosing species to plant in combination with EMR-measures, preferably using pioneer species at newly accreted sites (**Figure 8**).

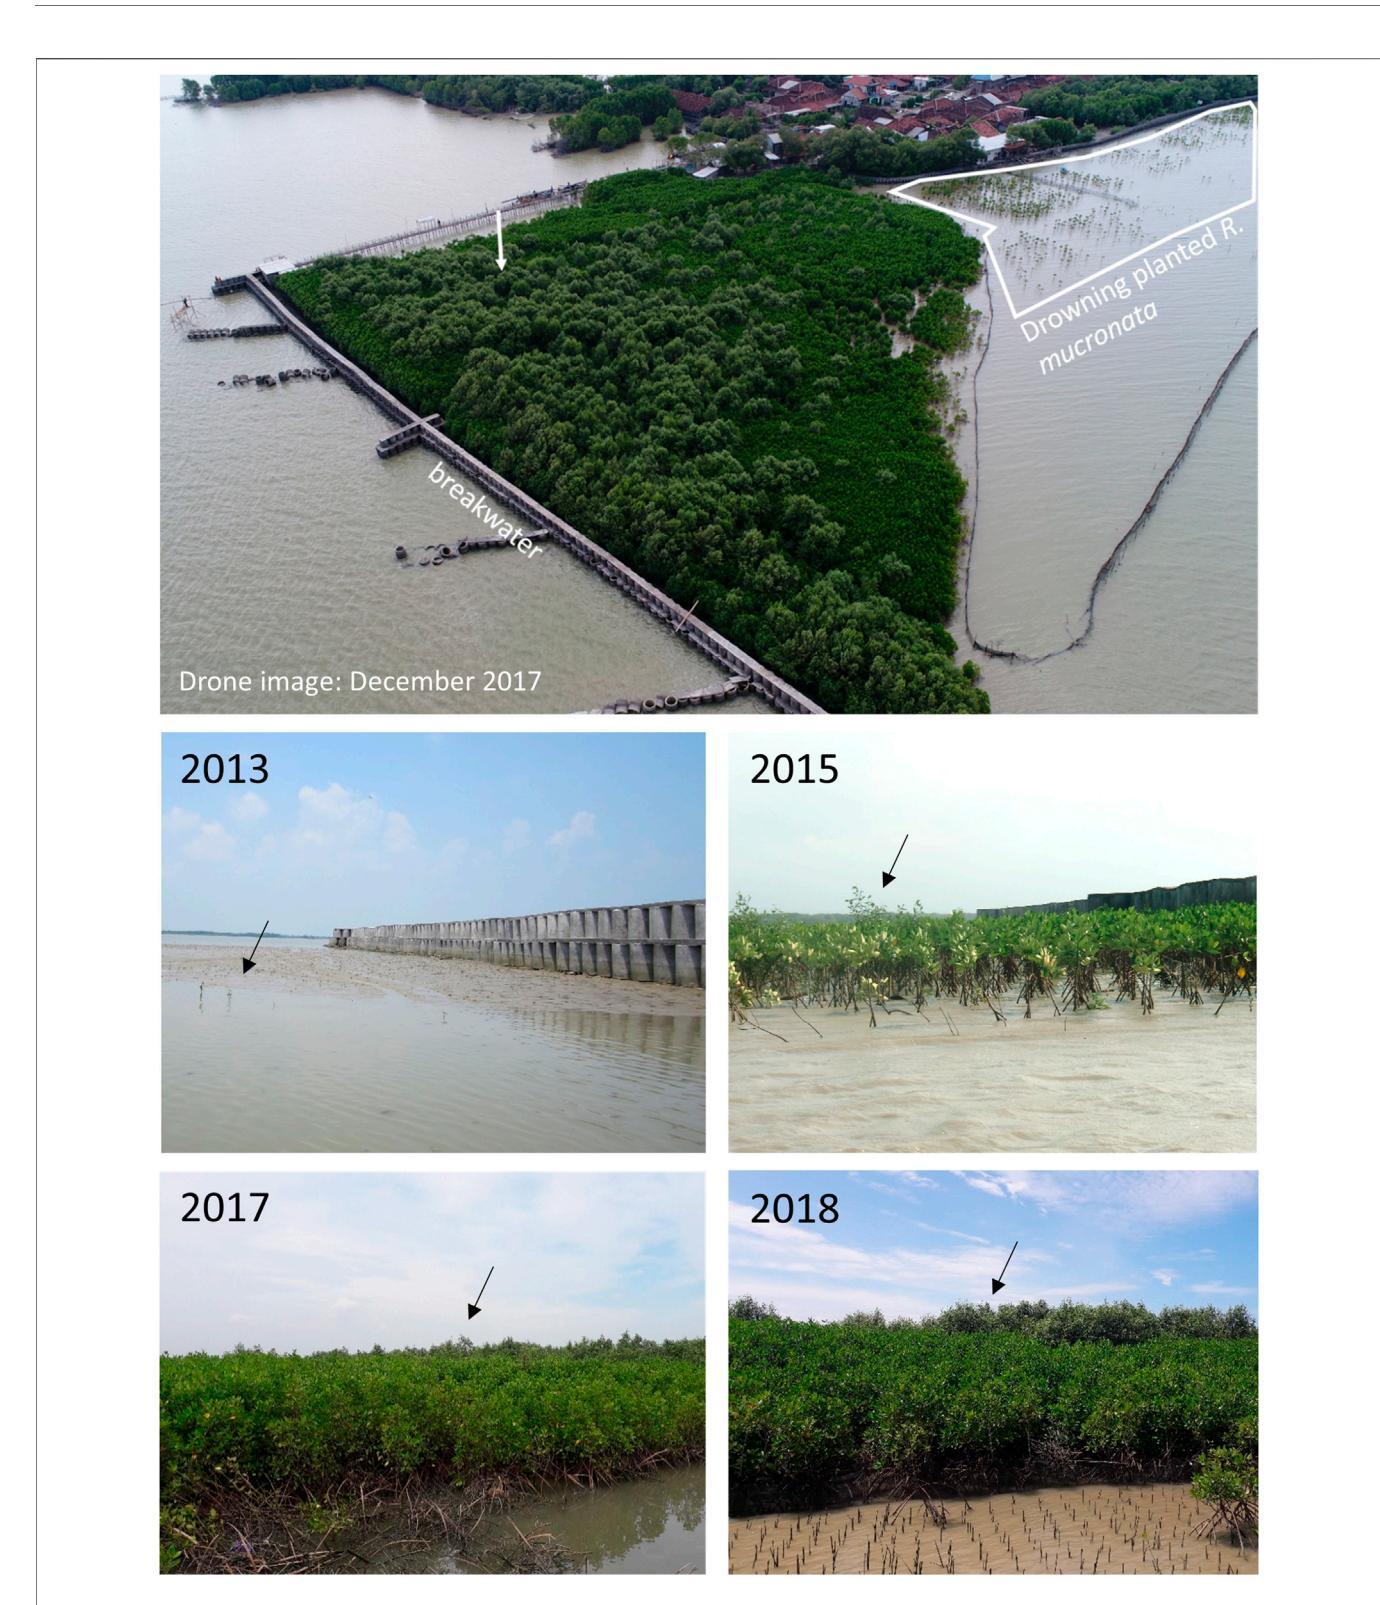
FIGURE 9 [Top: Bird's-eye view of the breakwater seaward of Wonerejo, Demak in 2017 (drone image courtesy of CoREM-UNDIP). The white arrow indicates the direction of the picture time series. The time series show the development of a mudflat after construction of the breakwater in 2012, followed by natural colonization in 2013 and subsequent planting of *R. mucronata* in 2014. Note the relative height difference in all pictures of the naturally colonized *A. alba* trees (black arrows) versus the surrounding planted *R. mucronata* trees (2015–2018).
