KATOENVEEM

MSc III Heritage & Architecture

Architectural & Building Technology Analysis Lidy Meijers - Bas Gremmen - Nicholas

07/04/2017

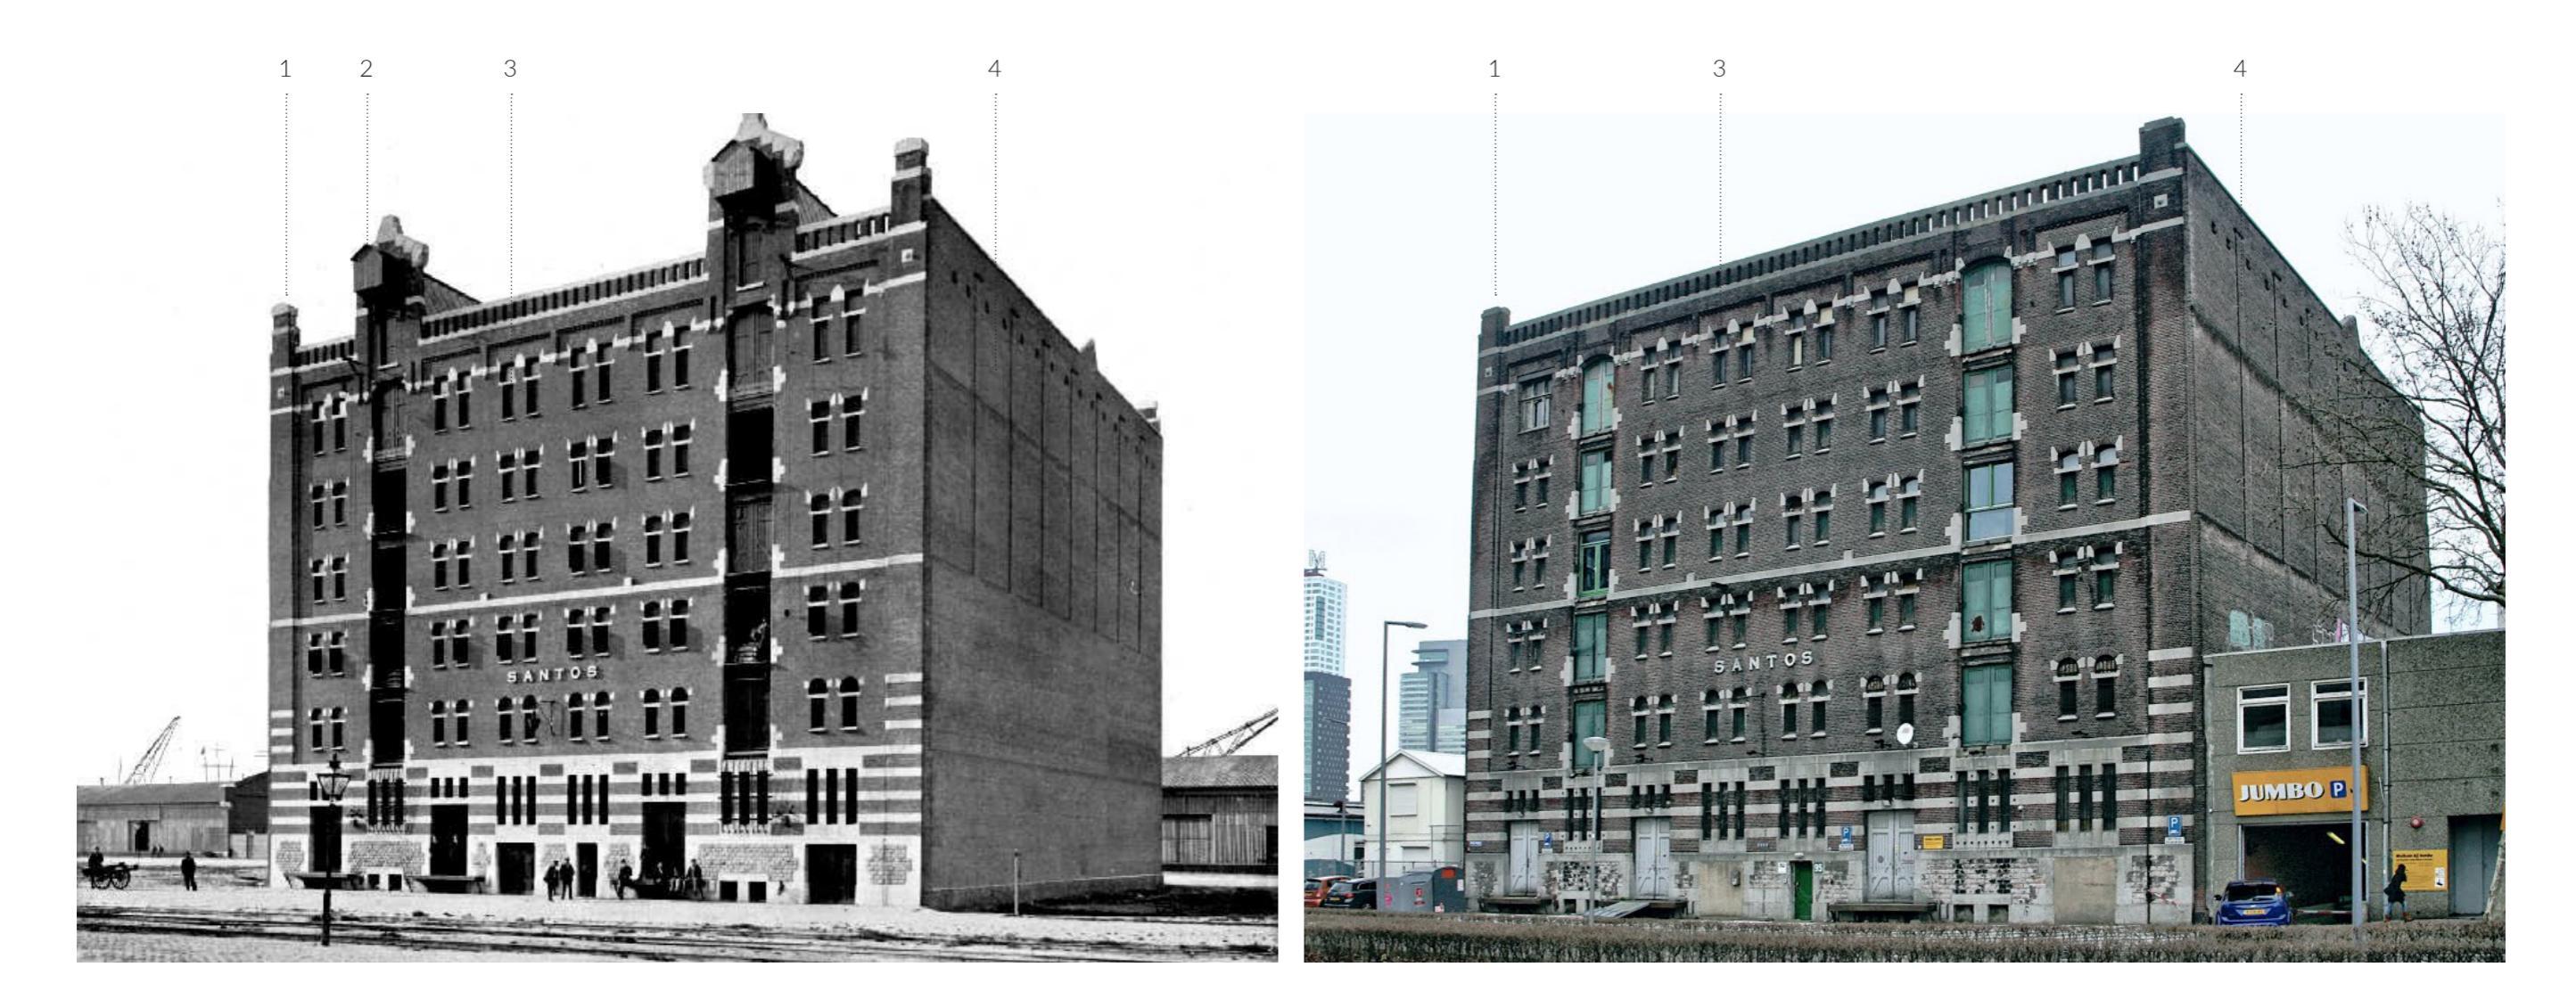
warehouse Santos by J.J. Kanters (Plevier, R., Adema, T., Hoope, J., Katoenveem Analysis & Values AR3AR02, Delft: TU Delft (2009))

This warehouse by Katoenveem's architect J.J. Kanters was built in 1903 on the south side of the Rijnhaven. The six story building was for a long time the highest warehouse in Rotterdam. The building was used for storage of coffee. The structure consists of revived cast iron columns on an outline of 4,22m by 5,3m. The foundation rests on a big number of wooden piles. All the floors consists of wooden beams and wooden boards, the ground floor however is built up out of concrete. This building seems to be a clear example of the transition of use in material in structure and building as their is made use of the conventional brick and steel with the at the time new material of concrete.

4. brick facades with hardstone lintels

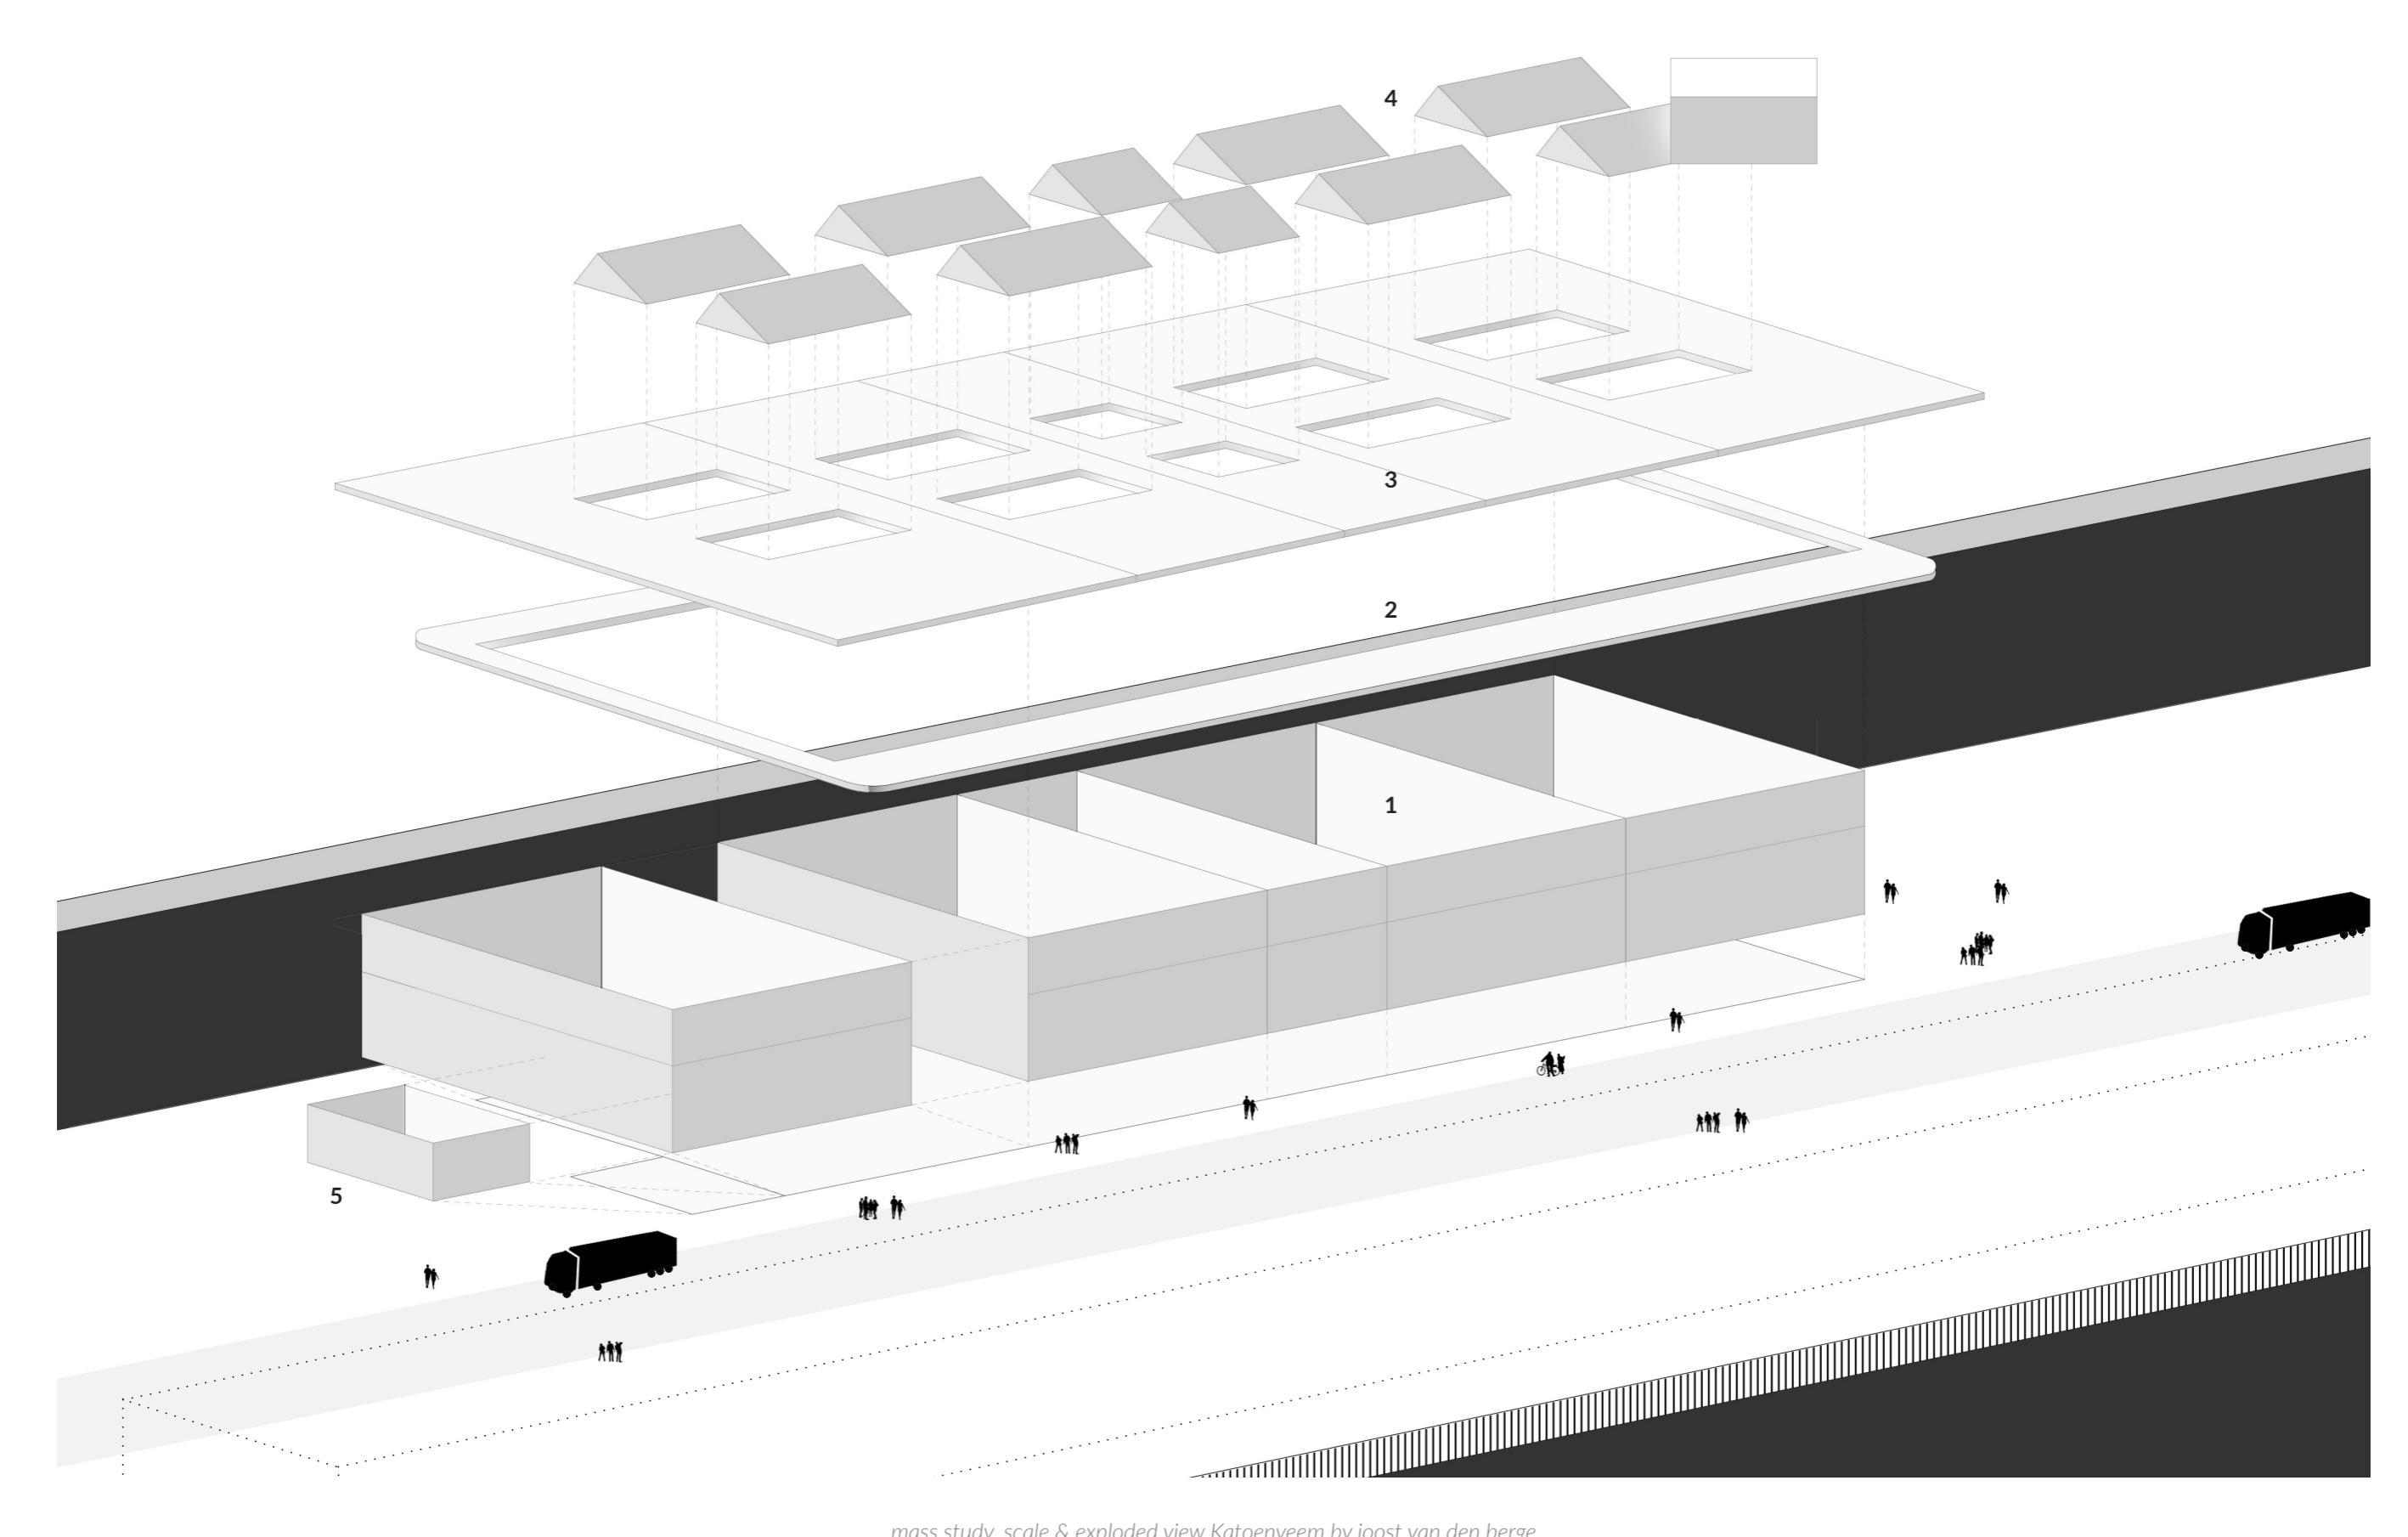
mass study, scale & exploded view Katoenveem by joost van den berge

When you would explode the building in it's main elements you could clearly see the five compartments (1), the gallery as one element (2), the roof, also cut up in five pieces, with holes for skylights (3) and the skylights themselves (4). Last but not least; some smaller volumes are built against the main structure (5) as you can see on the left of the illustration

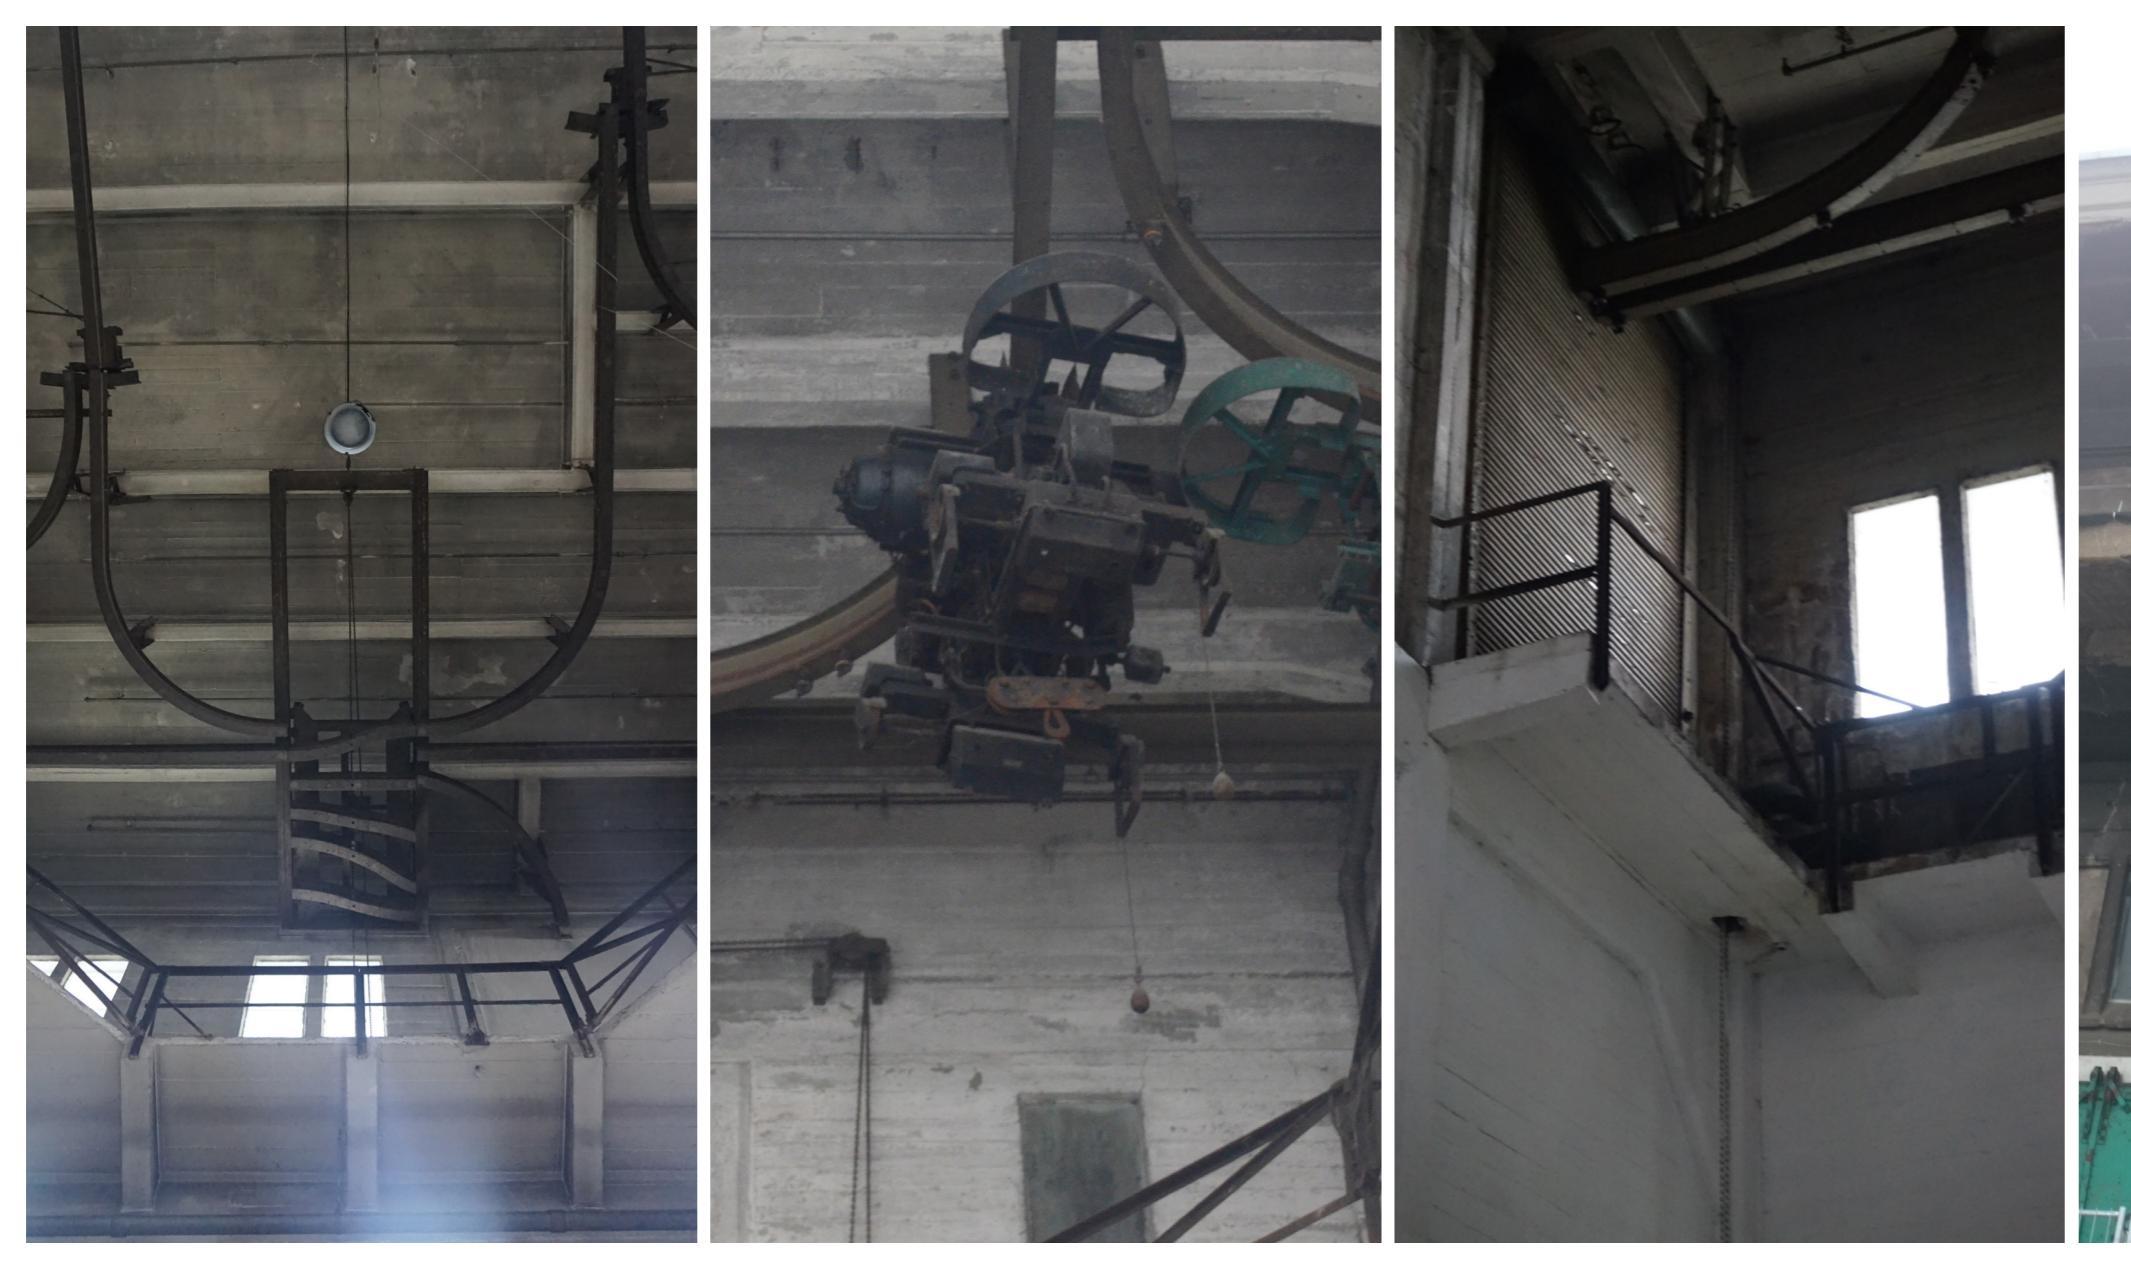
illustration 2,3,4&5 by Elmer (source: personal photographs)

These images show the conveyor system as it currently is in the Katoenveem. The second image shows a actual traveller of which several still remain inside the building. These travellers were powered via electrical cables that ran underneath the I-beams. In most places this electrical system is no longer in place. However the I-beams themselves are still in the original place.

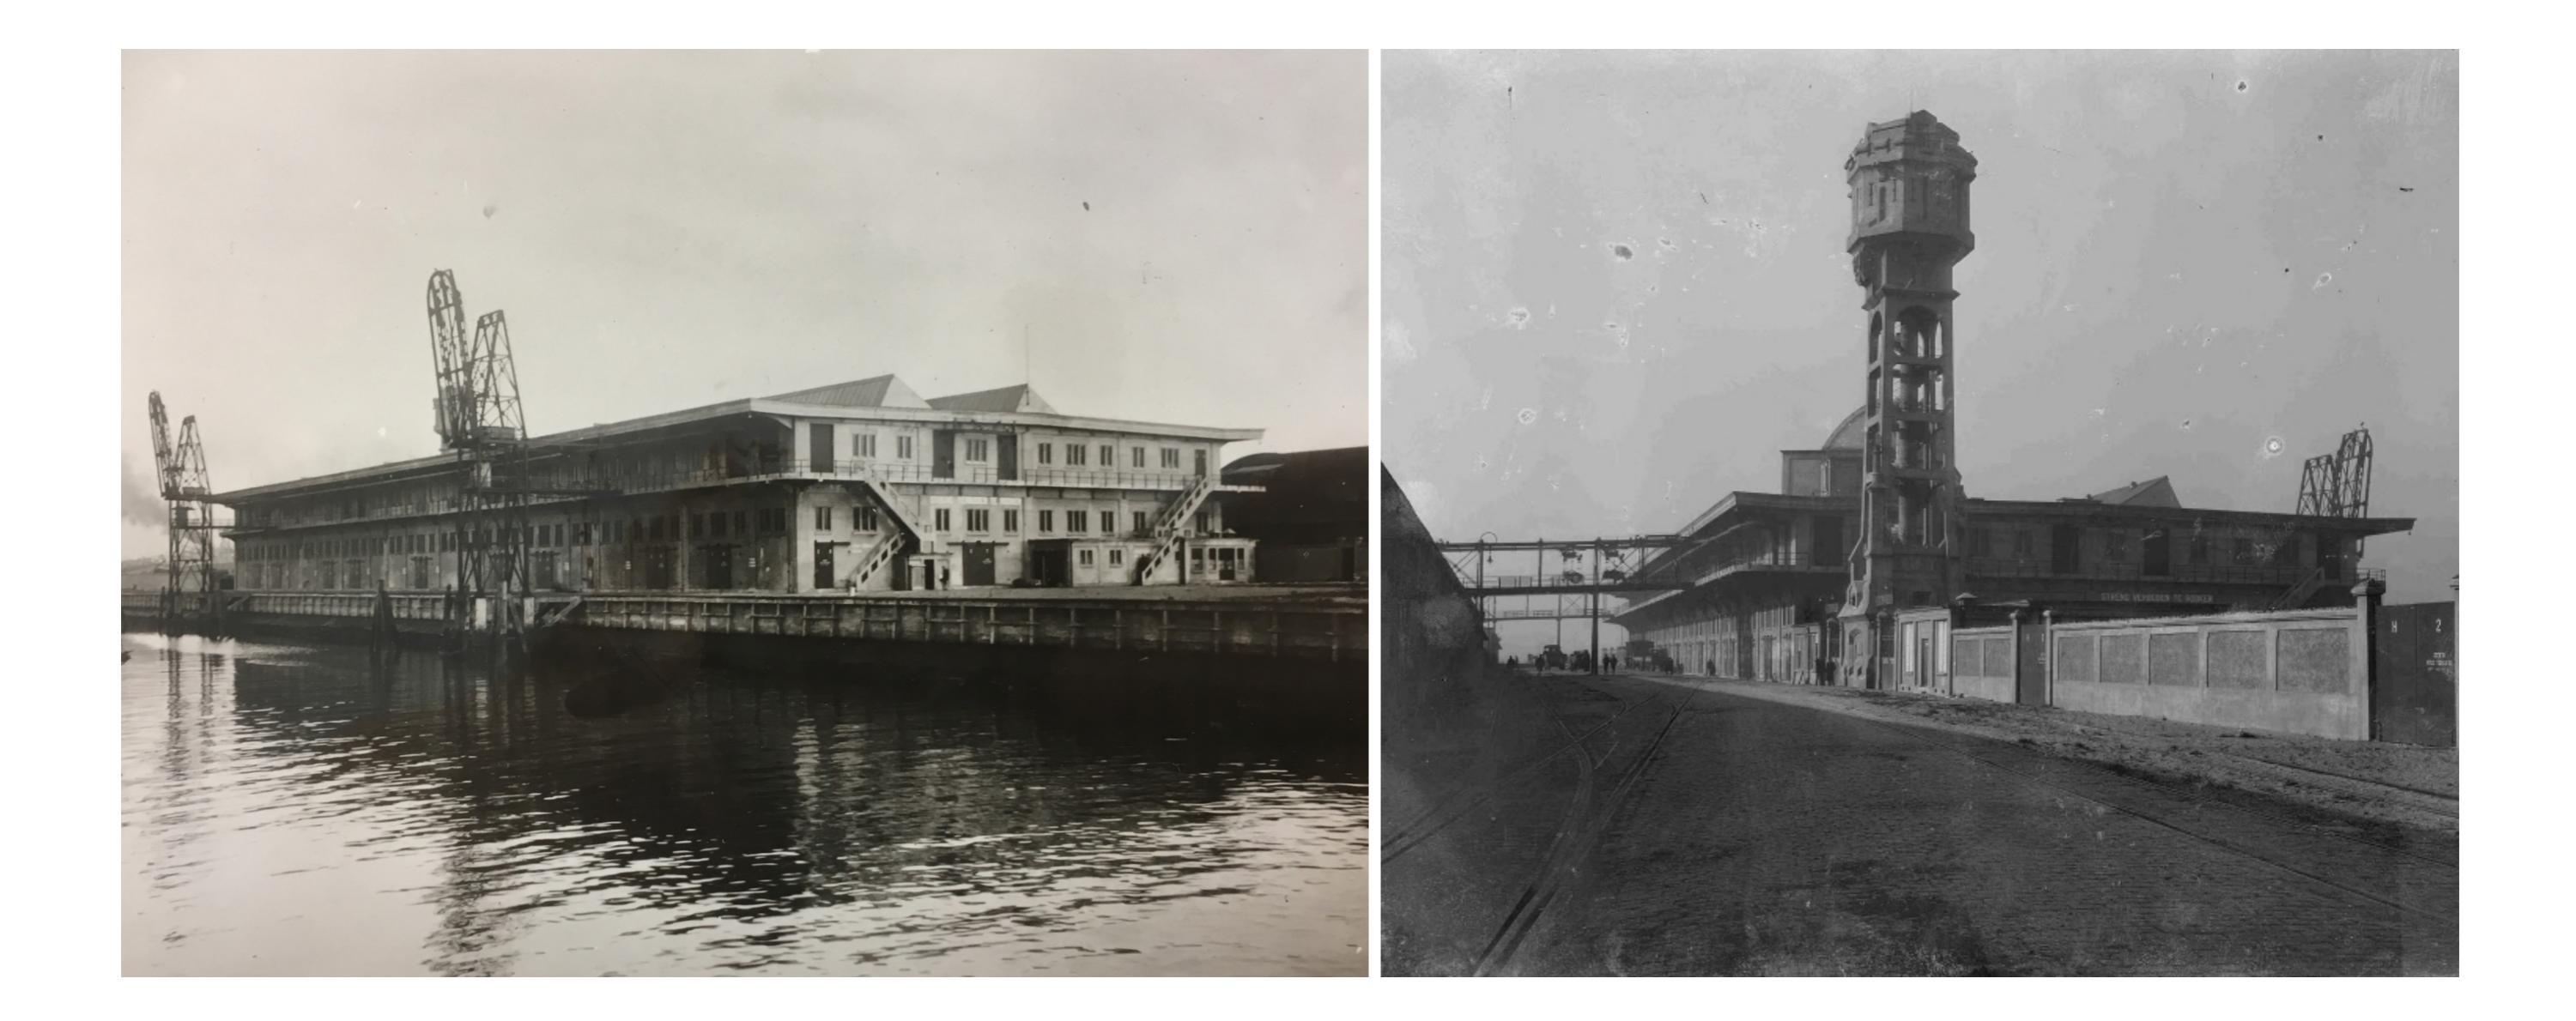
Photographs showing the original state of the conveyor system (Images owned by Municipal Archive Rotterdam)

On the next page, two original photograph taken shortly after completion in 1920, show the original state of the conveyor system.

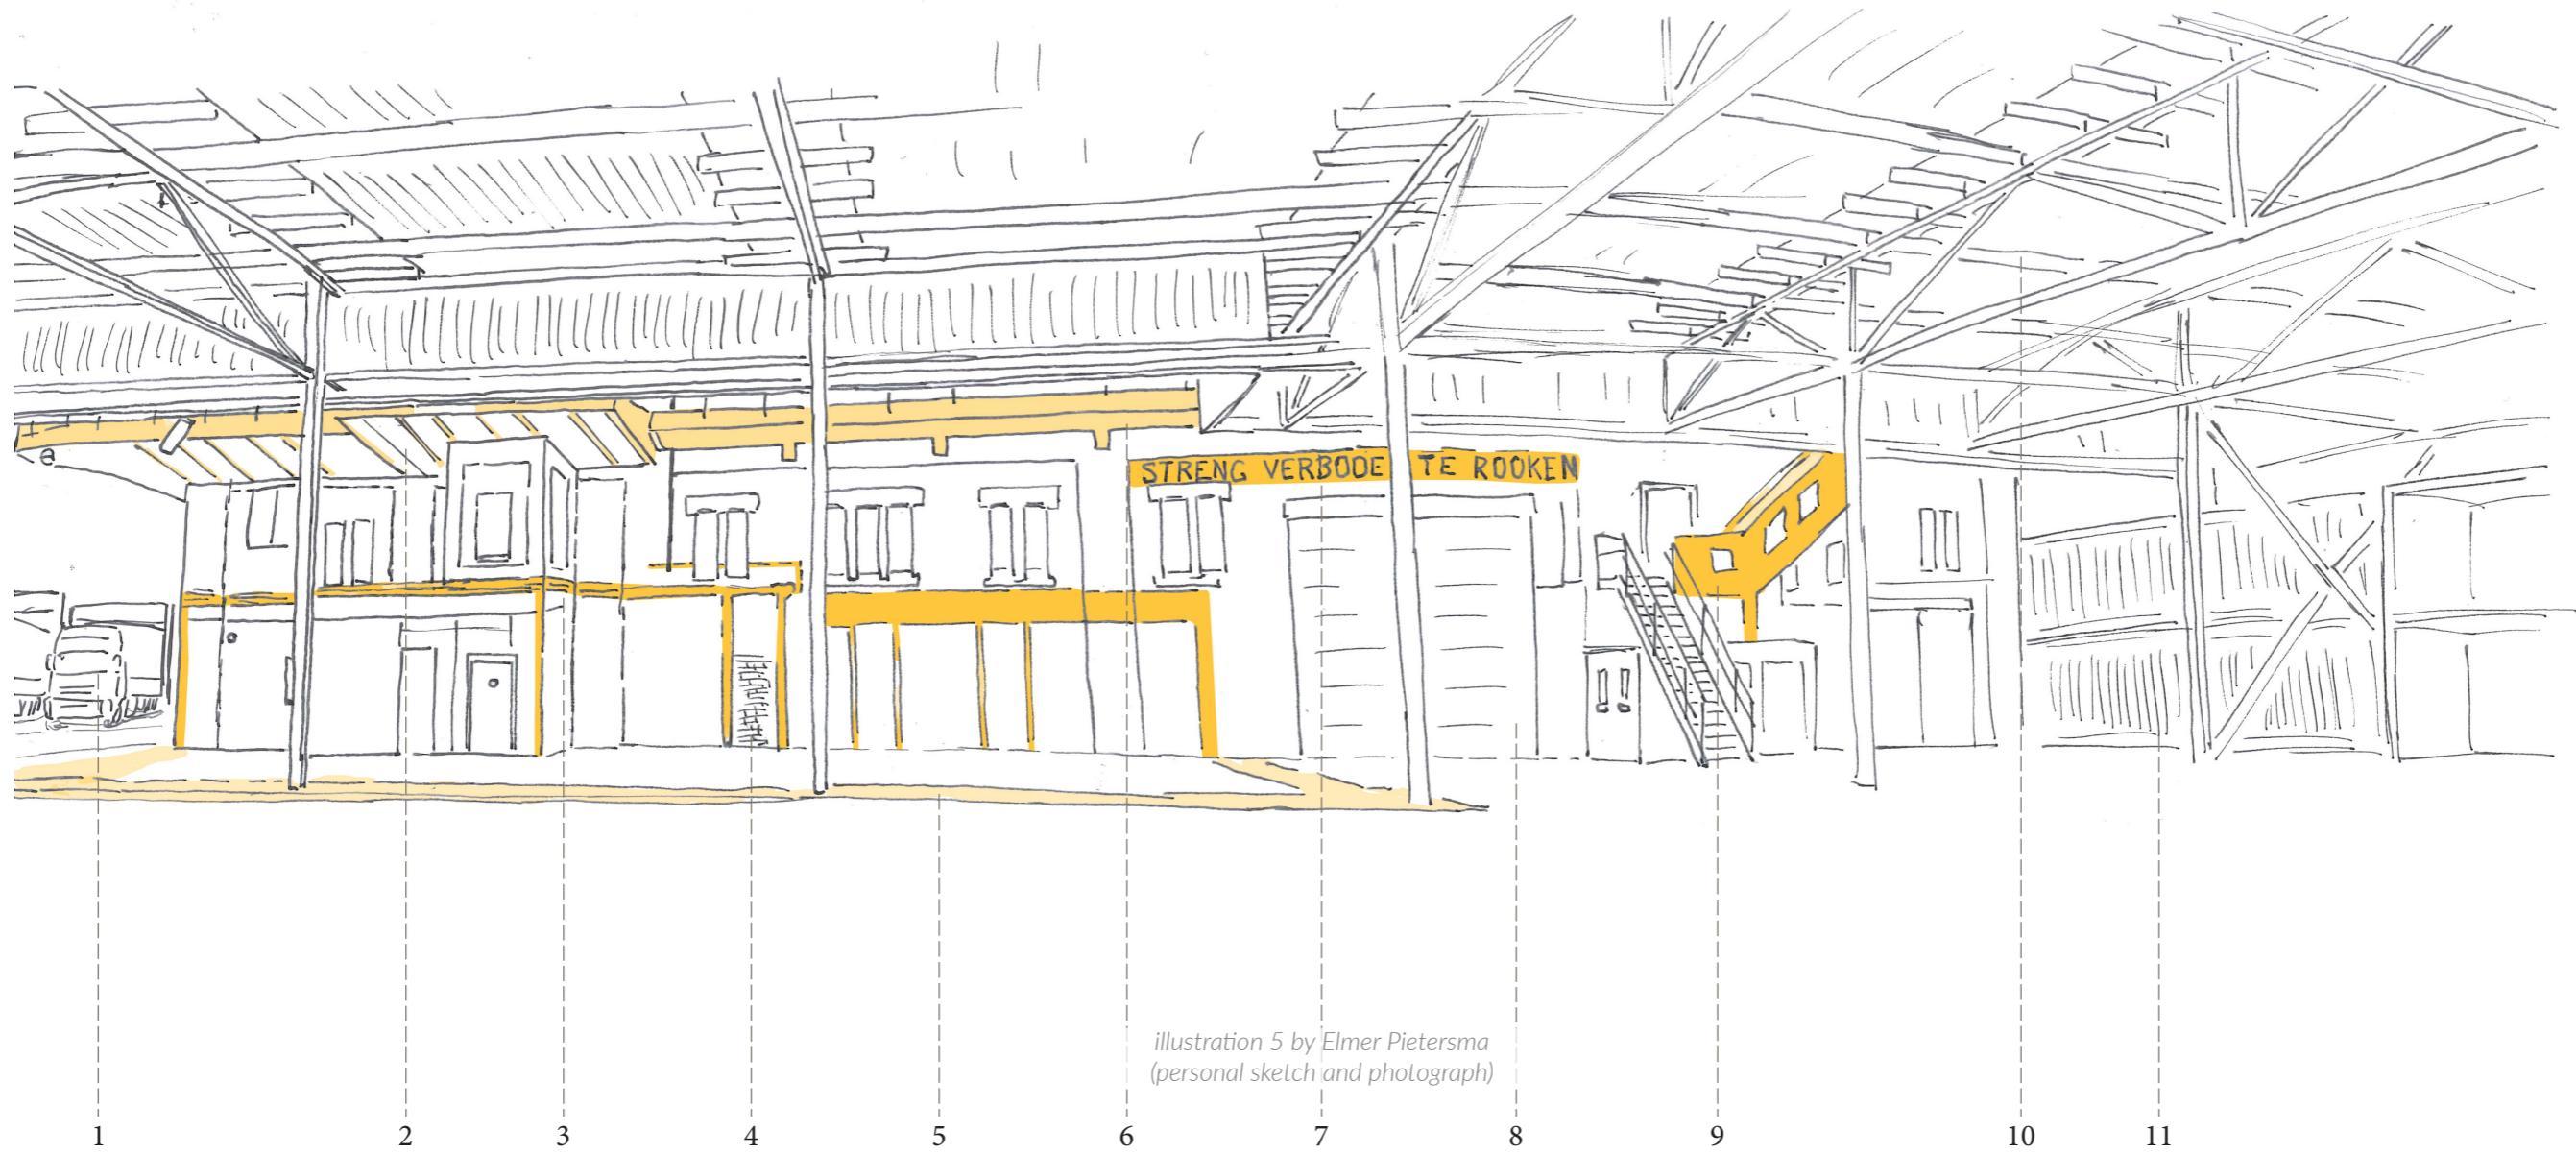
KATOENVEEM - MAIN ENTRANCE

At number nine, one of the original concrete stairs is visible. It is in a very bad shape, the bottom part has already been replaced by a new, metal staircase.

- 1. Fruit transshipment warehouse
- 2. Traces of boarding that used to protect the skin
- 3. Traces of the removed directors office
- 4. Bricked up entrance
- 5. Traces of the removed directors office
- 6. Still present white boarding to protect the skin
- 7. Original warning against smoking
- 8. Roller door giving acces to the warehouse
- 9. Original but broken, concrete stairs.
- 10. Metal roofing added in 1991
- 11. Shipping containers blocking the view to the har-

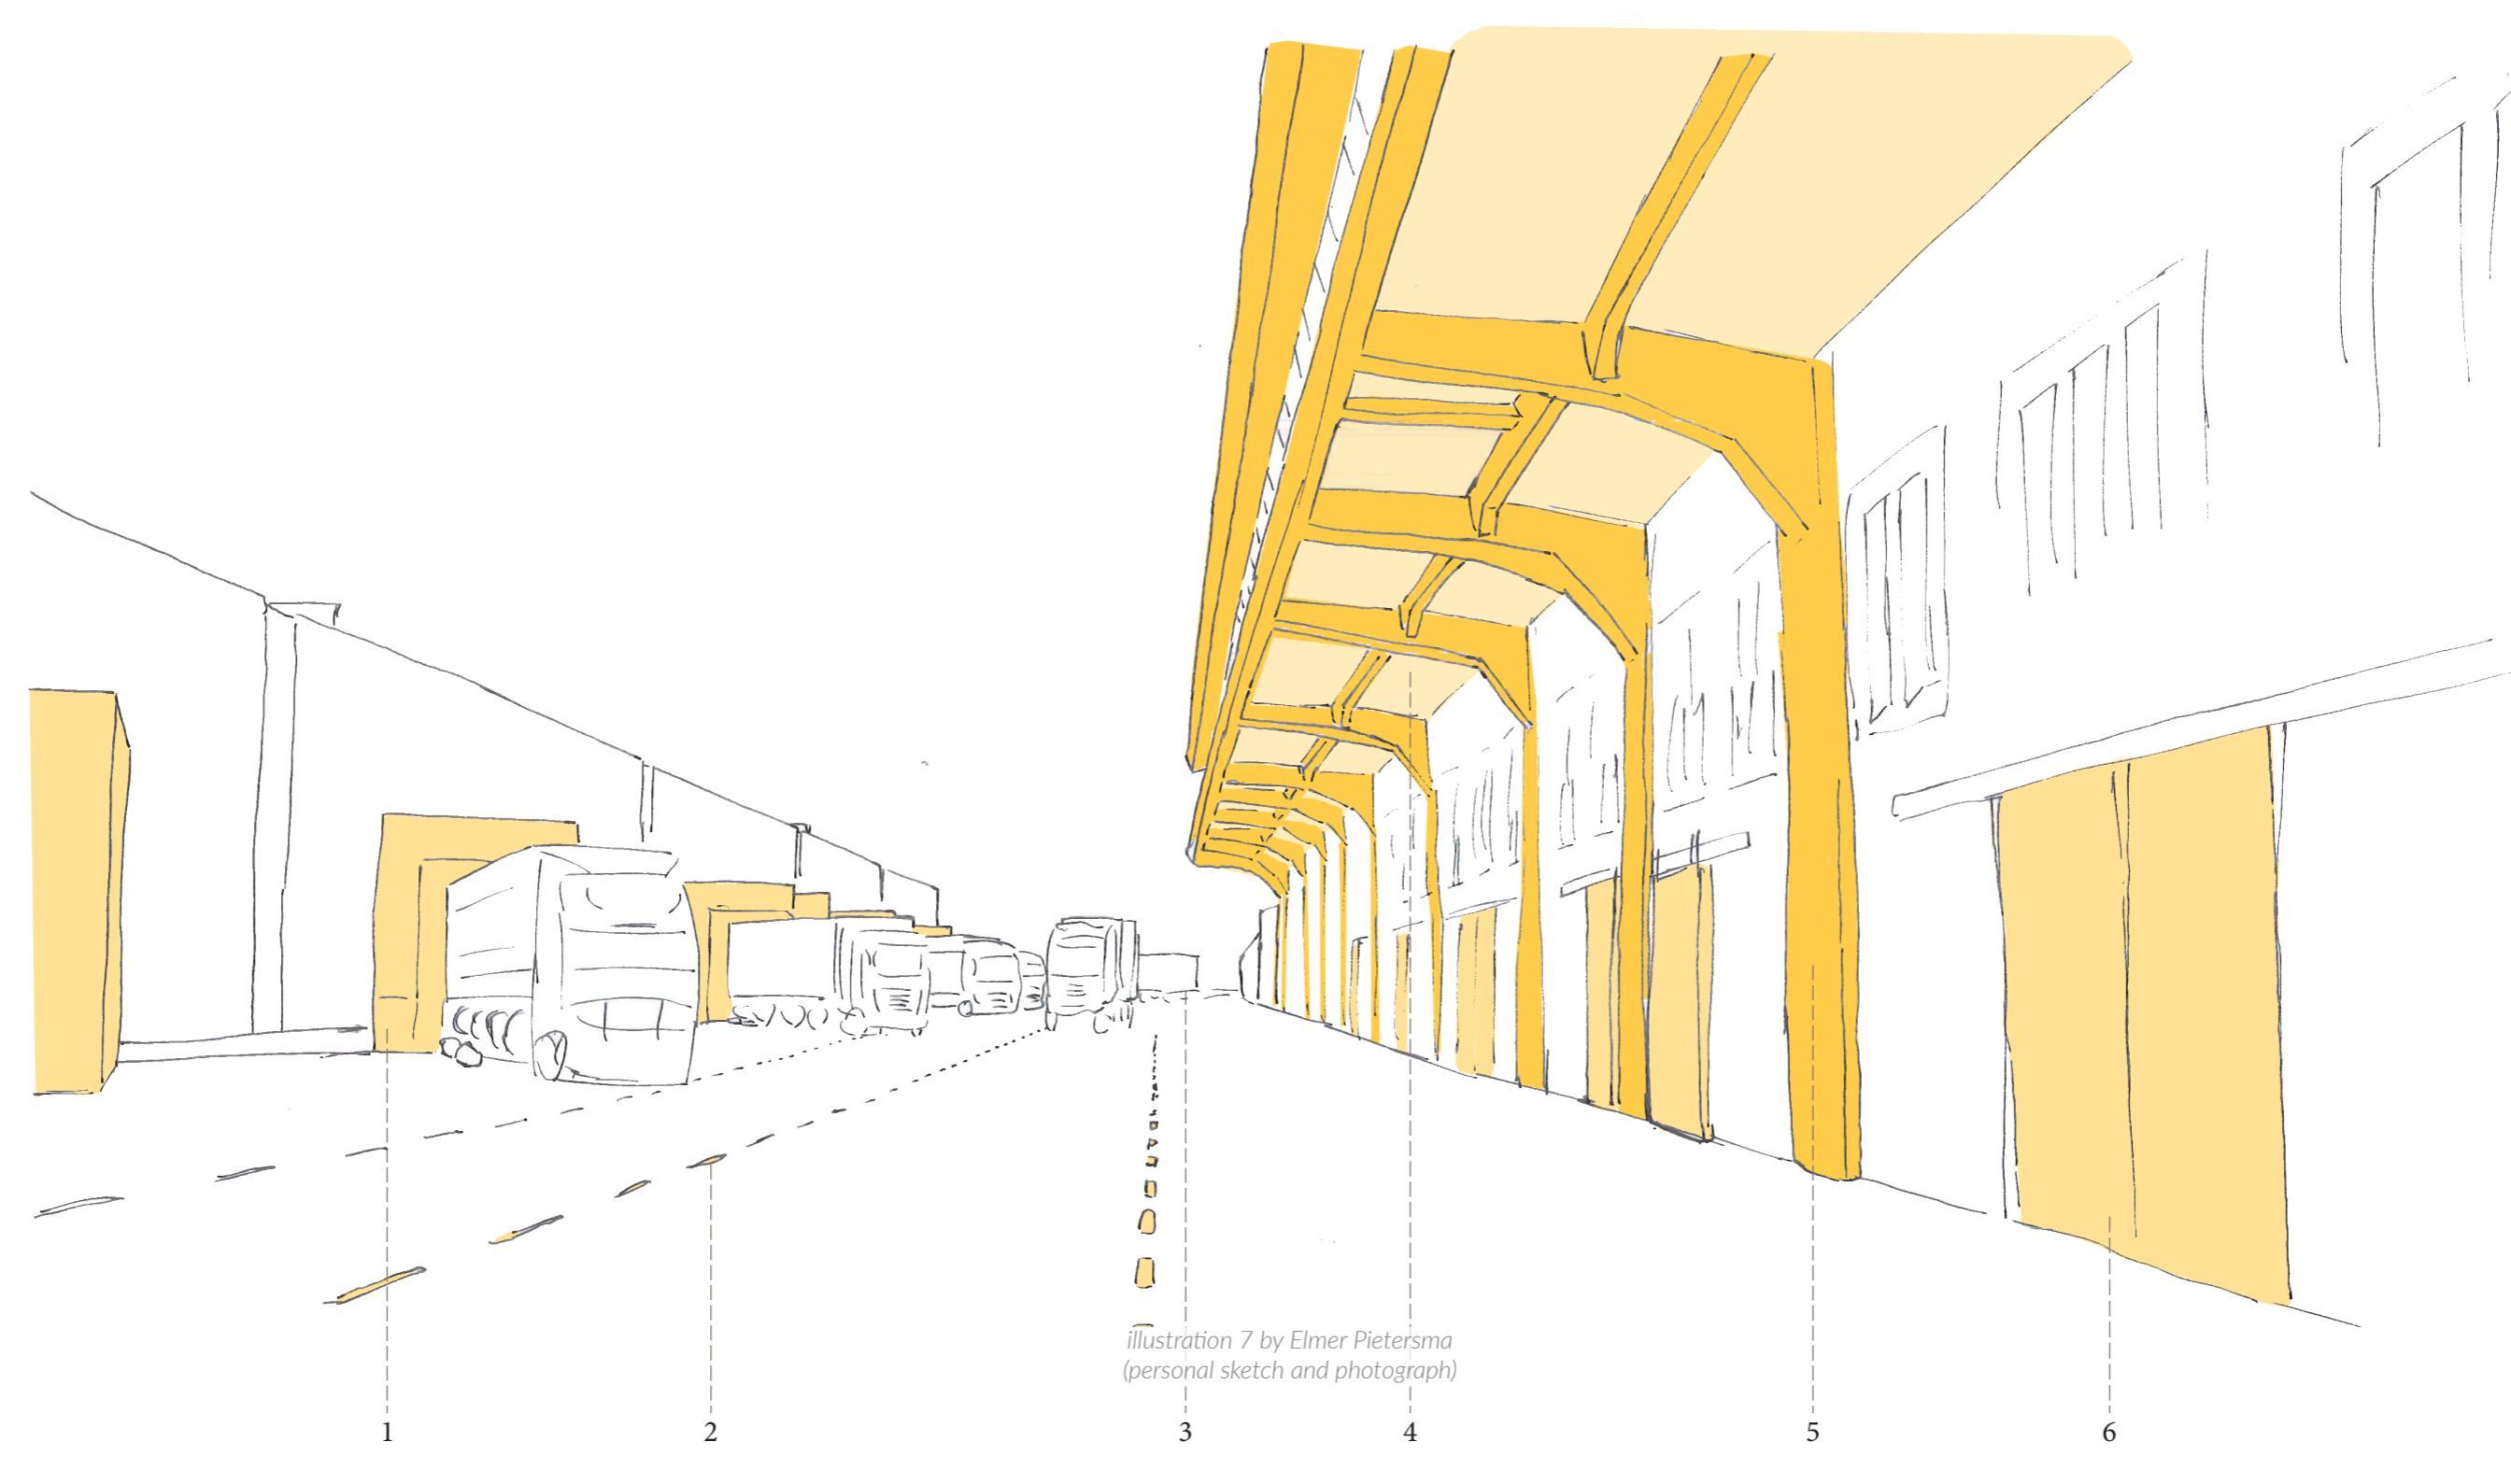
KEILEWEG 3

The balcony of the Katoenveem is now seen from below, showing it's slimming structure. The function and hidden treasures of this balcony are discussed in a later chapter. The current state of this balcony is very poor; it is due to the degradation of this balcony and especially the falling off of concrete is the reason this building is no longer safe to use. As a safety measure netting has been added along the entire underside of the balcony.

The yellowed sliding doors on the right side, are the original metal doors that were installed nearly a hundred years ago. Although they show clear signs of rust they are in relatively good state.

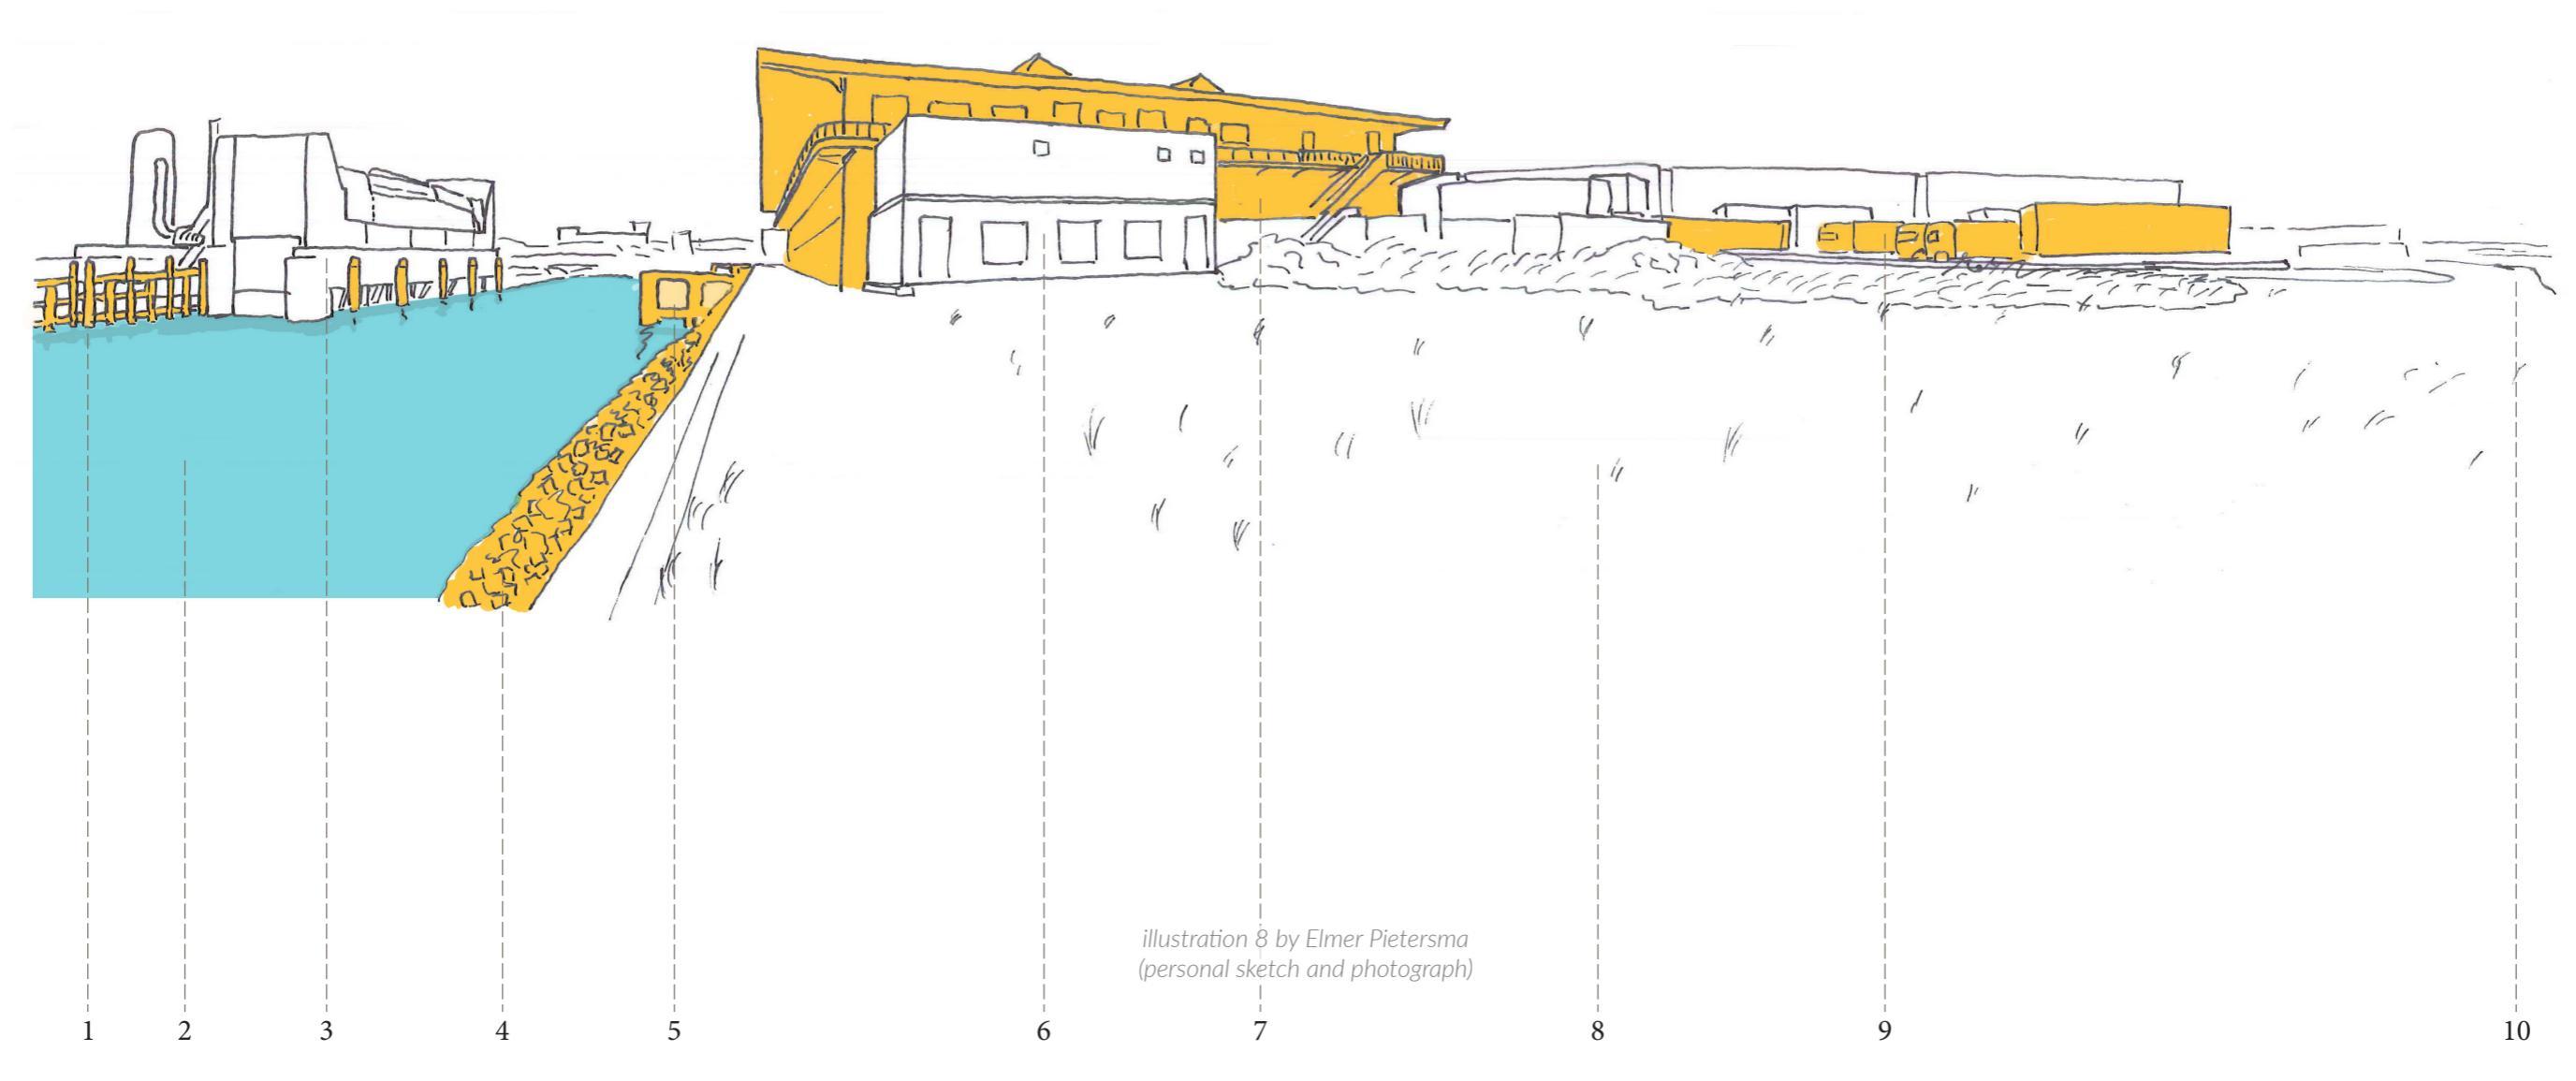
END OF THE PIER

At five, the original foundation of the two cranes is visible. This is the position of the dismantled cranes that used to connect the interior conveyor system to the ships that docked next to the building (more on that later).

- 1. Wooden posts to guide the ships
- 2. The Keilehaven
- 3. Industrial ship cleaning facility
- 4. Breakwater
- 5. Foundation of the demolished cranes
- 6. Derelict barracks and containers
- 7. Katoenveem
- 8. Empty grass field
- 9. Fruit transshipment warehouse
