KATOENVEEM

MSc III Heritage & Architecture

Architectural & Building Technology Analysis Lidy Meijers - Bas Gremmen - Nicholas

07/04/2017

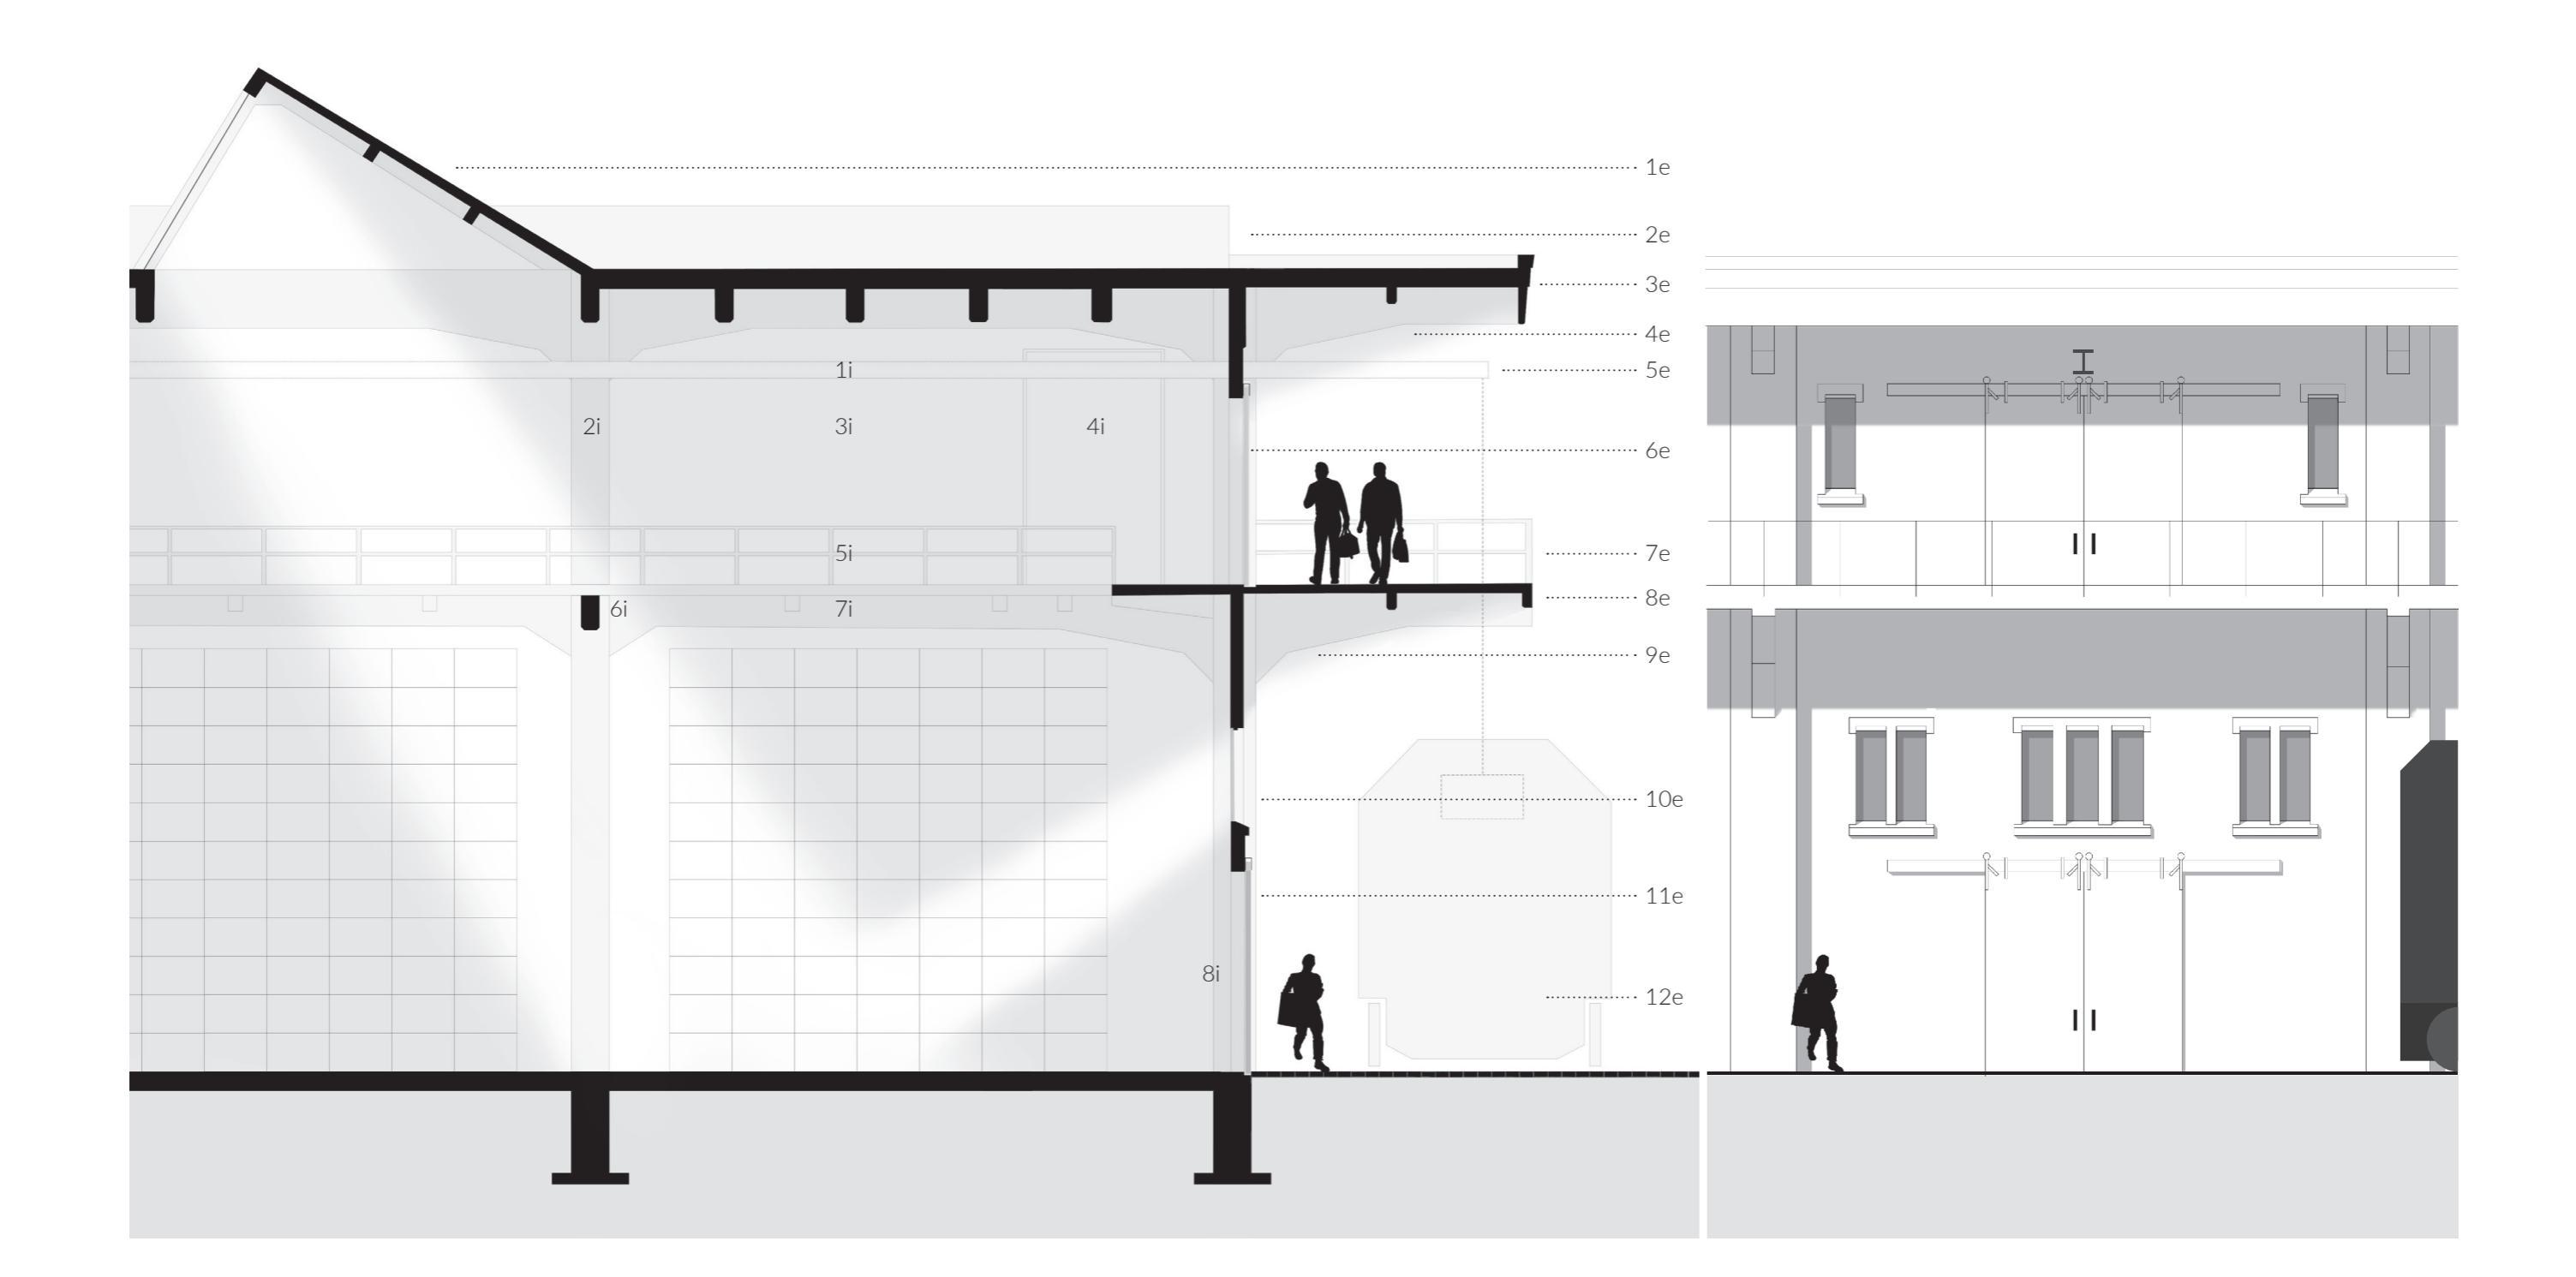
Katoenveem facade section & elevation 1:100 by joost van den Berge

exterior: 1. steel railtrack for easy transshipment of cotton bales - 2. large in situ concrete columns with paint finishing from ground floor till 2 meters above ground- 3. concrete in situ seperation walls without finishing (traces timber casings still visible) - 4. Kinnear iron curtain doors/roller doors - 5. iron balustrade - 6. in situ concrete beams which connect columns and walls - 7. concrete in situ gallery's supported by small in situ concrete beams - 8. steel double sliding door suspended from a steel railing

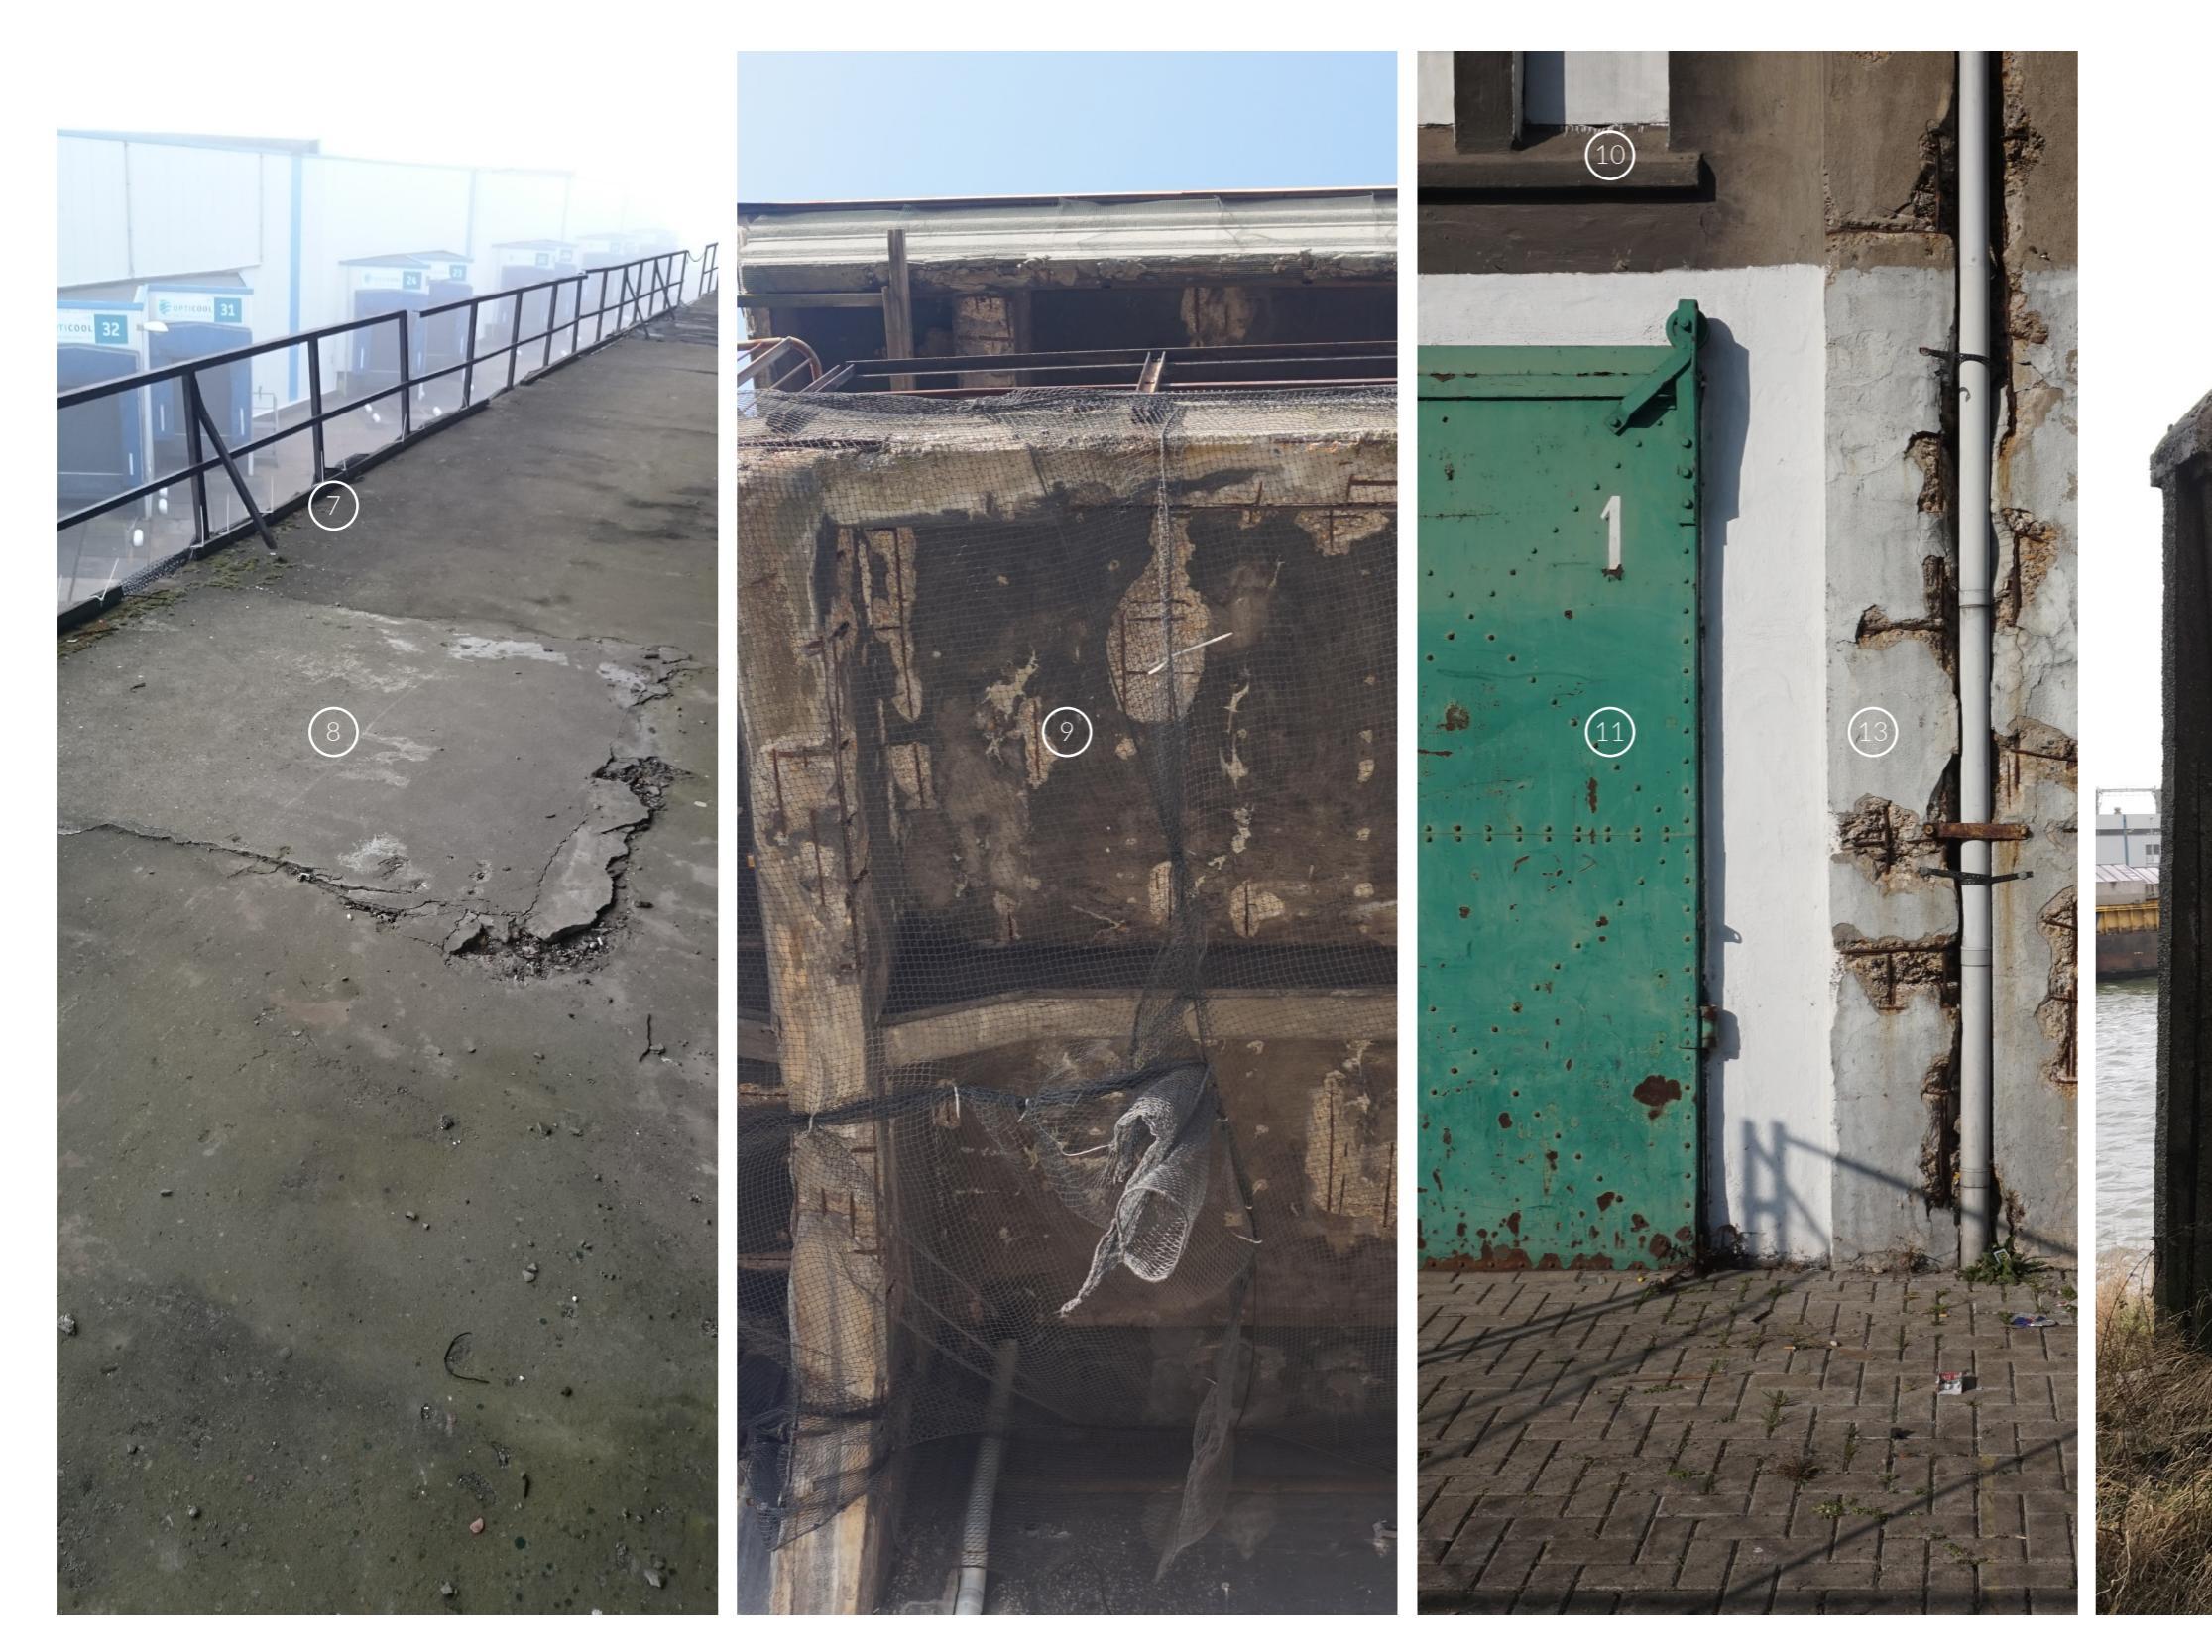
materialisation exterior and main elements by joost van den berge

7. here you can see the steel balustrade on the gallery and the bad state it is in. The balustrade is extremely weathered and damaged and some parts are even gone or destroyed - 8. at no. 8 you can see traces of the former holes in the gallery - 9. here you can see the bottom of the gallery with it's supporting beams and the reinforcement in the concrete. Clearly it has weathered in great measure and at several places the sand cement layer has come of. Next to that you can still see the black/greyish soot layer at many points derived from the industry, ships but mainly the trains that used to drive underneath the gallery's. - 10. the window sill and the window itself is visible at no. 10, also constructed in concrete (more about this on the next pages) - 11. here is one of the many green finished steel sliding doors of the American Kinnear system visible. They have many traces of damage and rust but are still in quite a good state - 13. here you can see the dilatation and a water drain between the different building volumes with extreme damages and rust - 14. in the last picture you can see the small part that is left of the former enclosing wall of the site with the same concrete structure as the Katoenveem building

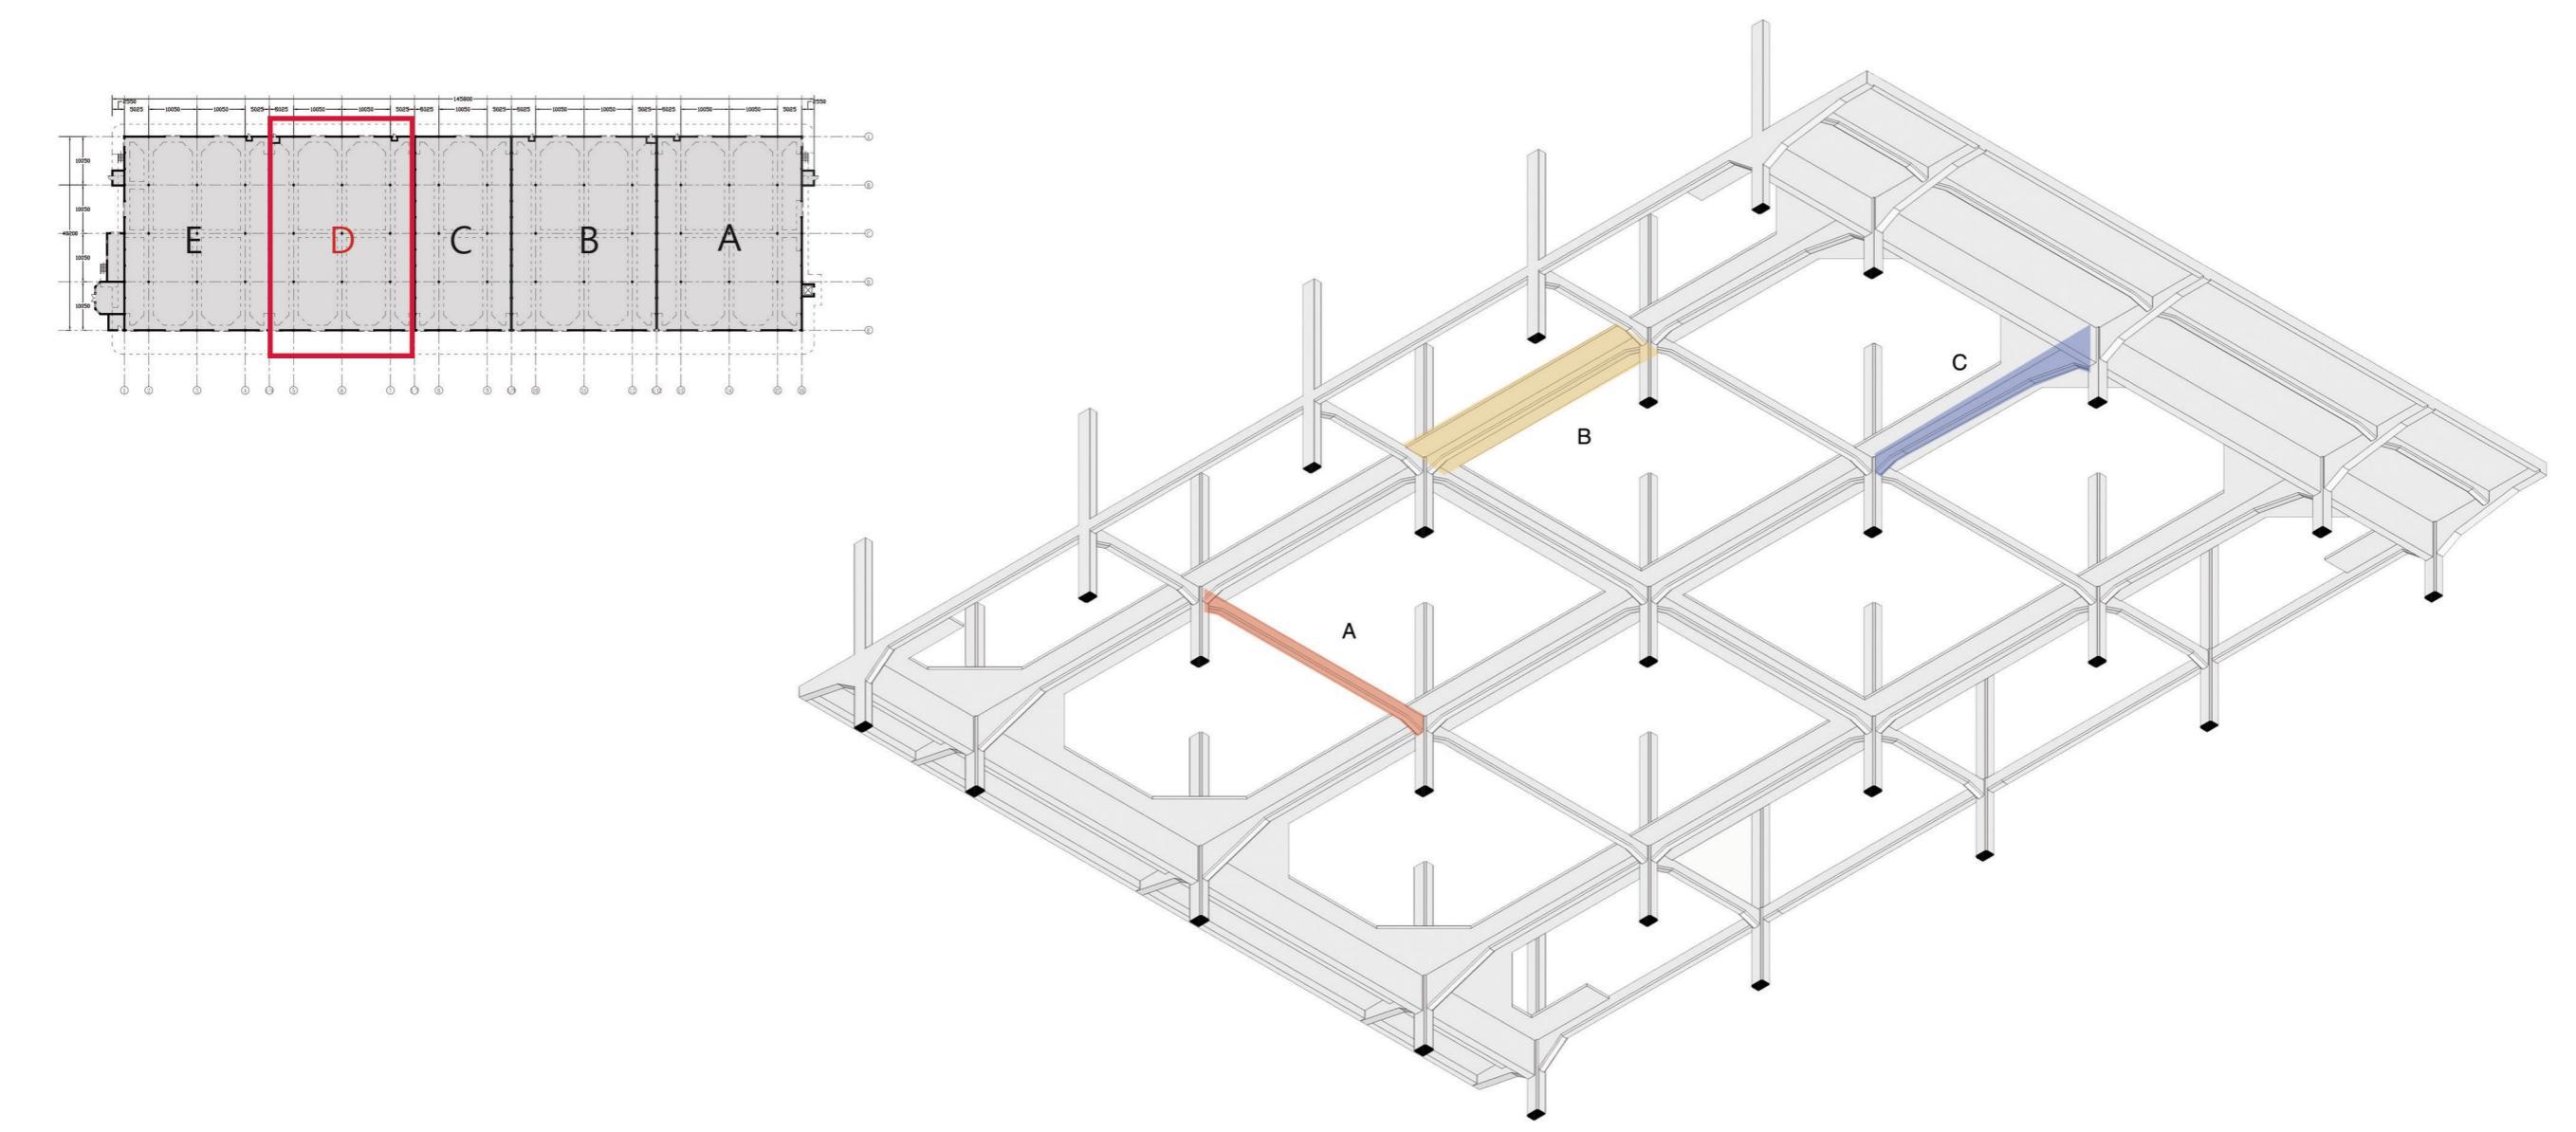
upward axnometric view of 1F structure

The third one is the beams with a slope top surface. This is presumably done to prevent that it could be walked on the beam to the other side of the void for safety reasons.¹ We suggest that it it can also prevent dust to some

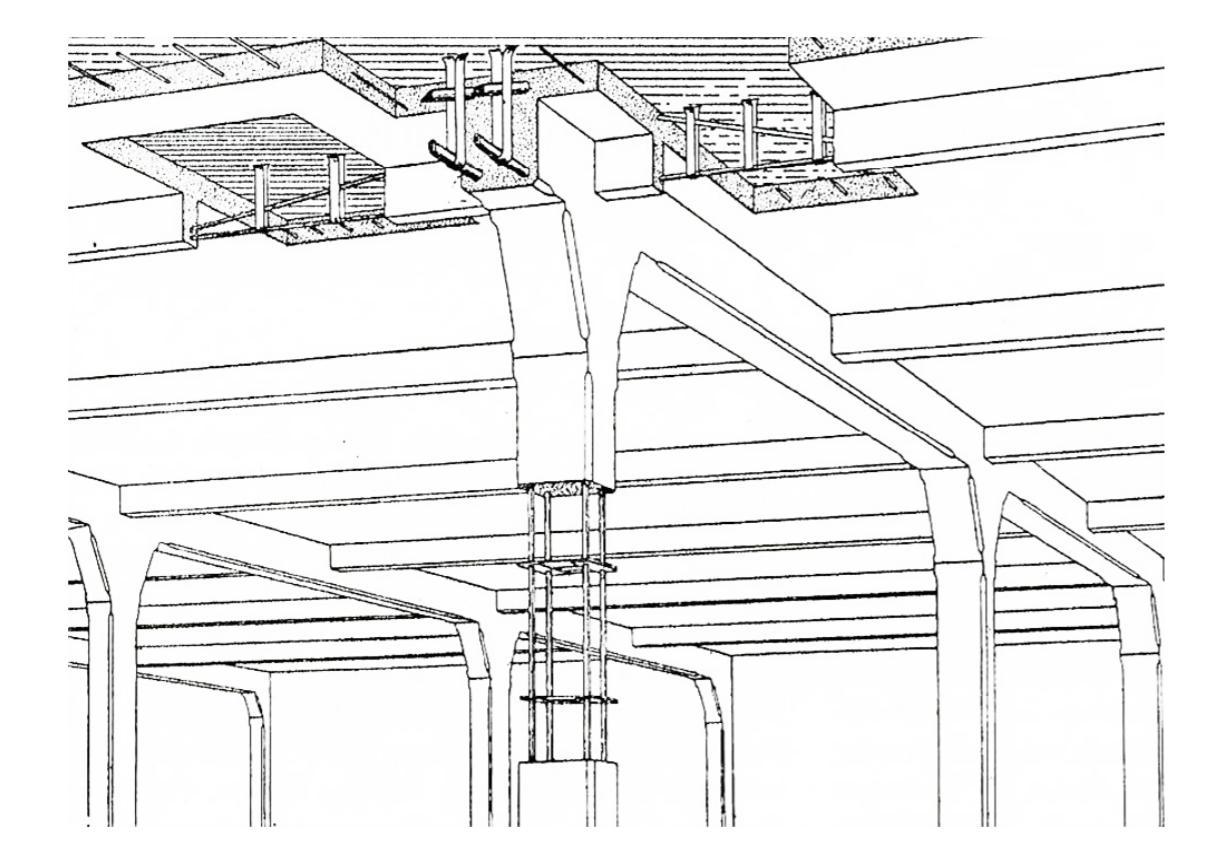
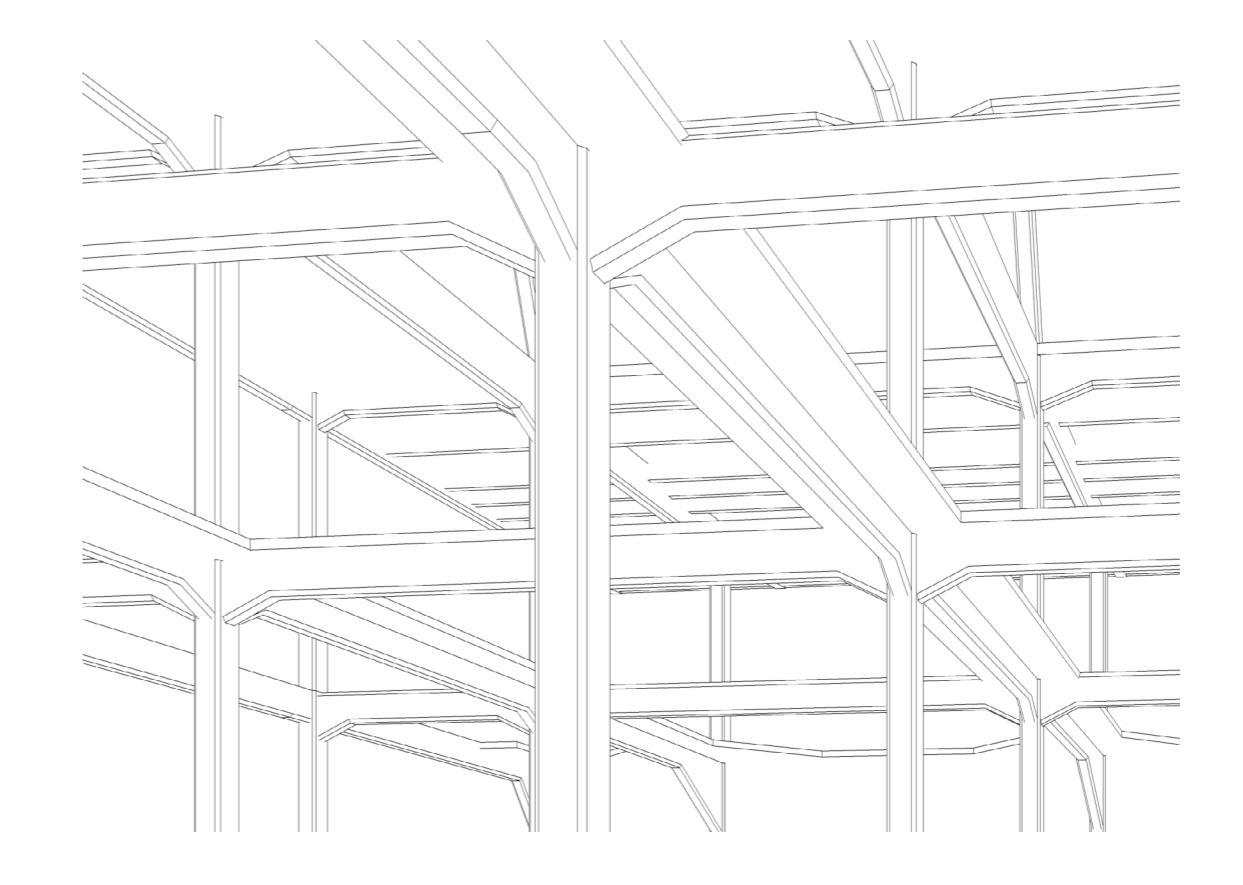
Hennebique System 3 by Jan Huis in 't Veld (Radfords encyclopedia of construction - Volume 6: Concrete Construction)

foundation of the Katoenveem. The system of the columns in the Hennebique system and the Katoenveem appear to be similar. In certain damaged parts of the Katoenveem the structure was visible. Additionally the construction photograph of the Katoenveem shows a resemblance with the Hennebique system column (illustration 2).

We can conclude that the Katoenveem has an Hennebique-like system that constitutes the entire construction. The complete construction; foundation, floors, beams, columns and the roof, is interconnected through the reinforcement of the steal. Certain elements of the Katoenveem bear a striking resemblance to the Hennebique system, where as other elements have been altered to fit the specific building.

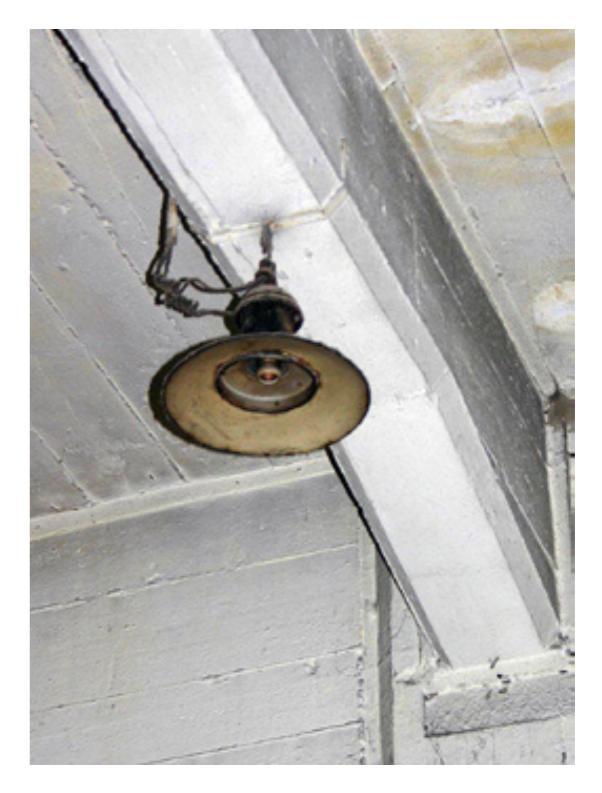
fig3. Fixed light

It is worth mentioning that the fixed lights shown in the Building Report does not exist in the building anymore, while the moveable lights can be found in every halls. With the two kinds of lights, the storage and transportation of cotton was operatable when the natural lighting was not enough.

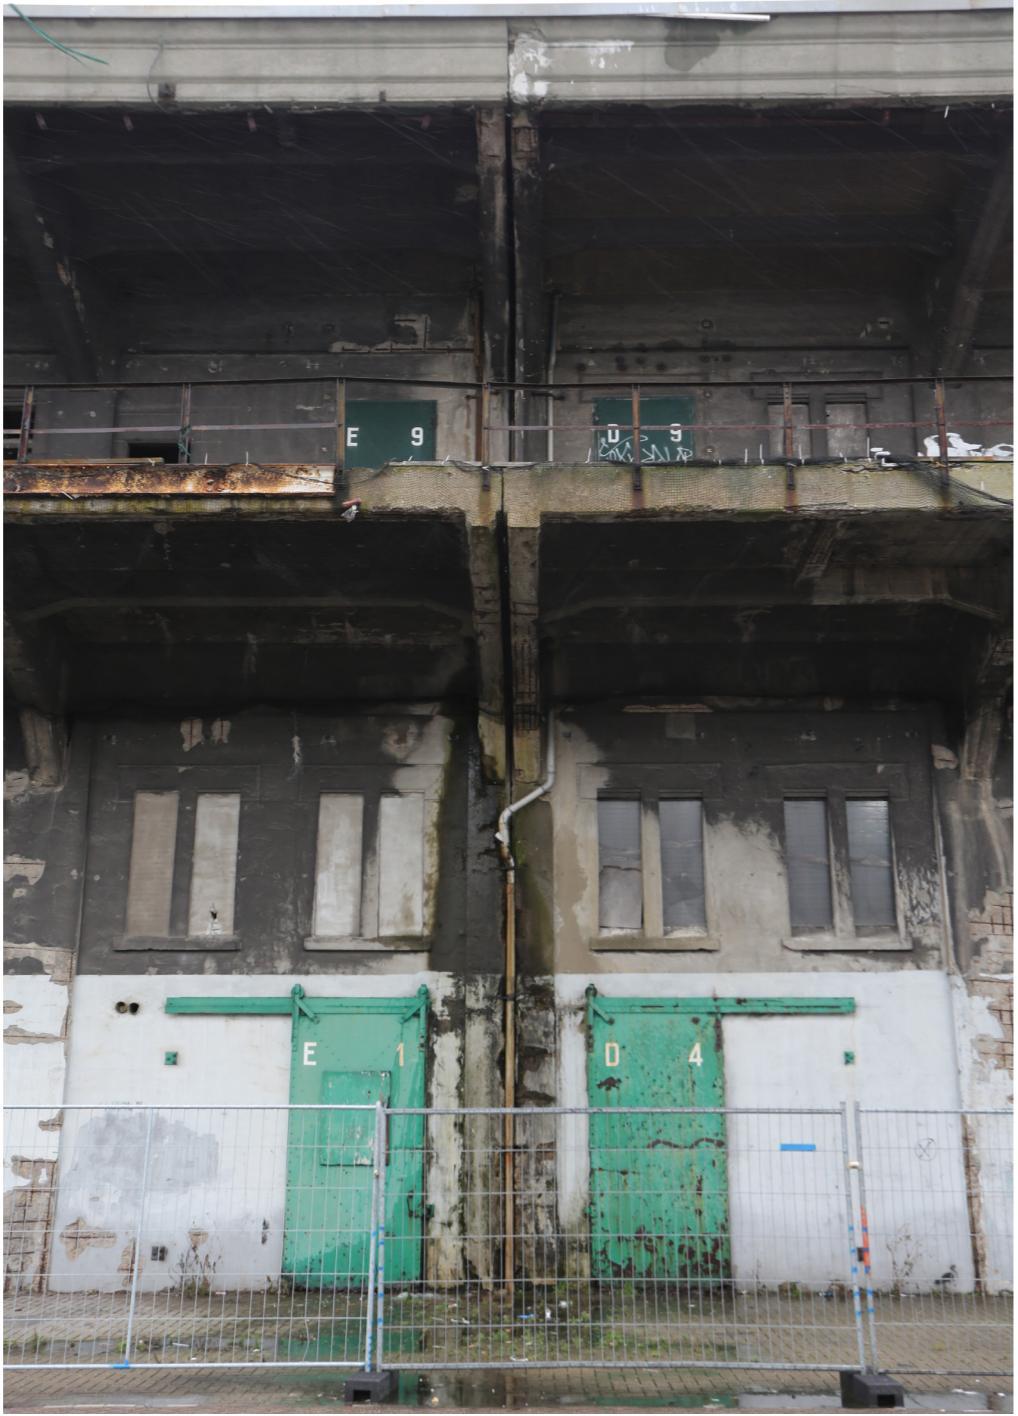
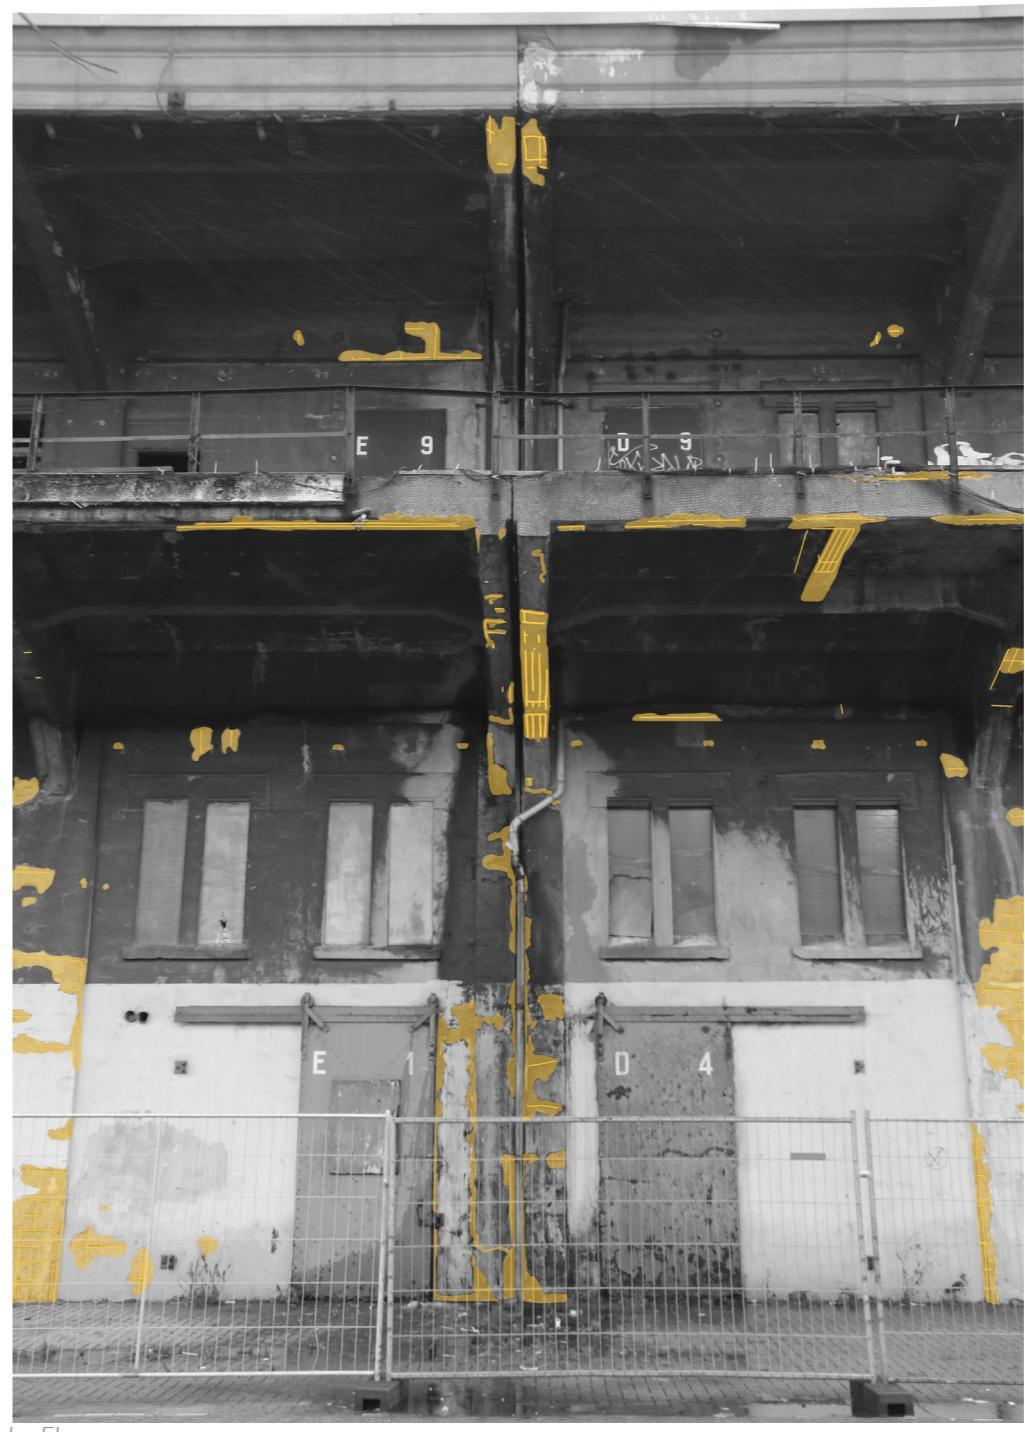
illustration 1&2 by Elmer (source: personal sketch and photo)

DAMAGED CONCRETE

First up is the visual damage, as can be seen when visiting the building. On the right image above, the yellow represents the damage to the concrete.

The source of this damage becomes clear at some point, the bright yellow shows this. This is where the metal reinforcement has been laid bare and is rusting away. The reason this happened is probably because the covering of the concrete that is supposed to protect the reinforcement has been to shallow; allowing the metal to come in contact with water and to start rusting. As rust takes up more space than the iron it comes from, pressure is created. This pressure builds until the concrete cover cannot hold it any longer and breaks, leading to cracks originating at the reinforcement, as seen above here.

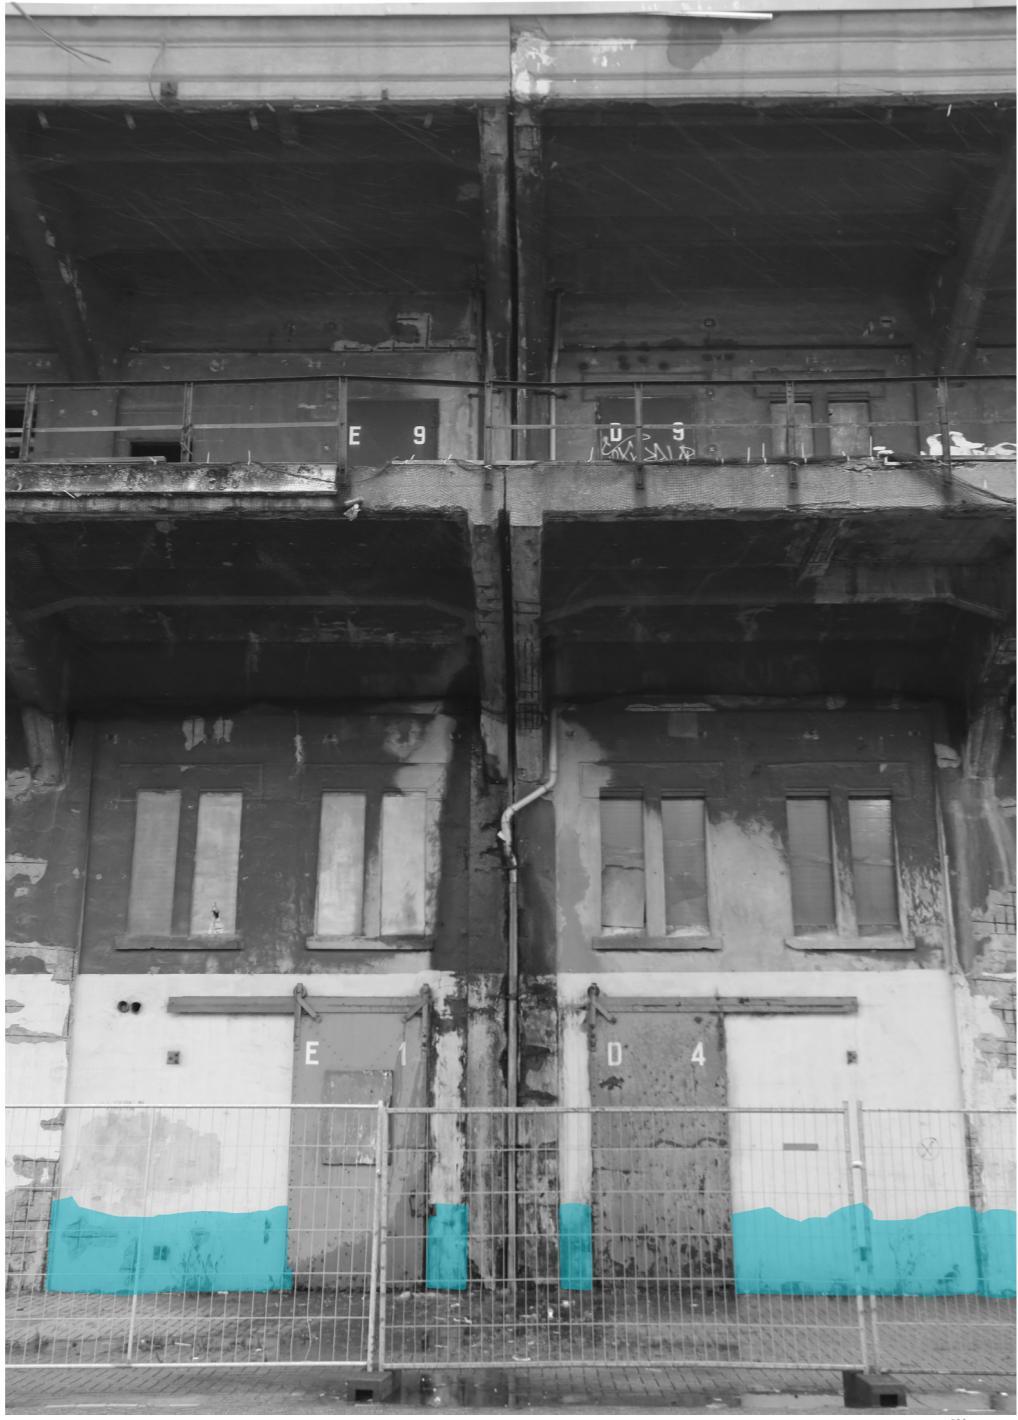
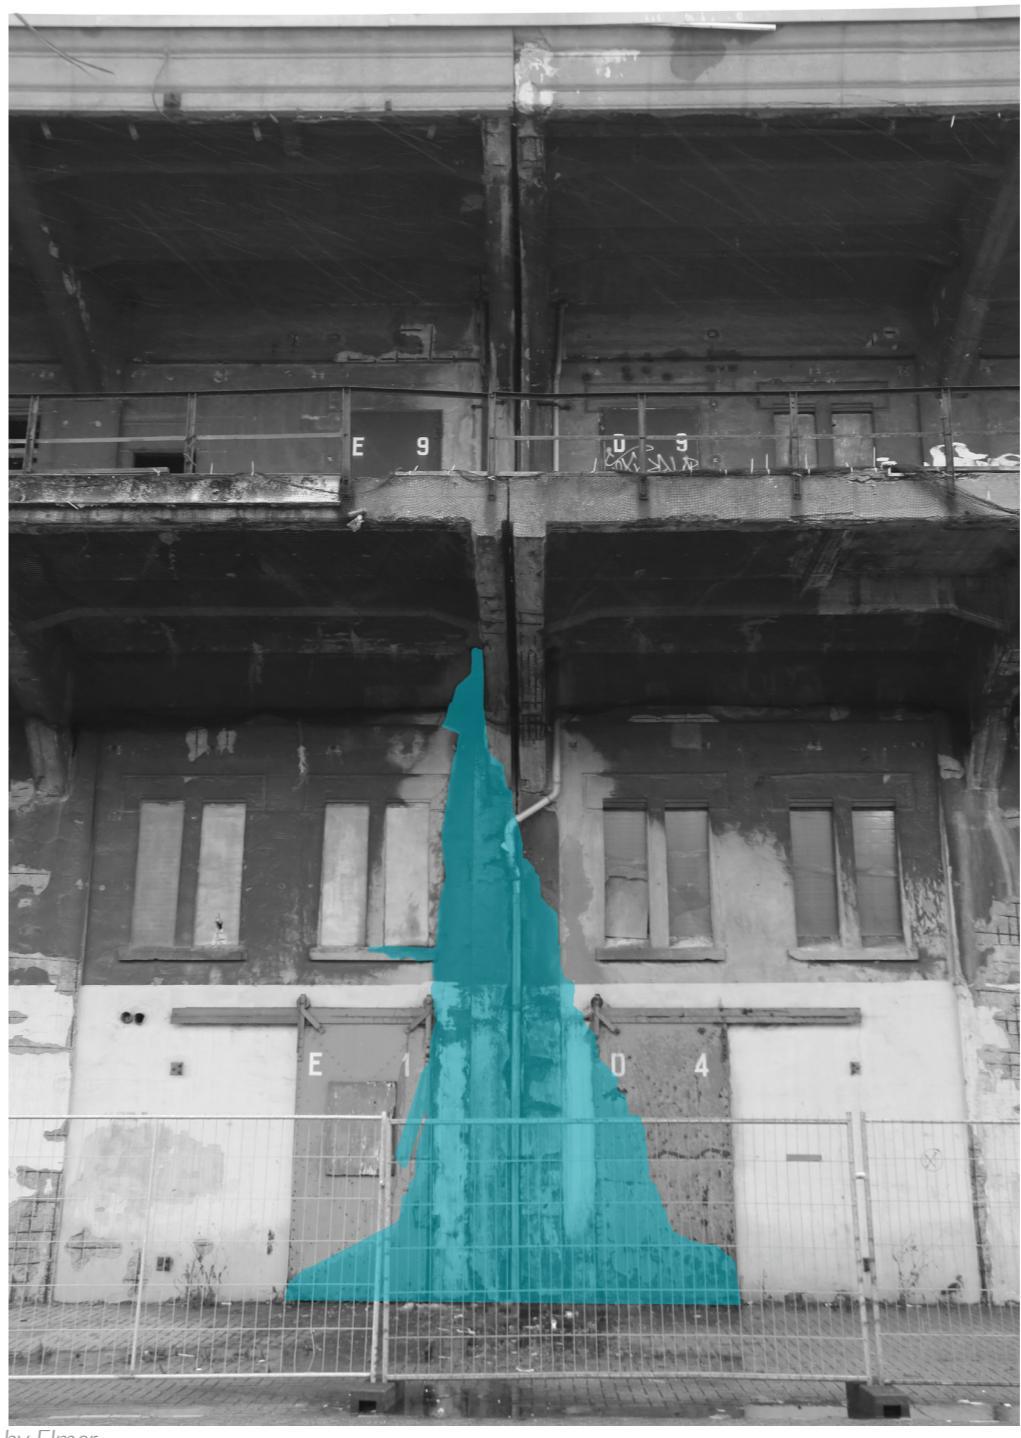
illustration 3&4 by Elmer (source: personal sketch and photo)

SPALLING DAMAGE

Rusted reinforcement Spalling damage caused by rusted iron

The major damage to the facade is caused by spalling, as discussed by on the previous page. This phenomena is caused by water coming in contact with the reinforcement, causing it to rust. The water that causes this comes from three sources in this situation: directly from the sky in precipitation, in splashing from the street and from leakage in the drainage system. A fourth source could be noted, the salt water spray that comes from the river. The effects of precipitation are difficult to single out as the area this affects has been painted white, the rest of the facade is shielded by the roof and balcony. Because of this we will focus mainly on the splash and leakage.

The splash water originates from the streets, when trucks ride past and cause the water lying on the street to splash up. This wetness is further increased by the precipitation and perhaps even rising damp from the soil.

The second major source is leakage, caused by broken

drainage pipes. This can be easily be fixed by replacing the broken pipes, but the effects can be devastating as seen in the image above here. The second image shows the traces of water as they were present there on the day of our visit. It was dry at the time of this picture, showing that a leakage such as this keeps a certain area wet for long periods than the rest of the building. The fact that the facade has been cleaned of the darkening soot (following page), shows that this leaks has been there for some time.

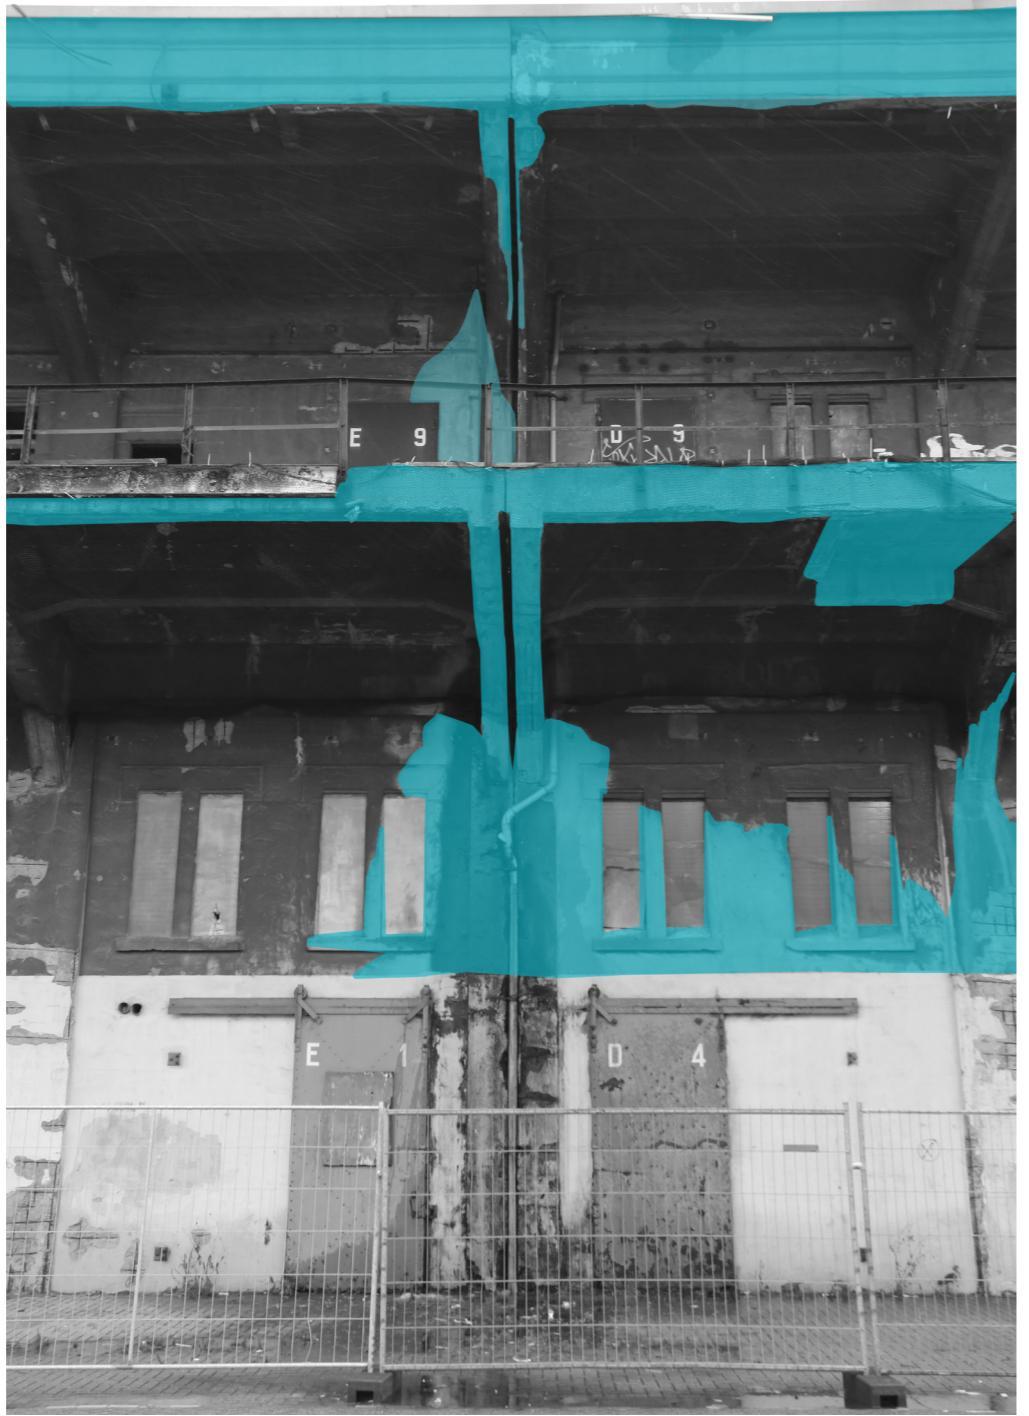
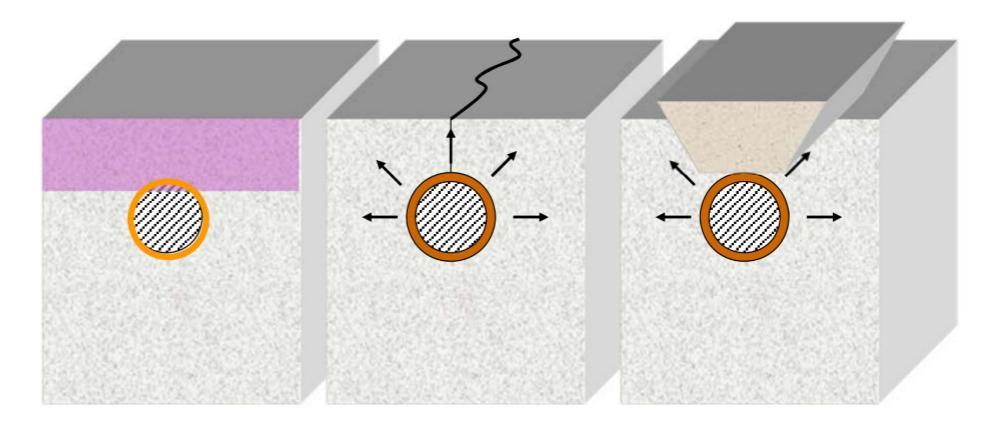
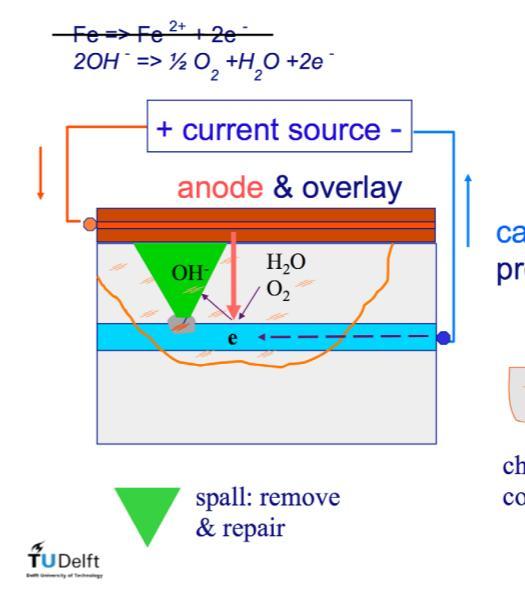
illustration 5 by Elmer Pietersma (personal sketch and photo) Illustration 6 by Barbara Lubelli (lecture degradation mechanisms: concrete 12-11-2015, p21) Illustration 7 by Rob van Hees (lecture Corrosion and treatment: Cathodic protection of rusting iron, p.47)

PREVENTING AND REPAIR

The damage caused by the spalling is permanent and irreversible. To prevent it from happening in the future, the sources of water must be removed or stopped. For the leakage the remedy is clear; repair the drainage system and the problem is fixed.

For the splash water at the bottom of the facade, the fix is more difficult. The concrete that has fallen off needs to be replaced, and in order to prevent it from happening again a cover needs to protect the concrete and the reinforcement. The cover that is present on the concrete right now is not more than 5mm, whereas it is advised to have a cover of concrete protecting the reinforcement of at least 15 to 55mm depending on the environment (Lubelli, 2015, p10).

If rising damp is involved the problem becomes bigger, because there will need to be a physical separation between the source (the ground) and the concrete to prevent further damage. To obtain this, the entire length of the facade will have to be adjusted, which will cost a lot of effort and money. However, restoring the concrete and removing the water will not be enough.

The damaged reinforcement must also be treated. First it needs to be checked for structural integrity, needing replacing there were it fails. Secondly further spread of rust needs to be stopped. This can be done by cathodic protection. In this reaction a metal of lesser nobility will degrade instead of the iron, making sure the rust is not eating away the reinforcement any further as is shown by the image 7.
