# State of Conservation of Concrete Heritage Buildings

# A European Screening

Published in Infrastructures

# State of Conservation of Concrete Heritage Buildings: A European Screening

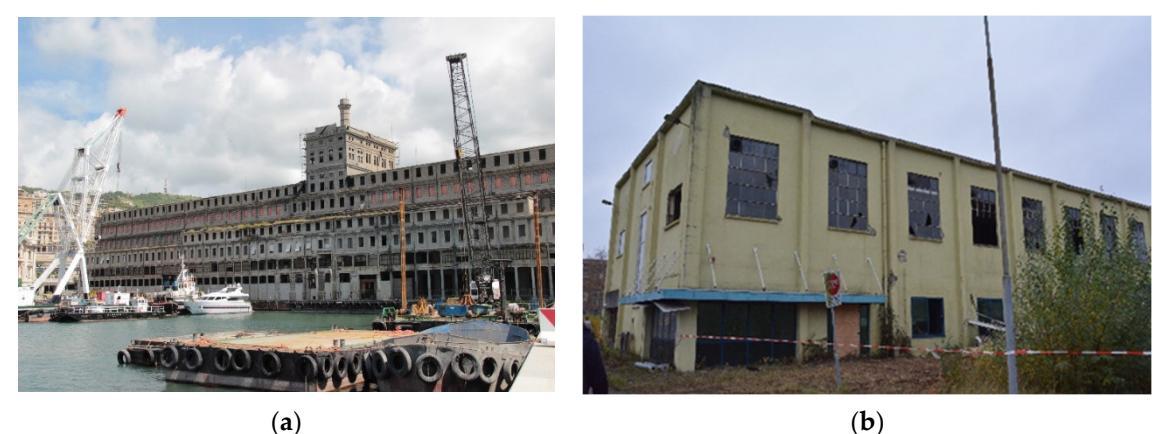
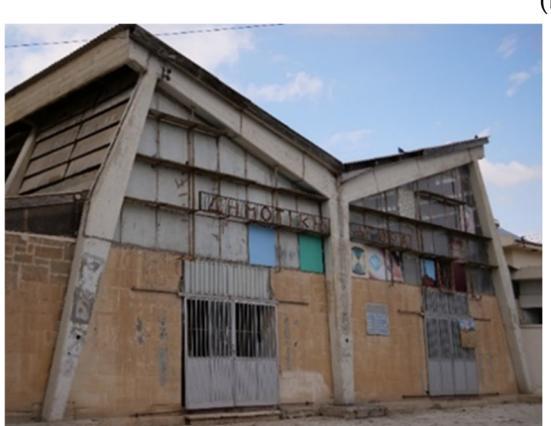
**Figure 1.** Historic concrete buildings. (**a**) Hennebique Silos in Genova (1901–1906). Source: Authors 6; (**b**) Calve Building (1908) in Delft, the Netherlands. Demolished in 2019. Source: Author 1; (**c**) Athienou Municipal Market (1951–1955) in Cyprus. Source: Authors 3 and 4.

Reinforced concrete (RC) started to be used in Europe in the late 19th and early 20th centuries. The new material was eagerly adopted in some countries to construct new buildings; whereas in others, concrete boomed in a later period. In Genova, Italy, for instance, the Hennebique silos (1901–1906) (Figure 1a) exhibited an early mastery in the use of concrete systems in a large-scale building with a system patented nine years before [1]. Whereas, in the same period, in the Netherlands, RC buildings tended to be of less entity and complexity like the Calve building in Delft (1908) (Figure 1b) as concrete had not yet found its niche in the country.

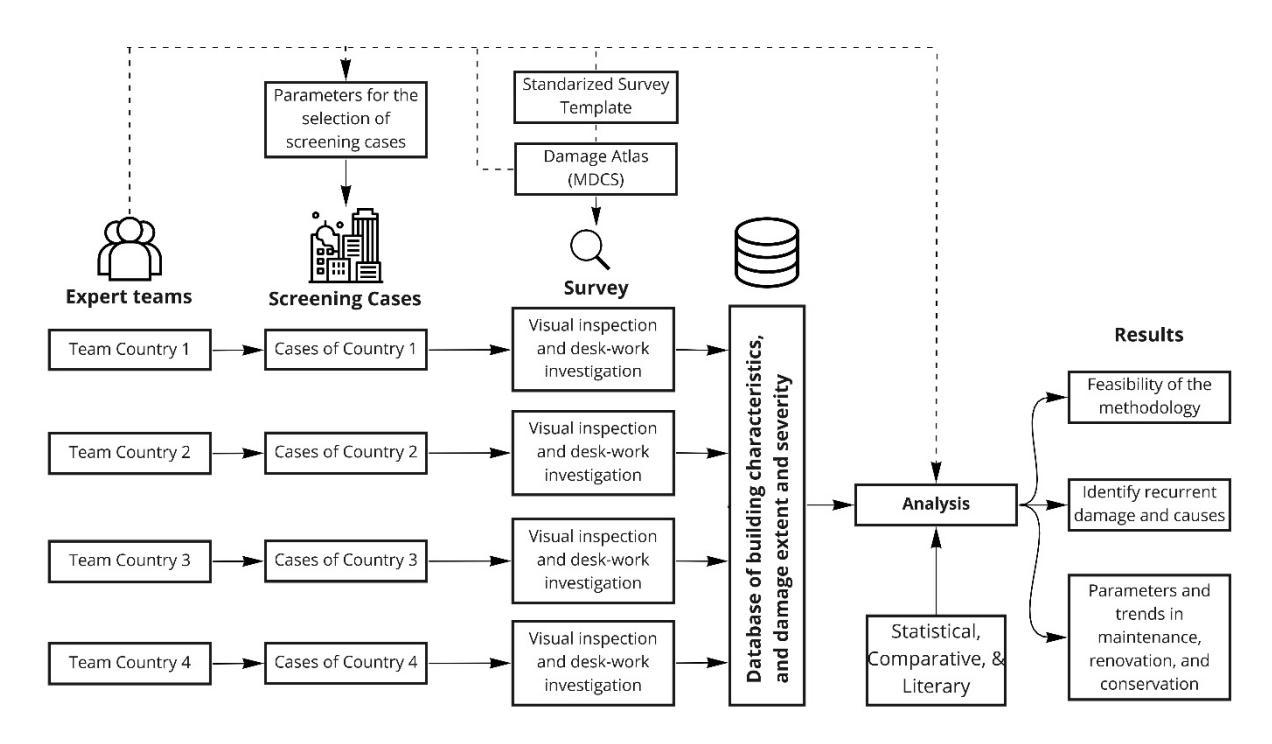
Figure 2. Flow chart of the proposed methodology.

A scheme of the methodology can be found in Figure 2. The survey for each building was carried out by a designated team in each country. Each team was specialized in damage assessment, conservation, and concrete degradation. Starting from the visible damage, each team recorded the most common damage types and evaluated the possible cause(s) of each damage. For this task, the Damage Atlas of the online tool MDCS was used [9], which defines illustrative examples and explains the characteristics and plausible causes of the different damage types.

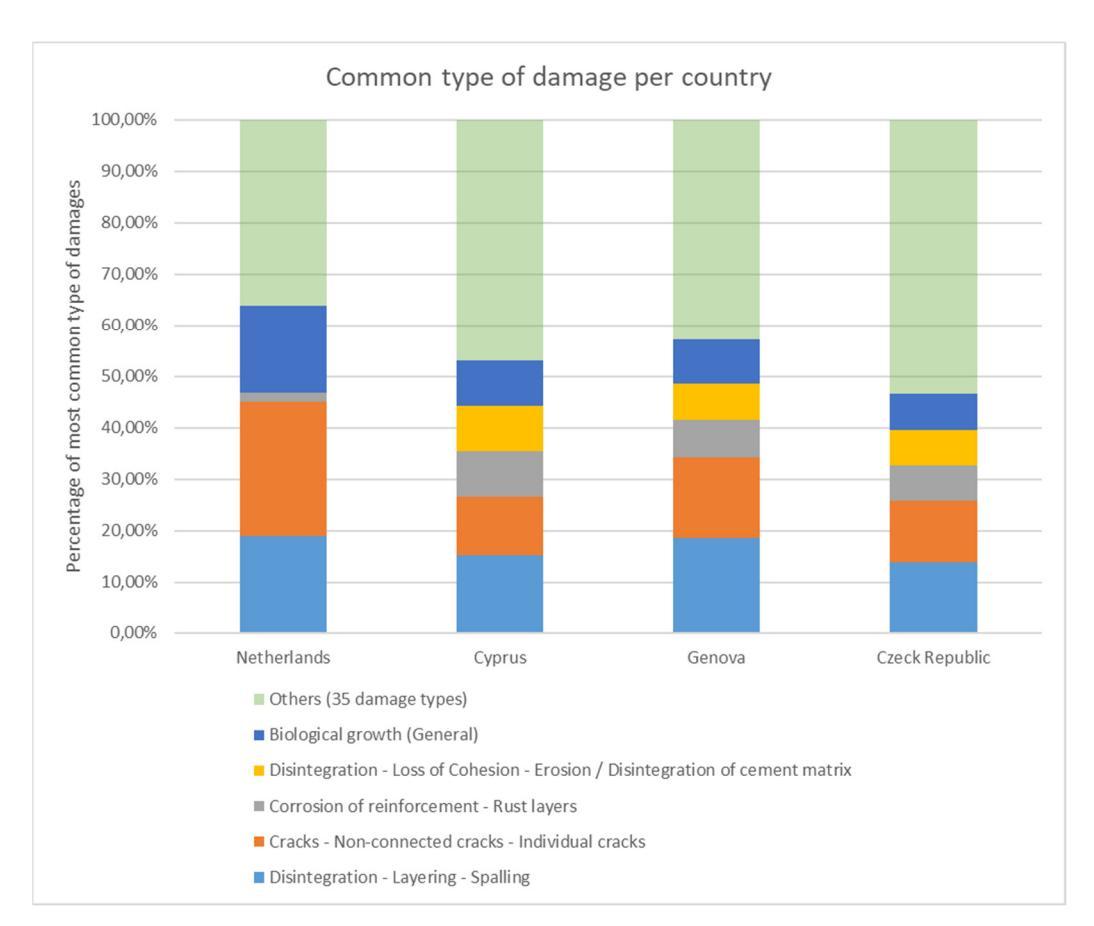
Figure 4. Damage types per country.

Among the types of damage defined for concrete in MDCS (Figure 3), the most recurrent ones were: spalling and delamination (16.42%), individual cracks (11%), corrosion of reinforcement-rust layers (8%), disintegration of cement matrix (6%), and biologicalgrowth-related damages (discoloration and moist spots, 3.85% each). These five types of damages formed around 50% of the damages found across the countries, although the orders of magnitude have slight variations as shown in Figure 4.

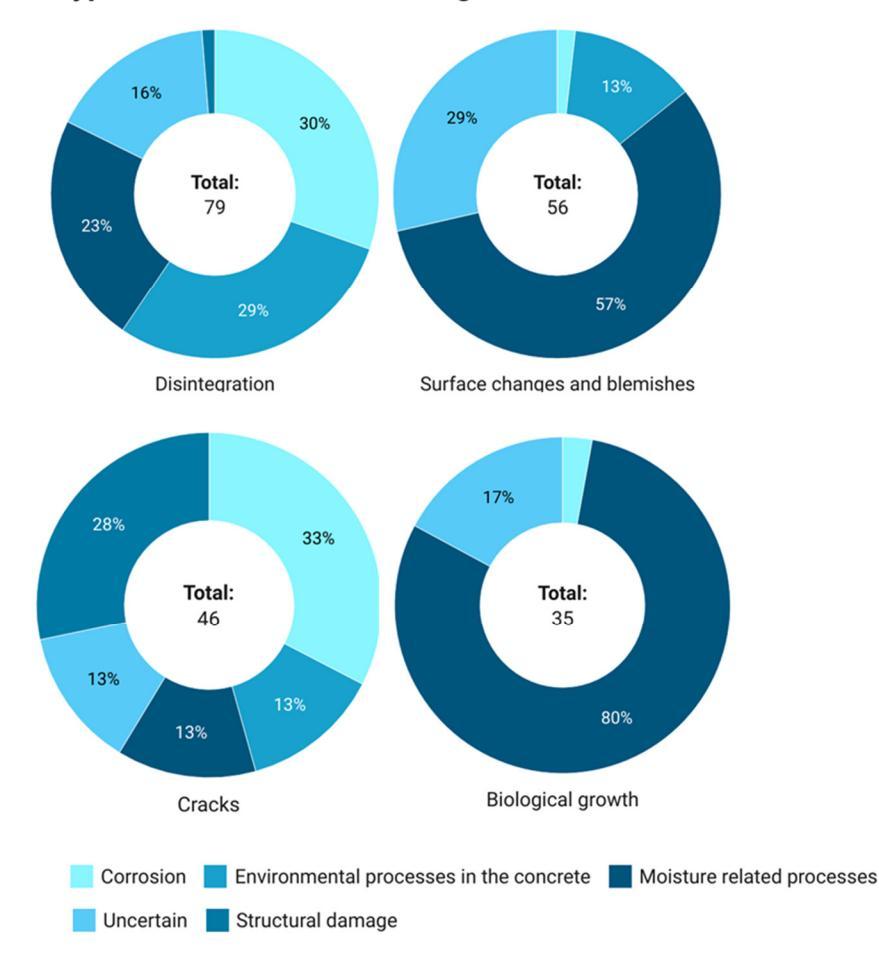
Figure 5. Hypothetical causes of damage per type of damage group.

Regarding the hypothetical causes of damage, the most recurrent were carbonationinduced corrosion (29%), biological growth (24%), and surface condensation (12%). When alike, damage processes were grouped in four categories with the following results: Moisture related (35%), Structural damage (13%), Environmental related (17%), and Corrosion (35%). The correlation between the damage and the potential cause/s is summarized in Figure 5. The most relevant results were that Cracks were predominantly related to corrosion and structural damage, and Disintegration was primarily linked to corrosion, moisture, and environmental processes. The rest of the correlations did not provide significant findings.

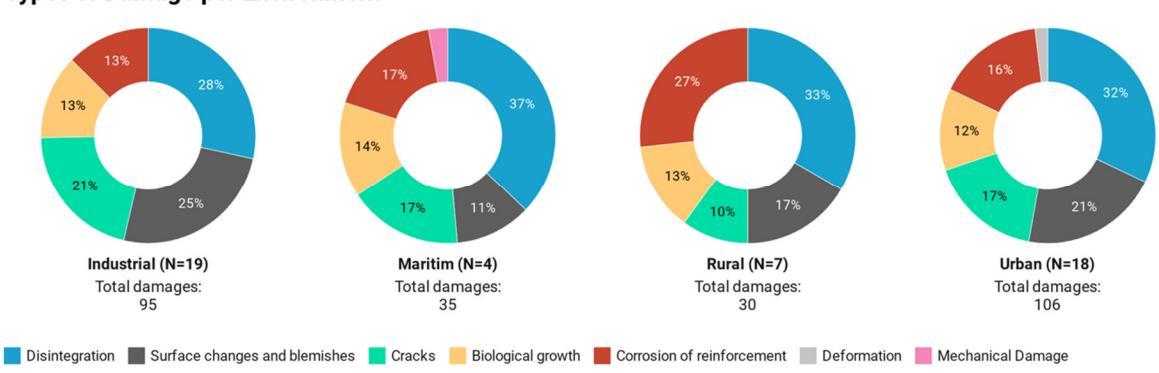
Figure 6. Types of damage per environment.

The environment is believed to be one of the leading causes of concrete degradation [15]. This non-physical characteristic was also studied by comparing different environments. Buildings in urban areas showed more extent and severity of damage than buildings in industrial areas (refer to Table 3). The highest severity of damage was found in buildings in maritime areas, although the number of buildings was limited to only three. A relation was also expected between specific types of damage, depending on the environment. However, the relative distribution of the types of damage was similar across all environments studied (refer to Figure 6). Disintegration was the most common damage, followed by surface changes and blemishes in most environments. Corrosion, cracks, and biological growth appeared in lesser numbers.

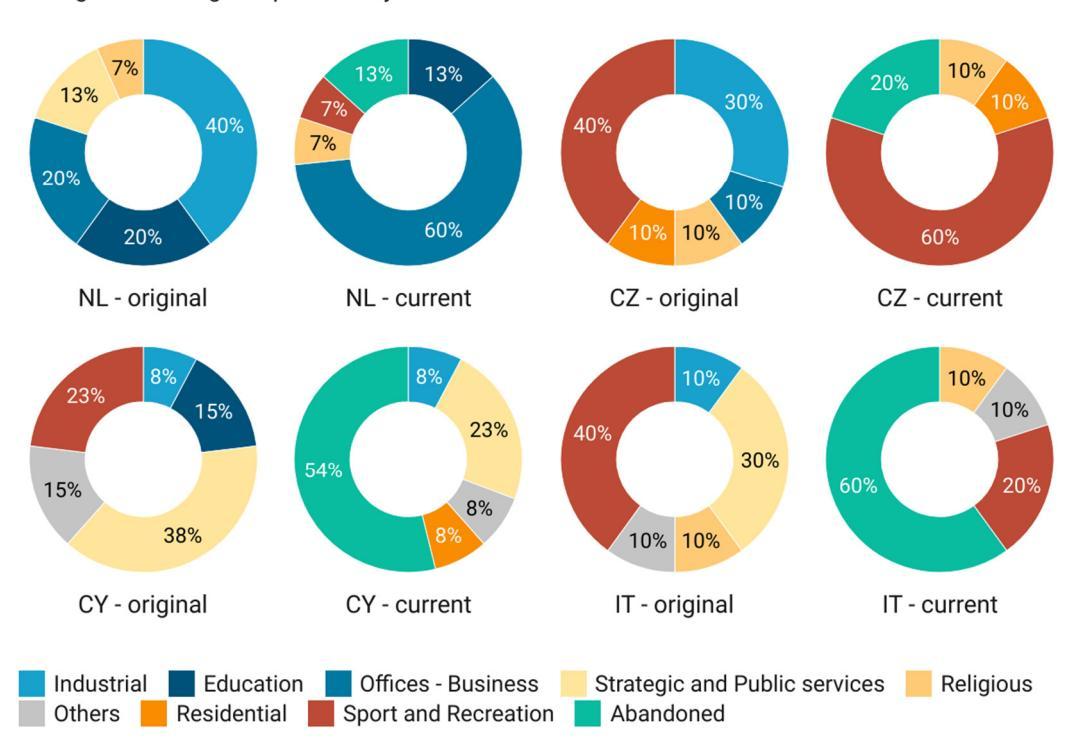
Figure 7. Change of building use per country.

Whether the building had changed its original use or not did not have a noticeable impact on the state of its conservation. Most of the industrial buildings had been converted or abandoned. Educational and Sport and Recreational buildings have been abandoned in Cyprus (CY). In Genova (IT), the only buildings that did not fall into abandonment were religious and "others" (Figure 7).

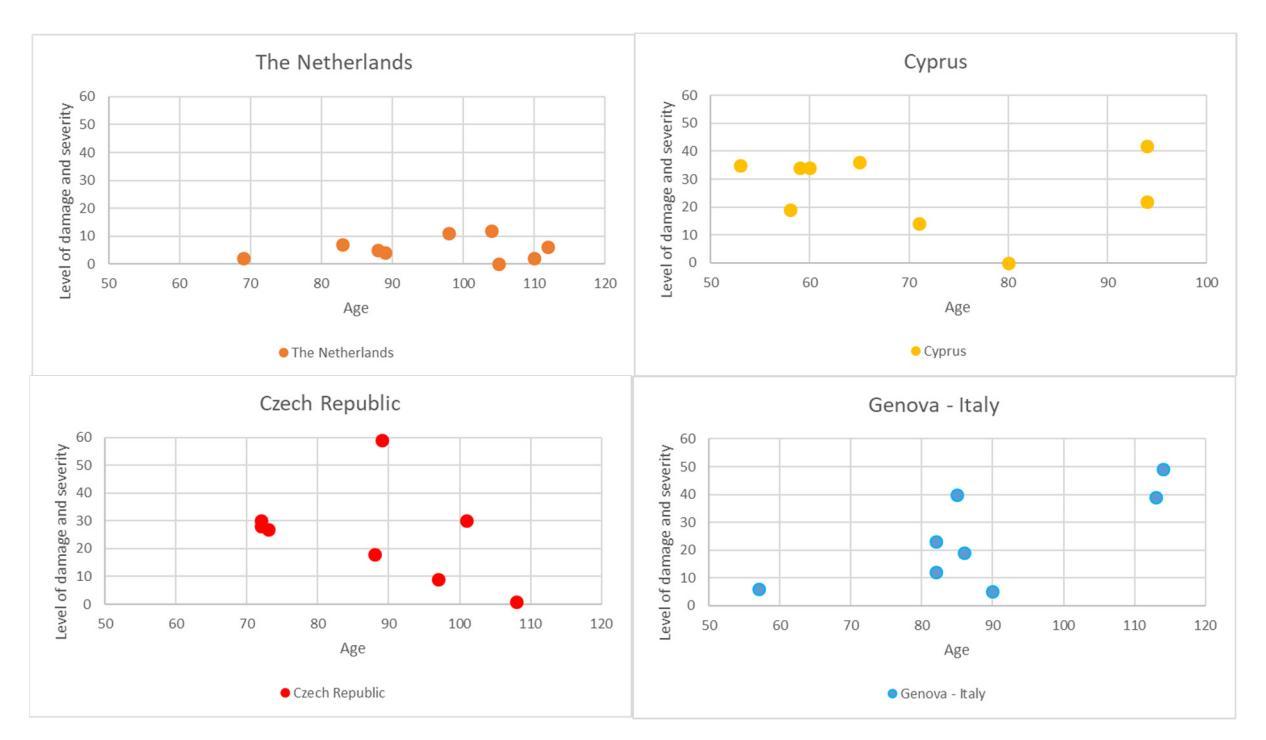
Figure 8. Age (X axis) and Level of damage (Y axis) of the non-restored buildings in each country.

By comparing the state of conservation of non-restored buildings, a trend in building maintenance could be observed among countries. In Figure 8, the non-restored buildings of each country are displayed in terms of Age (X axis) and Level of damage extent and severity (Y axis). The large scatter of the results does not allow for precise conclusions, but some trends can be extracted. Buildings in the Netherlands showed a better state of conservation, having the lowest level of damage across all ages. Cyprus had, on average, higher damage—even in younger buildings. The Czech Republic had scattered results but there seems to be a tendency for a better state of conservation of older buildings. On the contrary, Genova had an opposite trend, where the younger buildings were in a better state than older buildings.

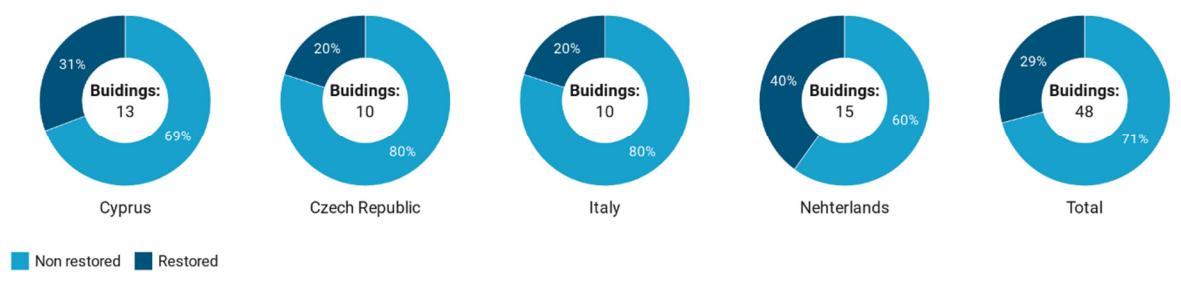
# **Restored and Non-Restored building per Country**

Non-restored buildings accounted for 71% of the buildings studied, showing a similar percentage (from 60 to 80%) in all countries (Figure 9). As expected, restored buildings showed a lower level of damage severity than non-restored buildings.

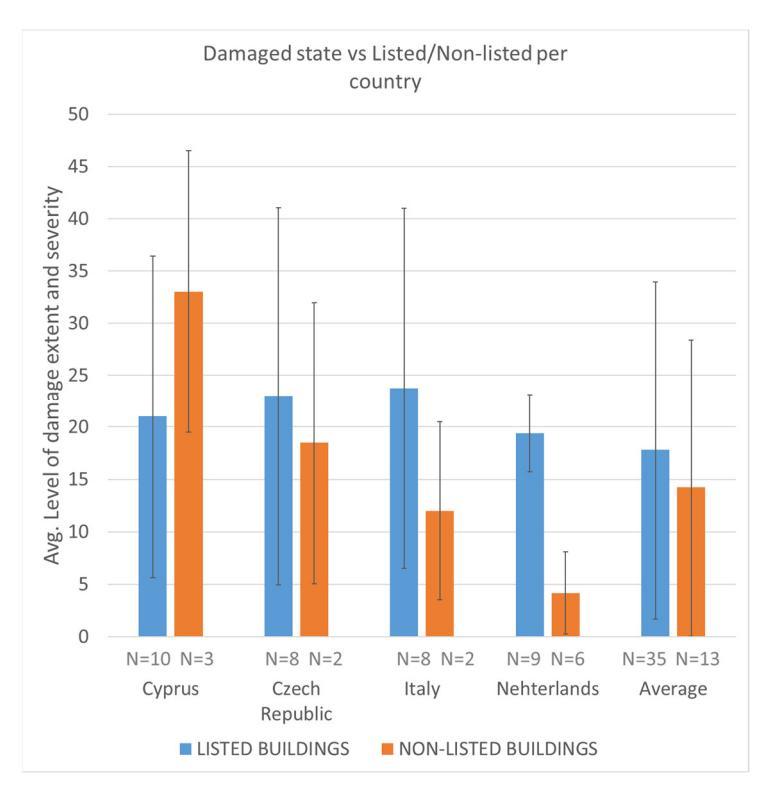
Figure 10. Level of damage severity vs. Building protection per country.

On average, 73% of all buildings had some type of monumental protection. The protection could be local, provincial, or national. Interestingly, the level of damage severity was higher in listed buildings, compared to non-listed, in all countries except Cyprus (Figure 10).

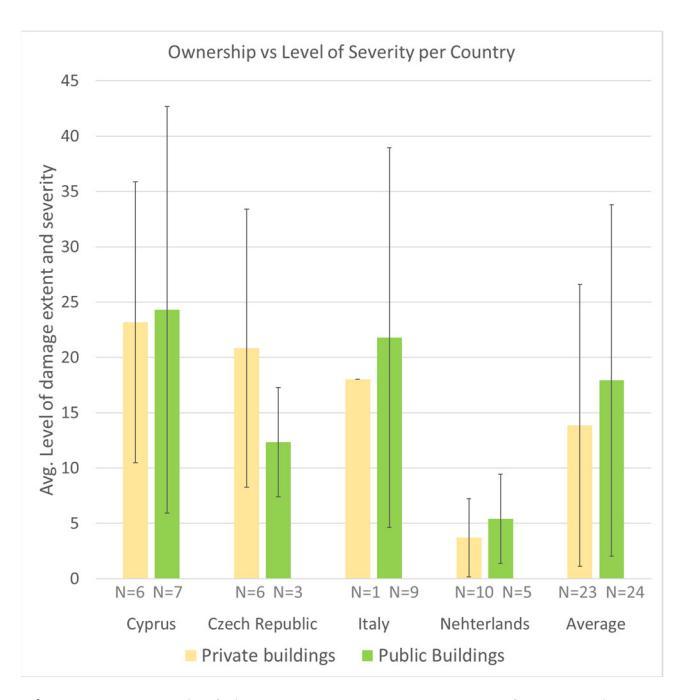
Figure 11. Level of damage severity vs. type of ownership per country.

Generally, there is an even number of private and public buildings in the sample, although there are significant differences in their state of conservation among countries. Considering all the buildings, restored and non-restored, the Netherlands and Czech Republic have similar ratios, 67–33% and 60–40% ratios of private–public buildings, respectively. On the contrary, the buildings in Genova were predominantly public ones (90%). Cyprus had an even ratio, 46–54% of private to public buildings. There is not a clear indication between the level of damage and the ownership; although, private buildings tend to be in a better condition than public ones (Figure 11).
