Bart Bliek, 4684540

AR3AH105 Graduation Studio | Resourceful Housing, Adapting 20th Century Heritage

How can the post-war public housing heritage of Amsterdam Niew-West support sustainable urbanisation towards a social foundation while remaining within our planetary boundaries?

Design Case: Confuciusplein Building

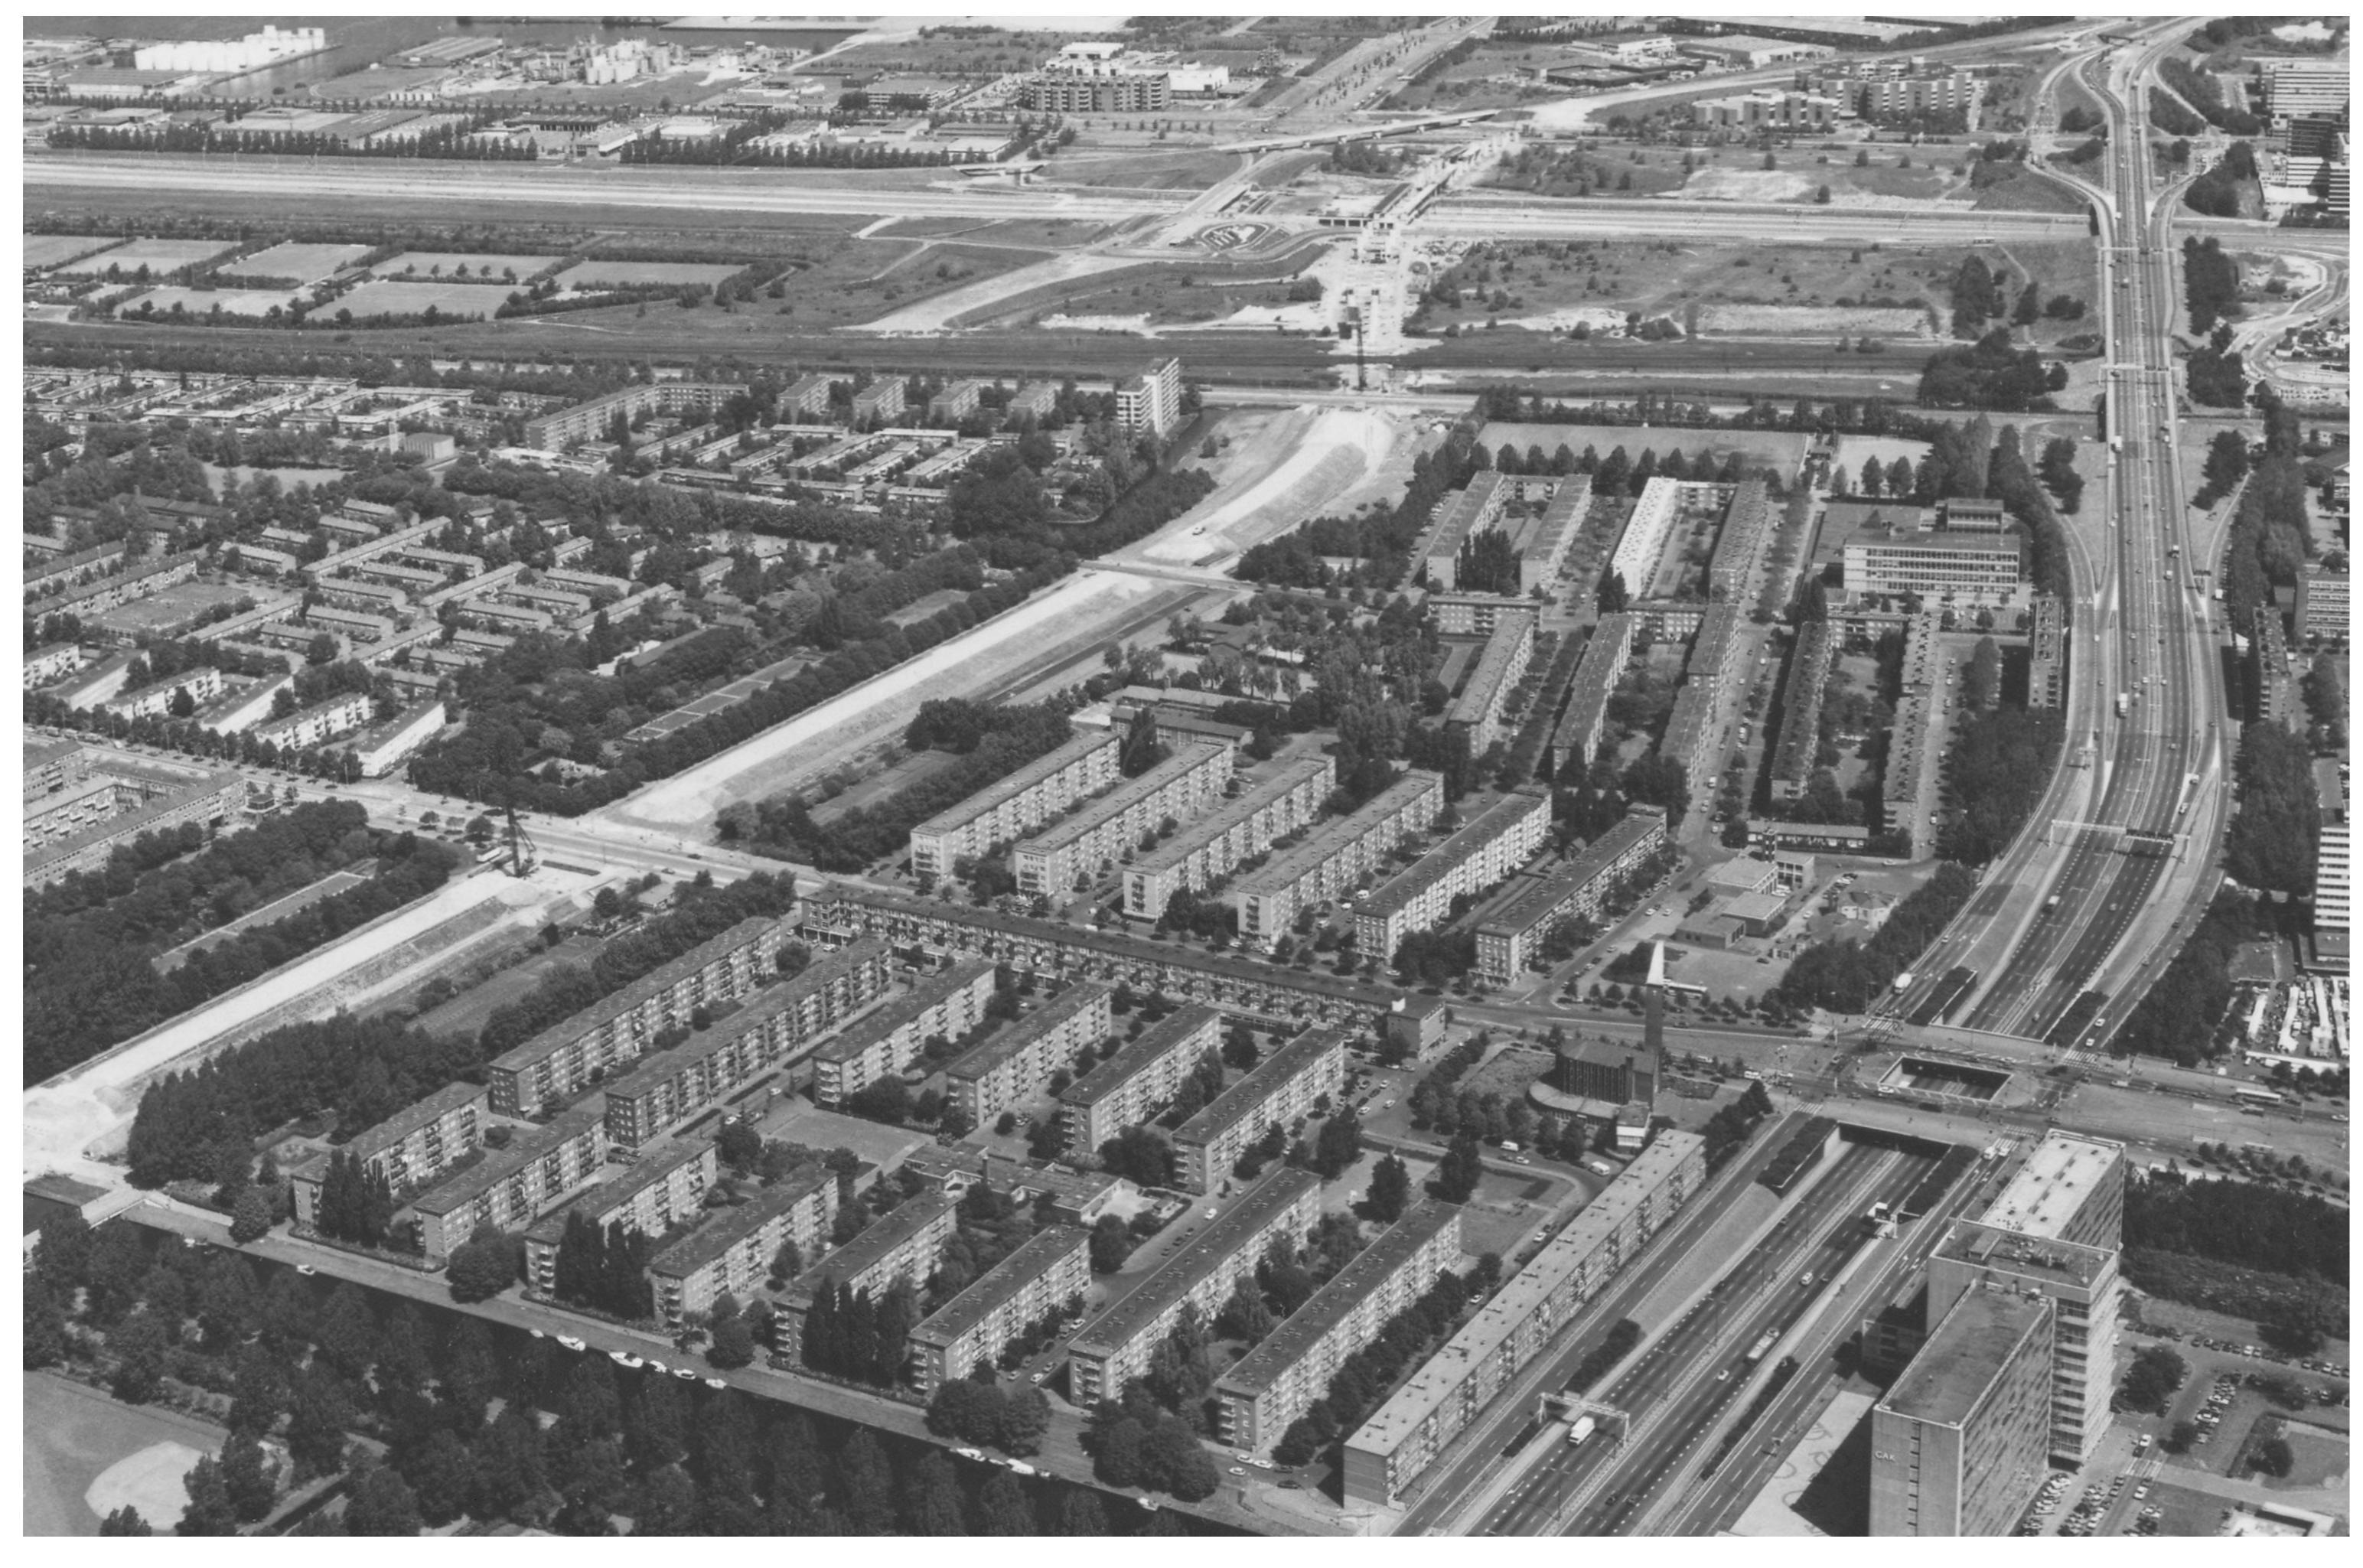
Areal photograph of the Kolenkitbuurt, Stadsarchief Amsterdam, June 17th 1983.

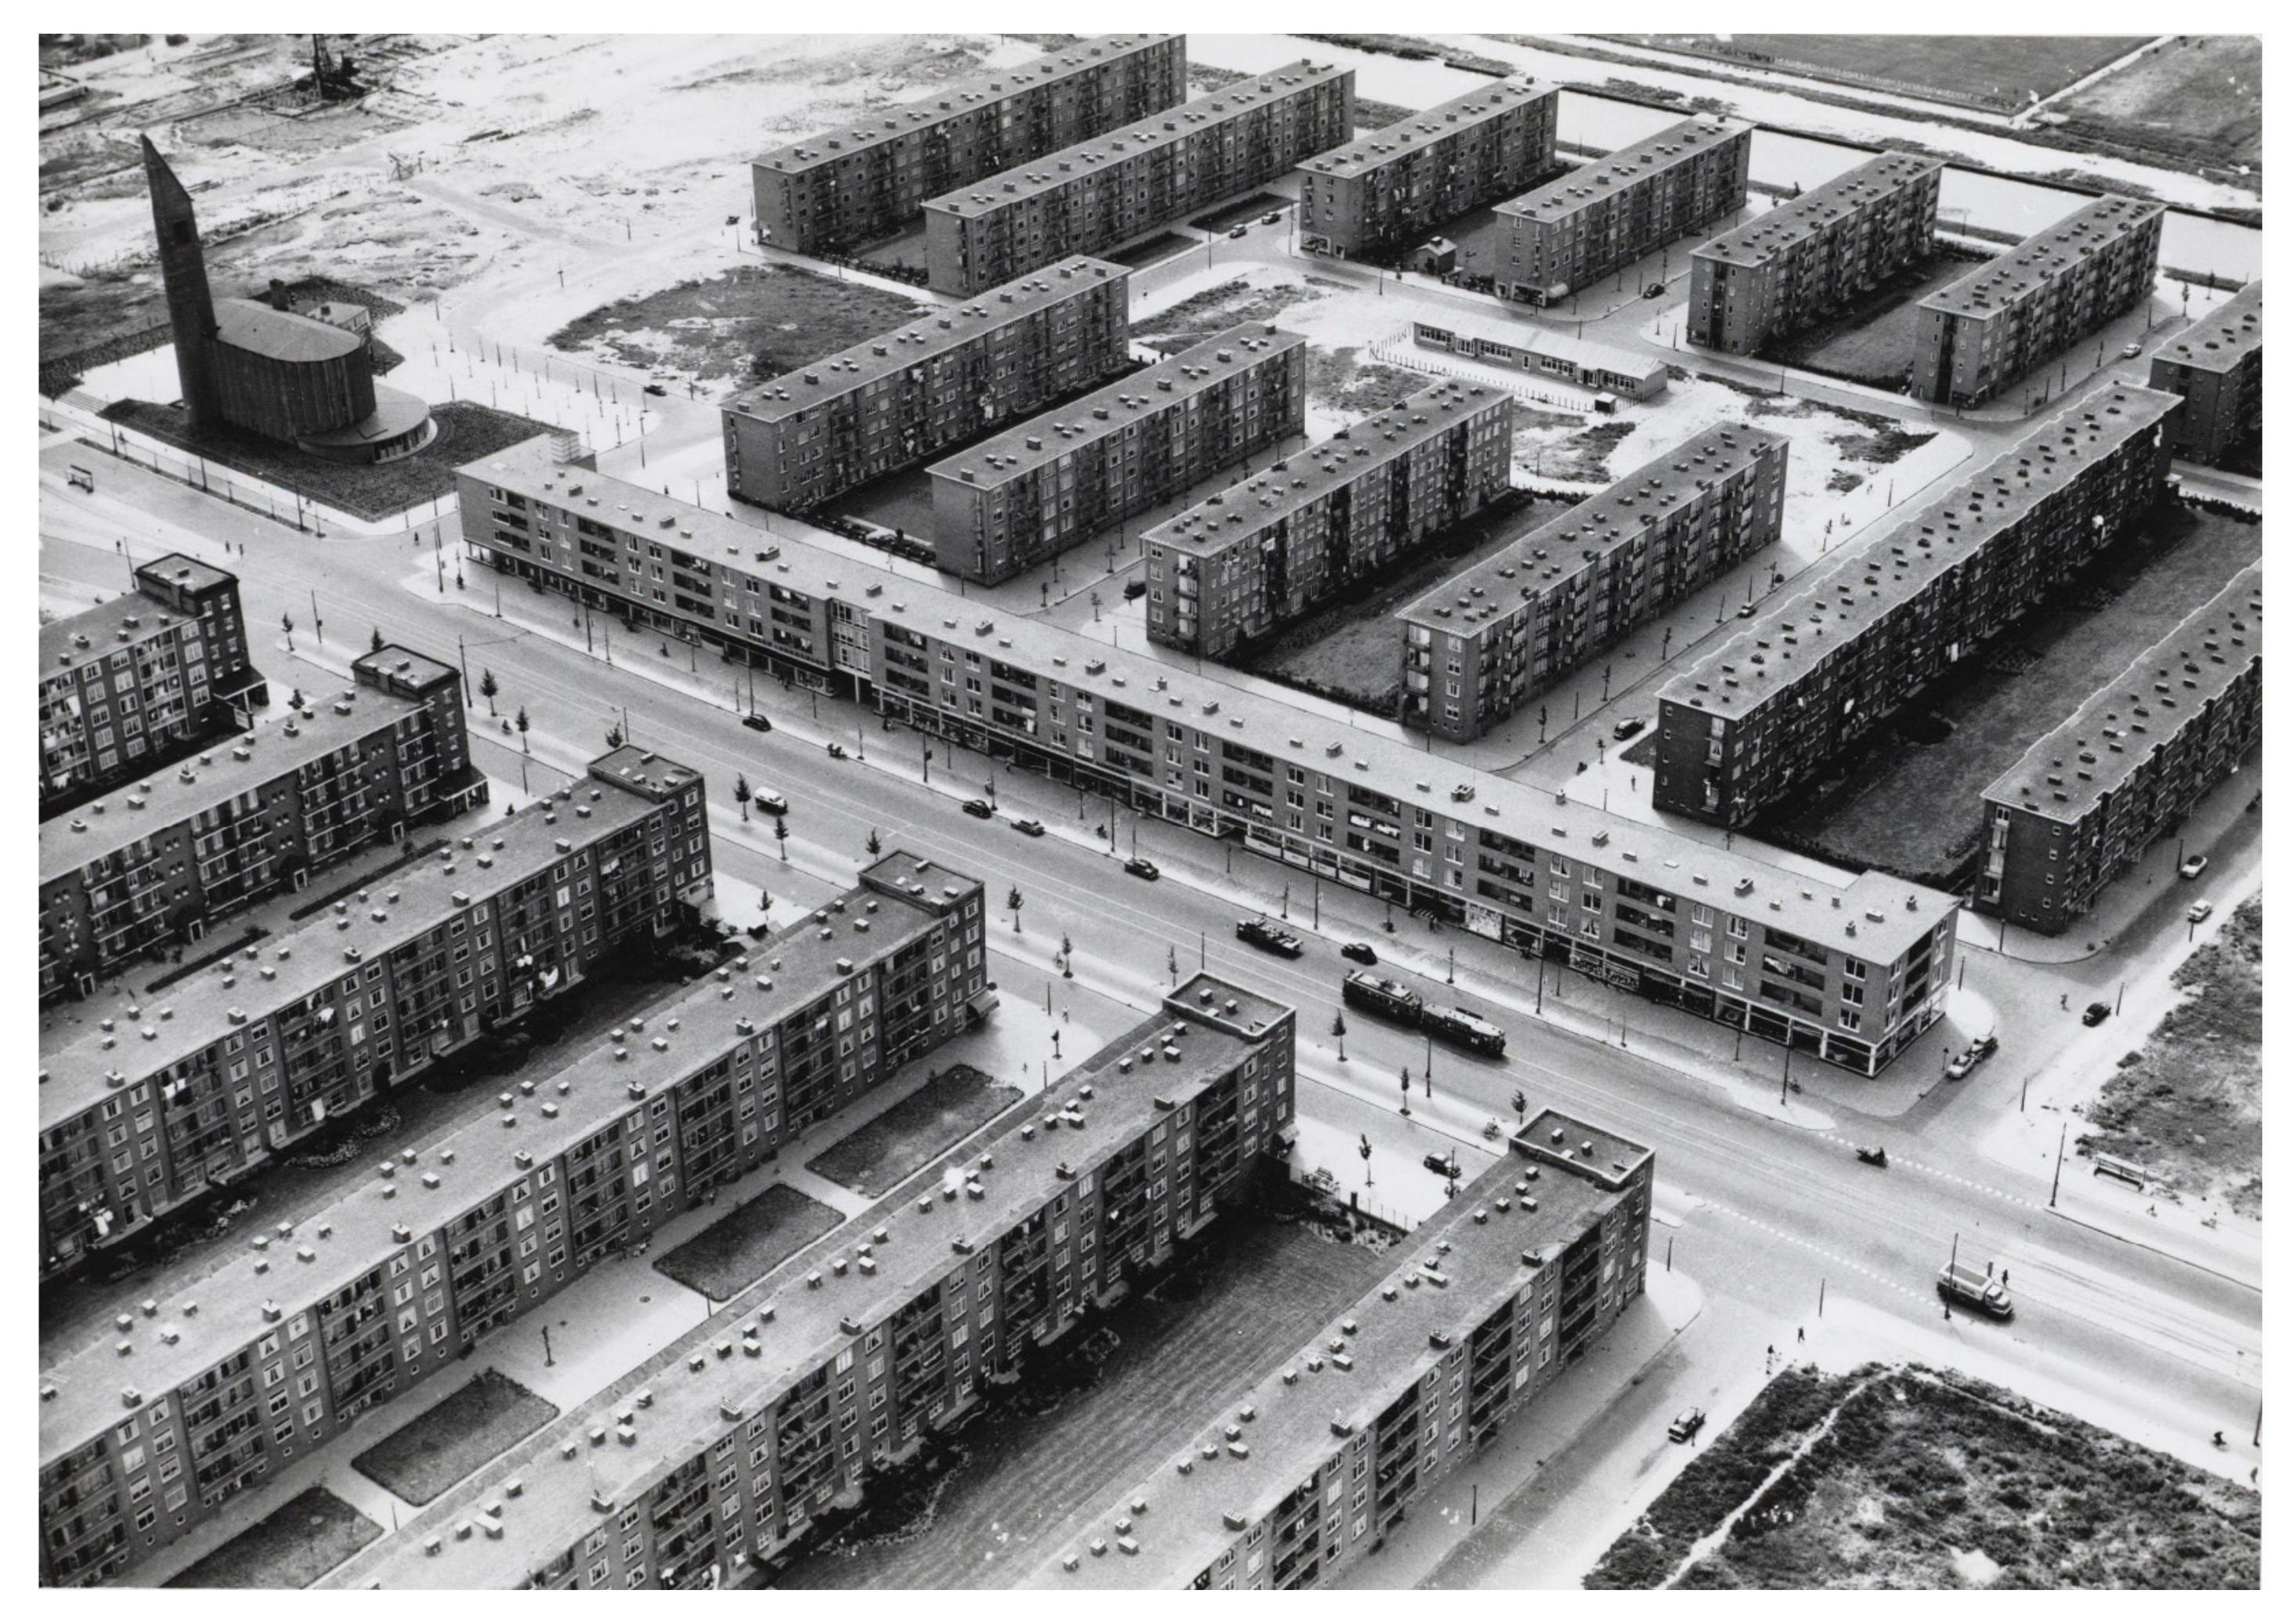
Areal photograph of the Kolenkitbuurt, Stadsarchief Amsterdam, July 9th 1957.

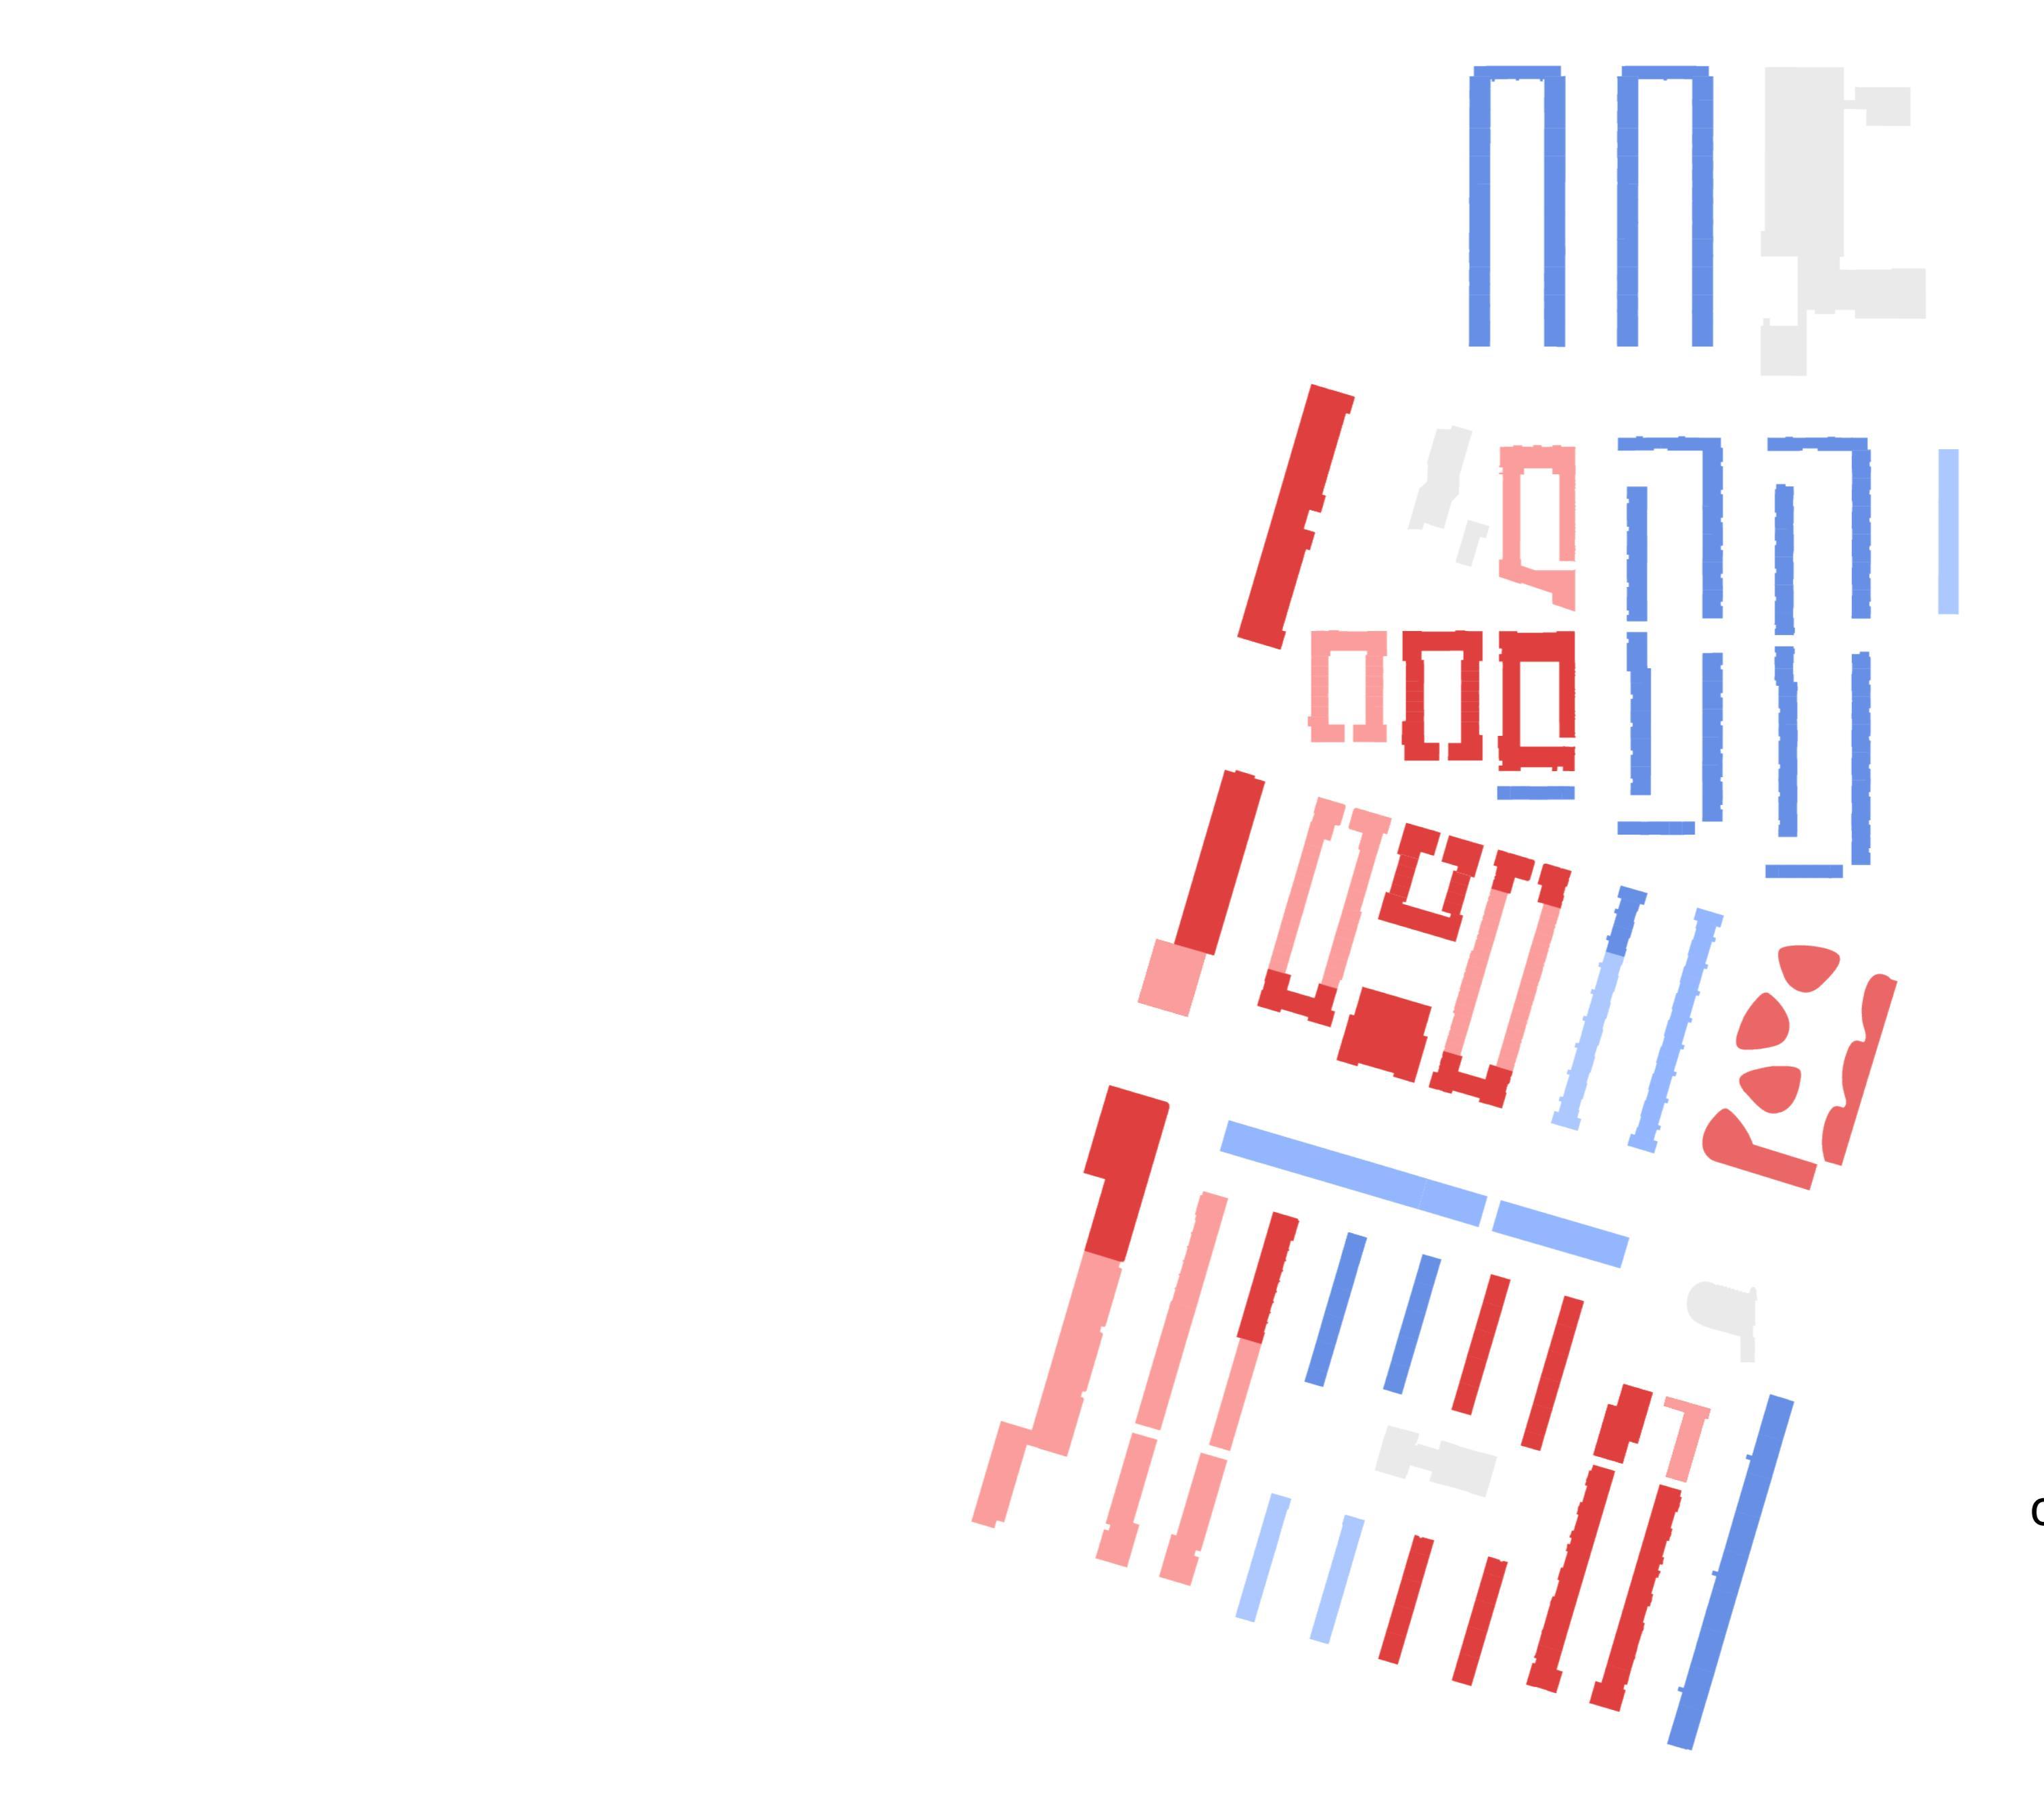
Renewal and Number of Dwellings by Tenure

original corporation housing converted to private rent converted to owner occupied new corporationhousing new private rent new owner occupied

- **C** = corporation housing
- **O** = owner occupied
- P = private rental

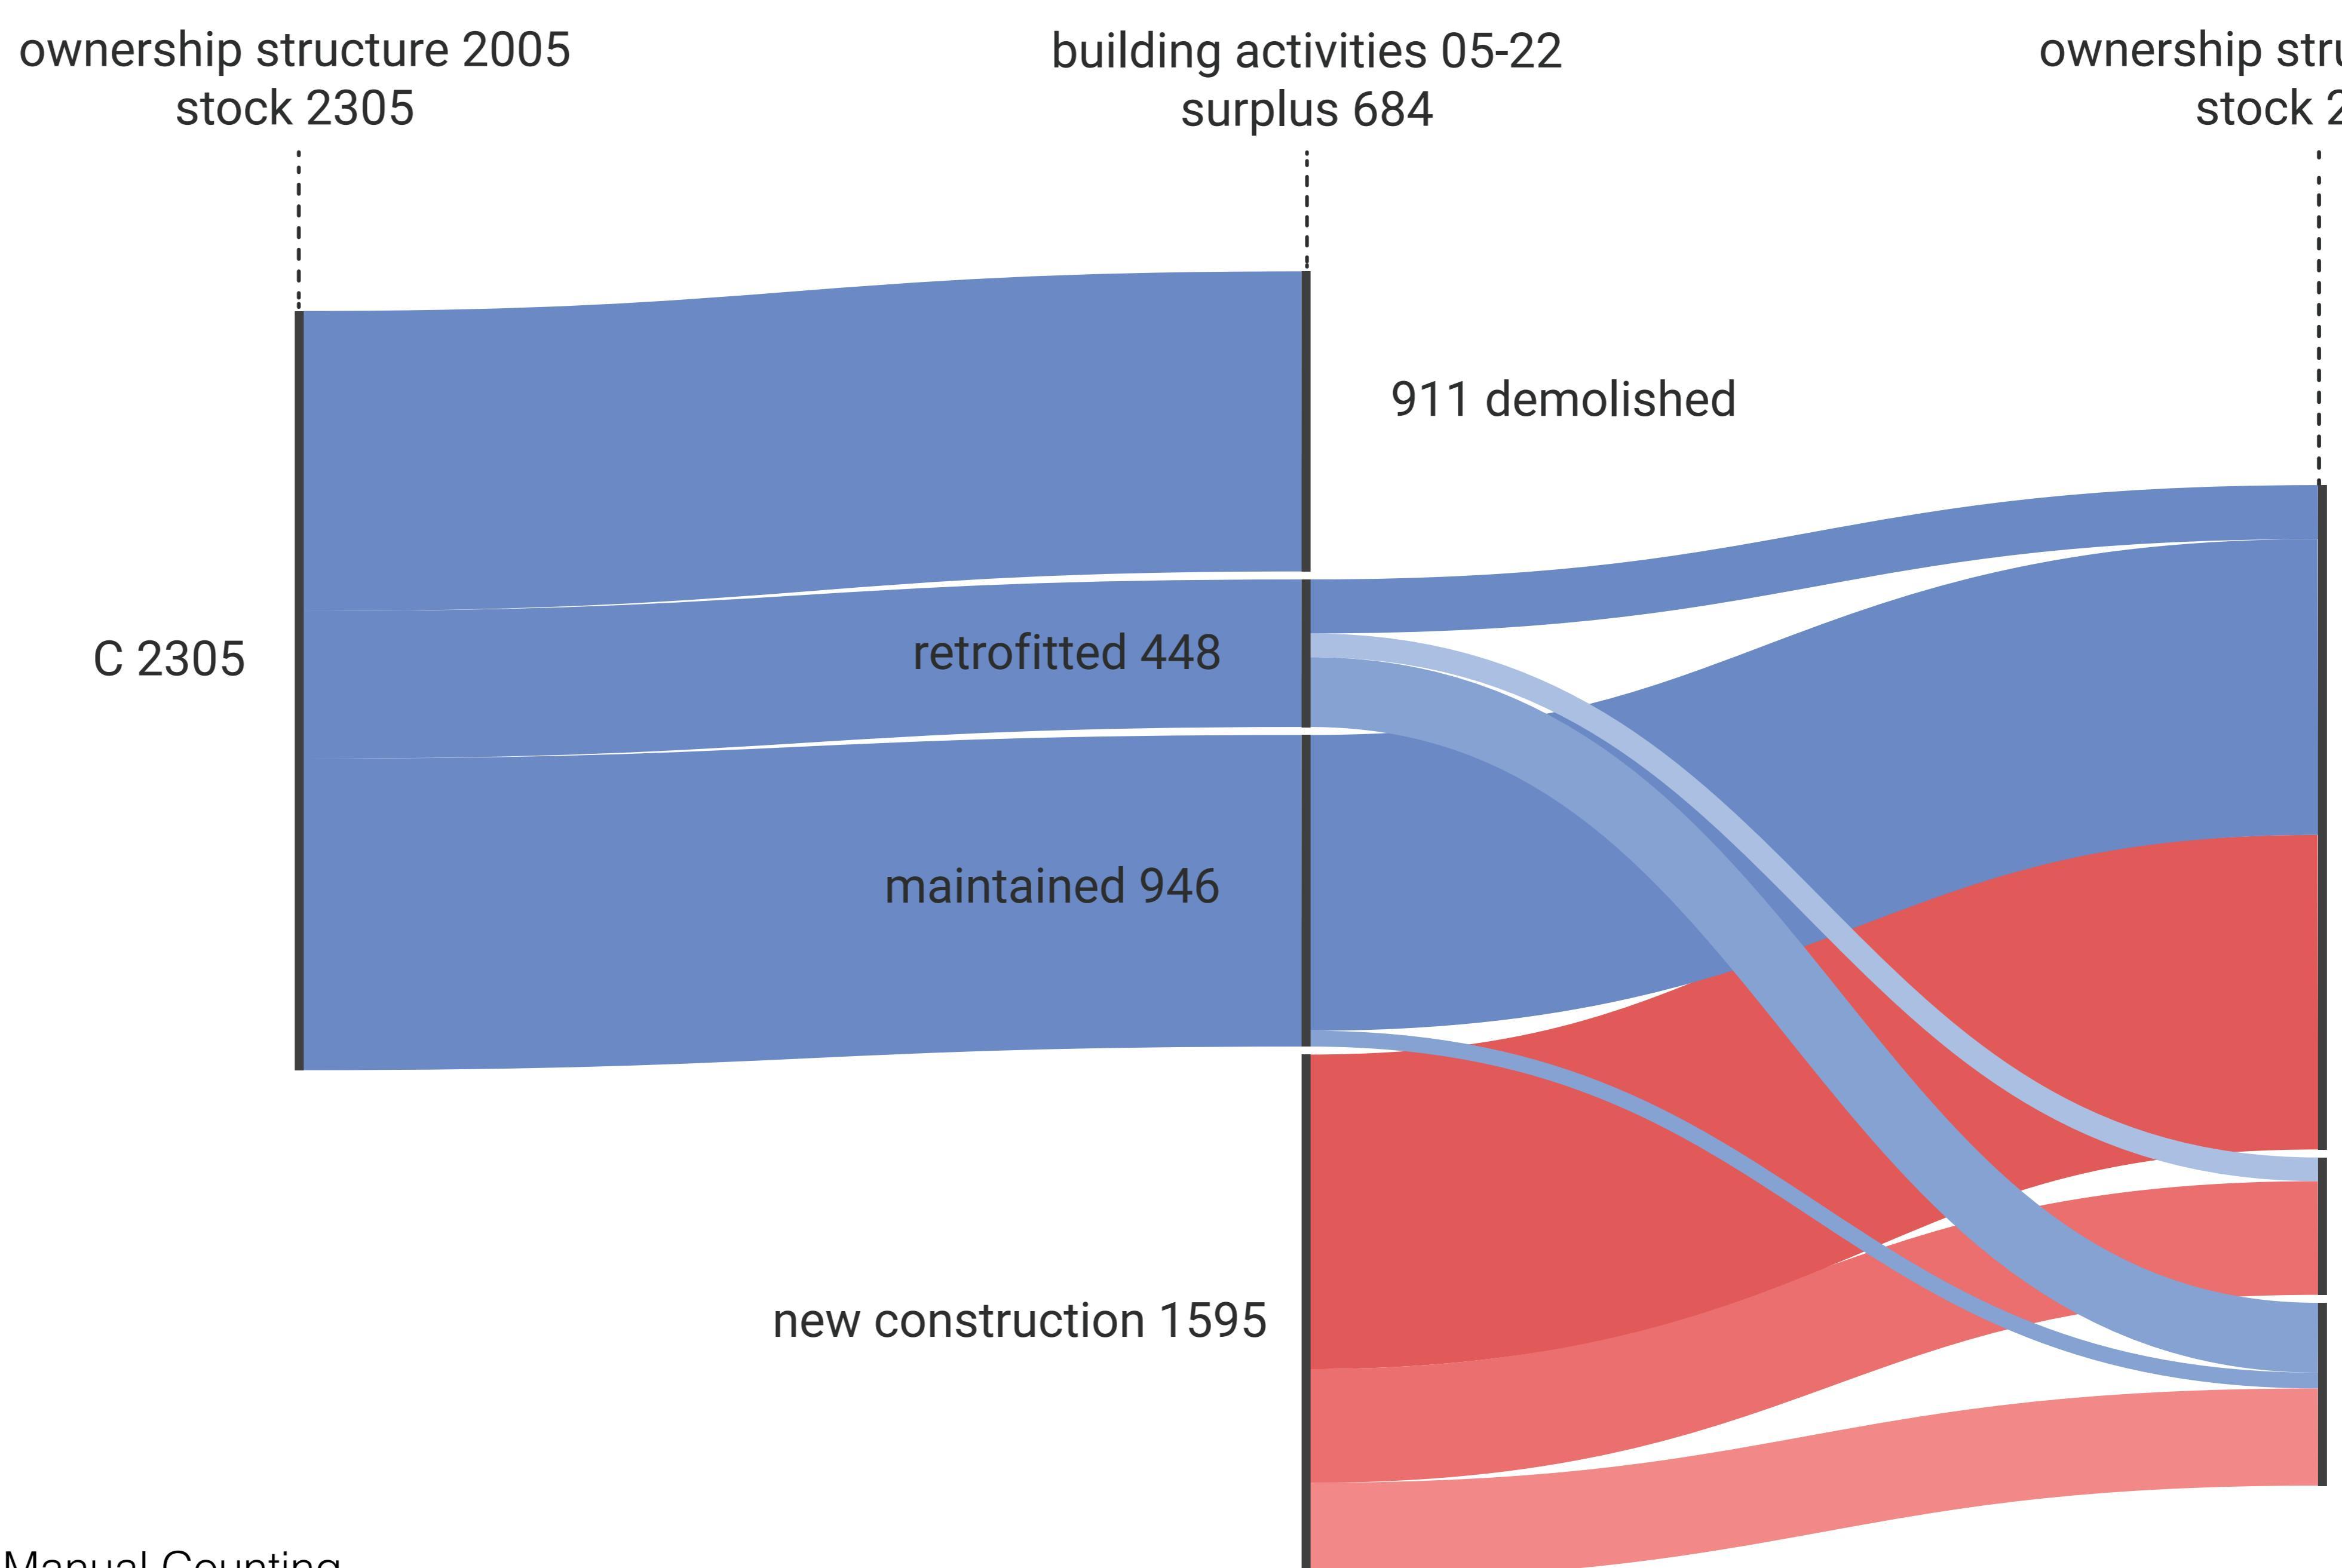
Renewal and Total Floorspace by Dwelling Size

ownership structure 2022 stock 2989

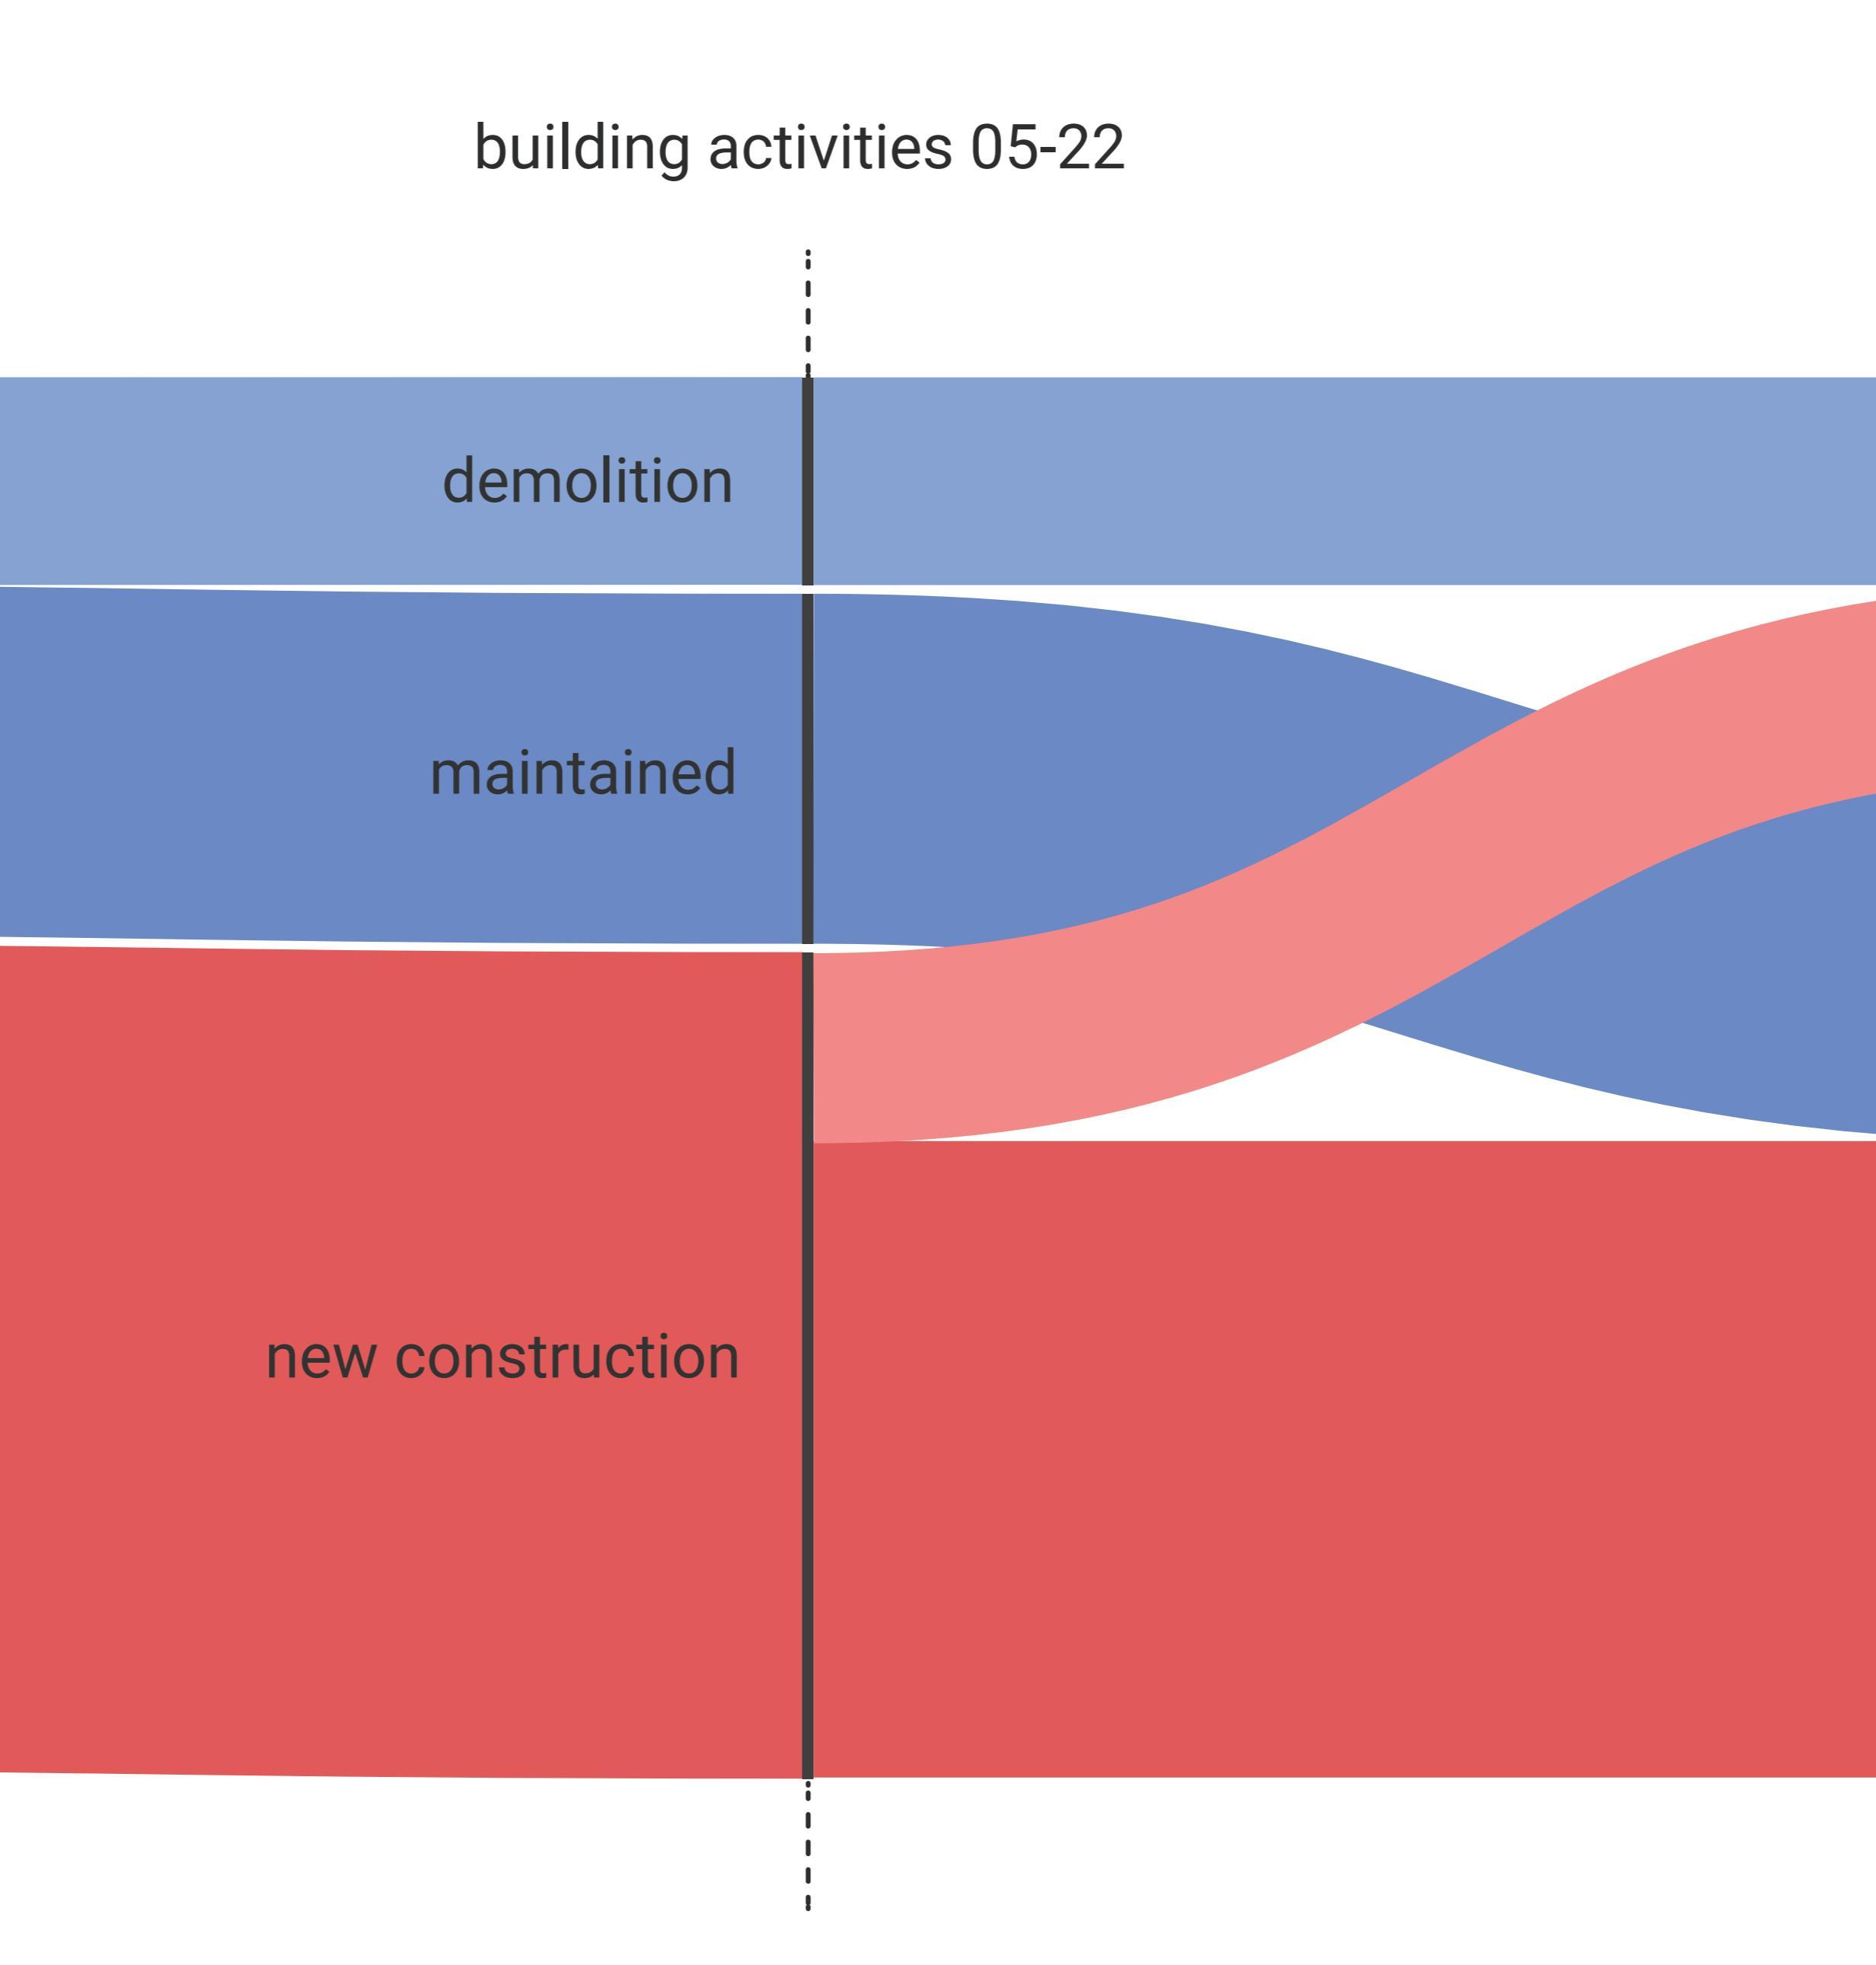
Material Flows

stock 142.700 t

inflow 211.482 t

*Calculation for existing based on modeling of typical building, new construction based on average figures for new construction of a comparable building (Bosch et al. 2023).

outlfow 101.789 t

stock 252.393 t

Extensive demolition and new construction leads to high envirionmental cost for relatively small expansion of housing stock. In this context re-use could have reduced material consumption by 48% and material based emissions by 67%.

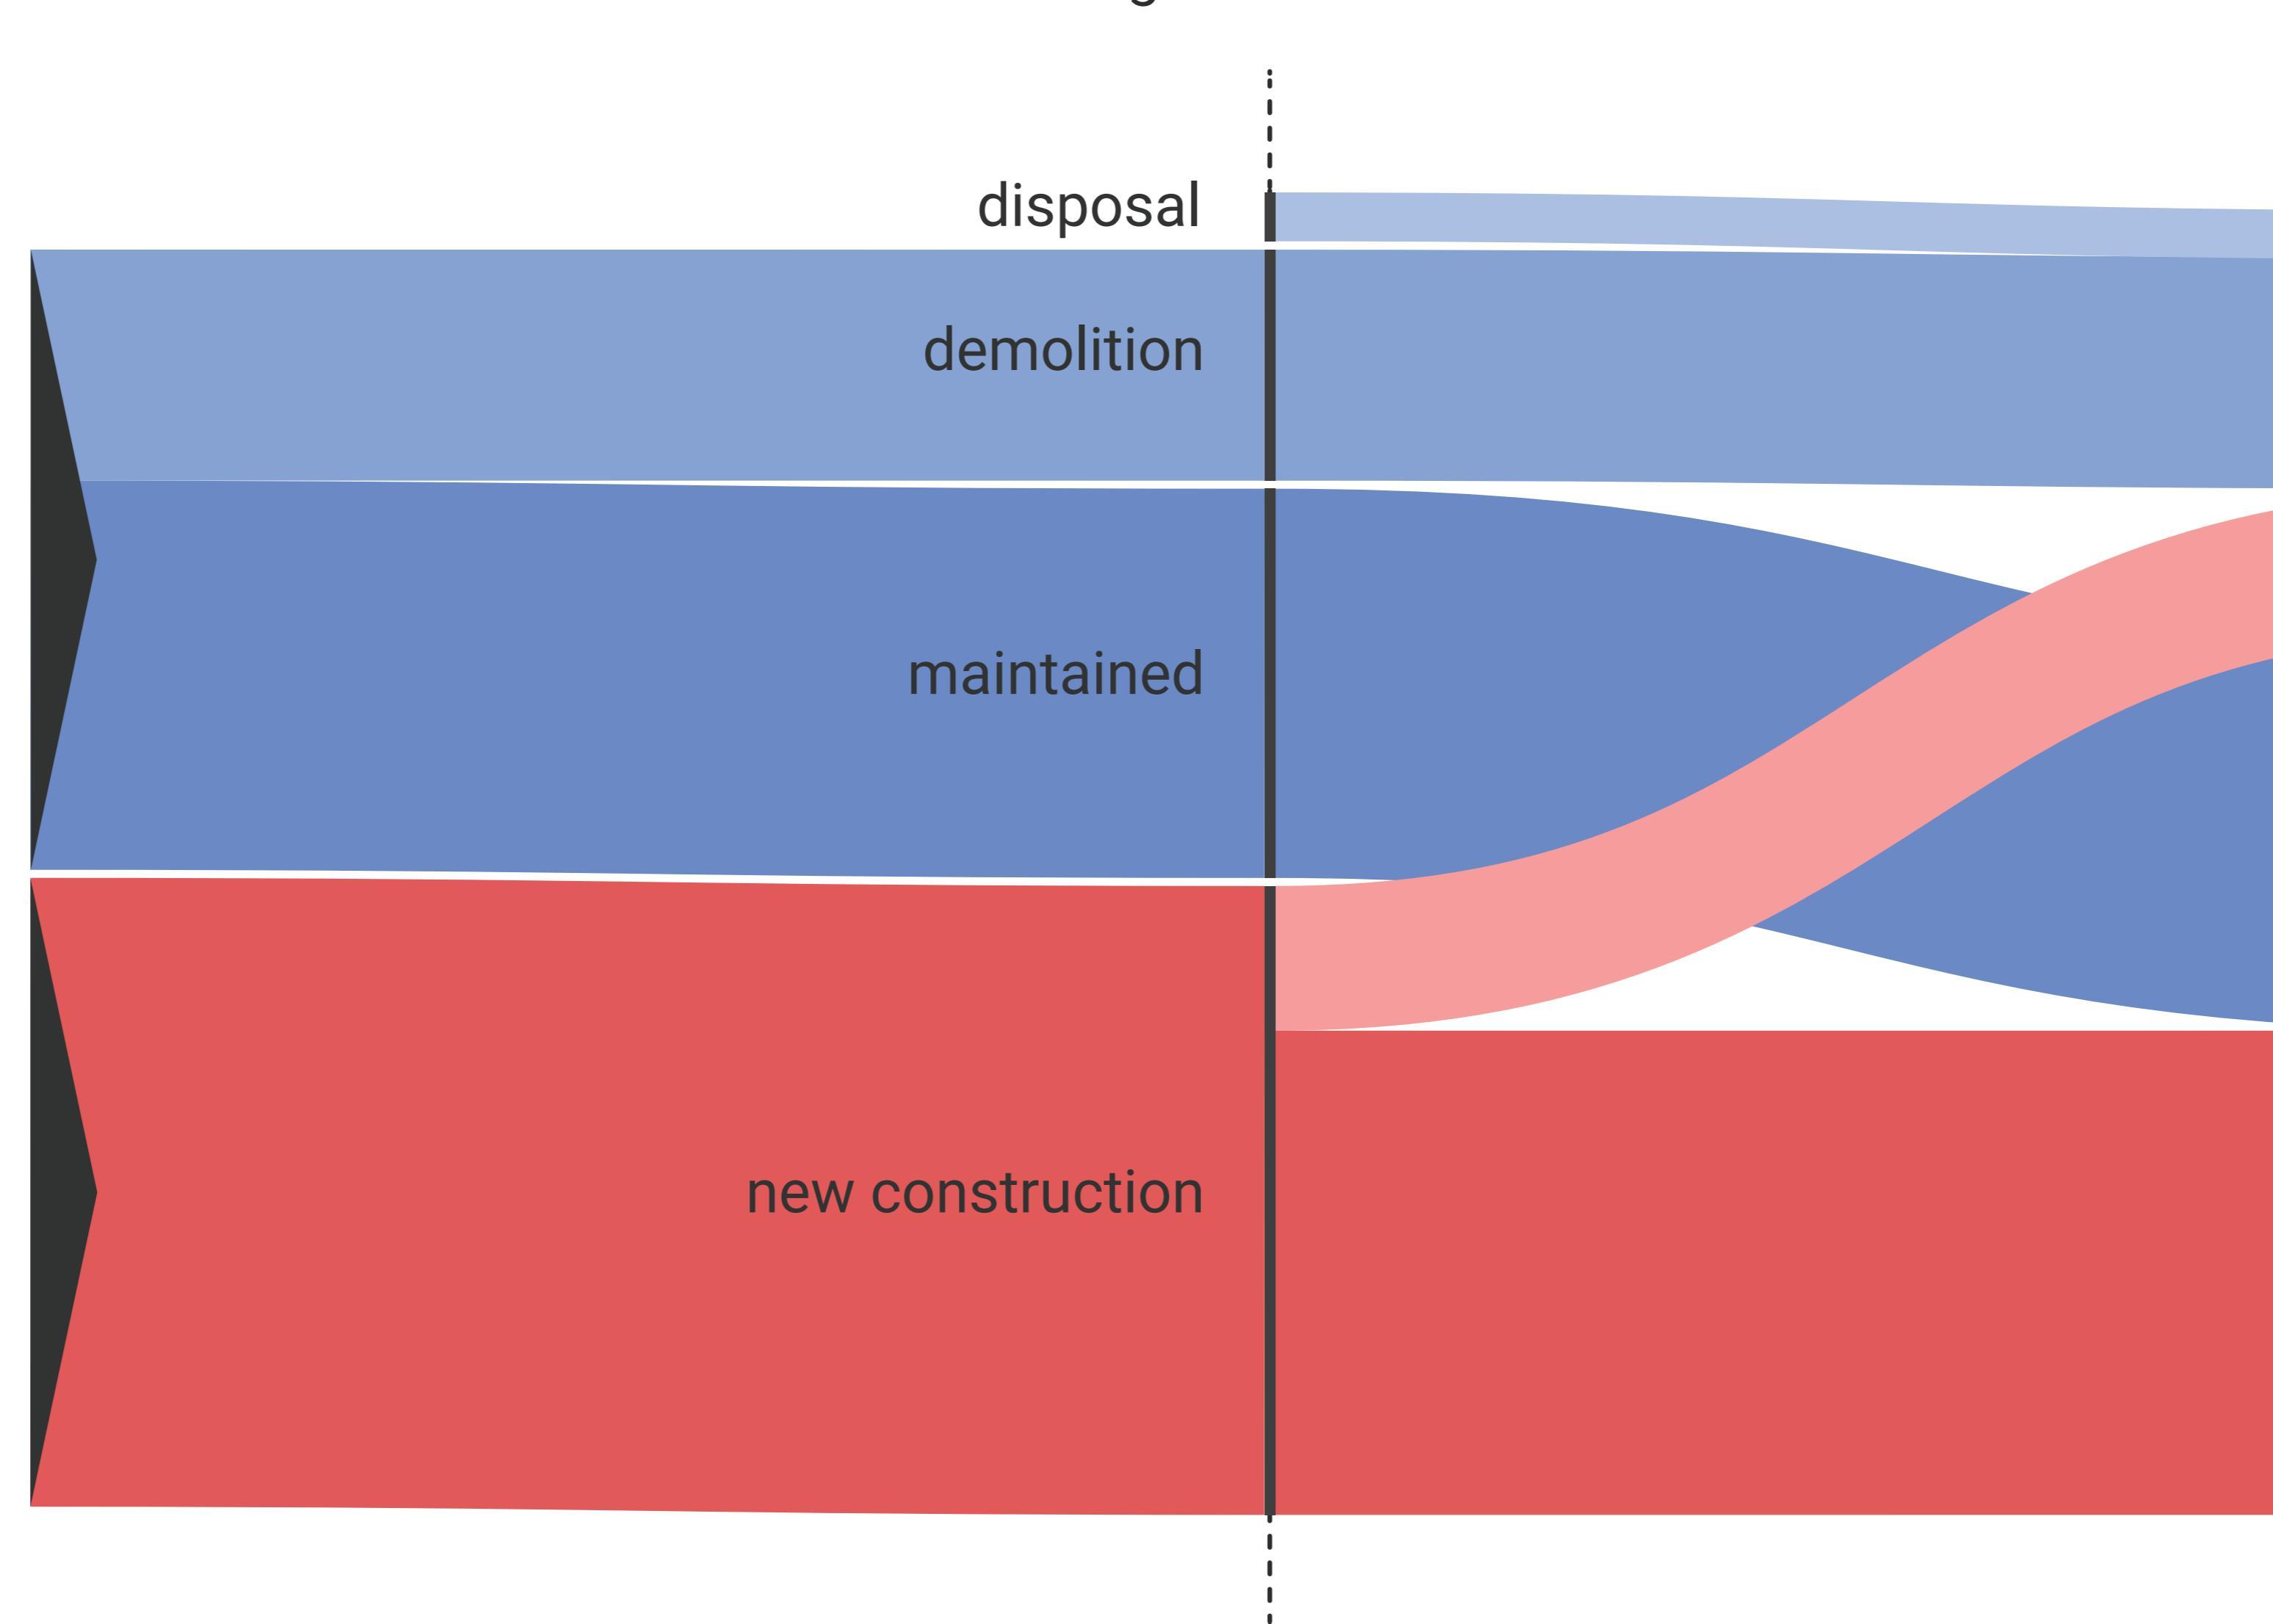
Embodied Carbon Flows

45.648 t CO2

inflow 46.285 t CO2

*Calculation based on generic figures using Granta Edupack data set

outflow 31.239 t CO2

64.287 t CO2
