Bart Bliek, 4684540

AR3AH105 Graduation Studio | Resourceful Housing, Adapting 20th Century Heritage

How can the post-war public housing heritage of Amsterdam Niew-West support sustainable urbanisation towards a social foundation while remaining within our planetary boundaries?

Design Case: Confuciusplein Building

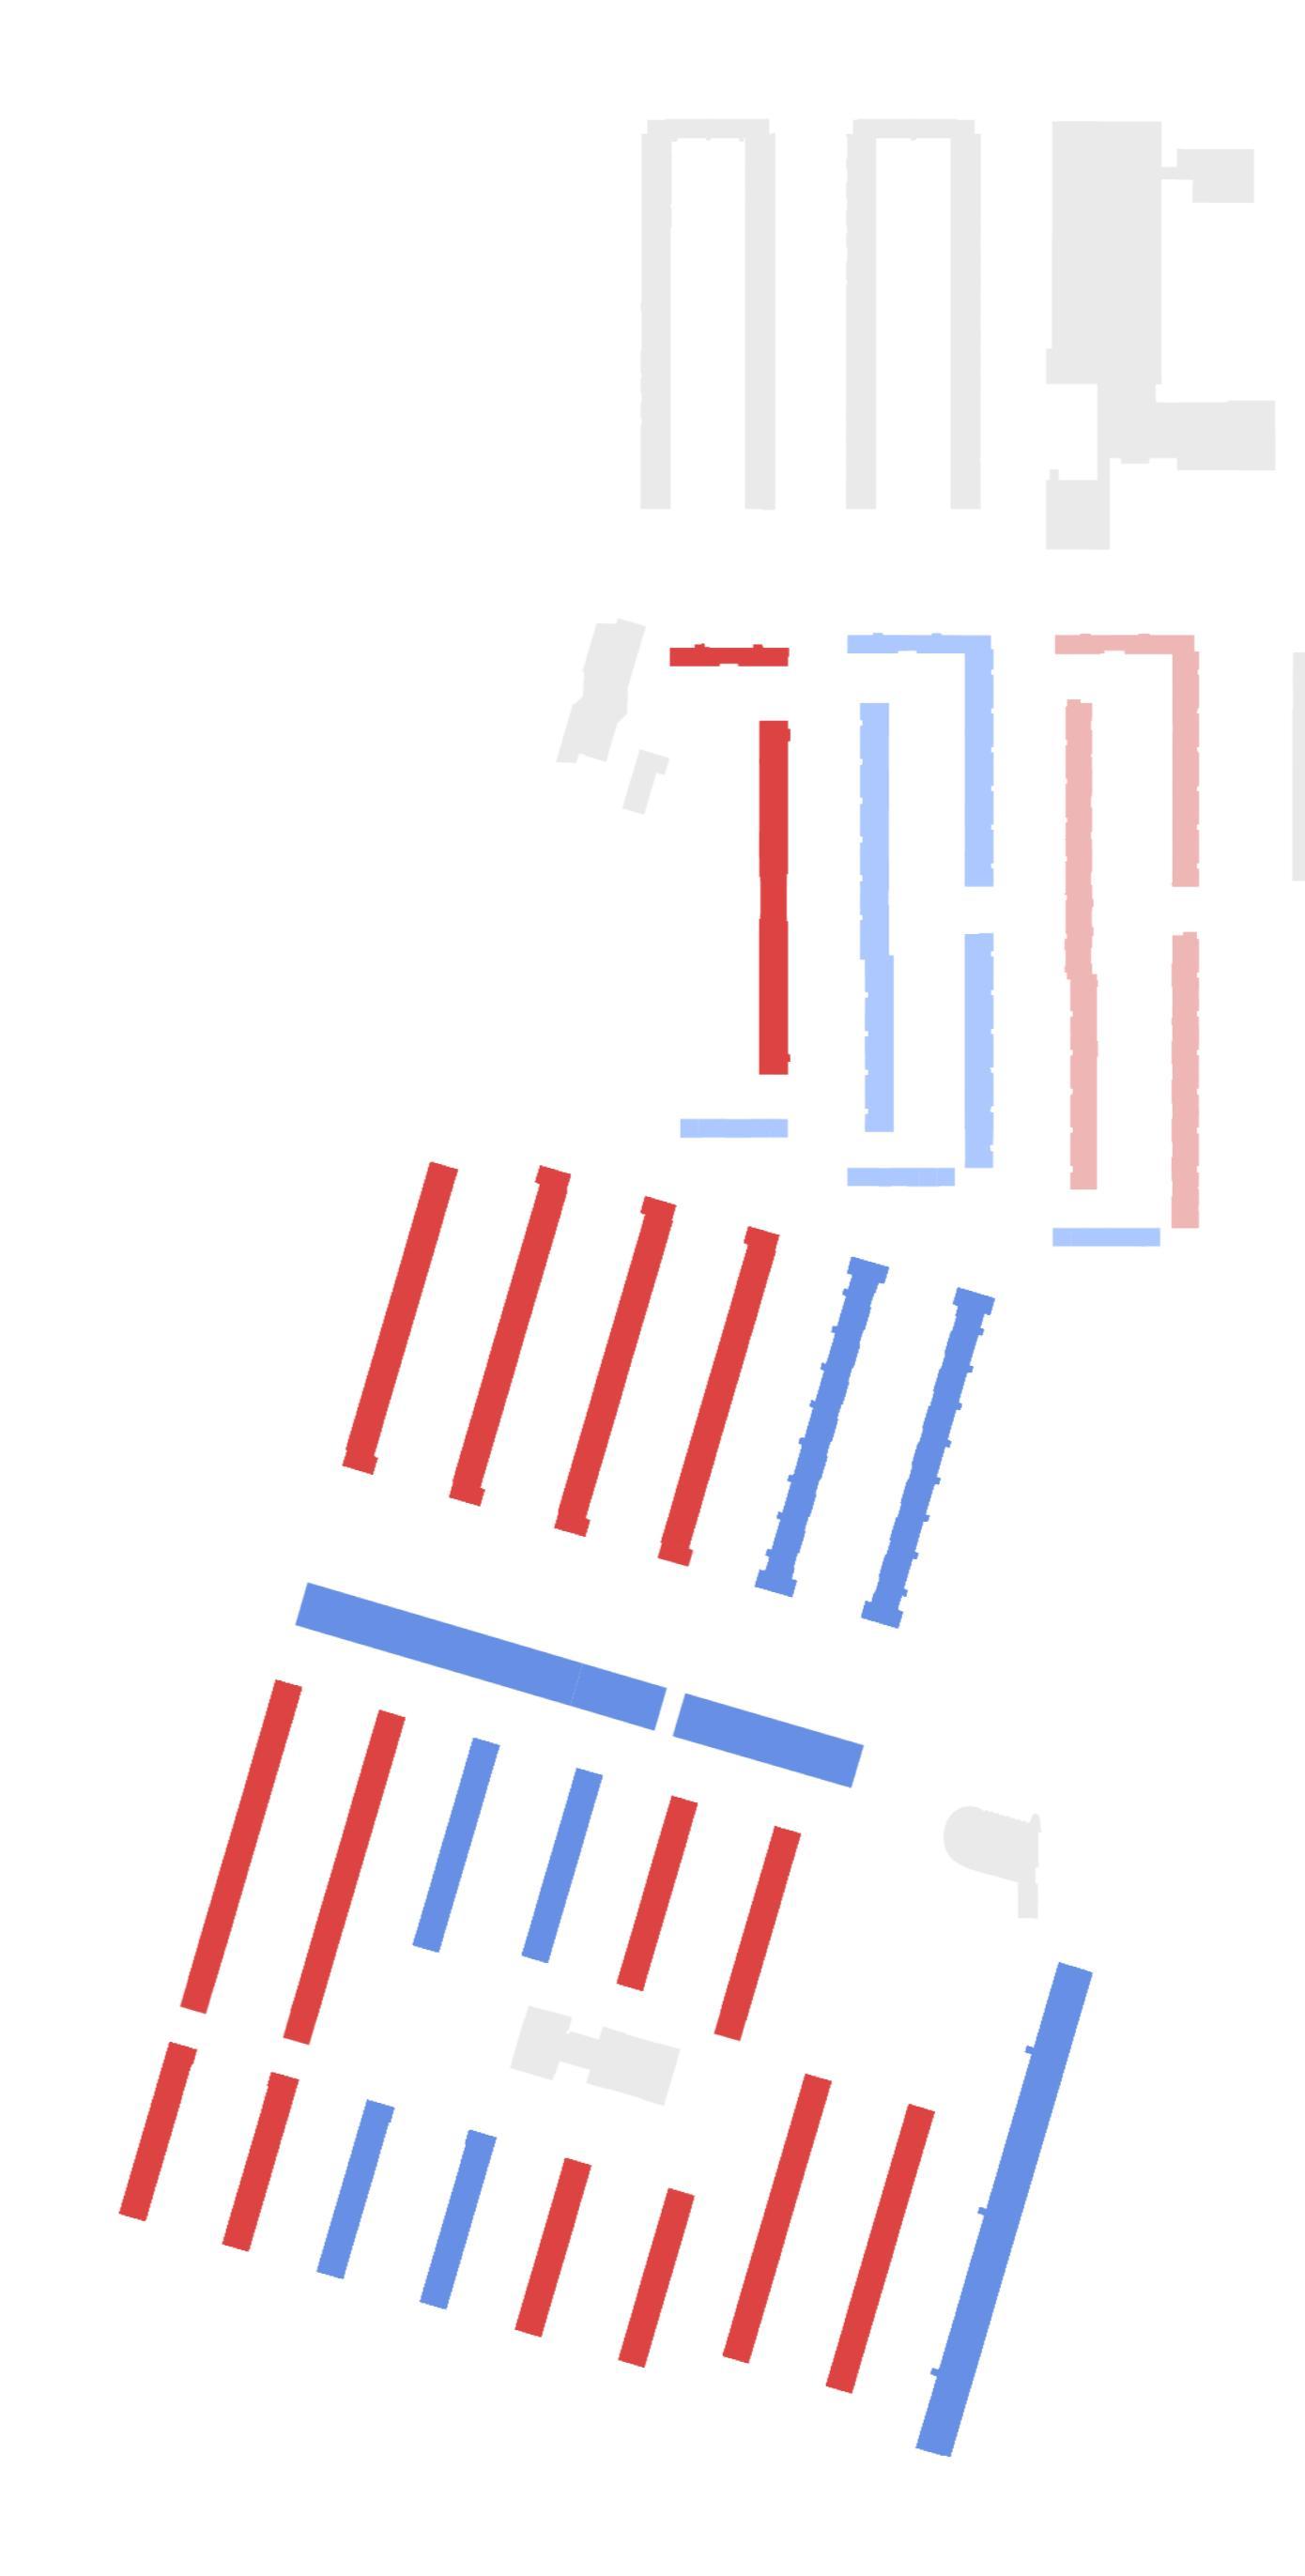
Demolition

demolished

planned demolition

renovated

planned renovation

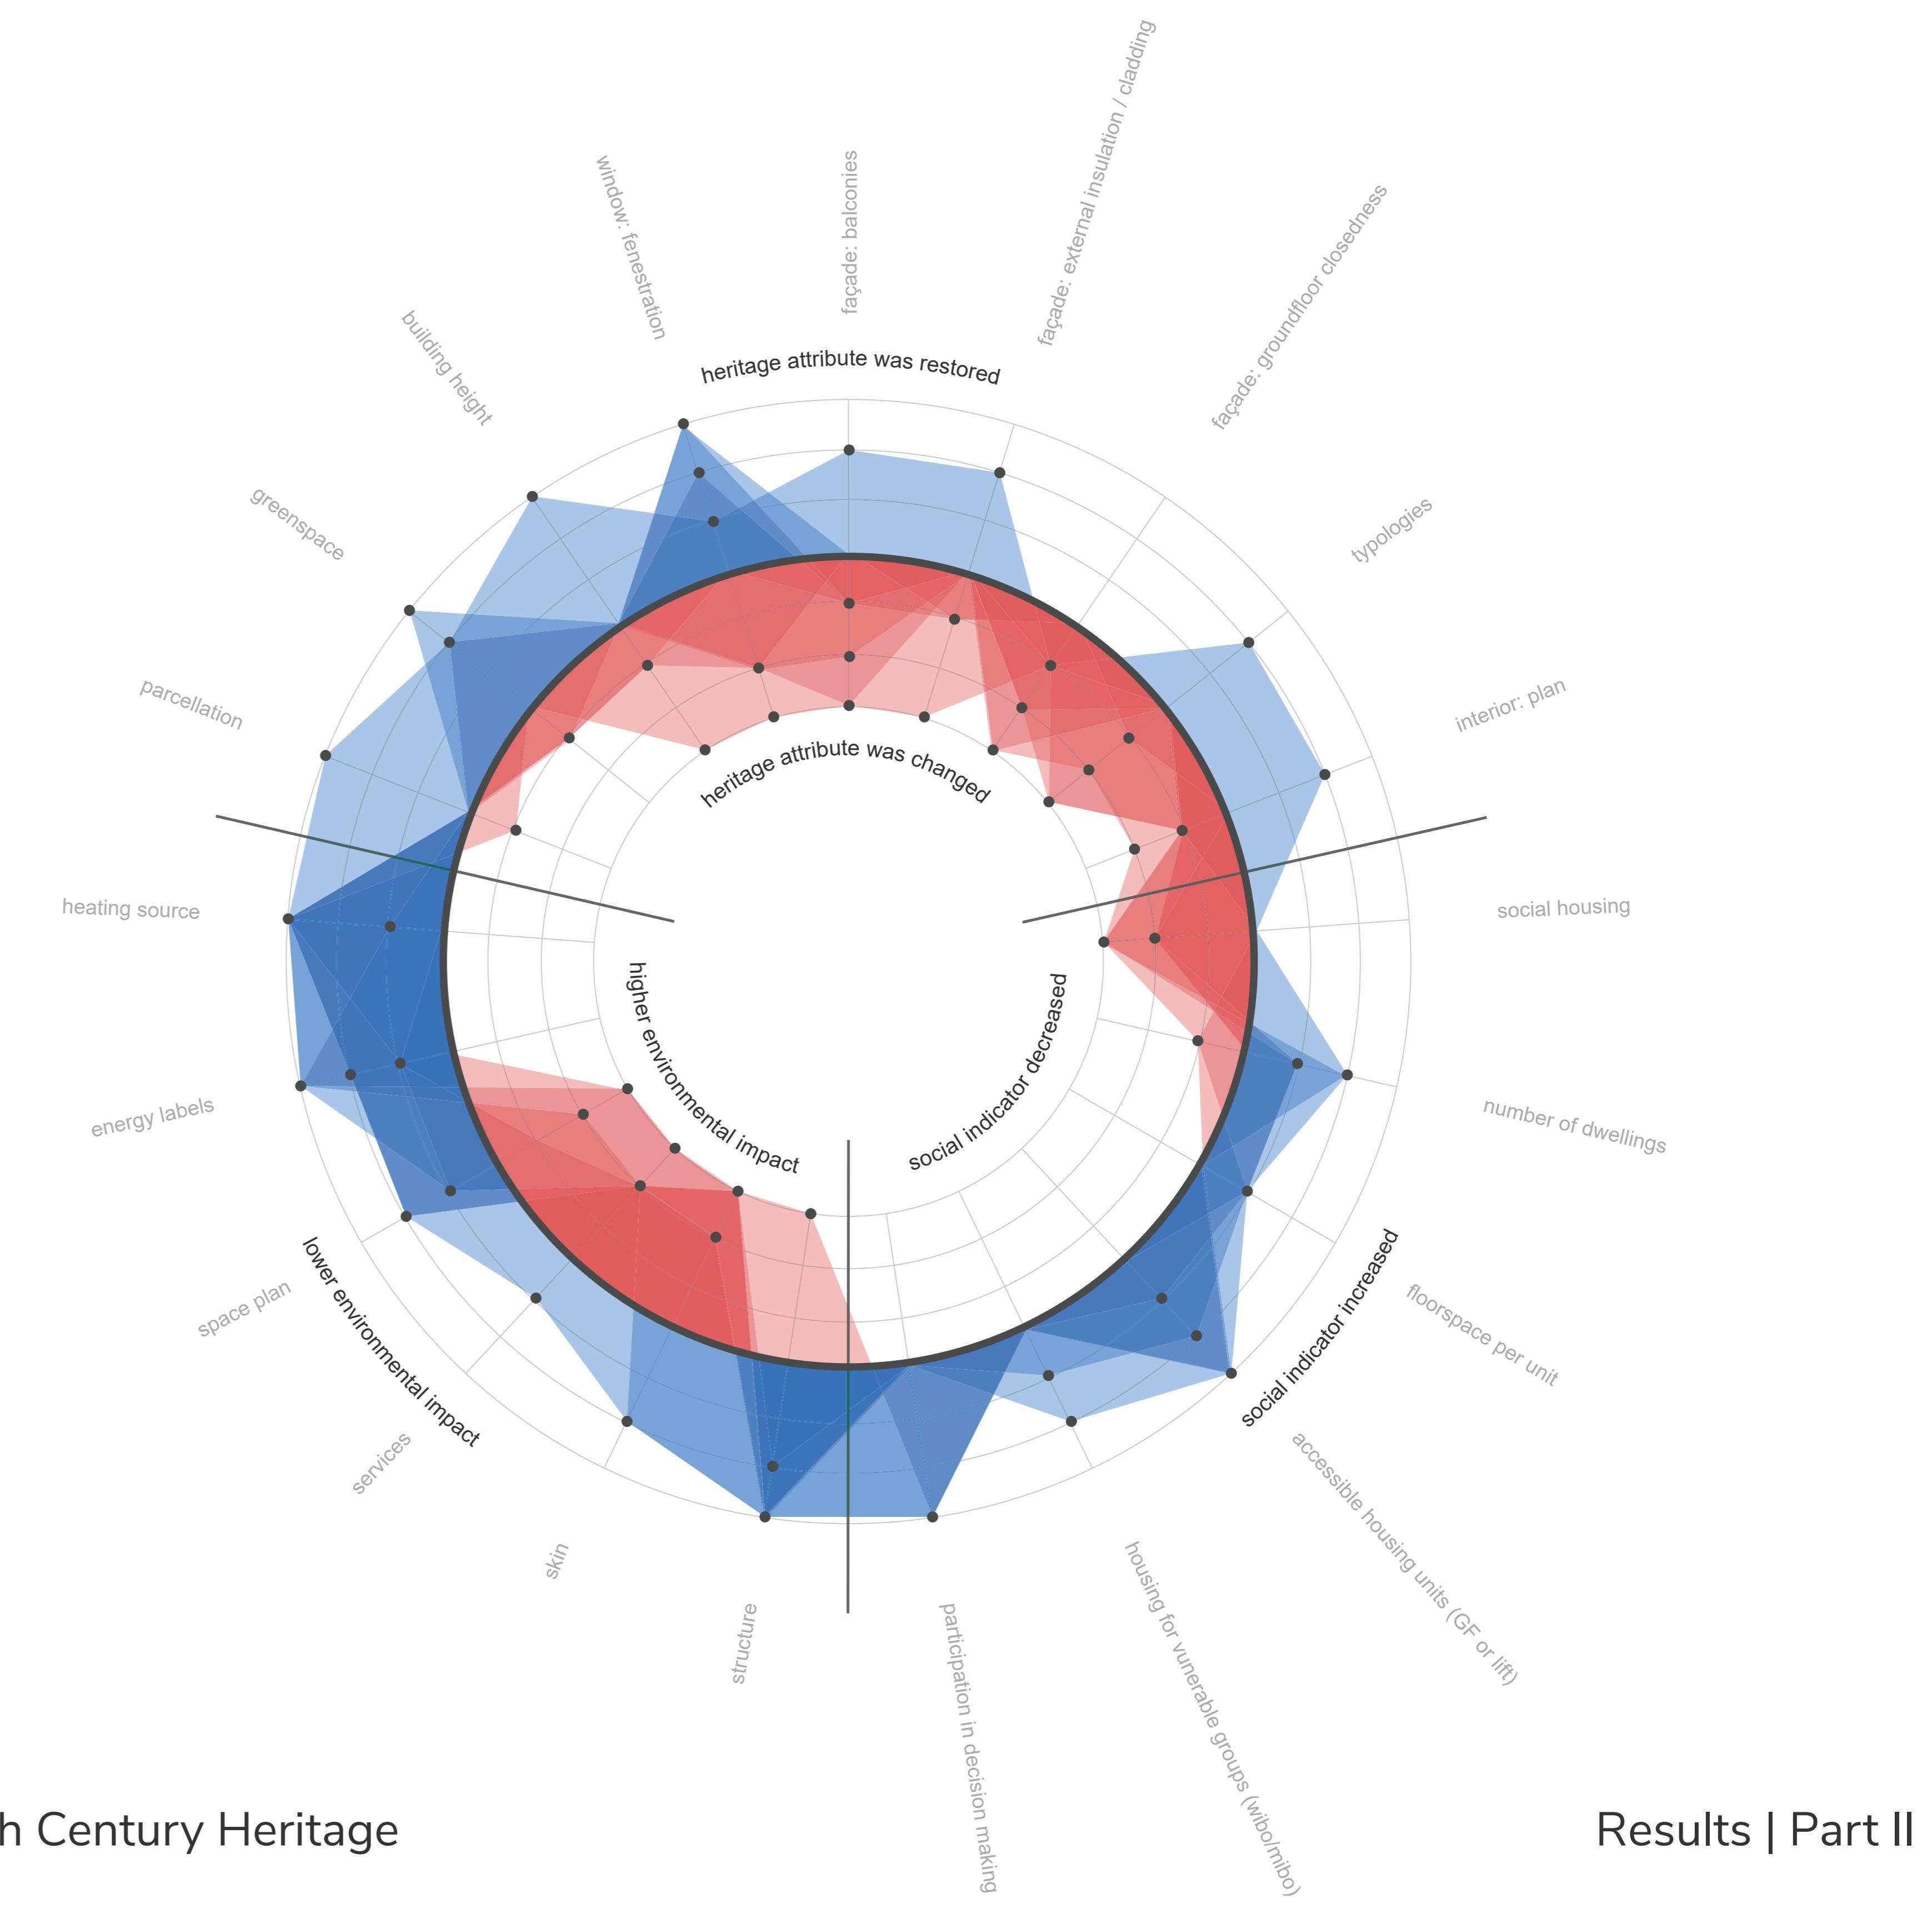
Visualisation

heritage values scale	1	2	3	4	5	6	7
compared to the original state this attribute was	completely changed	mostly changed	partially changed	neither changed or restored	partially restored	mostly restored	fully restored
social values scale	0%	33%	67%	100%	133%	167%	200%
change relative to starting situation	0x	x0,67	x0,33	x1	1,33x	1,67x	2x
re-use values scale		1	2	3	4	5	
this layer was		completely replaced	mostly replaced	around equal parts re-used and replaced	mostly re-used	fully re-used	
energy label scale		1	2	3	4	5	
		E or lower	D	С	В	А	
heating source scale			1	3	5		
			natural gas	no data	heating grid

There is a general lack of awareness of heritage value at the building scale, leading to poor preservation of heritage attributes over the buildings life time.

Some interventions make a concious effort art restoring valuable attributes to their orginal state, but there is not always room for this in the budget.
