Iterative Prototyping of Aircraft Tire Wear Measurement using Laser Profilometer

Published in AIAA Aviation 2019 Forum

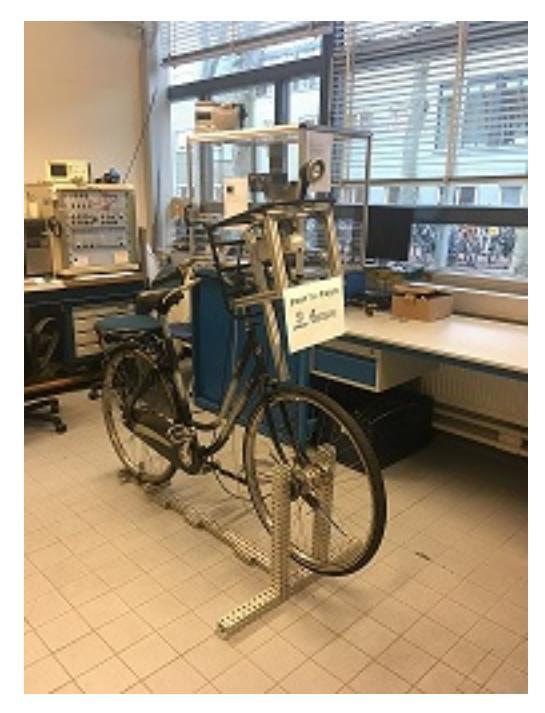
(a) Test setup bicycle.

The first step in the profilometer system development was to source and connected components together for prototyping. The objective in this first phase was to integrate the system and allow data to be recorded for later analyses. For this phase, an off-the-shelf Dutch city bicycle was procured. The bicycle was equipped with a five speed internally geared rear hub with 28 inch front and rear wheels with used tires. The front bicycle wheel tire tread would be measured. By attaching a purpose-built aluminum rack to the steering column the laser could attached and pointed downwards at the tire treads for measurement. For static testing a stand was built which would elevate the front wheel axle and allow the front wheel to rotate freely. The bicycle test setup used for static testing is shown in Fig. 1a.

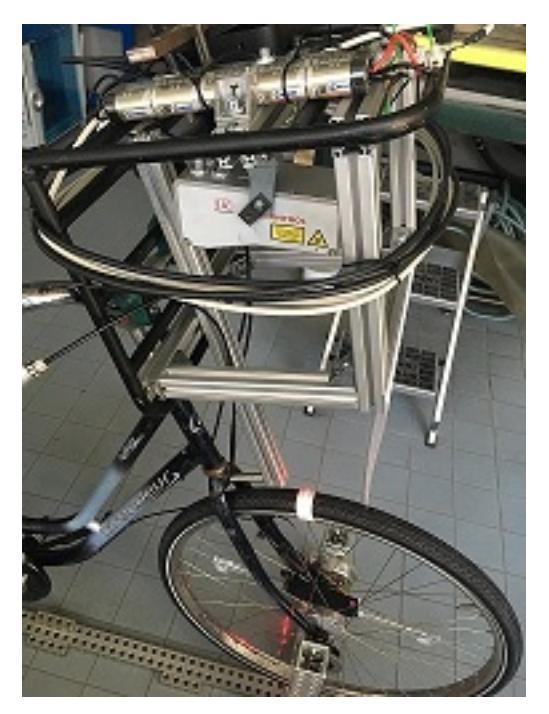
(b) Close up laser setup on bicycle.

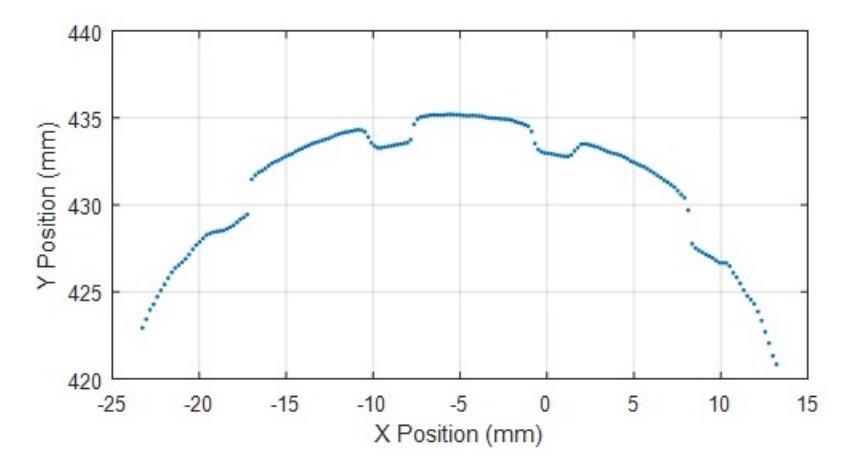
Fig. 2 Profilometer output bicycle front wheel cross section (one data sample).

One data sample (cross section) from the profilometer unit is shown in Fig. 2. By stitching together multiple data samples (cross sections) as the bicycle tire rotated a three-dimensional model was created, which could be used for anomaly detection (flat spot or foreign object damage). Analyses of the static test revealed that a tire wobble was detected through data analyses. Furthermore, small stones and debris embedded into the tread area was detected during data analyses. Data visualization and deviation detection algorithm forms the basis for identifying anomalies. The dynamic

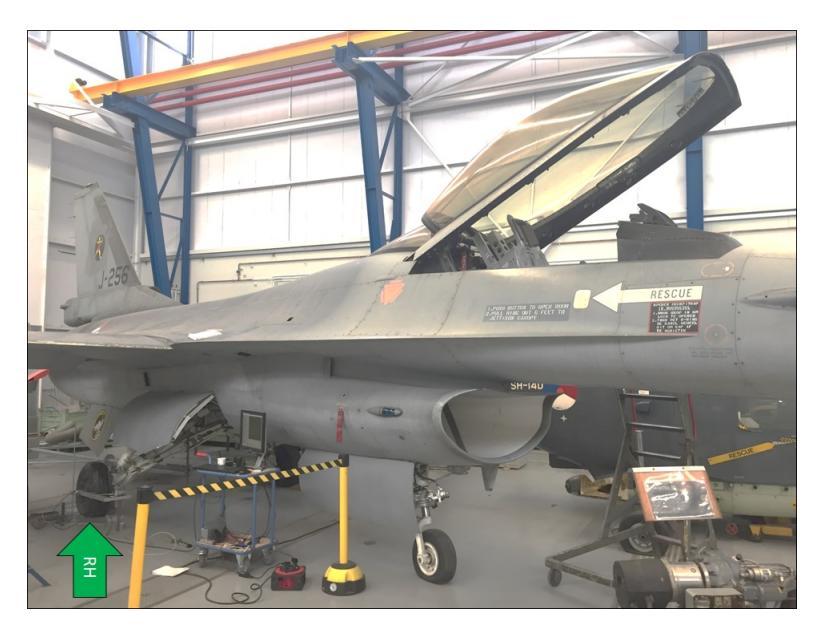
Fig. 3 F-16 profilometer Ground Test, main landing gear tires (right hand main wheel shown with green arrow).

In order to get a more representative tire measurement it was decided to make use of the available aircraft on static display at the Faculty of Aerospace Engineering. In the faculty hanger, a F-16 (Fig. 3 was available which is fitted with Goodyear 25.5x8.0-14, 20-ply aircraft tires (NSN 2620011426461) having a width of 200 mm. The main left and right hand tire were chosen as they were at both ends of their service life.

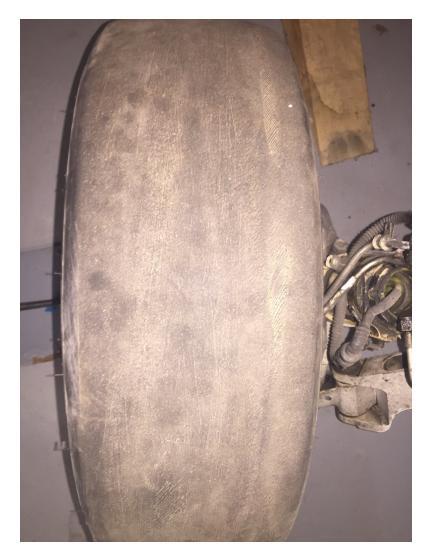
(a) Left hand tire - bald tread.

The left hand tire (Fig. 4a) was bald and in one area the ply was visible, which meant this tire was well beyond its operational service life. The right hand tire (Fig. 4b) on the other hand, was new and showed no signs of wear, which meant it was at the beginning of its operational service life. Despite efforts, equipment was not available which would allow the F-16 up to be hoisted in the air or jacked-up to allow for free rotation of the tires. Therefor a purpose-built armature attached to the wheel axis was build that could be rotated around the tire circumference for an almost full tire tread sweep (290° angle). Because the armature with the laser unit was rotated around the tire axis, a comparison could be made between the two tire tread measurements.

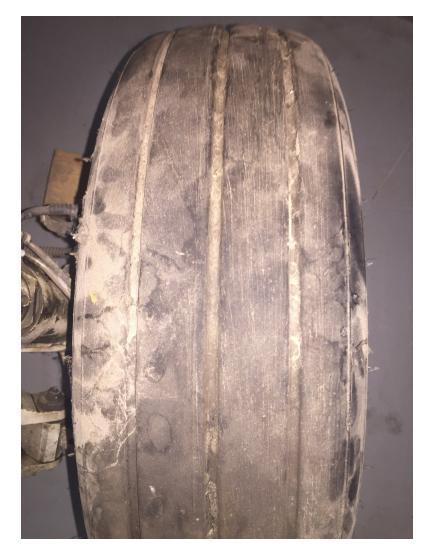
(b) Right hand tire - new tread.

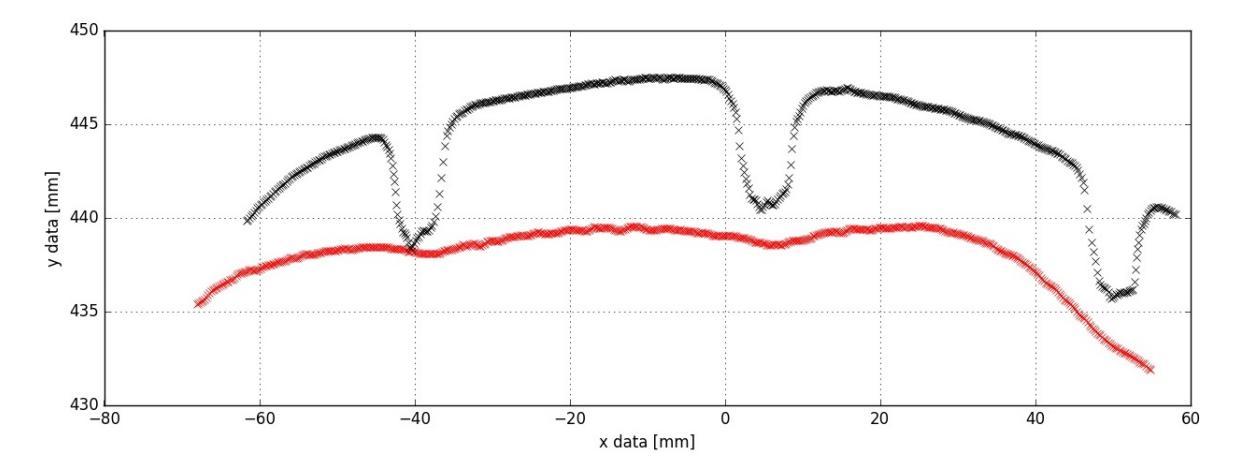
Fig. 5 F-16 Tire cross section comparisons between a new right hand (black) and left hand bald (red).

Analysis between the left and right hand F-16 tire data shows a distinct difference. Fig. 5 depicts the right main landing gear tire (top trace) and the left main landing gear tire (bottom trace) cross-section. Clearly, the three treads are detected in the right hand tire, but are not present for the left hand tire. The delta between the two traces shows the tire wear. Further analysis also shows that in one area (right side) the left hand tire wear is past the two bottom grooves of the right hand tire. This suggests the tire ply should be visible at that location, which was already noted before. The 110 mm scan width of the measurement system was not sufficient to detect the full 200 mm width of the tire, as no information is captured on the state of the tire shoulders.

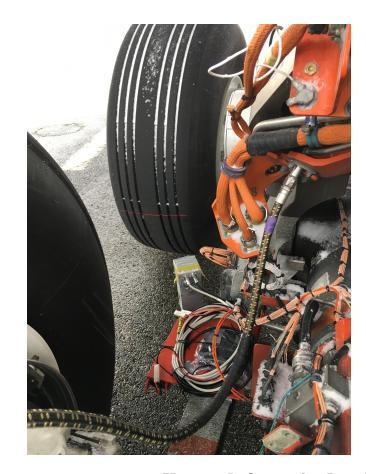
(b) Profilometer system cradle on left main landing gear outboard brake strut.

On February 28th 2018 a towing test was performed on Toulouse-Blagnac Airport with the profilometer unit attached to the A350 Flight Test Aircraft brake strut. Due to the weather conditions, the scheduled route and test were shorted due to airport snow operations. An example tire cross-section recorded is provided in Fig. 7. The data recorded during this towing test showed that no wear (delta), this was also expected due to the limited recording time and towing operation.

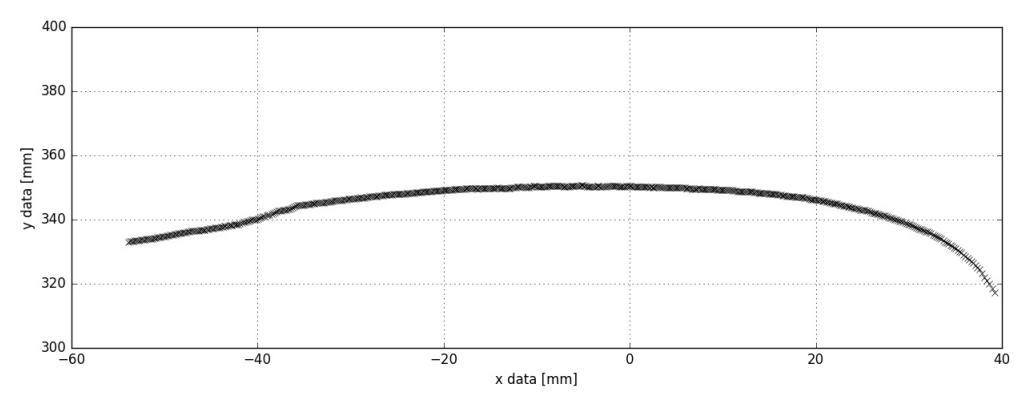
Fig. 7 Profilometer plot showing cross section A350 Main Landing gear tire.

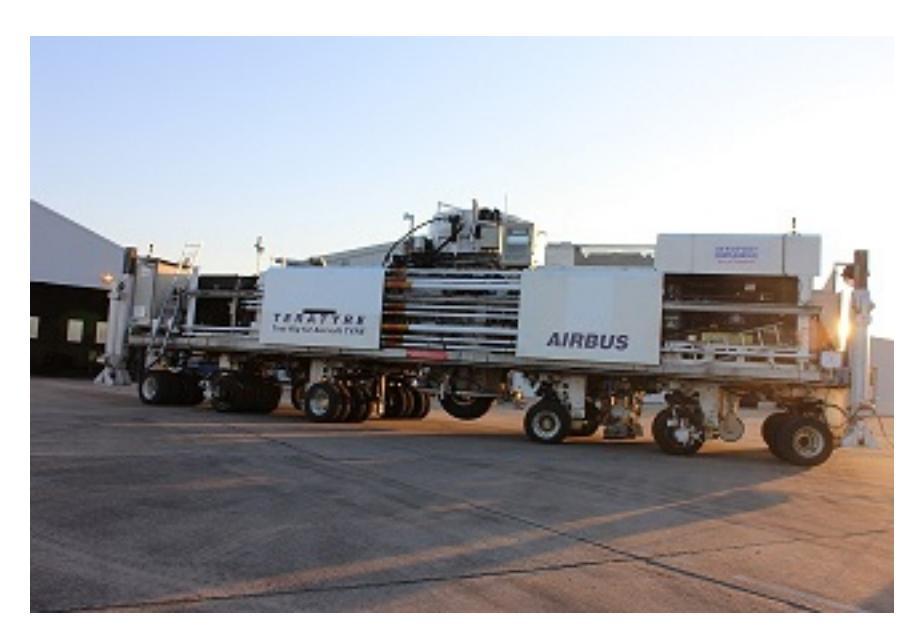
Fig. 8 Test Rig for Aircraft Tires (TeraTyre) at Châteauroux Airport with in the centre the aircraft tire being tested.

The developed tire test rig can rotate the tire at a high slip angles which normal dynamo-meters cannot do. The TeraTyre test rig has overall dimensions of 14.5 x 4.5 meters and is 5 meters tall. The rig weighs 115 metric tons and is powered by a 1500 horsepower engine which allows the rig to reach a maximum speed of 90 km/h. The TeraTyre test rig can move and test one aircraft tire at a time along a linear or curved trajectory. With its pneumatic turret system the tire can be loaded to different weights. Due to the high slip angle capabilities, the aircraft tire is tested to its limits and well beyond ordinary wear seen in normal service life operation. With the extreme conditions to which TeraTyre is testing tires, the profilometer capability can be investigated and aircraft tire wear can be evaluated.

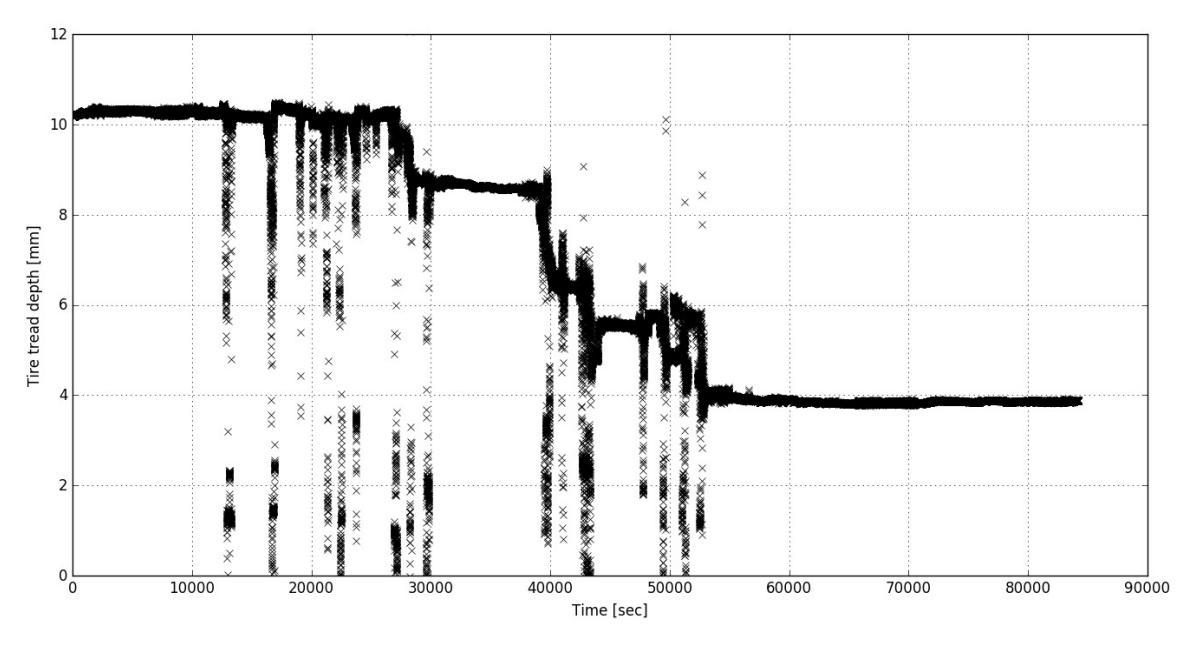
Fig. 9 TeraTyre Profilometer tire wear plot result Test wheel 9.

Fig. 9 shows an unfiltered data set for Test wheel 9. The data is for a single measurement point which was in the field of view, the tread depth is calculated by subtracting the profile measurement of the valley and the groove. At the start of the test, the detected tread depth was ten mm, which is reduced by the end of testing to four mm. Depending on the test profile speed, slip angle and weight differences a distinct difference in the data traces and amount of wear. The preliminary data analyses showed a decrease in tire tread depth, which demonstrates wear was detected by the profilometer system. In a follow-up paper, the test results will be discussed in more detail.
