Wolf Rock Lighthouse Long-Term Monitoring

Article Wolf Rock Lighthouse Long-Term Monitoring

Abstract: Wolf Rock Lighthouse is a Victorian era masonry structure located in an extreme environment facing the fiercest Atlantic storms off the southwest coast of England whose dynamic behaviour has been studied since 2016. Initially, a modal test was used to determine modal parameters; then, in 2017, a monitoring system was installed that has operated intermittently providing response data for a number of characteristic loading events. These events have included wave loads due to storms, a small UK earthquake, helicopters landing on the helideck, and the grounding of a ship on the reef. This is believed to be the most extensive experimental campaign on any structure of this type. This paper briefly describes a unique project involving the characterisation and measurement of dynamic behaviour due to different forms of dynamic loading.

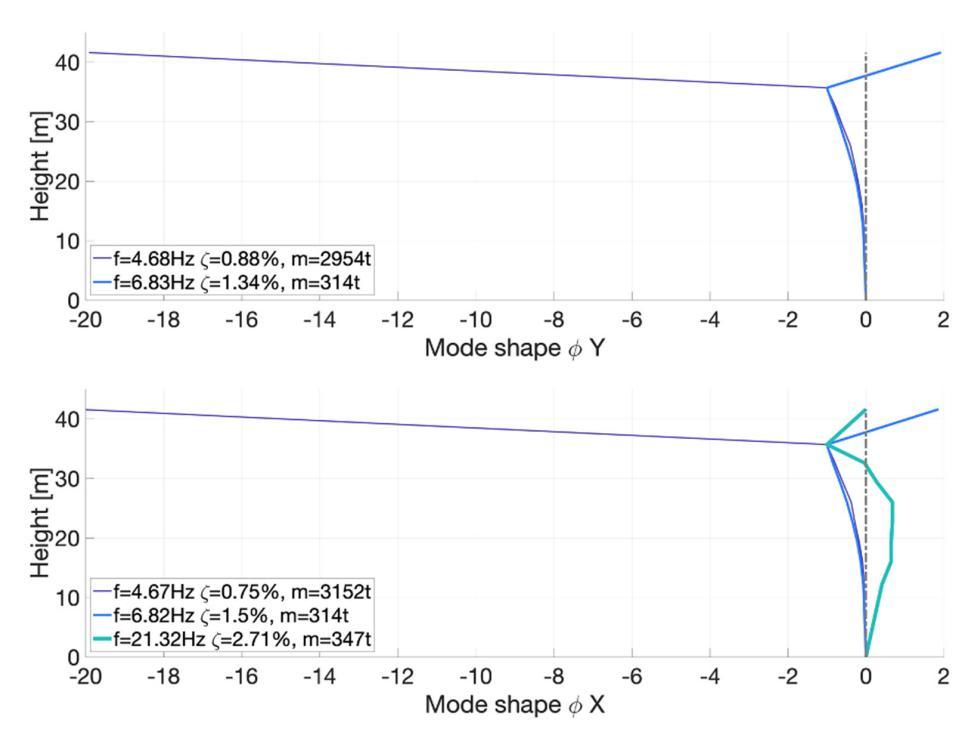
Figure 5. Key modal properties from forced vibration test.

The best estimates for modal parameters obtained using the global rational fractional polynomial method [22] on the FRFs are given in Figure 5. For practical purposes, only the first two modes in each direction are relevant, having almost identical mode shapes, masses, and damping ratios and frequencies for the two directions, so that direction of loading will have a negligible effect on the response. The helideck responds much more strongly in the lowest freuqency pair of modes, which have much larger modal mass for unity scaling at the top of the tower and which will be less strongly excited by horizontal (wave) loads on the tower.

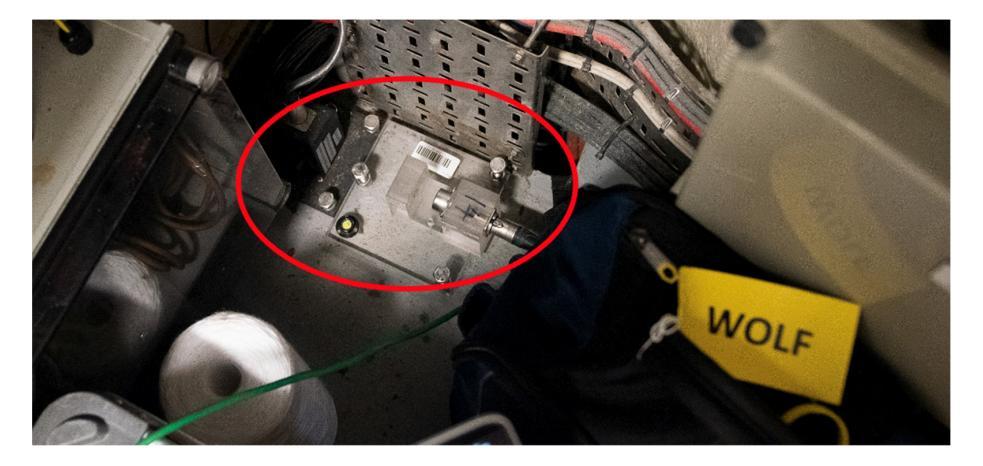
Figure 6. y-direction uniaxial accelerometer in corner of battery room (level 7) adjacent to triaxial monitoring accelerometer.

The ambient response data from the 2016 measurements were limited and insufficient to identify mode shape orthogonality other than for the assumed directions imposed in the forced vibration test. This is rather a curiosity of structural dynamics, but the issue of distinguishing distinct orthogonal eigenvectors and their preferred alignment in axisymmetric vertical structures has parallels in other applications such as telecoms towers and industrial chimneys. Hence, in 2019 [13], an ambient vibration survey limited to selected locations in the tower (excluding the helideck for operational and weather reasons) but with extended duration (due to an overnight stay) was used to track the modal parameters (frequencies, mode shapes, and damping ratios) of the first two modes. The identified eigenvector/mode shape directions happened to align with the triaxial accelerometer installed for long term monitoring in September 2017 (and discussed in the remaining sections of the paper). Figure 6 shows the y-direction uniaxial QA 750 accelerometers aligned with the (negative) y axis of the triaxial monitoring accelerometer at level 7.

A single JA-70SA triaxial servo accelerometer was installed in level 7 (battery room) (Figure 6) on 7 September 2017 with the positive x axis having a compass bearing of 33°. A National Instruments data acquisition system located in the lantern room (Figure 9) samples acceleration signals at 128 Hz and stores them as 10 min TDMS files on a USB drive, with the system automatically reset at midnight once a week to deal with the system crashing. Communication to land using 4G mobile communication was initially established but failed after a year of operation and it has never been possible to retrieve data other than manually during a visit by maintenance crew. Ideally, the system records 144 data files every day, but occasionally fewer are recorded and there are days of no data. For the period of available data (at time of writing, 8 September 2017–12 July 2023) 972 full or partial days of data are available with numerous gaps, for example during the COVID-19 pandemic when maintenance visits could not be used to retrieve data. From the collected data, significant events have been recorded, some of which are described here.

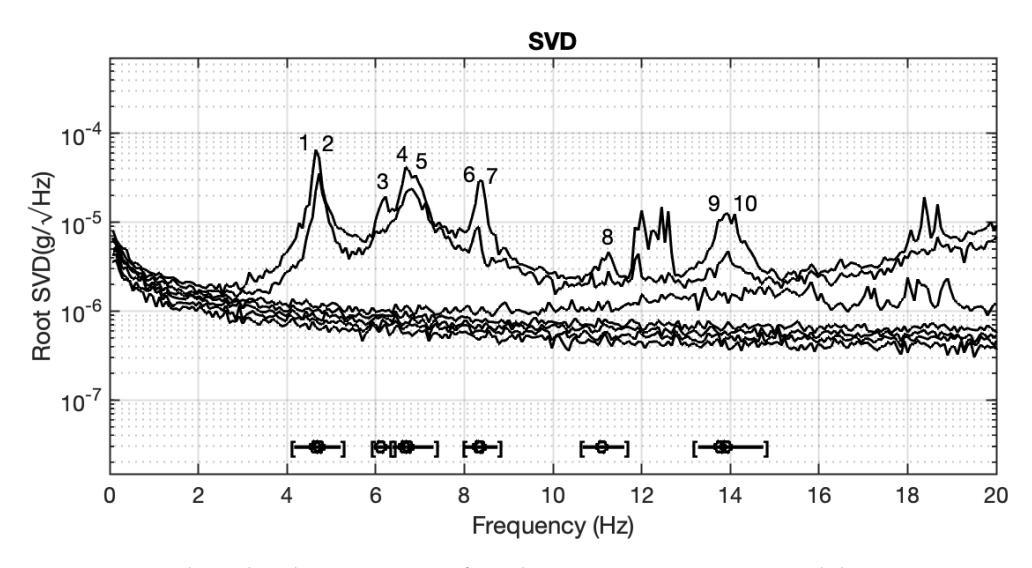
Figure 7. Singular value decomposition of acceleration cross-power spectral density.

The Bayesian operational modal analysis (BAYOMA) procedure [23] was applied to acceleration signals recorded for eight hours starting 23:11 on 18 January 2019 from four biaxial accelerometer pairs, at levels 1, 5, 7, and 8. The recording was broken into 96 5 min segments from each of which mode shapes, frequencies, and damping ratios were estimated. Singular value decomposition (SVD) of cross-power spectral densities from a sample is shown in Figure 7 indicating four mode pairs. Mode 3 at ~6.16 Hz was not distinct in the overnight recording and was not tracked.

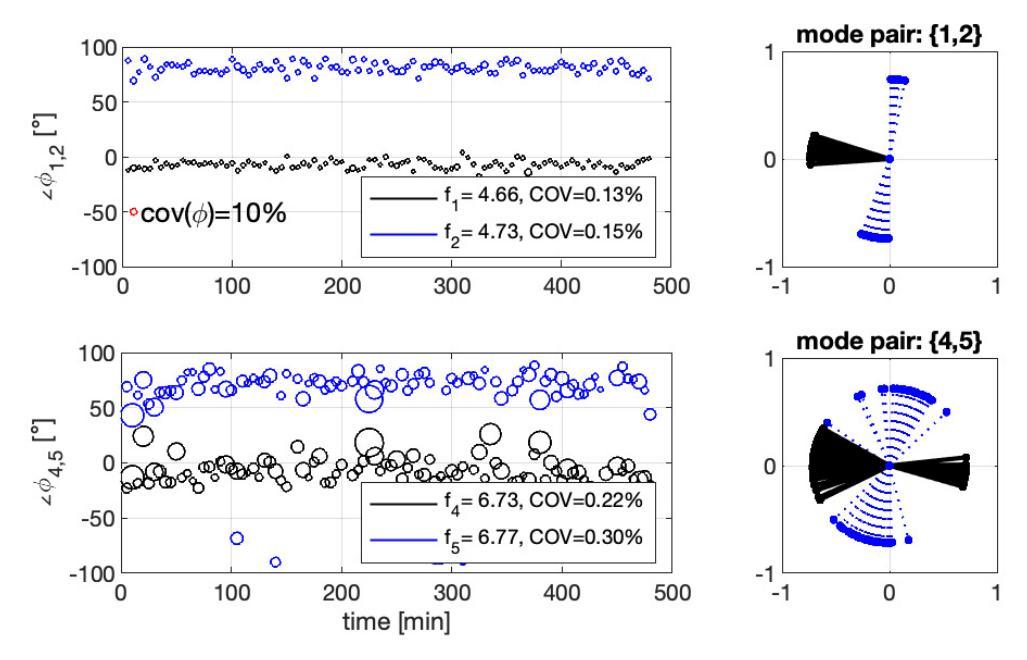
Figure 8. Mode shape level 8 ordinates for first two mode pairs from Figure 7.

Variation of natural frequencies for mode pairs 1/2 and 4/5 over the eight hours is shown in Figure 8. Mode pair 1/2 frequencies are well separated compared to the forced vibration test values and are identified with high certainty (i.e., with low variance error). Mode pair 4/5 frequencies are close, have higher variance errors and are lower than the forced vibration test values.

Mode shapes for these mode pairs are, apart from the missing helideck ordinate, similar to the first two mode pairs in Figure 5, and variation in the level 8 (service room) ordinate over the 8 h is shown in two ways in Figure 8. This indicates that, for the

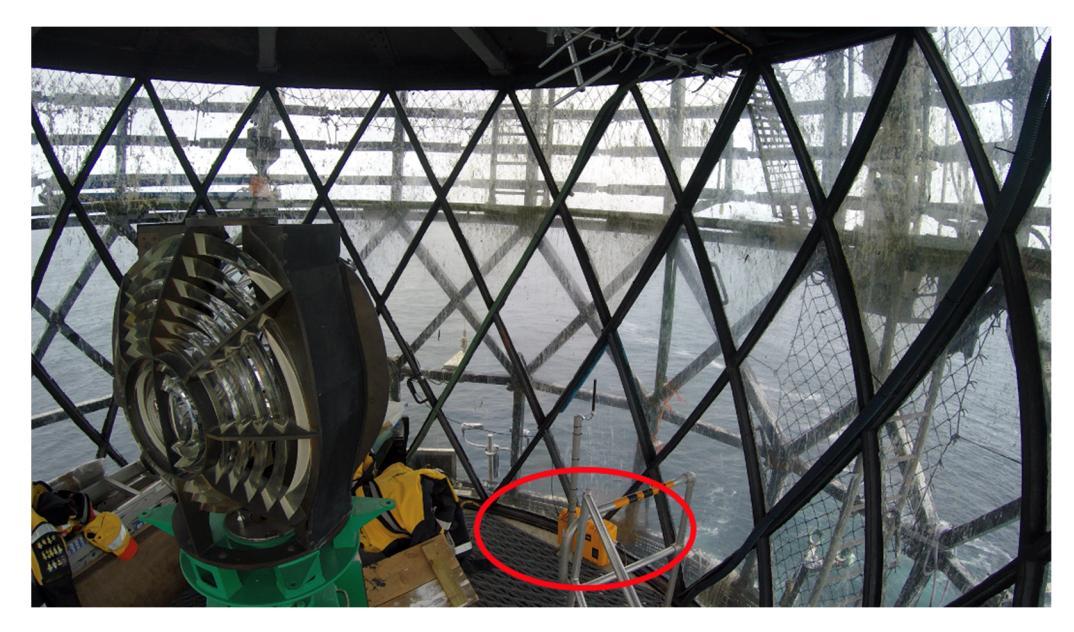
Figure 9. Yellow logger (data acquisition, storage, and communication) box in lantern room. Steel framework of helideck is visible outside.

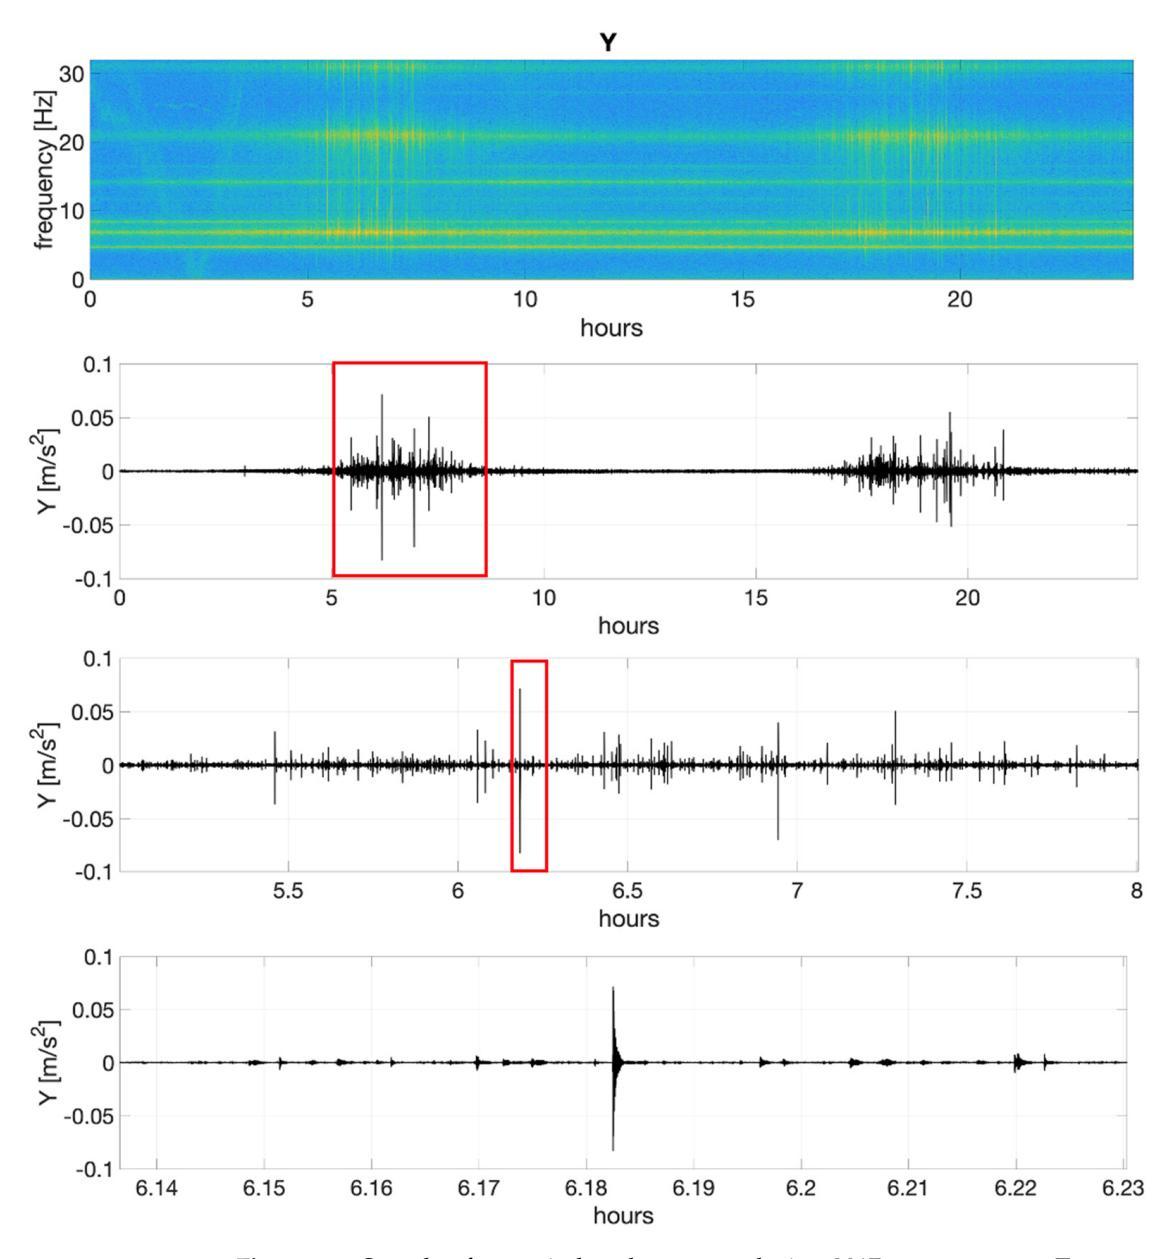
Figure 10. Sample of wave-induced response during 2017 storm season. Top two rows: time-frequency plot (spectrogram) and time history for complete day, lower two plots successive zoom into single wave impact.

A sample of acceleration data is shown in Figure 10 for one day of relatively strong wave-induced response (23 September 2017), successively zooming in to individual transient responses to breaking waves. The stronger response occurs during the two periods

of high tide (tidal range can reach 5 m), and the spectrogram shows that the mode pair around 6.8 Hz is the most strongly excited.

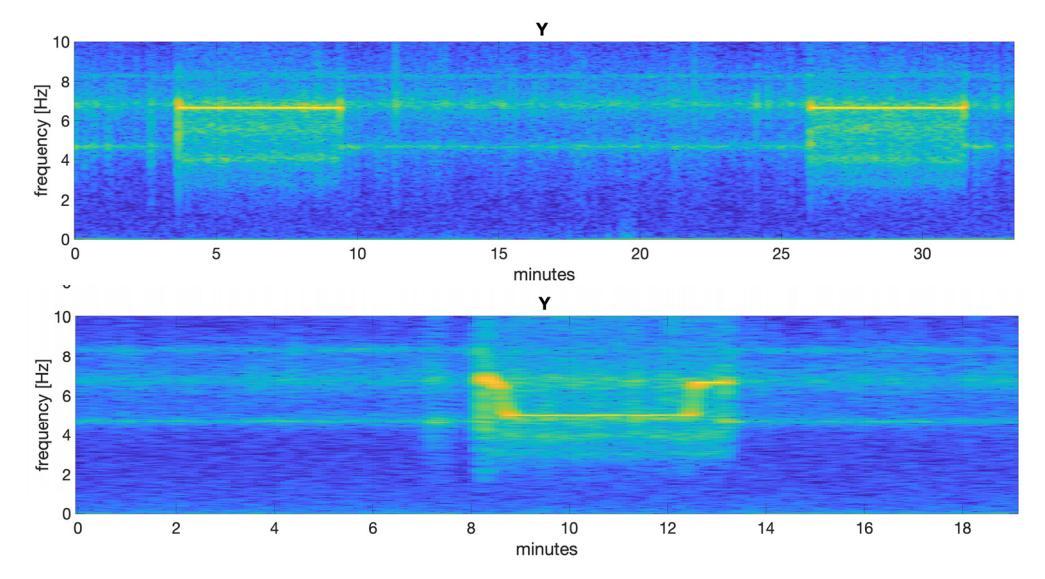
Figure 15. Spectrograms of level 7 response for helicopter visits in 2020 (upper) and 2019 (lower).

Two occasions are shown in Figure 15. The first is for the afternoon of 6 January 2020 when the same helicopter made two visits to ferry workers from the lighthouse to Land's End (St Just) airport, a distance of approximately 20 km. There is a strong steady state signal around 0.03 m/s^2 with an amplitude of 6.65 Hz. This is consistent with other known helicopter visits. The second occasion is during the ambient 2019 vibration survey (for which simultaneous monitoring data are not available) showing three periods: a steady 5.02 Hz period between two short periods of vibration, first at 6.66 Hz then at 6.69 Hz. This appears to be a unique recording (among all the monitoring data). The higher frequency corresponds to ~400 (rotor) RPM observed using video recording of the aircraft landing at the lighthouse, while the lower frequency corresponds to ~300 RPM observed from audio recording of the aircraft (idling) on the ground at Land's End Airport.

The upper and lower frequencies correspond closely to the 5.01–5.1 Hz mode evident from 2016 ambient response (Figure 3) and the 6.73 Hz and 6.77 Hz estimates obtained from the 2019 ambient response (Figure 8). The forcing function due to the rotors at both full and idling speeds is apparently close enough to mode frequencies to cause resonant amplification.

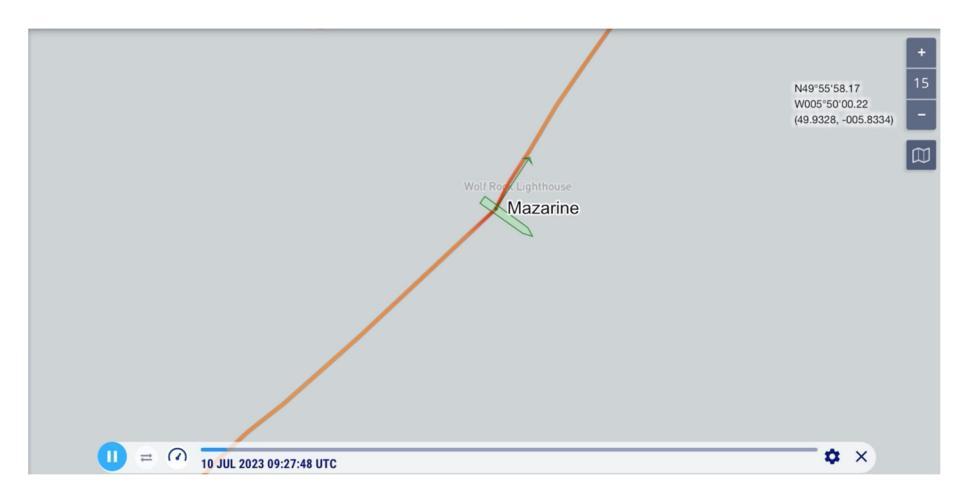
Figure 18. Trajectory of Mazarine, indicating grounding at 09:27.

On 10 July 2023, the RoRo cargo ship Mazarine, enroute from Ireland to Belgium, lost power and drifted onto the reef of Wolf Rock. Marine tracking shows that the grounding occurred at 09:27 UTC (10:27 local time). The tide was still rising at the time (high tide at 10:00 UTC) and the ship rotated around the stern, resuming a drift towards the Cornish coast at 09:50 (Figure 18).

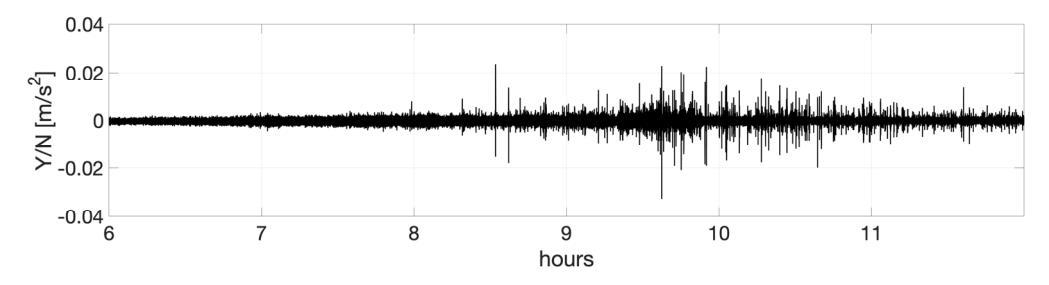
Figure 19. Acceleration response between 6 A.M. and 12 noon, 10 July 2023.

The y/north acceleration for the period from 6 A.M. to noon is shown in Figure 19 and features typical breaking-wave impacts (for a relatively windy summer day) but no evidence of the ship directly impacting the structure.
