Experimental study of cavitation erosion around a surface-mounted semi-circular cylinder

Saad Jahangir^{*1}, Ebrahim Ghahramani², Magdalena Neuhauser³, Sébastien Bourgeois³, Rickard E. Bensow², Christian Poelma¹

Abstract

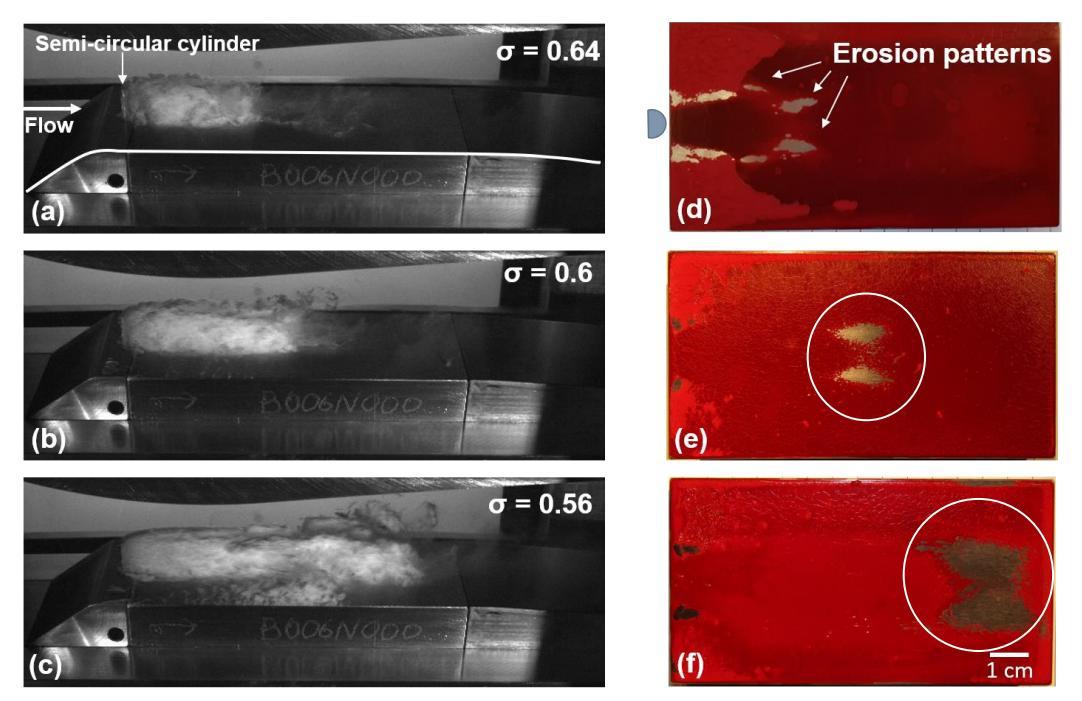
Figure 1: (Left) Video frames of cavitating flow behind the semi-circular cylinder. The flow is from left to right and light grey represents the cavitation region. (Right) Photographs representing the corresponding erosion patterns after 40-60 mins of operation.

A high-speed camera (Phantom v411) with a field of view of 640x232 pixels was used for imaging. A combination of two light sources from the front and an LED panel behind the measurement section were used to illuminate the cavity. The camera was placed at an angle of 32° to the horizontal to capture the cavity.

For the paint tests, red stencil ink was applied on the flat plate downstream of the cylinder - as thinly as possible with a syringe. The tests were conducted once the paint was dry (~24 hours of drying time). The results indicated the location of the most erosive cavitation implosions.

Three erosive cases at different cavitation numbers are shown in Figure 1 (a) – (c). The flow is from left to right and light grey represents the cavitation region. At lower cavitation number more intense cavitation can be seen. In Figure 1 (d) – (f), the erosion patterns (removal of paint) after 40-60 mins of operation can be seen for the corresponding cavitation numbers. At a high cavitation number, one would expect less erosion due to less intense cavitation as compared to the other two cases. However, a large number of Karman-vortex-like cavities are shed downstream of the obstacle. This results in a higher number of collapse events and ultimately more erosion (Figure 1 (d)). On the other hand, at the lower cavitation numbers (σ = 0.56, 0.6), most of the erosion took place at the closure line of the cavity (Figure 1 (e) and (f)). This is mainly because the vapor cavities are just shed at the closure line of the cavity, hence the collapse of vapor takes place in the same region but not upstream.
